BLUE SAGE ENVIRONMENTAL, INC.
Environmental Project Management

RE: Additional Groundwater Monitoring
Bud Clary Subaru FSID: 34656
961 Commerce Avenue CSID: 14902
Longview, WA VCP ID: SW1706

2.0 Groundwater Monitoring

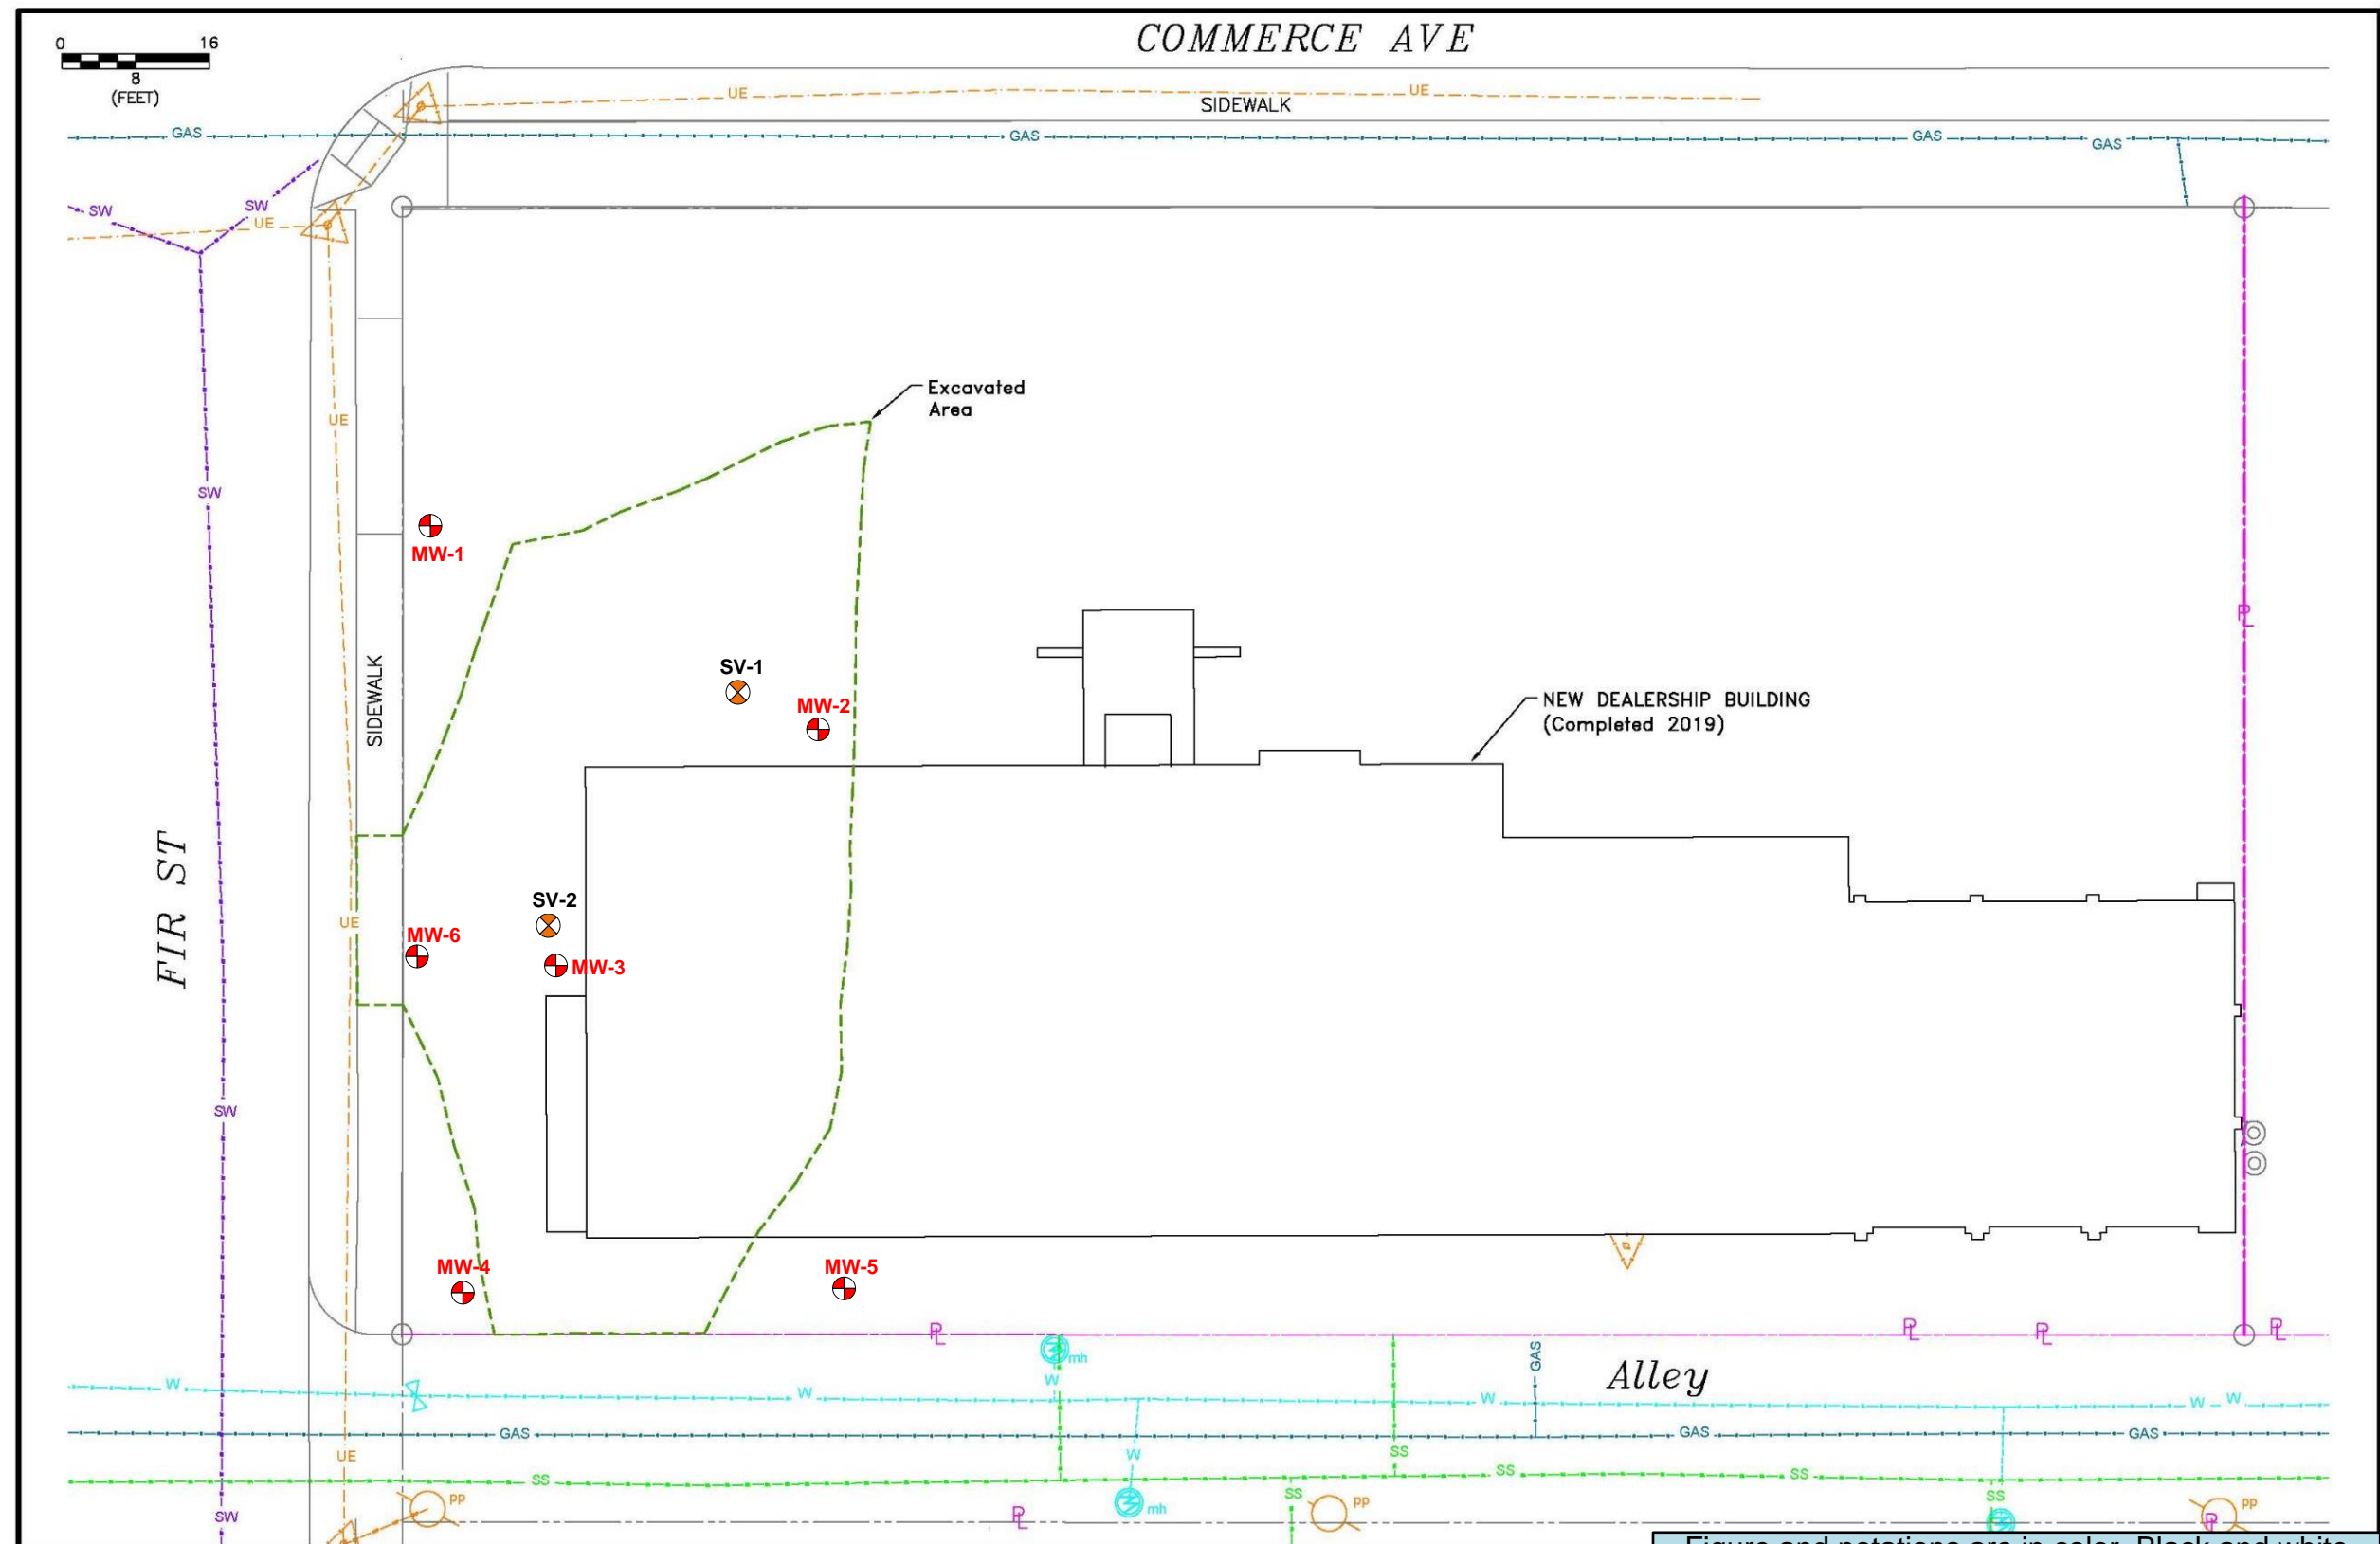
**Figure
2**

Five groundwater monitoring wells (MW-1, MW-2, MW-3, MW-4, and MW-5) were installed in April 2019. A sixth monitoring well, MW-6 was installed next to Fir Street in April 2024 (**Figure 2**). These wells were sampled per Ecology's request.

**BSE Groundwater and Soil Vapor Monitoring Wells
Bud Clary Subaru
961 Commerce Avenue
Longview, Washington**

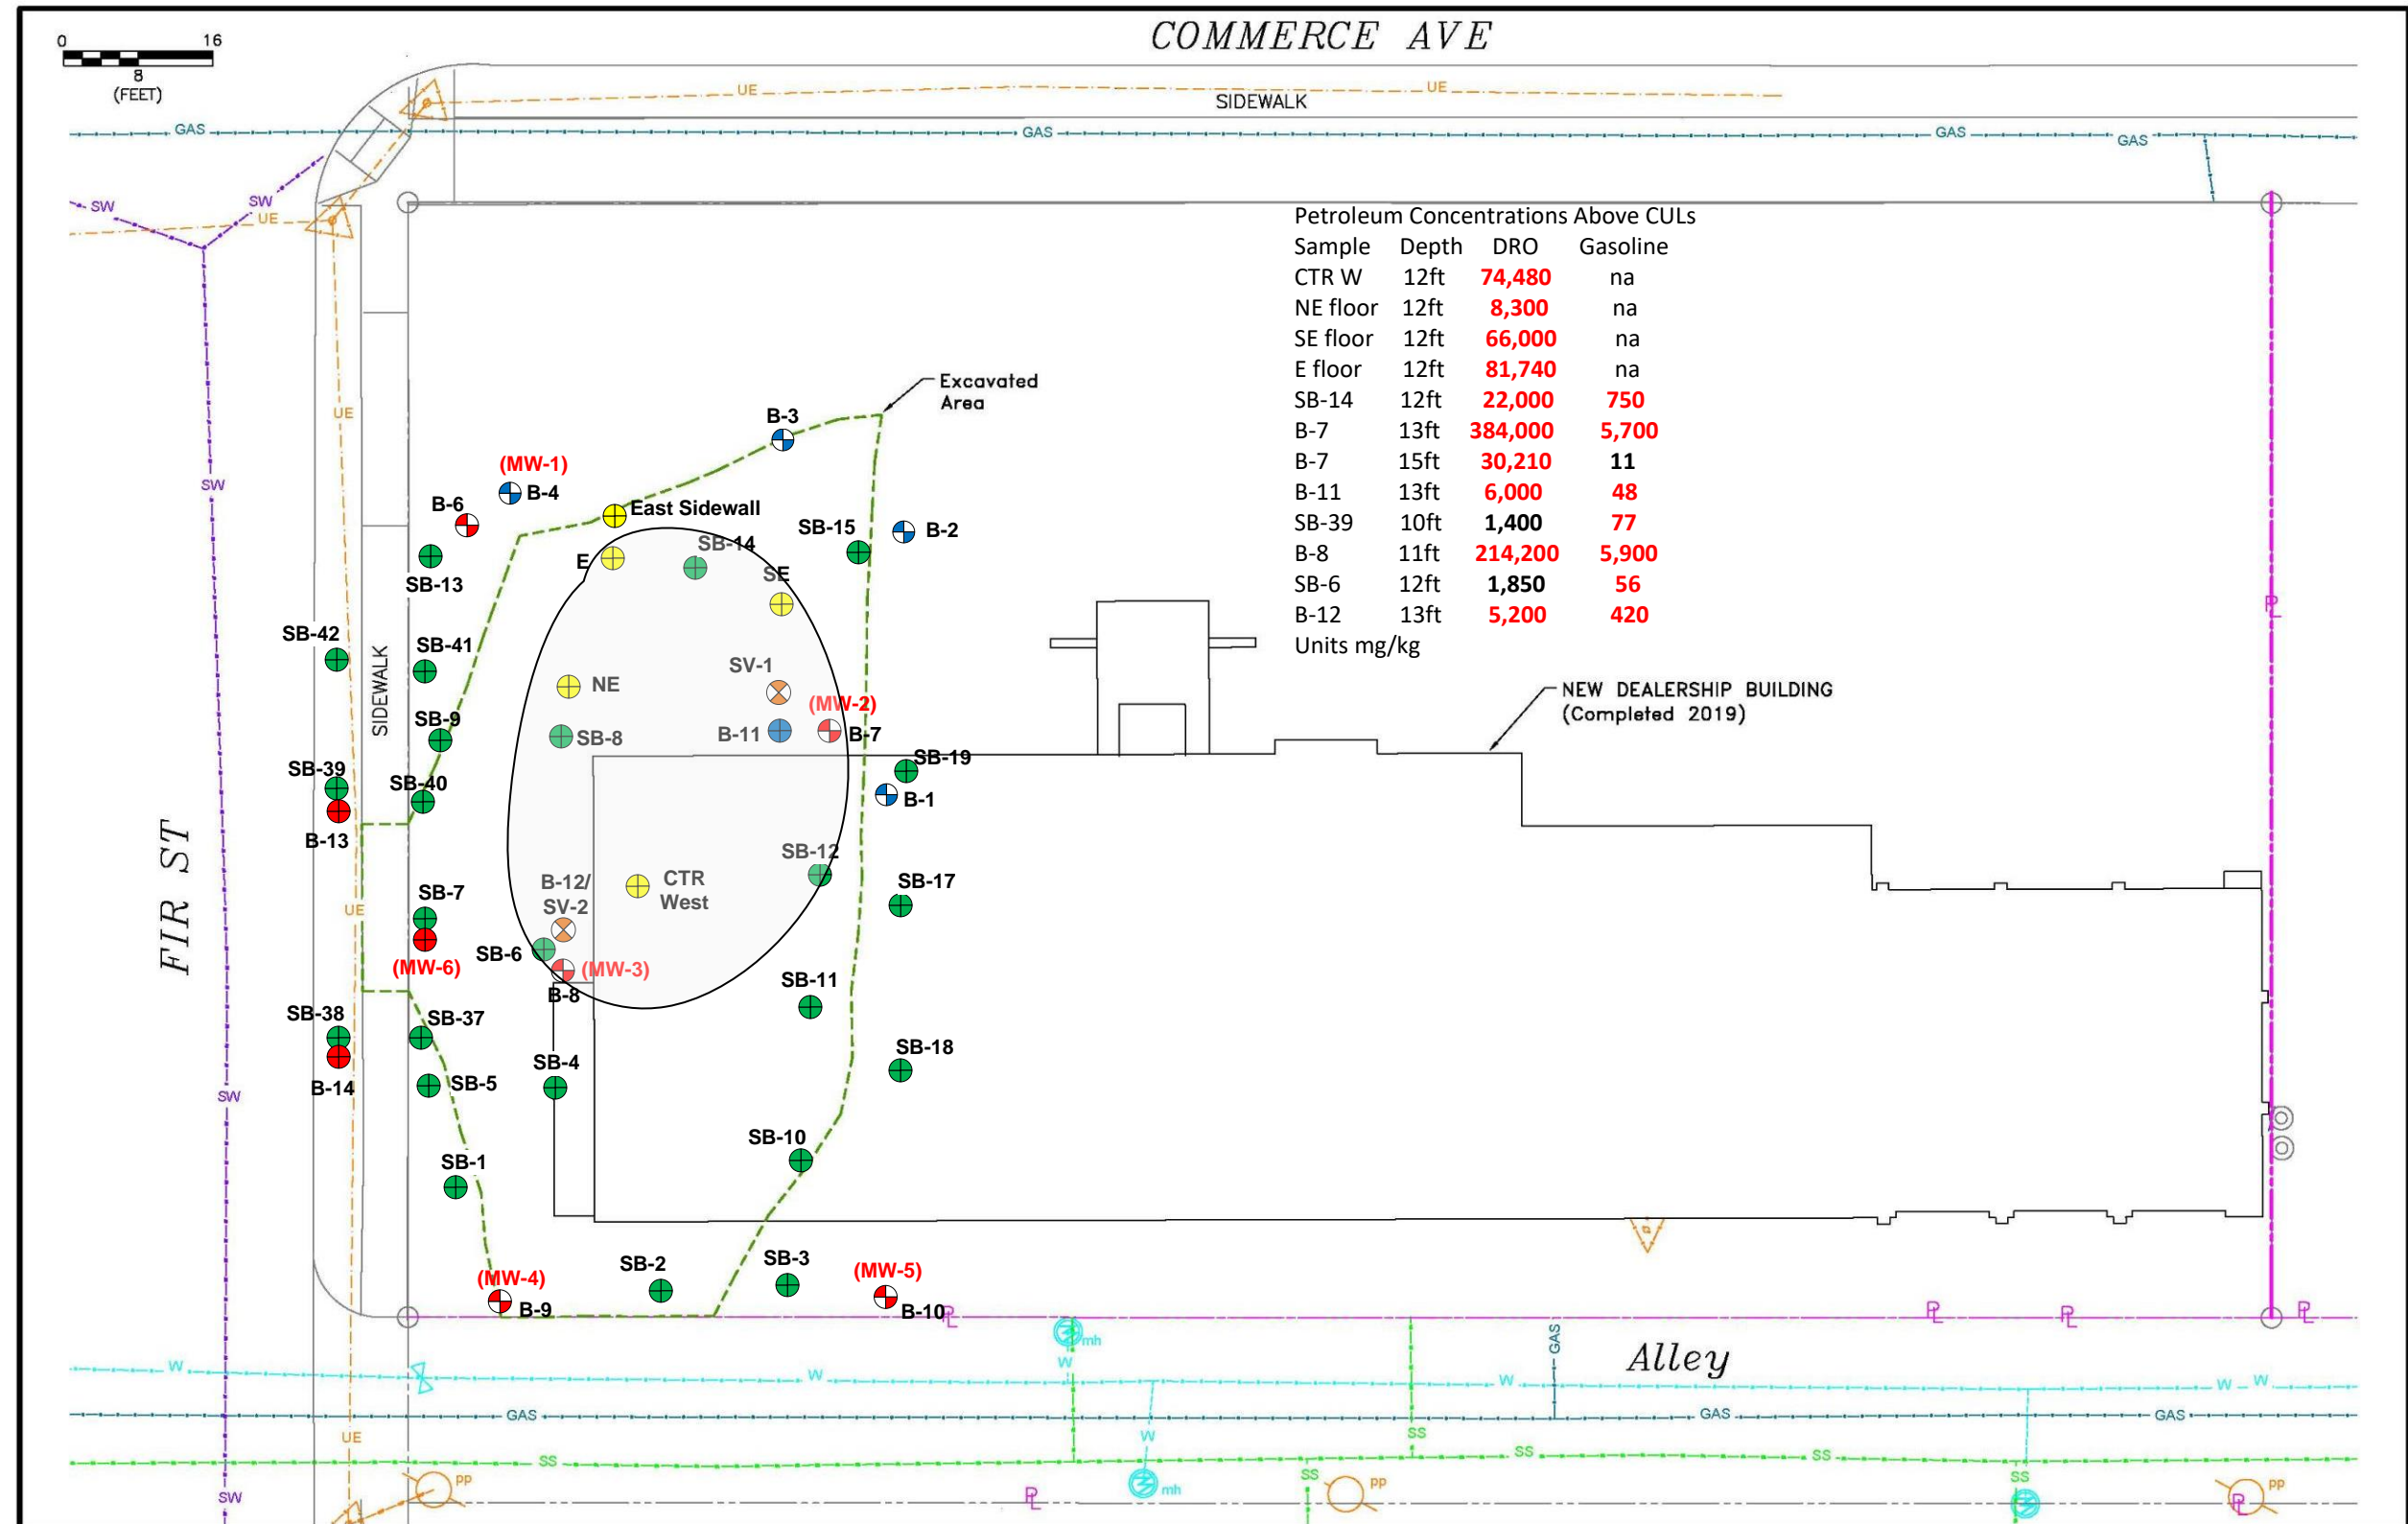
**Figure
3**

Soil samples from the boring B7 (monitoring well MW-2) detected elevated concentrations of gasoline and diesel/lube oil in soil between 13 to 15 feet. Soil samples from boring B8 (monitoring well MW-3) detected elevated concentrations of gasoline and diesel/lube oil in soil at 11 feet. Sample results from 15 feet in this boring did not detect any DRO, gasoline/BTEX concentrations above the laboratory reporting limits (**Figure 3**). Soil sample analytical results are summarized in **Table 3**.

**Petroleum Hydrocarbon Contamination In Soil
Bud Clary Subaru
961 Commerce Avenue
Longview, Washington**

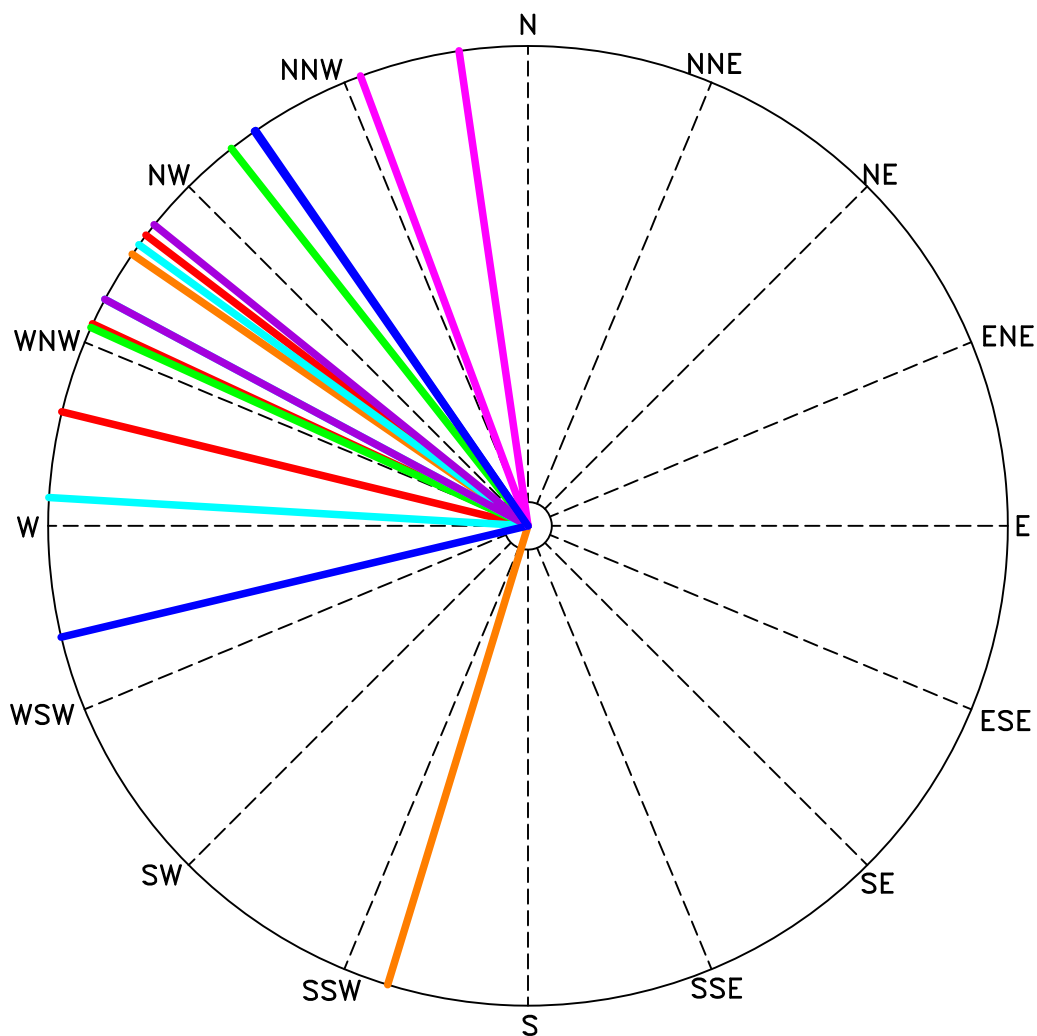
In October 2024, groundwater flow direction across the Site was to the west. In January and March 2025, groundwater flow direction was to the north-northwest. Water contour figures can be found in **Appendix II**.

Groundwater flow direction across the Site is generally in the direction of monitoring well MW-6. The pumping action of groundwater seasonally rising and falling around monitoring wells MW-2 and MW-3 occasionally dissolves remaining DRO in soil into solution. It appears that this is the source of occasional detections of fuel range petroleum hydrocarbons in monitoring well MW-6.
