# Monthly Progress Report

November 20, 2023

## **Re: Former Reynolds Metals Remediation – Monthly Progress Report, October 2023**

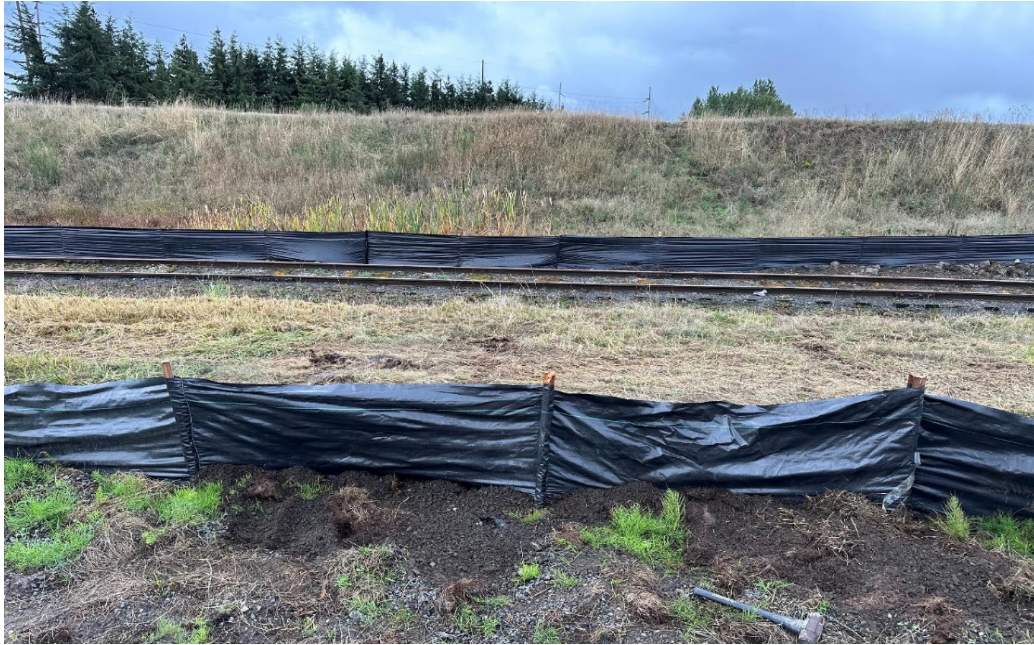
**Photograph 1**  
**East Landfill No. 1**

Repair of silt fencing along southern edge of East Landfill No. 1 (Site Unit [SU] 7).

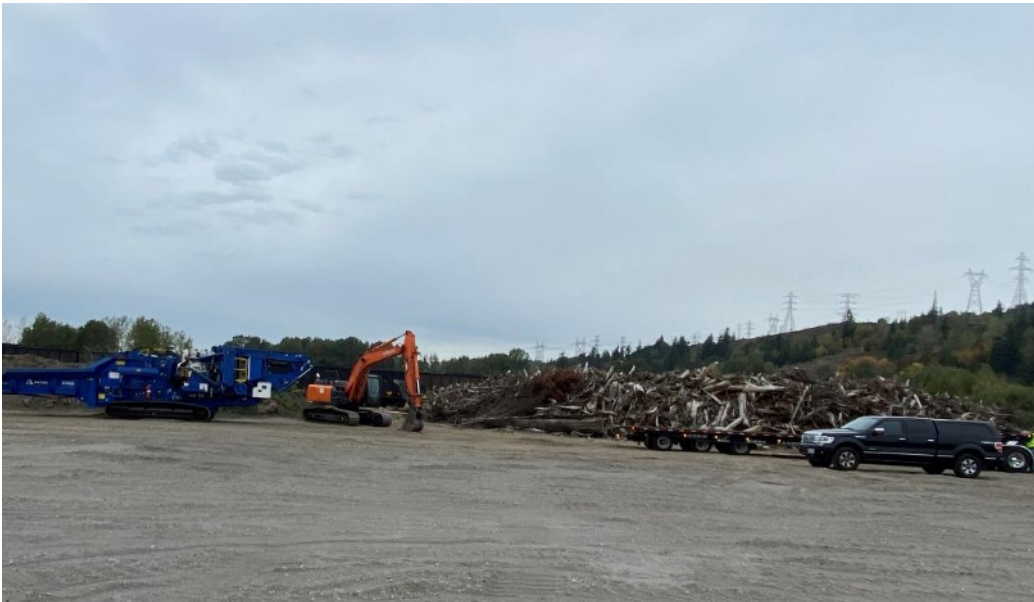
**Photograph 2**  
**West Staging Area**

Envirocon mobilizing wood grinding equipment in West Staging Area.

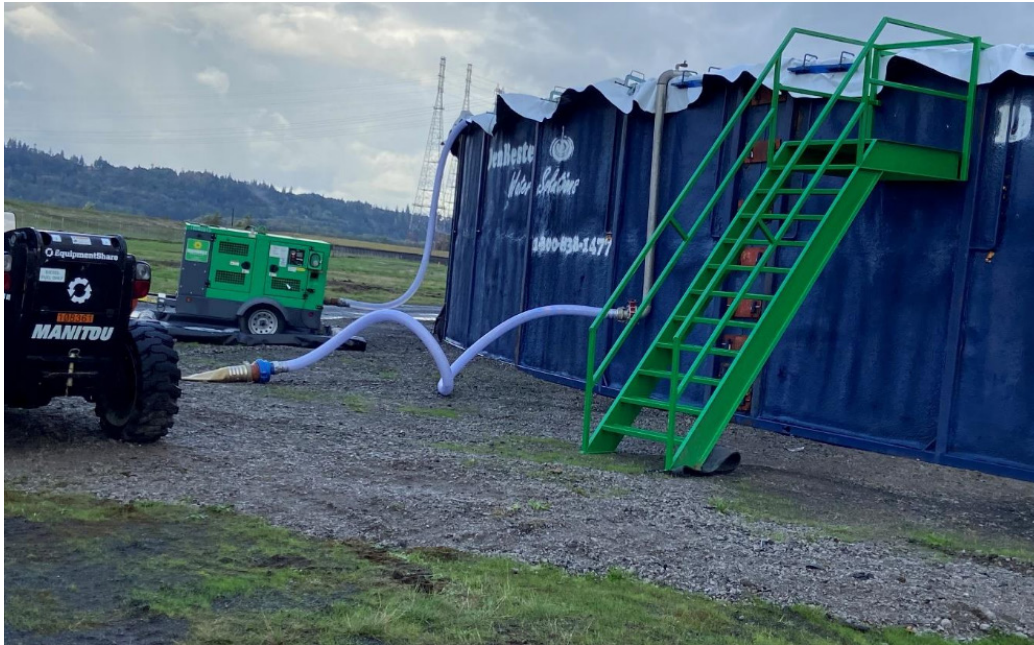
**Photograph 3**  
**1-Million-Gallon Water Storage Tank**

Installation of temporary connection from water storage tank to Facility 77.

- JH Kelly installed the temporary connection from the 1-million-gallon water storage tank to the existing Facility 77 sump.
- Installation and maintenance of stormwater control facilities and management of remediation water

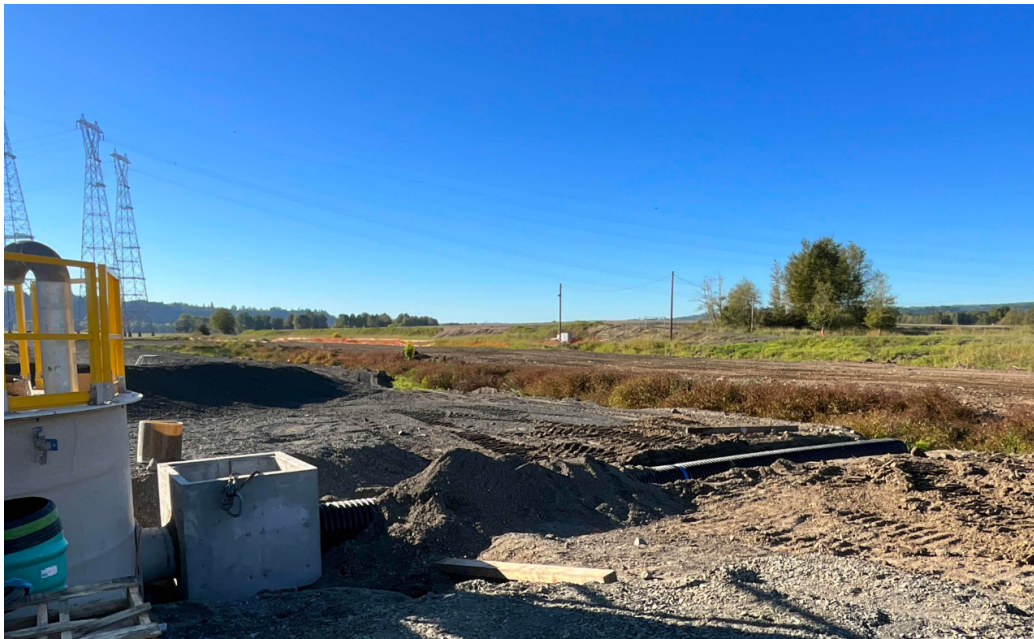
**Photograph 4**  
**West Pump Station**

Installation of overflow vault and 18-inch corrugated polyethylene pipe (CPE).

- **Stormwater infrastructure**
  - Precast concrete overflow weir vault was installed at West Pump Station.
  - Installation of 25 linear feet of 18-inch-diameter corrugated polyethylene pipe (CPE) was completed to connect the West Pump Station to the U-Ditch.

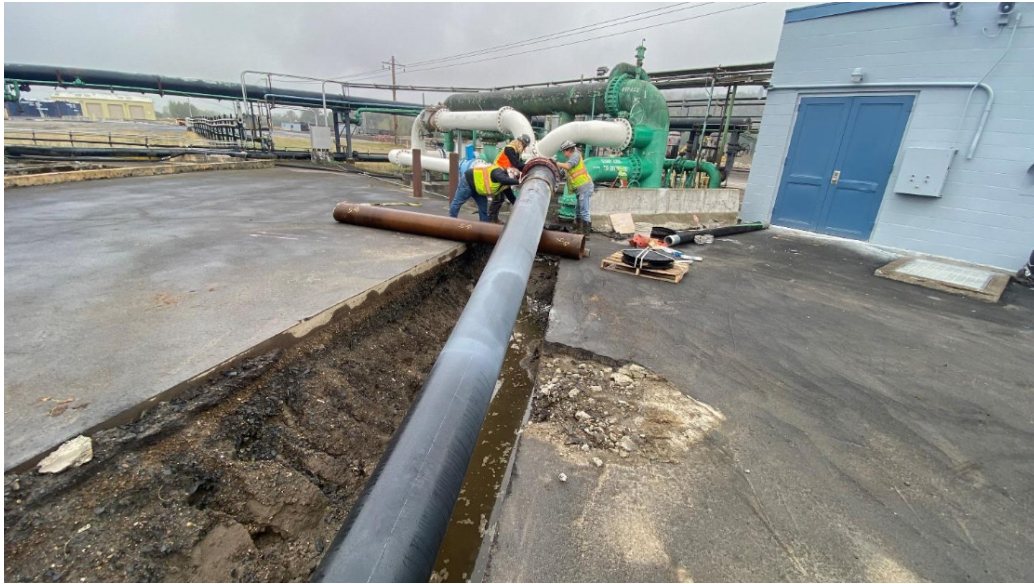
**Photograph 5**  
**Facility 77**

Permanent connection from force main to Facility 77 manifold.

- Quarry spalls were installed as scour protection at the U-Ditch from the West Pump Station overflow vault.
  - Installation of permanent connection from the force main to the existing Facility 77 manifold was completed.

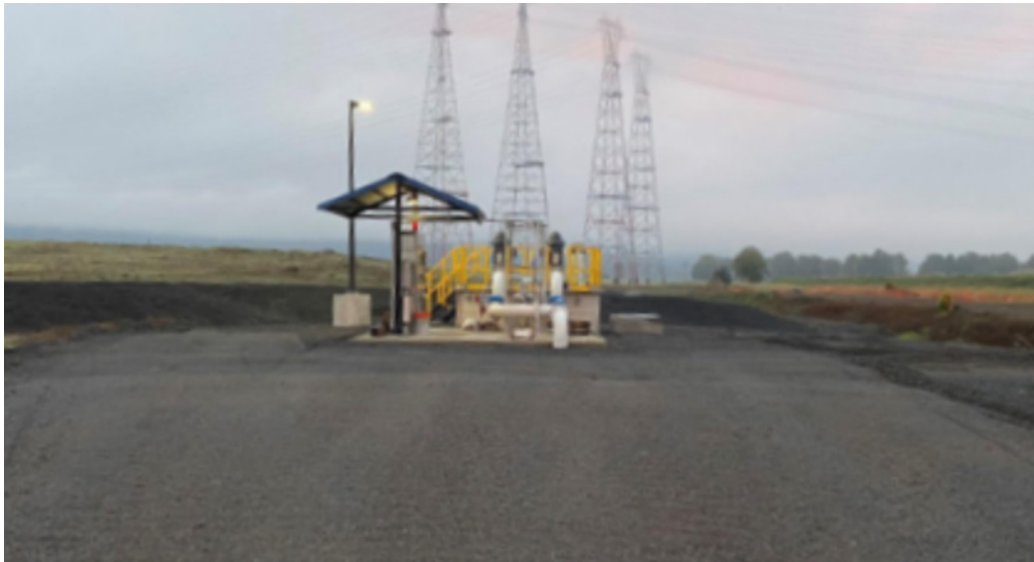
**Photograph 6**  
**West Pump Station**

Final grading of gravel pad surrounding West Pump Station.

- Final grading of gravel pad surrounding the West Pump Station was completed.
  - GPS and survey control activities were completed.
- **Excavation, consolidation, and backfilling**

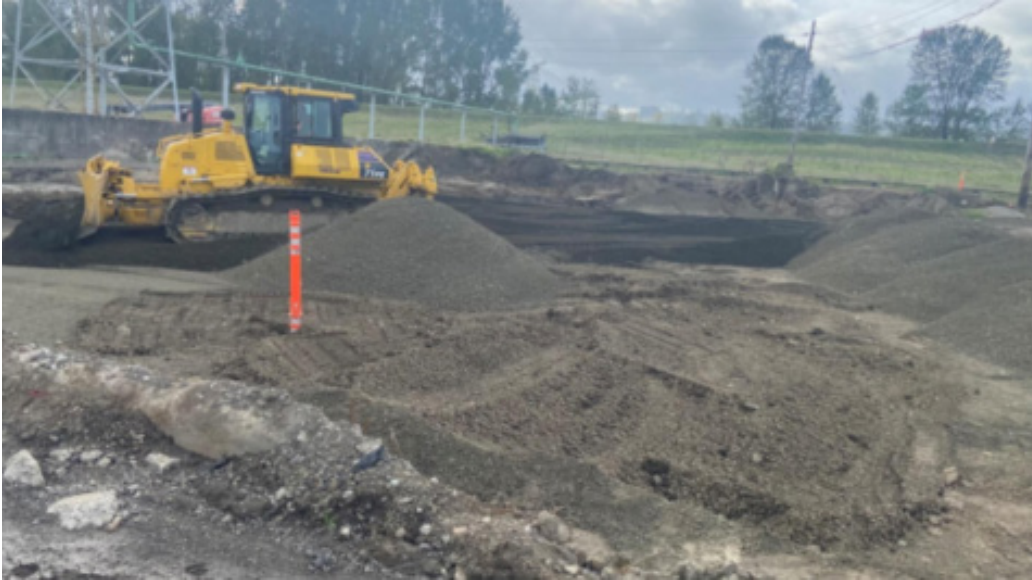
**Photograph 7**  
**Site Unit 9**

Placement of select fill in SU9.

- Analytical data will be included in the Completion Report.
- Once analytical data at all sample locations met cleanup levels, SU9 and SU11 were backfilled with select fill and 3 inches of imported crushed gravel surface material above imported select fill.

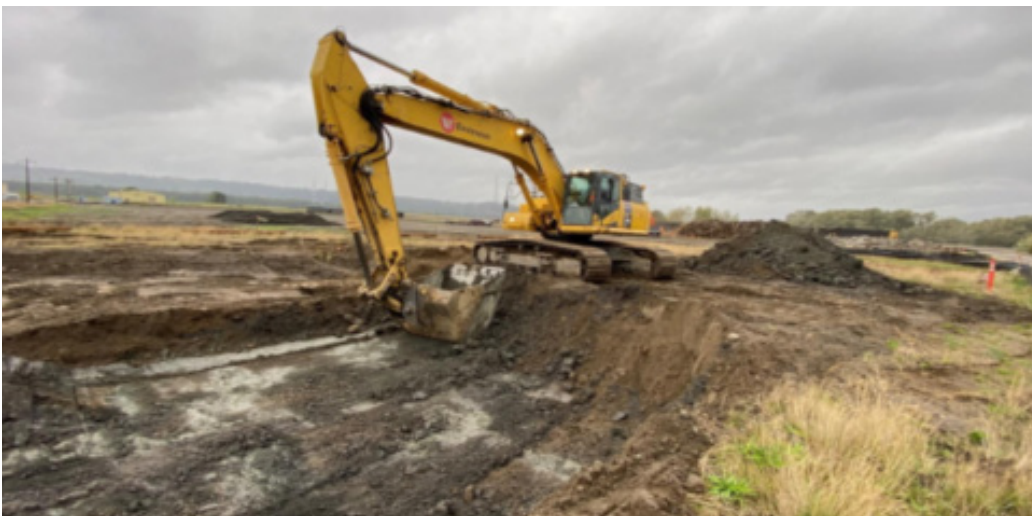
**Photograph 8**  
**Site Unit 11**

Additional excavation in SU11.

- Envirocon performed additional excavations in SU9 and SU11.

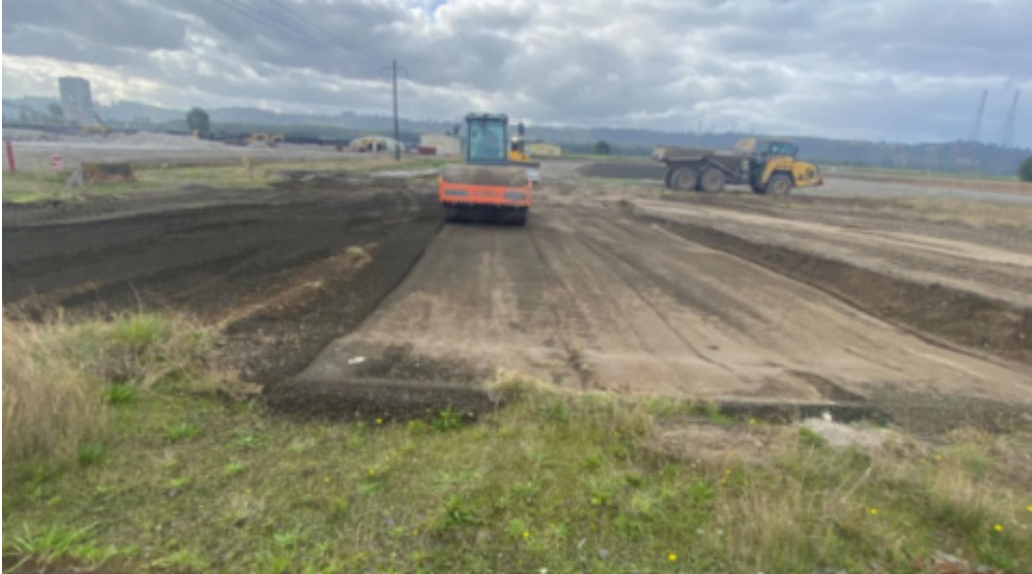
**Photograph 9**  
**Site Unit 11**

Final grading and compaction of crushed gravel surface material in SU11.
