Environmental Media Management Report Soil Removal and Sampling Auburn Way Properties 3025 and 3109 Auburn Way N Auburn, WA 98002

Subject: Environmental Media Management Report

Soil Removal and Sampling Auburn Way Properties

3025 and 3109 Auburn Way N.

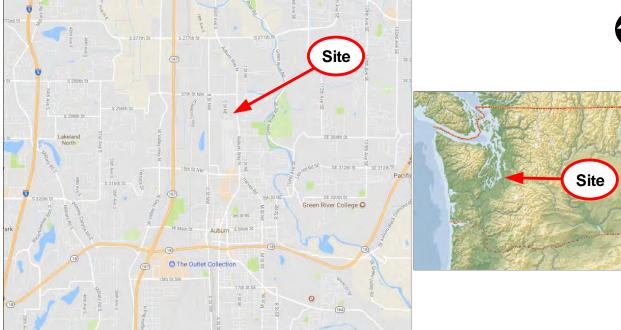
2

Exploration Locations and Approximate Impacted Areas
Auburn Way Properties
3025 and 3109 Auburn Way North
Auburn, Washington

To provide additional data for the former UST area, G-Logics conducted additional soil and groundwater sampling on the 3025 property in July 2017 (Figure 2). ORO hydrocarbons (understood to be associated with the former used-oil UST) were found exceeding the MTCA Method A cleanup level in soils along the northern property boundary (see G-Logics *Additional Soil and Groundwater Sampling* report dated August 13, 2017 for more information).

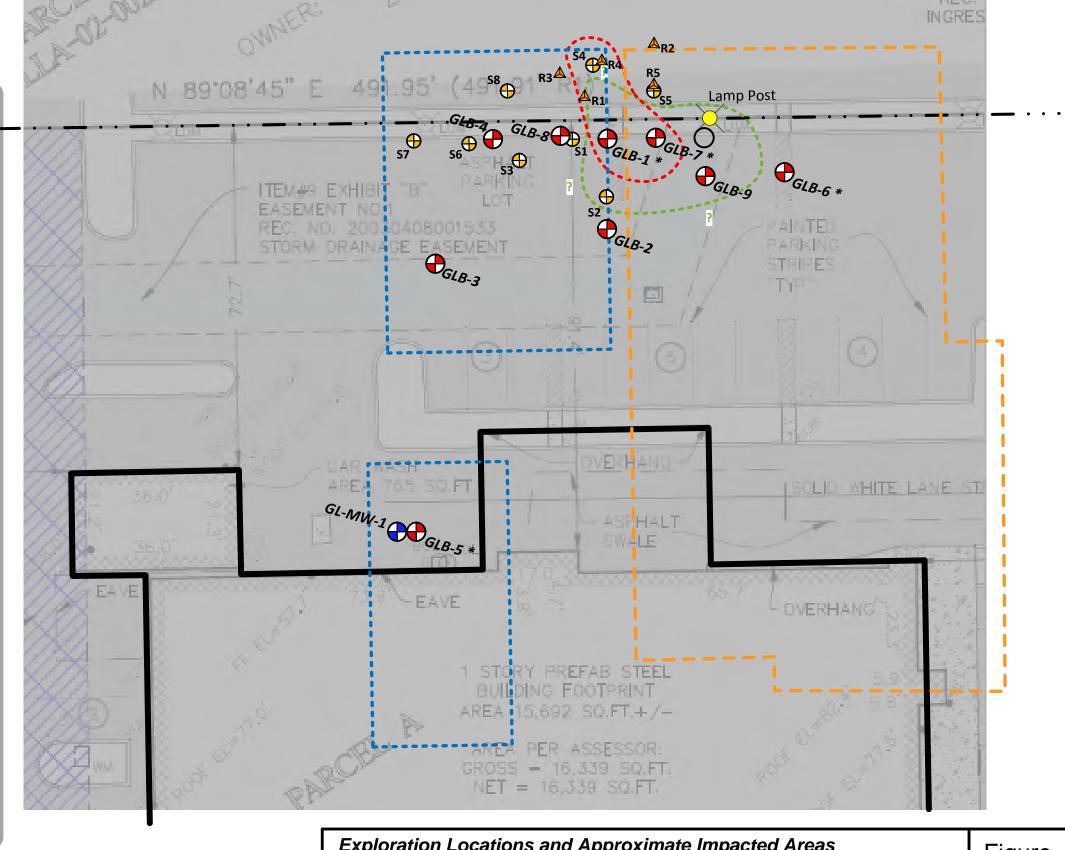
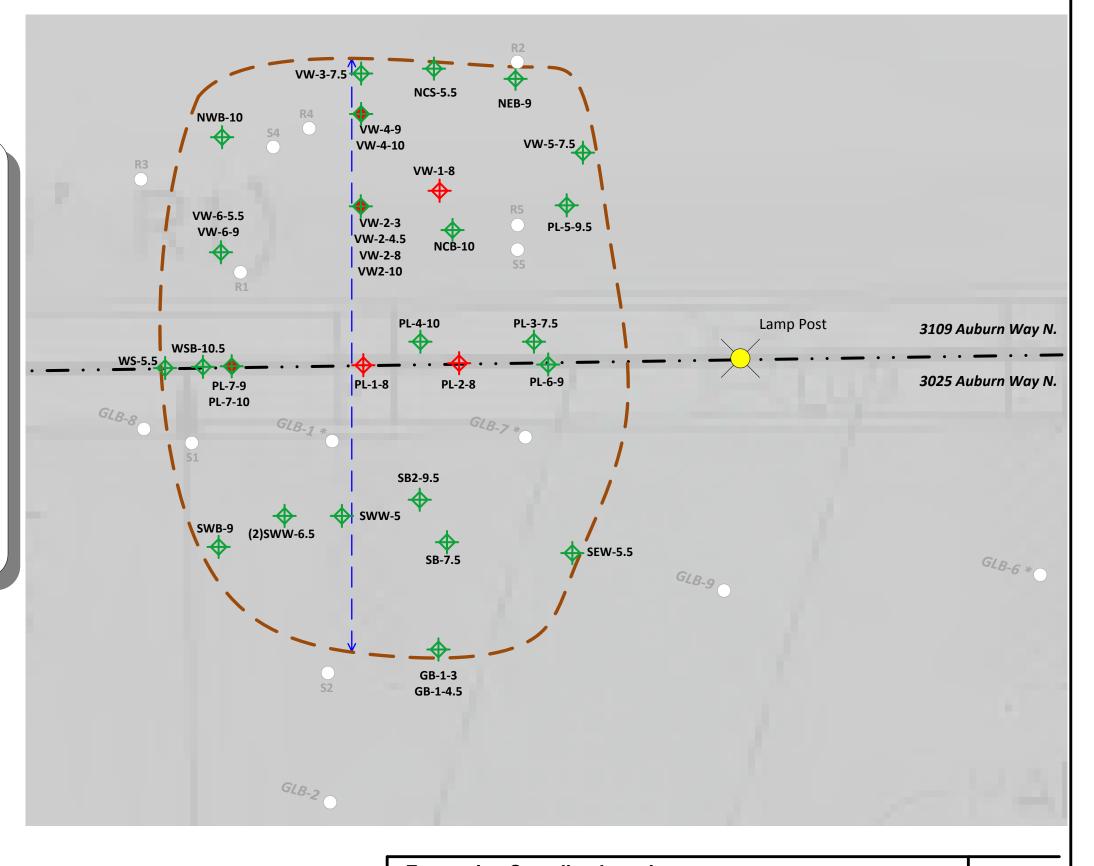
Excavation-Sampling Locations
Auburn Way Properties
3025 and 3109 Auburn Way North
Auburn, Washington

S4 Soil Boring (Stemen, 2012 and 2017) GlB-2 Soil Boring (G-Logics, 2017) GlB-1* Grab Groundwater Sample Pl-4-10 Excavation-Confirmation Soil Sample Location, Results Below MTCA Method A Cleanup Level Pl-1-8 Excavation-Performance Soil Sample Location, Results Above MTCA Method A Cleanup Level (soil subsequently removed)

Black ABS Pipe ("4) Containing Communication Lines

Area of Excavation

During the first week of November 2017, petroleum-contaminated media (soil and groundwater) was removed from an area spanning the property line. The approximate extent of the remedial excavation is shown on Figure 3.

Also shown on Figure 3 is the approximate location of a communications conduit linking the two properties. This conduit, not previously identified nor located prior to the excavation activities, was discovered at approximately 2.5 to 3 feet below ground surface (Photos 1-5). Soils were removed from around the conduit during the soil excavation and subsequent backfilling process without damaging or altering the line.

analytical results are summarized on Table 1 and discussed in Section 3.2. Performance and confirmation-soil sample locations are illustrated on Figure 3. Analytical reports and chain of custody documentation is attached in Appendix B.

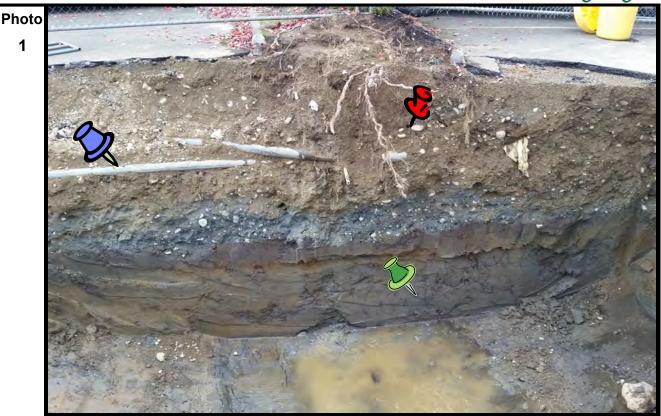
Description: Looking west, a communications conduit (blue pin) was discovered approximately 2.5 to 3 feet below ground surface.

Comments: Approximately 4 to 5.5 feet of gravely fill (red pin) was found on top of fine-grain native soils (green pin).

The excavated soils consisted of a structural-fill material from the surface to approximately 4 to 5.5 feet. The fill consisted of a silty sand and gravel mix. Fine-grain native soils were encountered below the fill, generally consisting of silt with clay to a depth of 8 to 9 feet, followed by silty, fine grain sand to the bottom of the excavation (Photo 1). Dimensional lumber and old car parts were observed occasionally in the fill deposits near the property line. Two concrete pipes, originating north of the property line appeared to terminate near the property line (Photo 2). Groundwater was encountered at approximately 8 feet below ground surface (Photo 2).

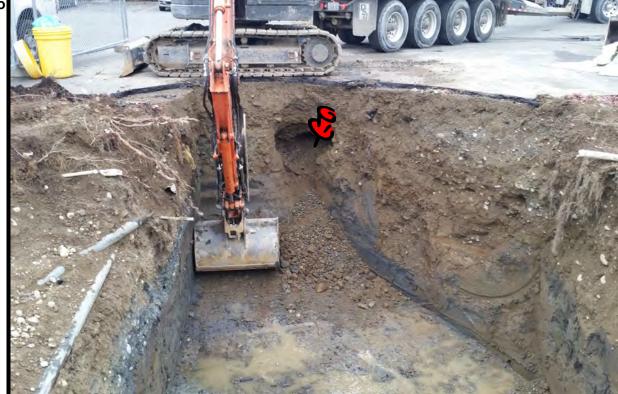
Photo 2

Description: Looking north, petroleum-contaminated soil was found at a depth of 5 to 10 feet with groundwater at approximately 8 feet.

Comments: Void space (red pin) left after the removal of a section of 12-inch diameter concrete pipe.

Petroleum-contaminated soil was found at depths ranging from approximately 5 feet to 10 feet below ground surface. A number of performance samples were collected near the property line and north of the property line to confirm and validate the need to extend the excavation onto the 3109 property. Soil was excavated both north and south of the property line until sidewall and bottom confirmation-soil samples exhibited petroleum concentrations below MTCA Method A Cleanup Levels. Sample locations, depths, and

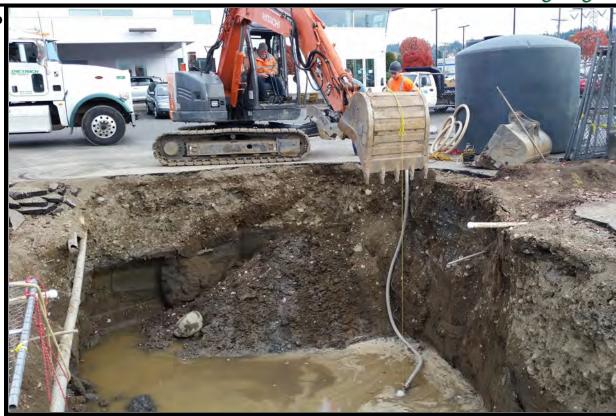
Photo 3

Description: Looking north, excavation dewatering.

Comments: 2,600 gallons of groundwater and rainwater were removed from the excavation and stored in a poly tank for off-site disposal.

During the excavation, approximately 2,600 gallons of groundwater and rainwater were removed from the excavation and stored in poly tanks (Photo 3). Before the water was removed and disposed, G-Logics collected a sample of the containerized water for chemical analysis. The sample was submitted to Libby Environmental and analyzed for ORO, DRO, GRO, BTEX, and RCRA 8 Metals, as well as Priority Pollutant Metals, copper, nickel and zinc. All analytes were below MTCA Method A Cleanup Levels. Following analytical results, Clearcreek contracted with Emerald Services for the removal and proper disposal of the stored water. Analytical reports and chain of custody documentation for the collected water sample are attached in Appendix B. Water-disposal documentation is attached in Appendix C.

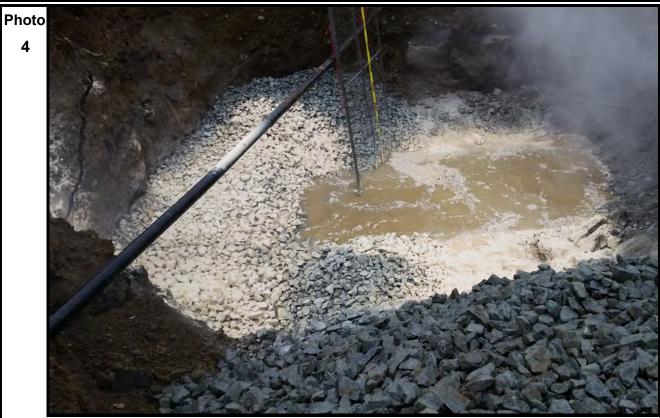
Description: Looking north, the white powder is an oxygen-release compound (ORC Advanced).

Comments: ORC was added to the excavation to assist the attenuation of possible residual petroleum contaminants in groundwater.

After the remedial excavation had been completed, 200 pounds of an oxygen-release compound (ORC Advanced) was added to groundwater in the excavation, as well as the backfill material near the groundwater interface (Photo 4). ORC was applied to assist in removing residual petroleum impacts in the groundwater. Clearcreek placed quarry spalls in the bottom portion of the excavation (Photo 5). "Gravel Borrow" and Type-17 also was used as fill materials (Photo 6). During the backfilling work, soil was compacted by Clearcreek for structural integrity. Finally, the parking lot surface was restored with asphalt.

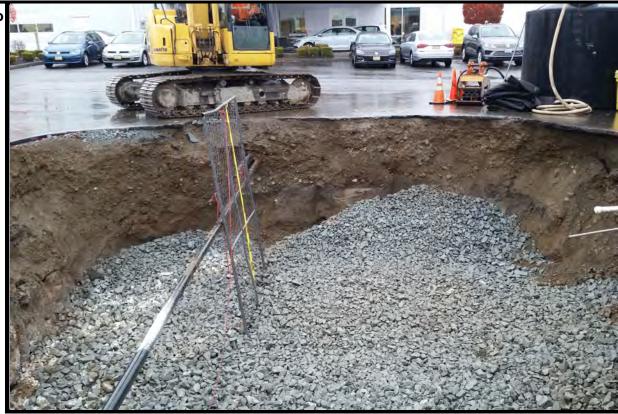
Photo 5

Description: Looking north, quarry spalls were added to the bottom of the excavation to just above groundwater level.

Comments: A section of fencing was used to support the communications conduit.

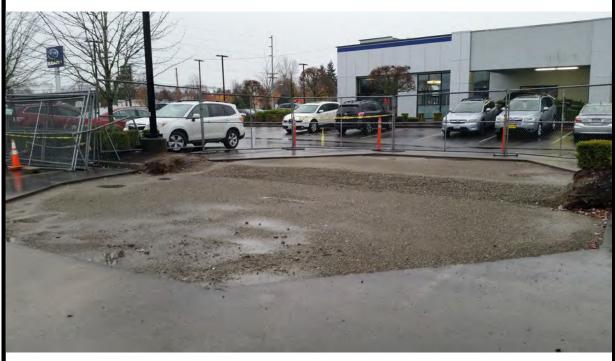
Photo 6

Description: Looking southeast, geo-textile cloth was placed over quarry spalls, followed by "Gravel Borrow", then type-17 materials.

Comments: Wet weather prevented repaving until approximately three weeks following backfill of the excavation.
