# Remedial Action Report

**J & J Auto Masters  
1110 Martin Luther King Jr. Way  
Seattle, Washington 98122  
King County Parcel No. 118900-0469**

**Project Number: 103701-7,8**

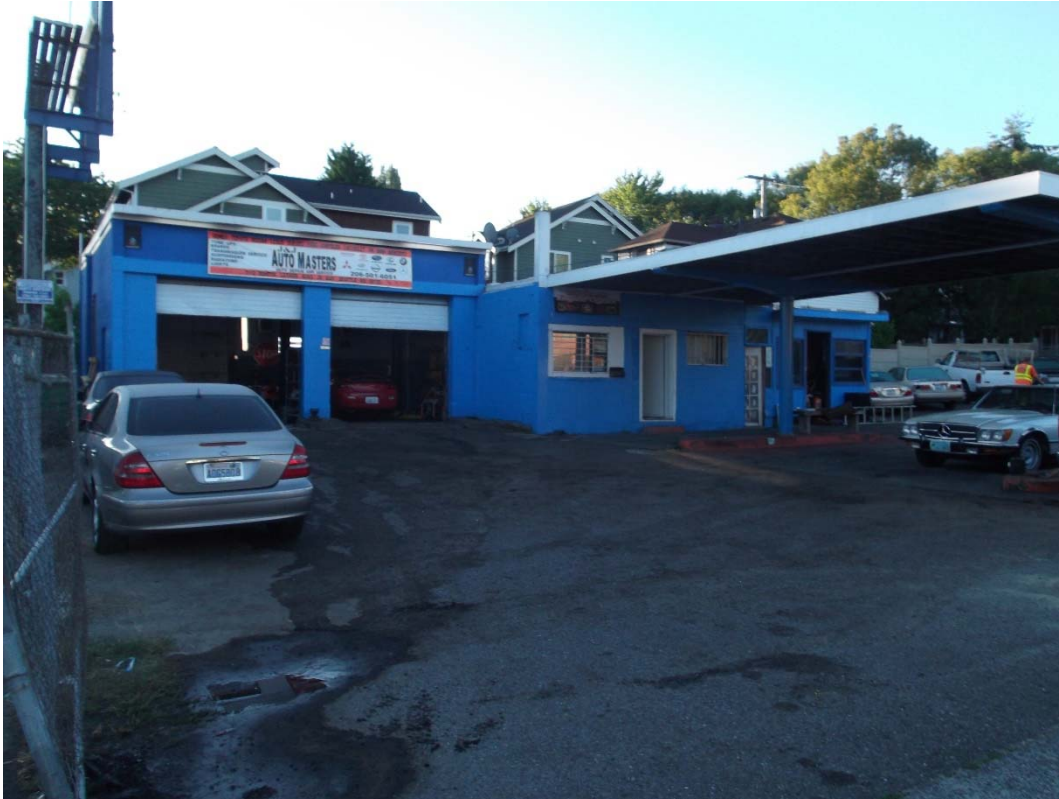
Photograph 1 – View east of the northern portion of the Property, showing the automotive repair shop and pump island canopy as they appeared in 2015. The billboard in the northern extent of the Property is also shown (left).

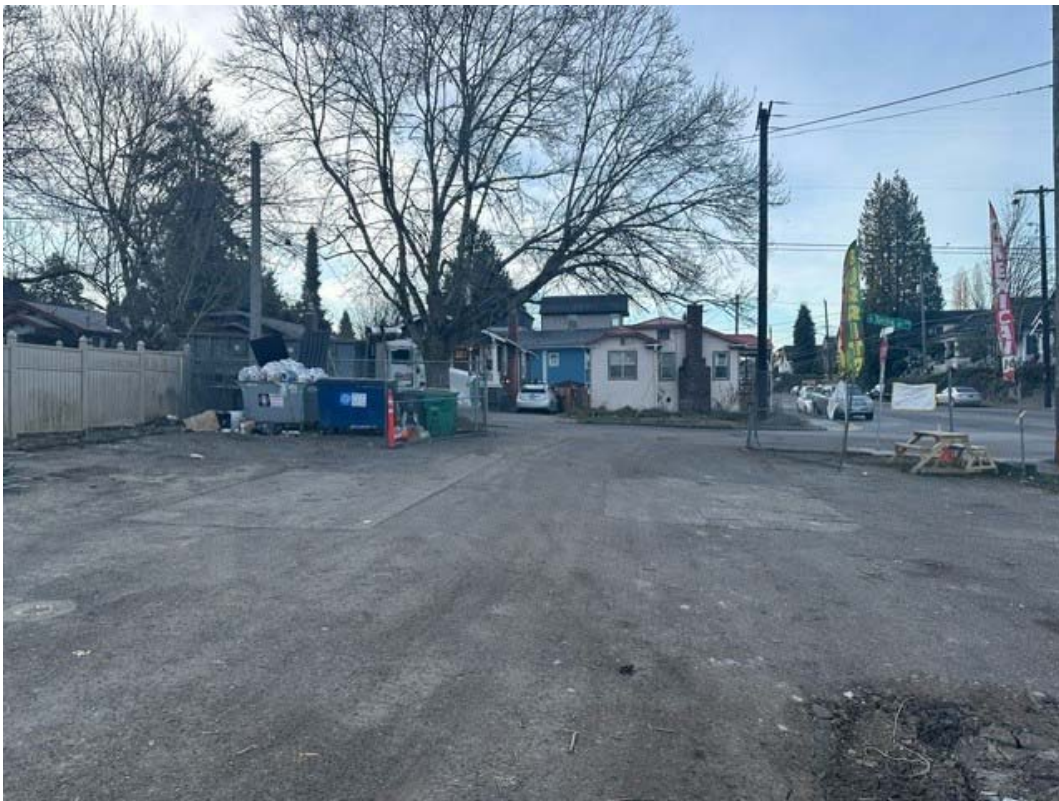
Photograph 2 – View south from the central portion of the Property, showing the Gas Station USTs AOC in the southern portion of the Property prior to excavation of removal of the four USTs and associated PCS. Groundwater monitoring well MW-1 is also shown (left).

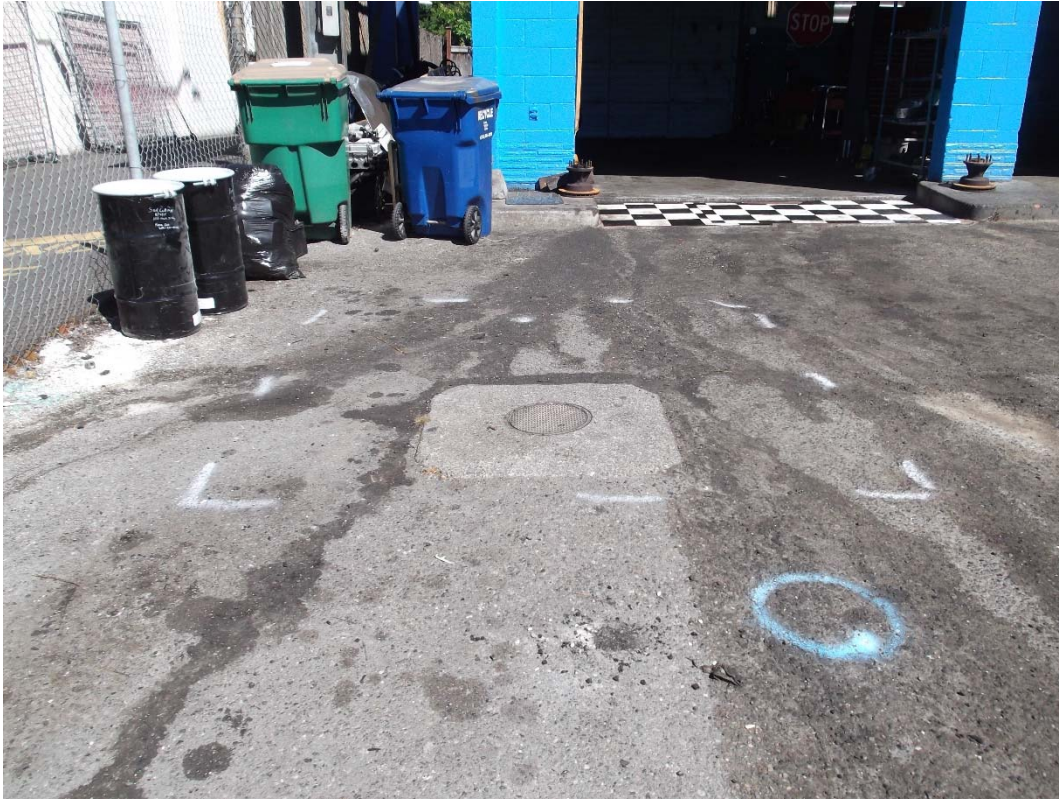
Photograph 3 – View east of the northern portion of the Property, showing the steel access port to UST-5 (center) prior to demolition of the automotive repair shop structure (background) and relocation of the northern fence line (left).

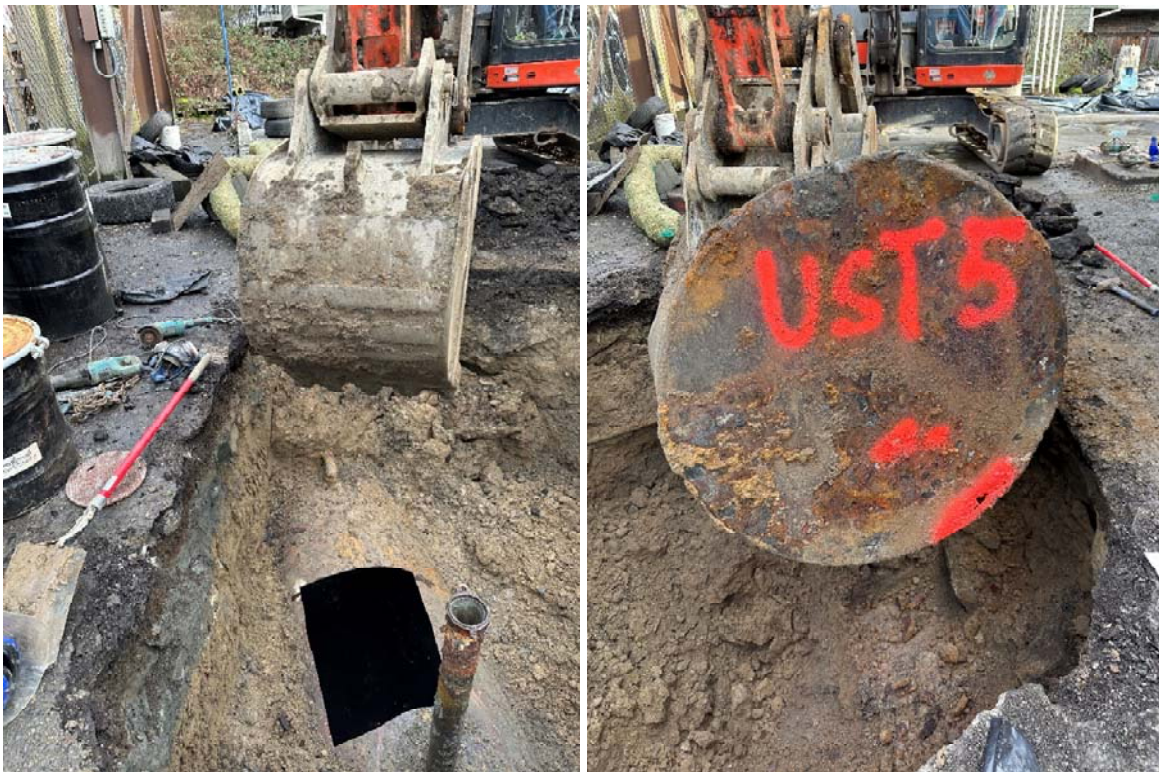
Photograph 4 – Two views showing the removal of the waste oil UST (UST-5), including in the ground with the top exposed and cut open (left), and removed from the ground with holes in the western wall of the UST painted (right).

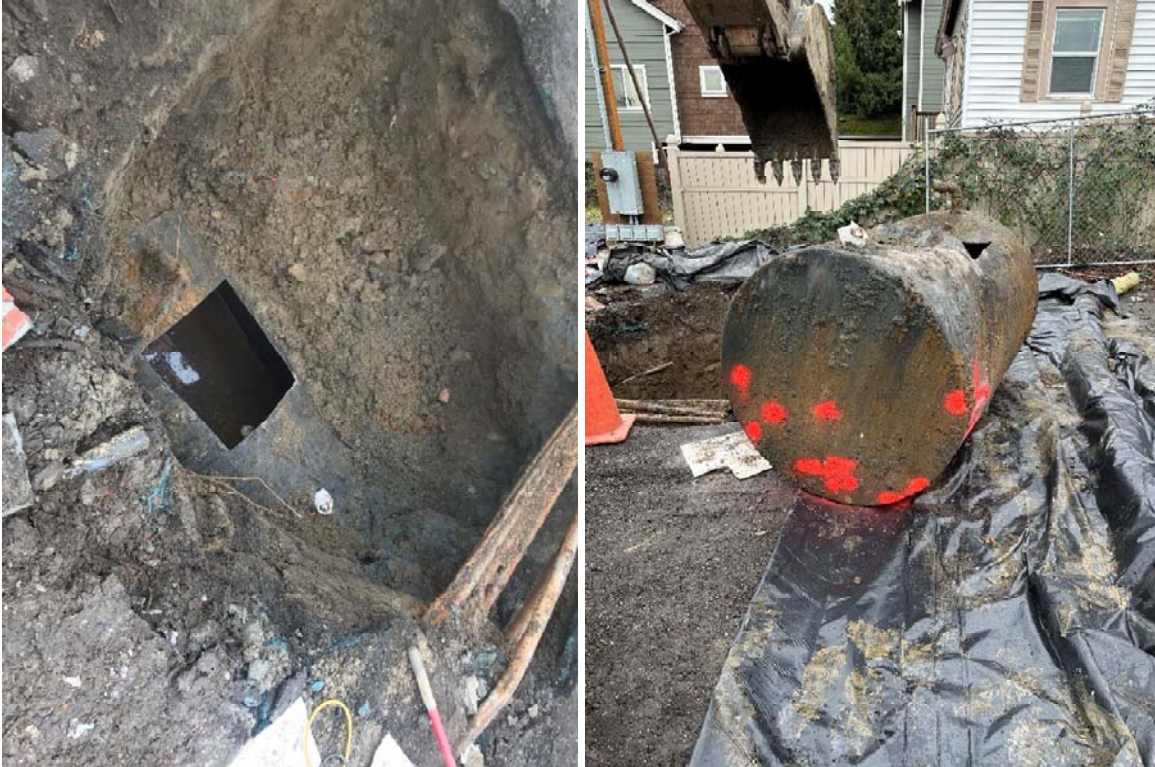
Photograph 5 – Two views showing the removal of the heating oil UST (UST-6), including in the ground with the top exposed and cut open (left), and removed from the ground with holes in the western wall of the UST painted (right).

A heating oil UST was found near the southwest corner of the former structure on the Property following the demolition of the structure in 2023. This UST has been designated UST-6. It was exposed, cleaned, and inerted prior to its removal from the Property on December 29, 2023. It was determined to be approximately 500 gallons in capacity and was observed to be in poor condition, with some corrosion and holes observed at or near the bottom of the UST. Soil samples, collected from the bottom of the UST pit from southeastern and southwestern ends of the UST at the time of its removal for initial characterization, revealed PCS exceeding applicable MTCA Method A cleanup levels at both locations. COCs in this AOC included TPH as GRO, DRO, ORO, and BTEX. The Heating Oil UST AOC, including sampling locations, is presented in Figure 6. It should be noted that the COCs found at this location do not indicate its exclusive use for storage of heating oil. The data reveal that soil in the vicinity of this UST had gasoline and associated constituent concentrations present above MTCA Method A cleanup levels.

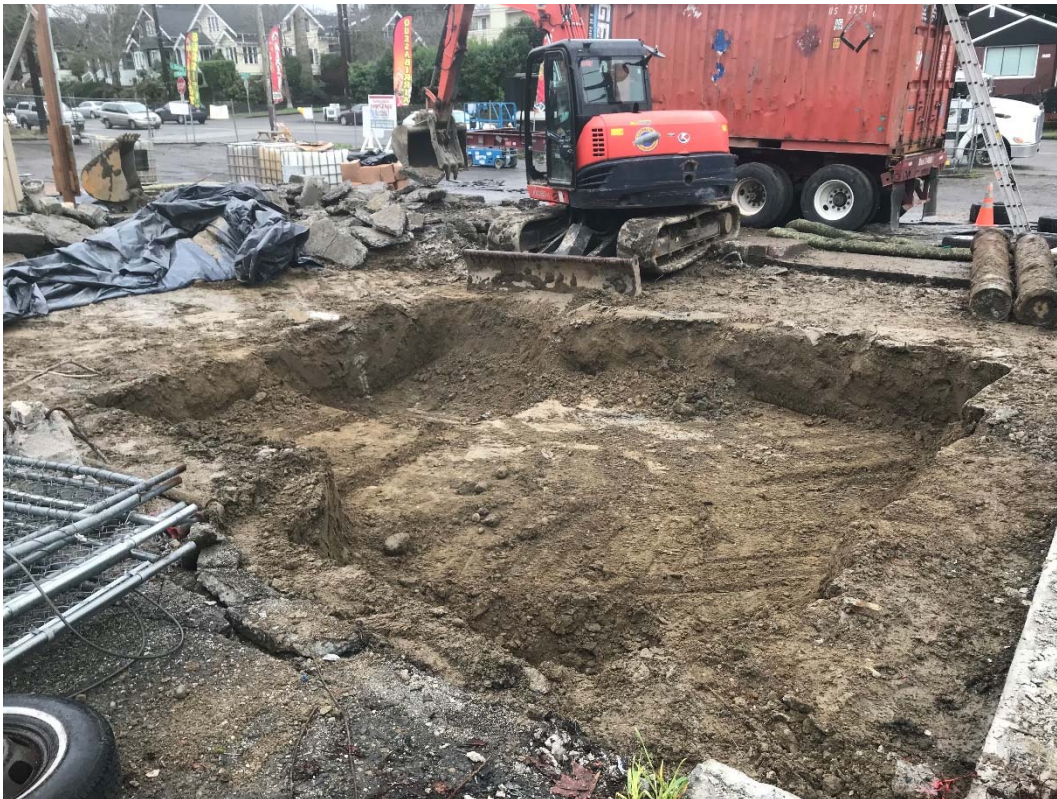
Photograph 6 – View of the initial excavation in the Automotive Repair Shop AOC, showing removal of soils for Contained-In Disposal (CID) to approximately 3 feet below ground surface (bgs). The two hydraulic lift cylinders removed from the ground are shown (right).

Underground hydraulic lifts were removed on December 29, 2023. In addition, a feature east of the northern hydraulic lift was removed, determined to be a concrete vault including a 4-inch-diameter cast iron pipe. Although it may have served as a hydraulic fluid UST as previously assumed, at the time of its removal no connection between the vault and the hydraulic lift cylinders was observed.

Following test pit sampling within the footprint of the former automotive repair shop to delineate the extent of CVOCs in the area requiring "contained-in disposal" (CID), excavation of the AOC for offsite disposal commenced on January 3, 2024. Additional delineation of CVOCs proceeded on January 4, 2024, with confirmation samples collected on January 4, 2024, and January 5, 2024, showing all CVOCs had been removed from the areas previously identified. In all, three containers of soil (approximately 87 tons) were removed from the AOC for CID over the course of January 3, 2024, and January 4, 2024.

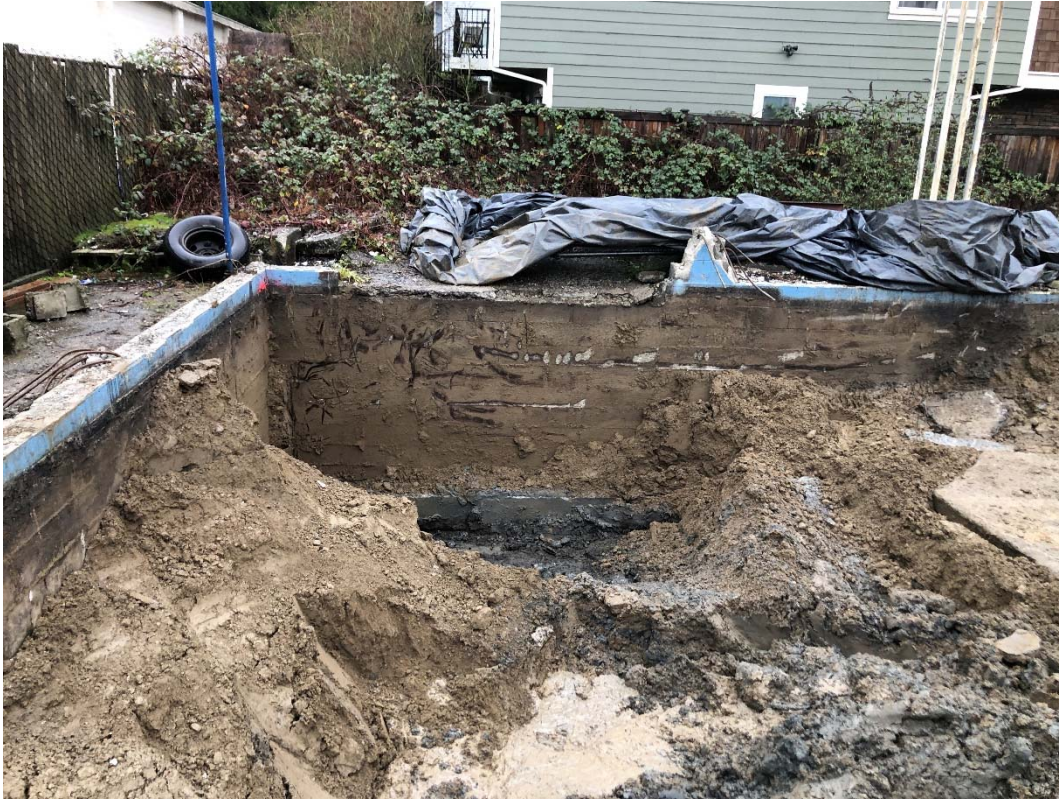
Photograph 7 – View of the excavation in the Automotive Repair Shop AOC, showing the removal of PCS in the northeastern portion of the excavation to the silty organic soil layer present approximately 8.5 feet bgs beneath the base of the western foundation wall. The northern foundation wall (left) remains supported by soil.

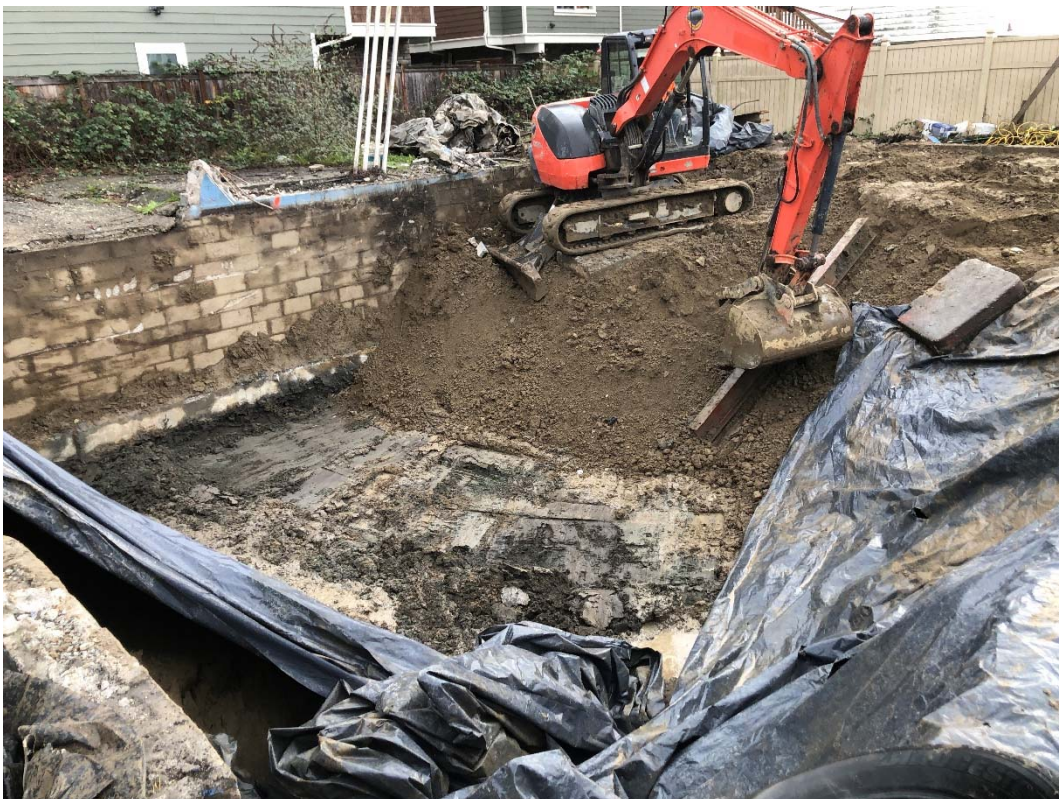
Photograph 8 – View of the excavation in the Automotive Repair Shop AOC, showing the completion of the excavation to the silty organic soil layer present approximately 8.5 feet bgs. Gas station UST vent pipes are shown.

eastern foundation. These concrete foundation walls to the north and east were found to extend approximately 7.5 feet below the top of the floor of the former structure. The excavation extended to approximately 8.5 feet bgs across the entire area, to a depth where the presence of silty organic native soils appeared to inhibit the downward migration of contaminants. Following removal of PCS, the excavation was backfilled with imported type-17 backfill to the original surface.

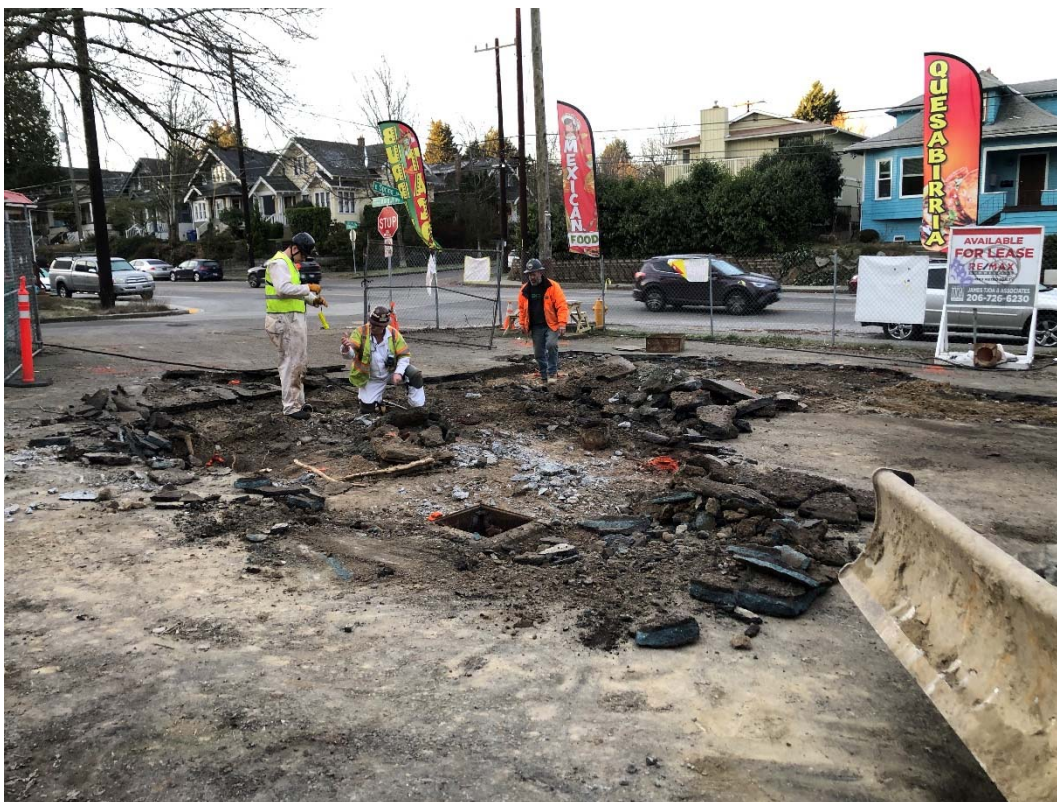
Photograph 9 – View of the Gas Station AOC in the southern portion of the Property, showing the removal of the asphalt surface. The Marine Chemist is shown testing vapors in UST-3 to determine that it is safe to cut open.

Excavation for removal of the four gas station USTs commenced on January 16, 2024, following triple rinsing, which was performed the previous day. The tops of the USTs were exposed, and following confirmation by a marine chemist that the internal atmosphere was safe, holes were cut in the tops of each UST to access the interiors. Following removal from the ground, each UST was inspected for holes and other signs of deterioration and possible sources of release. When removed from the ground, UST-1 was observed to have holes in the western portion of the UST. Visual inspection of the other USTs did not reveal visually obvious holes in the USTs; however, petroleum-impacted soil was observed beneath all four USTs following their removal from the ground. Spanning January 16, 2024, through January 25, 2024, 28 truckloads of PCS (approximately 427 tons) were exported for offsite disposal. The concrete debris encountered was removed and disposed of separately. Soils were excavated to approximately 12 feet bgs in areas with overlying indications of petroleum impacts.

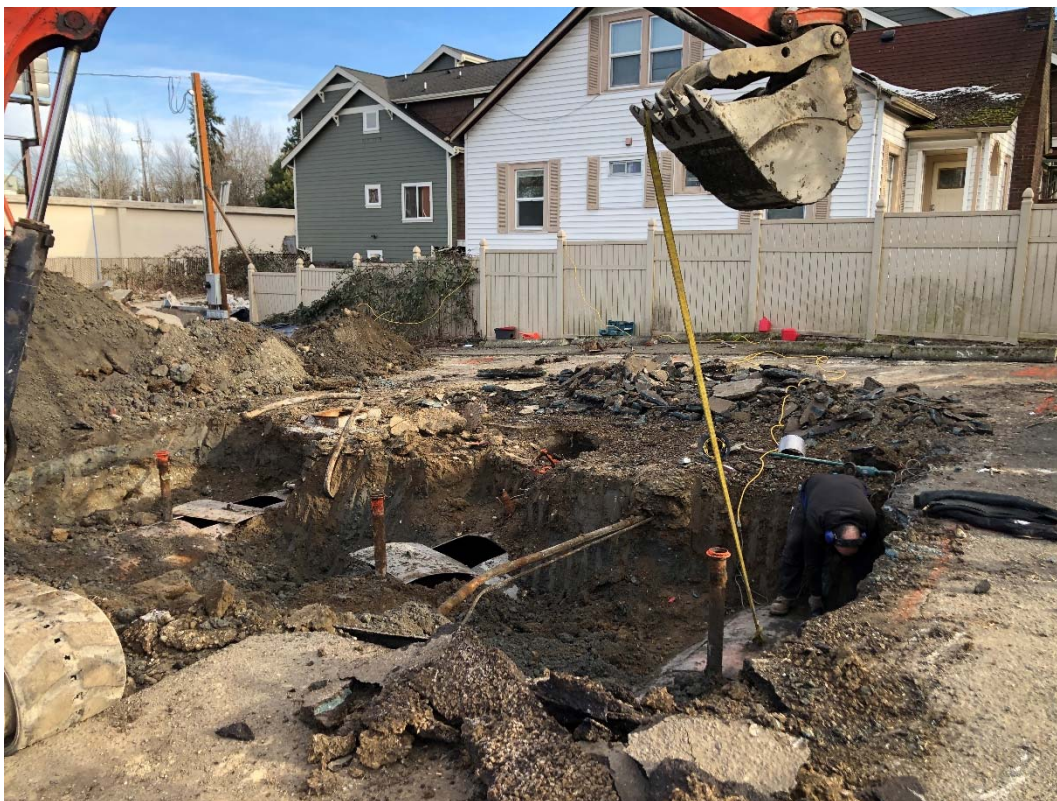
Photograph 10 – View of the Gas Station AOC in the southern portion of the Property, showing UST-1 (left) and UST-2 (center) exposed and cut open, and UST-3 (right) being cut open.

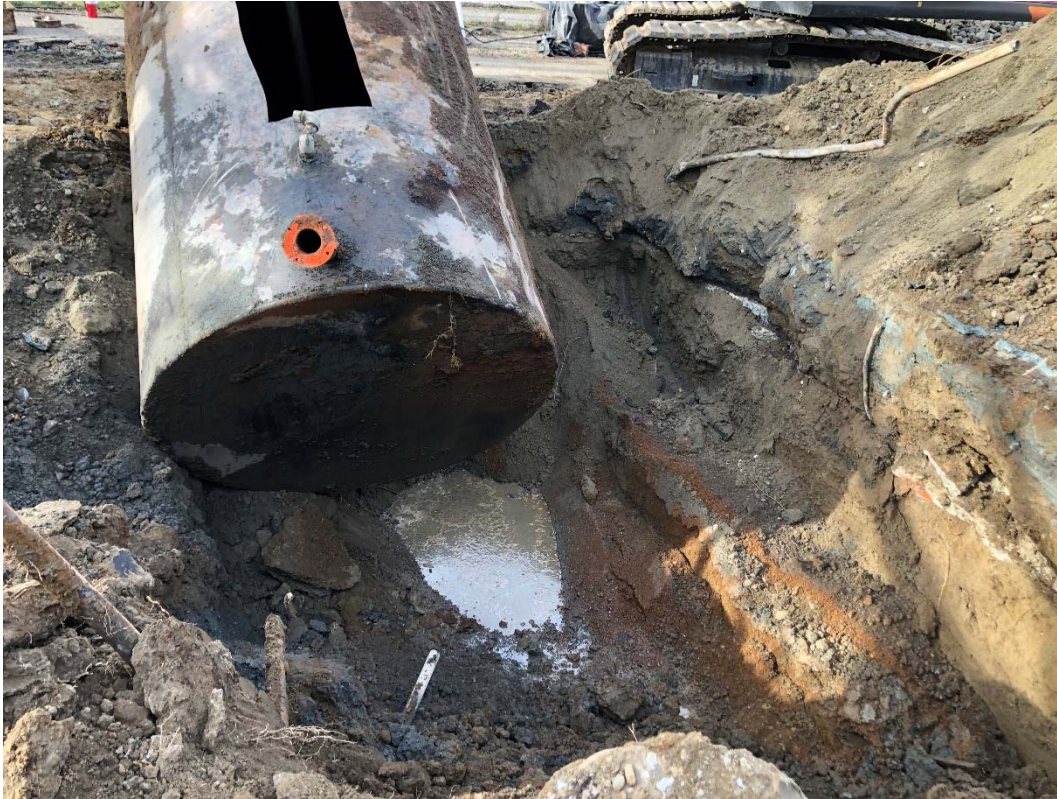
Photograph 11 – View of the Gas Station AOC in the southern portion of the Property, showing UST-1 being removed from the ground, exposing groundwater accumulated beneath with the UST pit fill material.

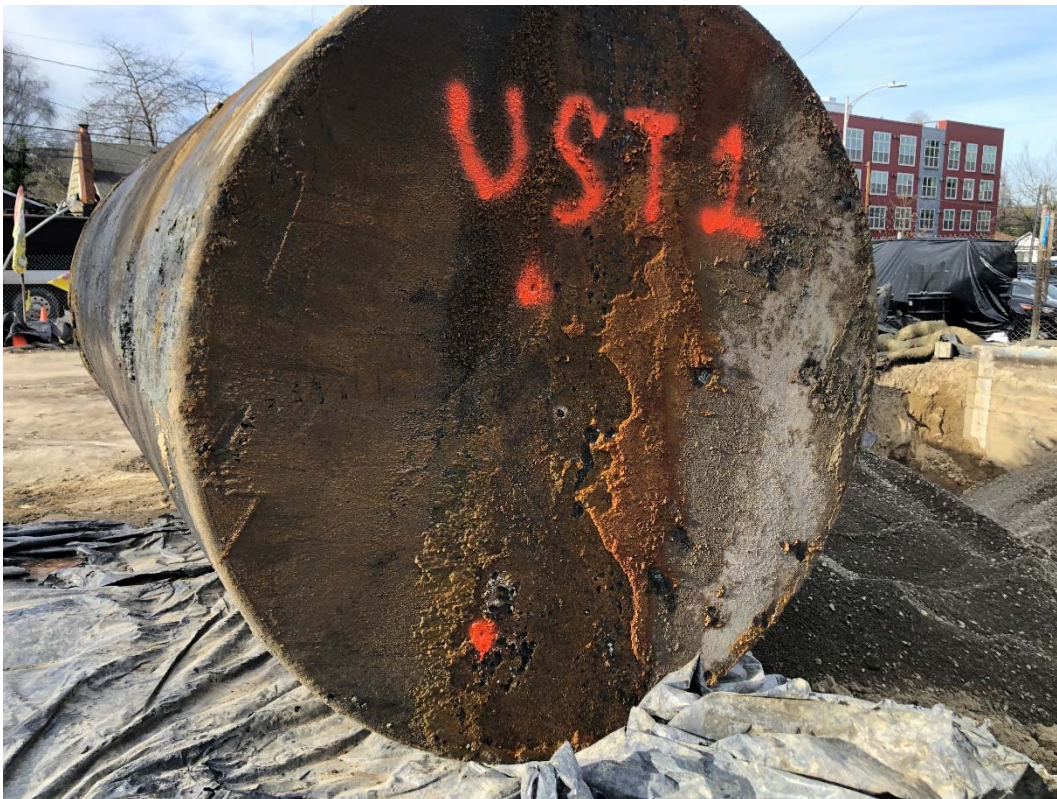
Photograph 12 – View of UST-1 removed from the ground, showing holes in the western wall of the UST painted in orange.

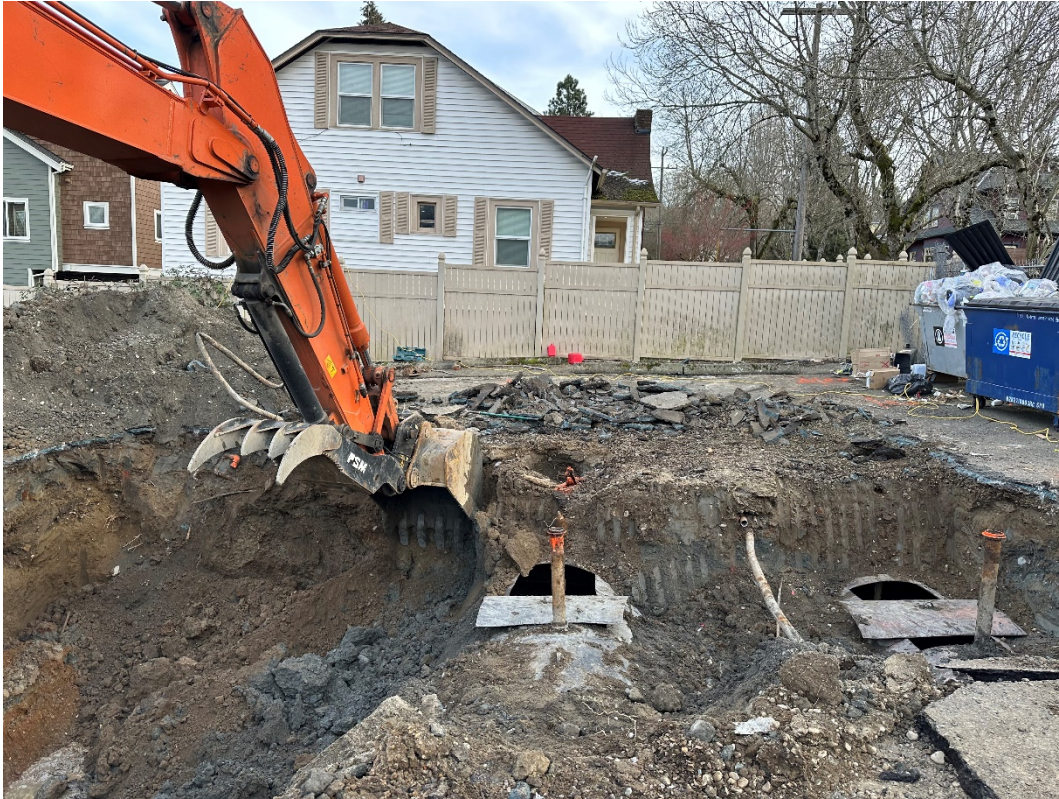
Photograph 13 – View of the former UST-1 location, PCS removal as indicated by the gray colored soil, and UST-2 (center) and UST-3 (right) awaiting removal.

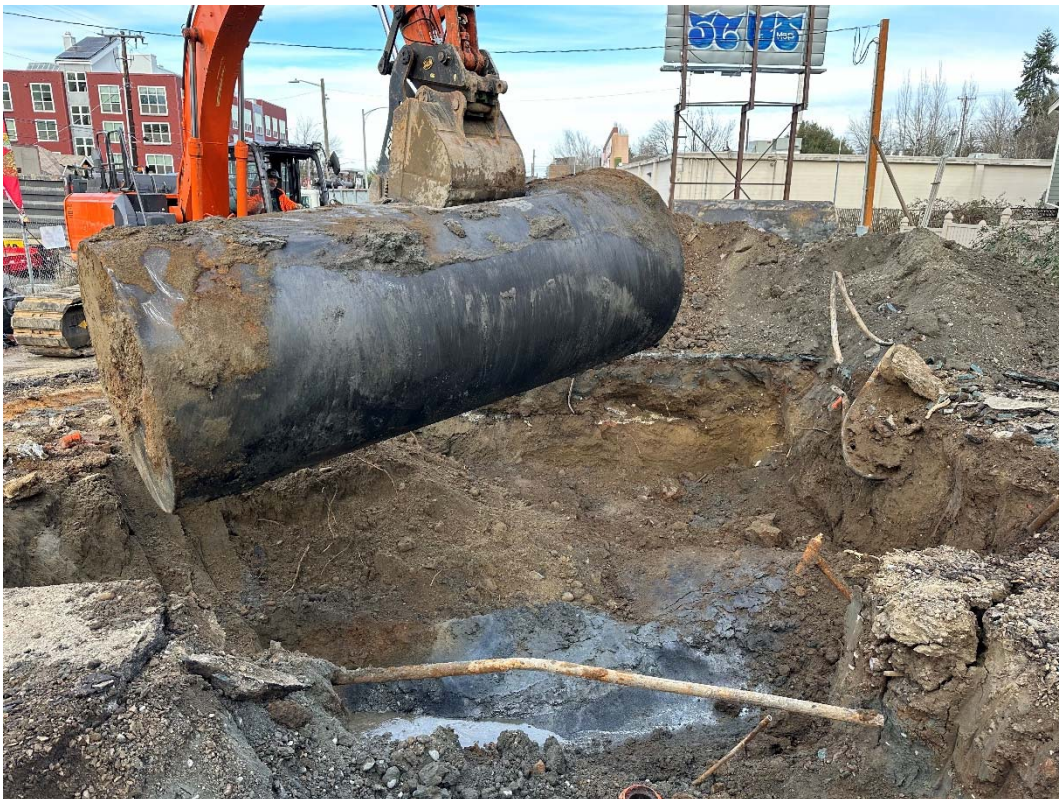
Photograph 14 – View of the UST-2 removal, showing underlying PCS indicated by the gray colored soil. UST-3 fill port is shown remaining in place (bottom-center).

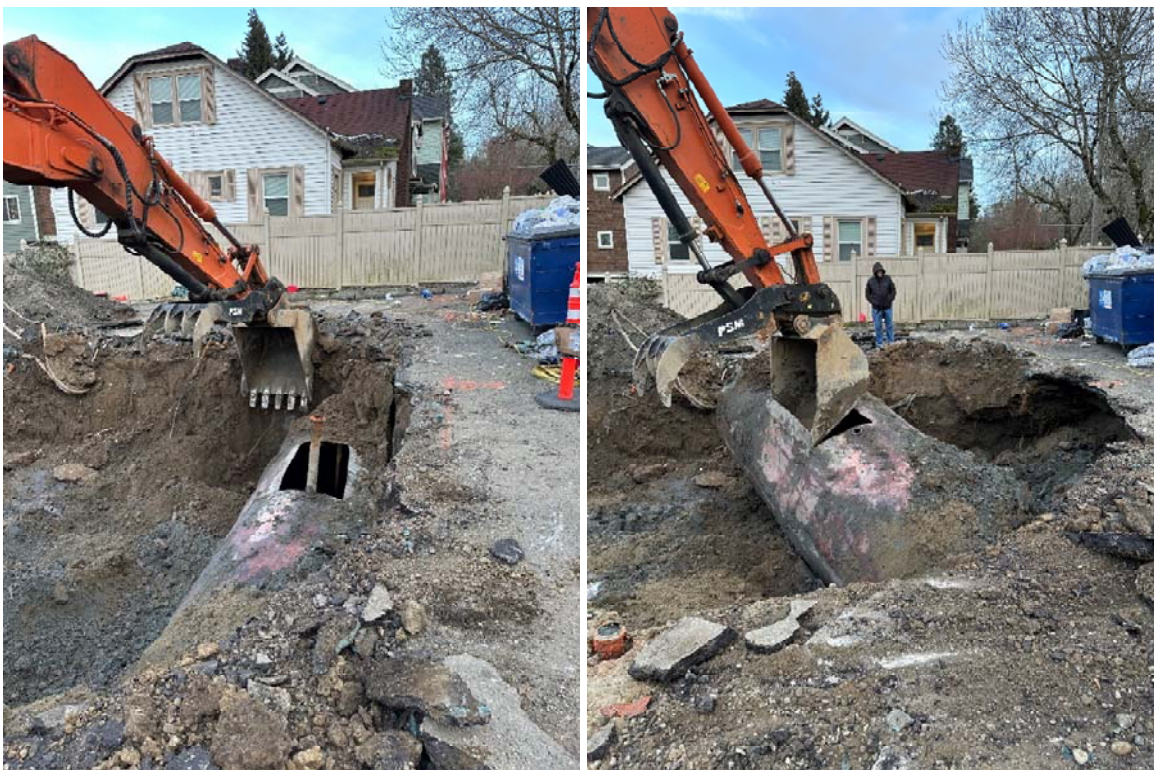
Photograph 15 – Two views of UST-3, showing it in place with top cut open (left) and being removed from the ground by the excavator (right).

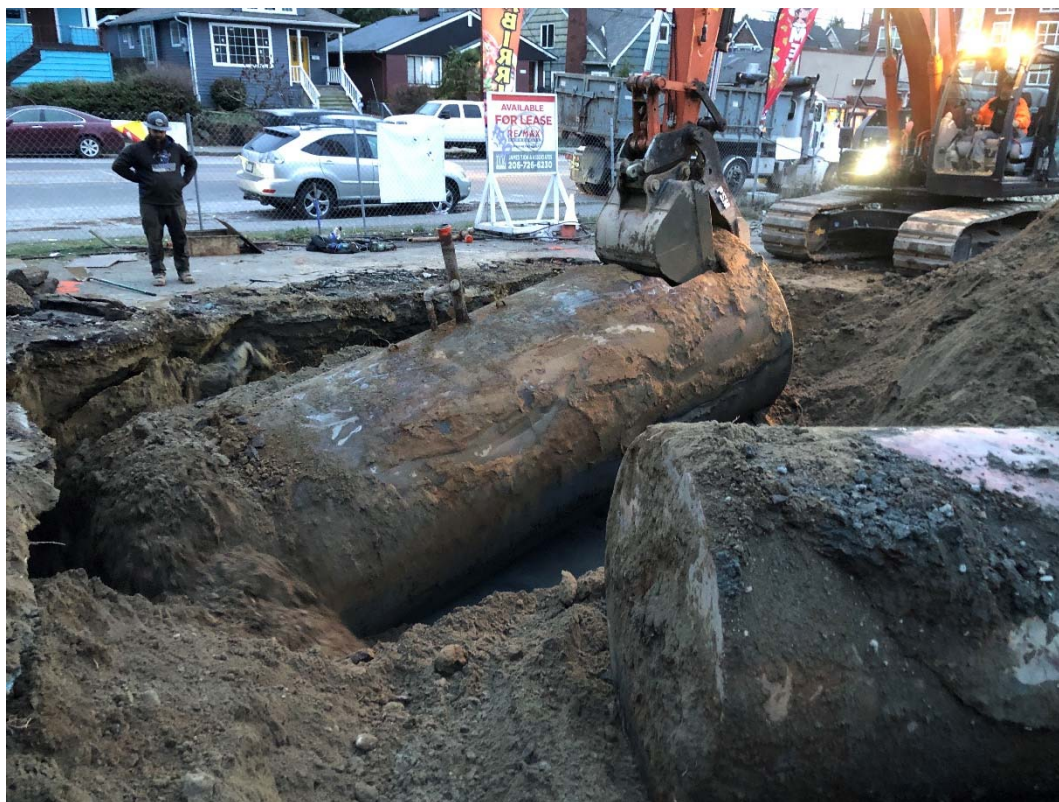
Photograph 16 – View of UST-4 being removed from the ground by the excavator.

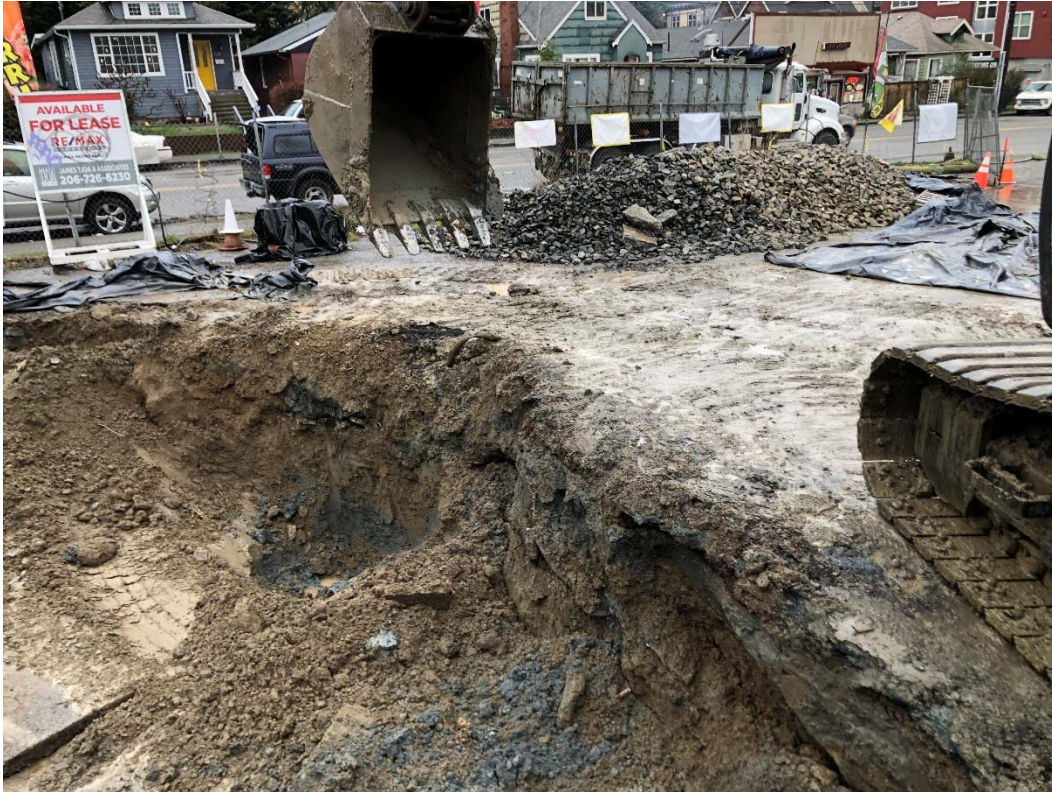
Photograph 17 – Representative view of Gas Station USTs AOC excavation following removal of all USTs, showing the presence of a zone of PCS approximately 7 feet to 10 feet bgs to the north of the former UST-4 location and west of the former UST-1 location indicated by gray soil (left of center).

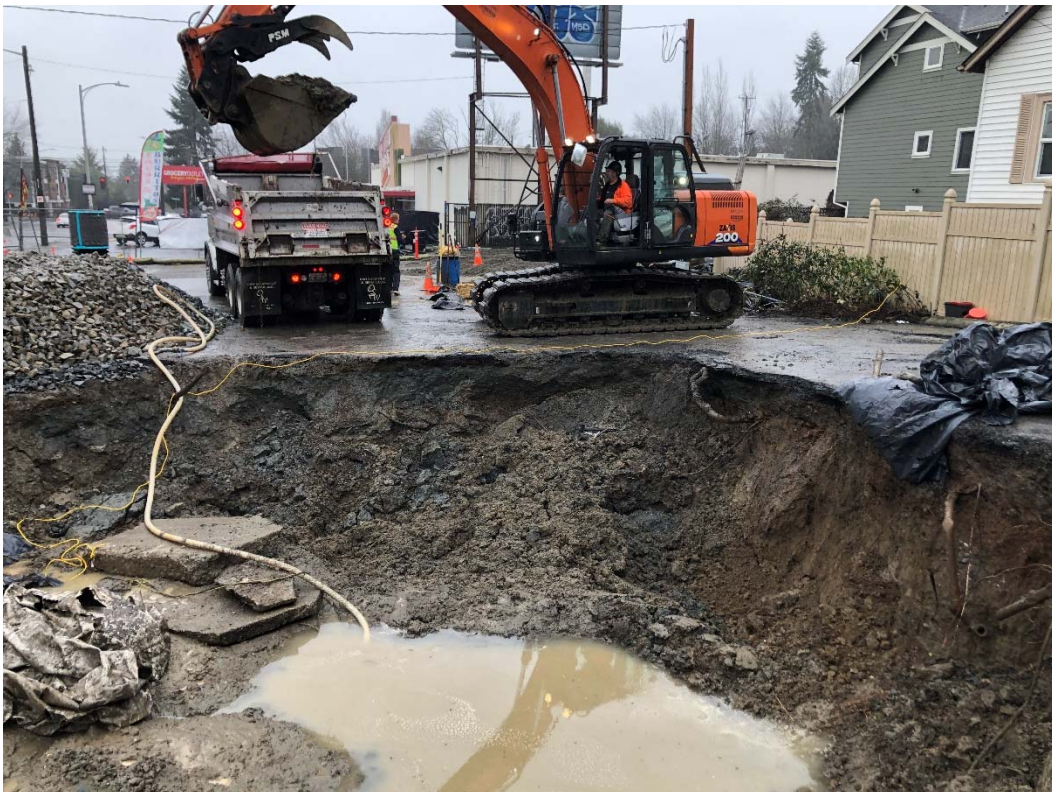
Photograph 18 – Representative view of Gas Station USTs AOC excavation, showing removal of PCS and the presence of accumulated rainwater and groundwater, which was pumped into totes for offsite disposal. Stockpiled quarry spalls backfill is present (left), ready to be placed following excavation to final depth.

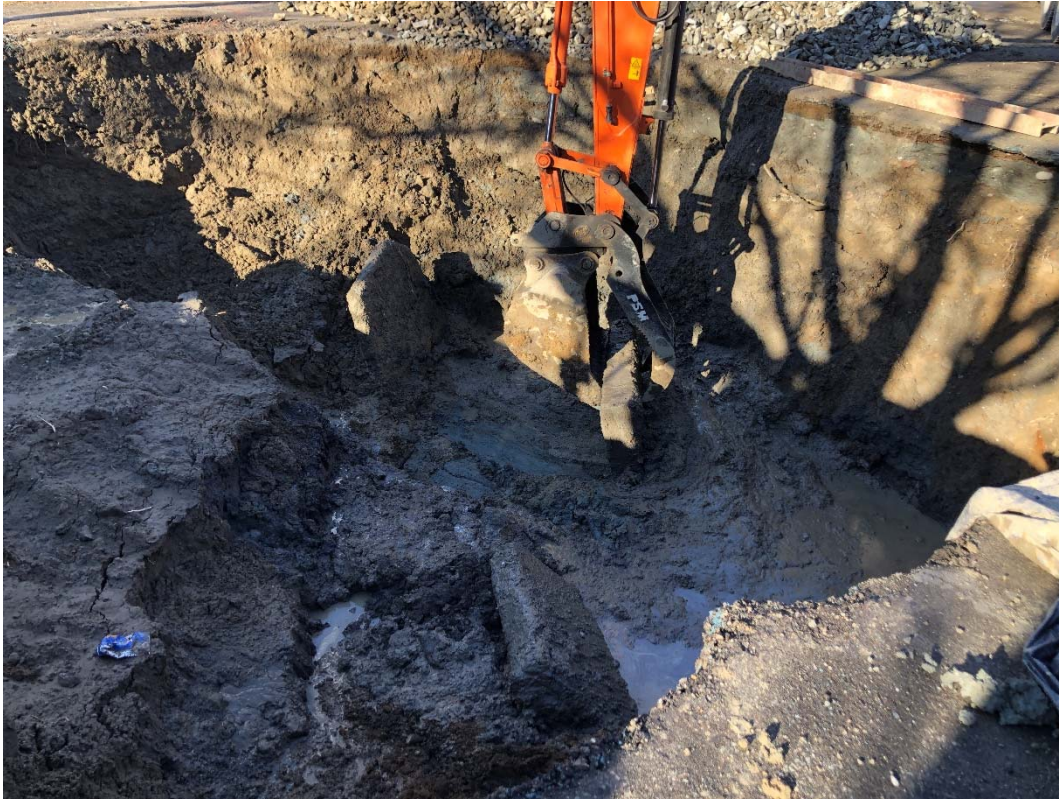
Photograph 19 – View of Gas Station USTs AOC excavation, showing the completion of the excavation to the depth of the silty organic layer encountered approximately 12 feet to 13 feet bgs in this portion of the Property.

Although this excavation was extended within close proximity to the southern and western Property boundaries, clearance soil samples were able to be collected beyond the extent of PCS, showing that no PCS remained in place following the excavation in this AOC. Due to the geotechnical concerns in this portion of the Property relating to the adjoining streets to the south and west, the bottom of the excavation was backfilled with quarry spalls up to approximately 6 feet bgs, at which point imported type-17 backfill completed the restoration to the original ground surface.

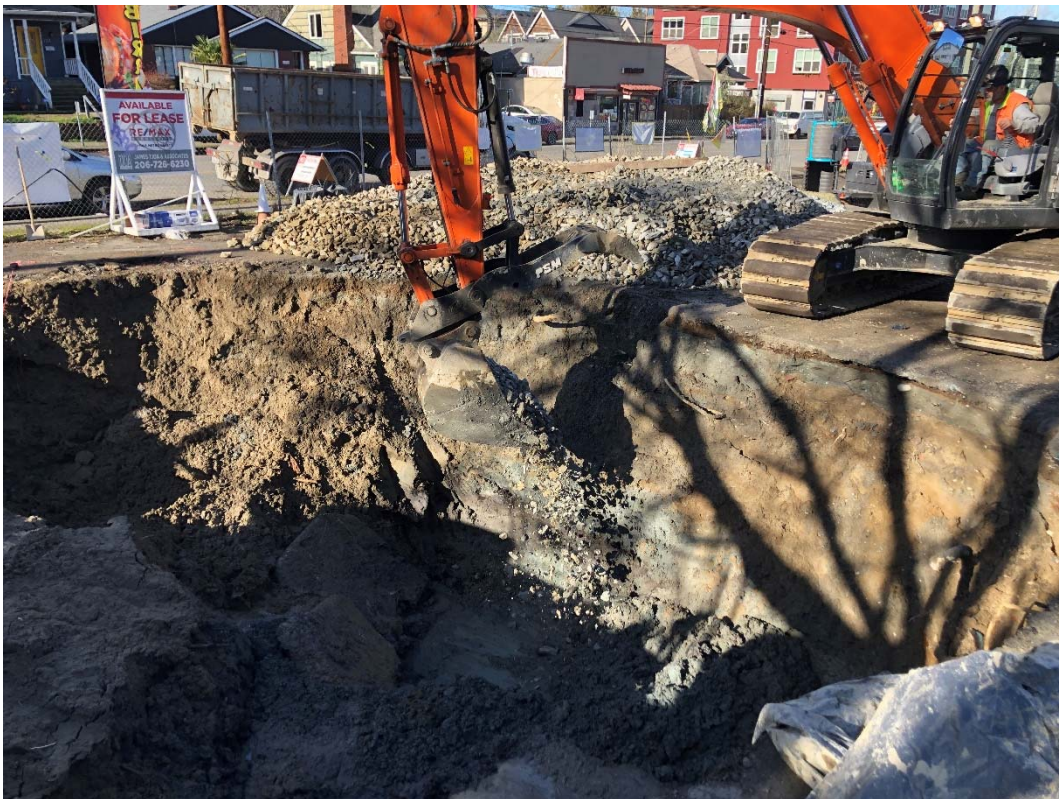
Photograph 20 – View of Gas Station USTs AOC excavation, showing placement of quarry spalls backfill at the base of the completed excavation.

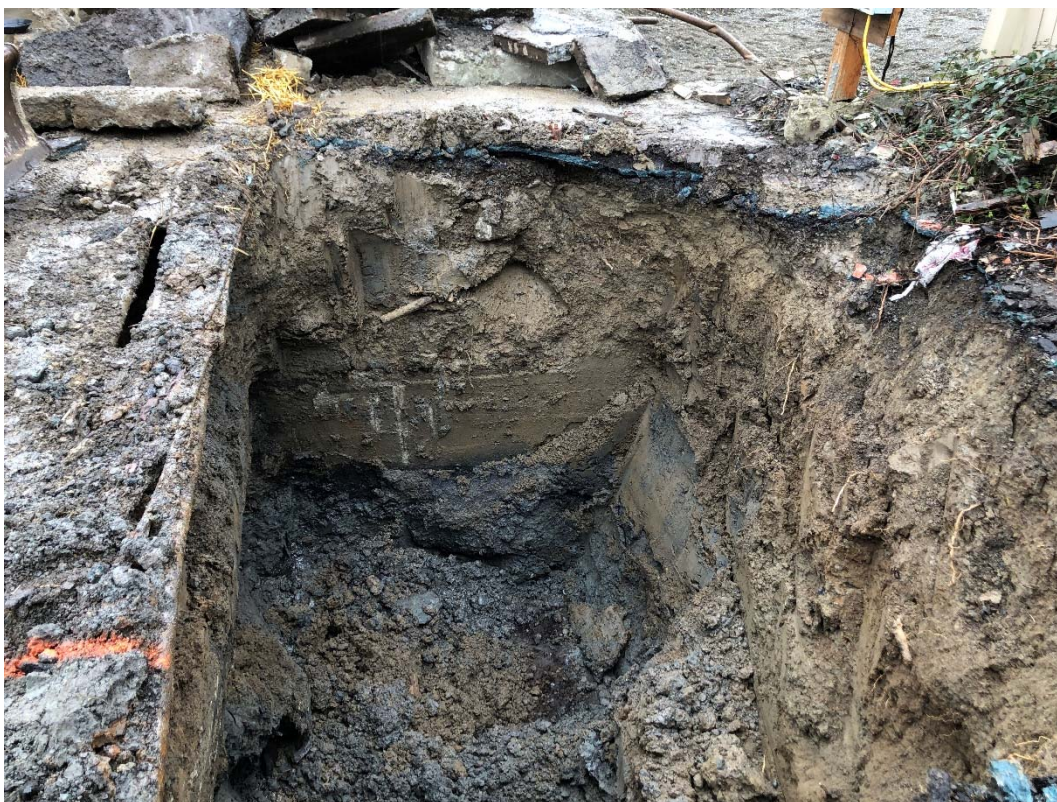
Photograph 21 – View of Heating Oil UST AOC excavation, showing the excavation extending to the depth of approximately 10 feet bgs where the dark brown silty organic soil was encountered beneath the gray PCS. Concrete debris is shown (center).

In addition to removal of soil, concrete debris was encountered within the excavation surrounding the original UST to the north, south, and west. The presence of this debris altered the excavation process and caused excavation sidewalls to collapse. A sanitary sewer line crossing the excavation was damaged during the excavation process and required repair by Zeppelin. The excavation extended south of the sewer line to provide access for the repair activity.

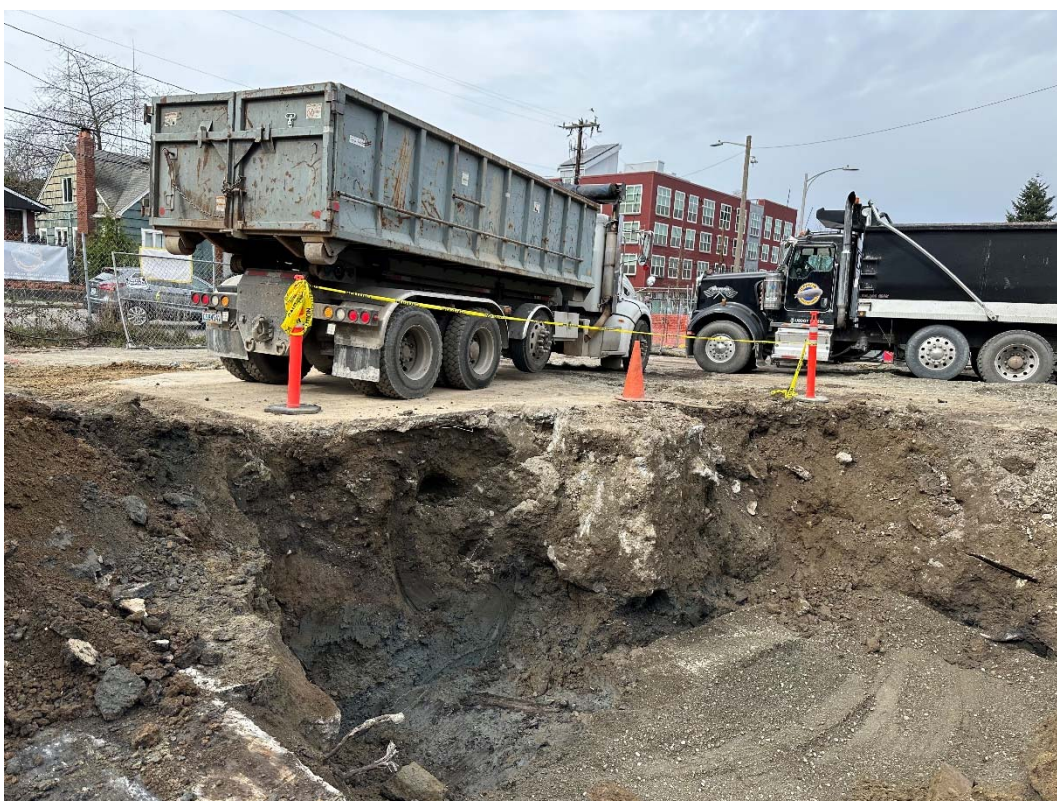
Photograph 22 – View of the completed Heating Oil UST AOC excavation, showing the type 17 backfill (lower right), and gray PCS associated with the Pump Island AOC remaining for upcoming removal.

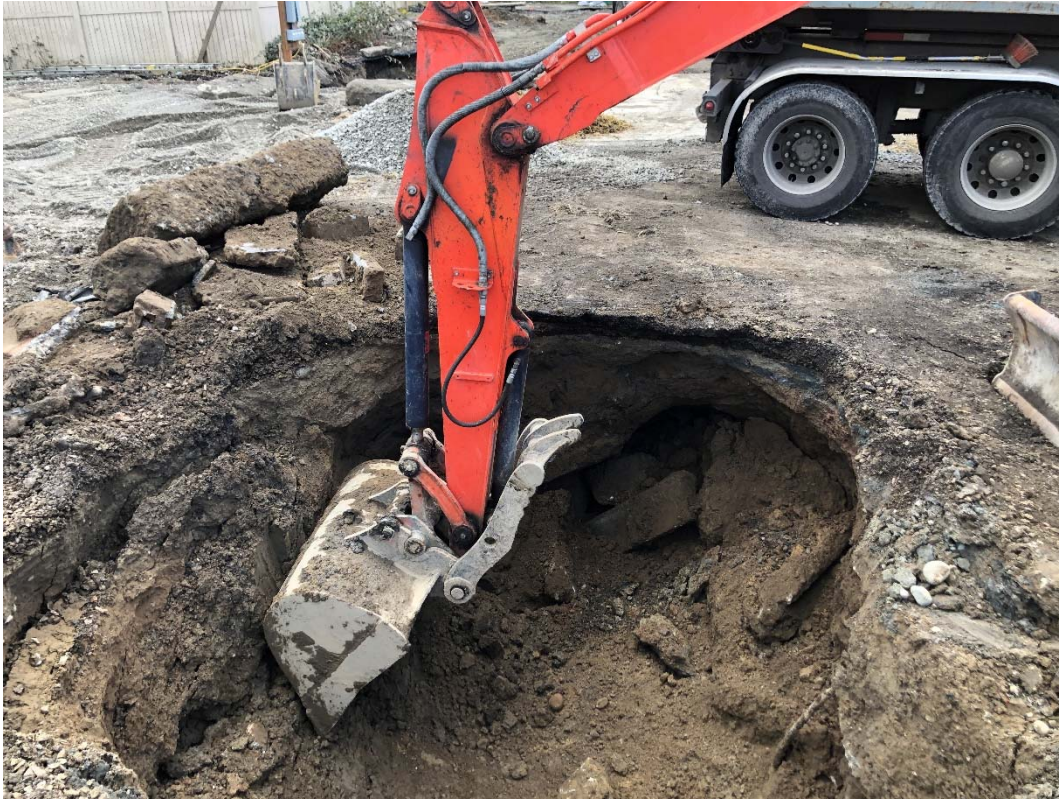
Photograph 23 – View of the Waste Oil UST AOC excavation, showing removal of PCS and the presence of concrete debris surrounding the former UST location.
