# Remedial Action Report

**J & J Auto Masters  
1110 Martin Luther King Jr. Way  
Seattle, Washington 98122  
King County Parcel No. 118900-0469**

**Project Number: 103701-7,8**

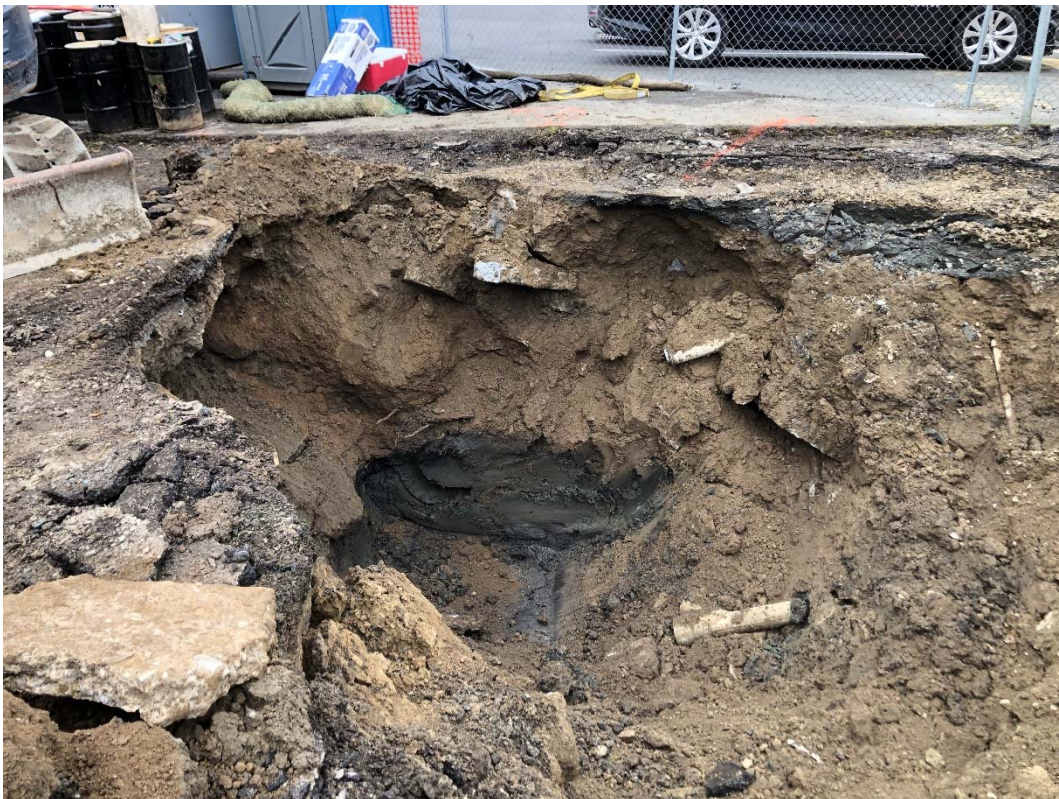
Photograph 24 – View of the Waste Oil UST AOC excavation, showing completion to the silty organic layer present approximately 10 feet bgs and PCS remaining in place approximately 7 feet to 9 feet bgs along the north sidewall (center).

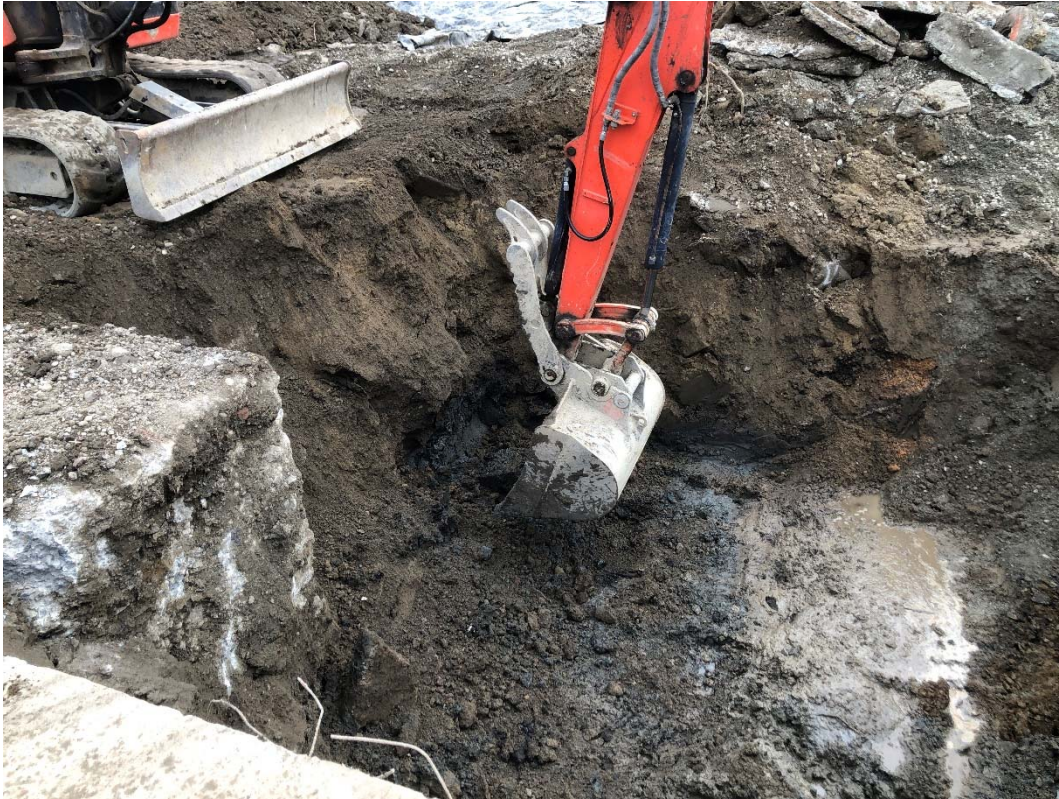
Photograph 25 – Excavation in the Pump Island AOC, showing removal of gray PCS and concrete debris. The large concrete block (left) was the eastern foundation for the pump island canopy support.

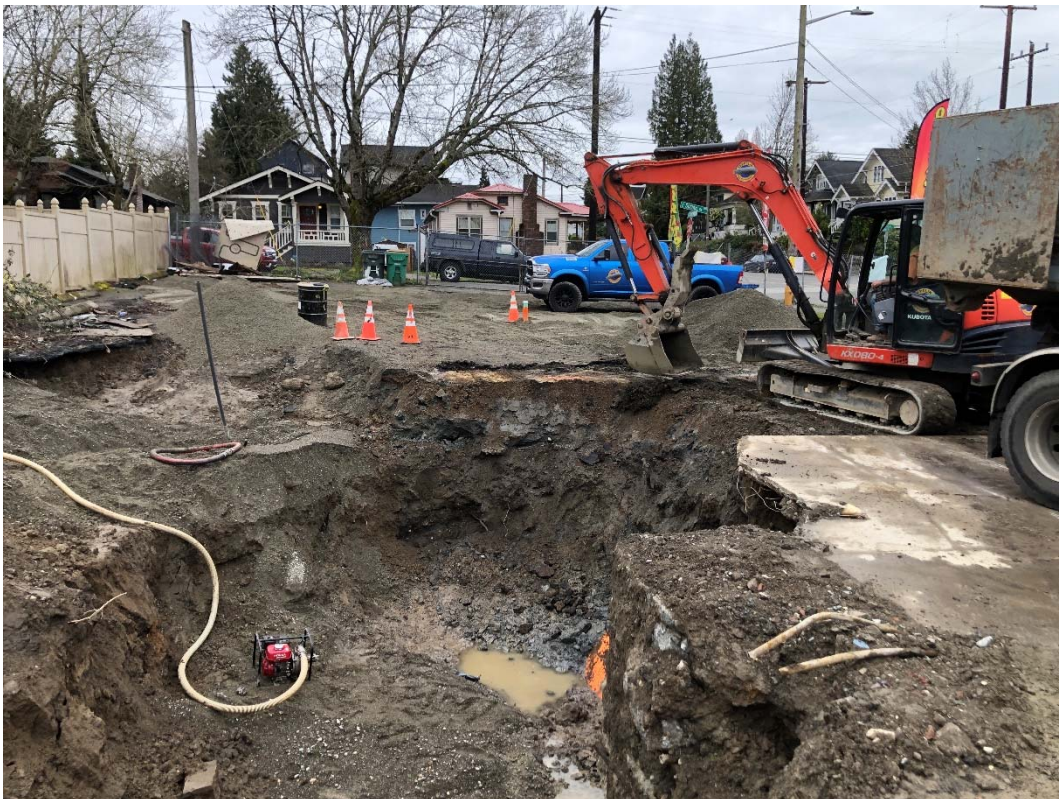
Photograph 26 – Excavation in the Pump Island AOC, showing gray PCS and remnants of the former pump island concrete slab. The mostly backfilled Heatin Oil UST AOC excavation area is shown (center-left).

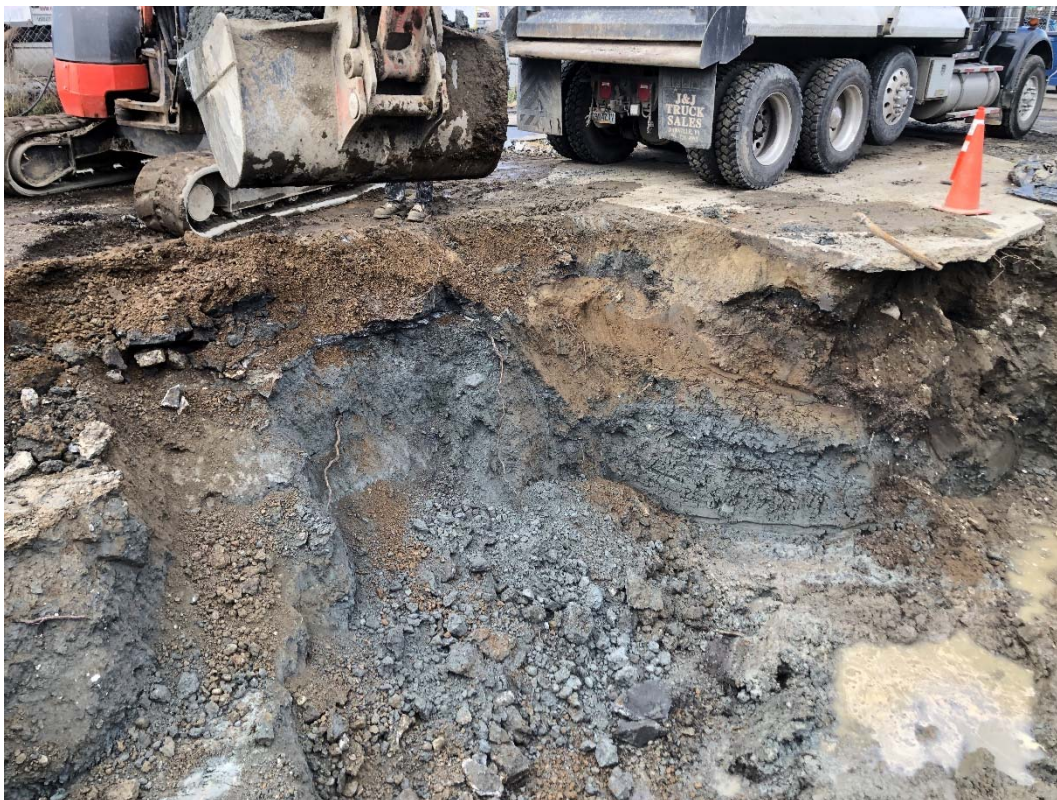
Photograph 27 – Further excavation in the Pump Island AOC, showing gray PCS and remnants of the former pump island concrete slab.

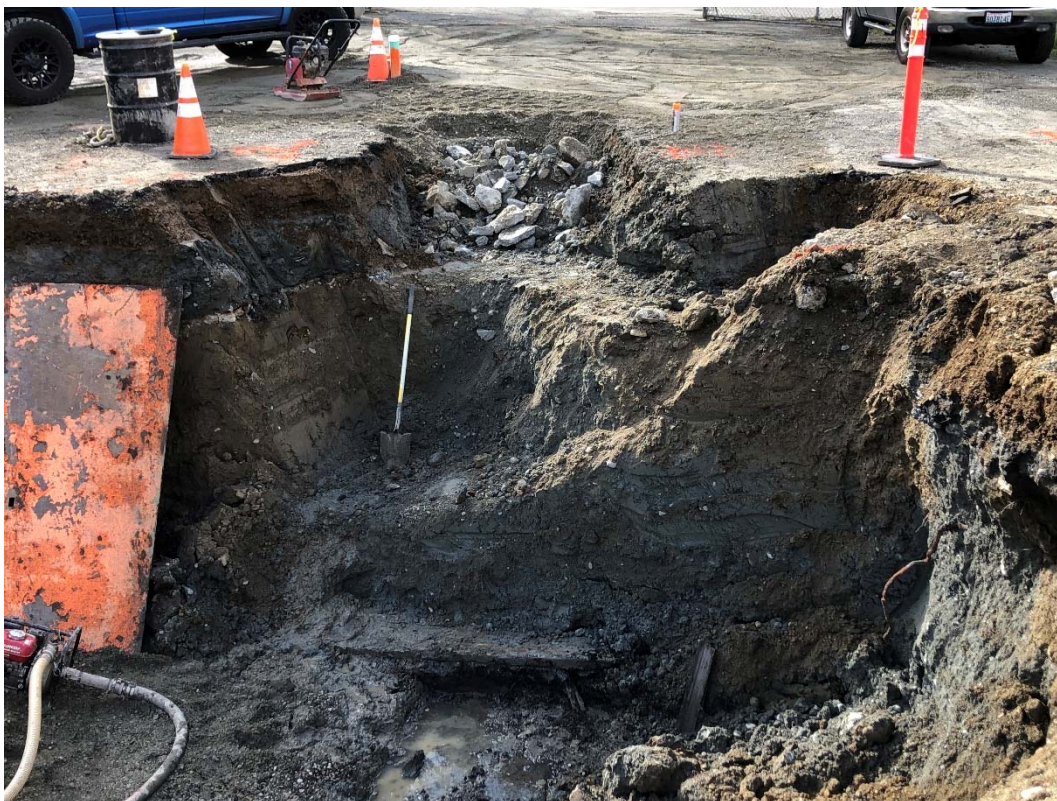
Photograph 28 – View south showing the southern extent of the Pump Island AOC excavation, and the 3-foot bgs excavation that followed the former transfer lines from the Gas Station USTs AOC (center-top) to the former pump islands.

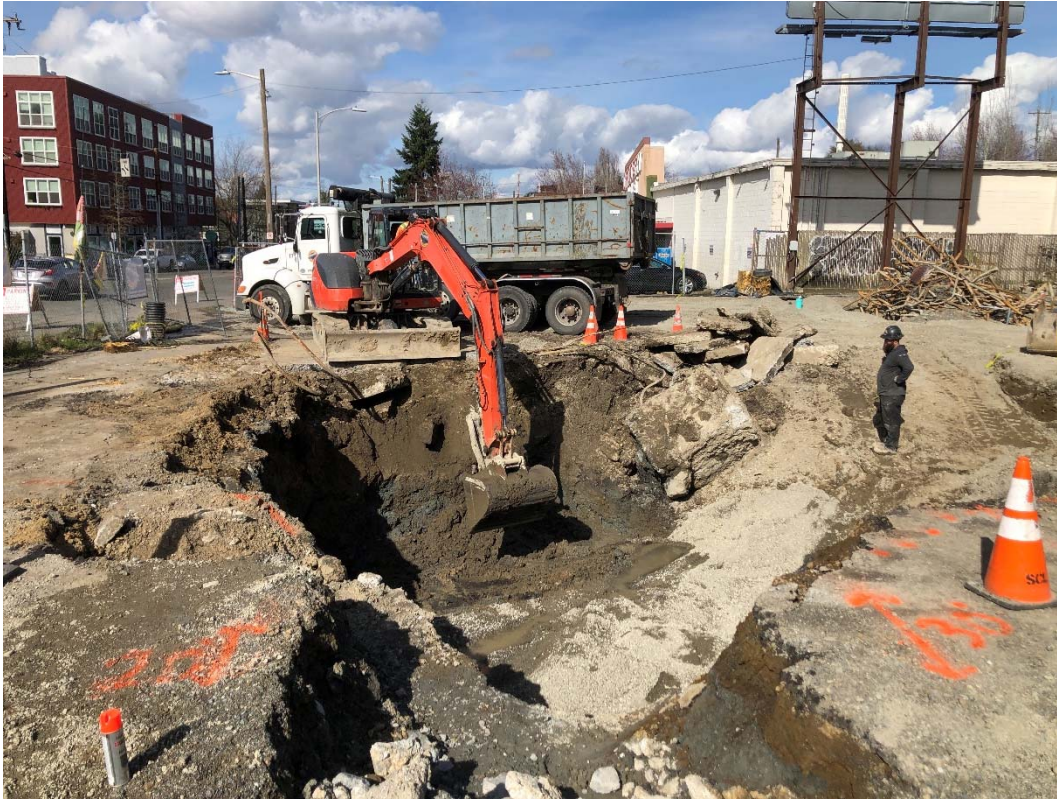
Photograph 29 – View north of the Pump Island AOC excavation, showing the backfilled eastern portion of the AOC and concrete debris. The eastern large concrete canopy support is shown (center-right).

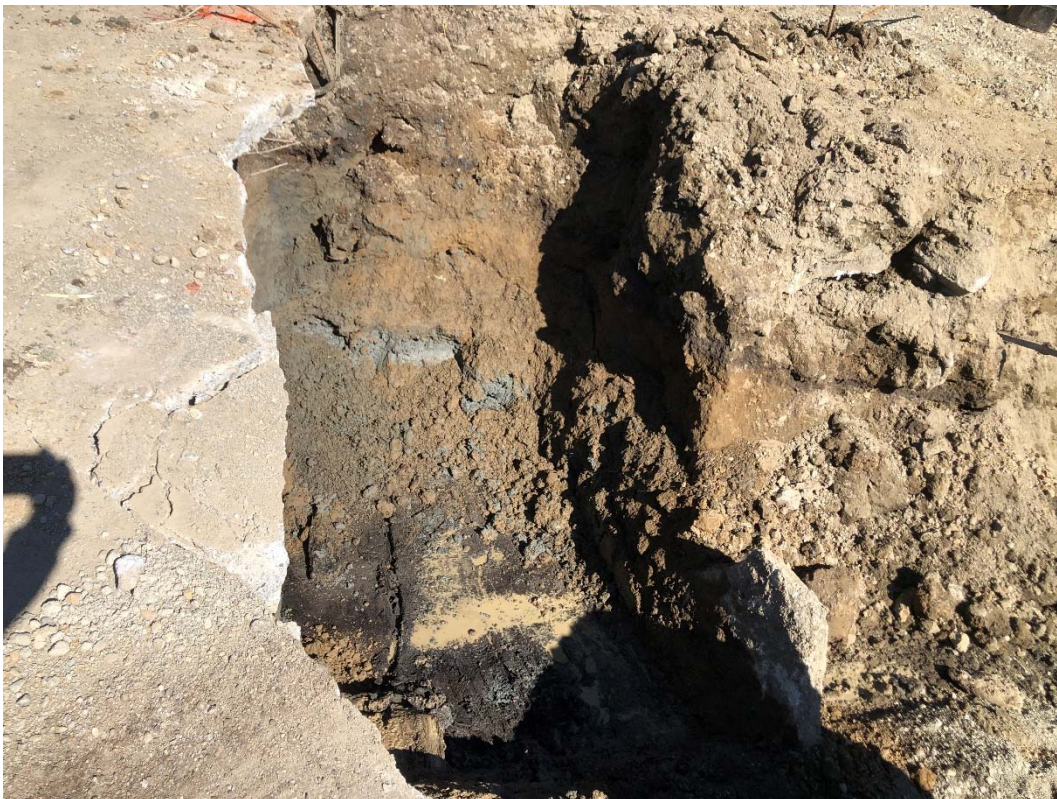
Photograph 30 – View of the Pump Island AOC excavation, showing the dark brown silty organic soil zone encountered approximately 8.5 feet to 9.5 feet bgs in this portion of the Property.
