Final Data Gaps Investigation and Cleanup Options Report

Raplee Property
Cleanup Site ID #5275

City of Stanwood

May 14, 2025

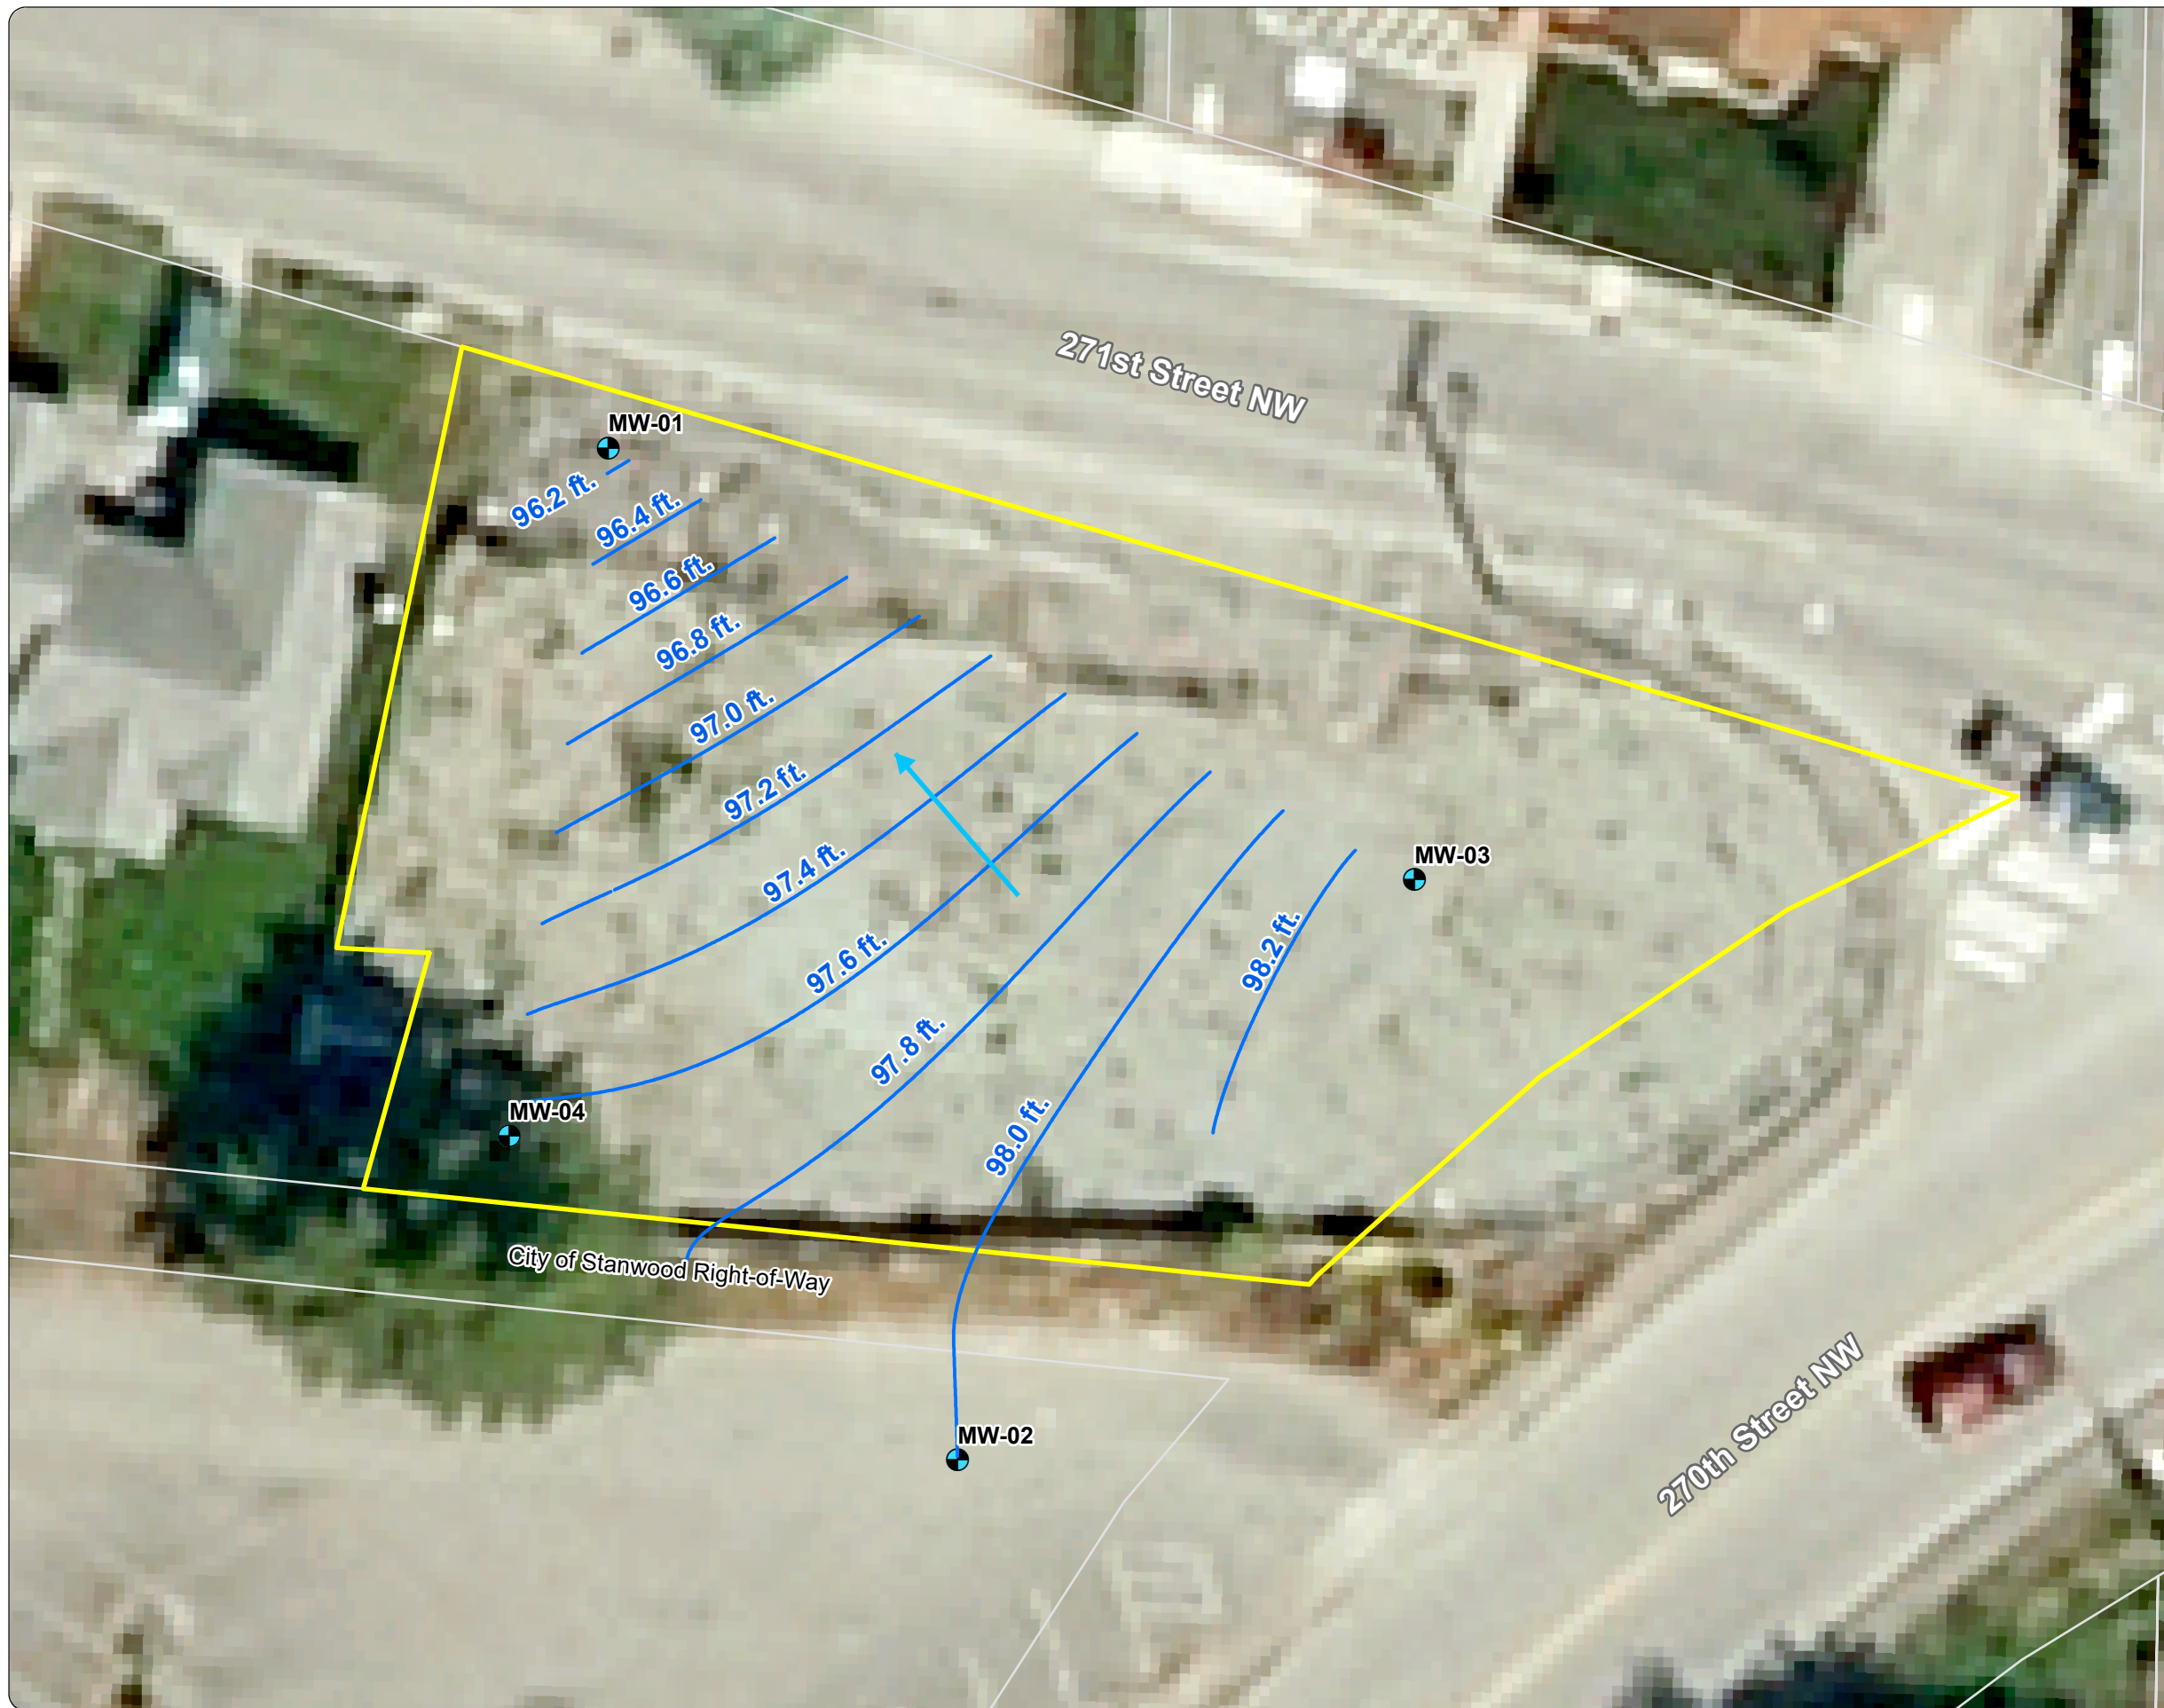
Notes:
 All property feature locations are approximate.
 TOC elevations are expressed in feet relative to an arbitrary datum of 100.00 feet at MW-1 (SAIC, 2006).
 TOC = top of casing.

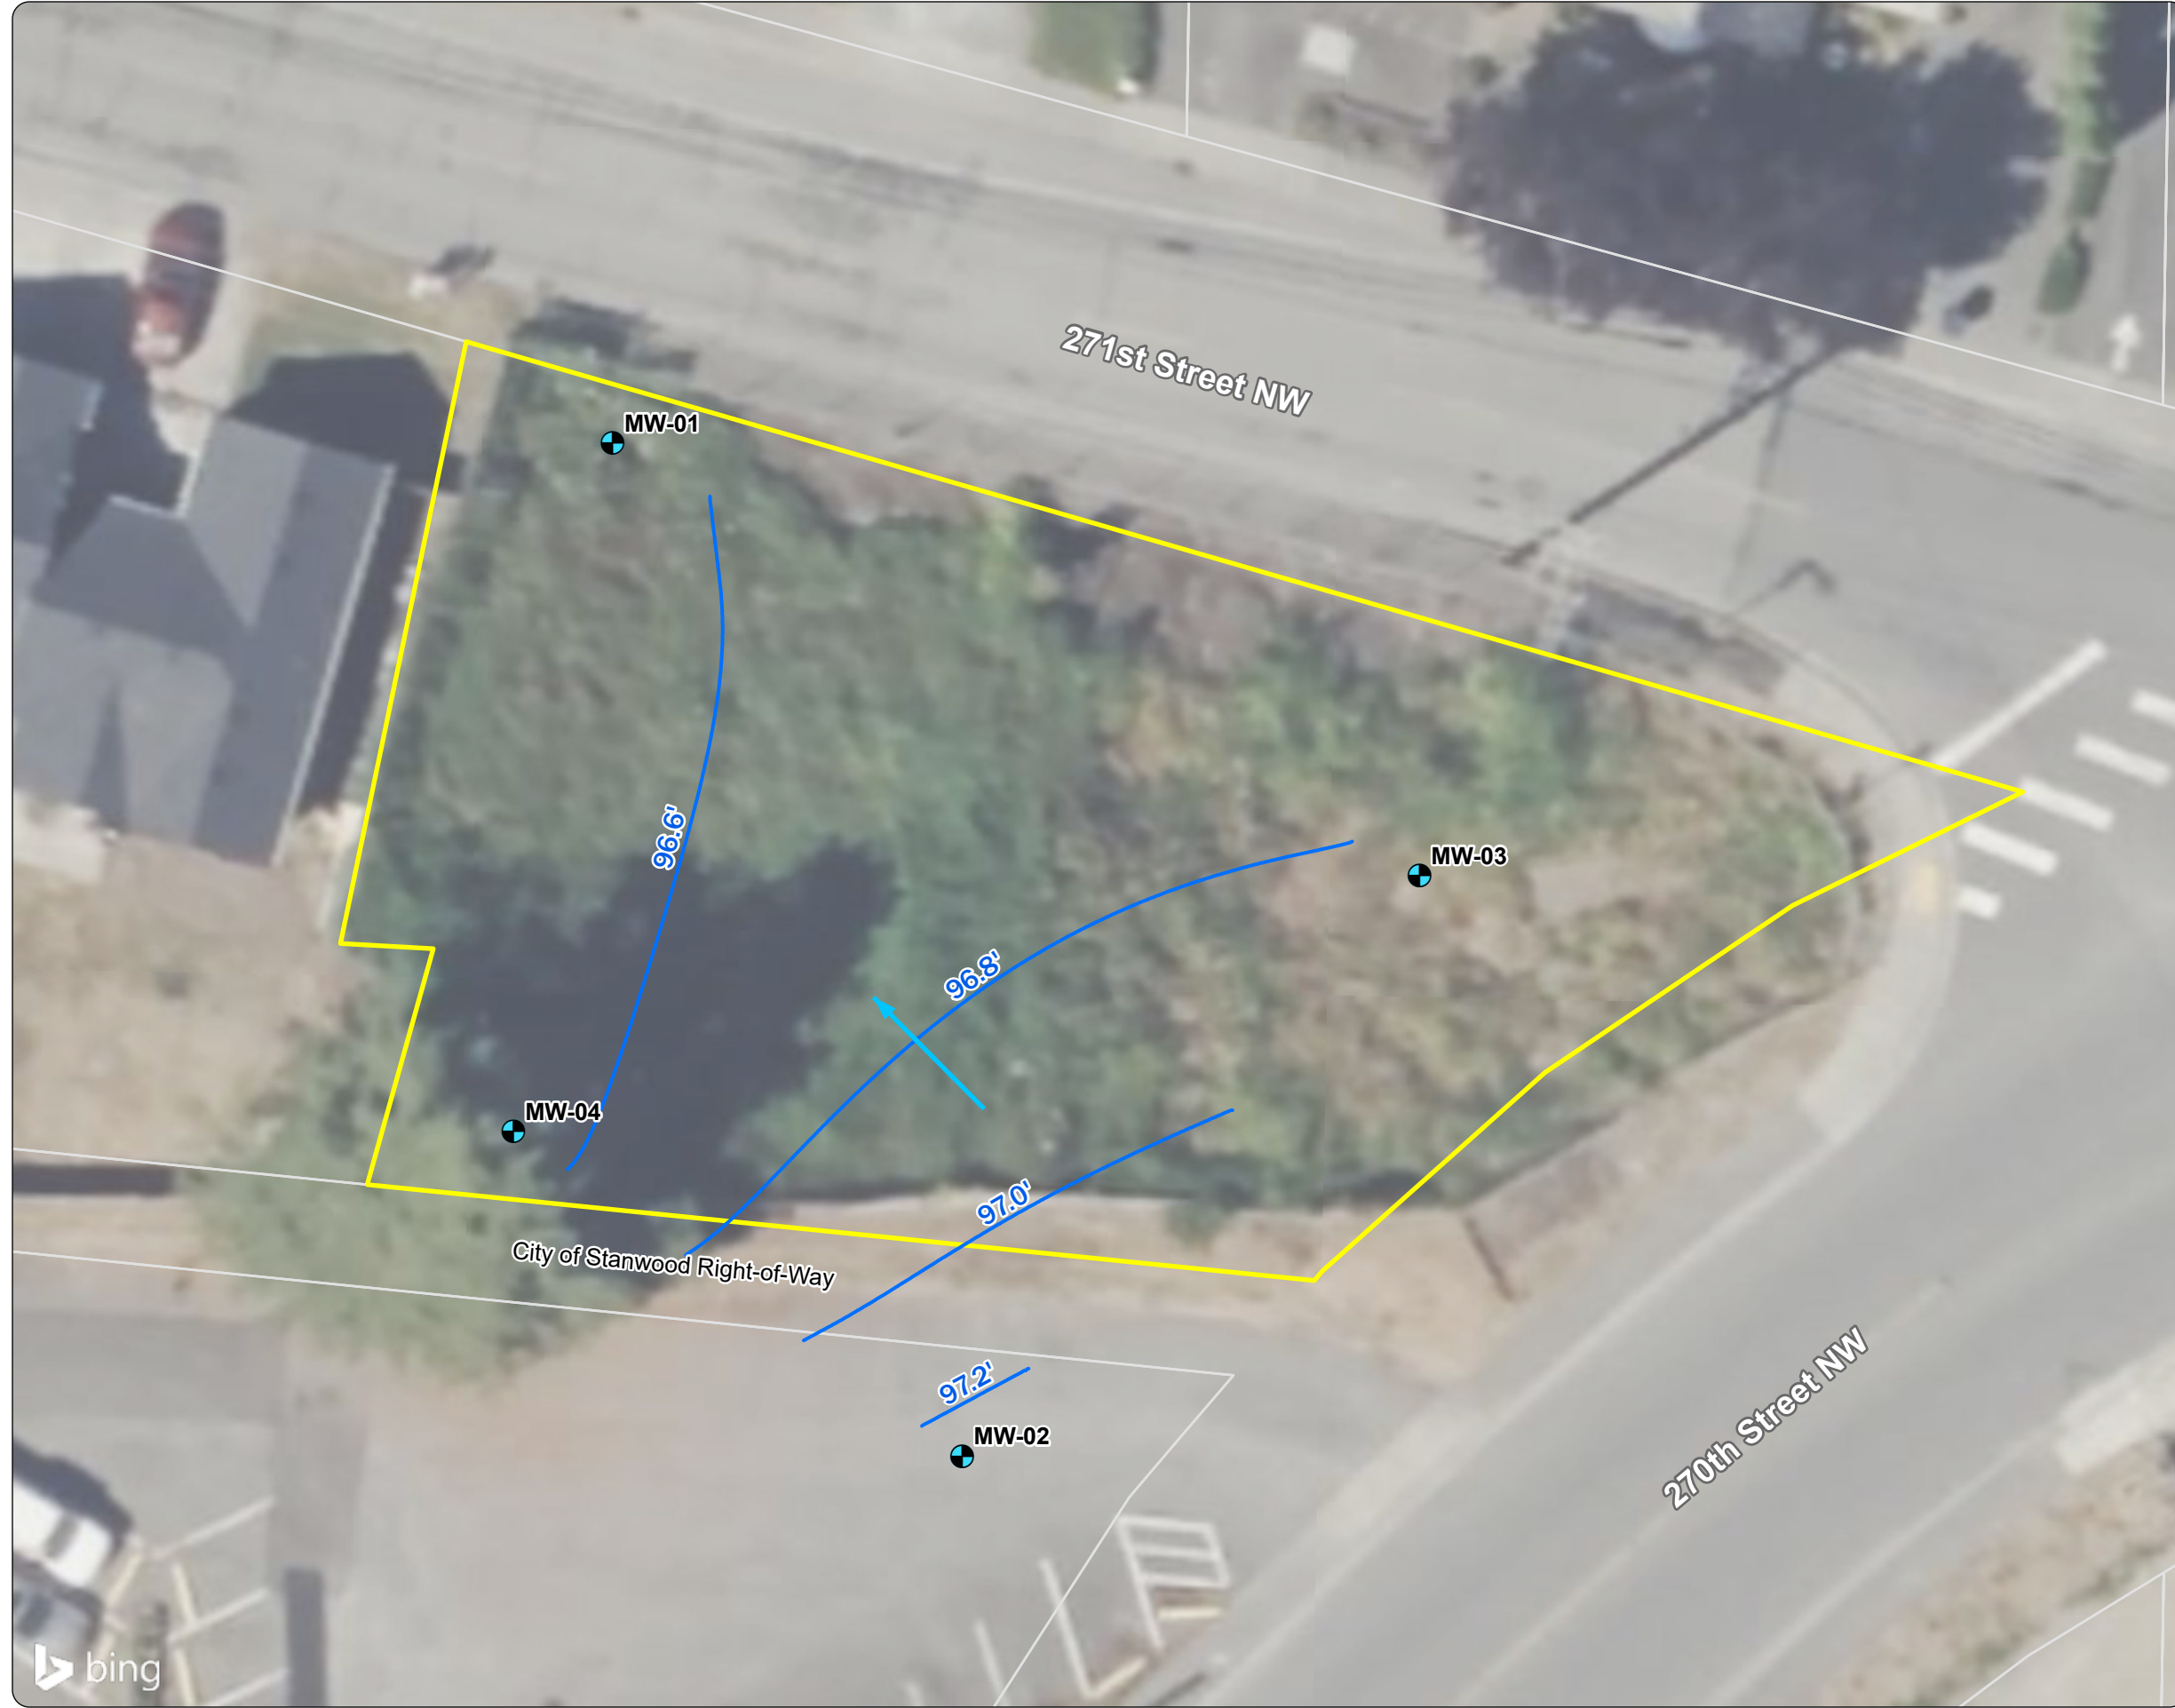
Notes:
Depths to groundwater measured between 1:01 pm and 1:27 pm on July 12, 2024. All property feature locations are approximate. TOC elevations are expressed in feet relative to an arbitrary datum of 100.00 feet at MW-04 SAIC, 2006). TOC = top of casing.

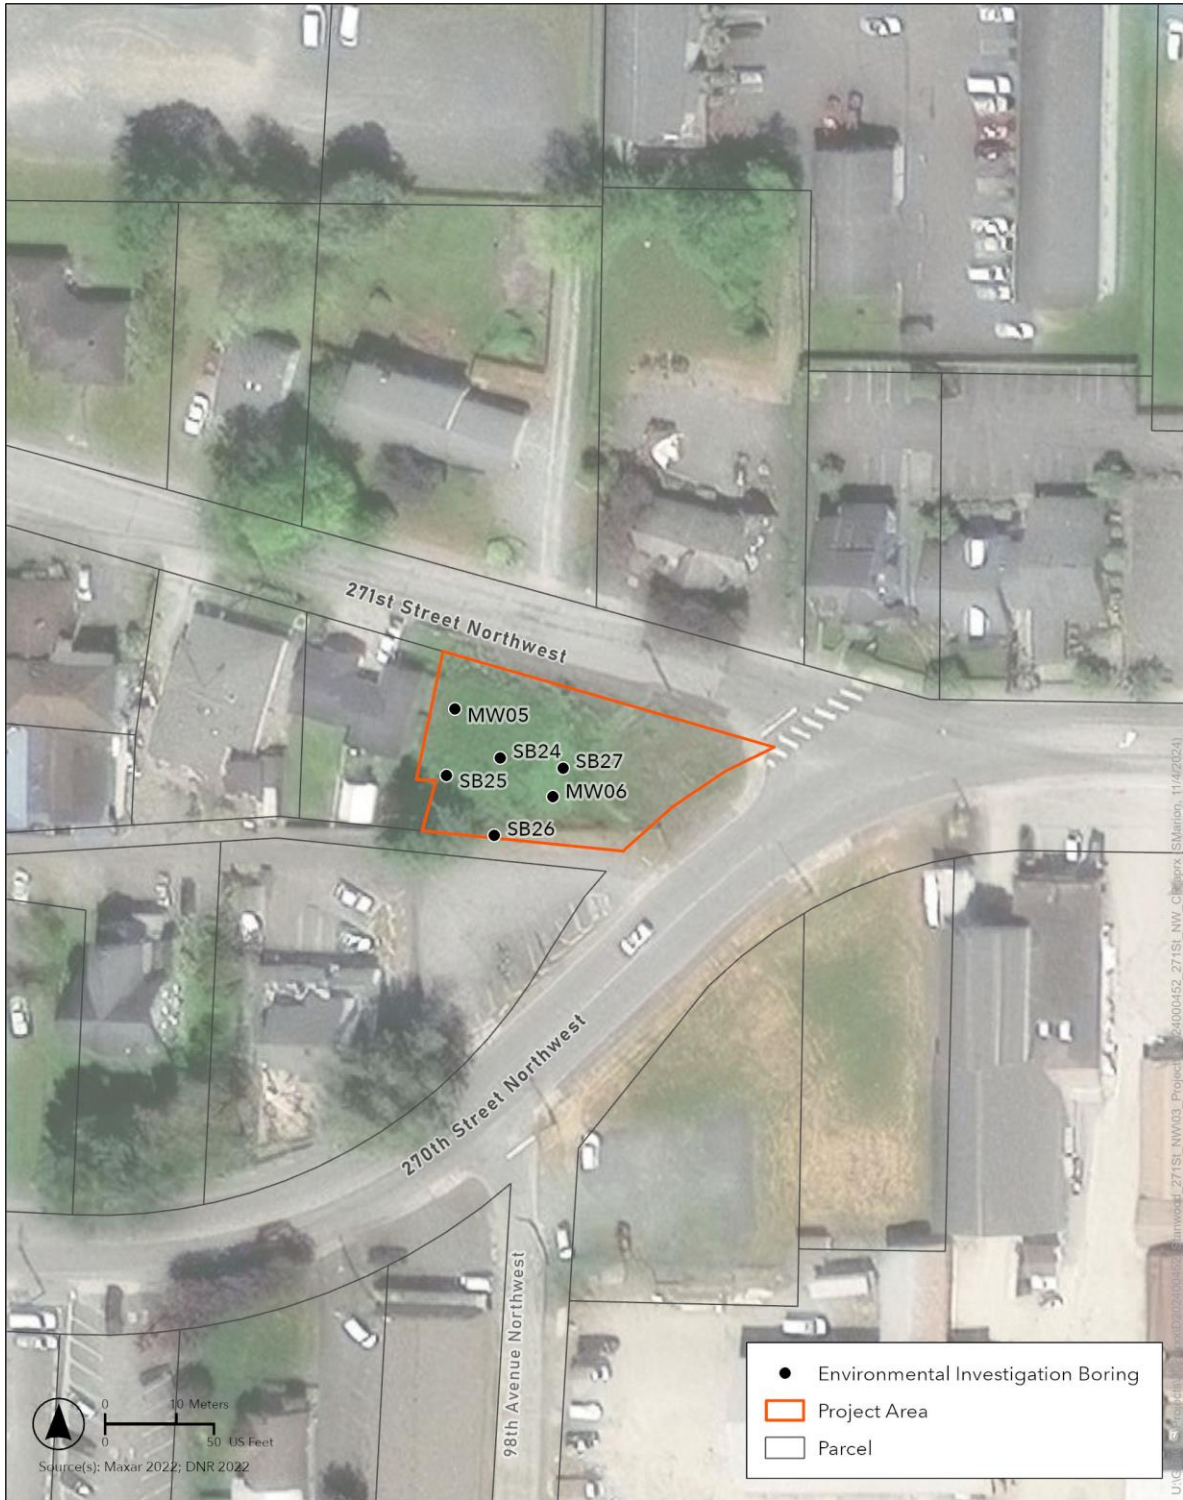
Figure 2
Locations of environmental investigation borings

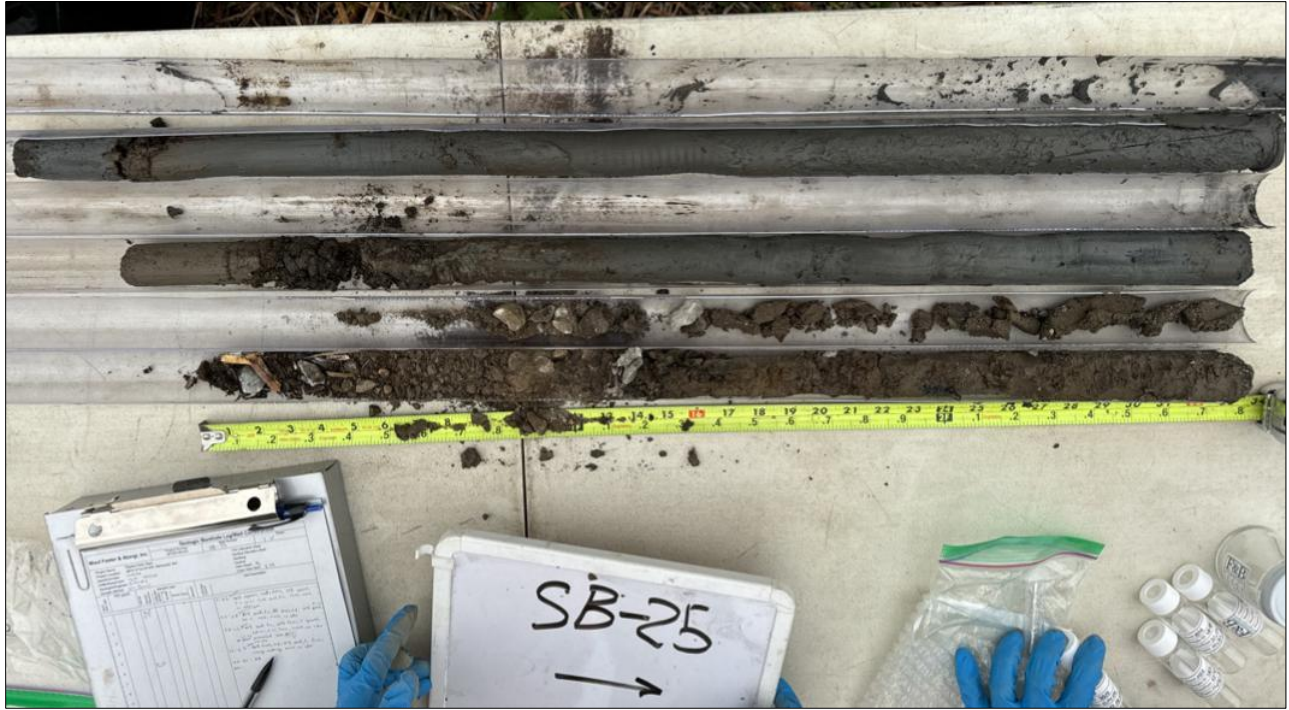
Figure 4
Close up view of typical sample as observed at SB25
