**2024 Q3 and Q4 GROUNDWATER AND SOIL VAPOR DATA REPORT  
AMERICAN LINEN SUPPLY CO DEXTER AVE SITE  
AGREED ORDER NO. DE 14302**

NV5 has prepared this data submittal on behalf of BMR-Dexter LLC (“BMRD”) for the American Linen Supply Co. Dexter Ave Site (the “Site”) located at 700 Dexter Avenue North, Seattle, Washington. This submittal provides the data collected from the third quarter of 2024 through the fourth quarter of 2024, including data from interim action performance monitoring wells at the 700 Dexter Avenue North property (the “Property”) and at the Seattle Department of Transportation Mercer Parcels Site (also known as 800 Mercer), and remedial investigation (“RI”) monitoring wells. Groundwater elevation contour maps for the third and fourth quarters of 2024 are included in the Draft Interim Action Work Plan Addendum No.3, submitted to the Washington State Department of Ecology (Ecology) on March 18, 2025.

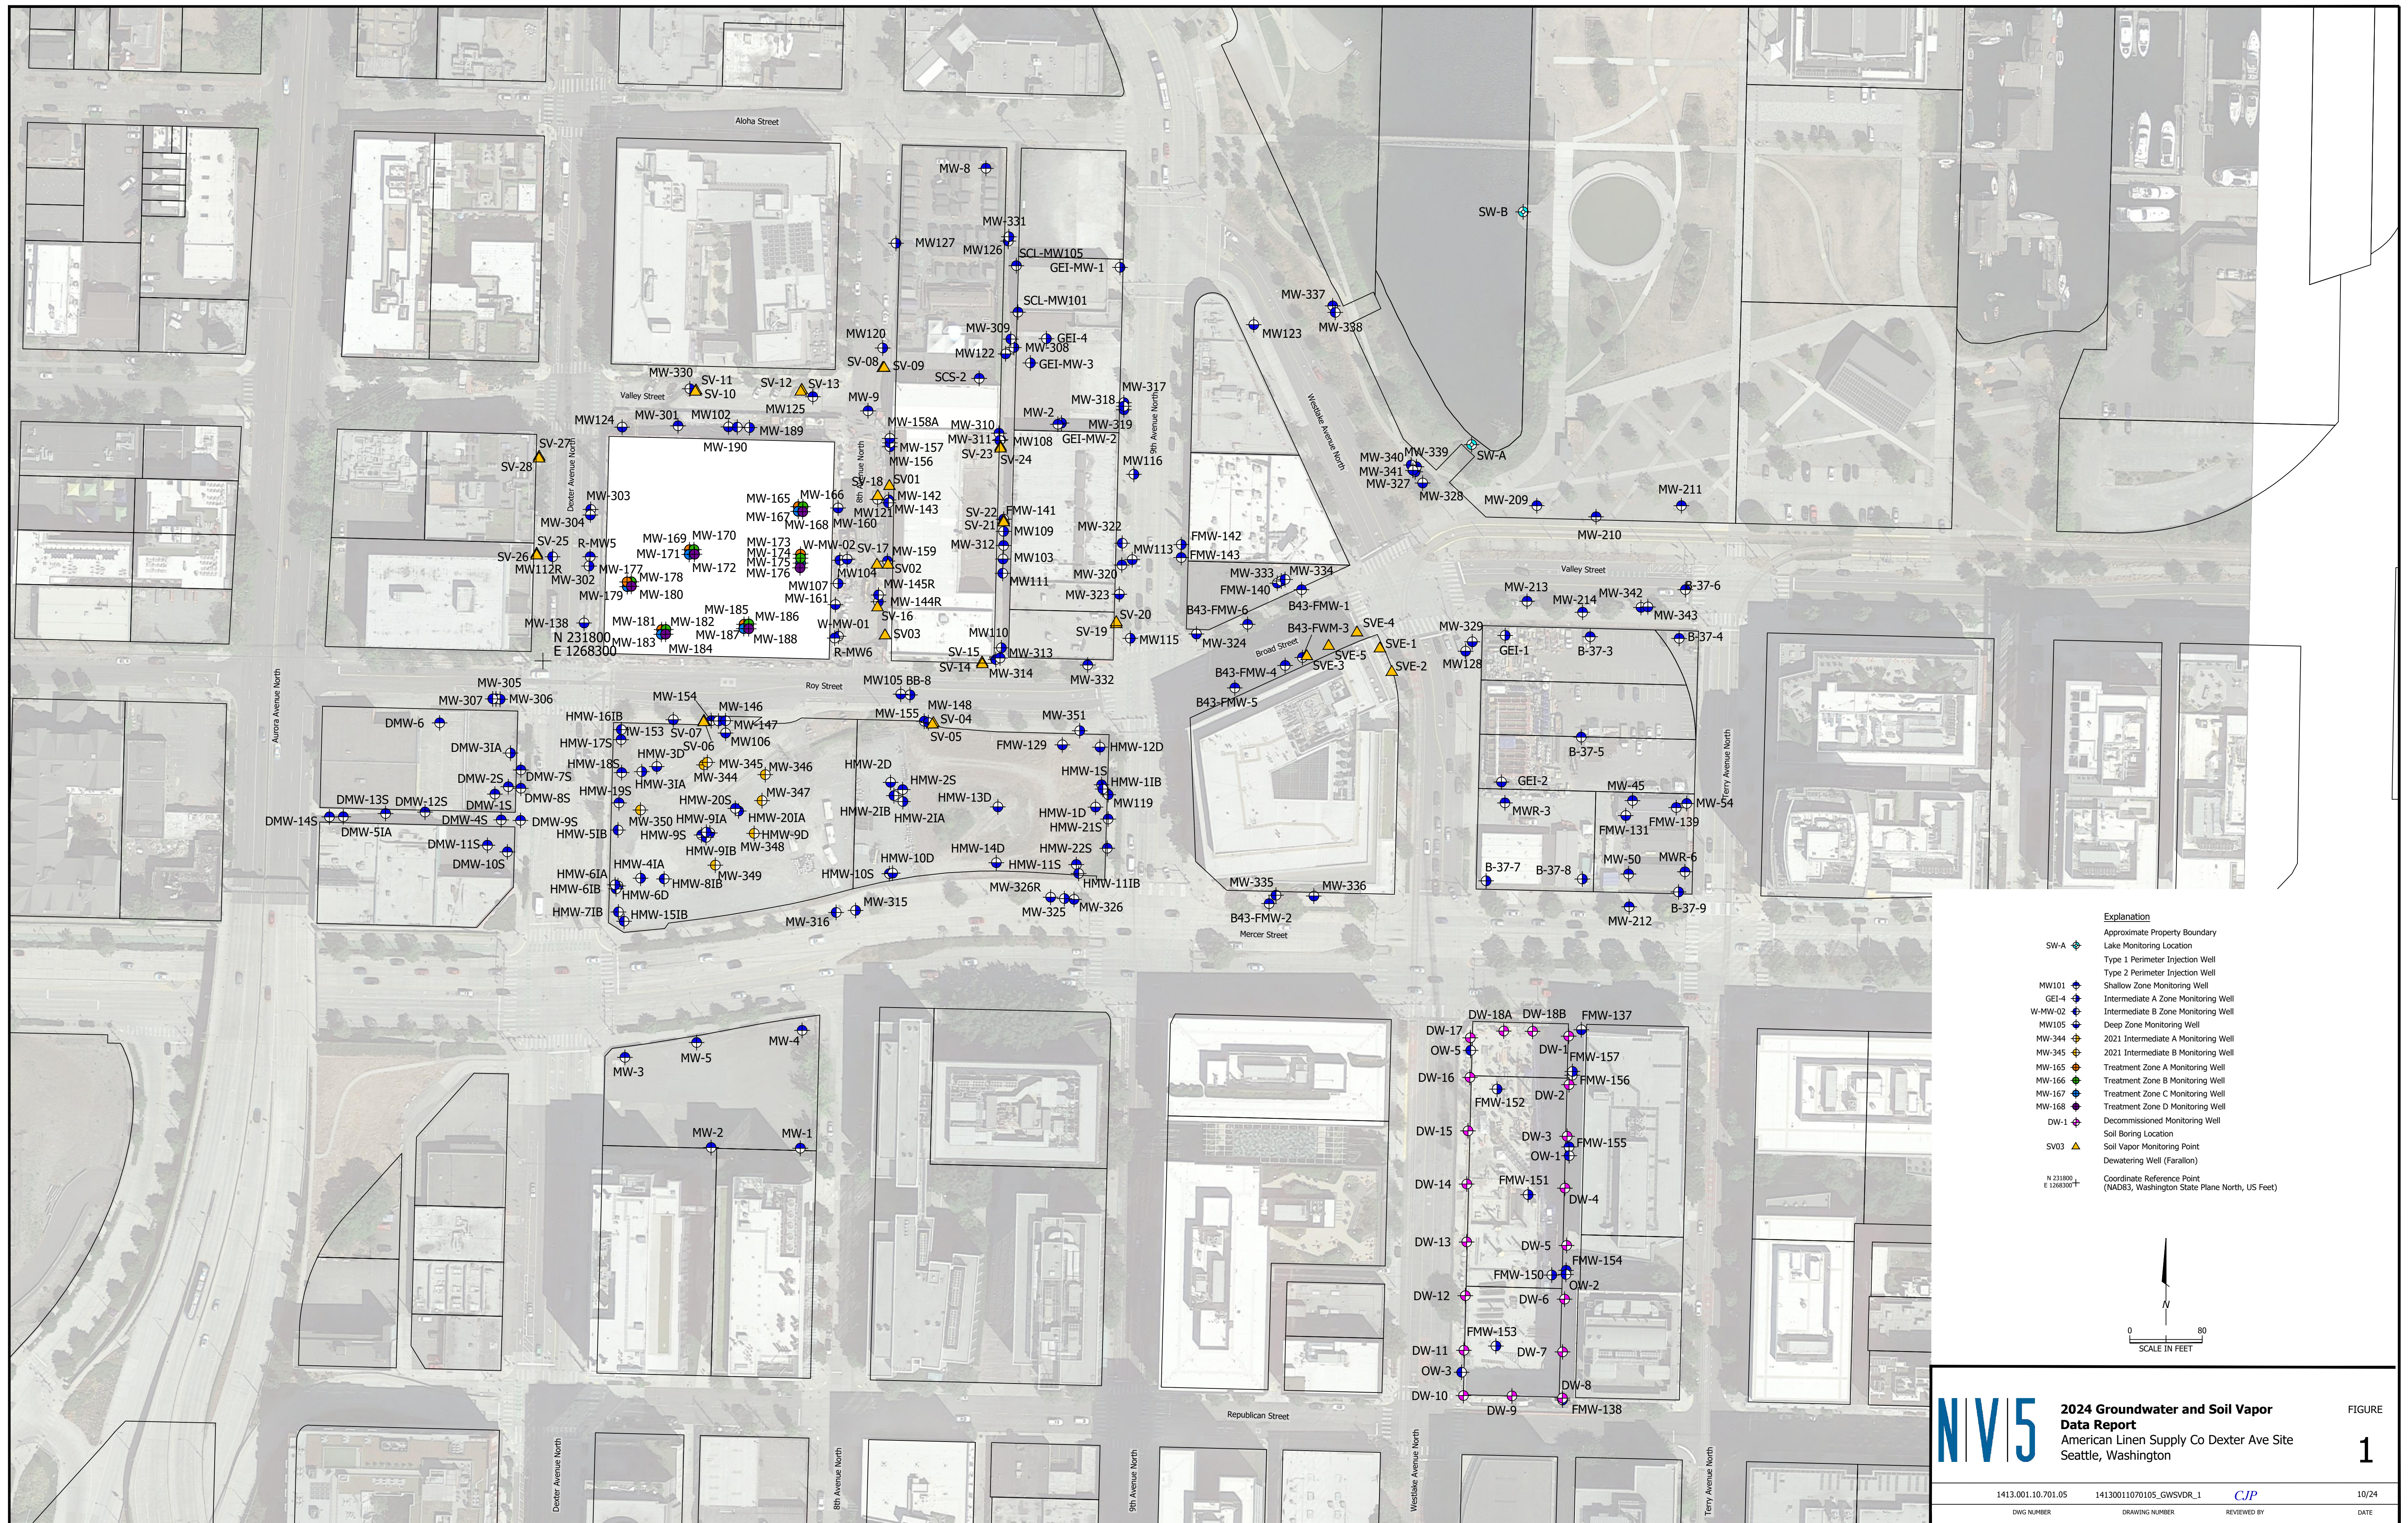
Figure 1 – Groundwater Monitoring Network

During quarterly groundwater monitoring, NV5 measured groundwater levels and performed groundwater sampling from wells within the RI/IA monitoring well network at the Site. Figure 1 shows the well and soil vapor probe locations. NV5 used an electronic water level probe to measure depth to groundwater in the wells, and a pressure gauge to monitor the flowing CAA wells in the Property basement. NV5 sampled the monitoring wells with a peristaltic or bladder pump depending on the depth to water in the wells. Wells were purged at pumping rates of 200 mL/min or less. Three casing volumes of water were purged from flowing Property CAA monitoring wells when the water level was above the well top of casing prior to sampling. One primary groundwater sample was collected from each monitoring well. Field quality assurance samples consisted of trip blanks, duplicate samples (one duplicate sample collected for every 20 primary groundwater samples), and equipment rinsate blanks for wells sampled with a bladder pump. All samples were shipped for analysis of VOCs by Environmental Protection Agency (“EPA”) Method 8260D. Groundwater samples from a subset of wells across the Site were also analyzed for geochemical parameters. All samples were shipped to Pace Analytical in Mount Juliet, Tennessee for analysis.
