REMEDIAL INVESTIGATION REPORT AND FEASIBILITY STUDY

Swinomish Market & Deli
Facility Site ID: 28128528
Cleanup Site ID: 16636

Prepared for: Swinomish Indian Tribal Community

Project No. 220230 • February 28, 2024 FINAL (REVISED)

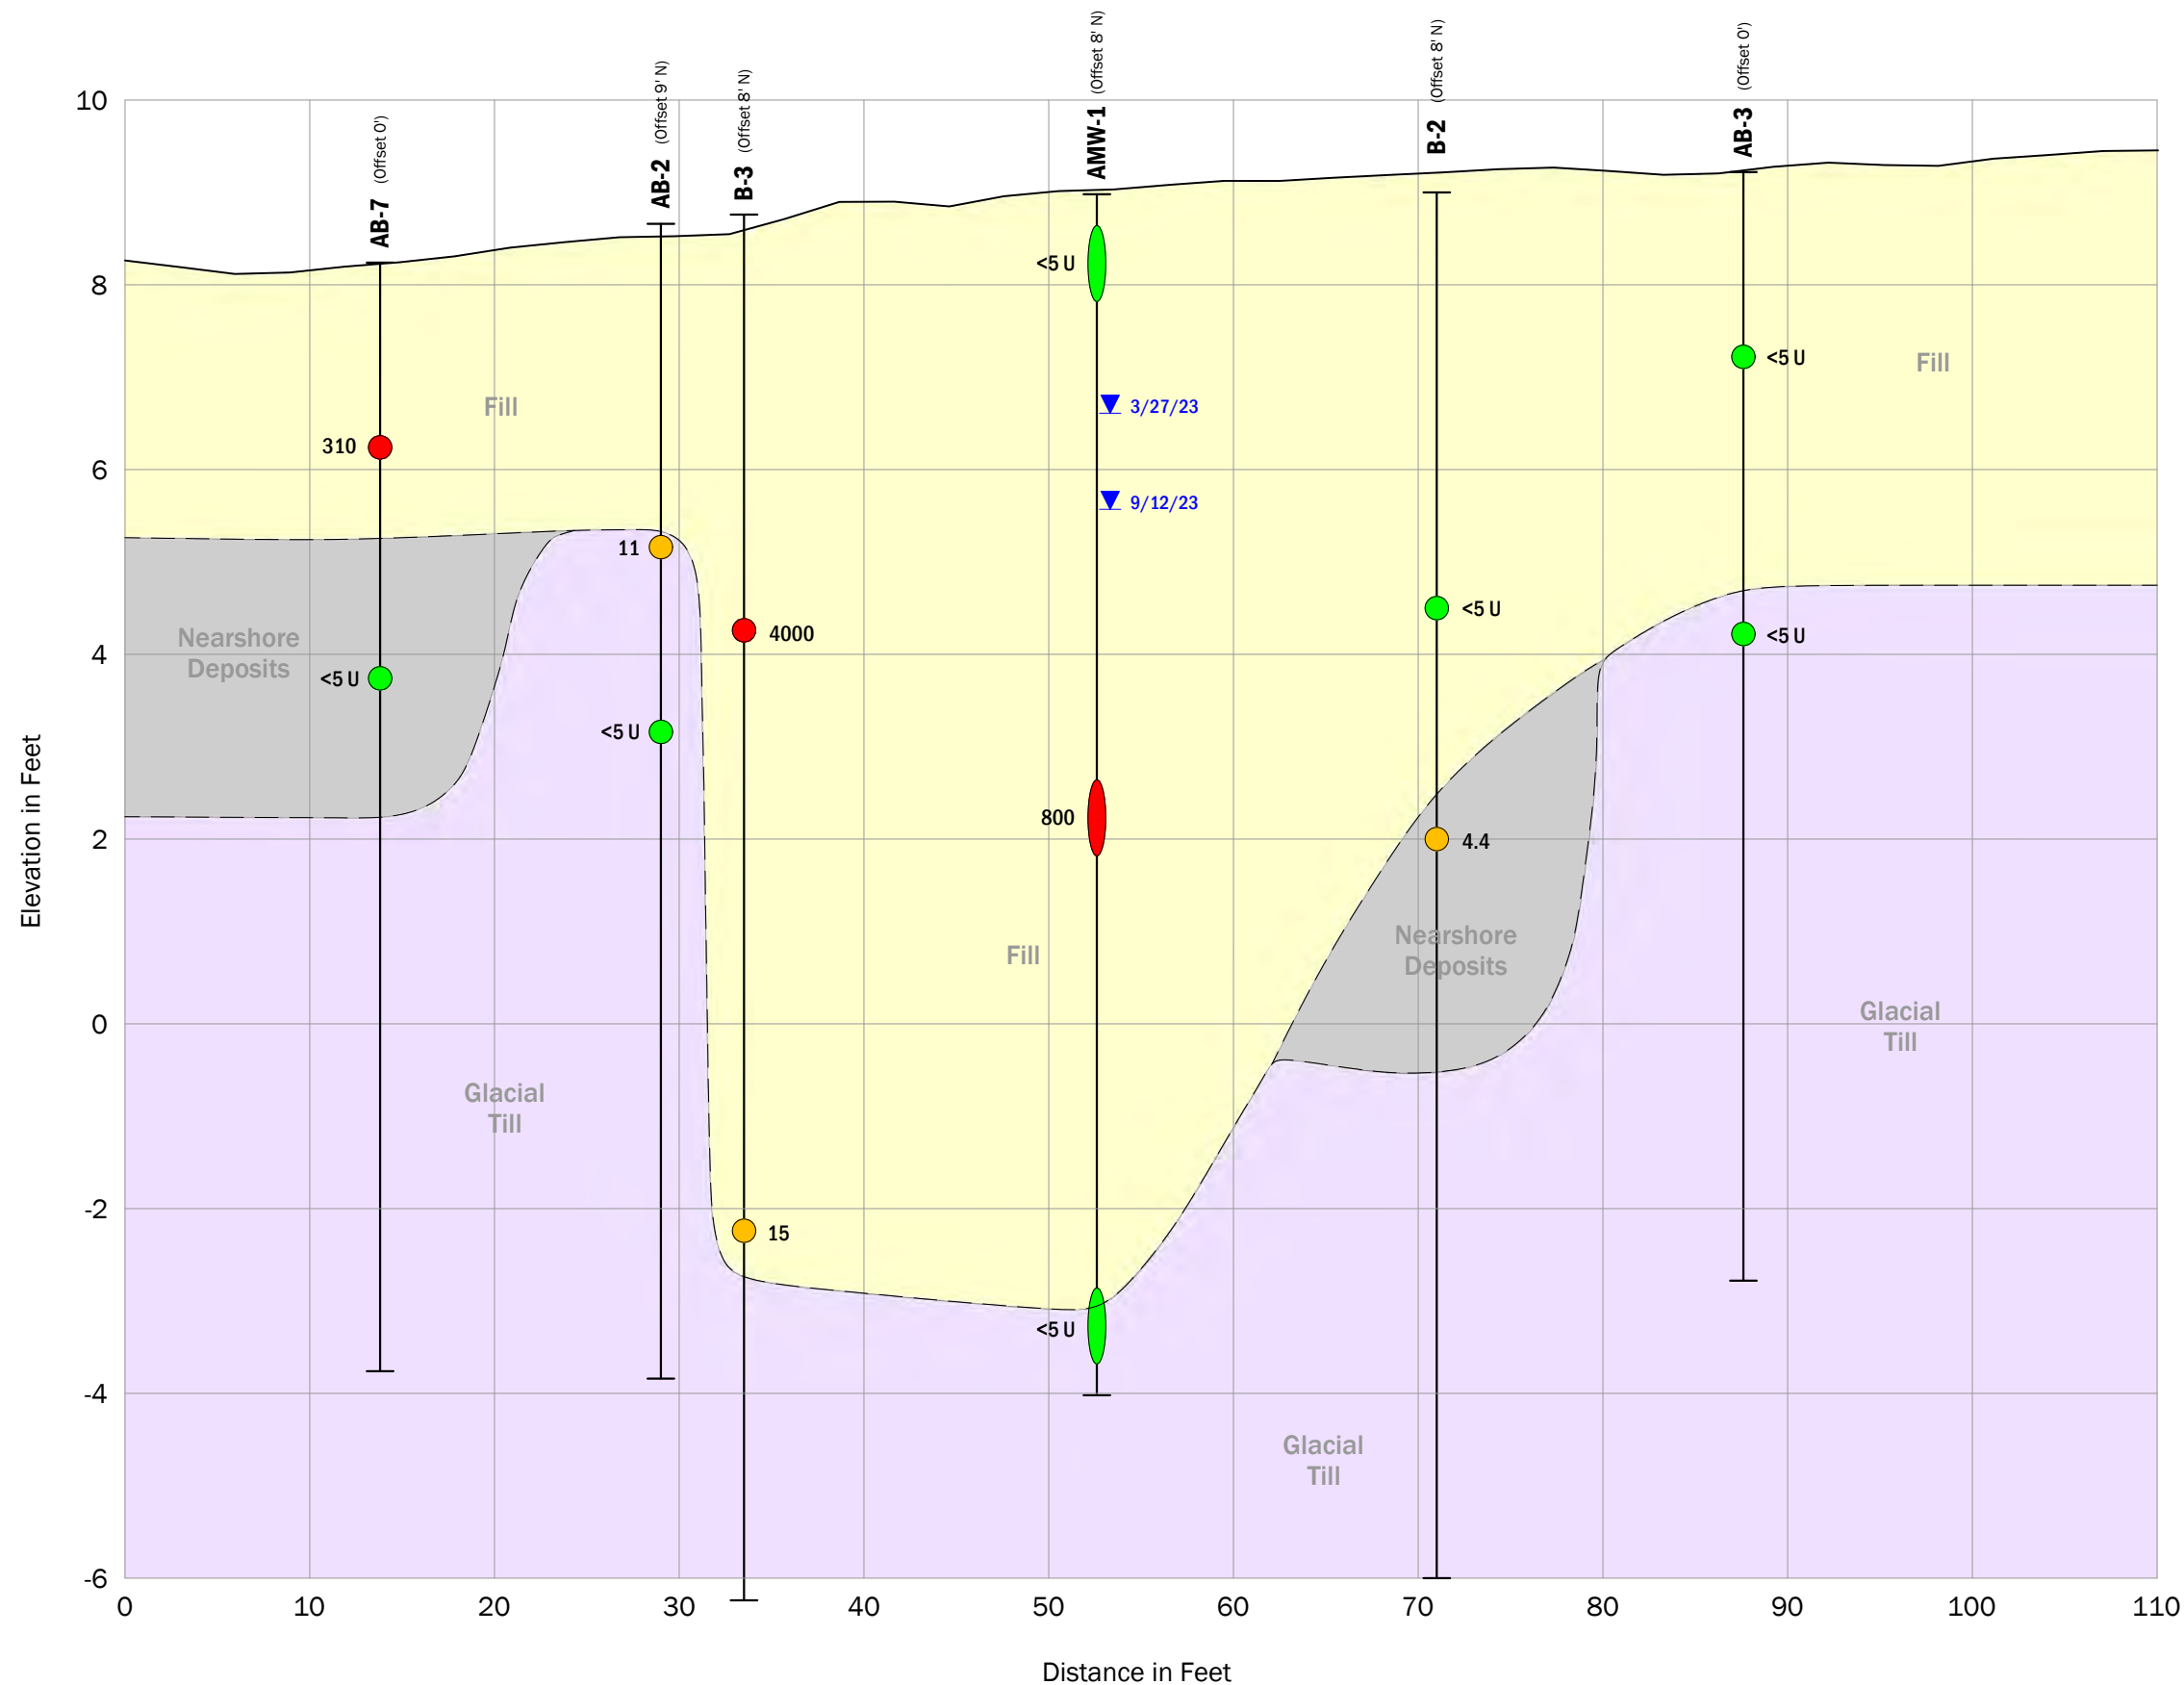
FIGURE NO.
4

Estimated Geologic Contact

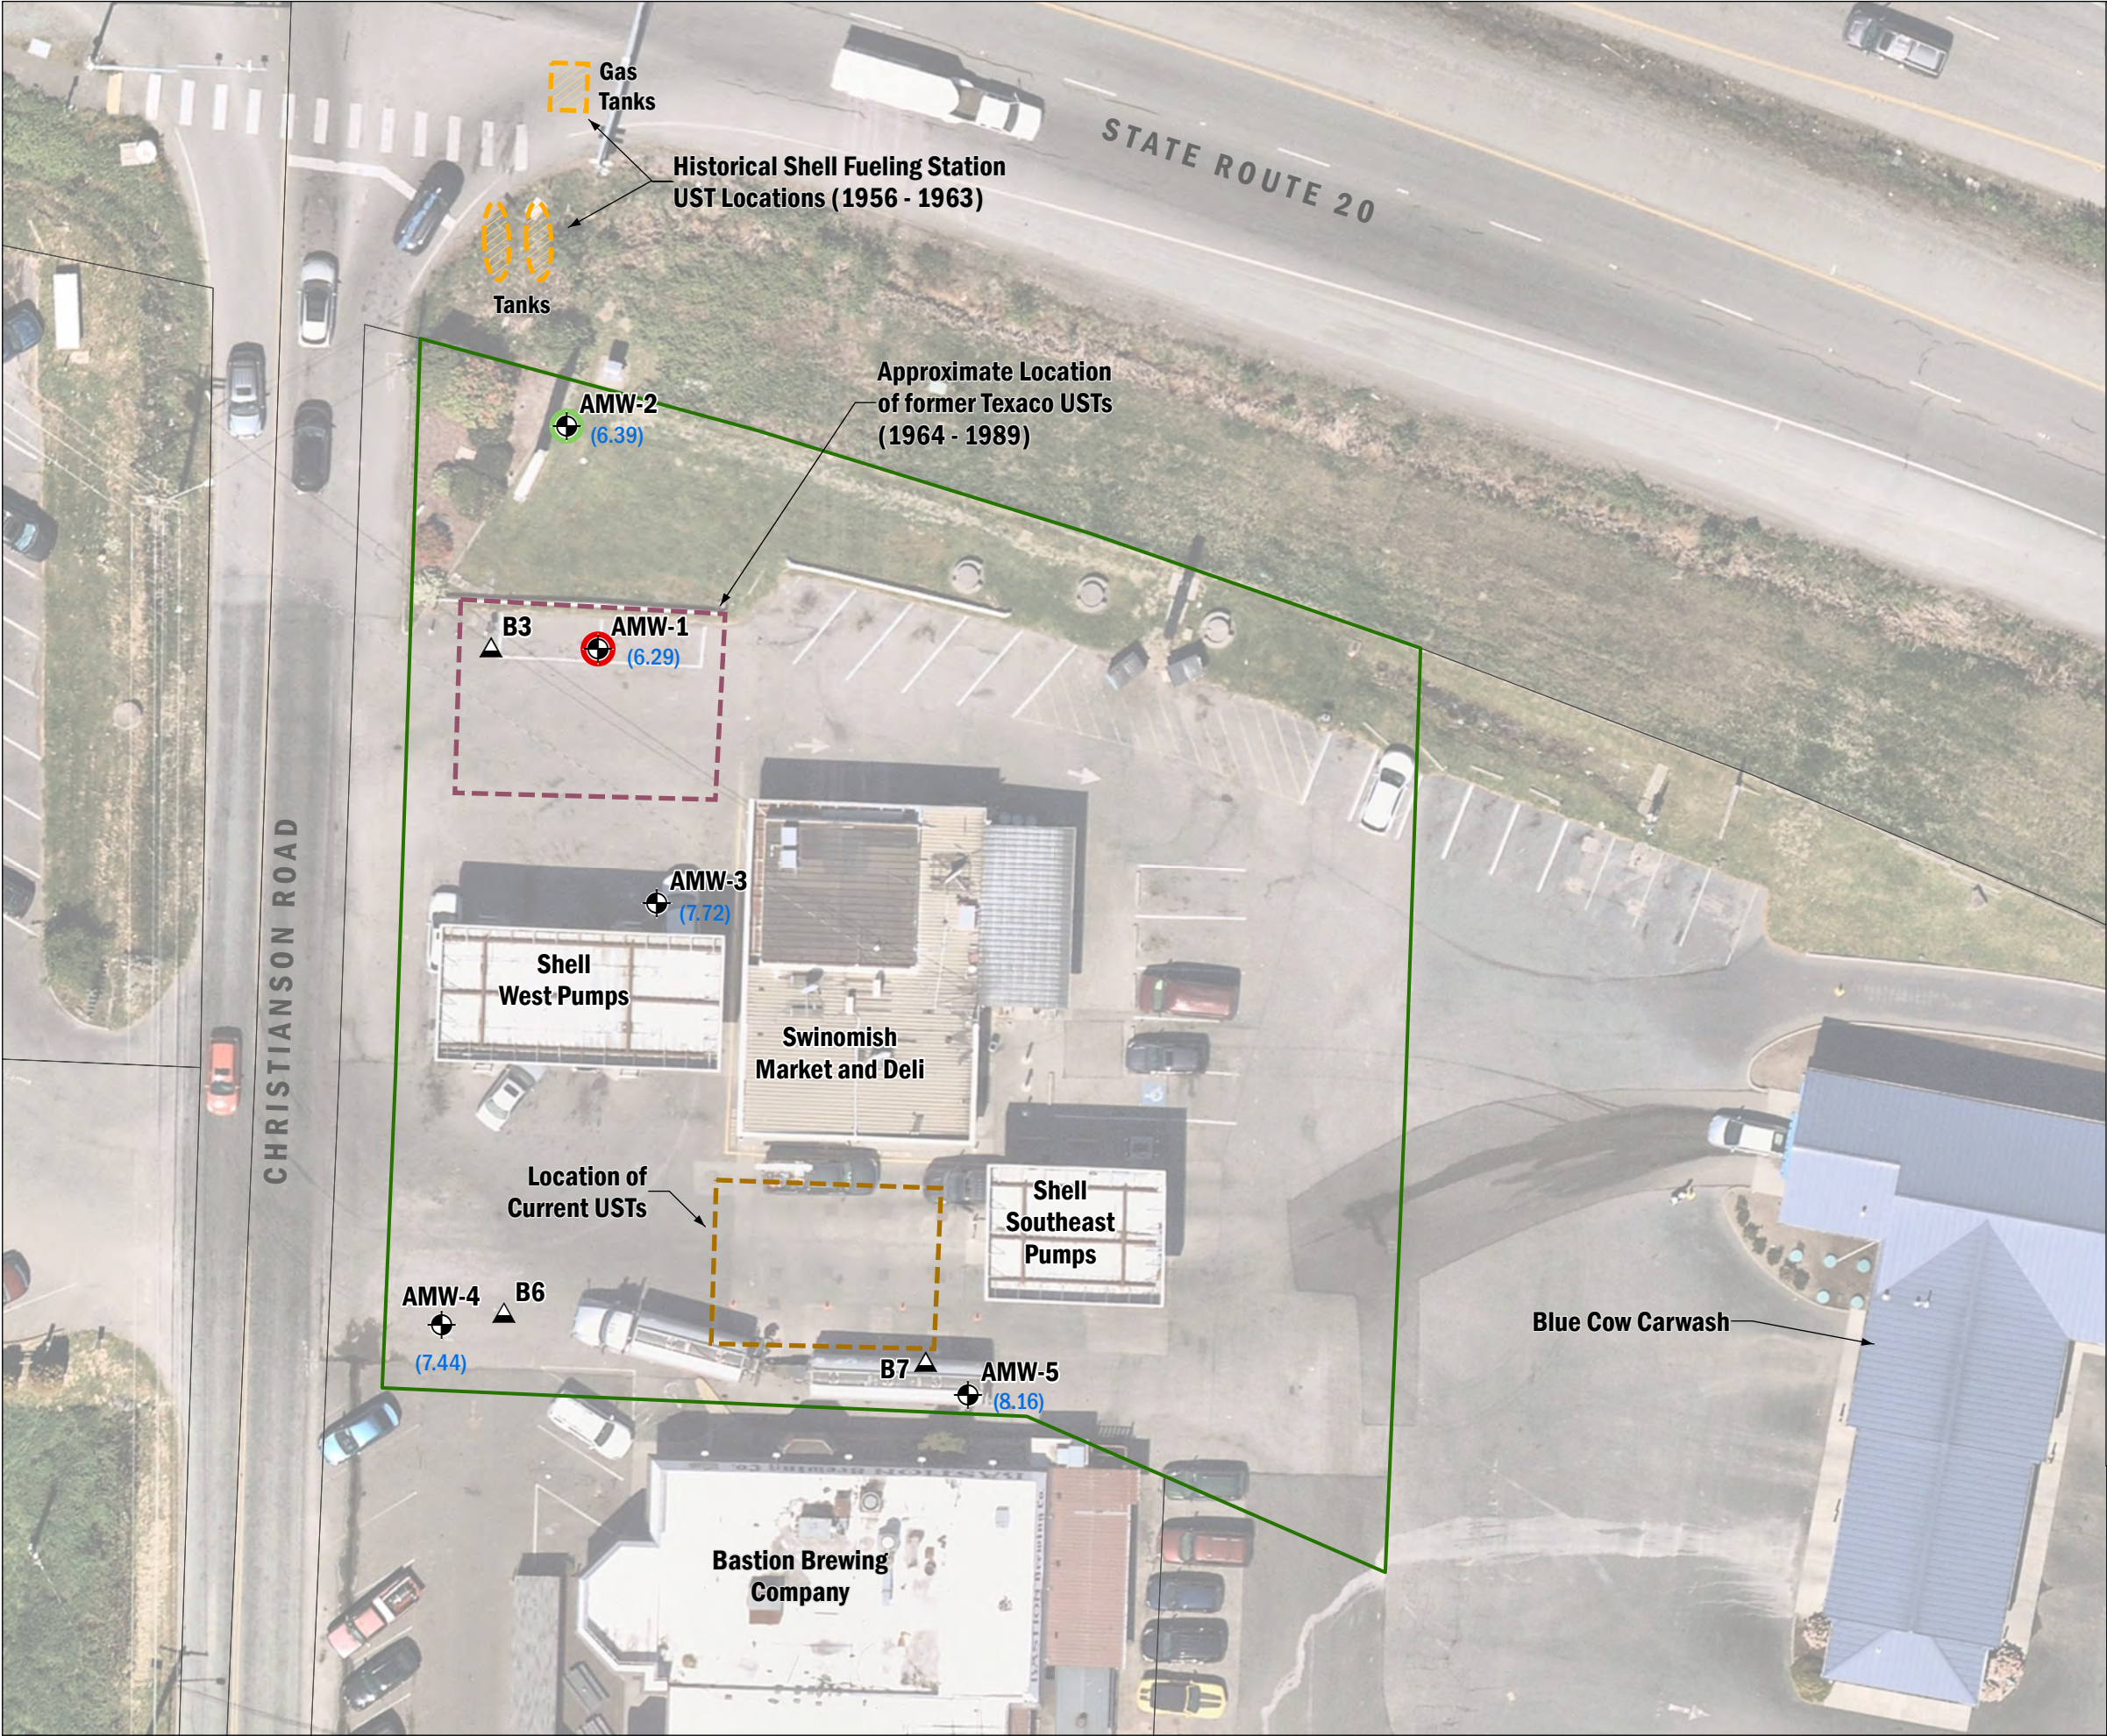
| Aspect CONSULTING | DEC-2023 | BY: MRE / SCC | FIGURE NO. 5 |

- Monitoring Well Location (Aspect 2023)
- Groundwater Grab Sample Location (Element 2022)
- GRO detected at concentrations greater than the MTCA Method A cleanup level
- GRO not detected above laboratory reporting limit
- Subject Property
- Skagit County Property Parcel
- (5.25) Water Level Elevation

Groundwater or evidence of saturated soil was not observed at locations AB-5 (south of the former UST area) and AB-7 (west of the former UST area) at the maximum depth of exploration (12 feet bgs). As noted above, soil contamination at these locations was limited to the upper 2-feet; Aspect did not find evidence of groundwater and/or contaminated groundwater extending to the south or west of the former Texaco UST area. Groundwater monitoring results are illustrated on Figures 5 and 6.

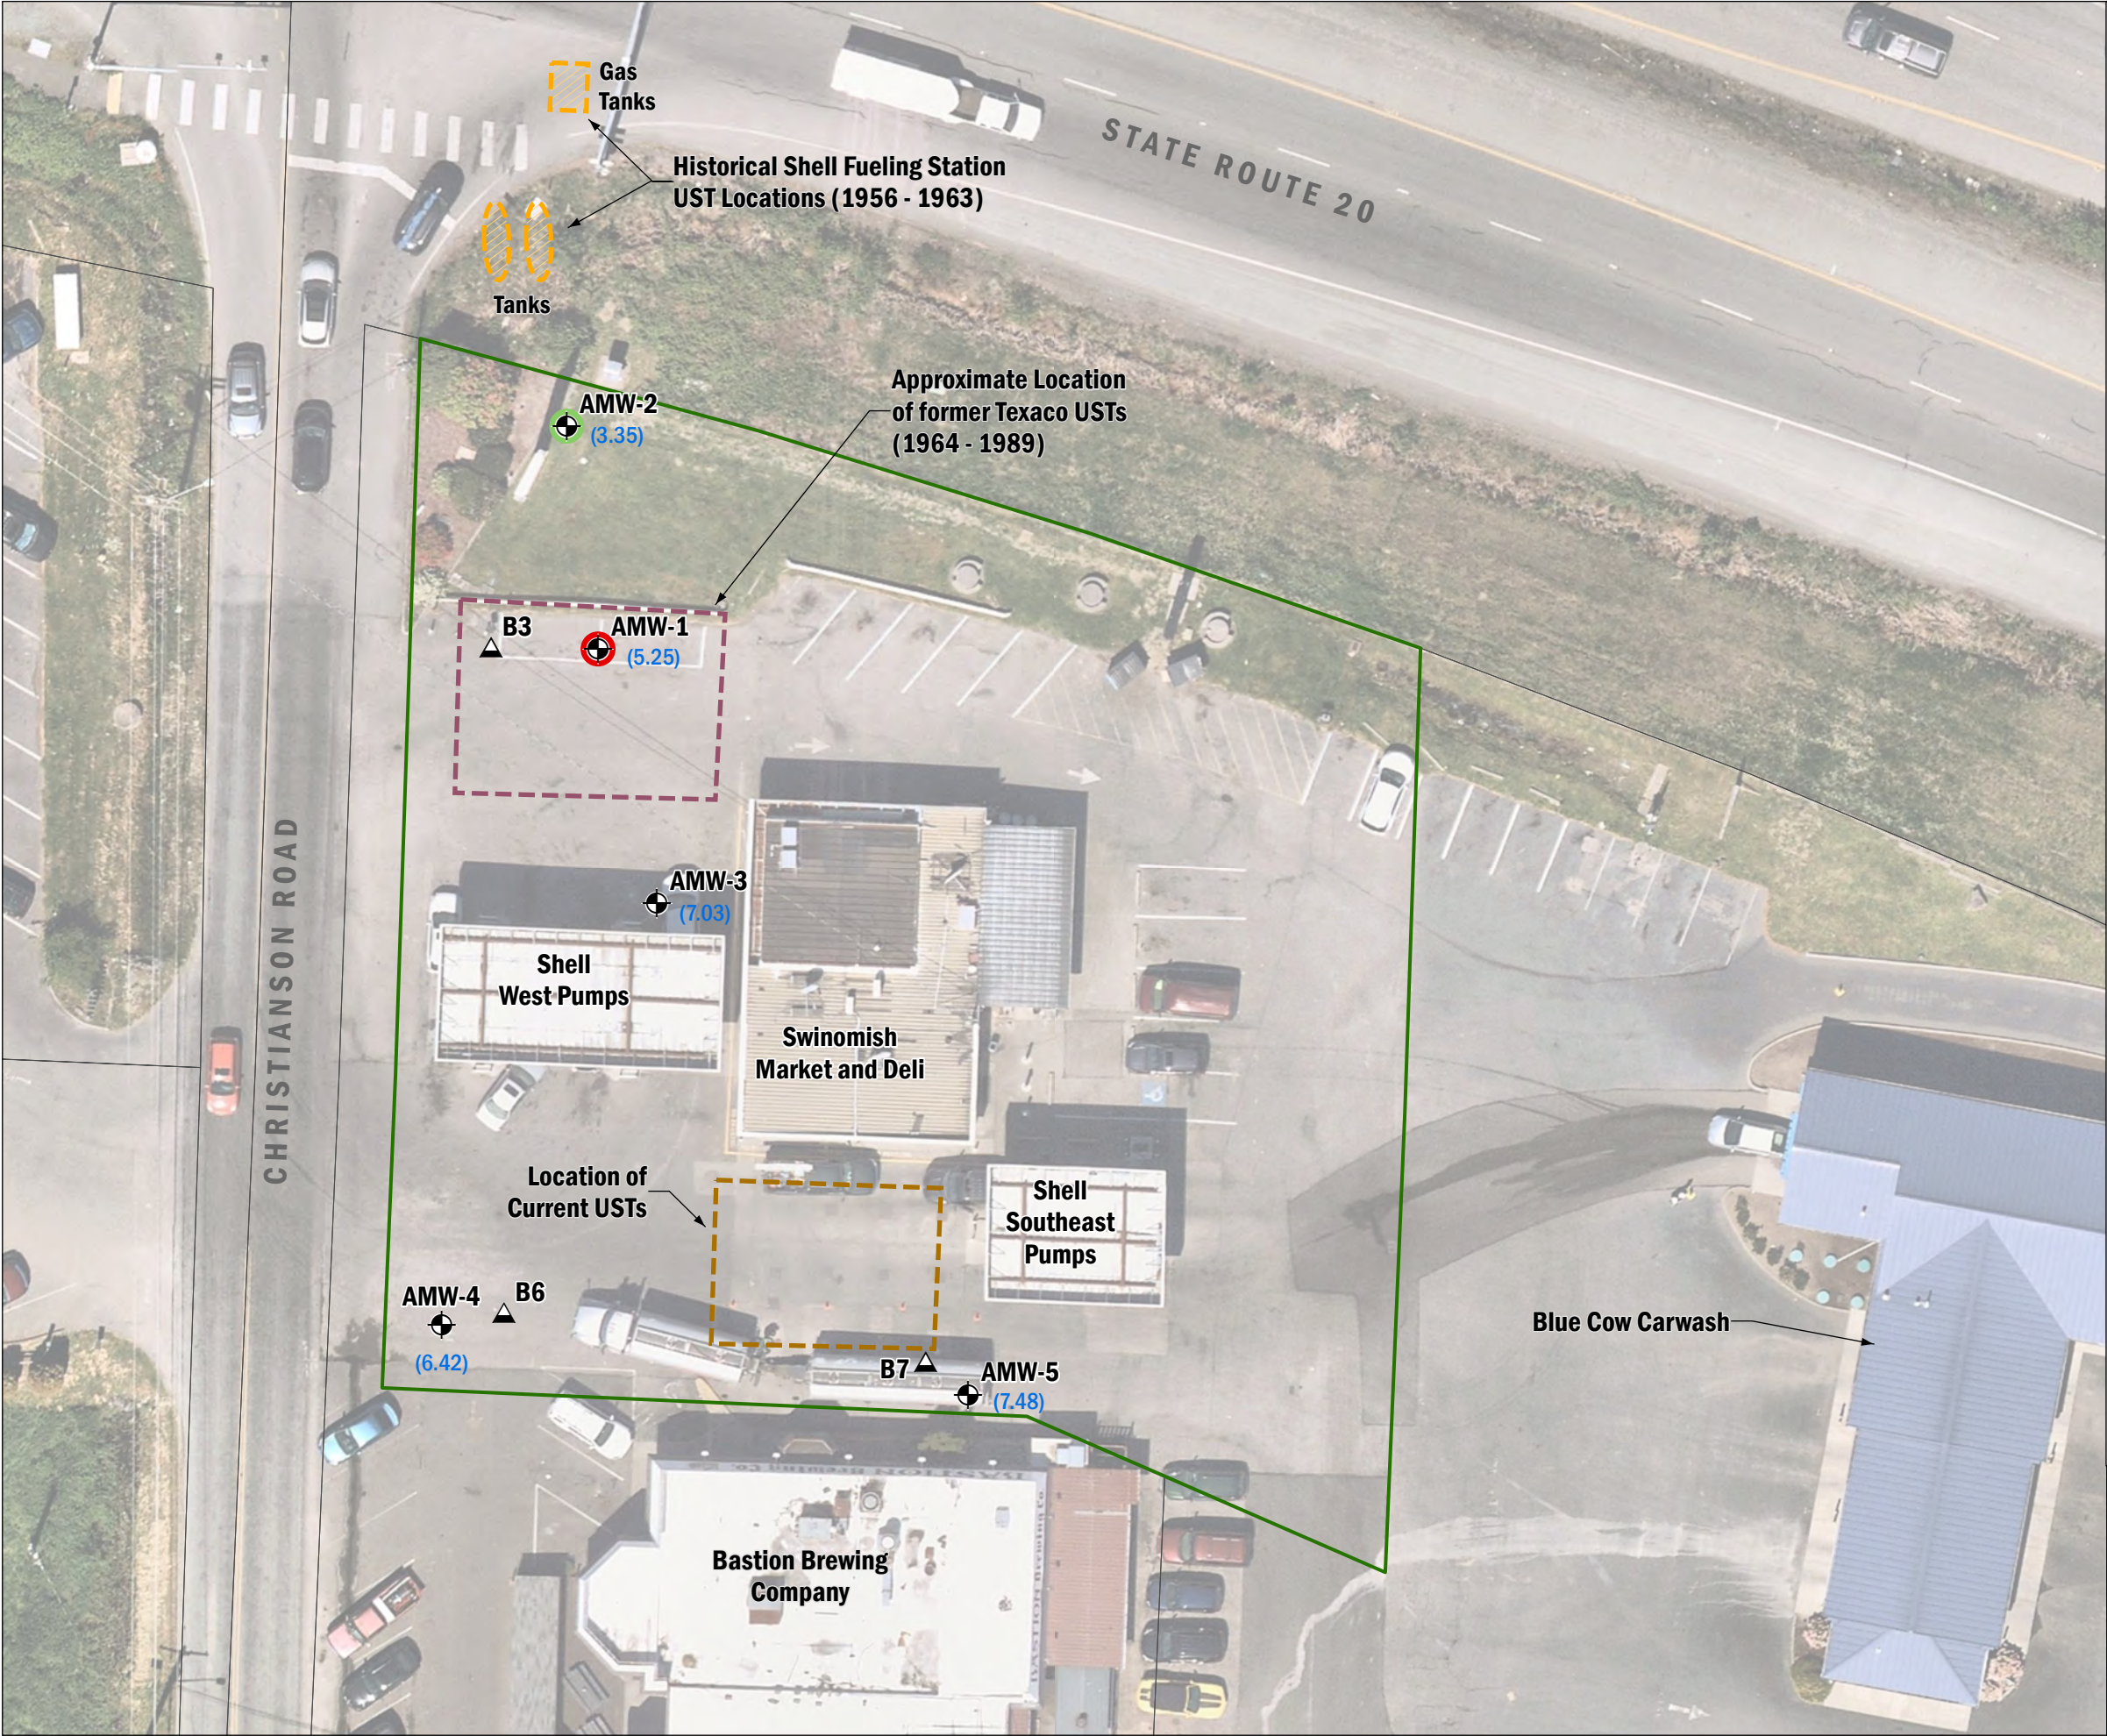
| Aspect CONSULTING | DEC-2023 | BY: MRE / SCC | FIGURE NO. 6 |

- Monitoring Well Location (Aspect 2023)
- Groundwater Grab Sample Location (Element 2022)
- GRO detected at concentrations greater than the MTCA Method A cleanup level
- GRO not detected above laboratory reporting limit
- Subject Property
- Skagit County Property Parcel
- (5.25) Water Level Elevation
