# Welcome to the Reserve Silica Reclamation Site Public Meeting

# Preliminary Site Boundary

# Mining and Reclamation History

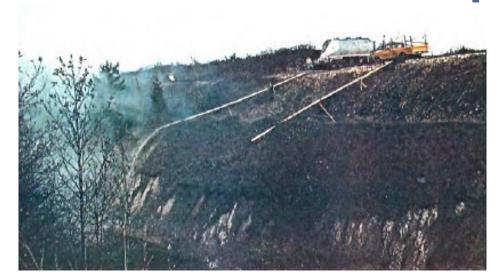
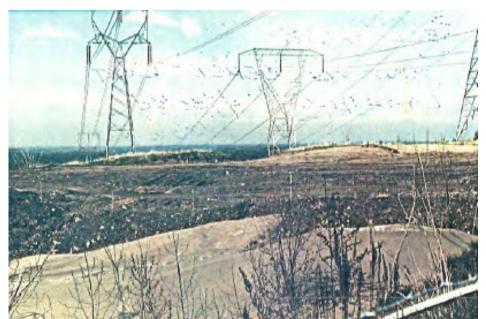
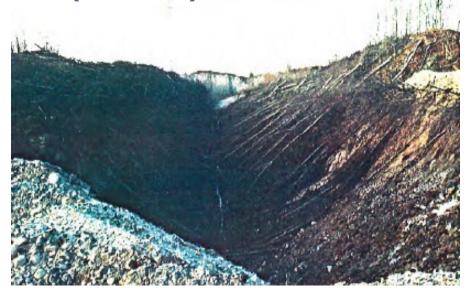
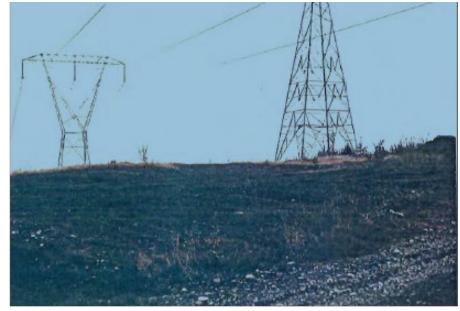
# Dale Strip Pit (DSP)

- Waste product from cement kilns
- Fine grained particles, primarily calcium and silica oxides, with concentrated alkalis and heavy metal impurities
- Generates caustic water (pH 12-13) when exposed to water
- Has ability to hydrate and harden
- Disposed in
  - Lower Disposal Area (1979 to 1982)
  - Dale Strip Pit (1982 to 1988)
- Resource Conservation and Recovery Act (RCRA) implementation

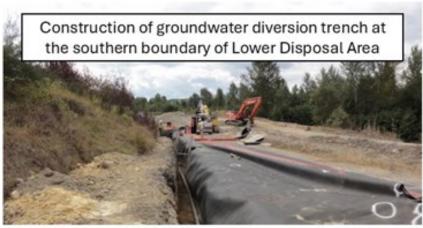
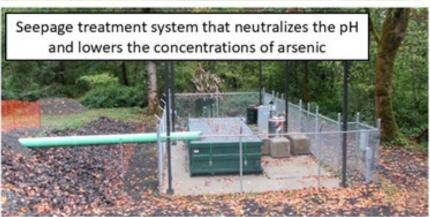
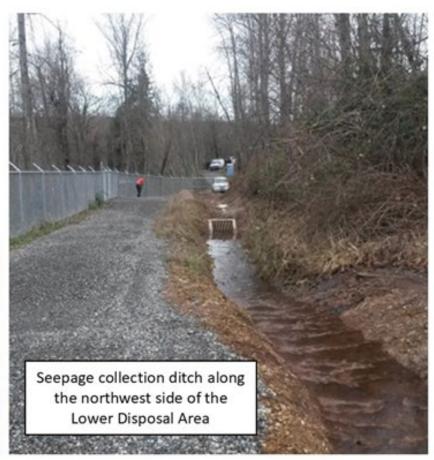
- Quarterly monitoring (2002-Present)
- Landfill cover upgrades (2007, 2010/2011)
- Seepage collection upgrades (2008-2015)
- Groundwater diversion (2013)
- Chain-link fencing (2017-2018)
- Seepage treatment (2018)
