**RE: STATUS REPORT – JULY THROUGH DECEMBER 2024  
NORMANDY PARK PCE SITE  
17847, 17855, AND 17817 FIRST AVENUE SOUTH  
NORMANDY PARK, WASHINGTON  
FARALLON PN: 578-002**

Farallon Consulting, L.L.C. (Farallon) has prepared this status report to summarize the remediation activities performed at the Normandy Park PCE Site (Site) from July through December 2024. The Site is comprised of the properties at 17847 and 17855 First Avenue South (the Manhattan Village Shopping Center) and 17817 First Avenue South (the Harris Property) in Normandy Park, Washington (collectively referred to as the Property) (Figures 1 and 2). The Site is enrolled in the Washington State Department of Ecology (Ecology) Voluntary Cleanup Program (VCP) as Normandy Park PCE and has been assigned Facility Site ID No. 4181060 and Cleanup Site ID No. 3214.

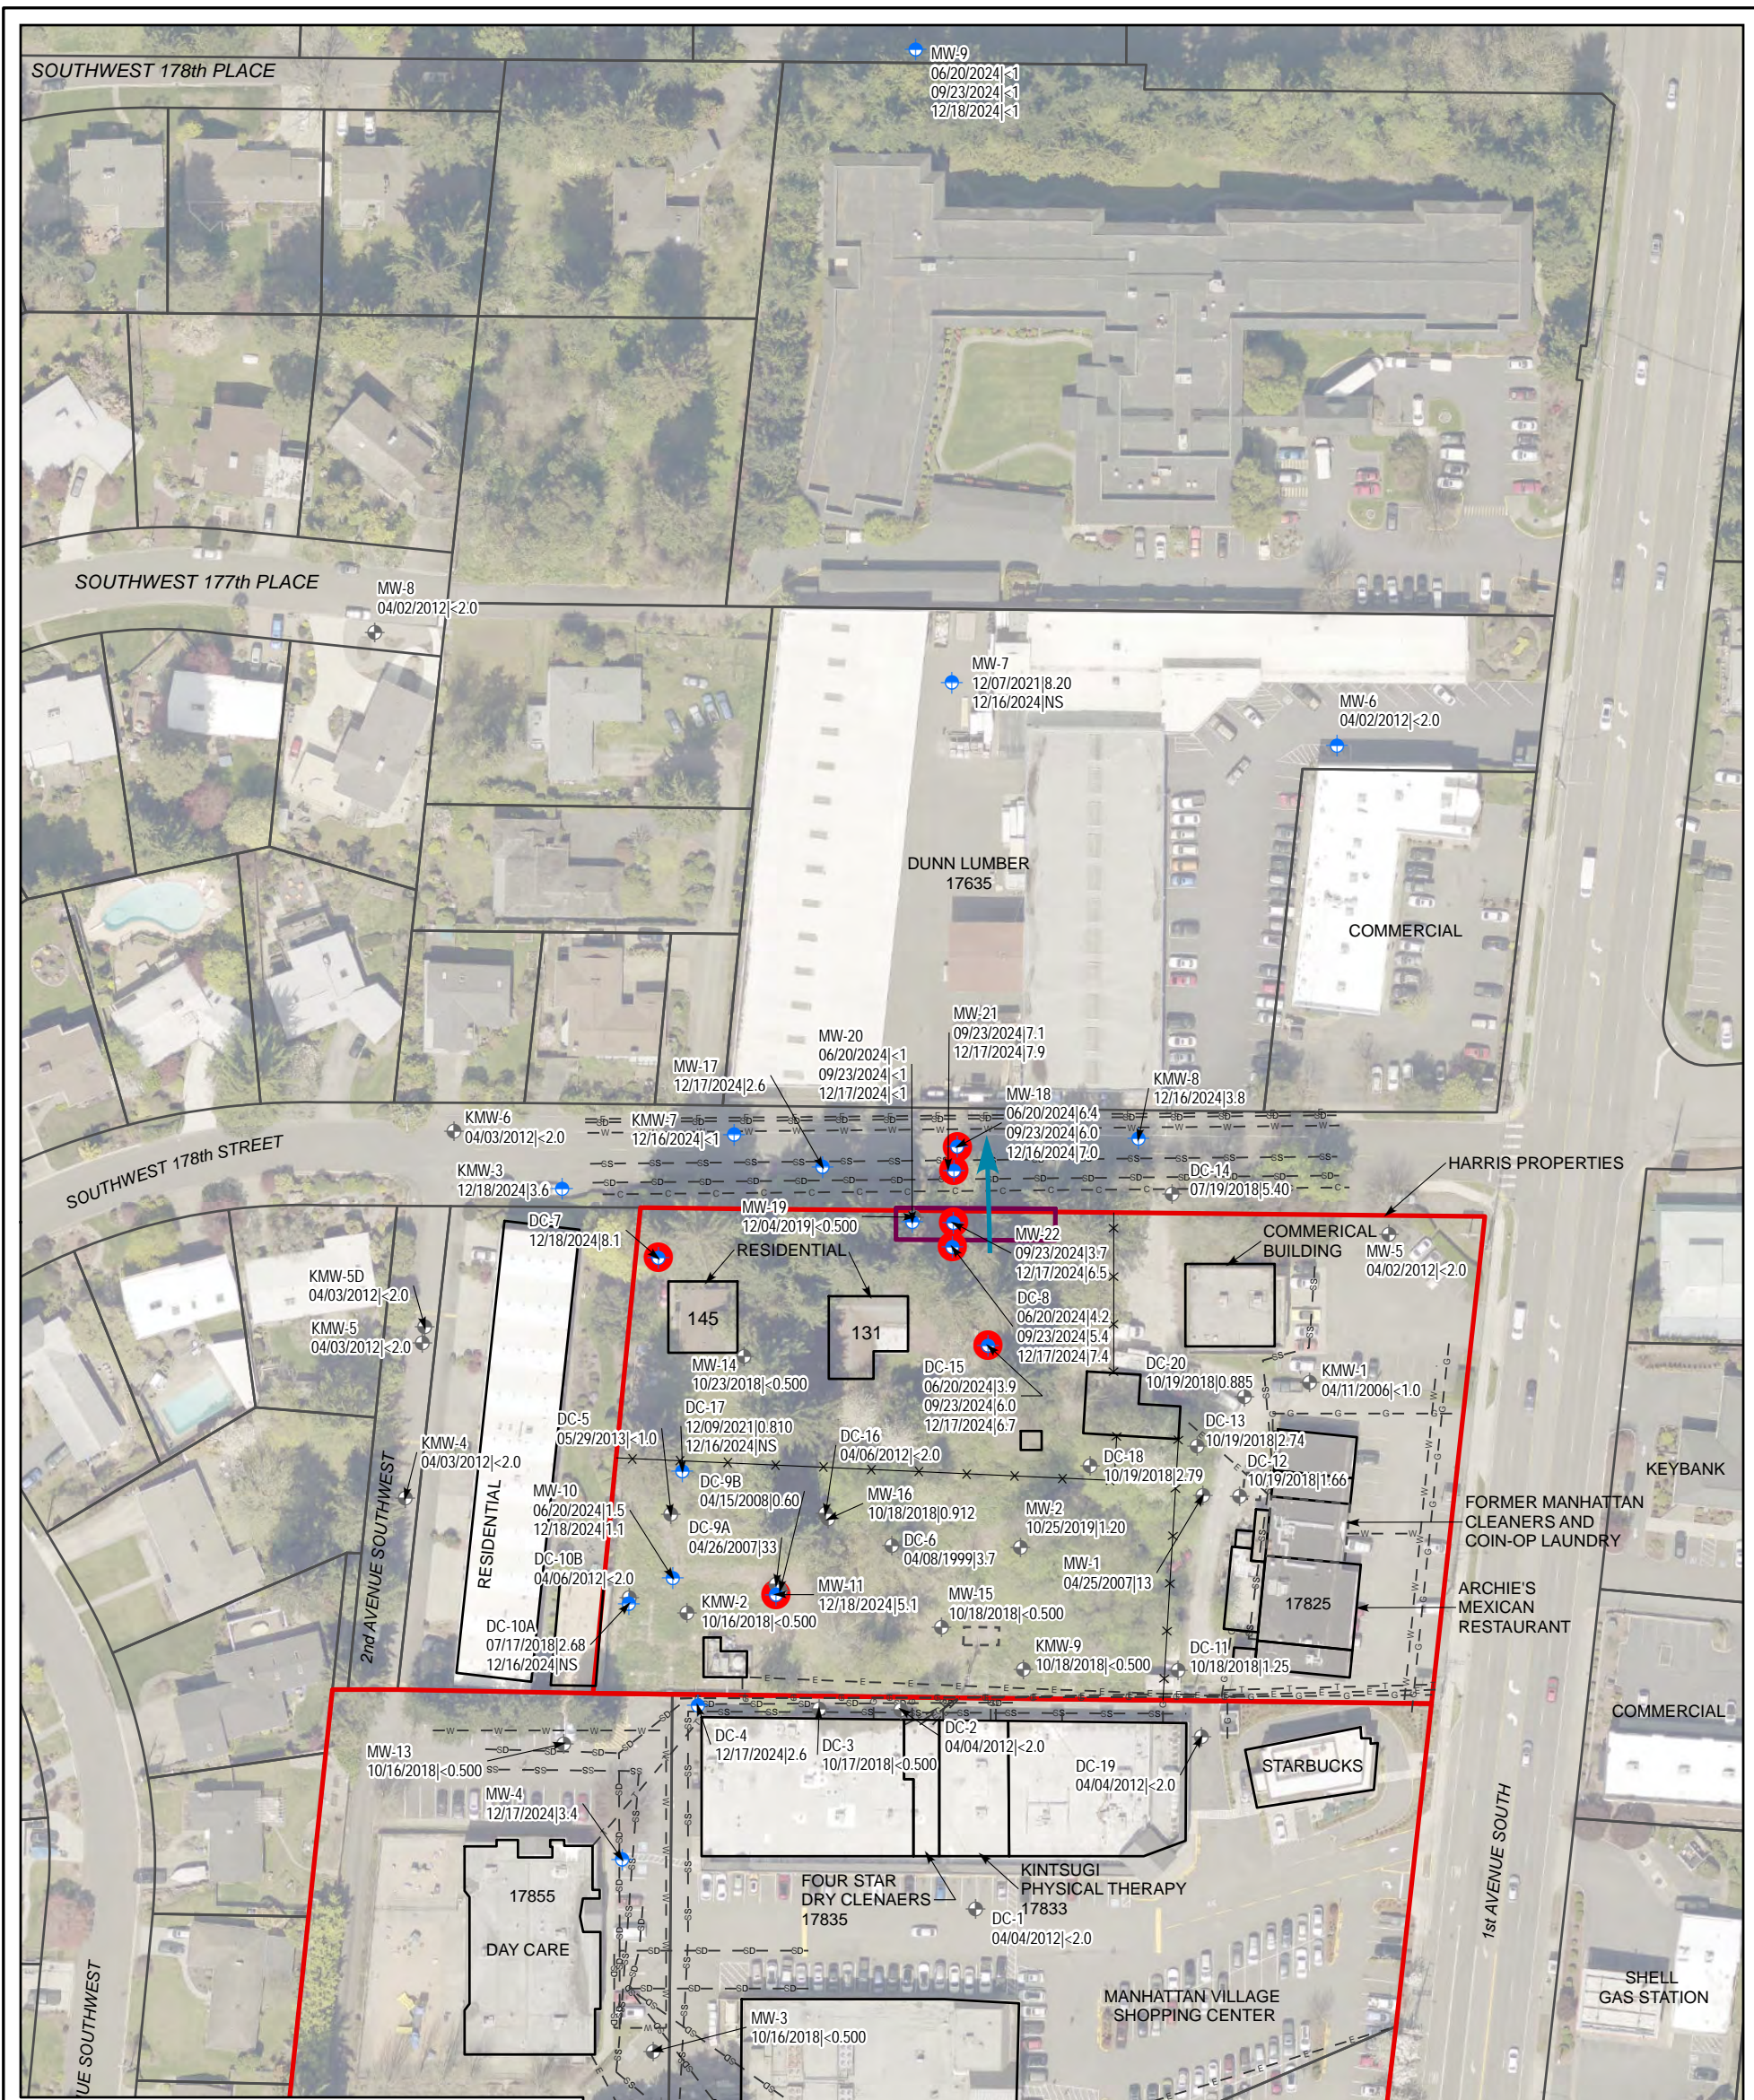
**GROUNDWATER ANALYTICAL RESULTS  
 MANHATTAN VILLAGE/HARRIS PROPERTIES  
 17817, 17825, AND 17835 1st AVENUE SOUTH  
 NORMANDY PARK, WASHINGTON**

PCE was detected at concentrations exceeding the Washington State Model Toxics Control Act Cleanup Regulation (MTCA) Method A cleanup level in samples at monitoring wells MW-18 and MW-21 located down-gradient of the PRB, and monitoring wells DC-8 and DC-15 located up-gradient of the PRB (Figure 4; Table 4). PCE was detected at concentrations slightly exceeding the MTCA Method A cleanup level of 5.0 micrograms per liter ( $\mu\text{g}/\text{L}$ ) in groundwater samples collected at MW-18, reported at 6.0  $\mu\text{g}/\text{L}$ , and at MW-21, reported at 7.1  $\mu\text{g}/\text{L}$ . PCE was detected at concentrations slightly exceeding the MTCA Method A cleanup level in groundwater samples collected from wells up-gradient of the PRB at DC-8, reported at 5.4  $\mu\text{g}/\text{L}$ , and DC-15, reported at 6.0  $\mu\text{g}/\text{L}$ . PCE was detected at concentrations less than MTCA Method A cleanup levels in samples taken from monitoring wells MW-20 and MW-22 located in the PRB area (Figure 4; Table 4).

PCE was detected at concentrations exceeding the MTCA Method A cleanup level in groundwater samples collected from monitoring wells MW-18 and MW-21 located down-gradient of the PRB; MW-22 located in the central portion of the PRB; and DC-8 and DC-15 located up-gradient of the PRB (Figure 4; Table 4). PCE was detected at concentrations less than MTCA Method A cleanup levels in the sample collected from monitoring well MW-20 located in the western portion of the PRB area.

- MW-11 at 5.1 µg/L;
- MW-18 at 7.0 µg/L;
- MW-21 at 7.9 µg/L;
- MW-22 at 6.5 µg/L;
- DC-7 at 8.2 µg/L;
- DC-8 at 7.4 µg/L; and
- DC-15 at 6.7 µg/L.

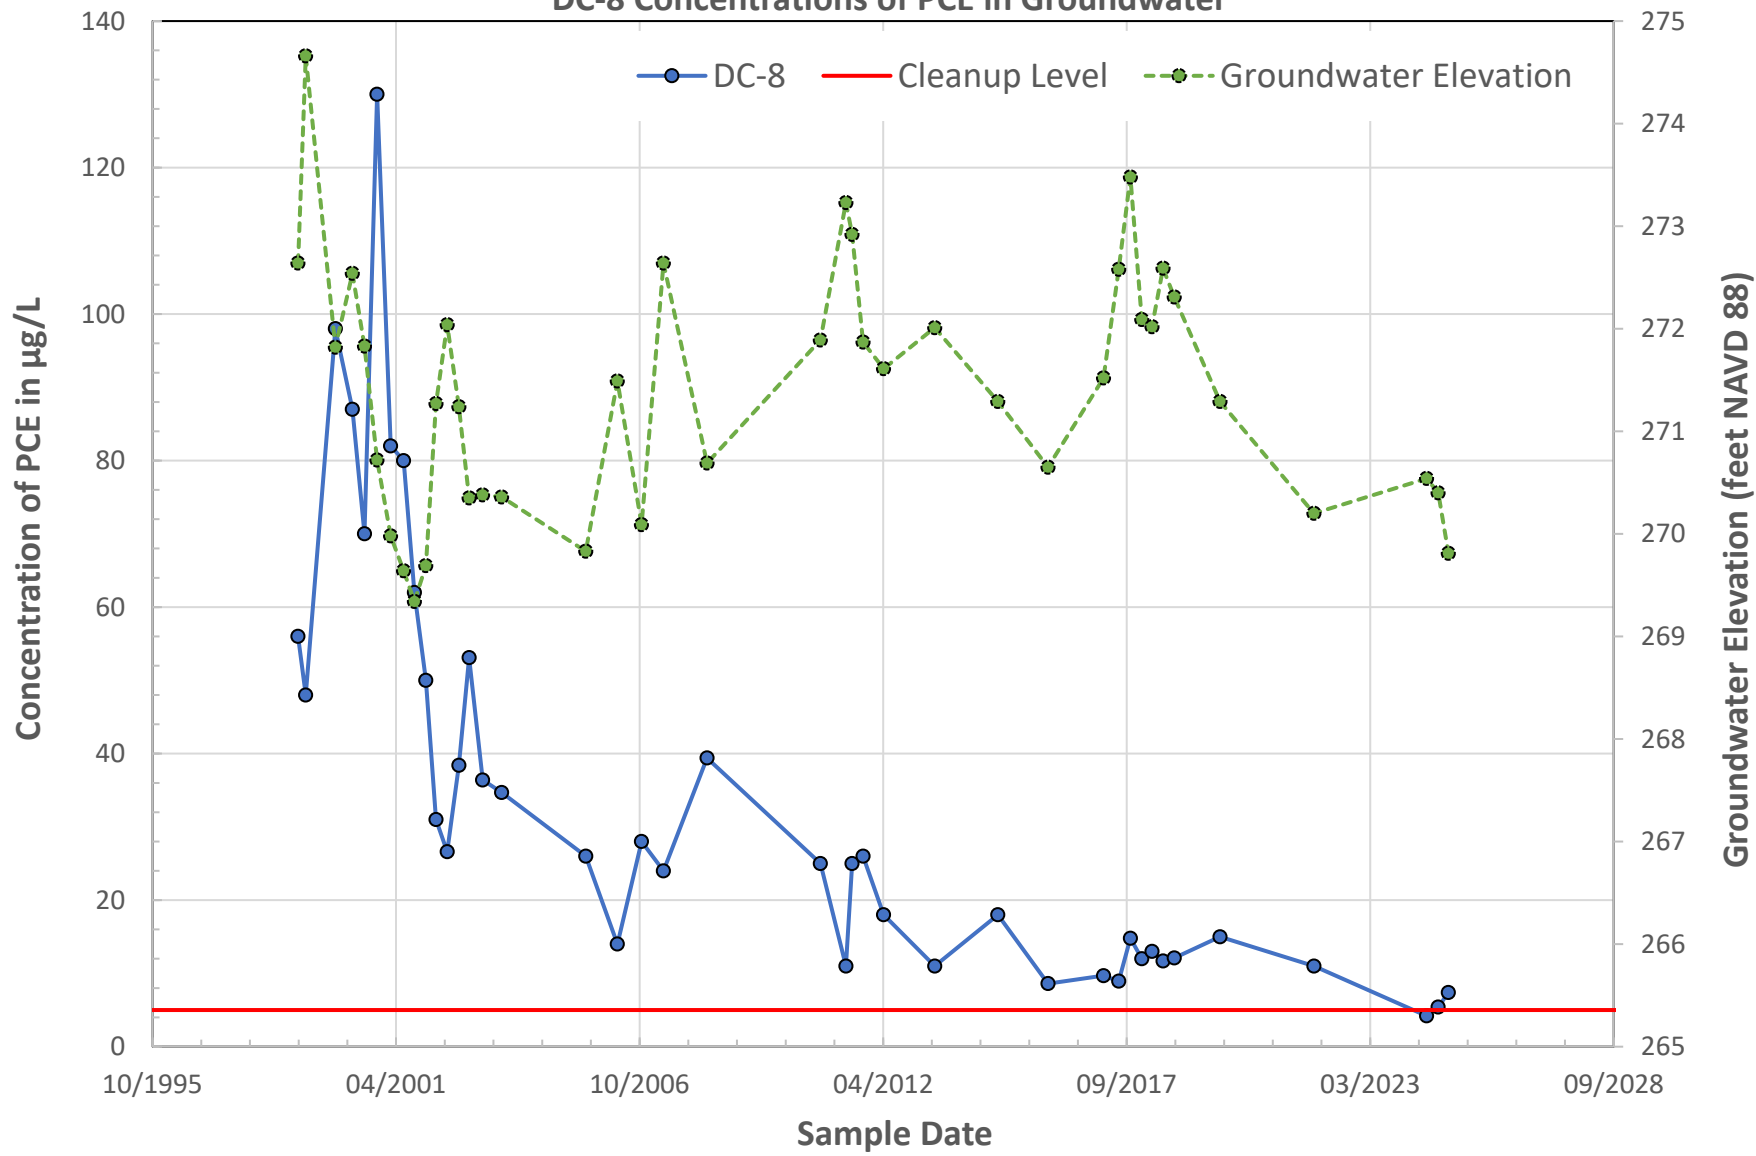
Chart 1

Farallon prepared the attached time-series plots of PCE concentrations in groundwater at monitoring wells DC-8, DC-15, and MW-18 (Charts 1 through 3). PCE concentrations in

groundwater are slightly above the MTCA Method A cleanup level in groundwater samples collected from monitoring wells DC-8 and DC-15, located hydraulically up-gradient of the PRB. Both wells showed slight increases in PCE concentrations with declining water levels during the December 2024 sampling event. PCE has been reported non-detect at the laboratory practical quantitation limit (PQL) in the last three monitoring events conducted at monitoring well MW-20, which is located within the PRB. Although limited data is available, concentrations of PCE in groundwater at monitoring well MW-21 were reported slightly exceeding the MTCA Method A cleanup level at concentrations of 7.1 µg/L in September 2024 and 7.9 µg/L in December 2024. MW-21 is located hydraulically down-gradient of the PRB. PCE in groundwater at monitoring well MW-22 was detected at concentrations less than the MTCA Method A cleanup level in September 2024 (reported at 3.7 µg/L) and slightly exceeded the MTCA Method A cleanup level in December 2024 (reported at 6.5 µg/L). MW-22 is located within the PRB.

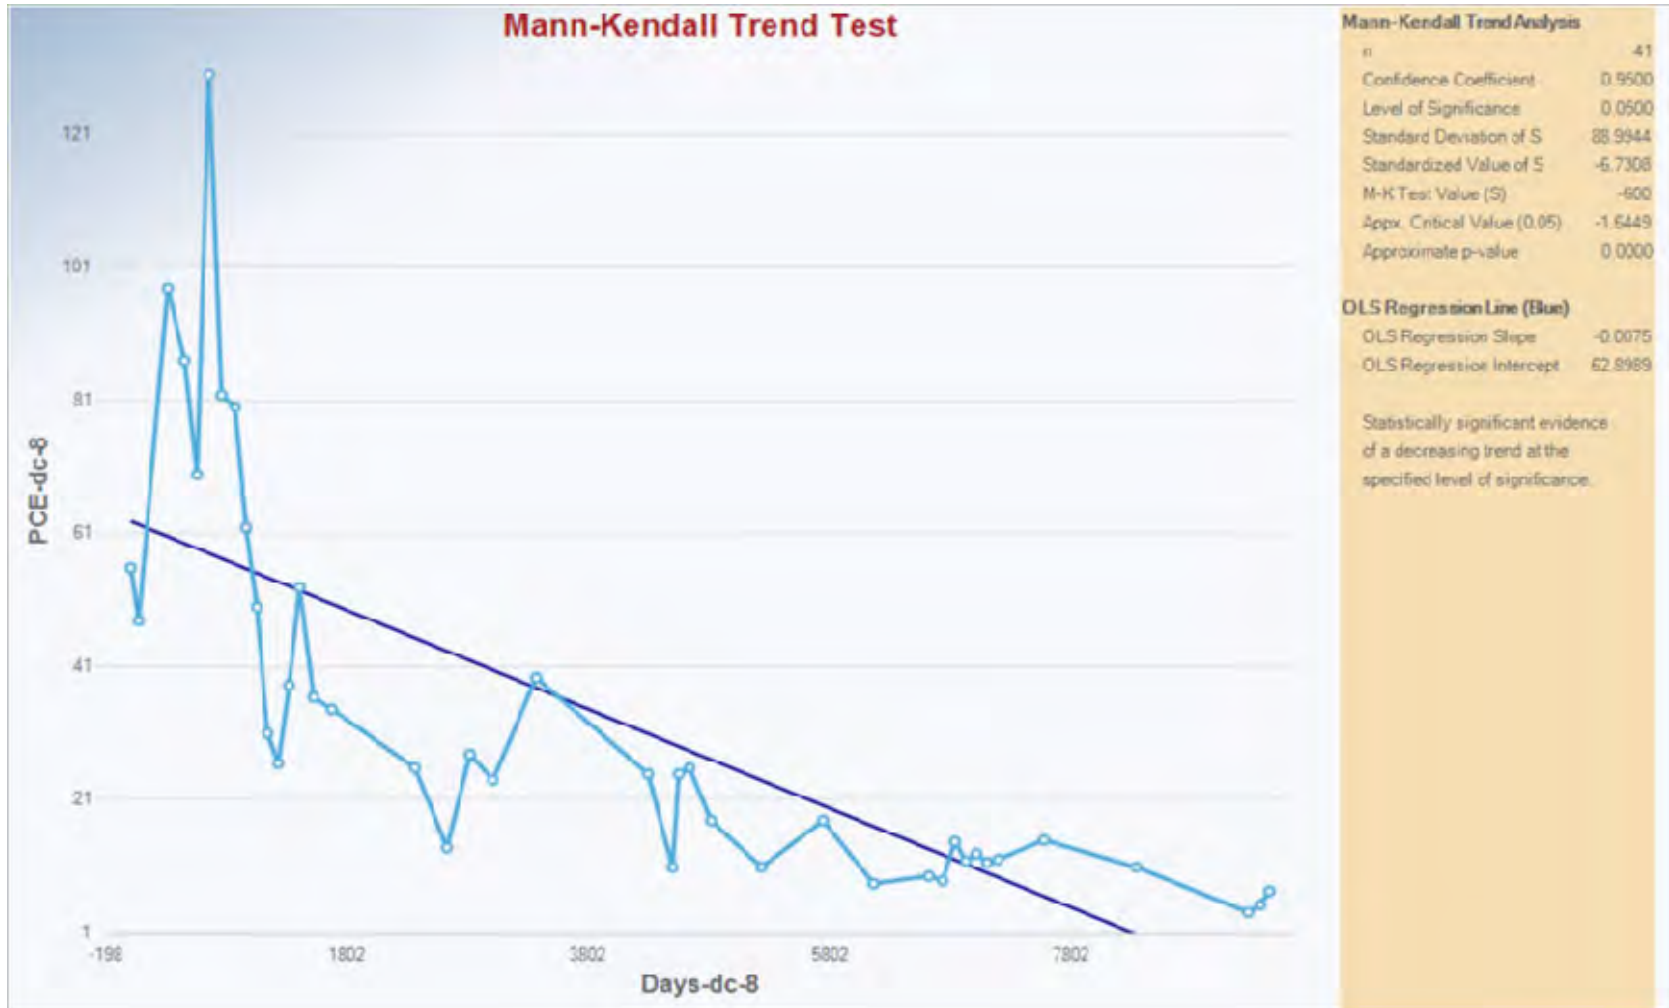
**Chart 4**  
**DC-8 Mann-Kendall Trend Test for PCE**  
**Manhattan Village Shopping Center and Harris Properties**  
**Normandy Park, Washington**  
**Farallon PN: 578-002**

Mann-Kendall analysis of monitoring wells DC-8, DC-15, and MW-18 indicate declining trends in PCE concentration at all three locations (Charts 4 through 6). 2024 monitoring data indicate that both DC-8 and DC-15 are seasonally in compliance with MTCA Method A groundwater cleanup levels. Further attenuation of PCE concentrations over time is expected to expand the period of compliance in the future. There is currently no completed exposure pathway for the groundwater that exceeds MTCA cleanup levels and the depth to groundwater is approximately 38 to 42 feet below ground surface.

Due to the high cost of additional injections (\$20,000 per location), the low potential for increased treatment efficacy, and overall minimal risk posed by the residual area of groundwater contamination; Farallon recommends two additional quarterly groundwater monitoring events to confirm trends at monitoring wells MW-21 and MW-22. If the groundwater monitoring results indicate that PCE concentrations migrating off of the Harris Property are continuing to decrease over time and should be less than the MTCA Method A cleanup level within a reasonable timeframe, Farallon will request that Ecology issue a property-specific No Further Action opinion for the Harris Property with an environmental covenant for groundwater and provisions for long-term compliance monitoring.
