**STATE OF WASHINGTON
DEPARTMENT OF ECOLOGY**

Site Name: Rockwell Apartment

Subject: Sampling Activities Summary and Variance Report

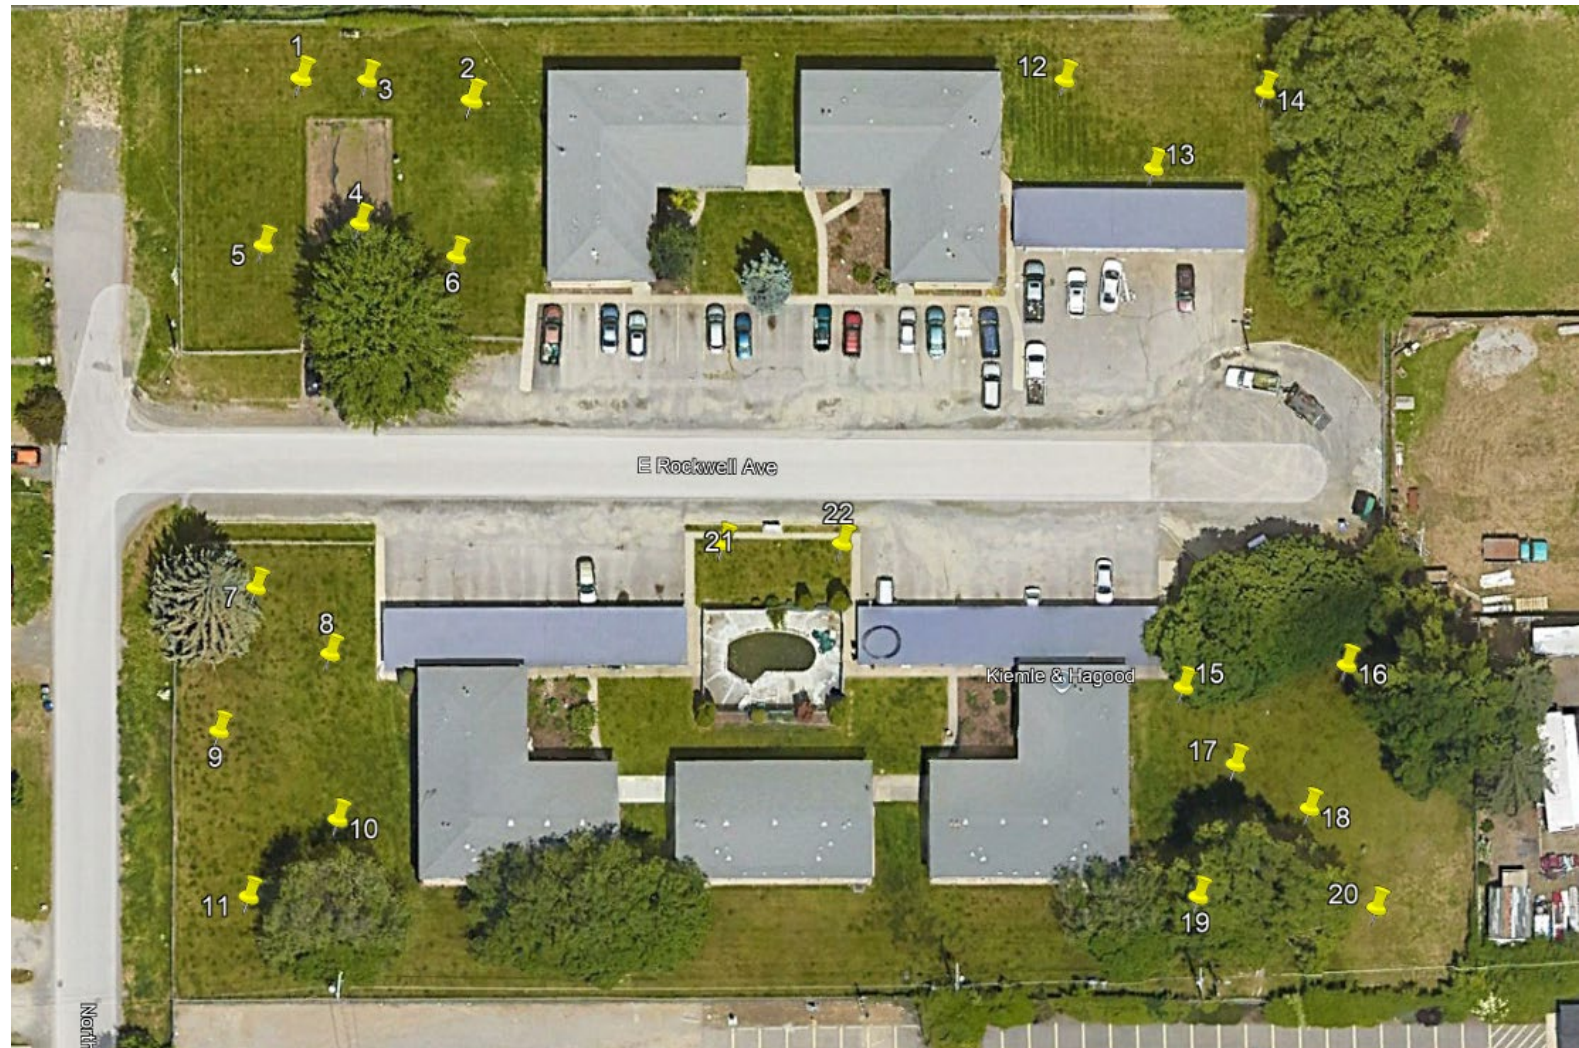
Figure 1: Rockwell Apartments Site and actual soil locations.

Sampling was conducted as outlined in the SAP, with samples collected from designated locations at a depth of 12-18 inches. All efforts were made to adhere to the established protocols and achieve the intended sample volume and quality. Figure 1 includes the updated sampling locations with latitude and longitude information.
