# PHASE II ENVIRONMENTAL SITE ASSESSMENT

1700 Airport Way South, Seattle, WA

Prepared for: Evergreen Treatment Services

Project No. 180043 • February 21, 2019 • FINAL

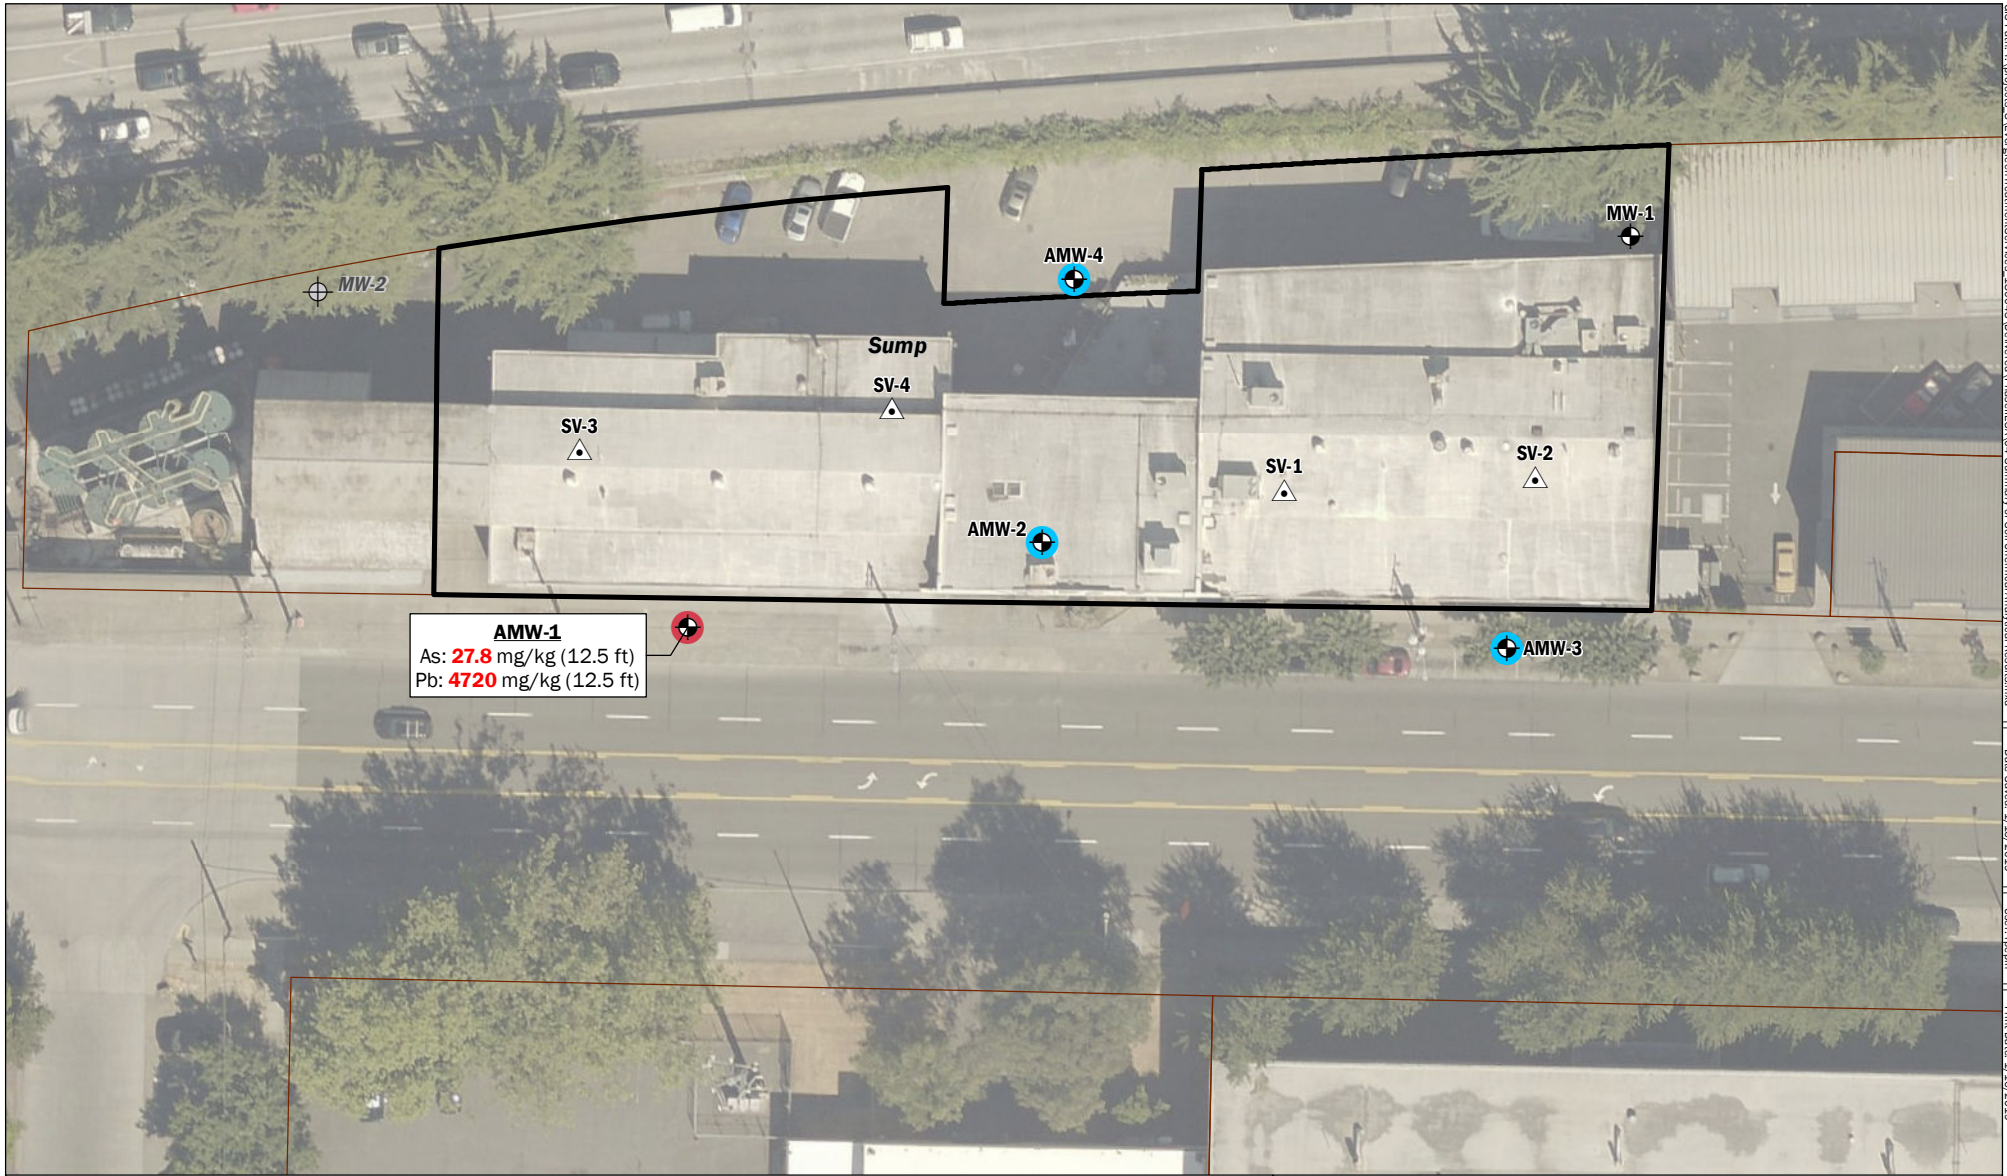
FIGURE NO.  
**4**

Chemical analytical results of the soil samples obtained from this study are presented on Table 1. Figure 4 present a summary of the contaminants detected in soil at concentrations greater than the MTCA Method A CULs for unrestricted land use (or Method B CULs if no Method A CUL is available). Laboratory reports are presented in Appendix B.

Two analytes were detected above the MTCA Method A (unrestricted land use) CULs. These exceedances were at 12.5 feet bgs at location AMW-1 at concentrations of 27.8 and 4,720 milligrams per kilogram (mg/kg) for arsenic and lead, respectively. The arsenic value slightly exceeds the CUL of 20 mg/kg while lead is more than an order of magnitude greater than the CUL of 250 mg/kg.

**AMW-1**  
 As: **27.8** mg/kg (12.5 ft)  
 Pb: **4720** mg/kg (12.5 ft)

Based on the chemical analytical results of soil from borings spaced at limited locations, soil impacts were limited to a sample collected from a depth of 12.5 feet, just west of the Subject Property (AMW-1). Fill material was observed to a depth of 15 feet bgs. Fill soils do not necessarily represent a regulatory reporting condition, but special handling and off-property management and disposal may be warranted for any subsurface maintenance activities. Also, any subsurface disturbances are to be completed in accordance with the existing restrictive covenant.

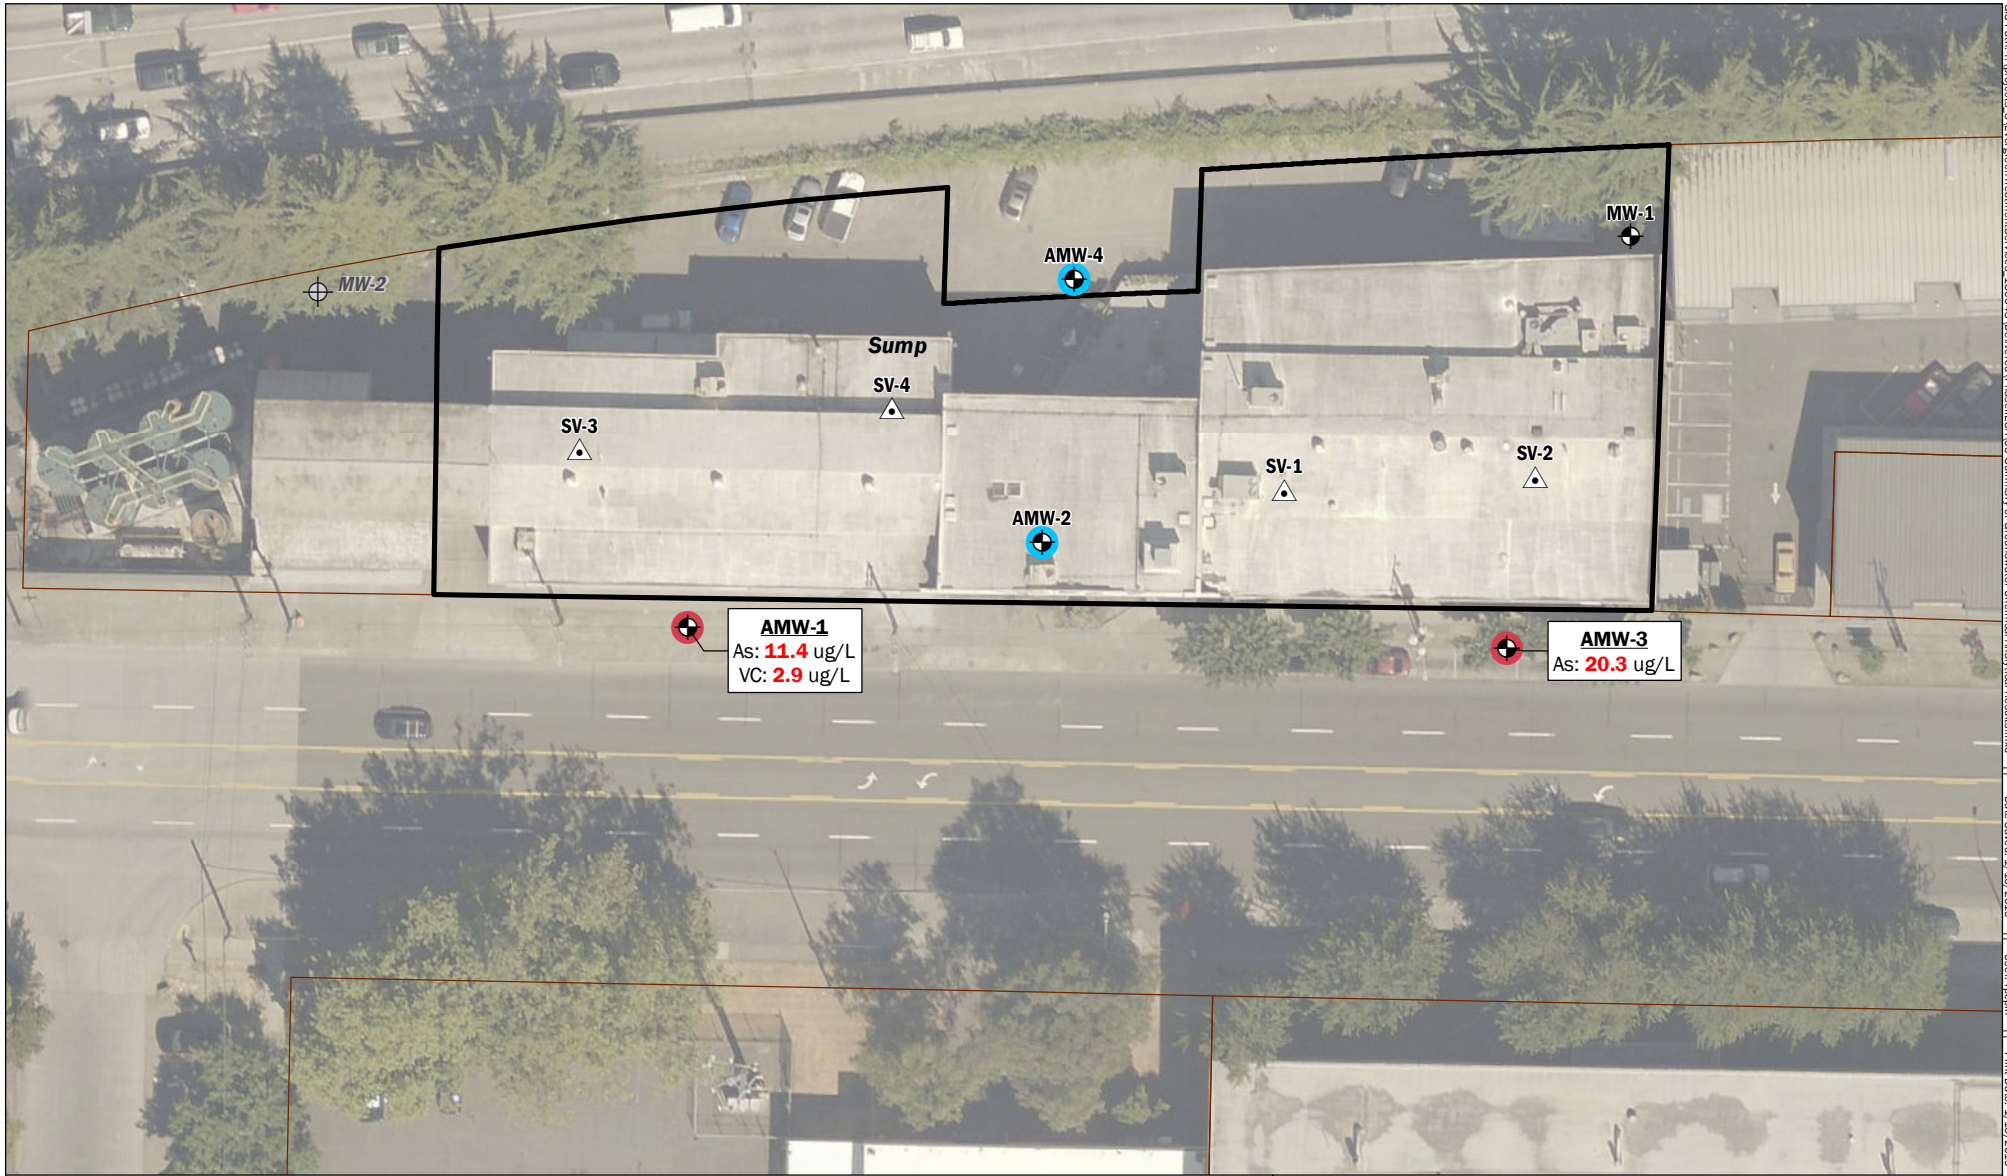
FIGURE NO.  
**5**

In the four monitoring wells Aspect installed, groundwater was encountered beneath the Subject Property at a depth of 4.5 to 5.7 feet bgs with a westerly flow direction. Four groundwater samples were submitted for analysis. At a concentration of 2.9 micrograms per liter ( $\mu\text{g/L}$ ), vinyl chloride exceeds MTCA Method CULs ( $0.2\mu\text{g/L}$ ) in well AMW-1, located west of the north wing of the building. Dissolved arsenic concentrations above the MTCA Method A CUL ( $5\mu\text{g/L}$ ) were detected in off-property wells AMW-1 and AMW-3 at concentrations ranging between 11 and  $20.3\mu\text{g/L}$ , respectively.
