April 2025
Meydenbauer Bay Yacht Club

Sediment Characterization Report for Proposed Maintenance Dredging

Sediment Characterization Report
 MBYC Maintenance Dredging Evaluation

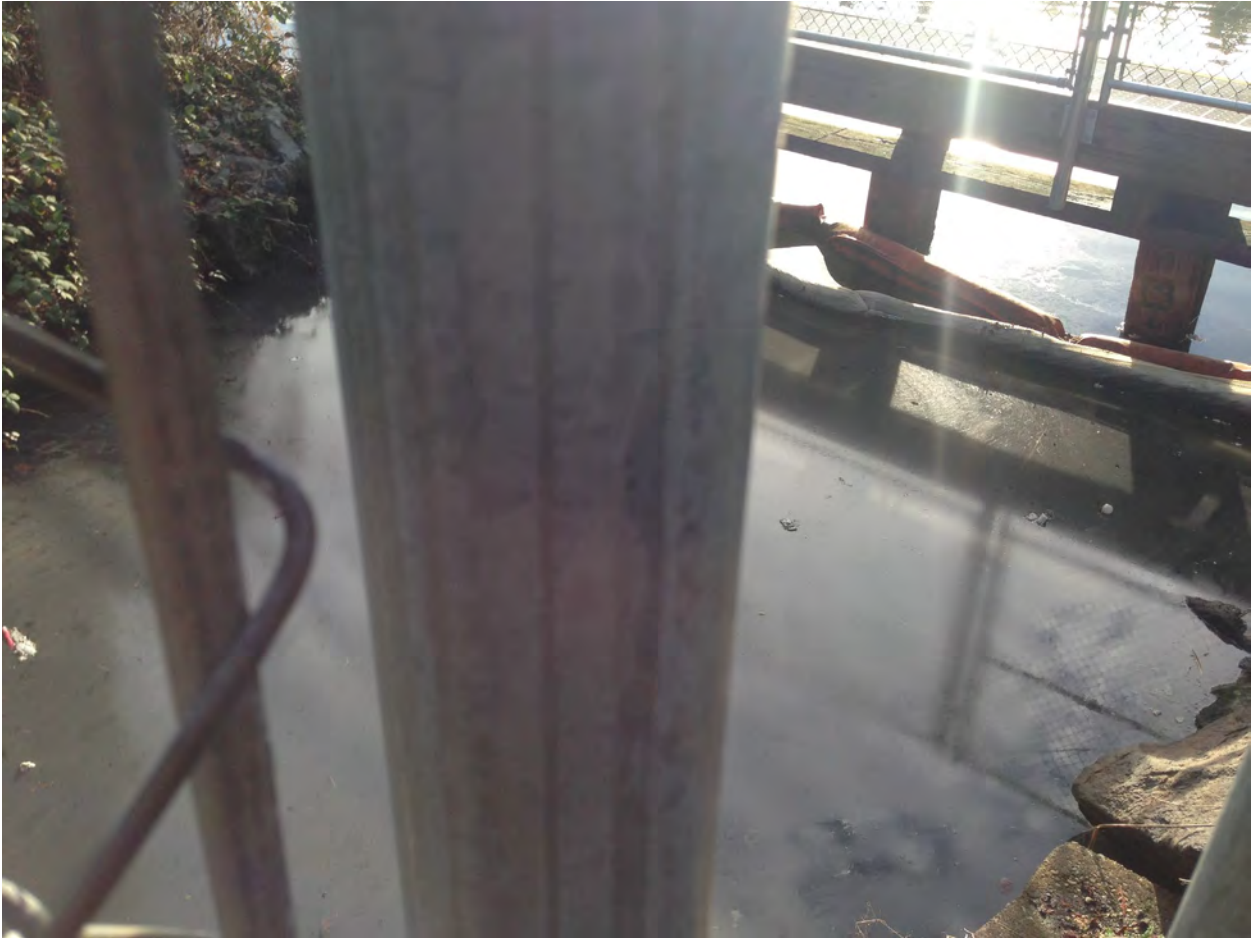
On January 13, 2018, a thick layer of oily scum was observed discharging from the City Outfall into the lake at the MBYC. City staff deployed sorbent booms in an attempt to recover some of the oil.

MBYC has observed evidence of non-stormwater discharges and/or hazardous materials discharging from the Outfall. Photograph 1 was taken during 2018 when an oily sheen was observed discharging from the Outfall. Photograph 2 was taken during August 2024 when a thick layer of foam was observed on the water discharging from the Outfall.

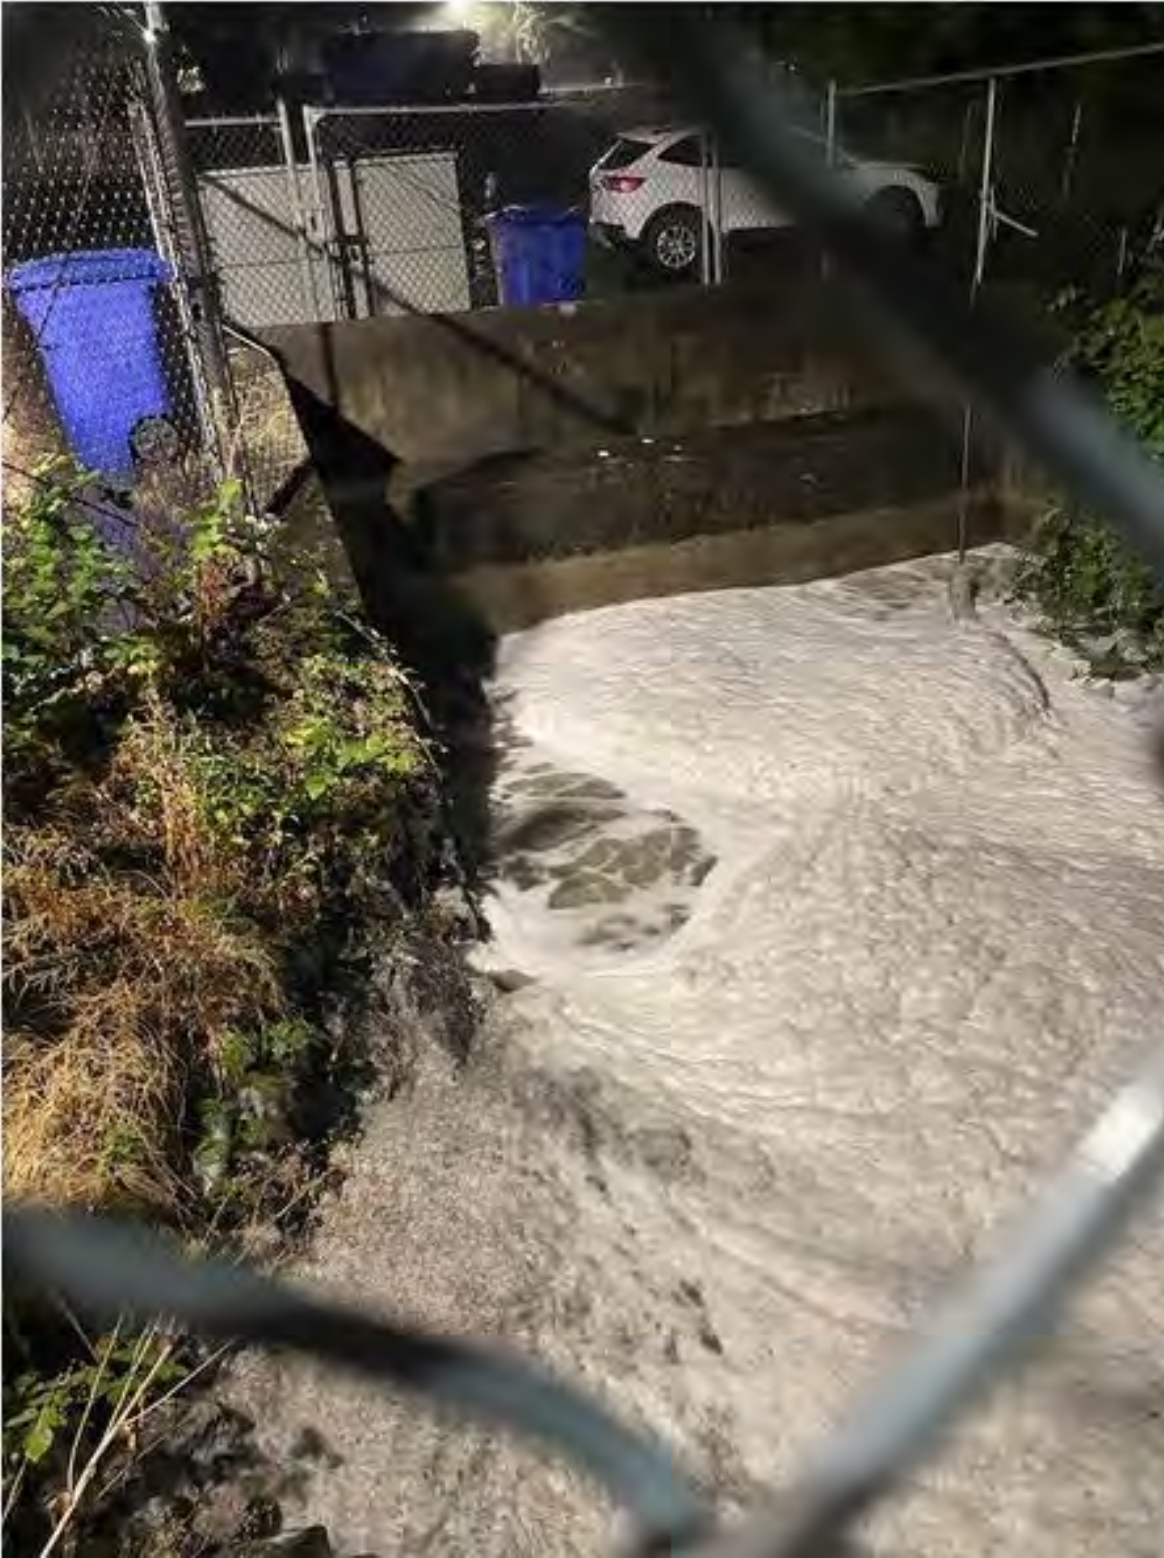
Figure 2

During August of 2024, a thick layer of foam was observed discharging from the City of Bellevue Outfall.

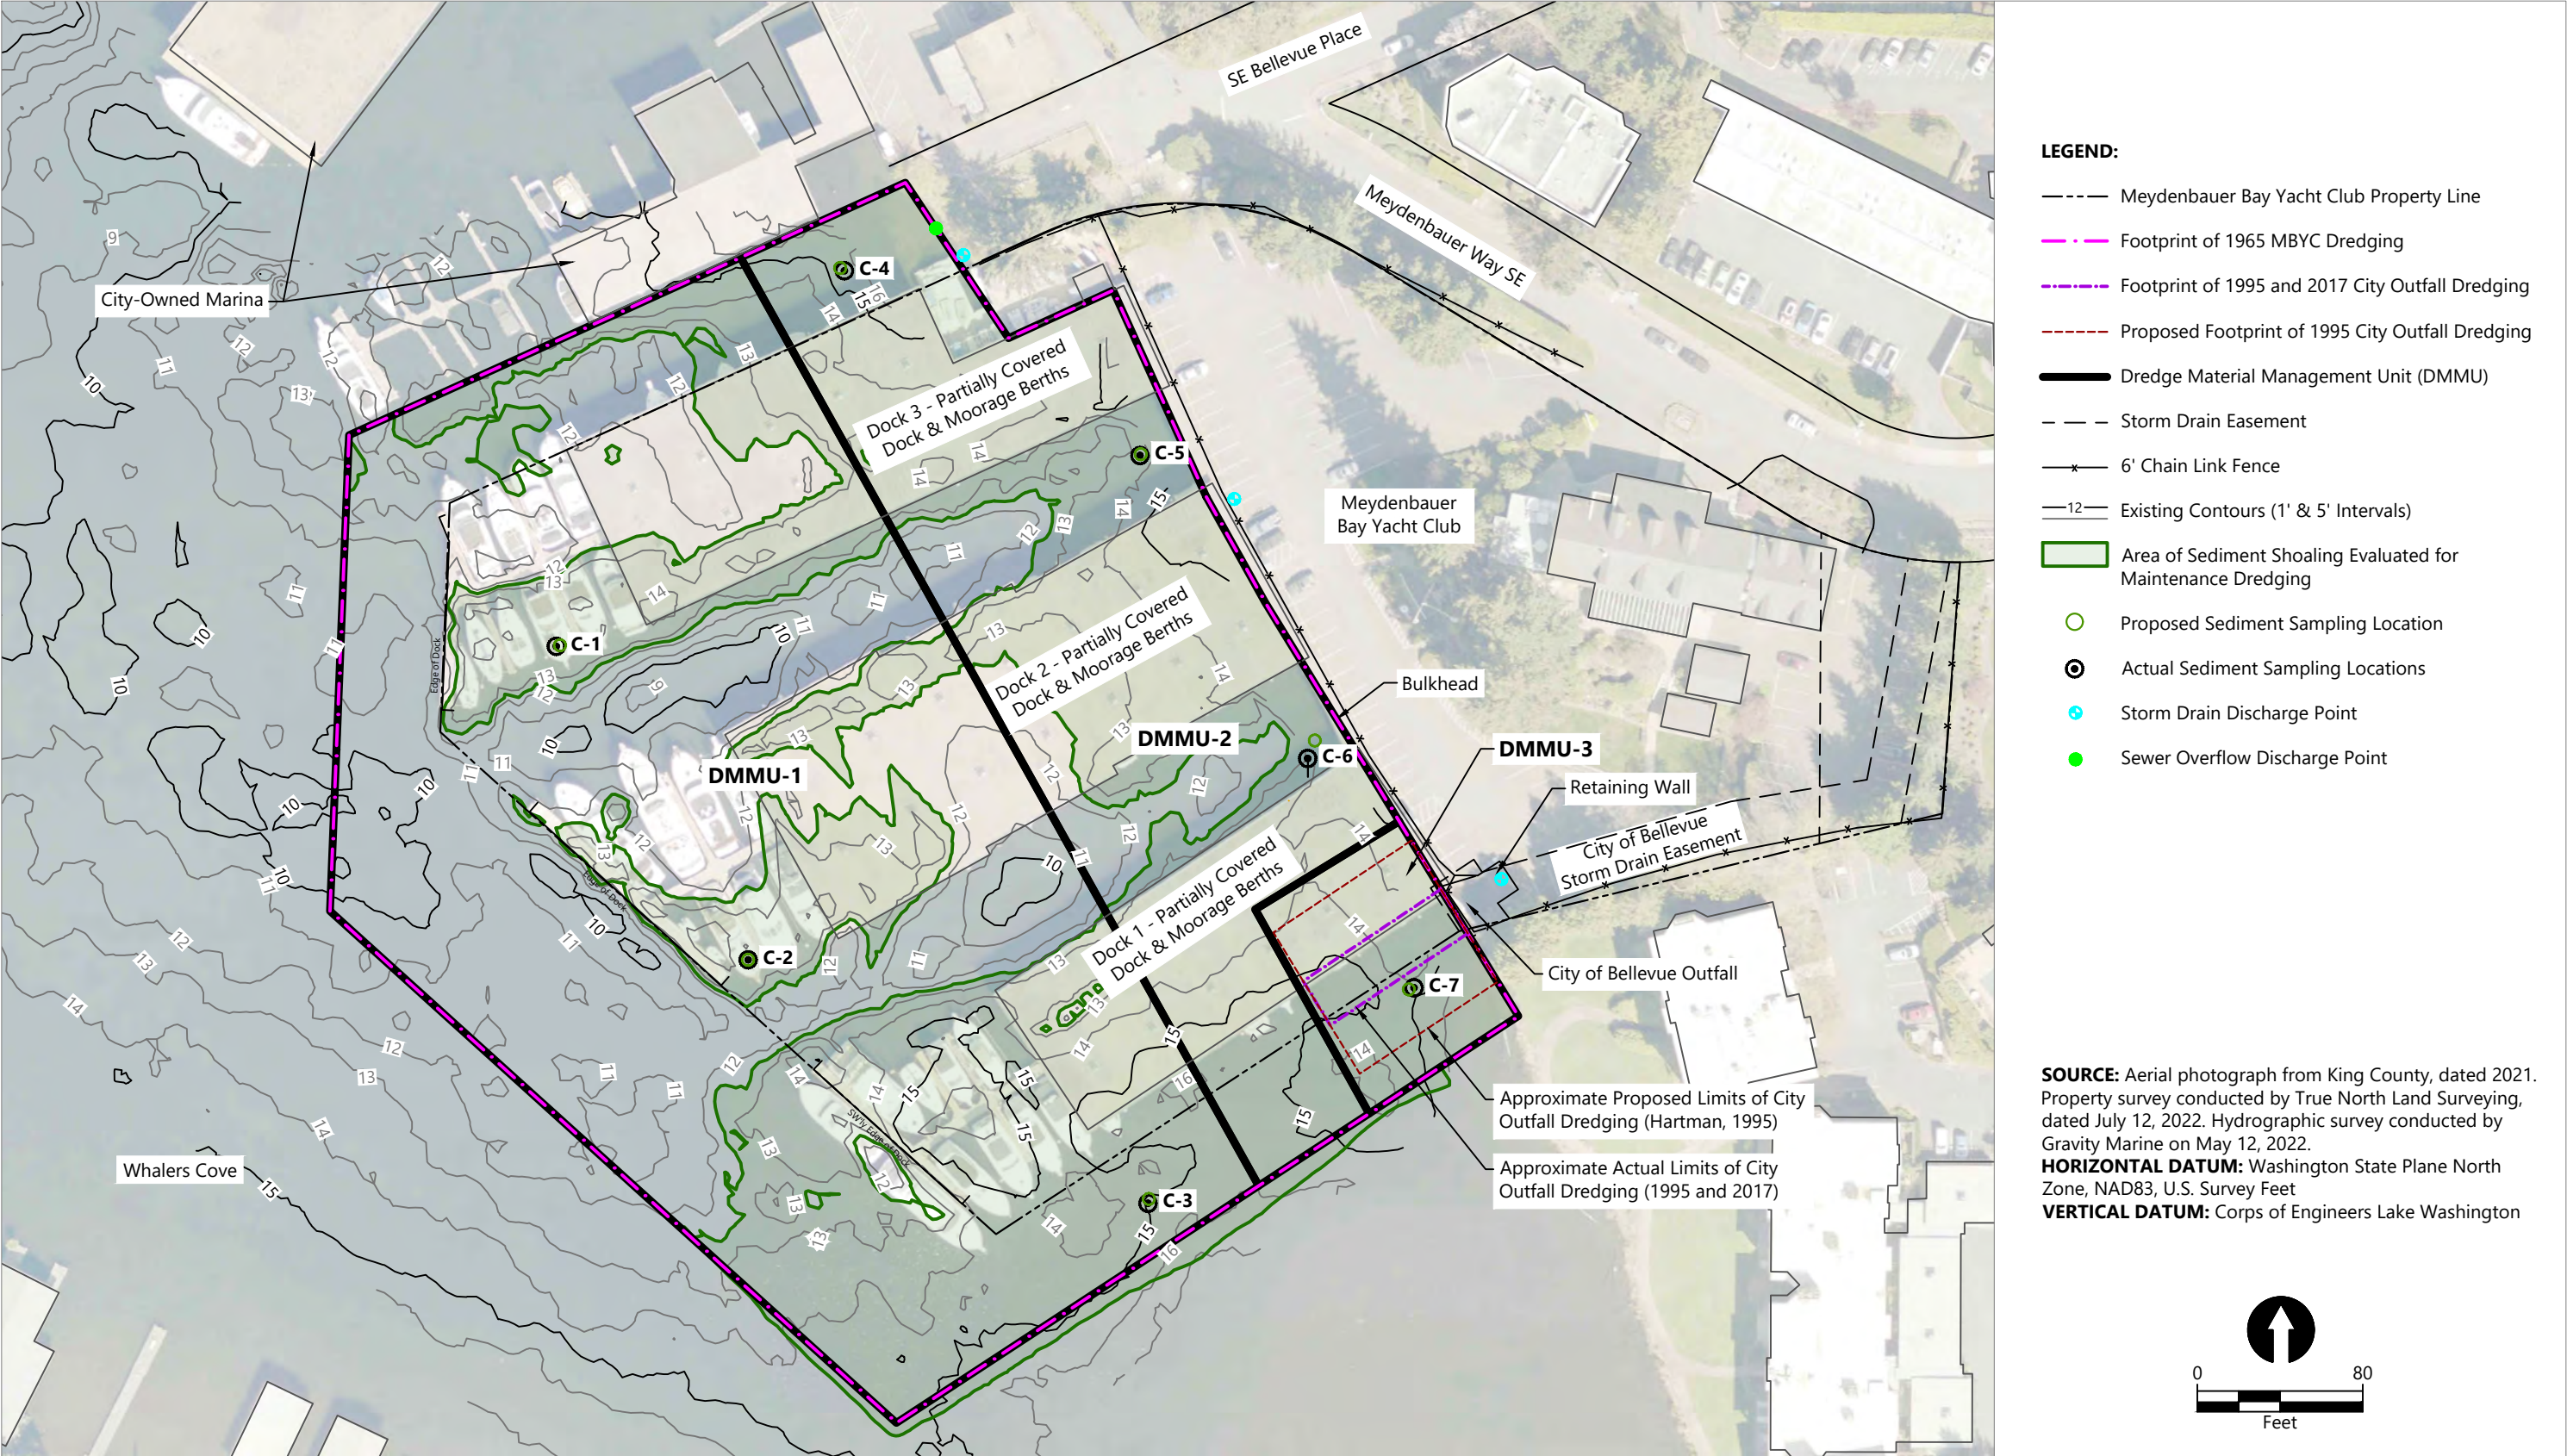
Figure 2
Proposed and Actual Sampling Locations
Sediment Characterization Report
MBYC Maintenance Dredging Evaluation

The dredge material management units (DMMUs), sampling location, target sample depth, and chemical testing methods were selected in accordance with the most recent DMMP guidance (DMMP 2021) and *Sediment Cleanup User's Manual II* (Ecology 2021). The established DMMUs and sampling locations are shown in Figure 2.

- DMMU 1: This DMMU includes offshore portions of the MBYC marina. Sampling included compositing of three cores (C-1, C-2, and C-3).
- DMMU 2: This DMMU is located in the shoreline areas within the MBYC marina. Sampling included compositing of three cores (C-4, C-5, and C-6).
- DMMU 3: This DMMU is located in the area where the City previously performed localized sediment removal during 1997, 2010, and 2017 dredging events (Section 2.3). Sampling included a single core (C-7).

The marina is located on MBYC-owned second class shorelands in Lake Washington. Figure 2 shows the MBYC property boundary based on a 2022 property survey. Properties located in the vicinity of MBYC include the following:

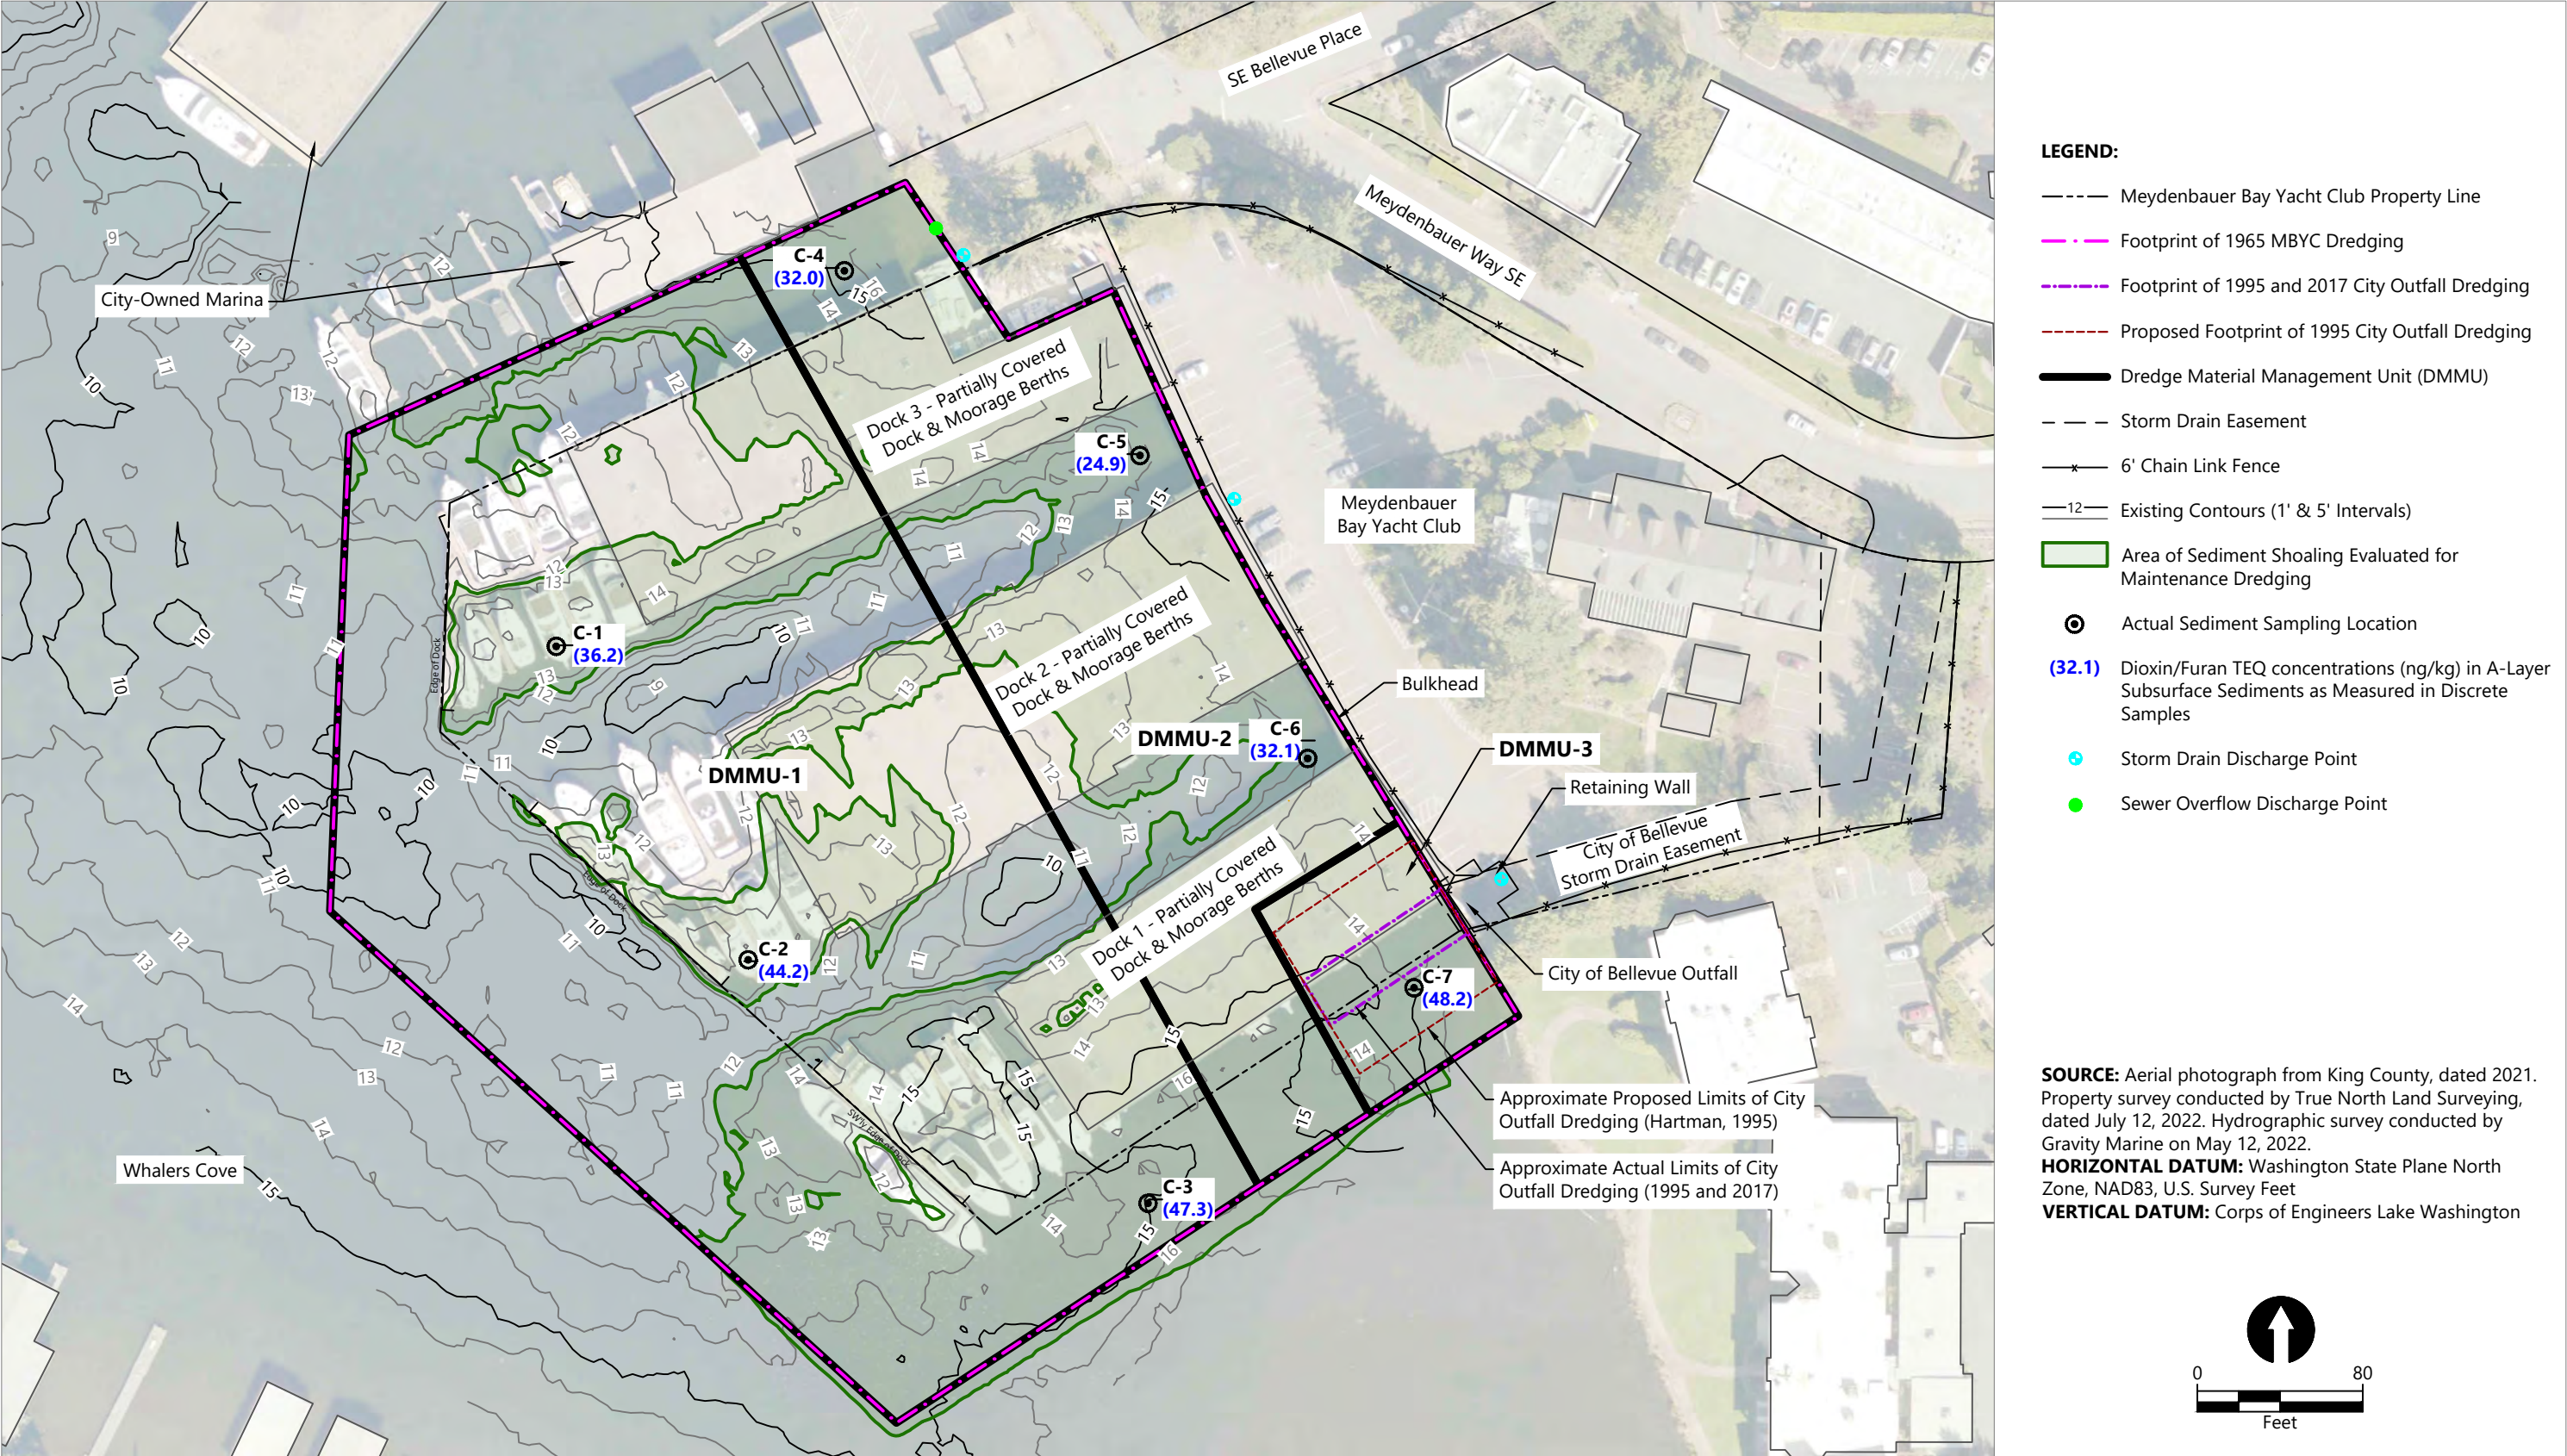
Publish Date: 2025/03/28 4:08 PM | User: jfoster
Filepath: K:\Projects\2595-Meydenbauer Yacht Club\MBYC Maintenance Dredging Eval\Sediment Characterization Report\2595-RP-003 (Results of Dioxin Furan).dwg Figure 3

Figure 3 summarizes the D/F results from the discrete sample testing by location, and Table 3 presents the analytical results for each sample. The highest concentrations were detected in DMMU-3 (core sample C-7) located adjacent to the Outfall. Concentrations generally decreased with distance from the Outfall.

- Discrete sampling of the A-layer sediments was performed throughout the potential MBYC dredging footprint. The highest D/F concentrations were measured in the discrete samples collected adjacent to the Outfall, despite this area having been dredged in 1997 and 2017. The results indicate that the Outfall is the likely source of this sediment contamination. Based on the distribution of D/F contamination observed, the contamination likely extends outside of the characterized area into other areas of Whalers Cove.
