# Cleanup Options Report

Bellingham School District Bus Garage  
Agreement No. TCPIPG-2123-BSD-00032

Project No. M0837.02.005

Maul Foster & Alongi, Inc.

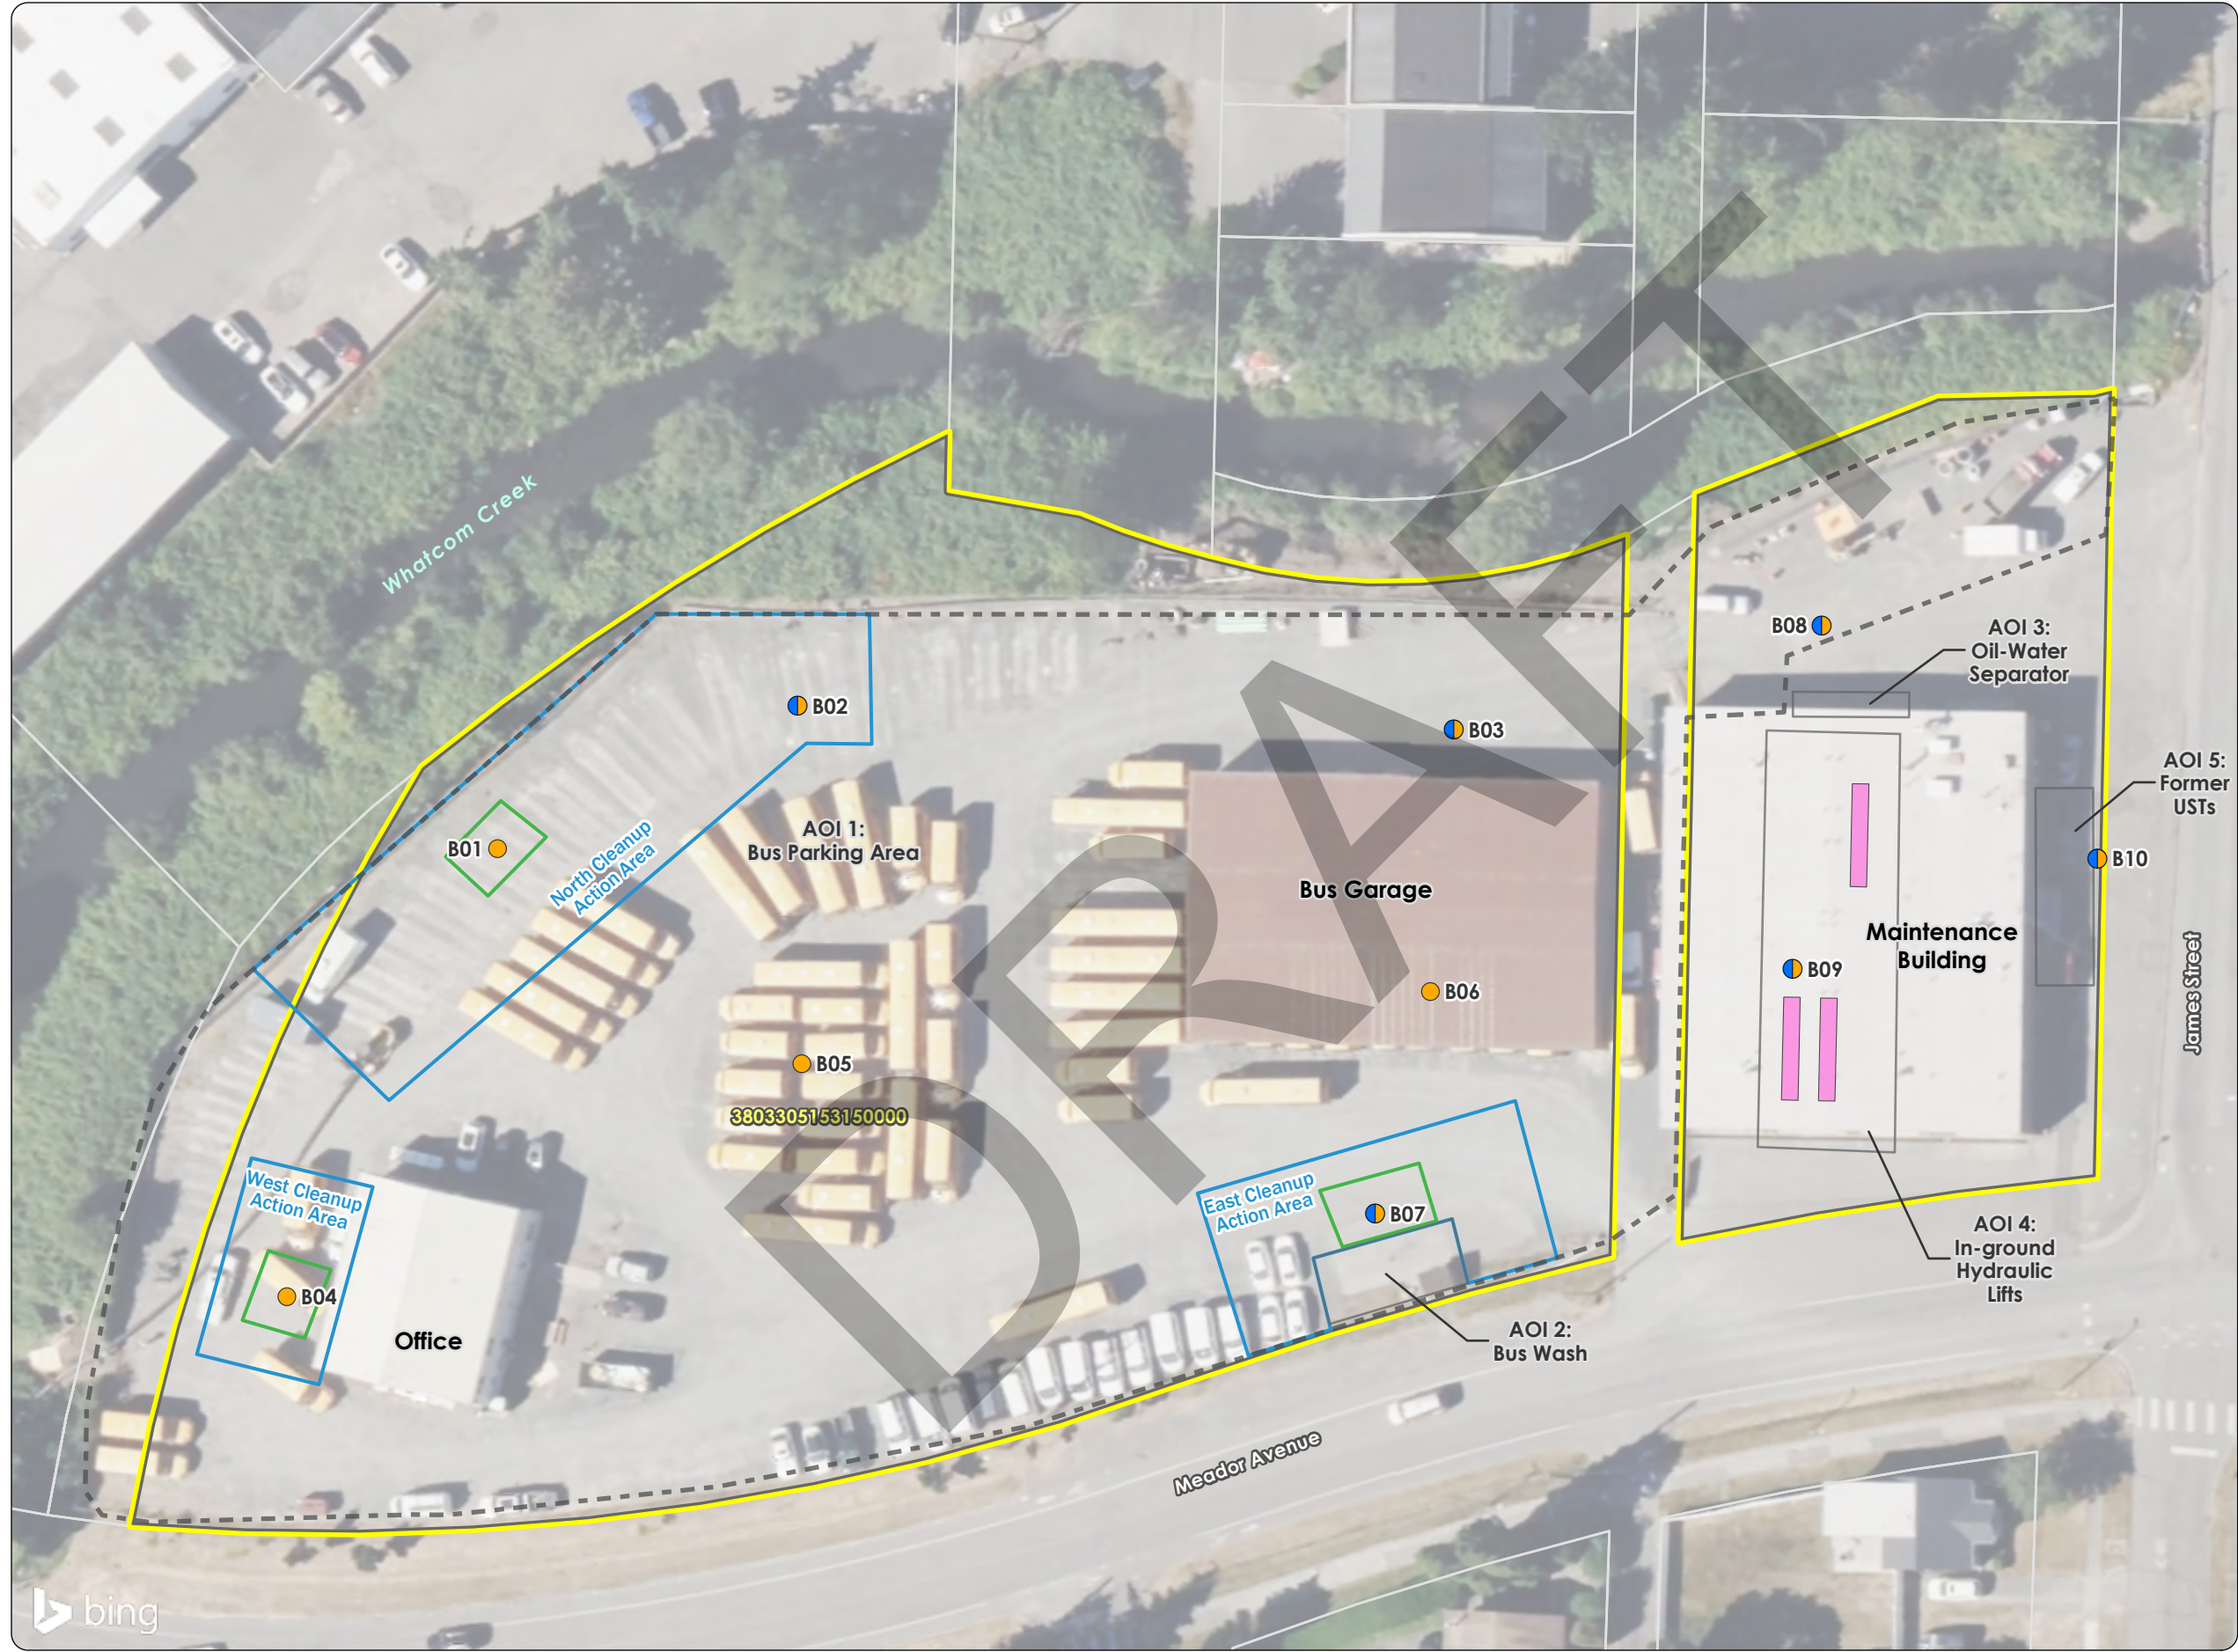
**Figure 4-1**  
**Cleanup Action Areas**

Cleanup action areas consist of three areas in the bus parking and bus wash portions of the Property. These areas, shown in Figure 4-1, were delineated based on soil data collected during the FEI. The North Cleanup Action Area is an approximately 11,100 square foot area around B01, where soil impacts were observed in the northern portion of the bus parking area. The West Cleanup Action Area is an approximately 2,300 square foot area around B04, where soil impacts were identified to the west of the office. The East Cleanup Action Area is an approximately 4,000 square foot area around B07, where soil impacts were identified near the bus wash.

- Limited Excavation and Capping—Excavation of shallow soil (up to ~3 feet bgs and 160 bank cubic yards) to remove the highest exceedances (see limited cleanup action areas on Figure 4-1). Remedial excavations will be lined with demarcation fabric before being backfilled with clean material, which will act as a permeable cap for deeper exceedances.

- Excavation and Offsite Disposal—Excavate extent of soil impacts in the north, west, and east cleanup action areas, as follows (see cleanup action areas on Figure 4-1):
  - North Cleanup Action Area: Approximately 4,110 cubic yards of material, with a maximum depth of 10 feet bgs.
  - West Cleanup Action Area: Approximately 260 cubic yards of material, with a maximum depth of 3 feet bgs.
  - East Cleanup Action Area: Approximately 740 cubic yards of material, with a maximum depth of 5 feet bgs.
