**Reserve Silica Reclamation Site –
Historical Coal Facilities - Aspect
Consulting Memo**

Project No. 160315-A

Re: Reserve Silica Reclamation Site – Historical Coal Facilities

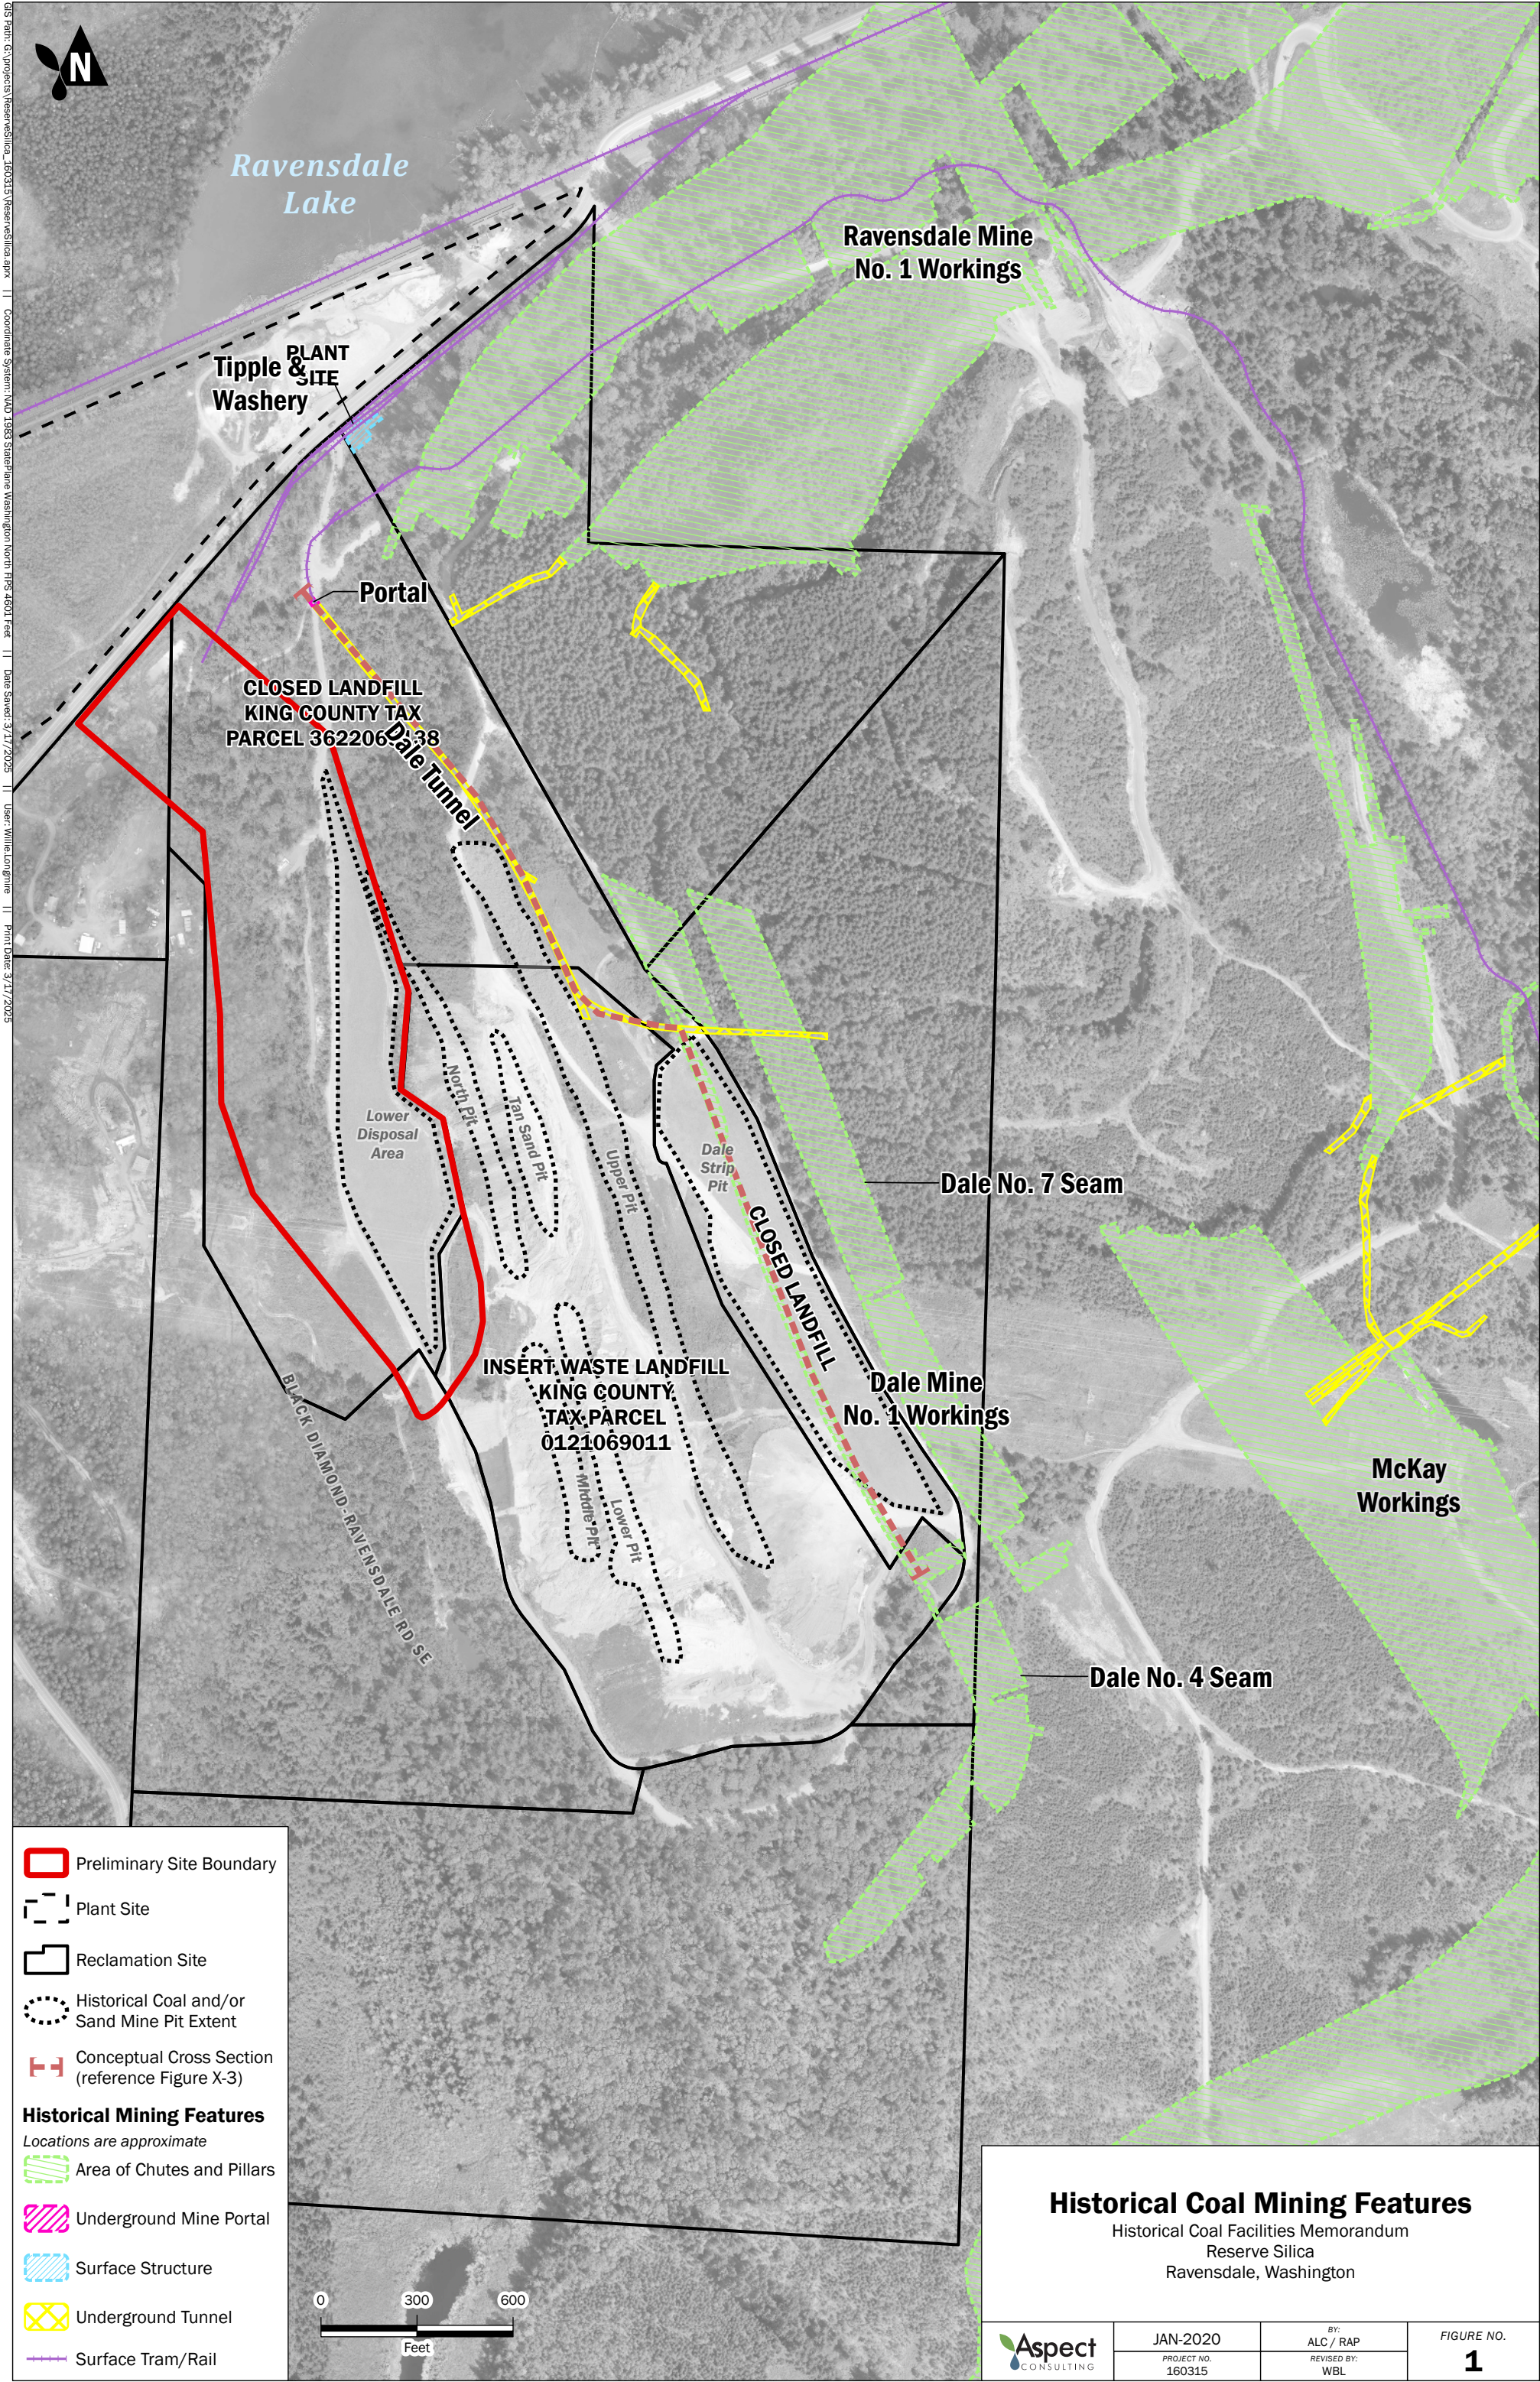
Attachments: Figure 1 – Historical Coal Mining Features
 Figure 2 – Dale Coal Mine Surface Structures

Based on the results of the remedial investigation (RI) work completed to date, the preliminary Site extent is depicted on Figures 1 and 2 and is based on areas where CKD is present (the LDA and DSP) and/or where data from monitoring wells has delineated the extent of CKD-related hazardous substances in shallow groundwater. There is no indication that the Site boundary will expand to the northeast (towards the historical coal facilities).

As depicted on the attached figures, the only location where the Site overlaps with historical coal facilities is near the mine portal, which has been extensively observed and studied for decades (Golder, 2021). There are no visual indications of releases attributable to former coal mining facilities in this portion of the Reclamation Site. Based on these results, no further work is necessary to evaluate potential releases of hazardous substances associated with historical coal facilities at the Reclamation Site.
