## REMEDIAL EXCAVATION REPORT

Ferndale High School  
5830 Golden Eagle Drive  
Ferndale, Washington

April 24, 2023

Project No.: 2000-054

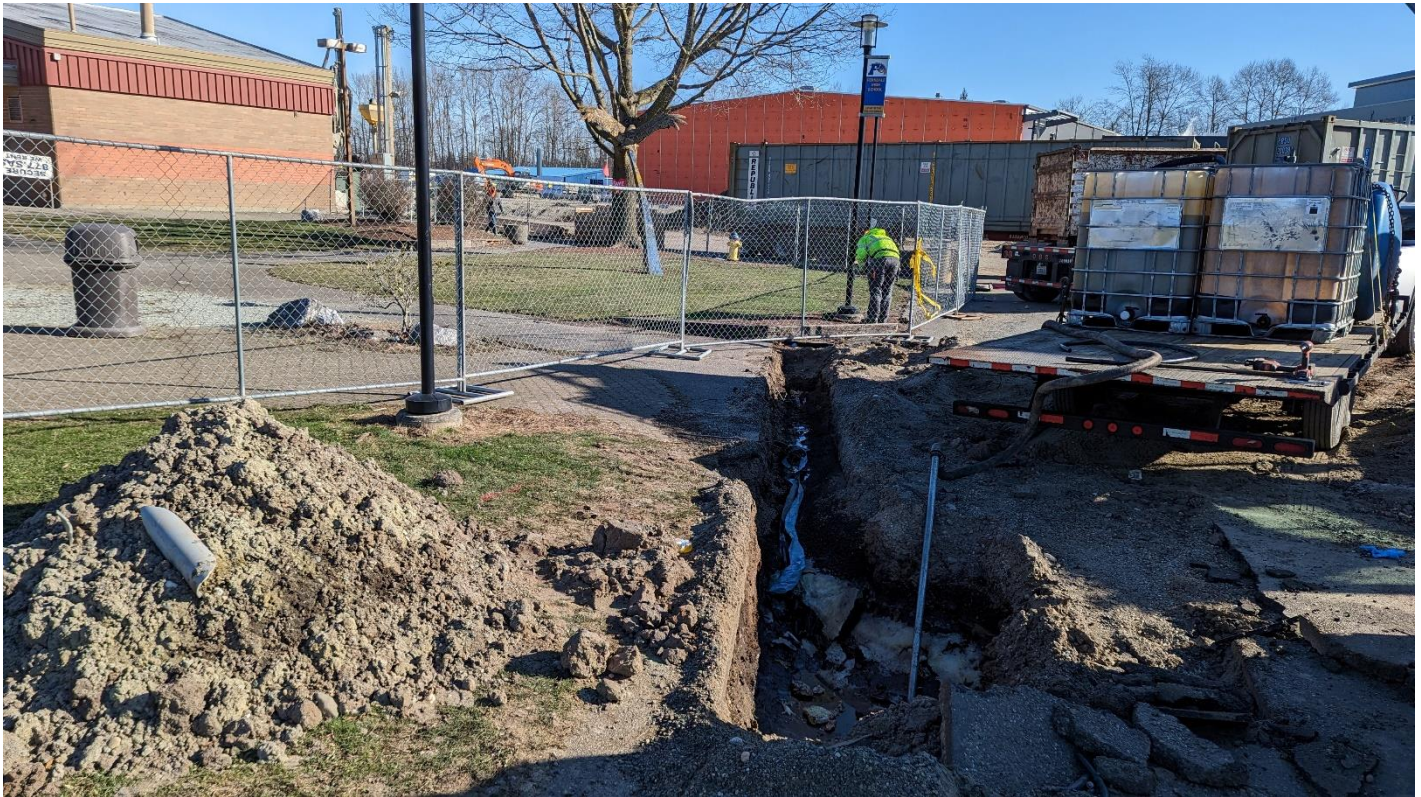
Photograph 1. Initial trench prior to remedial excavation activities.

On February 24, 2023, EHSI and CGI inspected trenching that contained unpowered transformer conduit lines that had been damaged during excavation activities performed by CGC that resulted in transformer fluid being released to the nearby soil.

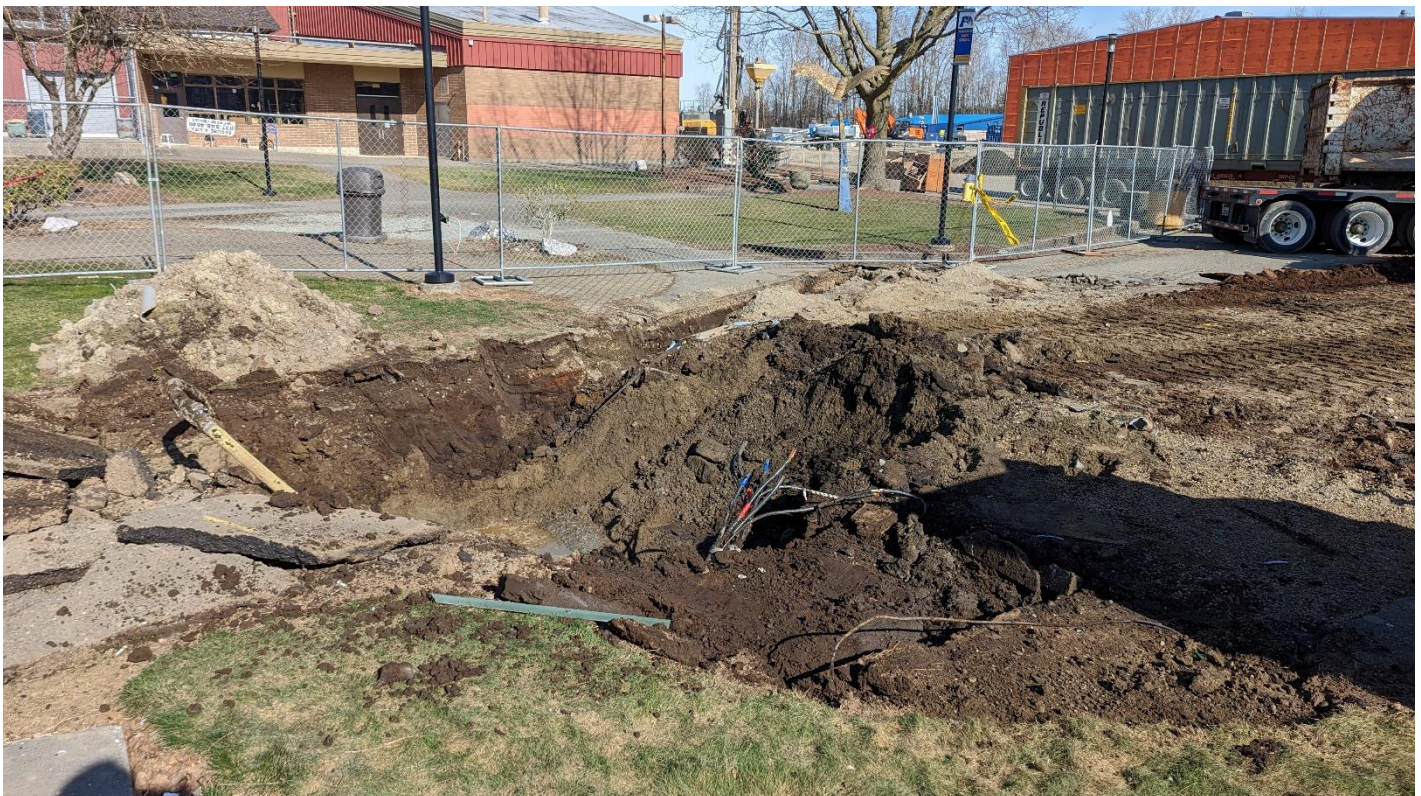
Photograph 2. Conduit extruding from the surface soil layer at the former location of the transformer.

- Damaged conduits within the excavation area were completely removed prior to resuming the excavation. Soil was direct-loaded for transport.
- Contaminated soil was excavated until visual observation and field screening indicated the extent of contamination had been reached.

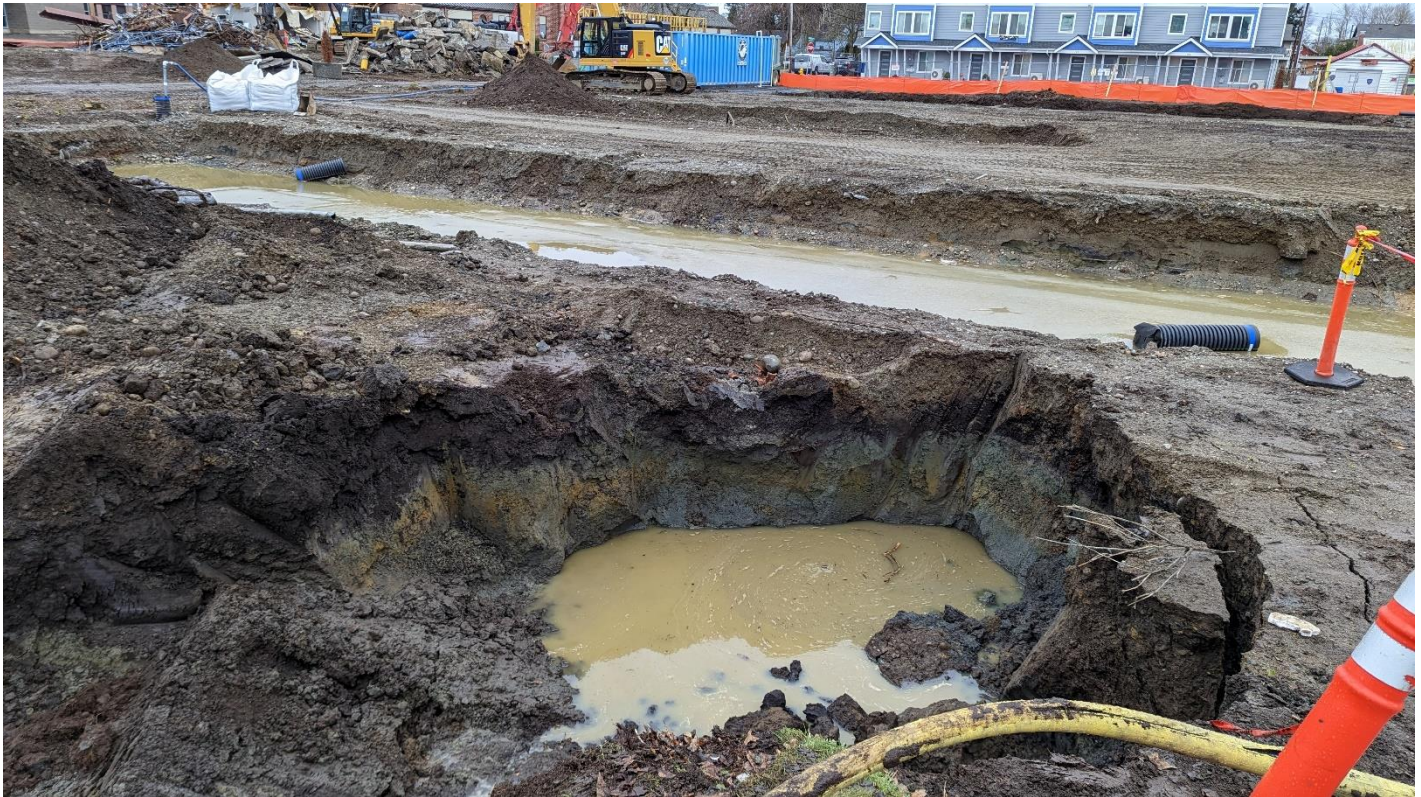
Photograph 3. Southern extent of excavation at a depth of 7 feet below ground surface (bgs), filled with groundwater at a depth of 5 feet bgs. No sheen observed.

- The following extents were measured and soil and groundwater conditions were observed within the remedial excavation:
  - The excavation area measured approximately 45 feet north to south, 18 feet east to west at its widest extent, and approximately 7 feet bgs at its maximum depth. The majority of the soil was excavated to a depth of 4 feet bgs; soil in a smaller area of the southern portion of the excavation that measured approximately 10 feet north to south and 7 feet east to west was excavated to a depth of 7 feet bgs.

- Groundwater was encountered at a depth of approximately 5 feet during the excavation. No sheen was observed on groundwater within the excavation, and there were no indications of impacts to groundwater observed at the conclusion of the excavation.

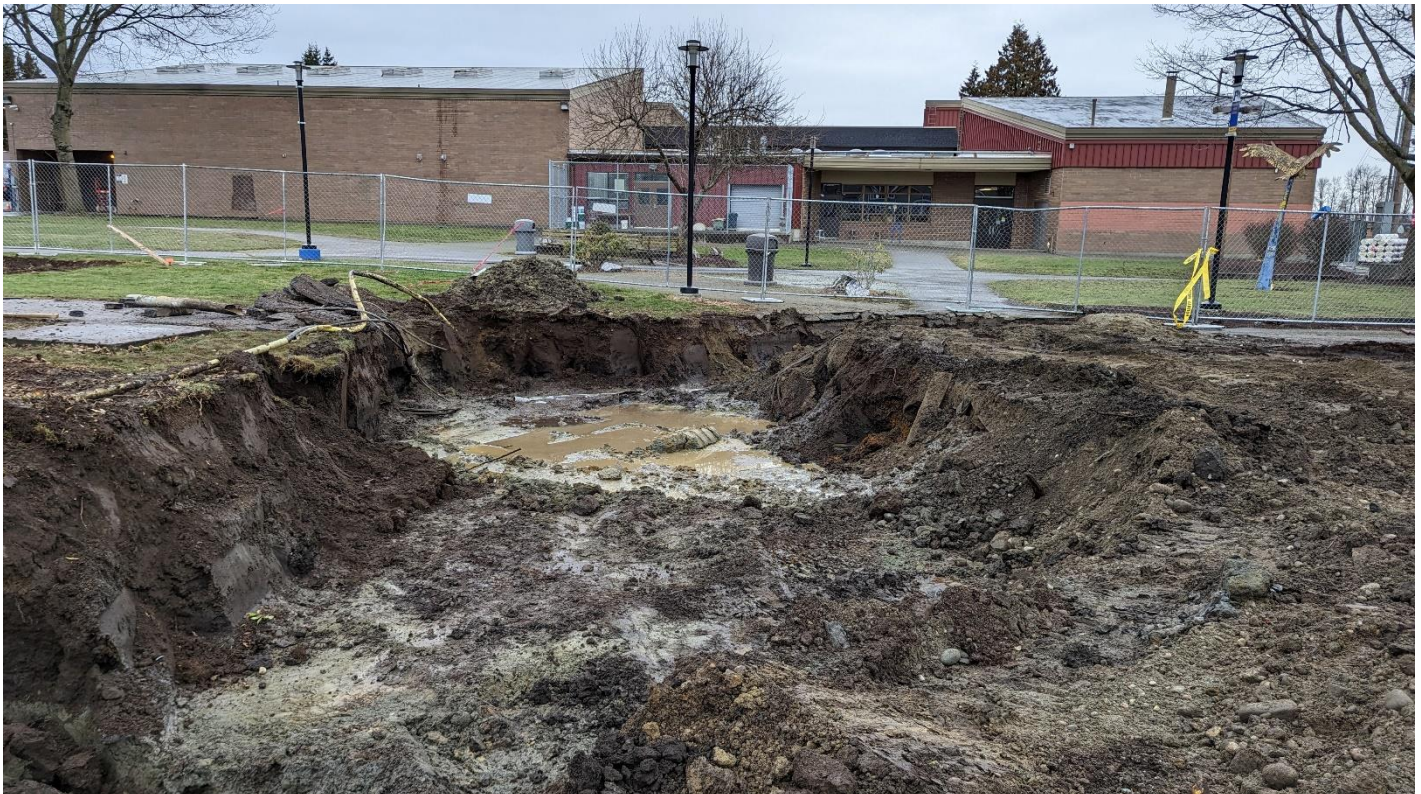
Photograph 4. Extent of the majority of the excavation at a depth of 4 feet bgs.
