Superlon Plastics Co Inc

2096 Superlon Plastics Co Inc 20250722

First SHARP

SHARP Report — Part 2 of 2

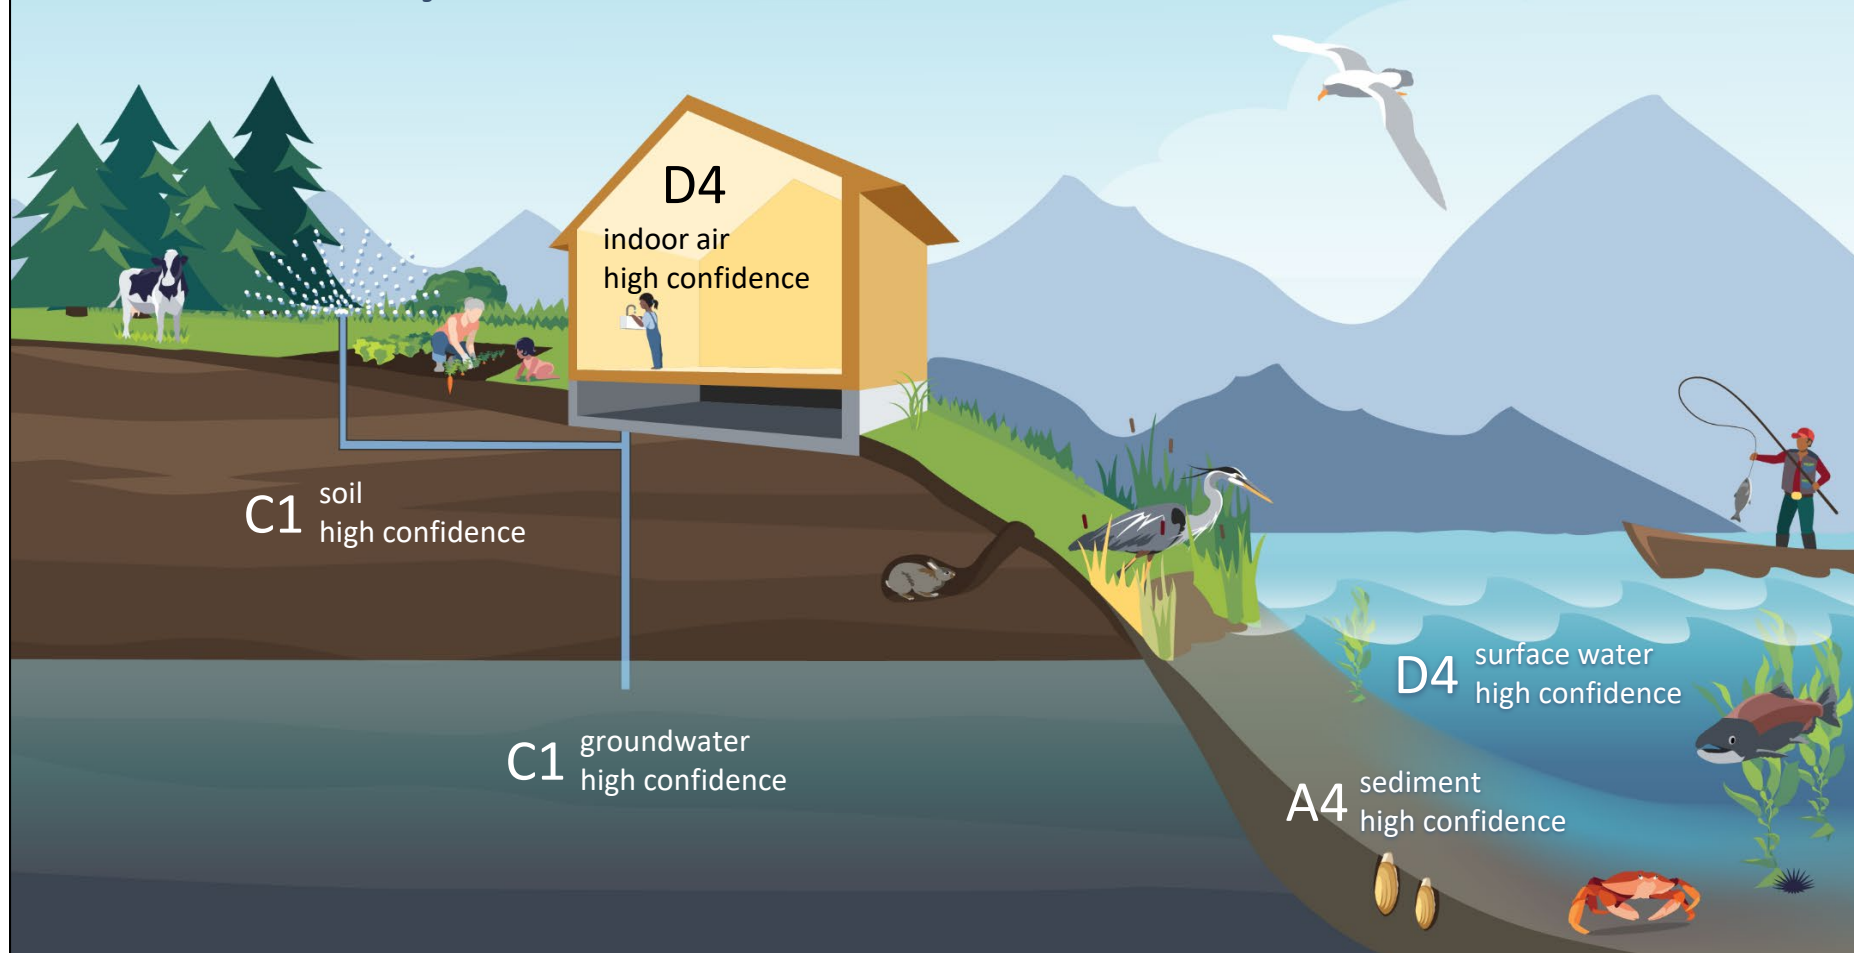
Conceptual site model

Assessment scores by environmental medium
