Eatonville Landfill

SHARP Report — Part 1 of 2

SHARP Report — Part 2 of 2

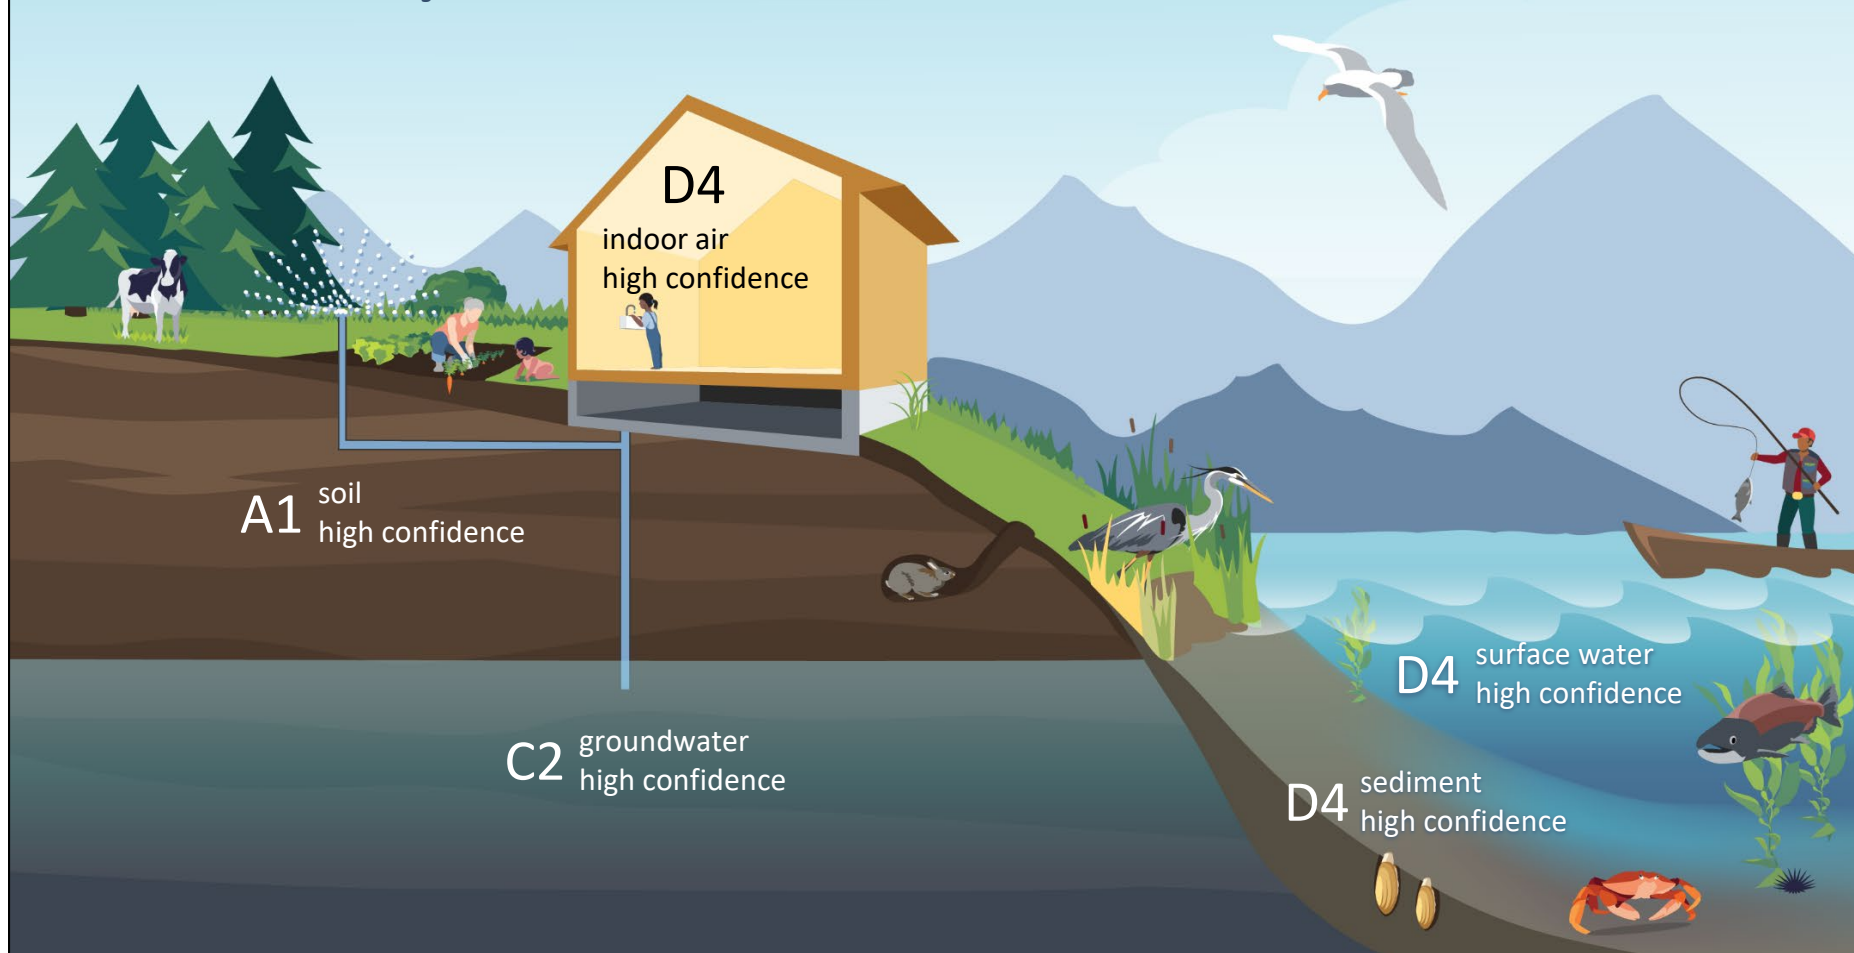
Conceptual site model

Assessment scores by environmental medium
