Re: Focused Vapor Intrusion Assessment Letter  
Snohomish Square Cleaners  
1419 Avenue D and 13<sup>th</sup> Street Southeast  
Snohomish, Washington 98290

J.S. Held, LLC (J.S. Held) is pleased to present this letter documenting a Focused Vapor Intrusion (VI) Assessment conducted at the former Snohomish Square Cleaners located at Avenue D and 13<sup>th</sup> Street Southeast in Snohomish, Washington (subject property).

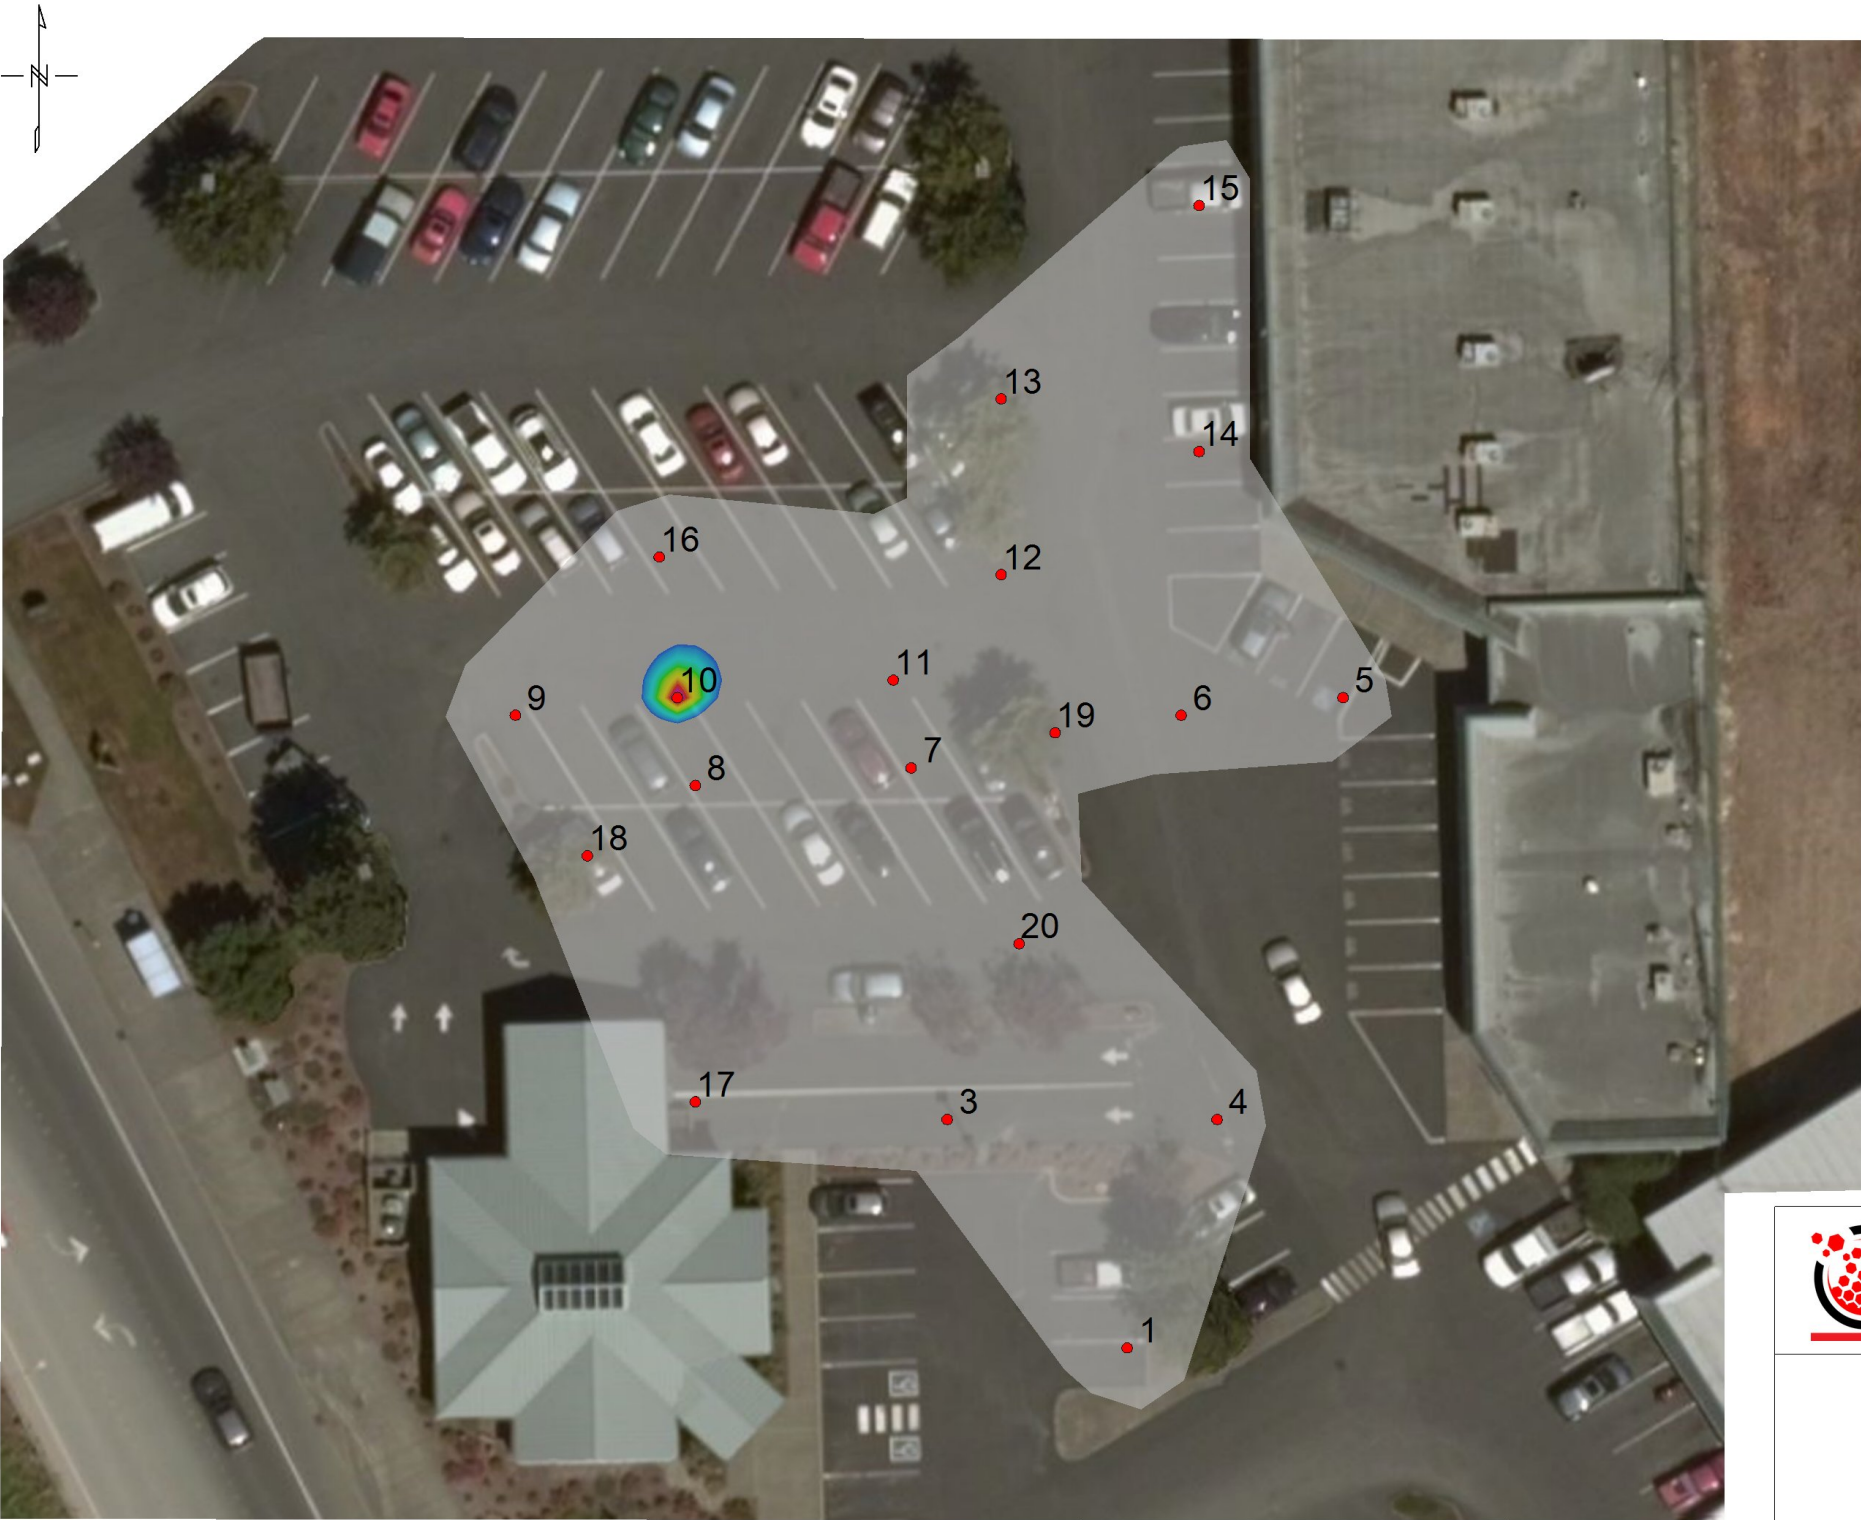
Environmental Partners, Inc.  
69402.2 - Skotdal  
Tetrachloroethene

A minimum curvature algorithm was used to interpolate the data from the sample locations to a regularly-spaced grid. The resulting surface is considered to be the smoothest possible surface that will fit the observed values at each sample location (i.e., data honoring). The interpolation is performed in log space, with grid cell sizes approximately one-tenth the average distance between sample locations. For example, when AGI Universal Samplers are placed about 50 feet apart, the grid cell size is set to five feet.

Contour minimums and maximums used in the color interval assignment are established based on the QA blank levels (trip and method blanks), method detection limits, and maximum values observed. The minimum contour level (gray color) is established using the maximum QA blank level or method detection limit, whichever is greater, per compound or groups of compounds. The maximum contour level is set at the maximum value observed, per compound or groups of compounds. Contour interval assignments can be modified at the client's request.

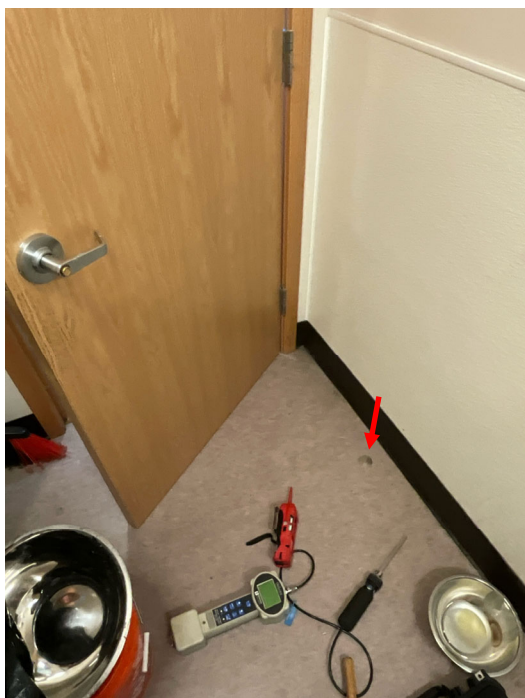
Photograph No. 01: View of newly installed vapor pin VP-1, located inside of the ELF Daycare building.

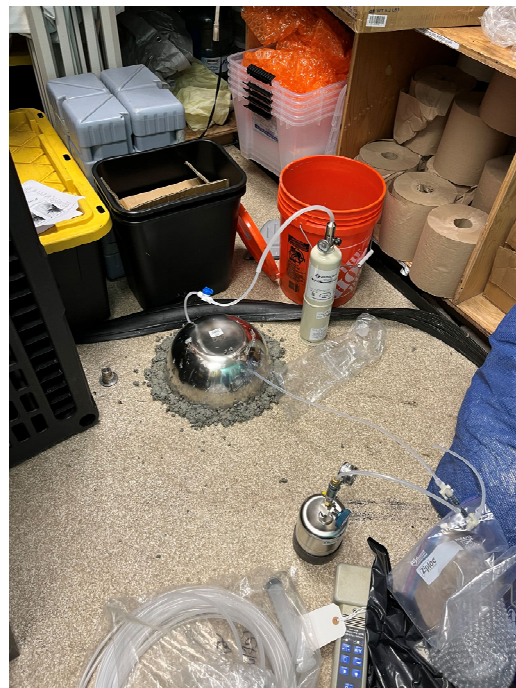
Photograph No. 02: View of existing vapor pin VP-2, under helium shroud, located inside of the Bliss Small Batch Creamery building.

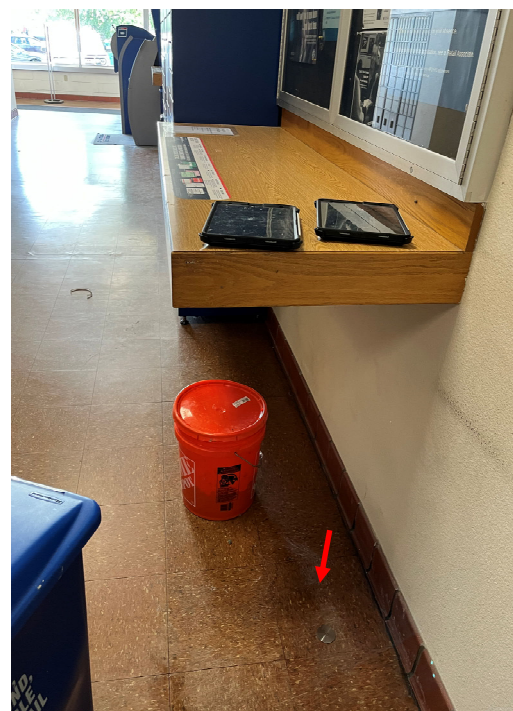
Photograph No. 04: View of newly installed vapor pin, VP-4, located inside of the U.S. Post Office building

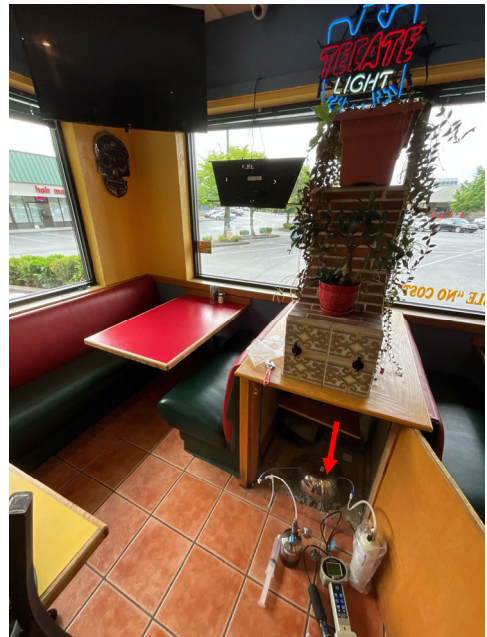
Photograph No. 06: View of newly installed vapor pin VP-6, under helium shroud, located inside of El Paraiso Mexican Grill building.

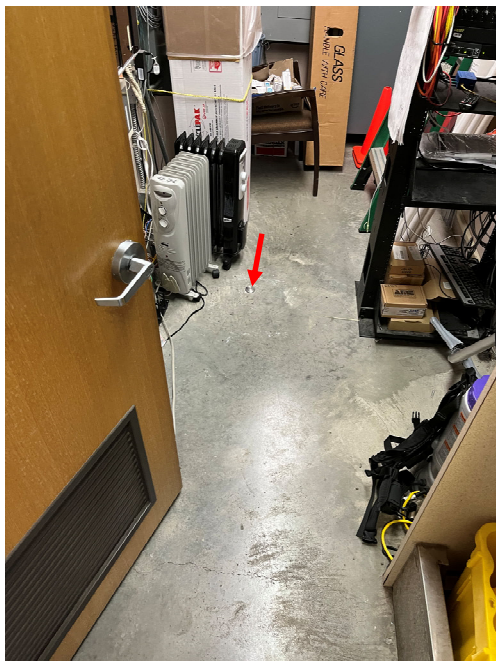
Photograph No. 07: View of existing vapor pin KB-VP2, located inside of the Key Bank building.

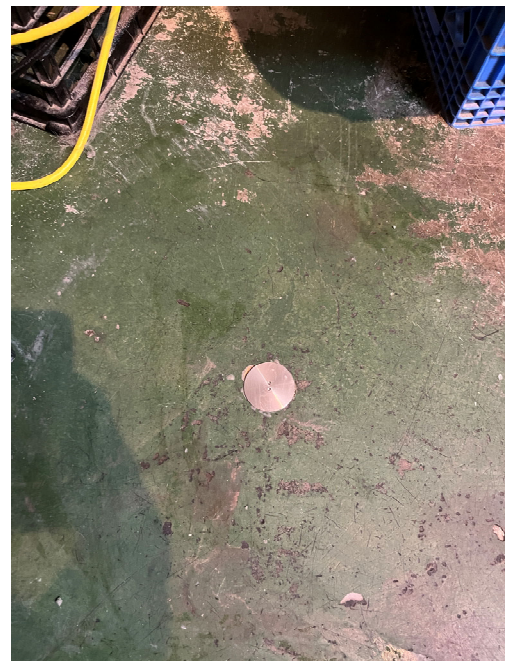
Photograph No. 08: Zoomed view of a vapor pin completed with flush, stainless steel covering following sample collection.
