**INTERIM ACTION REPORT
NORTH OMAK ELEMENTARY
OMAK, WASHINGTON**

October 9, 2006

**Prepared by Washington State Department of Ecology
Toxics Cleanup Program
Jeff Newschwander (509) 454-7842**

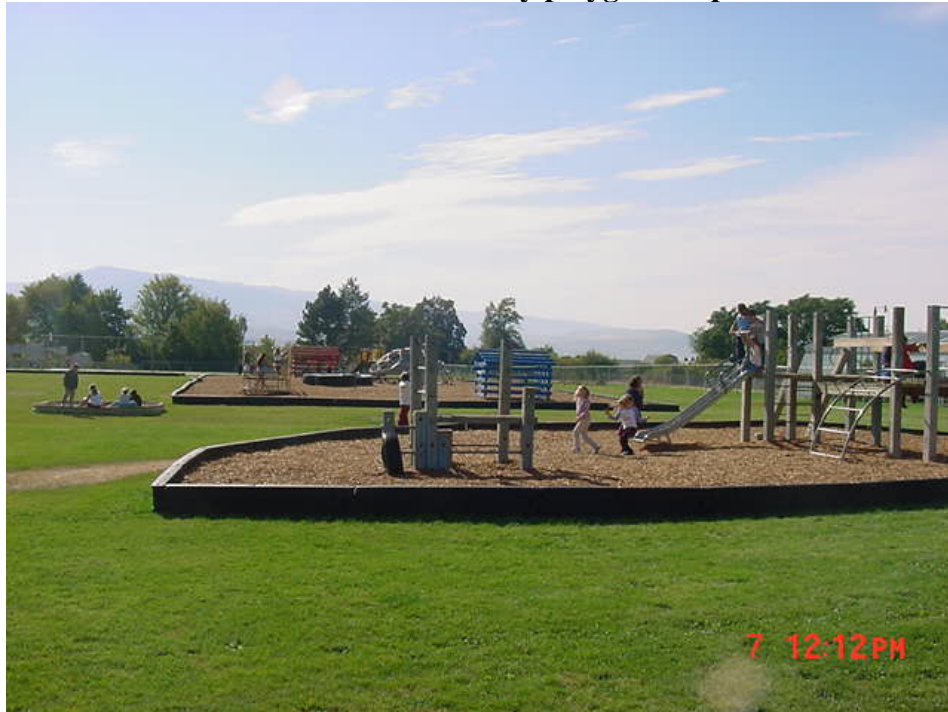
Photo D-1: North Omak Elementary playground pre-remediation

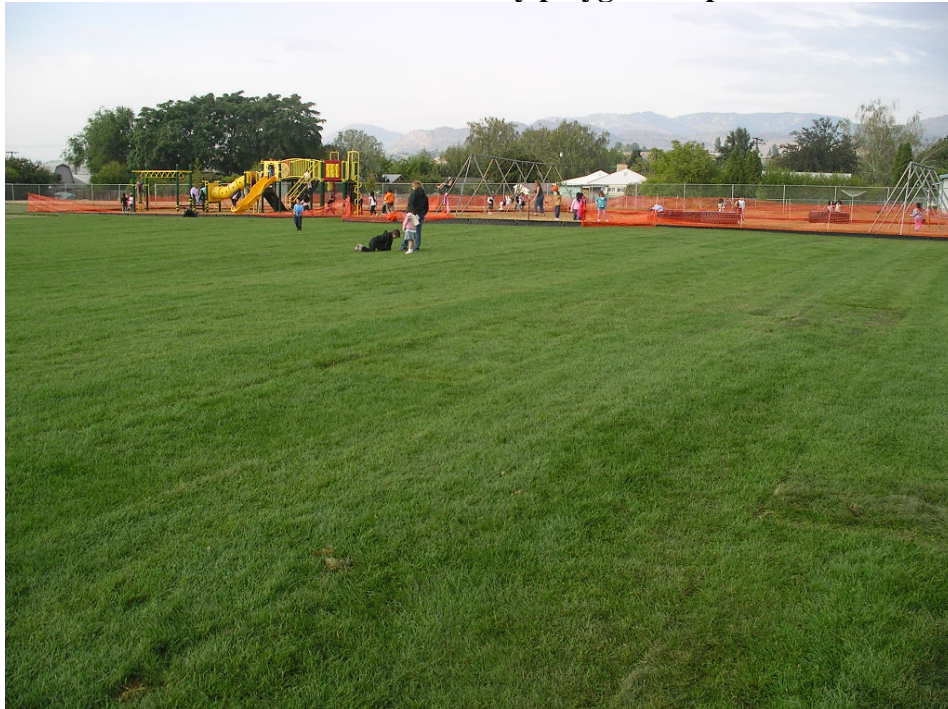
Photo D-2: North Omak Elementary playground post-remediation

After excavation was complete, a geotextile membrane was placed on the soil surface covered clean topsoil was imported to the site. The topsoil was taken from an undisturbed site and tested for lead and arsenic concentrations. Neither lead nor arsenic were detected above background concentrations in 10 samples taken from the import topsoil. Approximately 5000 yards of topsoil were imported onsite.

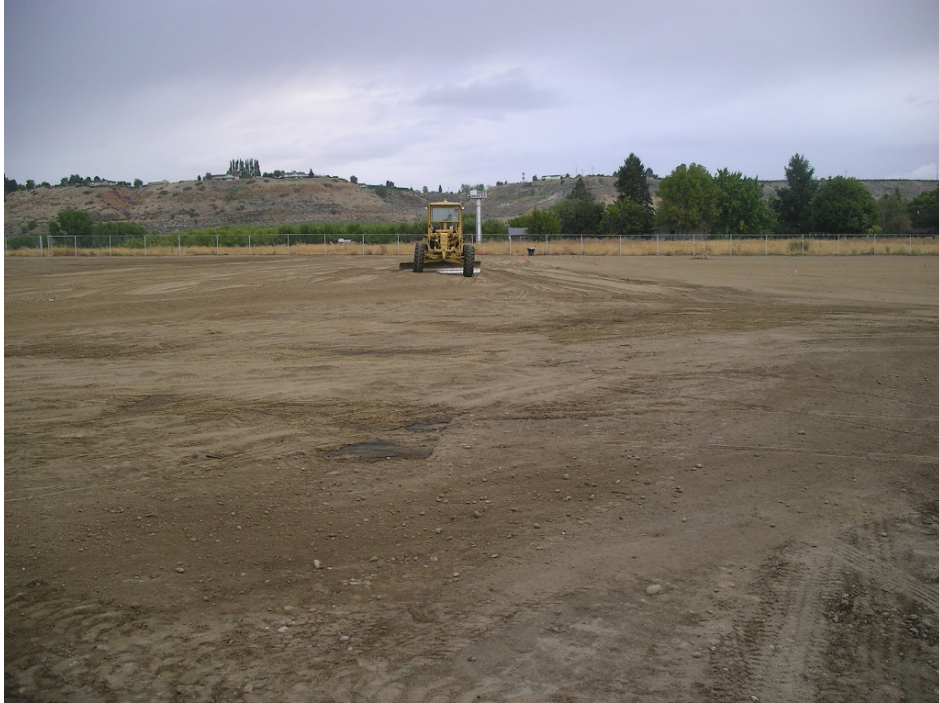
Photo D-3: North Omak Elementary during excavation and grading

A bulldozer was used for the excavation process. After the bulldozer had excavated an area down to a prescribed depth, X-ray fluorescence (XRF) was used to analyze post-excavation surface concentrations and determine whether more excavation was required. All arsenic contamination in excess of 75 ppm was removed from the site. When post-excavation surface concentrations of 75 ppm were reached, excavation was considered complete for that area. Approximately 6000 cubic yards of soil were excavated from the site. This exceeded the original estimate of approximately 2200 cubic yards by approximately 3800 cubic yards. This excess can be attributed to the fact that deep mixing was not possible at the site. Had deep mixing been possible, much of the contaminated soil would have been blended with clean soils below. A front-end loader was then used to load the stockpiles into trucks for transport to the landfill. Soil excavated from North Omak Elementary was transported to the Okanogan County Landfill located in Okanogan, Washington.

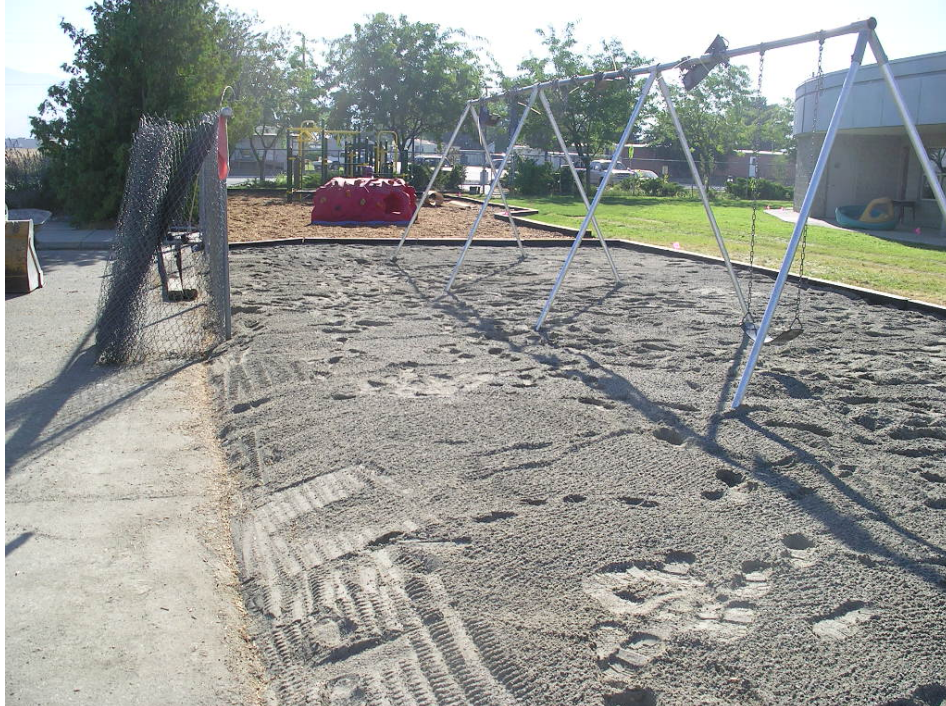
Photo D-4: North Omak Elementary fenced play area after remediation
