**INTERIM ACTION COMPLETION REPORT  
AMERICAN LINEN SUPPLY CO DEXTER AVE SITE  
700 DEXTER AVENUE NORTH  
SEATTLE, WASHINGTON**

**Agreed Order No. DE 14302  
Facility Site Identification Number: 3573  
Cleanup Site Identification Number: 12004**

**AUGUST 27, 2025**

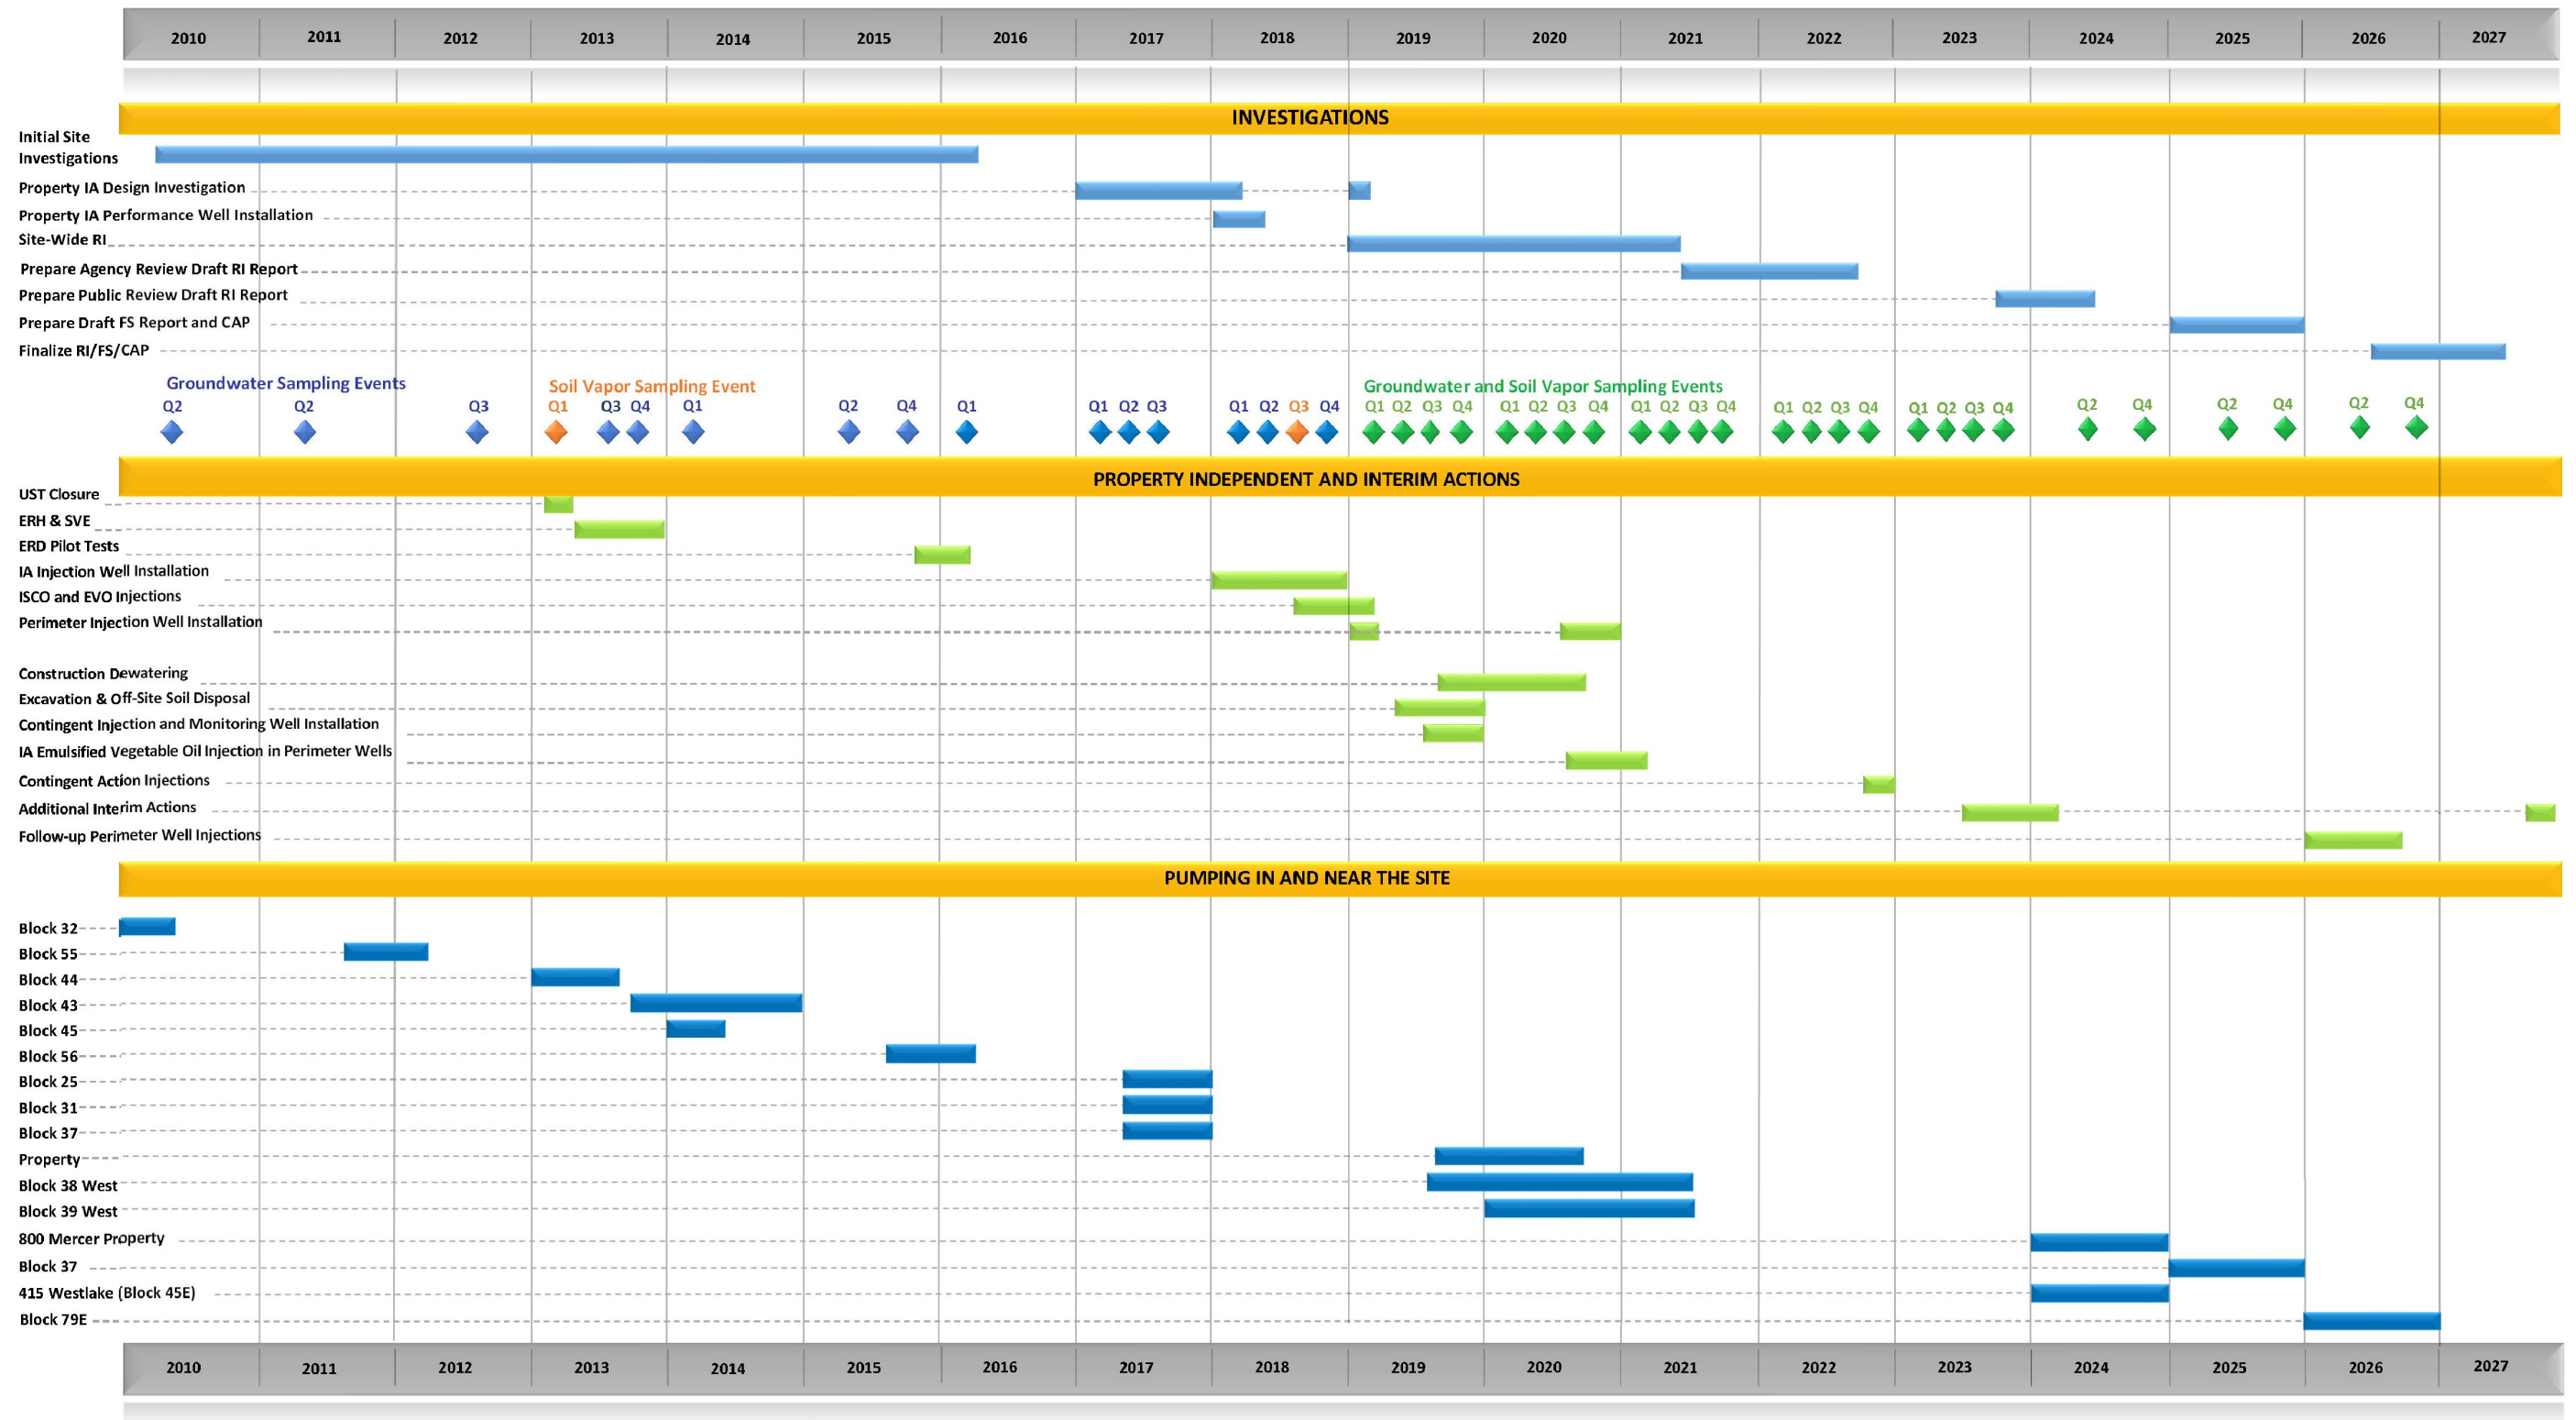
**Timeline of Investigations, Cleanup Action, and Dewatering at and near the Site**  
American Linen Supply Co Dexter Ave Site  
700 Dexter Avenue North  
Seattle, Washington

This section describes the IA activities on the Property (Sections 4.1 through 4.6, 4.8, and 4.10), at the perimeter of the Property (Sections 4.7 and 4.9), and near monitoring well HMW-9IB on the Seattle DOT Mercer Parcels property (Section 4.11), including the pre-injection activities, mass excavation activities, chemical-resistant vapor barrier installation, injection program design and execution, and performance monitoring. As noted in Section 1.1, the IA was conducted in accordance with the procedures detailed in the work plans (primarily the IAWP and addenda) and WAC 173-340-430. The IA discussions in this section briefly describe or refer to those procedures and note deviations from the IAWP. Figure 3 provides a timeline of the IA activities conducted to address the Site CVOCs.

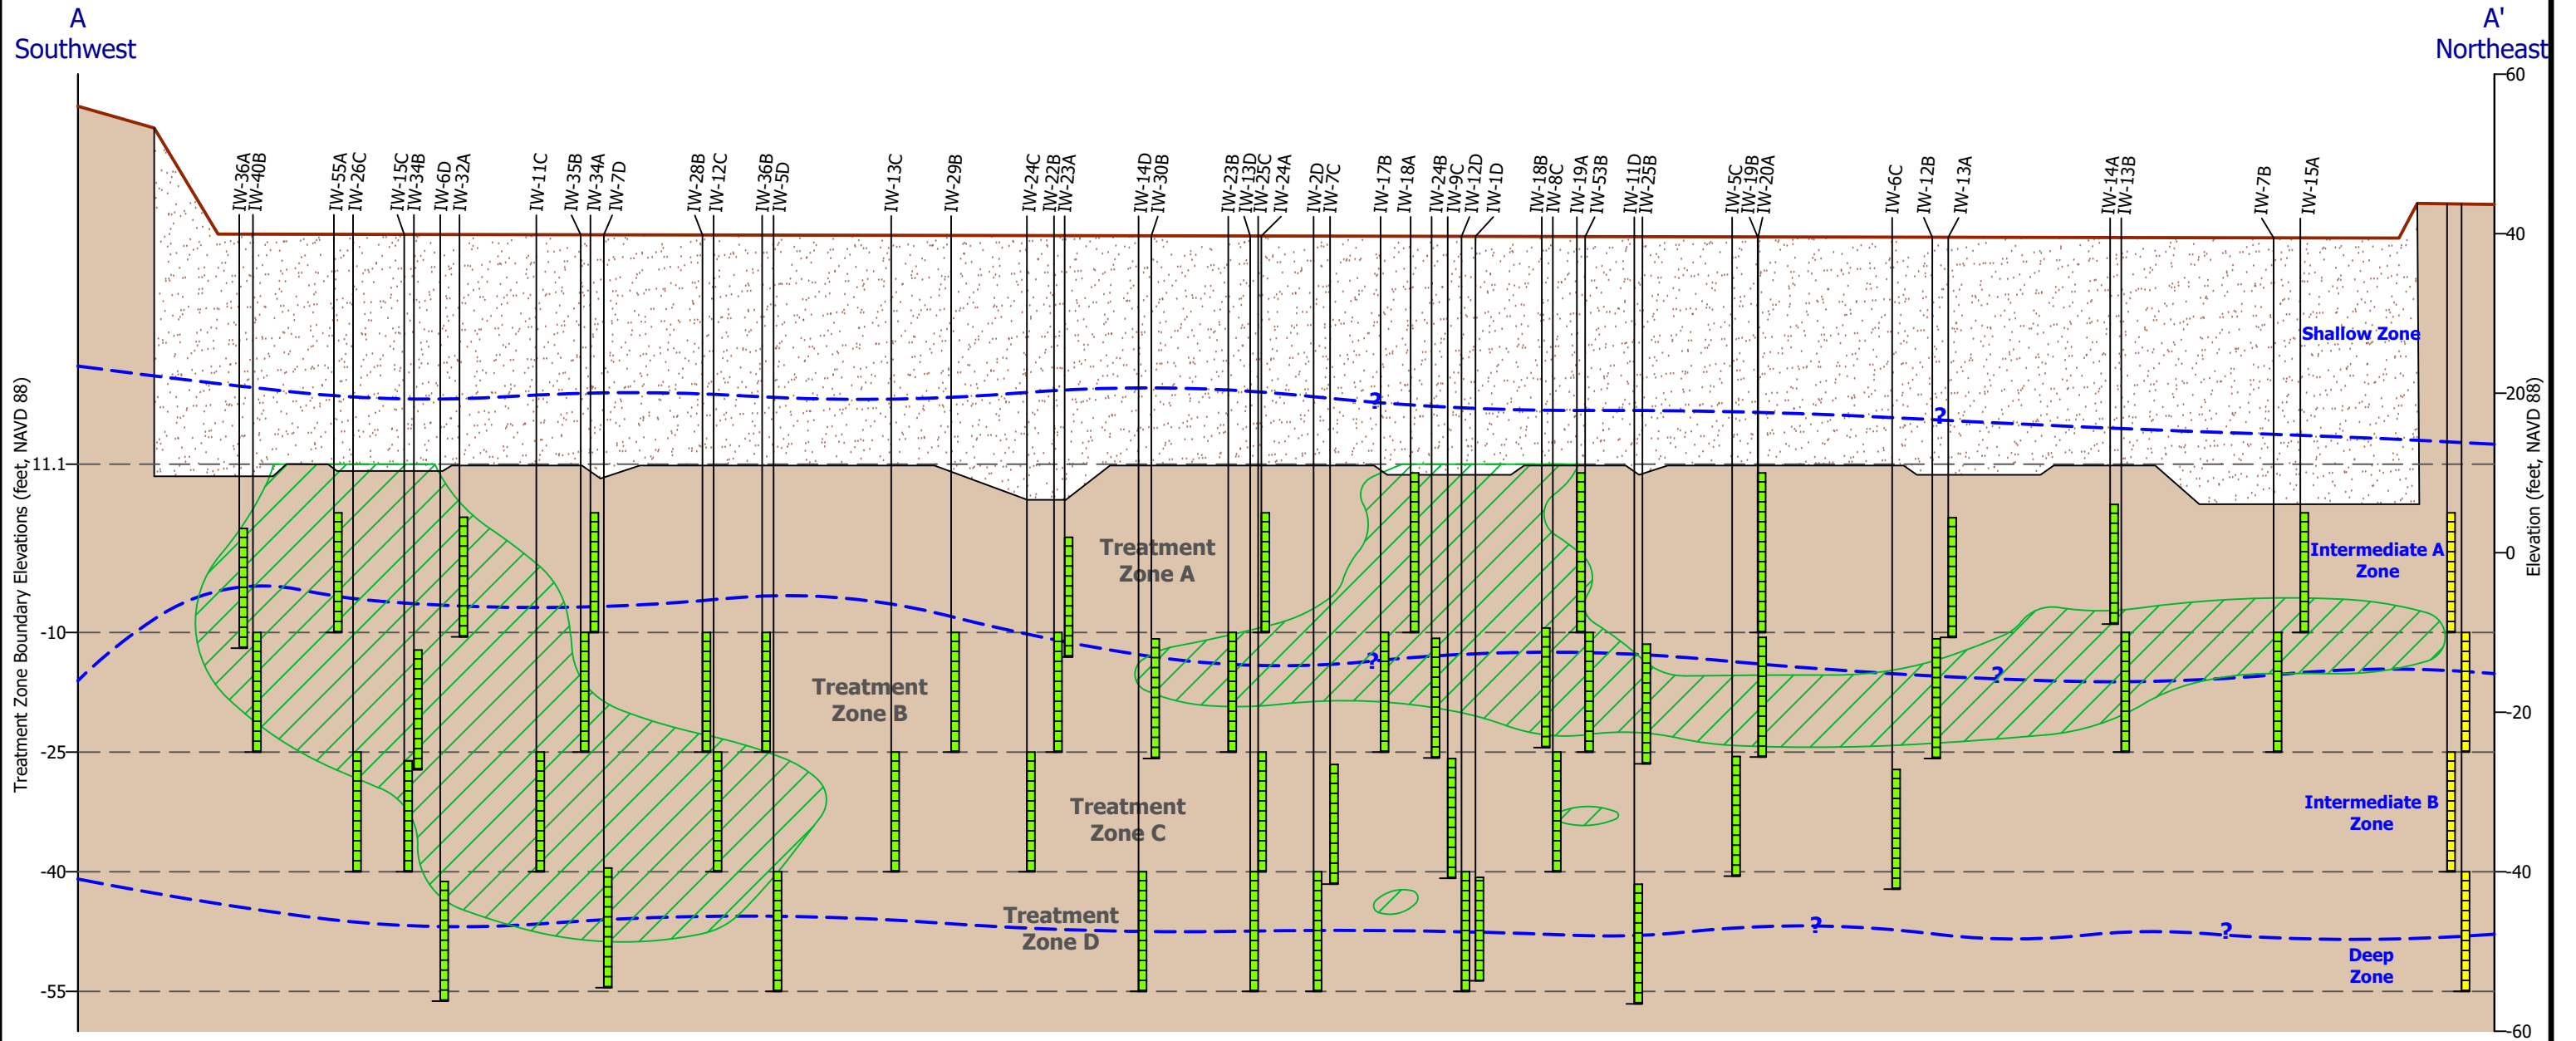
- Approximate Ground Surface Elevation
- Excavation Boundary (Per Foundation Plan)
- Approximate Water Bearing Zone Boundary (Queried Where Uncertain)
- Soil Excavated for Parking Garage
- Soil not Excavated
- Interpolated areas with tetrachloroethene (PCE) concentration greater than 0.5 milligram per kilogram

After the soldier pile installation and demolition of the remaining surface structures, JR Hayes began mass soil excavation of the Property on May 2, 2019. The mass excavation for the parking garage and foundations extended to elevations ranging from 10.7 to 0.7 feet across the

entire Property, this included approximately 8 inches (0.67 feet) of over-excavation beneath the bottom of the foundations to create a working surface (rat slab) for installation of the waterproofing and vapor intrusion barrier membrane, and then a second rat slab to protect the membrane and provide a working surface for construction of the building foundation.

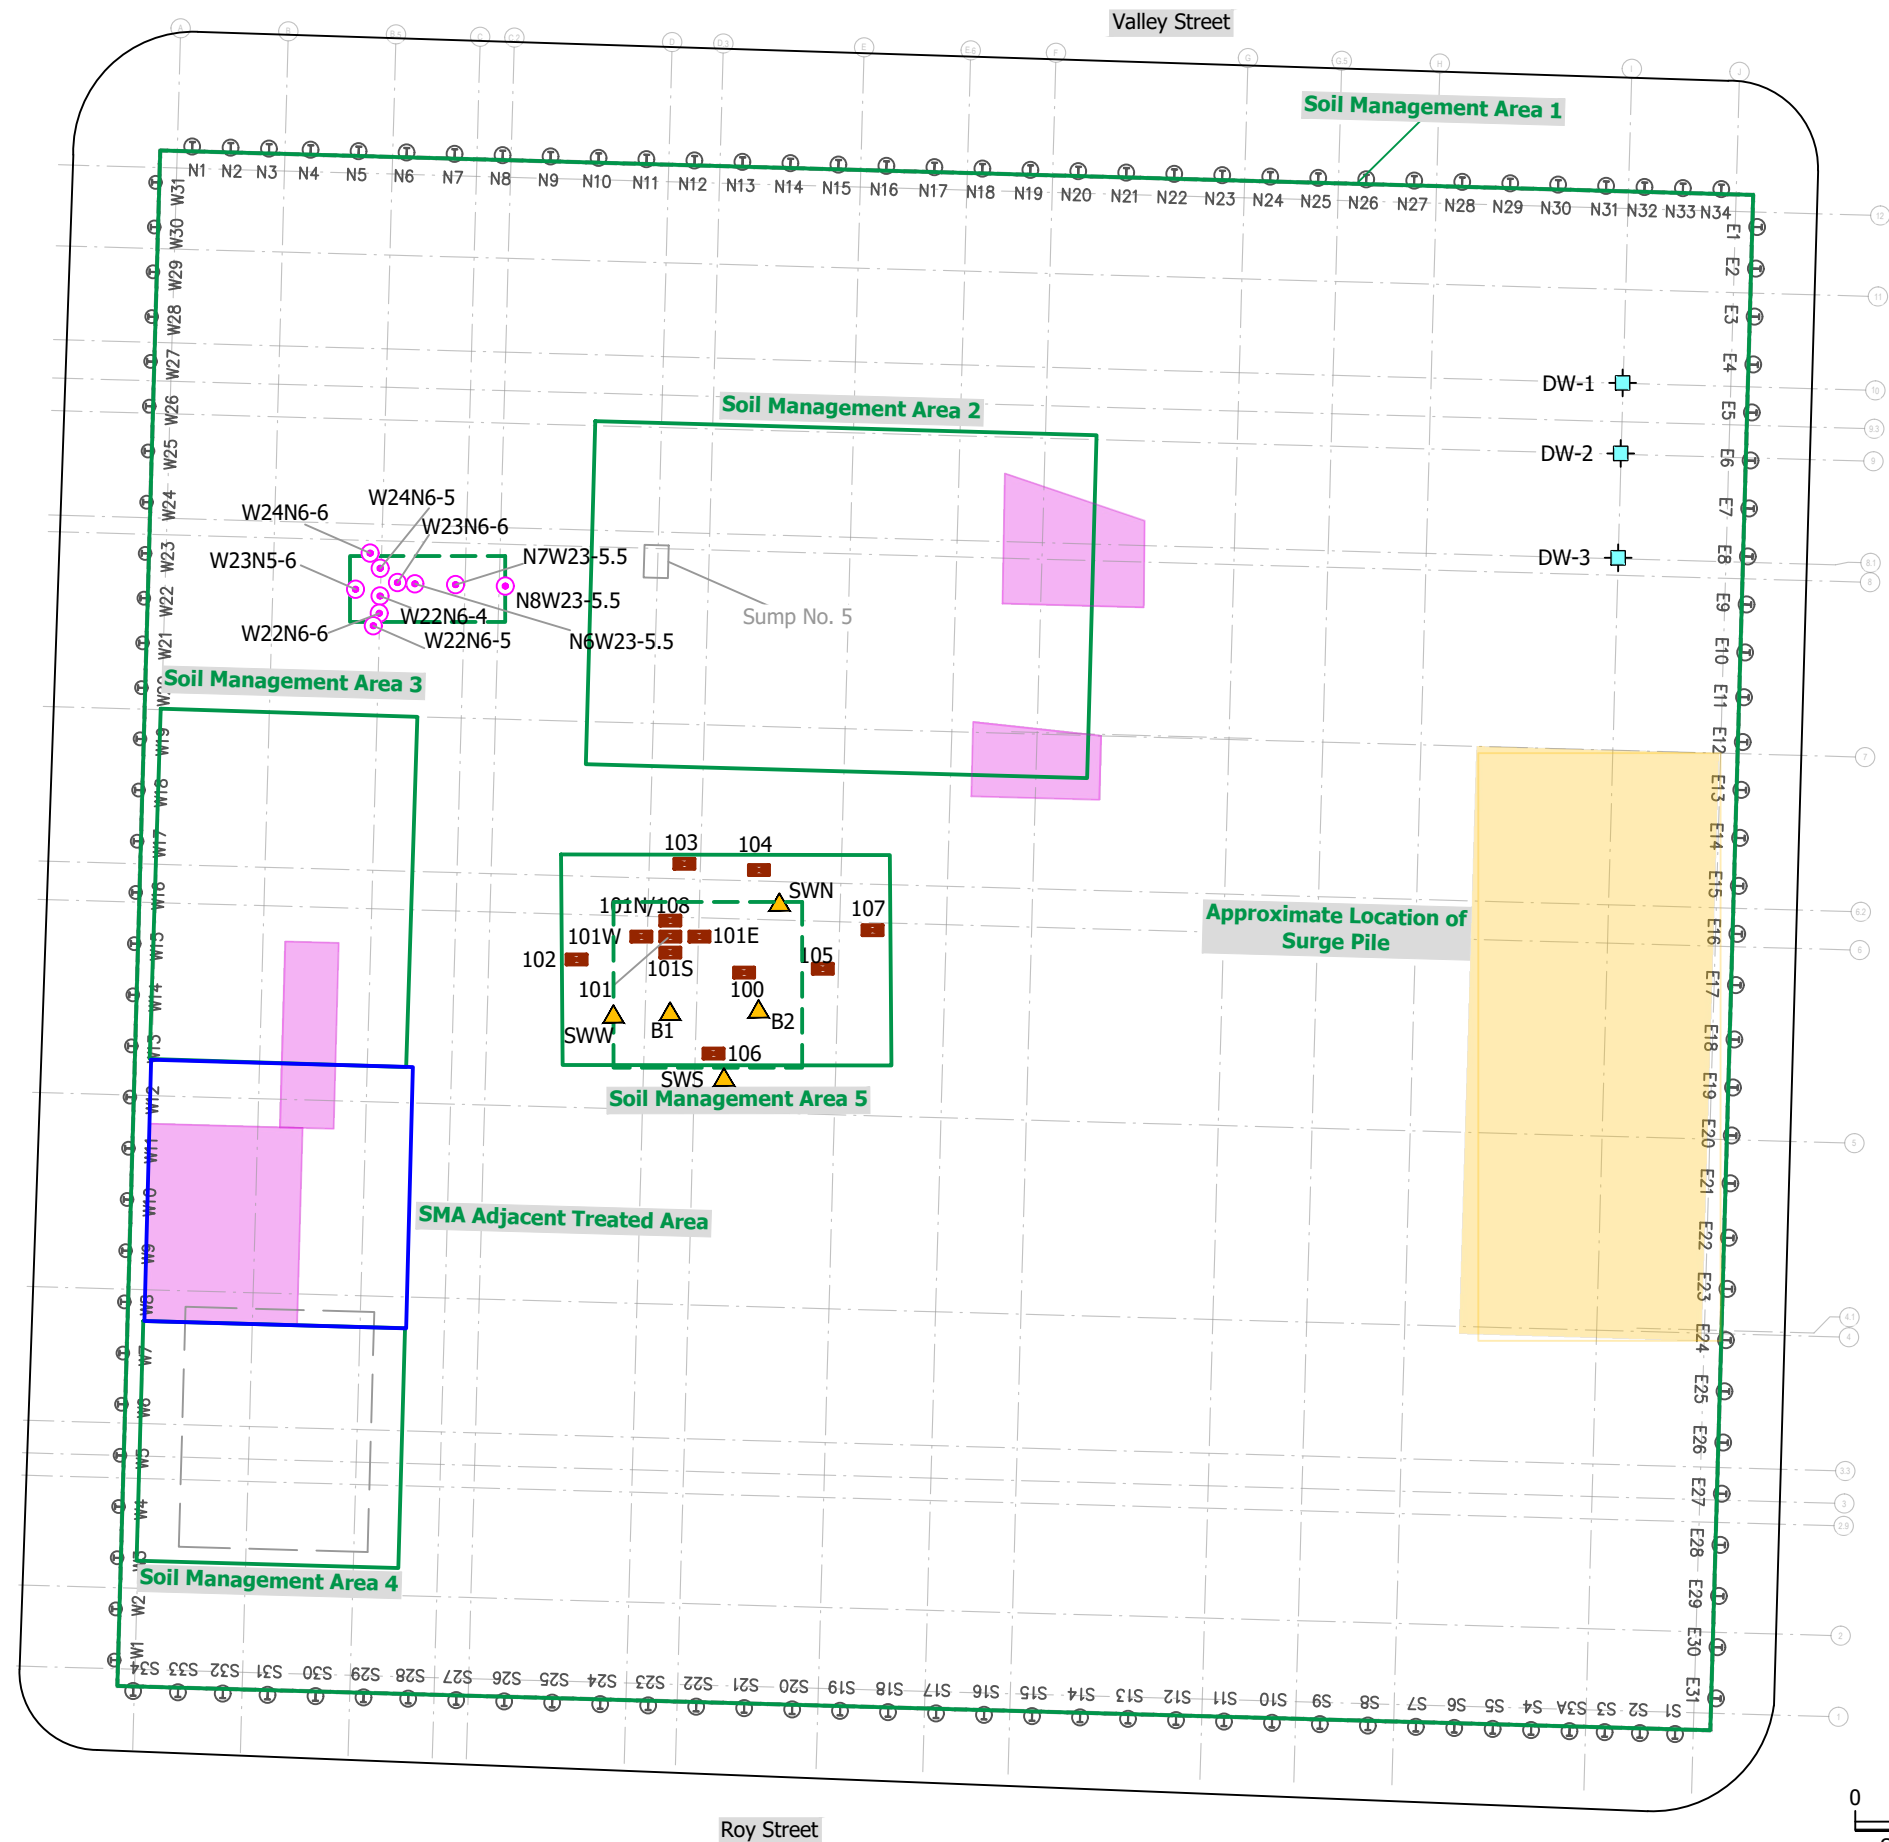
- Explanation**
- Limits of Soil Management Areas
  - Treated Area Adjacent to SMA-3 and SMA-4
  - Area over-excavated below the minimum design elevation down to elevation 5 feet
  - Approximate Location of Surge Pile
  - 101 Soil Management Area 5 Test Pit Location
  - DW-1 Dewatering Well
  - W24N6-5 DNAPL Soil Sample Locations
  - SWS Area 5 Compliance Sample
  - Soldier Pile Location  
Note: Soldier Piles and other shoring system components (tie backs and soil nails) are included in Soil Management Area 1
  - Area 5 and DNAPL Excavation Extent

On May 30, 2019, elevated field screening readings were observed during ongoing work in SMA-5 and a sample was collected (05-33-108-32). The results indicated CVOC concentrations were greater than the contained-in criteria. An additional 1 cubic yard of soil was excavated from this area on June 3 and 6, 2019, and a compliance sample was collected at the excavation bottom on June 6, 2019 (05-31-108-30.5). The results indicated the remaining CVOC concentrations were below the contained-in criteria. The sample location is shown on Figure 12 (location 108) and the analytical results are provided in Appendix E.

On September 20, 2019, during excavation at the base of the parking garage west of SMA-2 (Figure 12) and northeast of CA-A1 (Figures 13), DNAPL was observed leaching out of a 6-inch-thick sand seam located on top of a sandy silt layer. The DNAPL (less than 8 fluid ounces) was removed with absorbent pads and excavated for off-site disposal. The upper 6 inches of soil beneath the DNAPL location was removed and stockpiled. A sample of the DNAPL (DNAPL-092019) and three soil samples (N6W23-5.5, N7W23-5.5 and N8W23-5.5) were collected from the soil located beneath removed soil and analyzed for CVOCs. The results indicated that the DNAPL was primarily PCE and the soil samples indicated that DNAPL was not present in the soil beneath the area of removed soil (Figure 12). Tables summarizing the sampling data and copies of the laboratory reports are included in Appendix E.

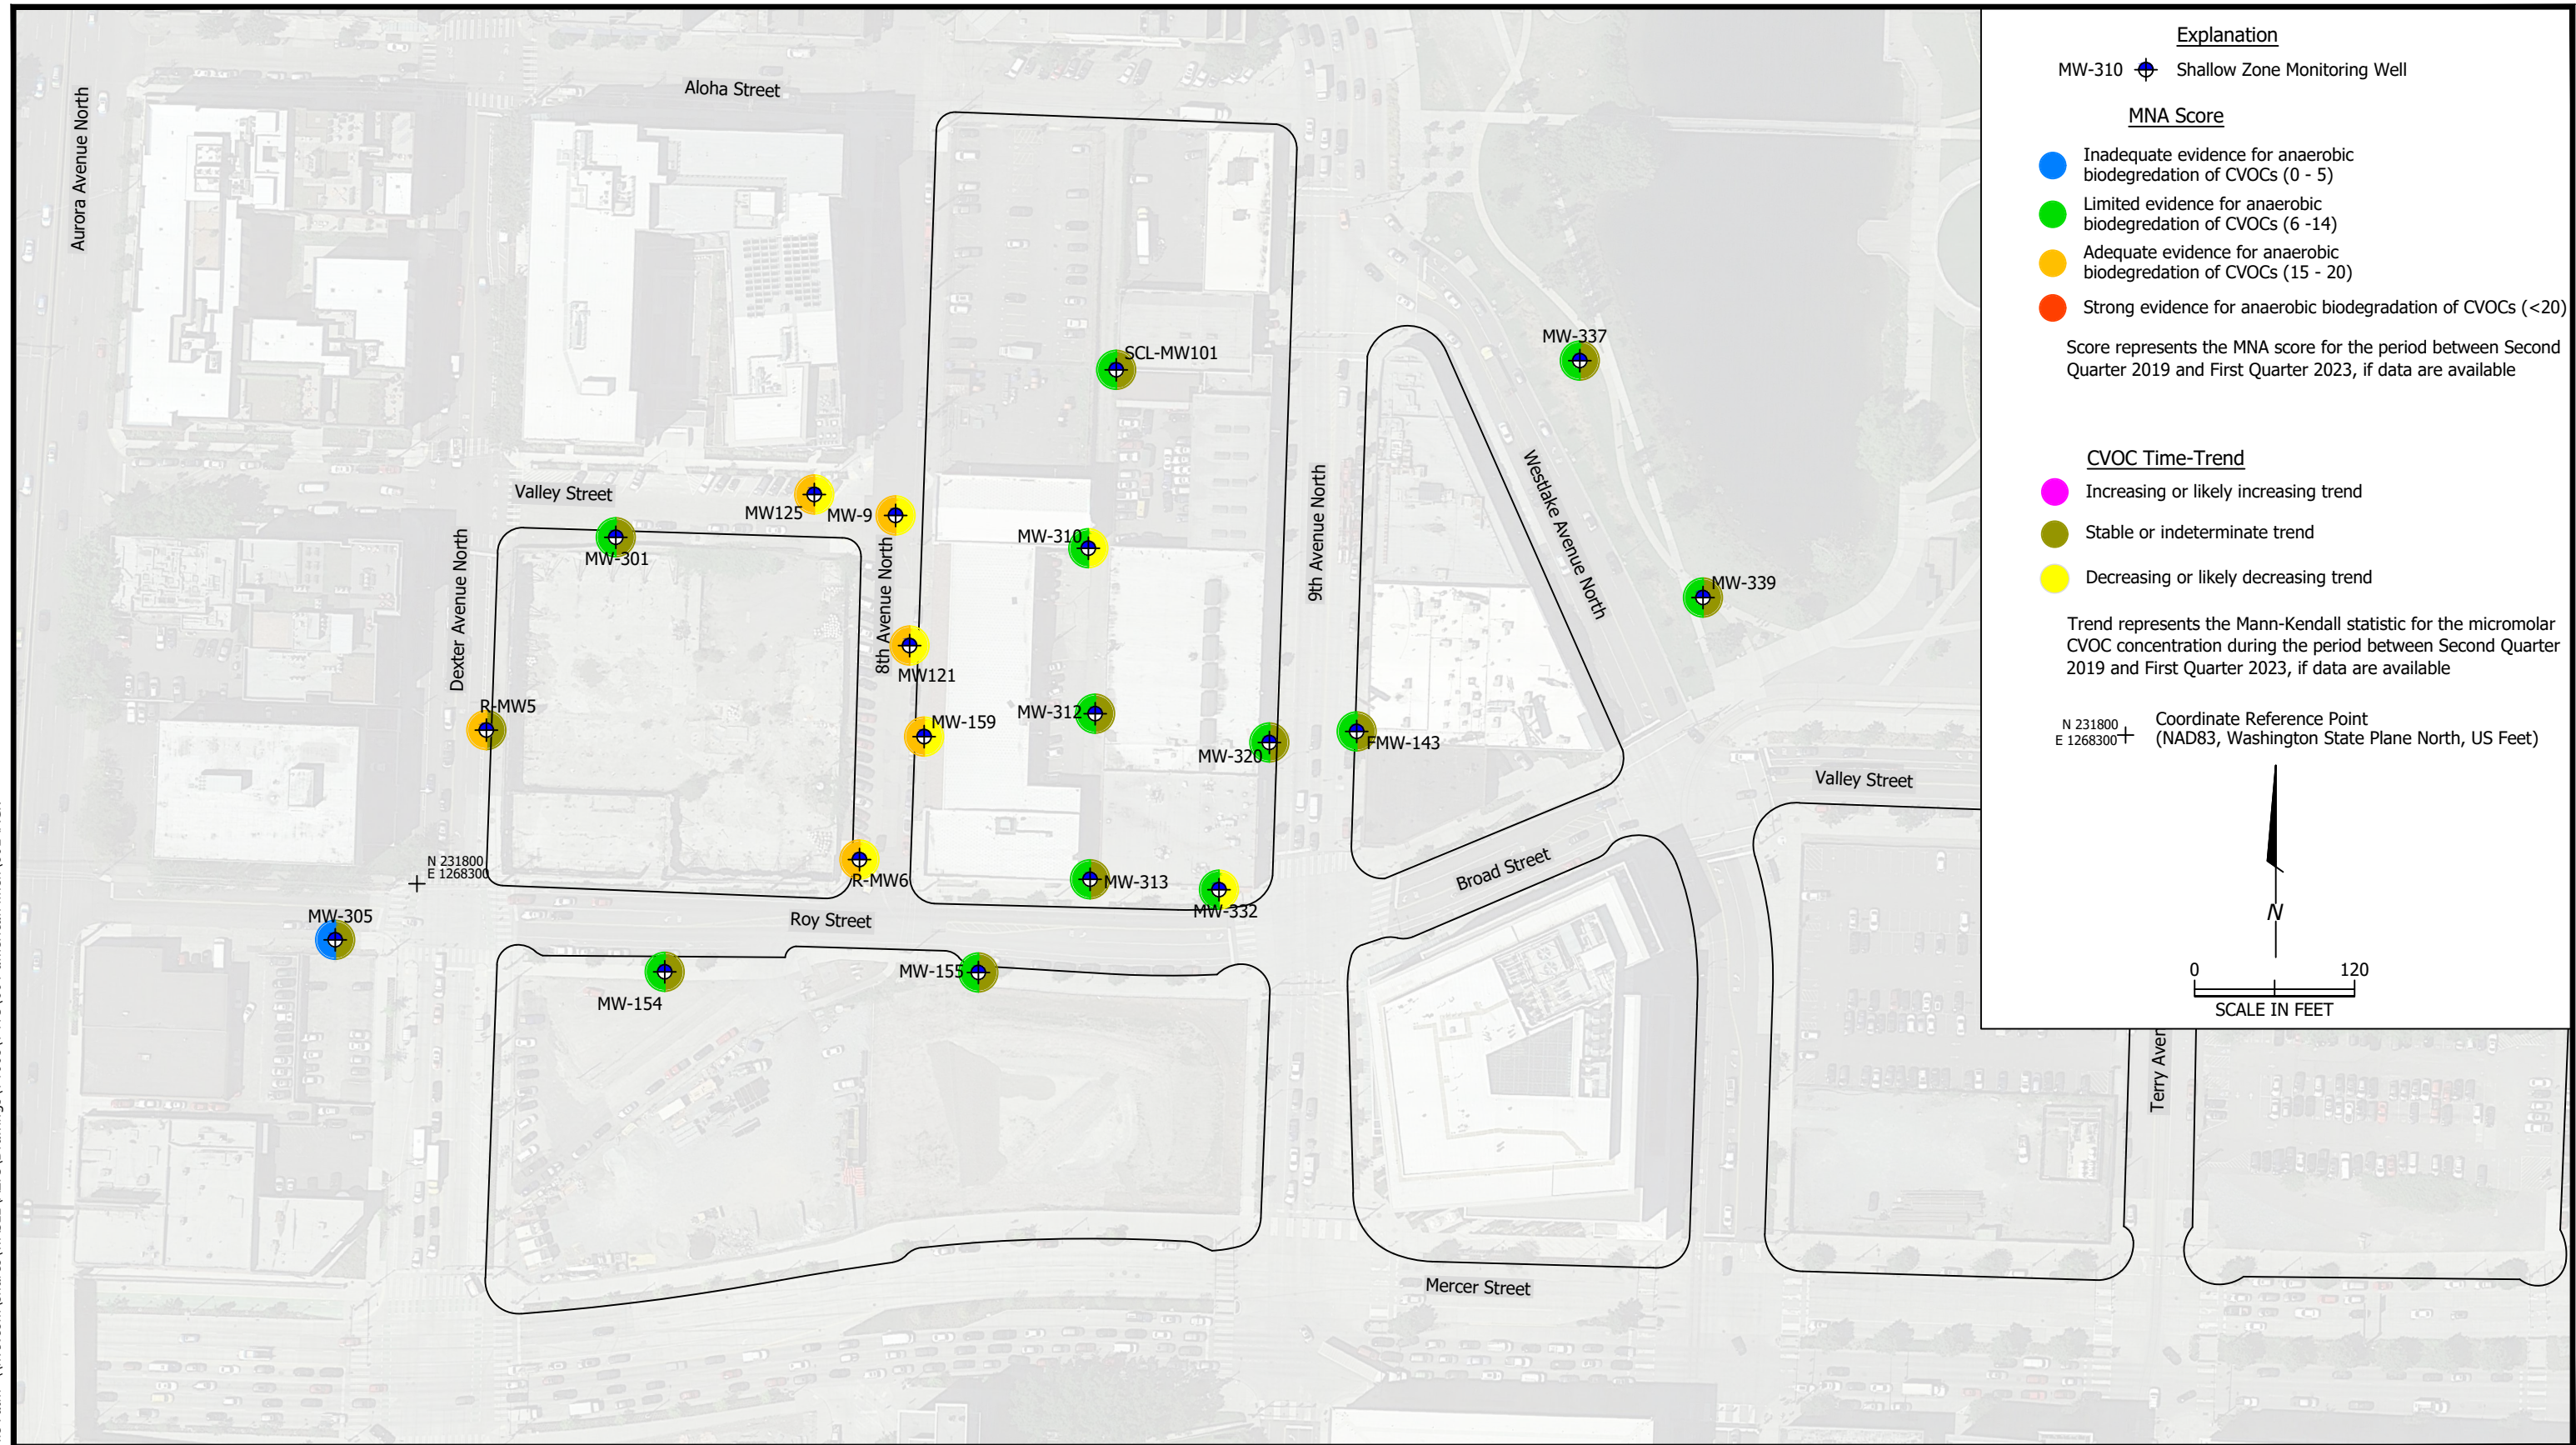
18

**Interim Action Effects on the Site Shallow Zone CVOC Plume**  
American Linen Supply Co Dexter Ave Site  
700 Dexter Avenue North  
Seattle, Washington

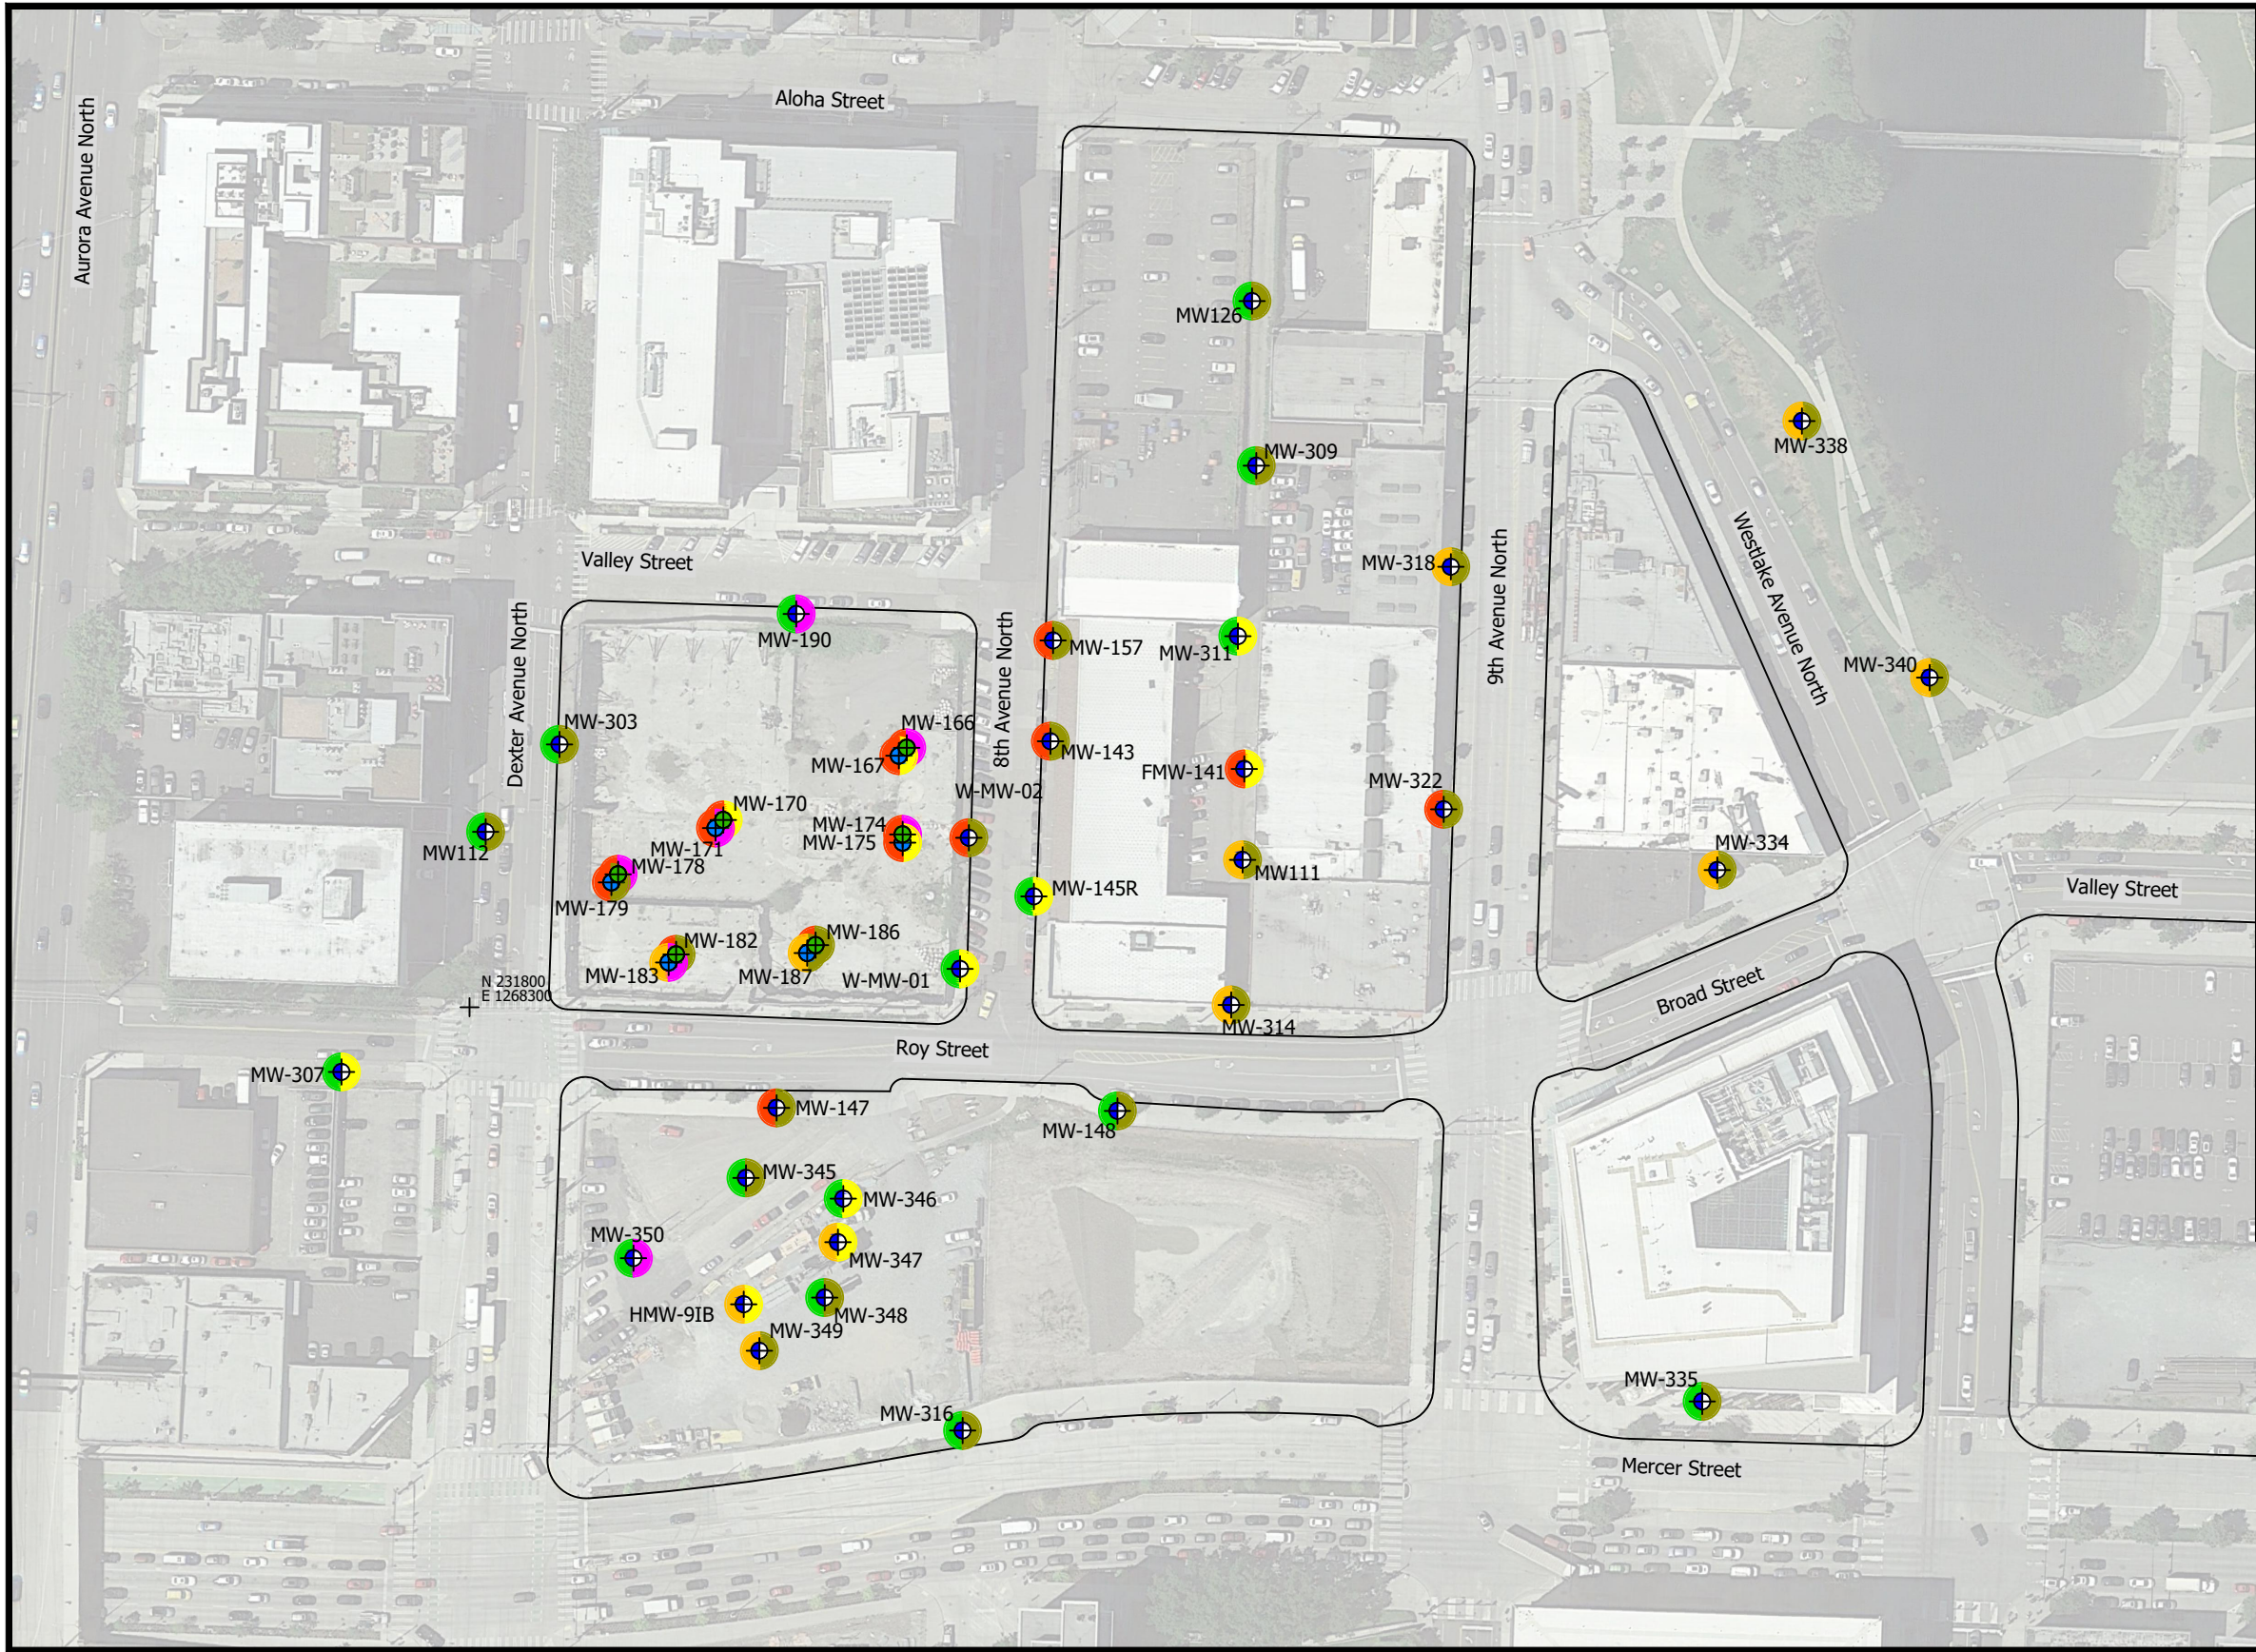
- Explanation**
- W-MW-02

Inadequate evidence for anaerobic biodegradation of CVOCs (0 - 5)
  -

Limited evidence for anaerobic biodegradation of CVOCs (6 - 14)
  -

Adequate evidence for anaerobic biodegradation of CVOCs (15 - 20)
  -

Strong evidence for anaerobic biodegradation of CVOCs (<20)
