BNSF Railway Company &  
Husky Oil Operations Limited

# Engineering Design Report

BNSF Railway Black Tank Property

November 2021

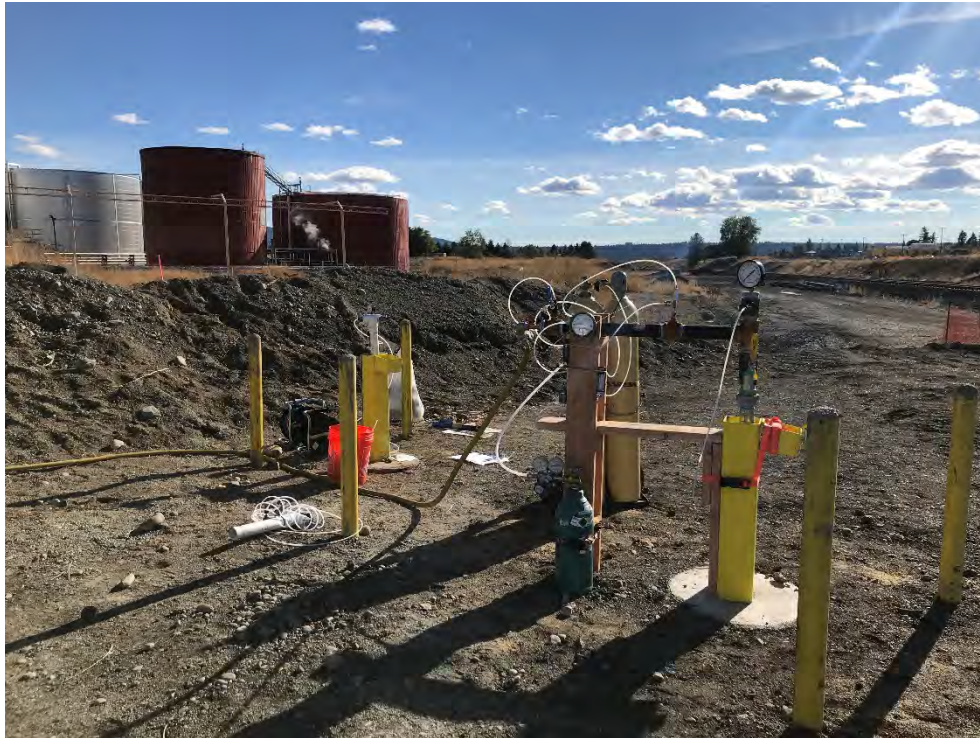
Photo 1: BS ROI set up

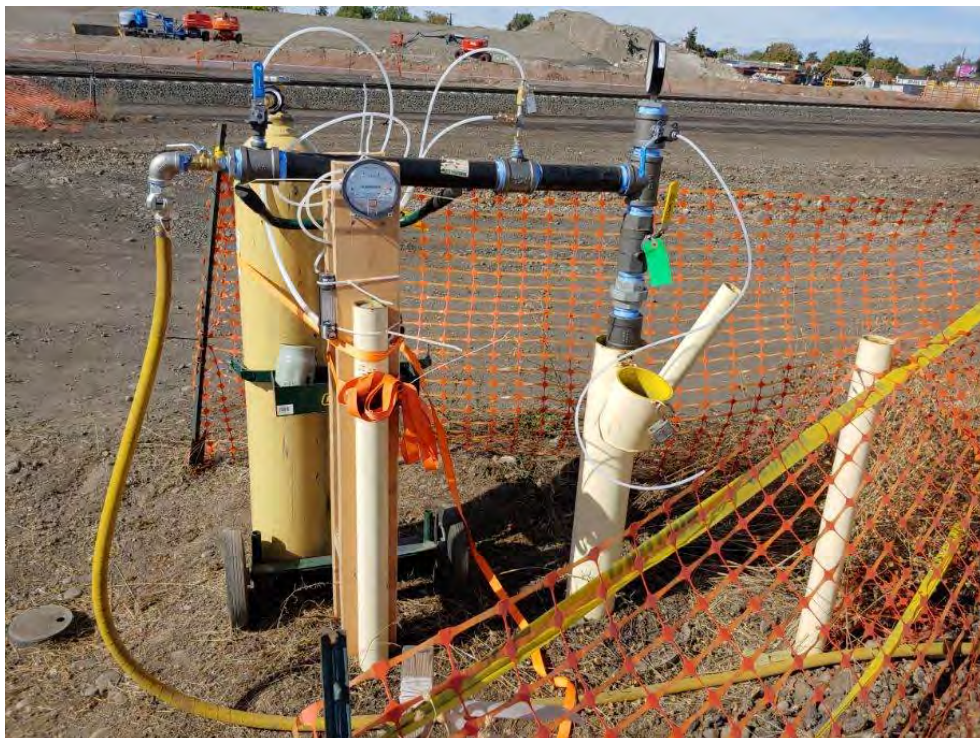
Photo 2: Manifold

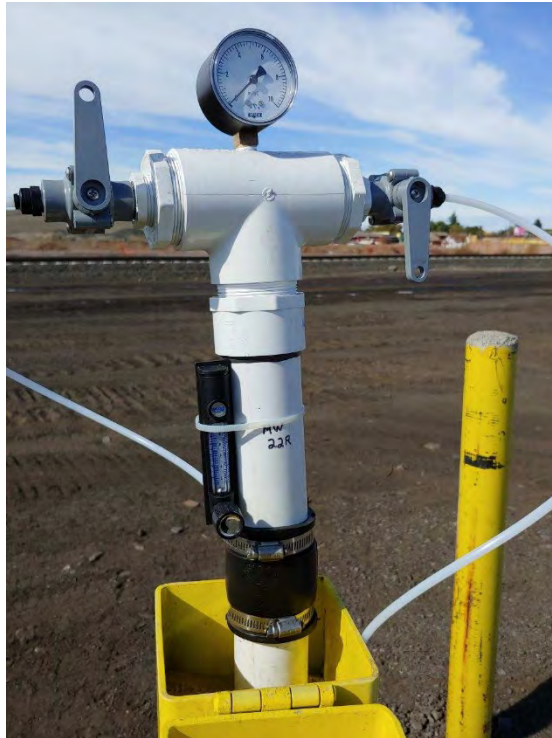
Photo 3: Wellhead
