INITIAL INVESTIGATION FIELD REPORT

WASHINGTON STATE
DEPARTMENT OF
ECOLOGY

SITE NAME
Inman Landfill

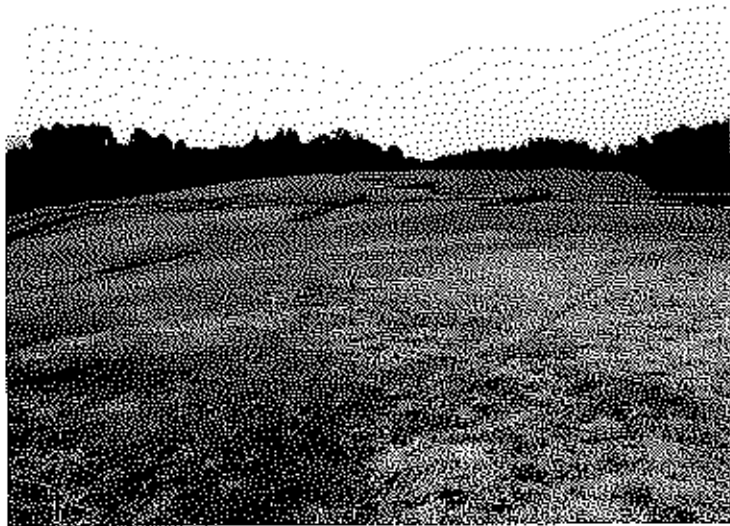
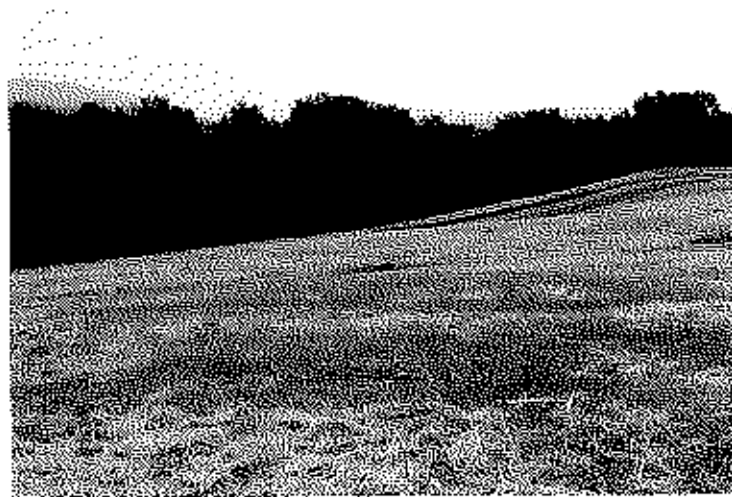
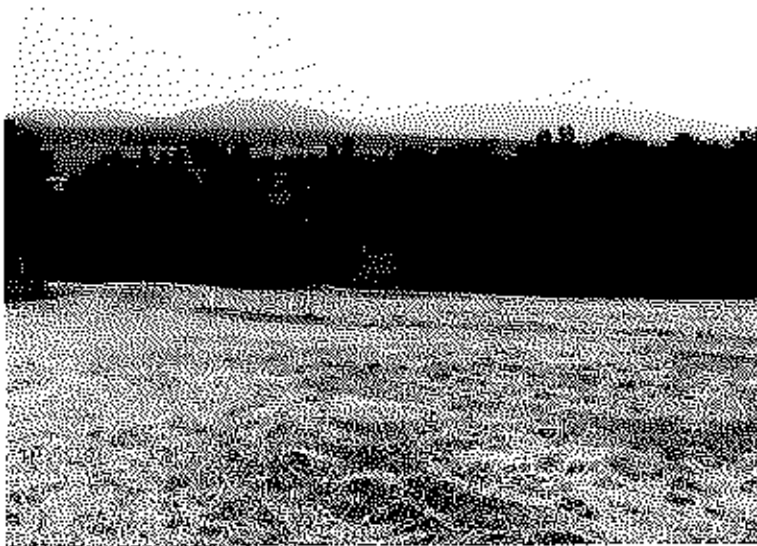
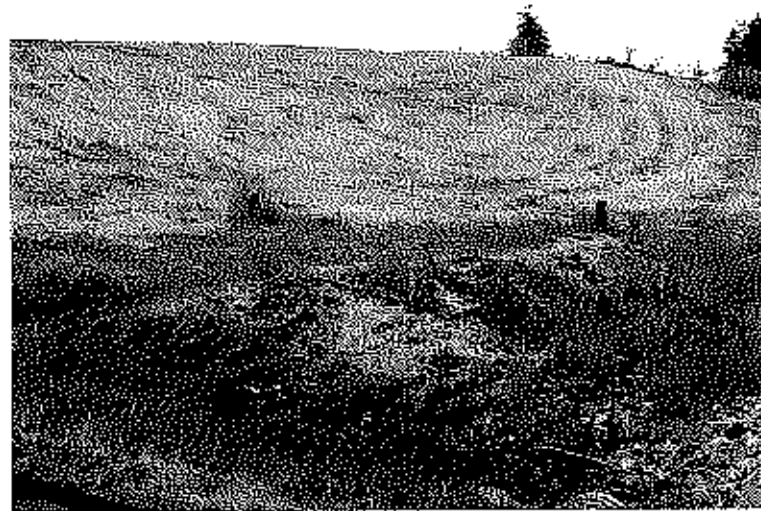
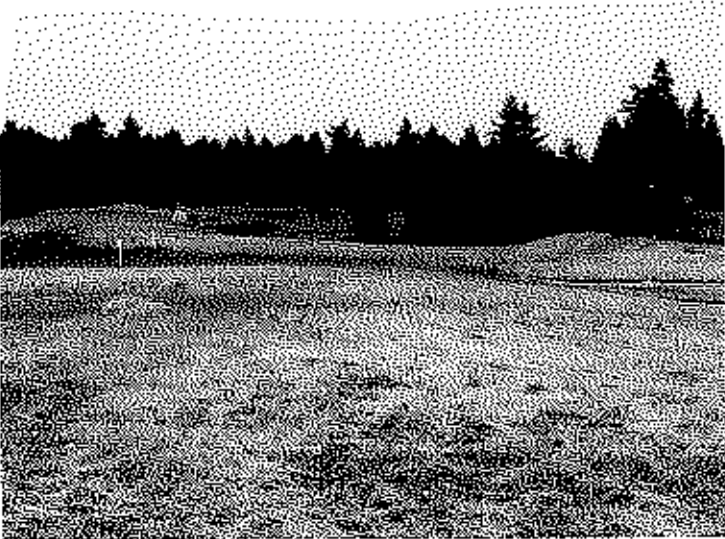
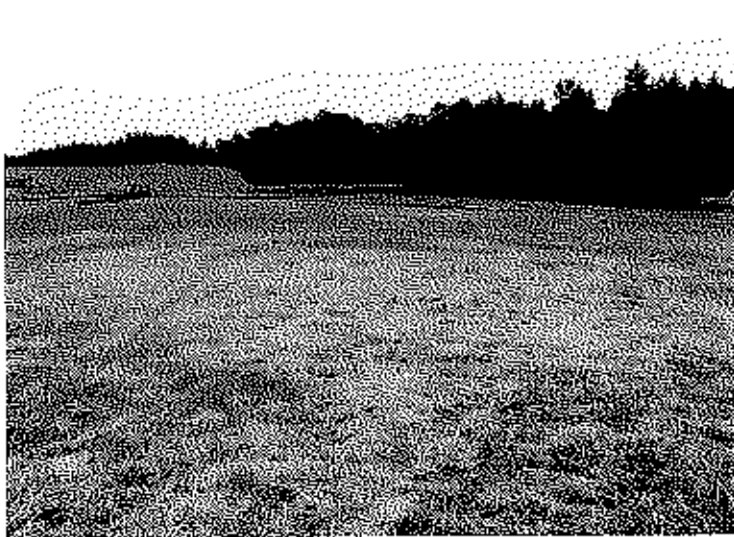
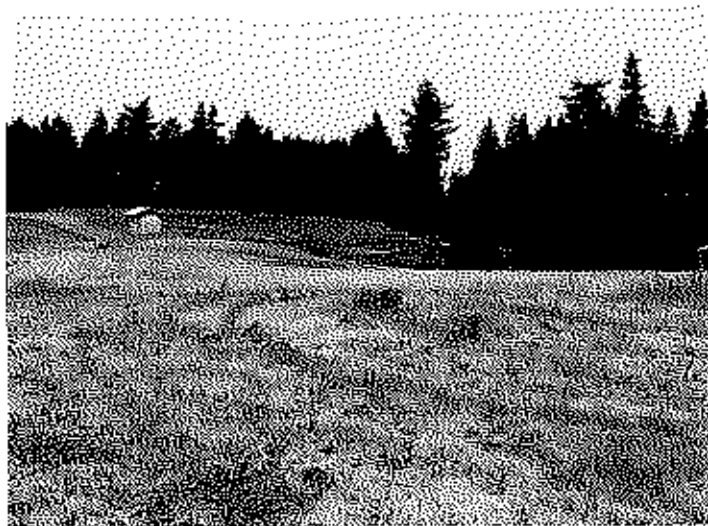
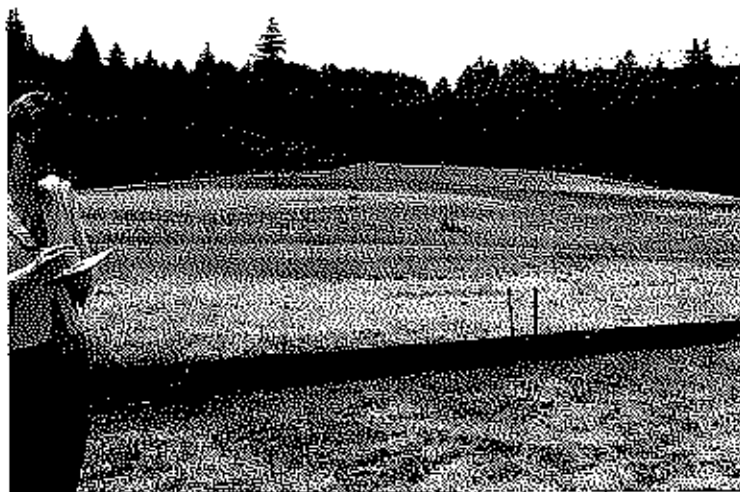
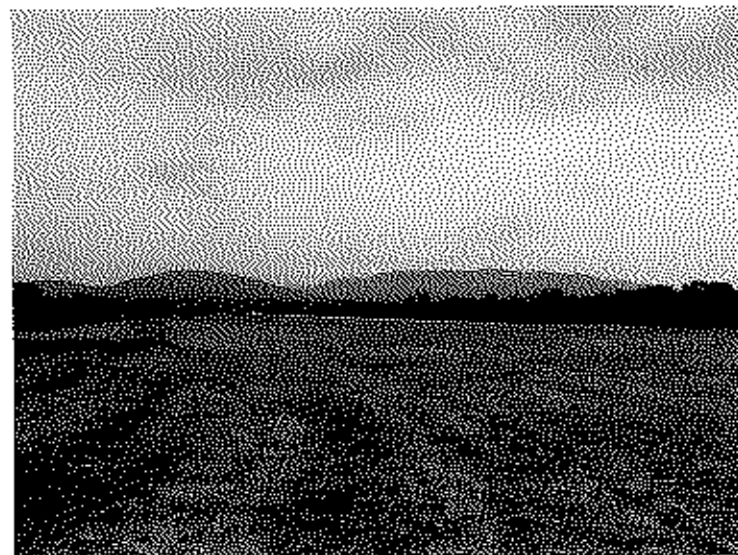
Figure 1 – Site Photos Inman Landfill Initial Investigation site visit June 24, 2008
Photos by Polly Dubbel Page 1 of 3

Description of observations: On the visit I drove into the landfill with Gary Lyka and Margo Burton from Skagit County Public Works. The site is entirely fenced. The landfill has a rolling sloped surface moving downgradient from the southwest to the northeast and dropping steeply from the high point of the landfill to the perimeter road on the south. The surface is planted in grasses and is mowed twice per year to keep larger vegetation from taking root. The area surrounding the landfill is rural residential and agricultural land. Photographs of the site visit are attached as Figure 1.

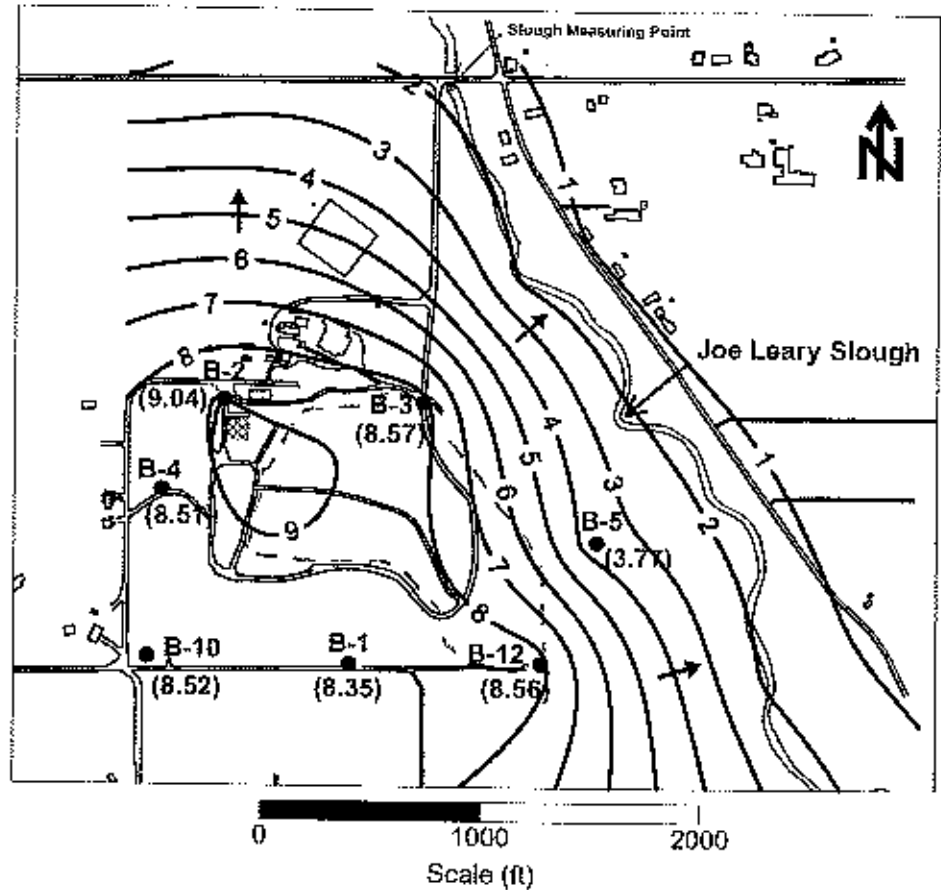
Figure 2. Potentiometric Surface Map for Landfill Area, Regional Aquifer, March 2001

Hydrogeologic investigation has shown that the landfill is underlain by two aquifers, a shallow, unconfined perched aquifer and a regional aquifer situated near or below sea level. The perched aquifer flows generally to the southwest and the regional aquifer flows generally to the northeast/east. A series of monitoring wells monitors each of the aquifers in the near vicinity of the landfill. Six wells are screened in the perched aquifer and seven wells are screened in the regional aquifer. Figures 2 and 3 show the locations of the monitoring wells. Quarterly and annual reports on groundwater water monitoring per WAC 173-304 and 173-306 are submitted to Ecology Solid Waste Division. Landfill contaminants have been detected in the groundwater since closure. For a full summary of data refer to the Annual Monitoring Reports for Inman Landfill from 1994 to 2007. What follows is a brief summary of conditions as of 2007. In the perched aquifer arsenic, vinyl chloride, and tetrachloroethene exceed MTCA Method B standard formula values (carcinogenic) for ground water in one well or all wells (arsenic only). In the regional aquifer arsenic and vinyl chloride exceeded the Method B Standard formula values (carcenogenic).

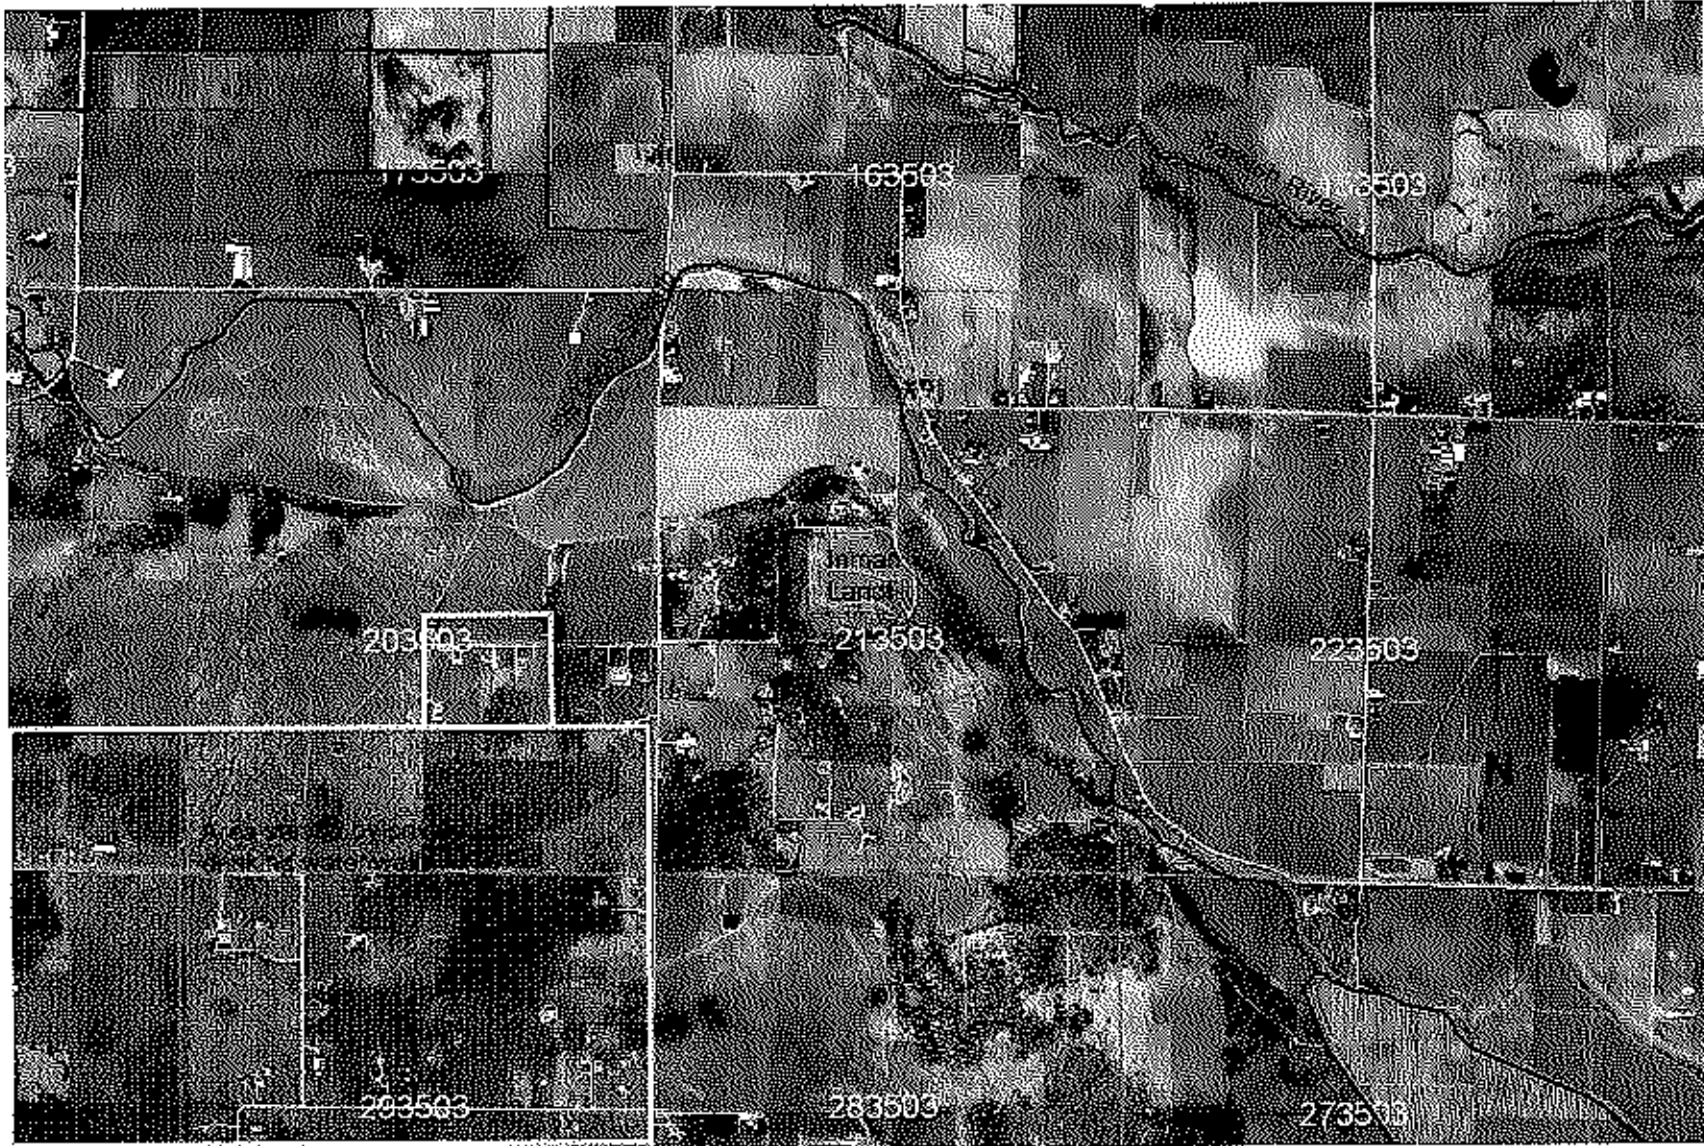
Figure 4 – Inman Landfill Initial Investigation
Aerial Map from Skagit View 2008 by Polly Dubbel

Between 1991 and 2000 Skagit County paid to supply public water to 10 properties and decommissioned 11 private wells in the area of the landfill in order to decrease public health risk from the landfill. Private wells deemed to be hydrologically at risk from the landfill were decommissioned. Public water supplies additional parcels in the landfill vicinity beyond these 10 properties. Figure 4 shows the landfill and the water supply for the surrounding properties.

Areas outlined in pink are NOT served by public water. The remainder of the map area is served by either PUD of Skagit County or Samish Farms Public Drinking Water. No public water system sources are within 2 miles of the landfill.
