**PORT OF FRIDAY HARBOR
ALBERT JENSEN AND SONS INC. BOATYARD AND MARINA
FRIDAY HARBOR, WA**

**MODEL TOXICS CONTROL ACT (MTCA)
AGREED ORDER No. DE 18071**

DRAFT IN-WATER REMEDIAL INVESTIGATION REPORT

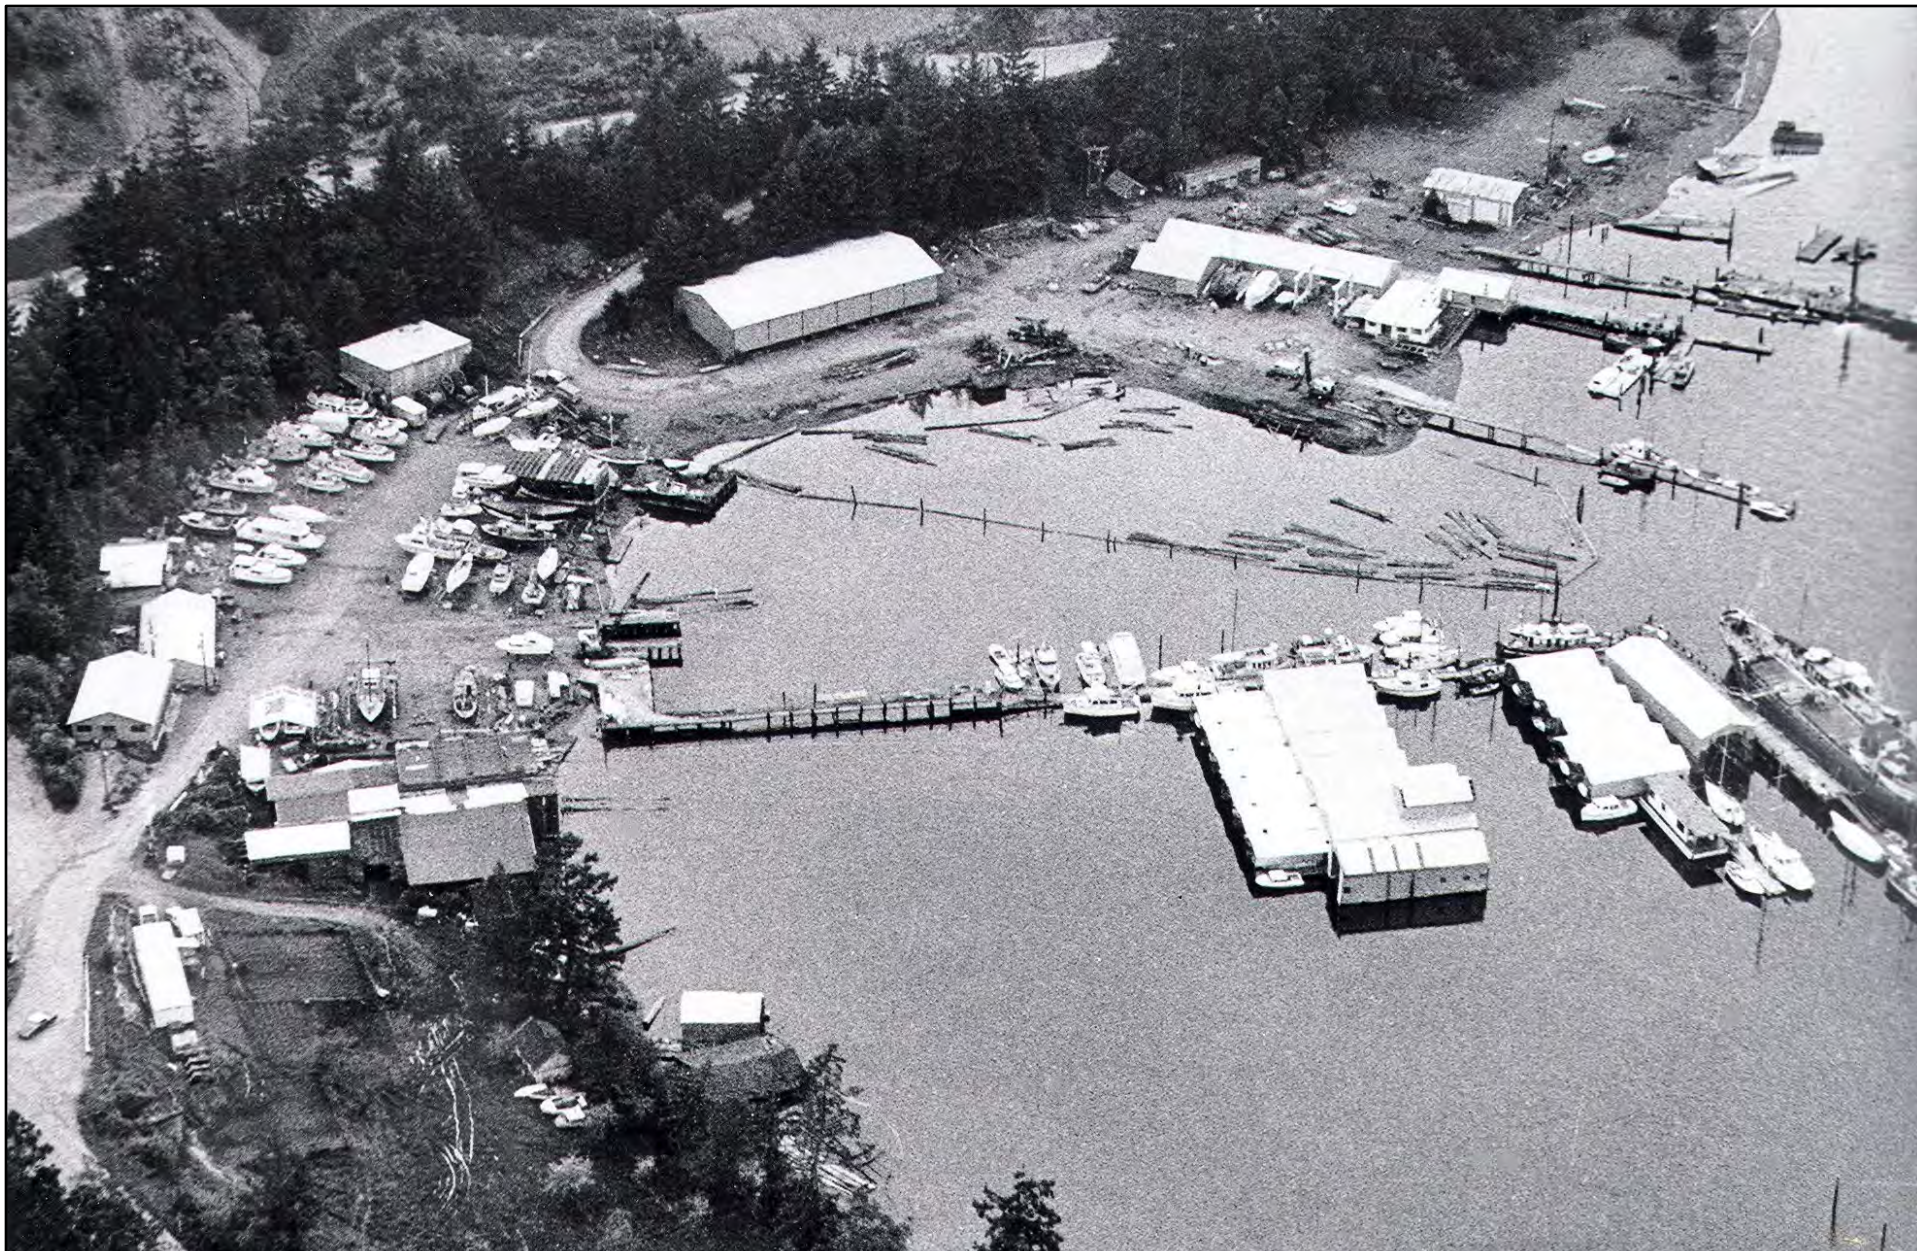
Figure 1-3. Overview of Historic Site Facility Uses

Images depicting prior Site facilities are provided in Figures 1-3, San Juan Historical Society Imagery, Overview of historic Site Facility uses and Figure 1-4, San Juan Historical Society Imagery, prior Site Facility uses, facing north, looking over Shipyard Cove. (Ecology 2024).

Over a century of industrial uses contributed to legacy contamination measured in Site soils and marine sediments. Anecdotal evidence suggests that Site operations began as early as 1910. Originally, wooden boats were manufactured at the Site, but when wooden boats were phased out in the middle of the 20th century, the Site transitioned from shipbuilding to boat repair and maintenance.

According to Ecology (Ecology 2024), the San Juan Historical Society reports that in the early 1940s a local entrepreneur started a shipyard business employing 15 men year-round who built wooden boats for fishing, towing and other uses. A large part of the business focused on hauling local fishing boats out of the water and lined up along the beach for winter maintenance and repairs. The business repaired, serviced and returned boats to the water one at a time until all were ready for the start of fishing season.

During World War 2, the shipyard held a contract to build military barges. The Site also contained a log dump for San Juan Island logging industry. Logs would be branded on the end, dumped into the water and formed into log booms to be towed to lumber mills around Puget Sound.

Additional facilities, including a marina extending from Jensen's central shoreline into deeper intertidal and subtidal areas, and an upland fill area along the western property boundary extending from the upland into shallow intertidal areas, were built sometime between 1941 and 1972. Jensen's shipyard activities that likely contributed to detected contaminants include antifouling paint application and removal; mechanical and general maintenance work over water and land, and treatment of wooden boats using pesticides. Other facilities that operated on Site previously include a former underground gasoline storage tank, a machine shop that was also used for hazardous chemical storage, a small dump site, and marine railways.

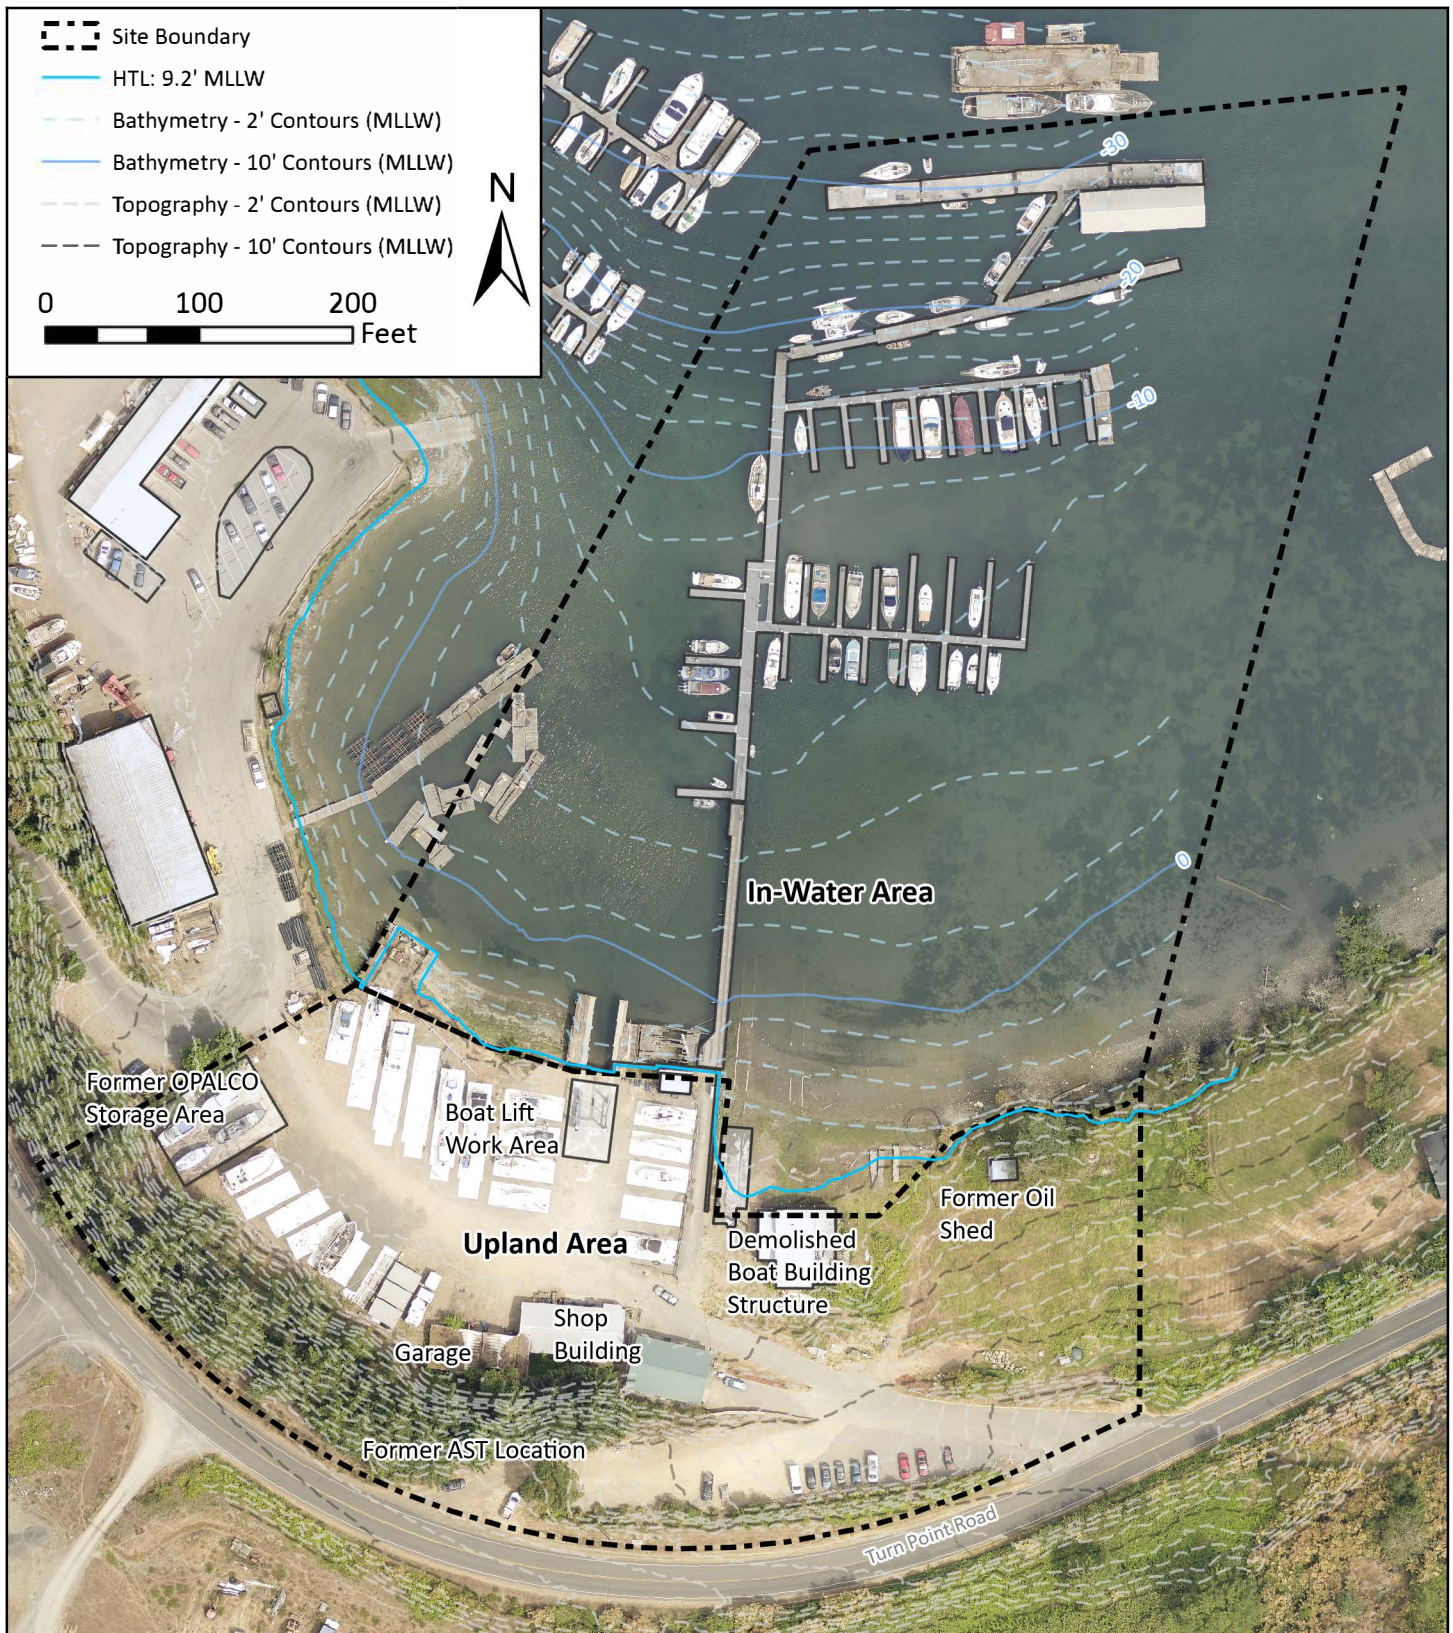
Figure 1-5. Existing Conditions

Jensen's is partially developed and is used currently as a boat maintenance facility and shipyard (Figure 15, Existing Conditions). Based on the needs of the Friday Harbor community, the Port plans to maintain and expand current facility operations.

The Site consists of three distinct areas: a boatyard, a marina, and an undeveloped upland and shoreline area. Jensen's is zoned as Rural Industrial, which allows for light industrial, light manufacturing, and some institutional uses.

Boatyard: The existing boatyard is located in the southern section of the Site, within the western portion of the upland parcel. It encompasses approximately 1.5 acres of active work areas, including boat storage, a laydown area, and a wash pad. Seven buildings are associated with current boatyard operations: an office/retail building, a machine shop, storage buildings, a water treatment building through which water from the wash pad is circulated and then discharged into an evaporating pond on Site, and a small shed. The remnants of a deteriorated cabin also remain on the undeveloped eastern section of the Site. The boatyard infrastructure also includes a 35-ton travel lift. The travel lift pier extends into the probable sediment cleanup area; therefore, the Port is in the process of removing the travel lift pier and replacing it with a new haul out pier located in the adjacent Shipyard Cove Marina section of the Port's larger Jensen's Shipyard Cove Facility. The Port may propose this work as an Interim Action under the Order in the future.

The marine services provided at the boatyard include haul-out, pressure wash, bottom paint, light mechanical, chandlery and parts, and boat storage. The boatyard area has several areas where maintenance was deferred by the prior owner. Ongoing releases from the degraded structures (e.g., visible sheen associated with the creosote pilings) have been observed. The Port is working to address these issues as work under the Order proceeds. For example, the Port installed sleeves around the travel lift pier pilings, which are reducing the extent to which piling creosote is exposed to marine waters.
