## **Final Remedial Action Report**

The BNSF Oil Pipeline Site  
Tacoma, Washington

*for*  
**BNSF Railway Company**

May 28, 2010

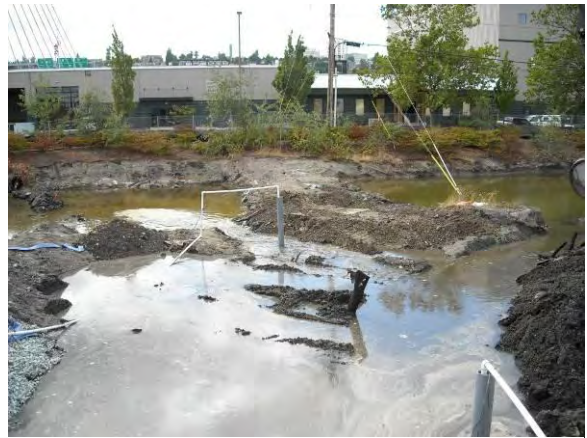
Photo 9A: Wood waste.

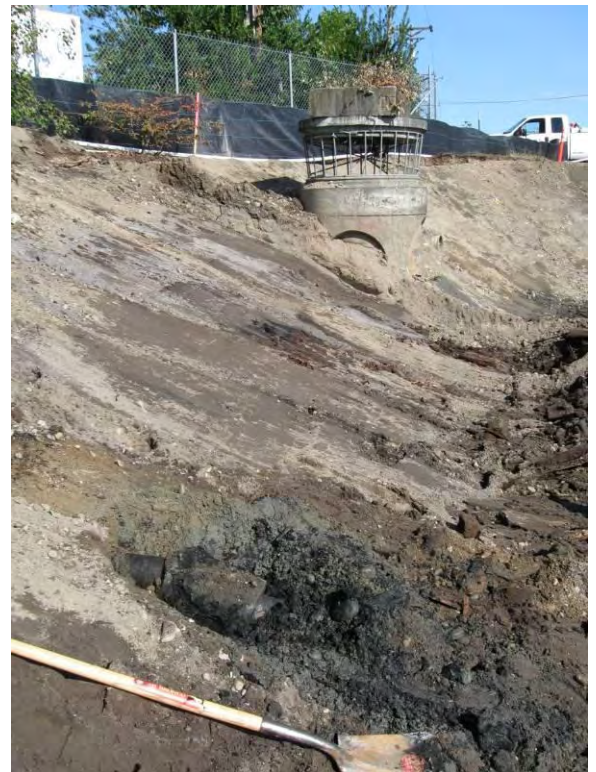
Photo 24A: 4-inch pipe in west sidewall of the north WSDOT pond looking north.

In the process of grading the northern pond west embankment slope, Glacier discovered a 4-inch steel pipe with a boiler-type coupler protruding from the sidewall. It was observed that the pipe had been broken off, bent down parallel with the slope of the embankment and buried under the original stormwater pond liner. A similar pipe was discovered in place directly to the east, crossing

over the BNSF oil pipeline and exiting Area A through the east sidewall. The purpose of this pipe is unknown, but visual observations of the relative age and condition of the pipe materials indicated that it was not likely in service at the time of its discovery. A soil sample (4IN-PIPE-SOIL-5) shown on Sheet C-6 was obtained to assess if petroleum-related contamination was present around this unknown pipe. Chemical analytical results are shown in Table 3, which indicate BRPH was detected at a concentration less than the CUL. The pipe was cut off and plugged with concrete at the limits of Area A.

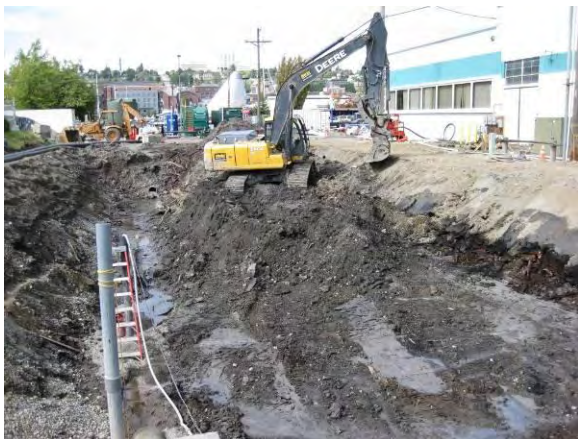
Photo 18B: Excavation area – northwest corner looking northwest. Note: observed 2004 Interim Action CDF and BRPH-like free product draining from wood waste at center of photo.

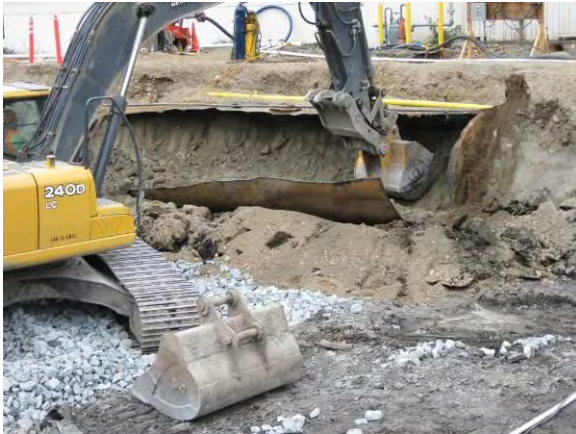
Photo 28B: East 19<sup>th</sup> Street UST - Note: observed fist-sized holes corroded through side of UST.

Glacier exposed the top of the UST and discovered that there was an approximately 75-gallon void space above the CDF inside the tank. A marine chemist from Sound Testing Inc. of Seattle, Washington, tested the atmosphere within the tank and gave Glacier the approval to cut the top and sides with a cutting torch. The tank was cut open and the CDF was removed on September 14, 2009. The UST was removed and stored on site on September 15, 2009. GeoEngineers observed large holes along with extensive pitting and weld failures in the sides and ends of the tank prior to its removal. Photos documenting the condition of the UST are presented in Appendix J. Given the degree of corrosion and the relative short period of time since the tank was closed in place (July 2005), it is GeoEngineers' opinion that the tank integrity was compromised prior to July 2005 when it still contained BRPH-like product. A representative from the Tacoma Fire Department was on-site during UST cutting and CDF removal. The steel from the UST was transported off-site to Schnitzer Steel for recycling on September 17, 2009.

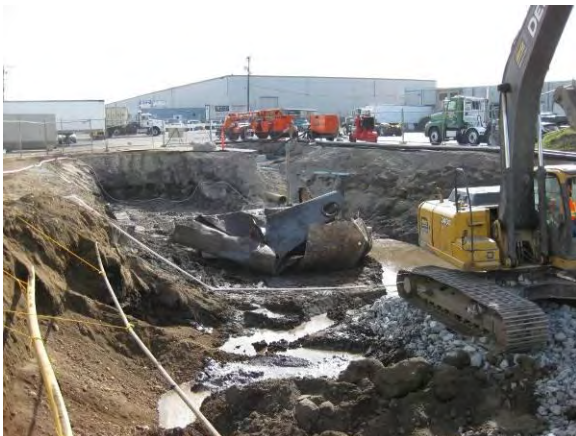
Photo 30B: East 19<sup>th</sup> Street UST - Note: observed failed weld seen inside UST.

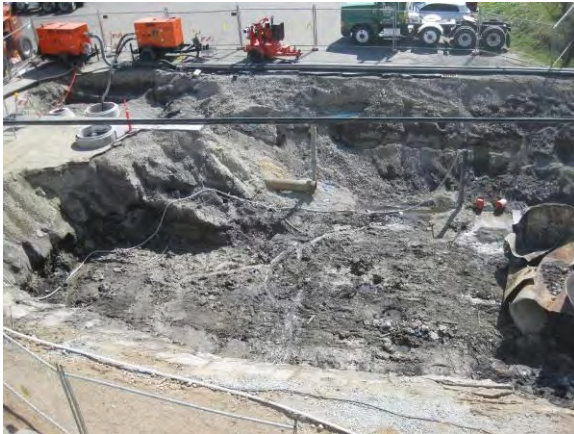
Photo 33B: East 19<sup>th</sup> Street UST – Note: observed fist-sized holes corroded through side of UST.

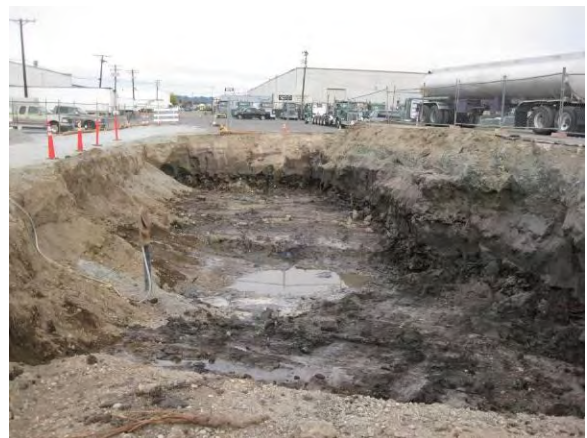
Photo 36B: West sidewall with 12-inch sanitary sewer line exposed. Pea gravel in sewer trench saturated with BRPH-like free product.

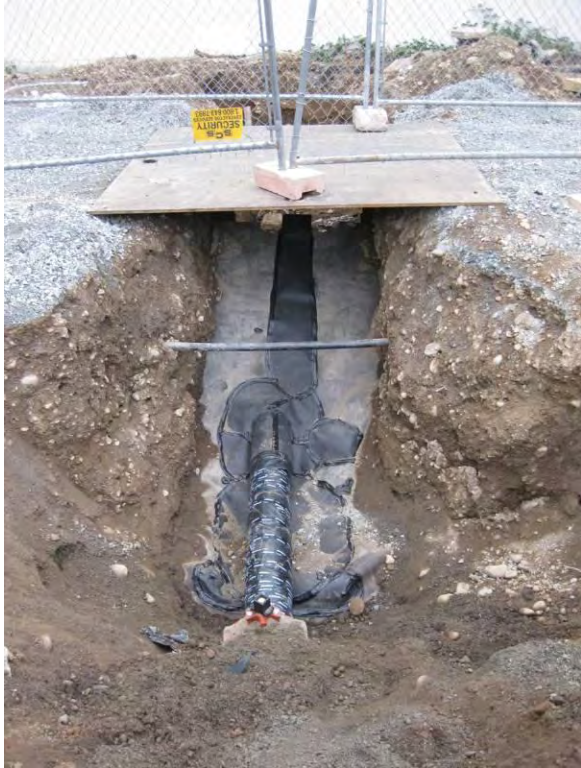
Photo 54B: Utility reconstruction – constructing the Phoenix Environmental sanitary sewer discharge lateral manhole.

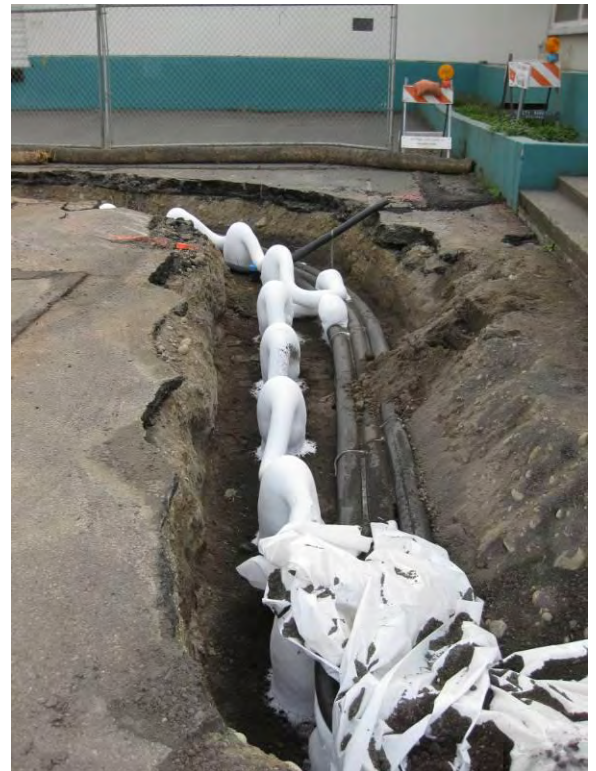
Photo 8C: Freeze wall chillers – north end of west side of excavation area. Freeze wall manifolding wrapped with foam insulation.

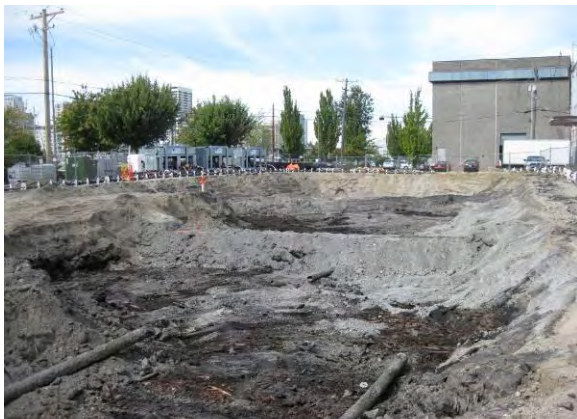
Photo 14C: BNSF Oil Pipeline – rust colored alignment crossing center of photo. Looking east toward SuperValu building.

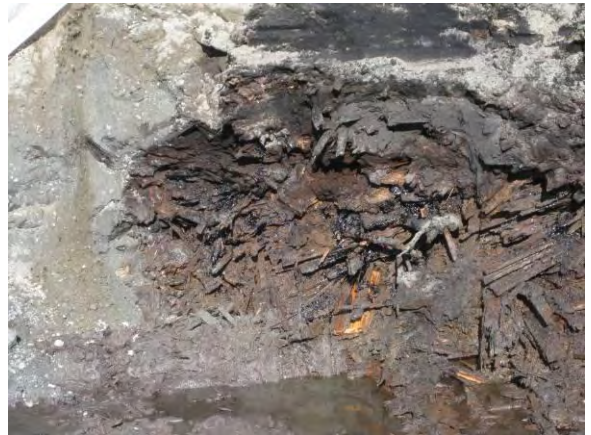
Photo 19C: BRPH free product – top of the northern extent of wood waste at the groundwater table.

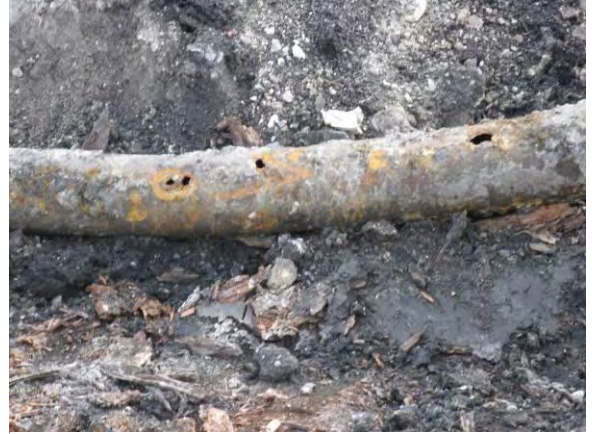
Photo 39C: BNSF Oil Pipeline – grouted at north end of excavation area.
