**Phase I/II Environmental Site
Assessment
Lots 11 and 12 of Block 24
of Sarah A. Bell's Second Addition
Ninth Avenue and Lenora Street
Seattle, Washington**

September 24, 2002

**For
Cornish College**

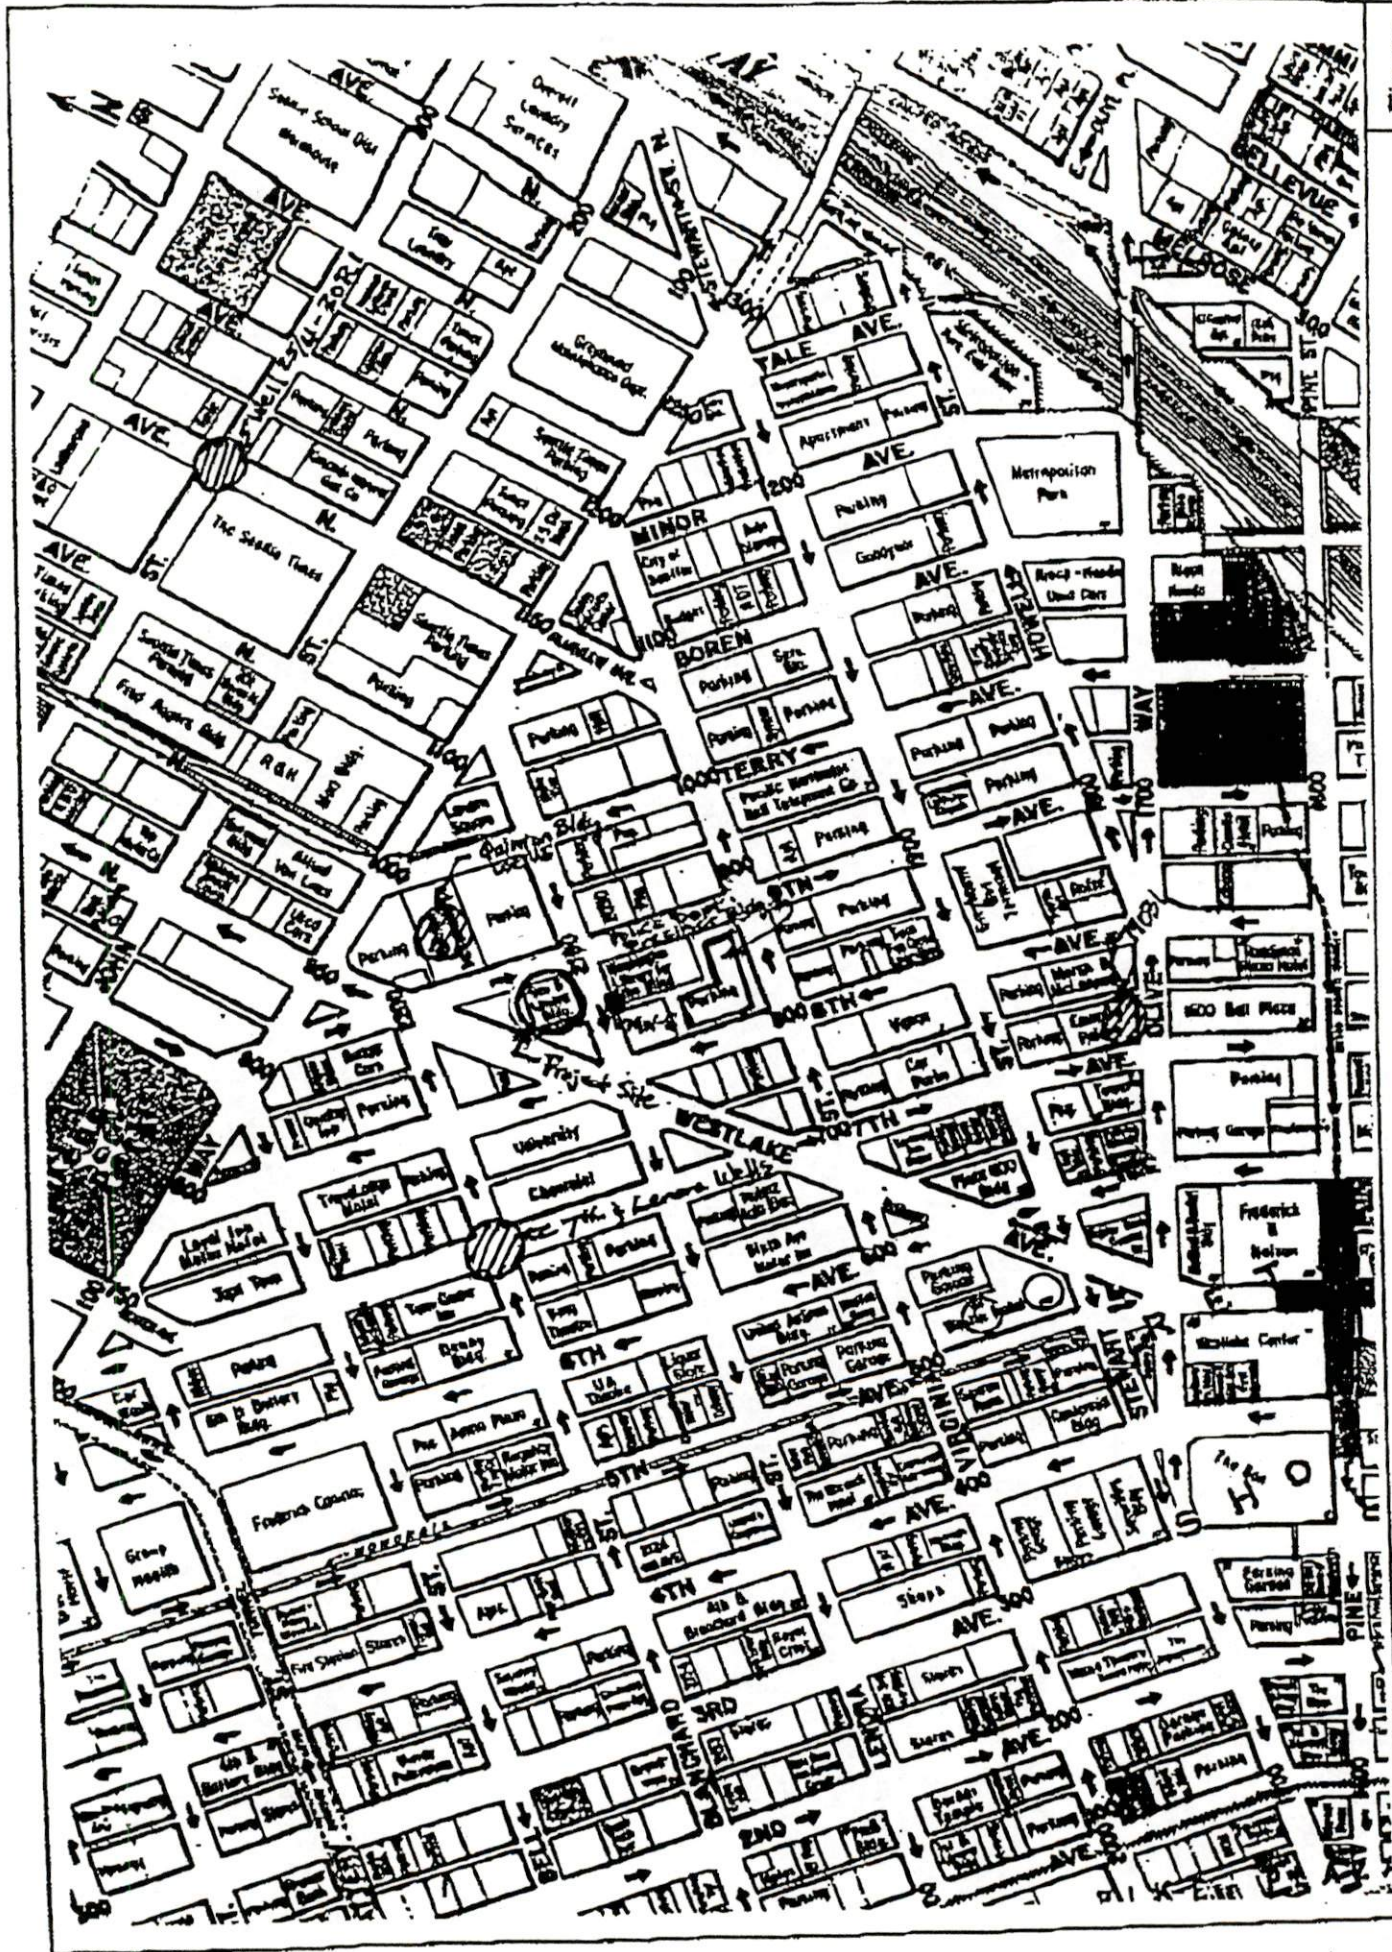
Figure 1

We have completed our investigations of soil materials underlying and adjacent to the building at 1201 Ninth Avenue, Seattle, Washington (9th and Lenora Building) for NEHRP seismic coefficient classification (FEMA-178, as required by the client). Based on the information gathered, we believe the soil conditions are characteristic of a seismic coefficient of S2 as described in the NEHRP Handbook for the Seismic Evaluation of Existing Buildings (FEMA-178 1992). This conclusion was reached following performance of the subsurface investigation described below and examination of existing boring and well information available in the site vicinity. The locations of the borings and wells used in this study are shown in Figure 1.

Boring and Well Location Map
