Subject: Phase IV Interim Action Report - On Property Soils and Perched Groundwater Remediation  
September 2025 Revision  
Superlon Plastics Site, 2116 Taylor Way, Tacoma, Washington  
Agreed Order No. De 5940

# PHASE IV INTERIM ACTION REPORT - ON PROPERTY SOILS AND PERCHED GROUNDWATER REMEDIATION

## Superlon Plastics Site Tacoma, Washington

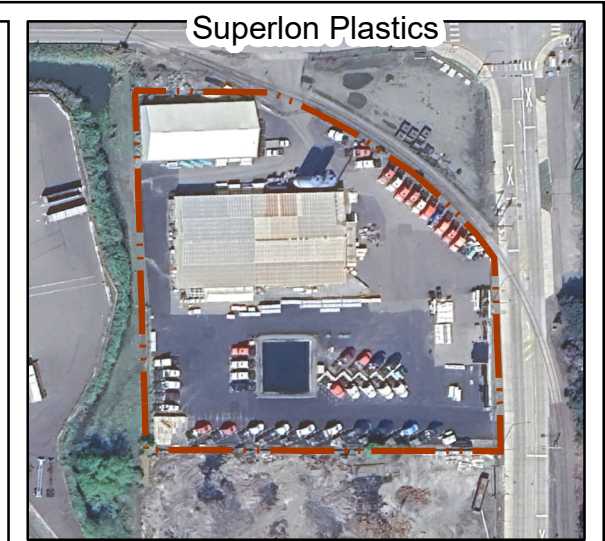
Figure 5

Remedial Action Units (RAUs)  
 OSP Interim Action Completion Report  
 Superlon Plastics Property, Tacoma, Washington

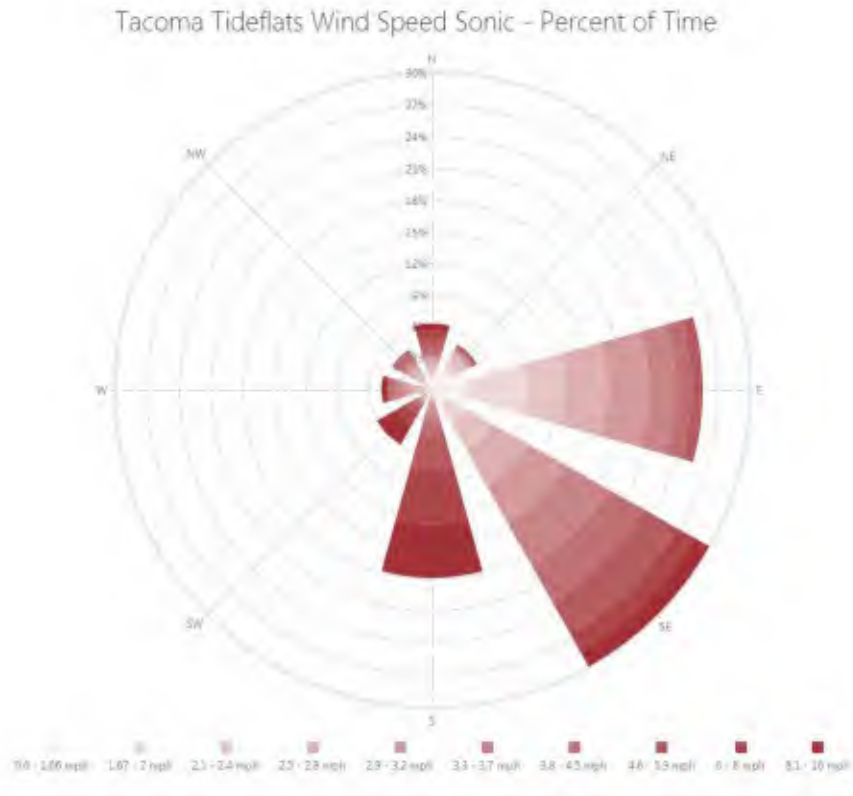
Figure 2 – Prevailing Wind Speed and Direction during October 22 through December 15, 2012  
Source: Puget Sound Clean Air Agency, 2017

**Notes:**  
The above wind rose shows the frequency of winds blowing from a particular direction.

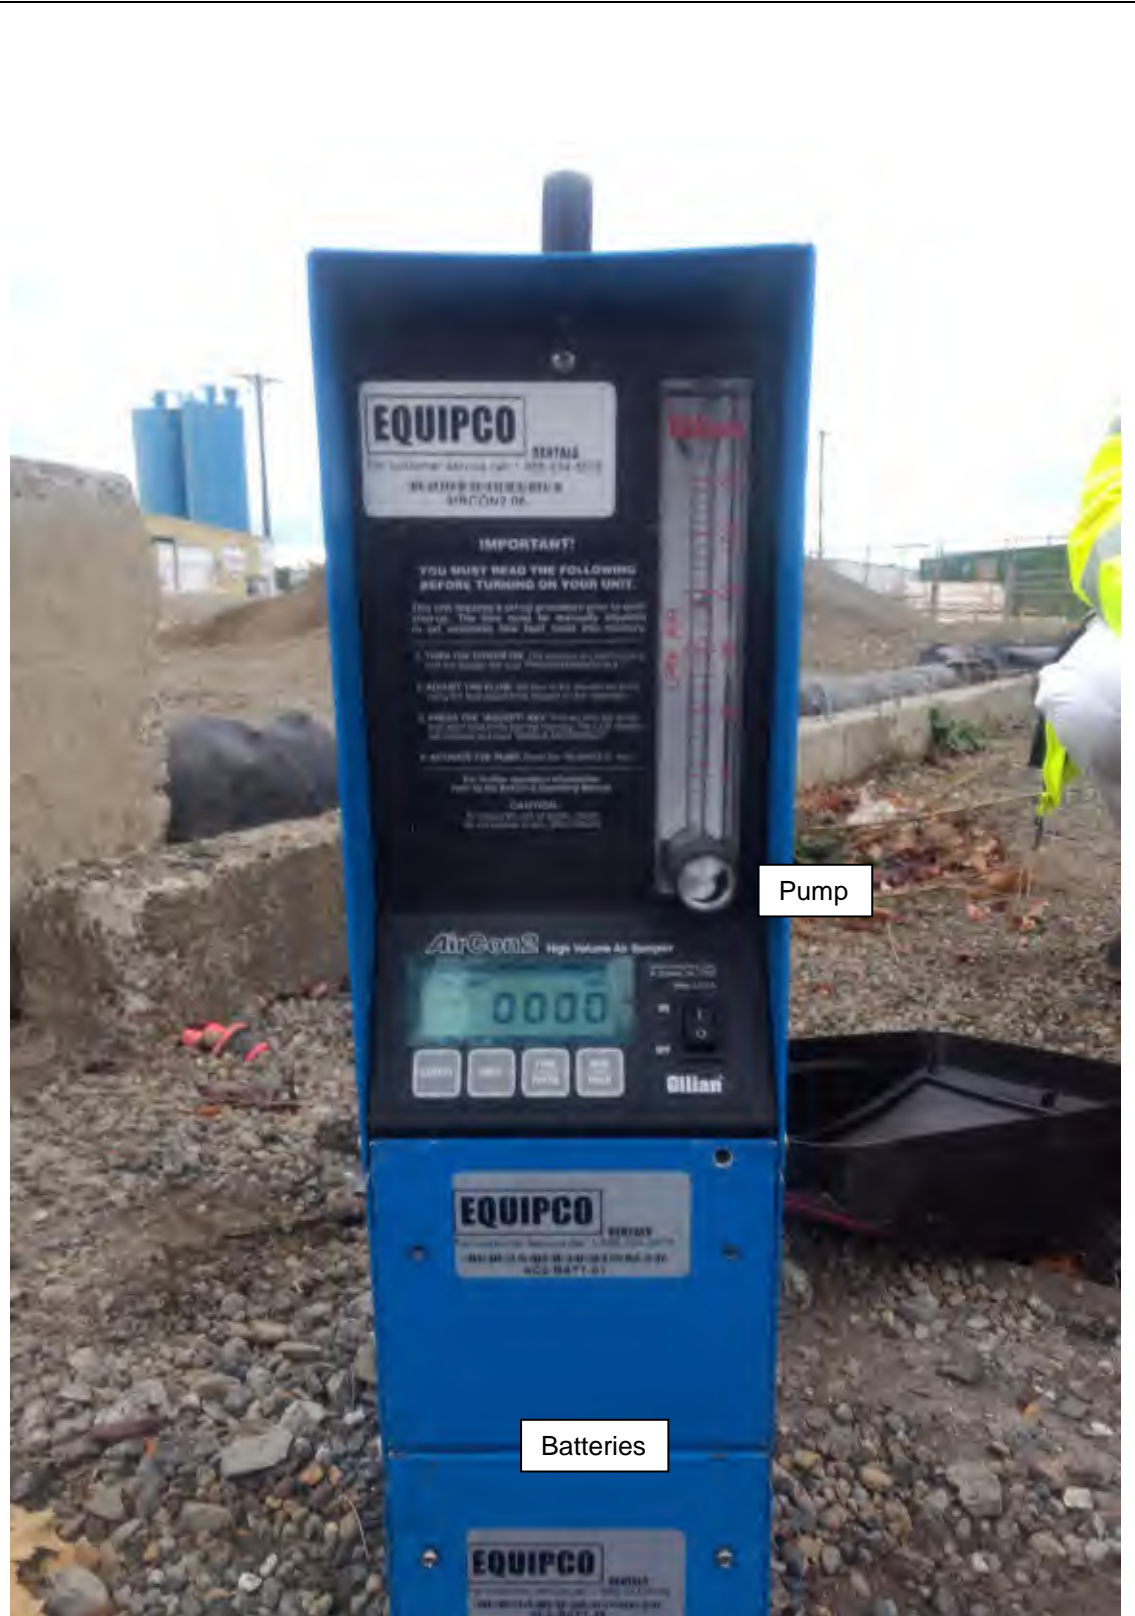
**Description:**  
An AirCon2 sampling pump on the ground before being placed into its weatherproof enclosure.

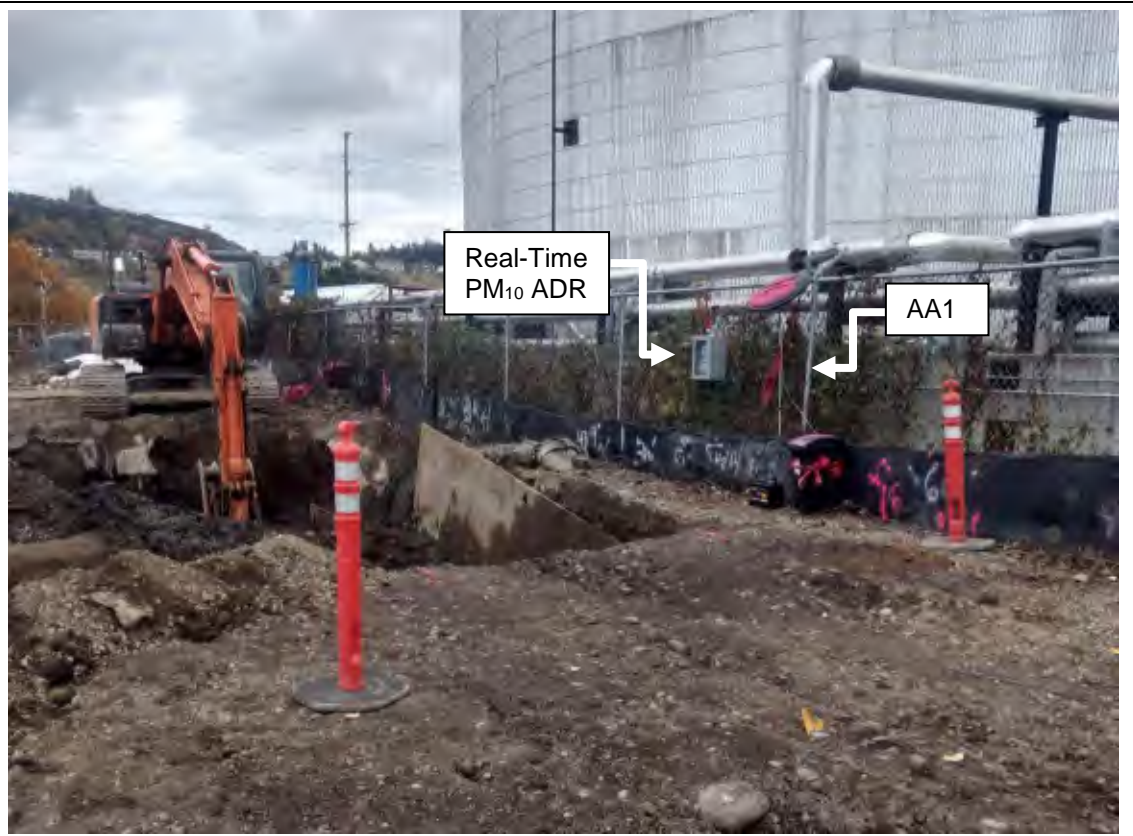
**Photo No. 3:** AA2 Location

**Description:** AA2 location near fence line.

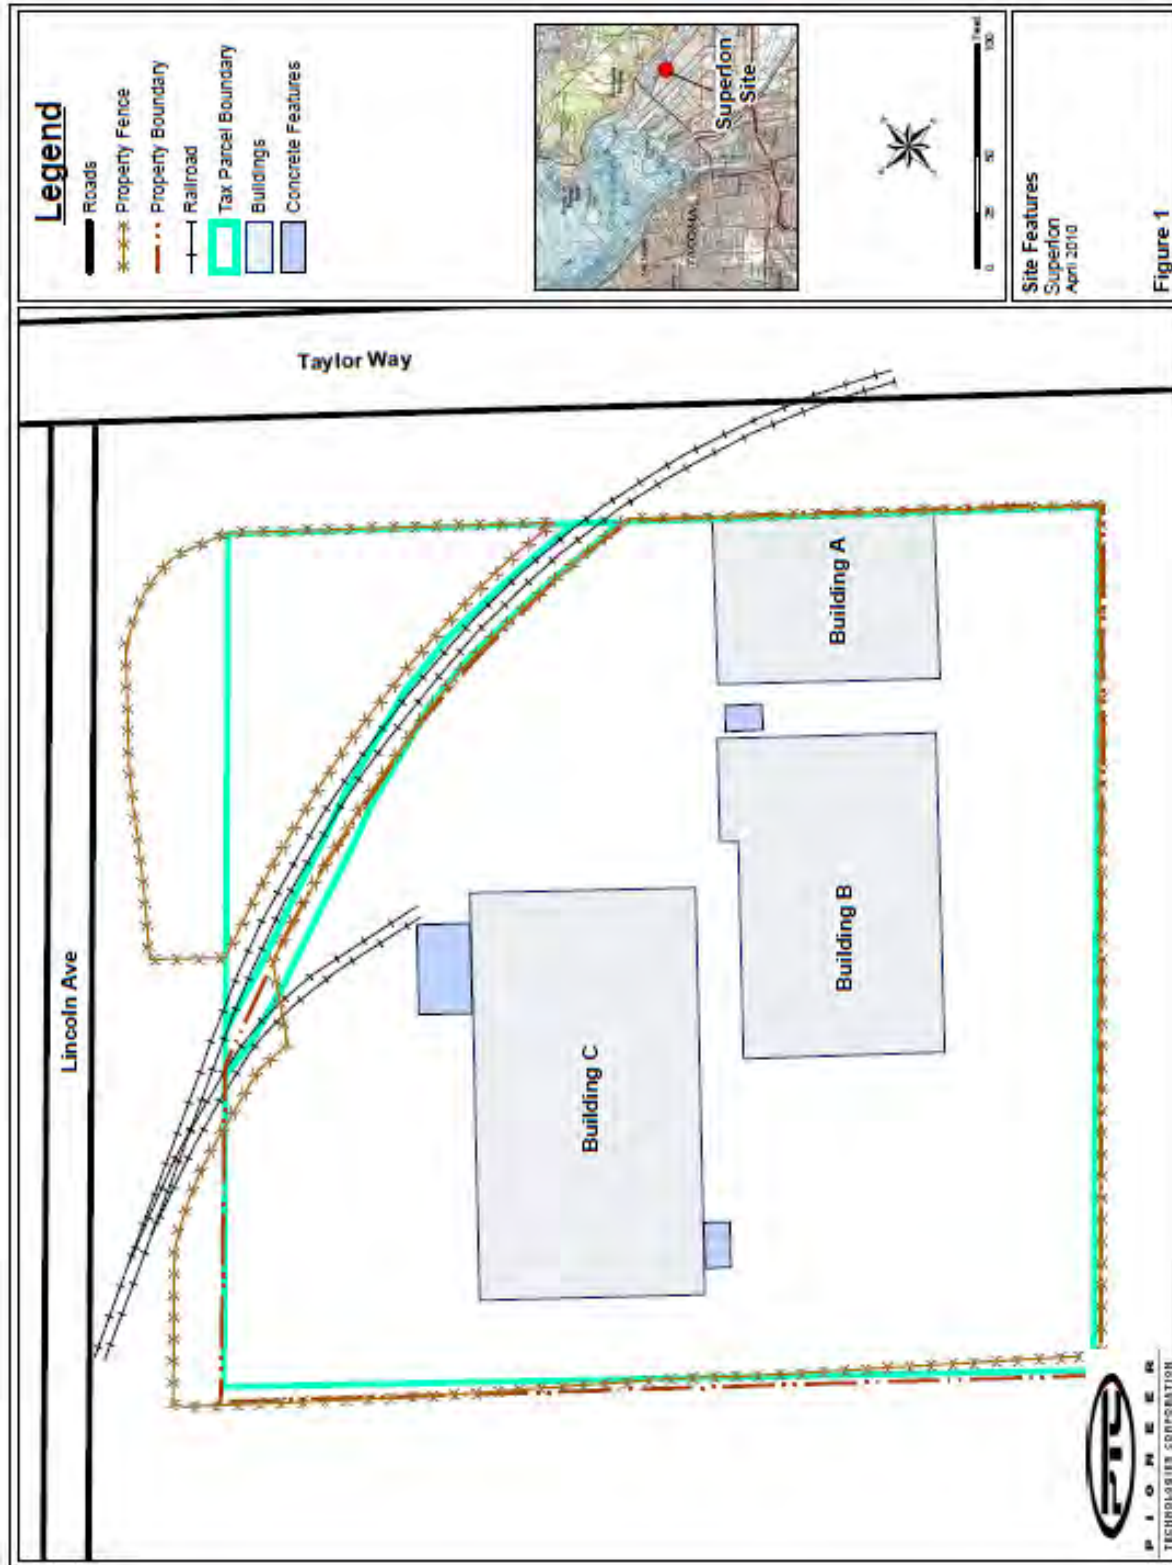
Figure 3. Plan view of the Project Area with related structures and streets.

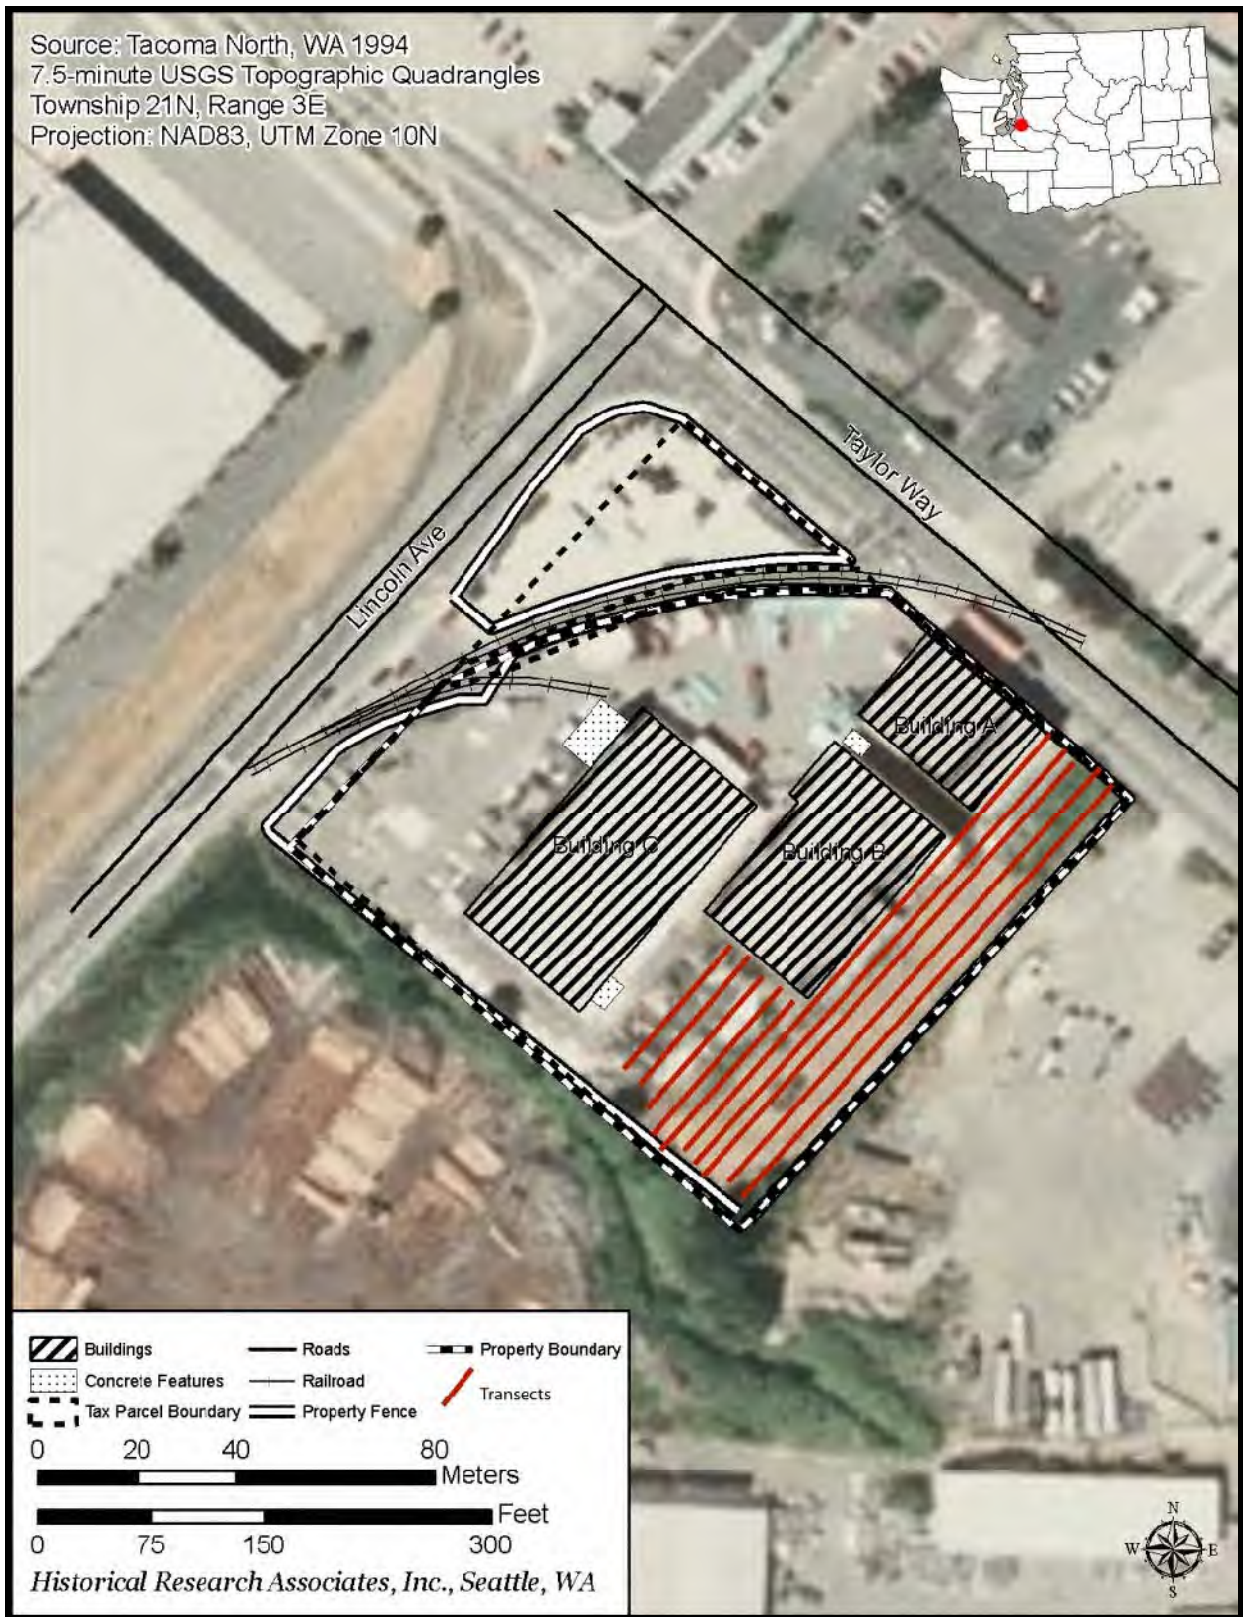
The survey consisted of several pedestrian transects among the buildings, parking lot, and wetlands area. Surface visibility was poor (up to about 20%) due to the dense vegetation and leaf litter. The Project Area is covered in a thick overgrowth of common local shrubs and forbs, including Himalayan blackberry (*Rubus discolor*) (Figure 5). During fieldwork, the HRA archaeologist did not identify any prehistoric, ethnographic or historic-period archaeological materials older than 50 years.

**Figure 5.** Pedestrian survey transects in the Project Area.

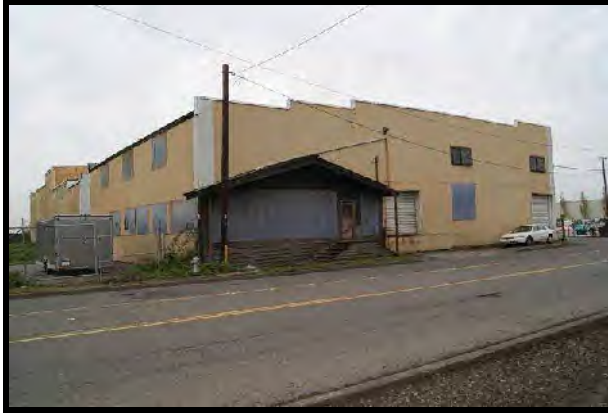
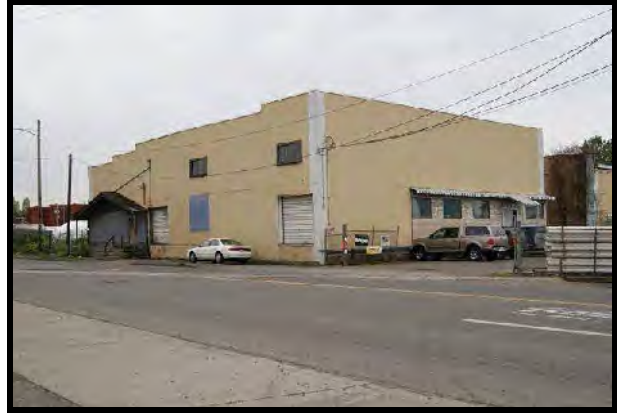
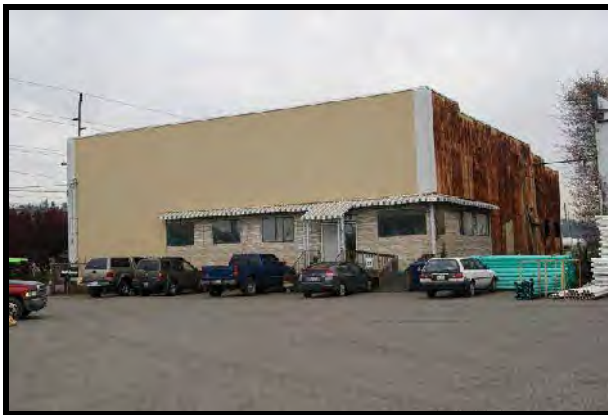
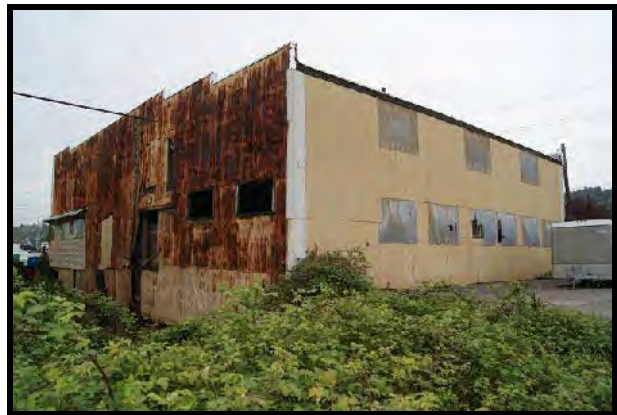
Building A is a two-story building with a basement, and is rectangular in plan. The building sits on wood pylons driven into the mud flats. The building has a flat-on-shed roof with a stepped parapet; the shed portion of the roof is on the southeastern third of the building. The building is clad primarily in corrugated metal siding, with faux-stone veneer surrounding the main entrance on the northwest elevation and partially wrapping the building to the southwest. A secondary entrance, no longer used, is located beneath a gable porch on the northeast elevation. This entry area is clad in horizontal board siding and features an original, one-light over 3-paneled wood door. The building has two roll-up doors on the first floor of the northwest elevation, and two 9-light by 9-light wood slider windows on the second floor of the northwest elevation. Metal sash windows wrap the building on the southwest corner. Though mostly covered with corrugated plastic, evidence of original one-over-one wood sash windows is extant on the southeast elevation. The southwest elevation features some evidence of original door and window openings, though these are mostly obscured by the corrugated metal siding.

**Figures 8-9.** Viewing west, east oblique of Building A, and viewing south, north oblique.

**Figure 10-11.** Viewing east, west oblique of Building A, and viewing north, south oblique.

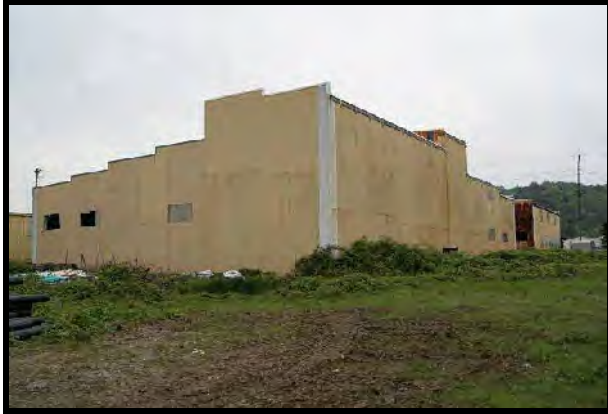
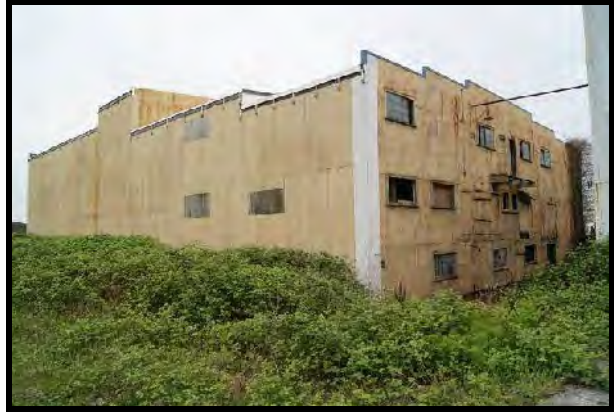
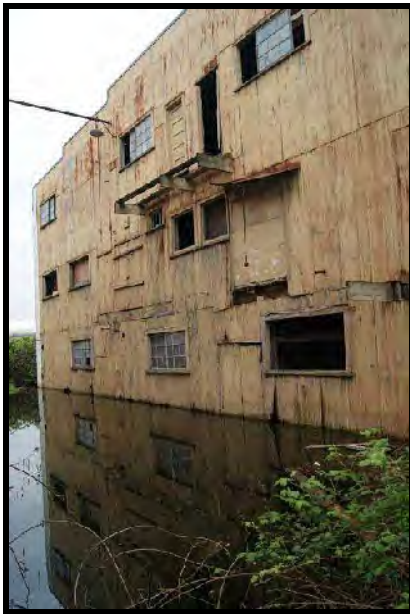
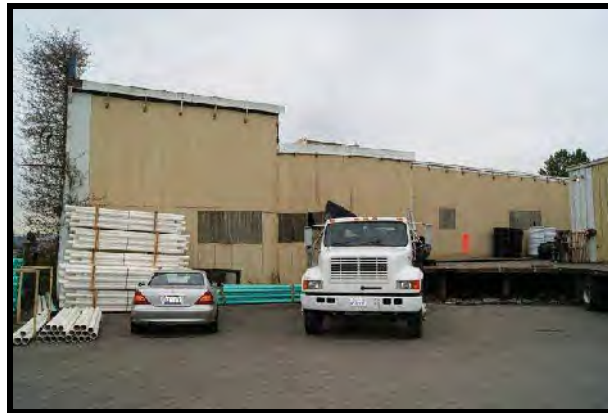
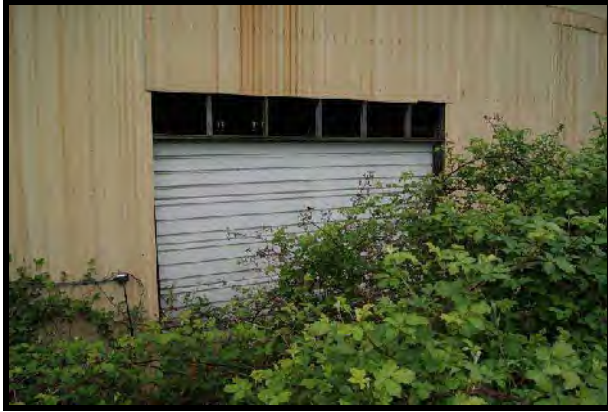
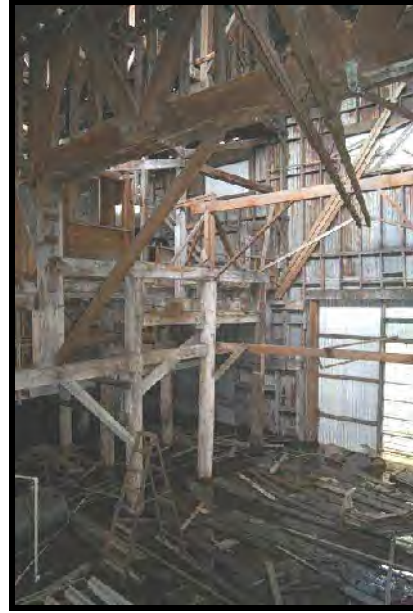
Building B is a two-and-a-half story building with a basement, and is rectangular in plan. The building sits on wood pylons driven into the mud flats, though the presence of some concrete footings beneath large wood posts are evidence of the building's expansion over time. The building has a shed-on-flat roof with a stepped parapet and is clad in corrugated metal siding. Window and door openings are mostly obscured on the southeast and southwest elevations; a roll-up metal door is centrally located on the basement level on the southeast elevation. The northeast elevation has some original nine-by-nine-light wood sash slider windows with panes of safety glass, and one original five-paneled wood door. The northwest elevation has two openings, but all doors and windows are obscured by corrugated metal siding, or have been removed altogether.

**Figures 12-13.** Viewing north, south oblique of Building B, and viewing west, east oblique.

**Figures 14-15.** Viewing east, northwest elevation of Building B, and viewing southeast, northwest elevation.

**Figures 16-17.** Viewing northwest, southeast elevation of Building B with roll-up door, and viewing east, interior view of roll-up doors, posts, and framing.

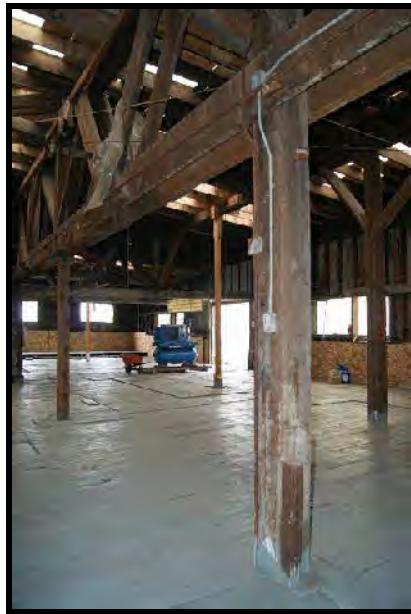
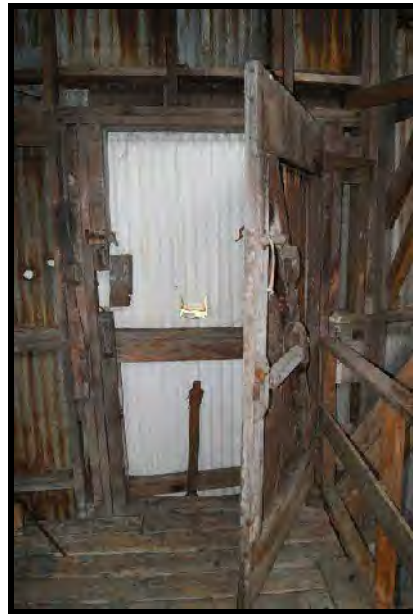
**Figures 18-19.** Interior view of Building B original support column in foreground, with new replacement post (background), and original door opening, as viewed from interior, showing corrugated metal siding covering opening from the exterior.

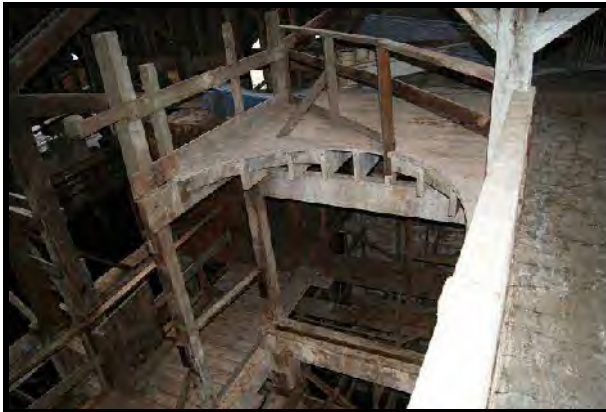
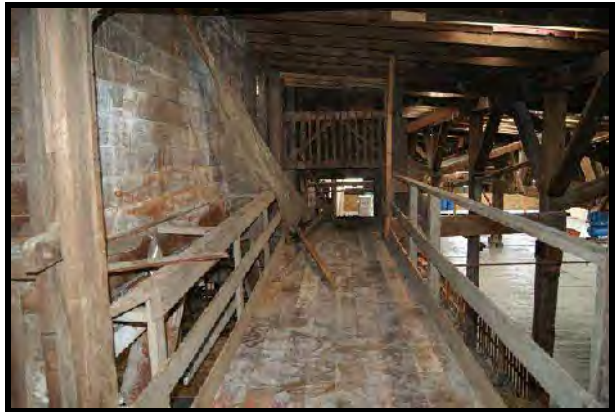
**Figures 20-21.** Interior view of Building B (roof and wall studs), and viewing from second floor to basement level (note pylons, oldest foundation) and posts on concrete footings (secondary foundation systems for alterations which occurred after original building was constructed).

No evidence of original siding, on the exterior or interior, of Building B was found. The interior may have always included exposed studs or may have been finished. The Sanborn maps depicting the structure note that the original exterior surfaces of Building B were metal, while the interior of this type of building may have either been left unfinished or finished, with metal or wood materials.

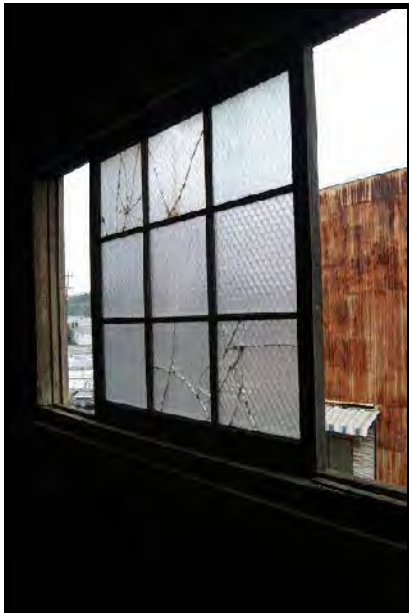
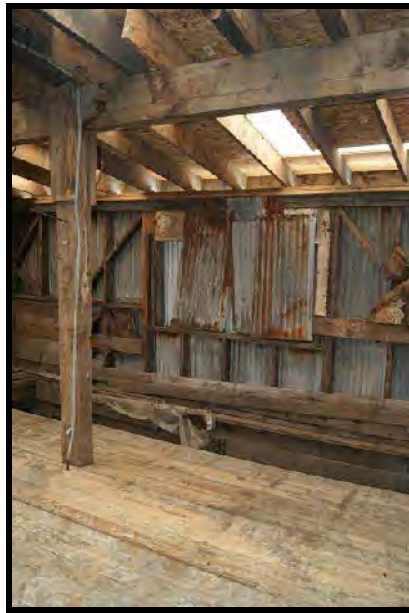
**Figures 25-26.** Original nine-light safety glass wood sash slider window, and interior space on top floor showing roof rafters.

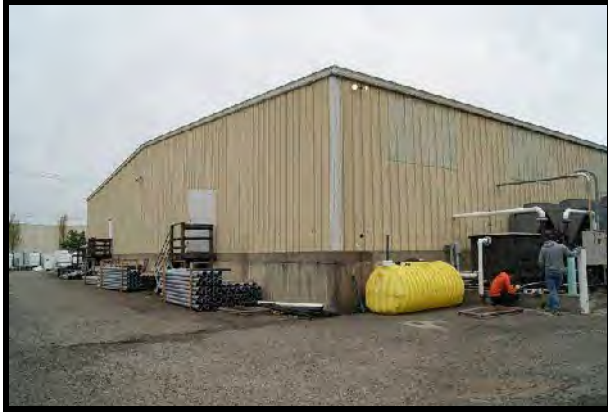
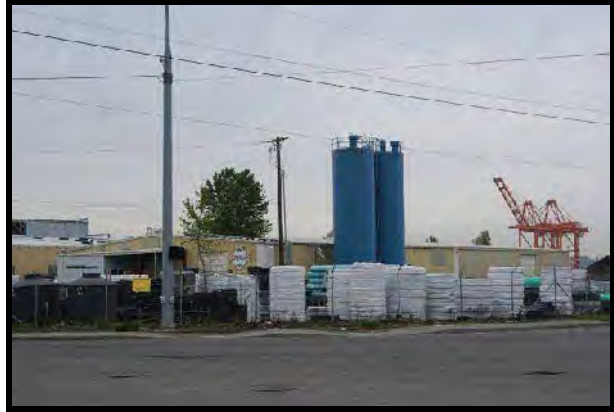
Building C is a one story building and is rectangular in plan. The building is constructed on a poured concrete foundation, has a low profile gable roof, and is clad in standing seam metal. The building is metal-framed, with the main entrance on the northeast elevation. Two metal doors are located on the southwest elevation. The building has a small shed-roof addition, centrally located on the southeast elevation.

**Figures 27-28.** Viewing north, south oblique of Building C, and viewing south, north oblique of Building C.

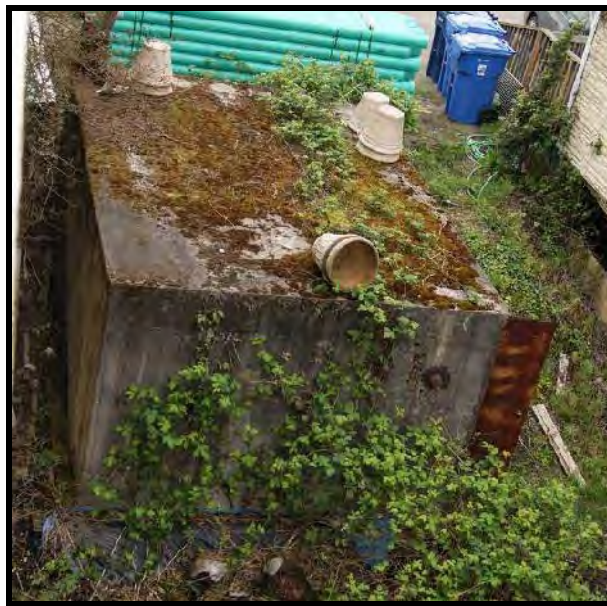
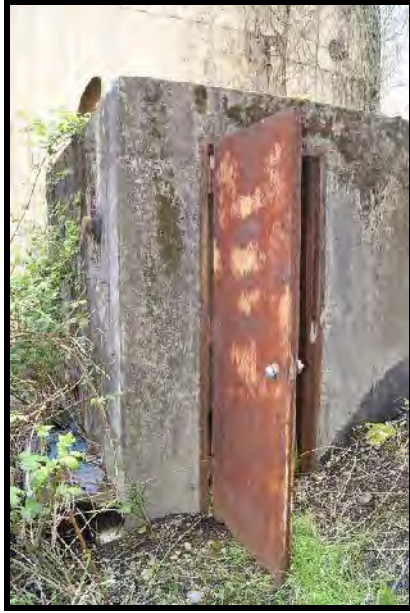
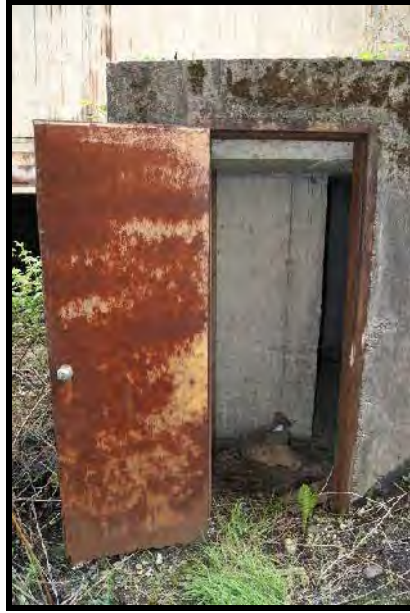
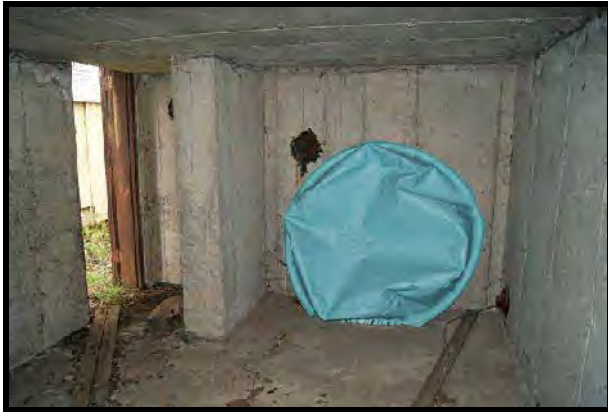
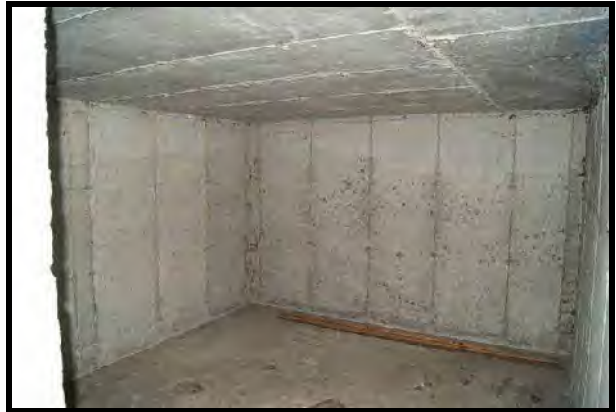
The concrete bunker is located between buildings A and B, at approximately basement level. The bunker is rectangular in shape and has a flat roof. The building is of concrete construction, and features no windows and one metal door, located on the northeast elevation.

**Figure 29.** Viewing north, south oblique of concrete bunker from above.

**Figures 30-31.** Viewing west, east oblique of concrete bunker, and viewing west, entry door of concrete bunker.

**Figures 32-33.** Interior of concrete bunker, viewing east, and interior of bunker, viewing west.
