## ENVISION ENVIRONMENTAL, INC.

Re: Spill Incident No. 11-4213  
REXAM Beverage Can Company  
1220 North 2<sup>nd</sup> Avenue  
Kent, King County, WA 98008-5452  
VCP Site No. 35918556  
VCP Reference No. NW1105

ENVISION Project ID: 302.REX

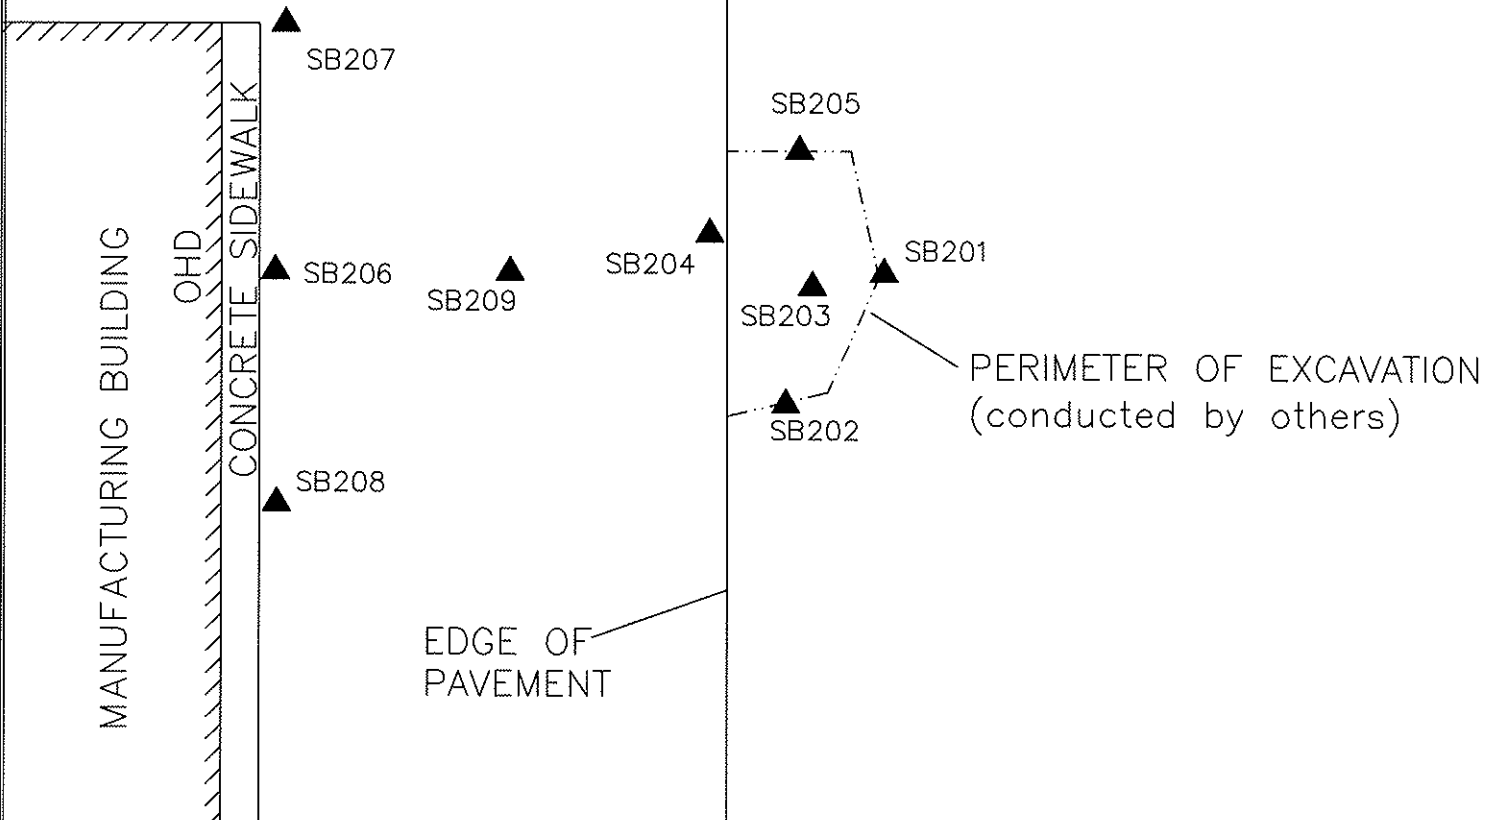
REXAM BEVERAGE CAN CO.  
1220 NORTH 2nd AVENUE  
KENT, WASHINGTON 98032  
HYDRAULIC OIL RELEASE  
SOIL BORING LOCATIONS

On December 29, 2011, ENVISION supervised the installation of nine (9) soil borings (SB201 – SB209) as shown on Figure 2. The boring installation was conducted by a licensed driller from ESN using a truck-mounted direct push technology (DPT) drill rig. All borings were installed to 4-foot bgs using a 2-inch diameter, 4-foot long stainless steel MacroCore sampler. The sampler was fitted with disposable PVC liners that were changed between samples. The soil cores were screened using an organic vapor monitor (OVM) equipped with a photoionization detector (PID) with a 10.6 eV lamp. The OVM was calibrated in the field before beginning work to a standard of 100 parts per million (ppm) of isobutylene. Lithologies were logged by an ENVISION geologist. Reusable downhole equipment (e.g. steel components of the MacroCore sampler) was decontaminated between borings by washing with a solution of Alconox and water, a tap water rinse, and a final deionized water rinse. Field personnel wore nitrile gloves which were changed between samples. Decontamination water and soil cuttings were placed into 55-gallon steel drums, labeled, and staged in an area designated by Site personnel for subsequent proper offsite disposal.

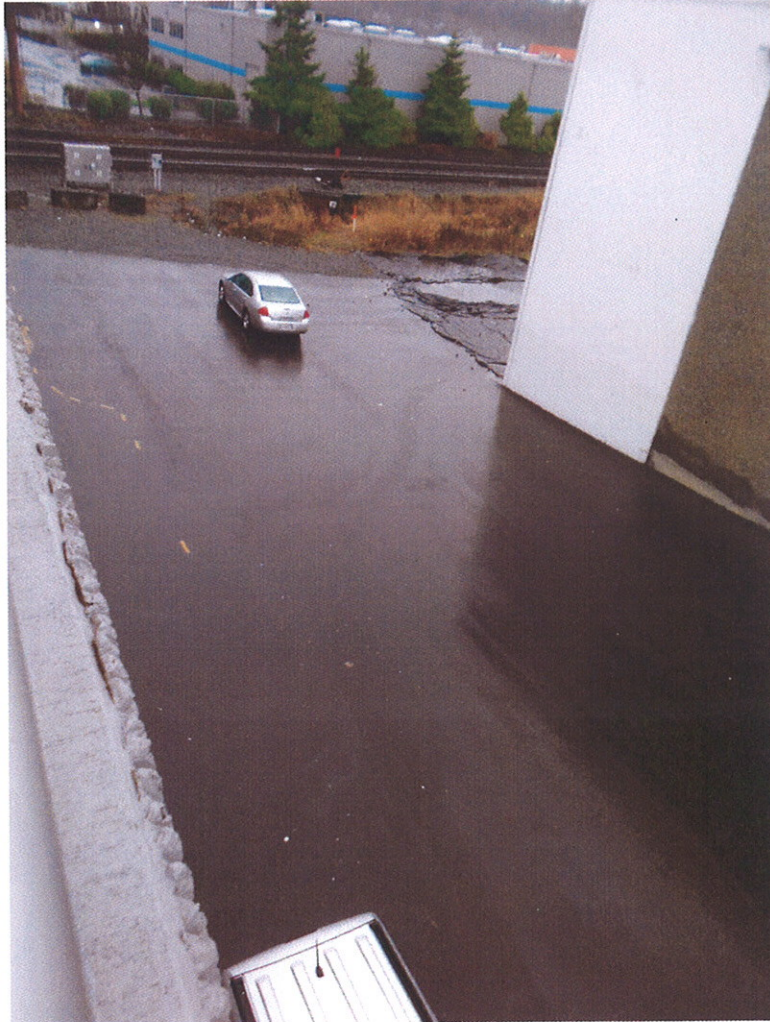
View looking east from the South 228<sup>th</sup> Street overpass at the northeast corner of the Site. Note the stormwater flow pattern to the east-southeast with a slight sheen on the asphalt pavement from typical parking lot runoff.

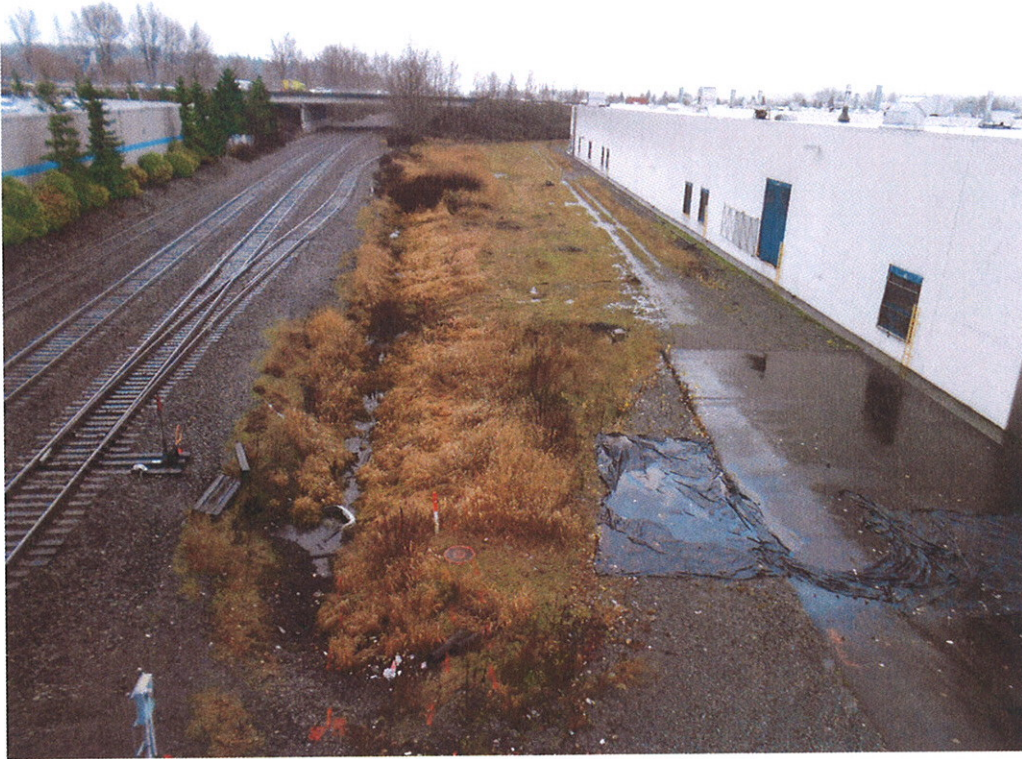
View looking south from the South 228<sup>th</sup> Street overpass showing the Manufacturing Building, release area, covered excavation, utility markings and drainage swale adjacent to the railroad main line.

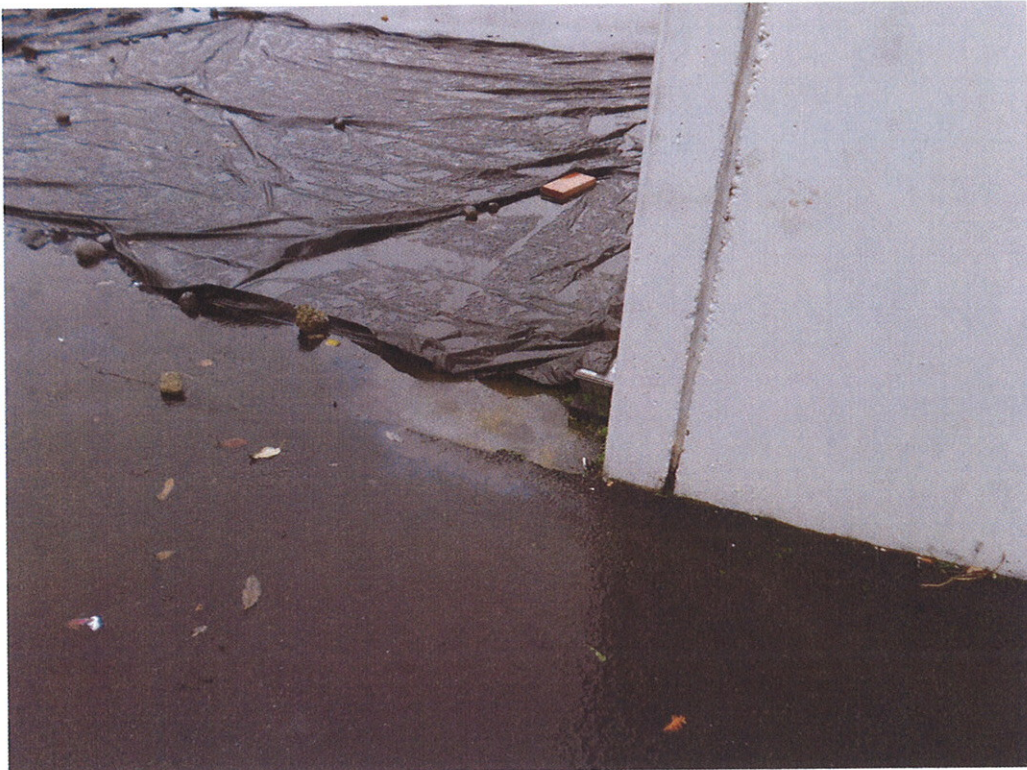
View of the northeast corner of the Manufacturing Building. Note the slight sheen from typical parking lot runoff flowing towards the hydraulic oil release area from the upgradient asphalt paved area.

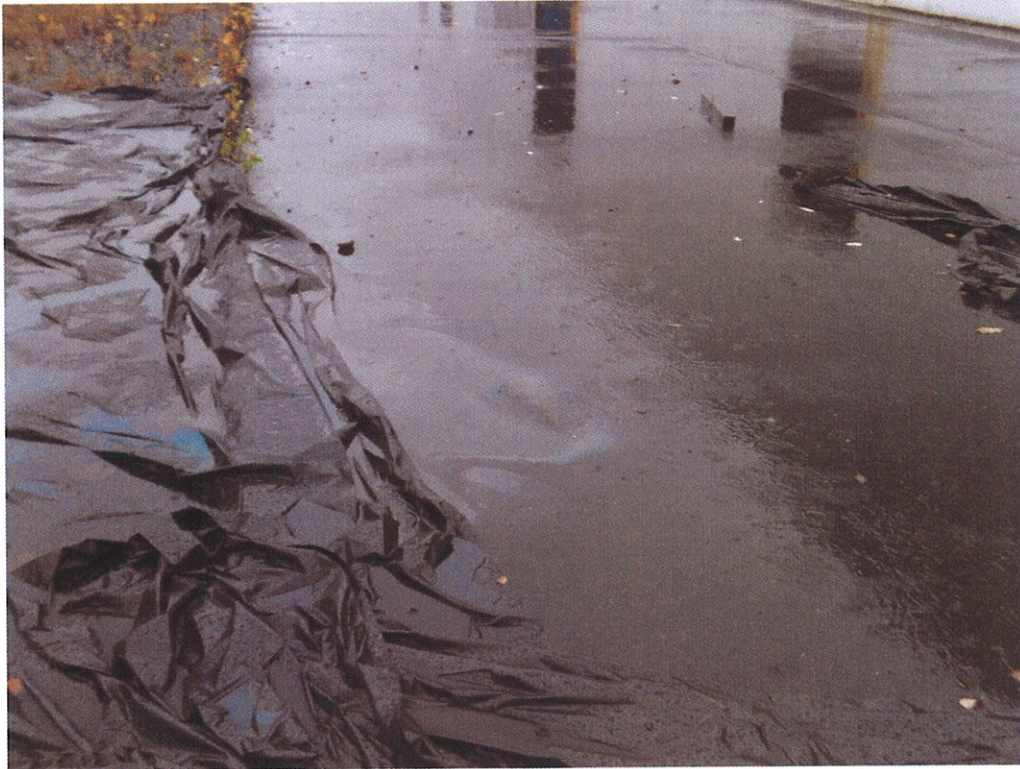
View looking south, note the slight sheen accumulation near the pavement edge downgradient of the hydraulic oil release area. This sheen is from typical parking lot runoff from an upgradient area.

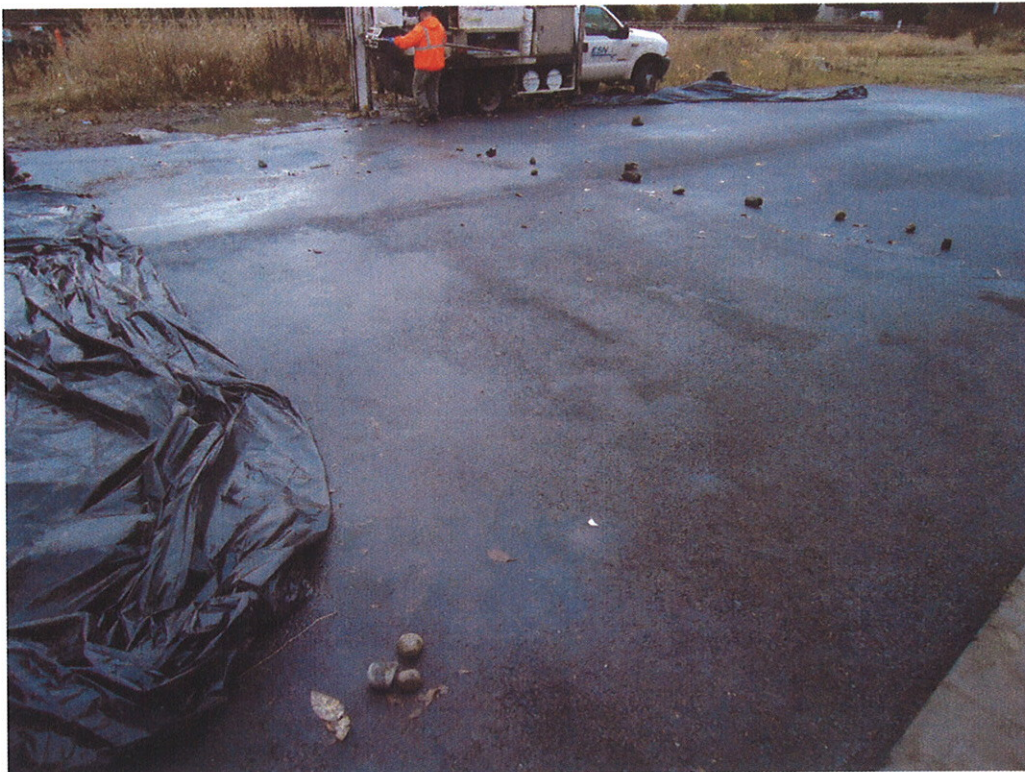
View looking southeast of the asphalt pavement adjacent to the overhead door to the Baler area of the Manufacturing Building where the hydraulic oil was released.

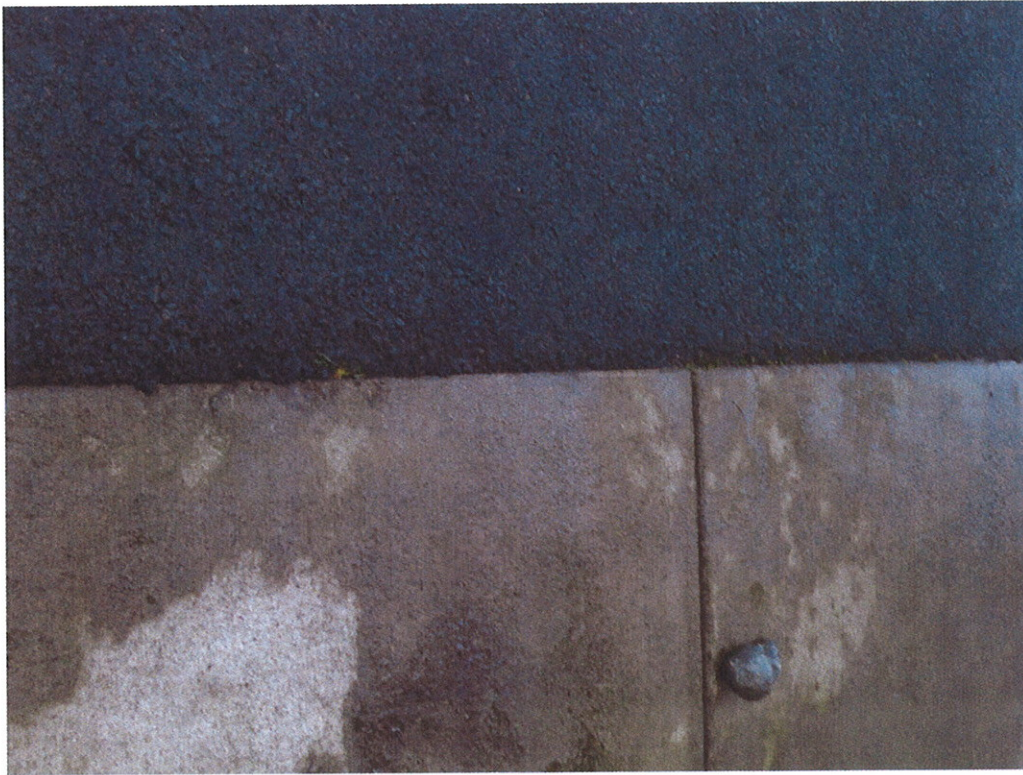
The pavement in the area of the hydraulic oil release was in excellent physical condition, with no cracks or deteriorated areas. The joint between the pavement and a concrete sidewalk along the east wall of the building was also in excellent condition. No stains or sheens were observed in the area of the joint and on the building wall. See pictures in the Photo Log.

View of the joint between the concrete walk and the asphalt pavement below the overhead door in the Baler area. Joint integrity is good. Note lack of staining. Soil boring SB206 collected at this location.

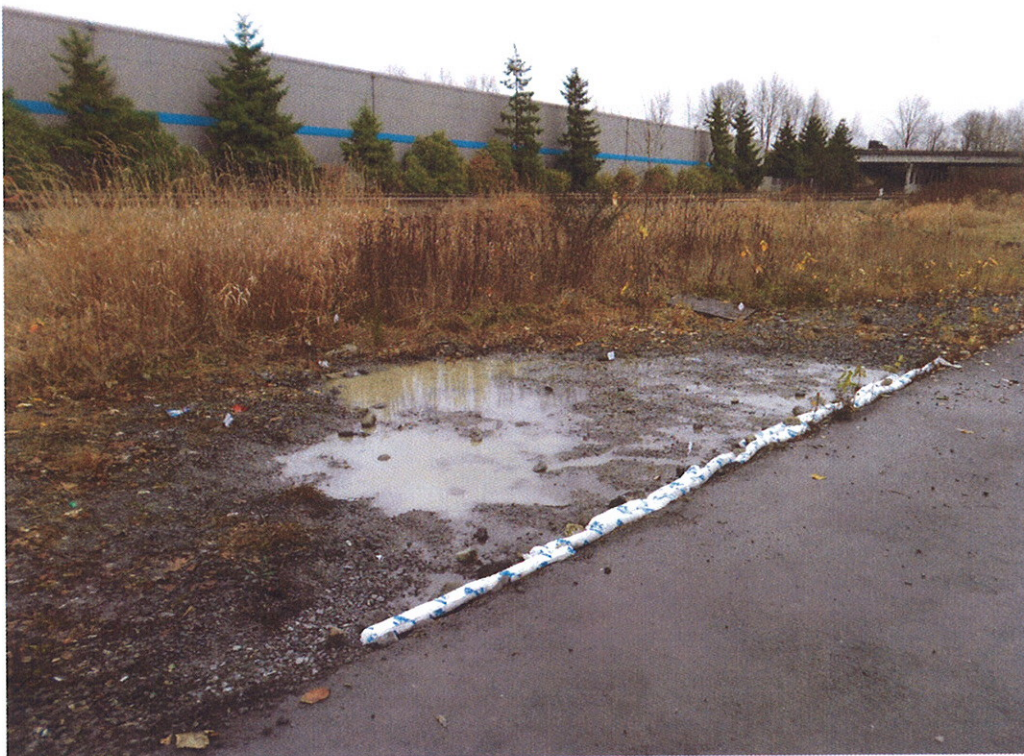
Sorbent socks placed at edge of gravel to capture any sheen on stormwater runoff from the asphalt pavement. White flags demark soil boring locations in center of and on four (4) sides of excavation.

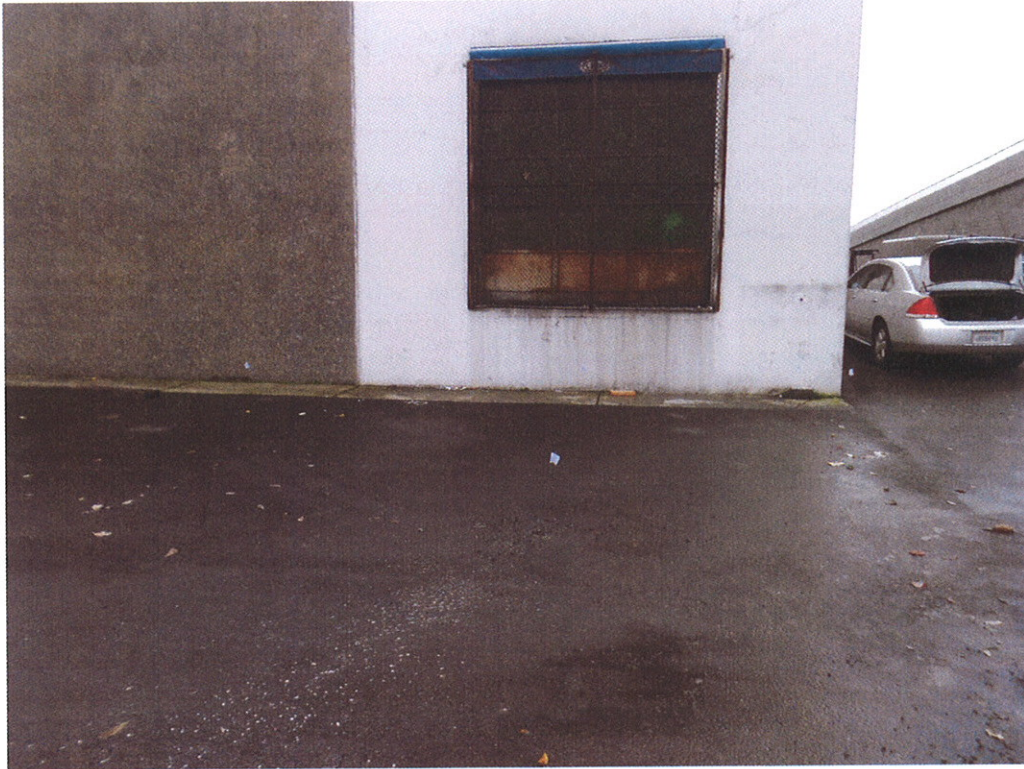
View looking west at the overhead door in the Baler area. The white flags demark soil boring SB209 (foreground) and (left to right) soil borings SB208, SB206, and SB207.

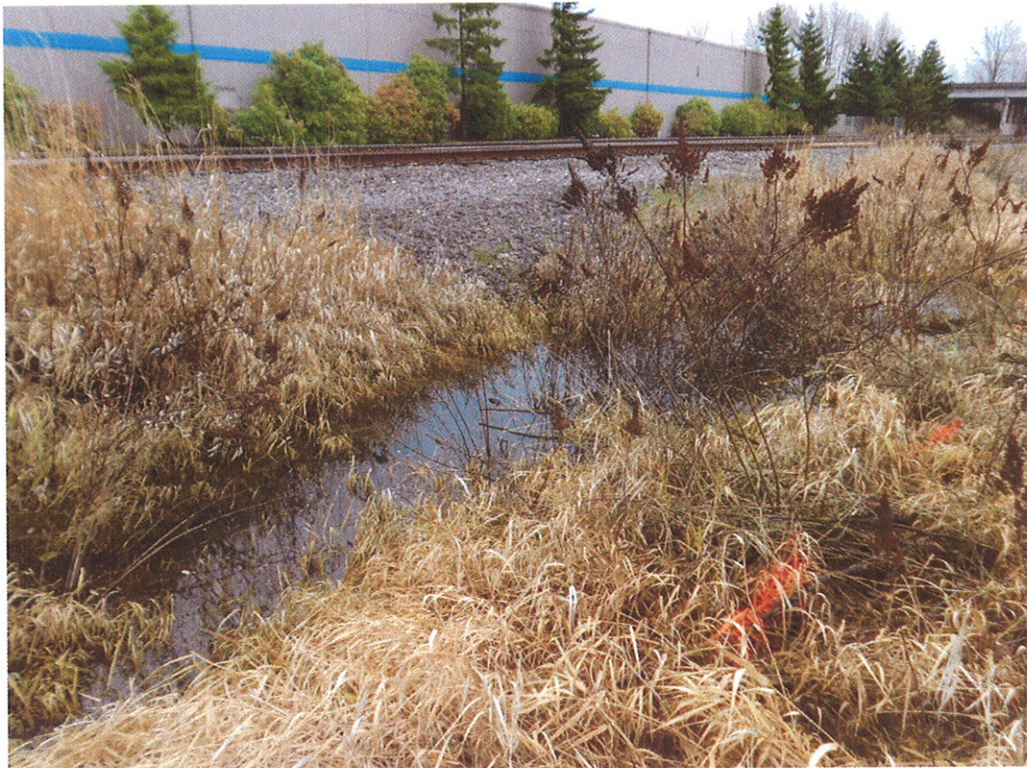
View looking southeast from the excavation area at the drainage swale approximately 20-feet (centered) east of the excavation edge. No sheen observed.
