ILLUSTRATIONS
PART 1

American Linen Supply Co Dexter Ave Site
700 Dexter Avenue North
Seattle, Washington

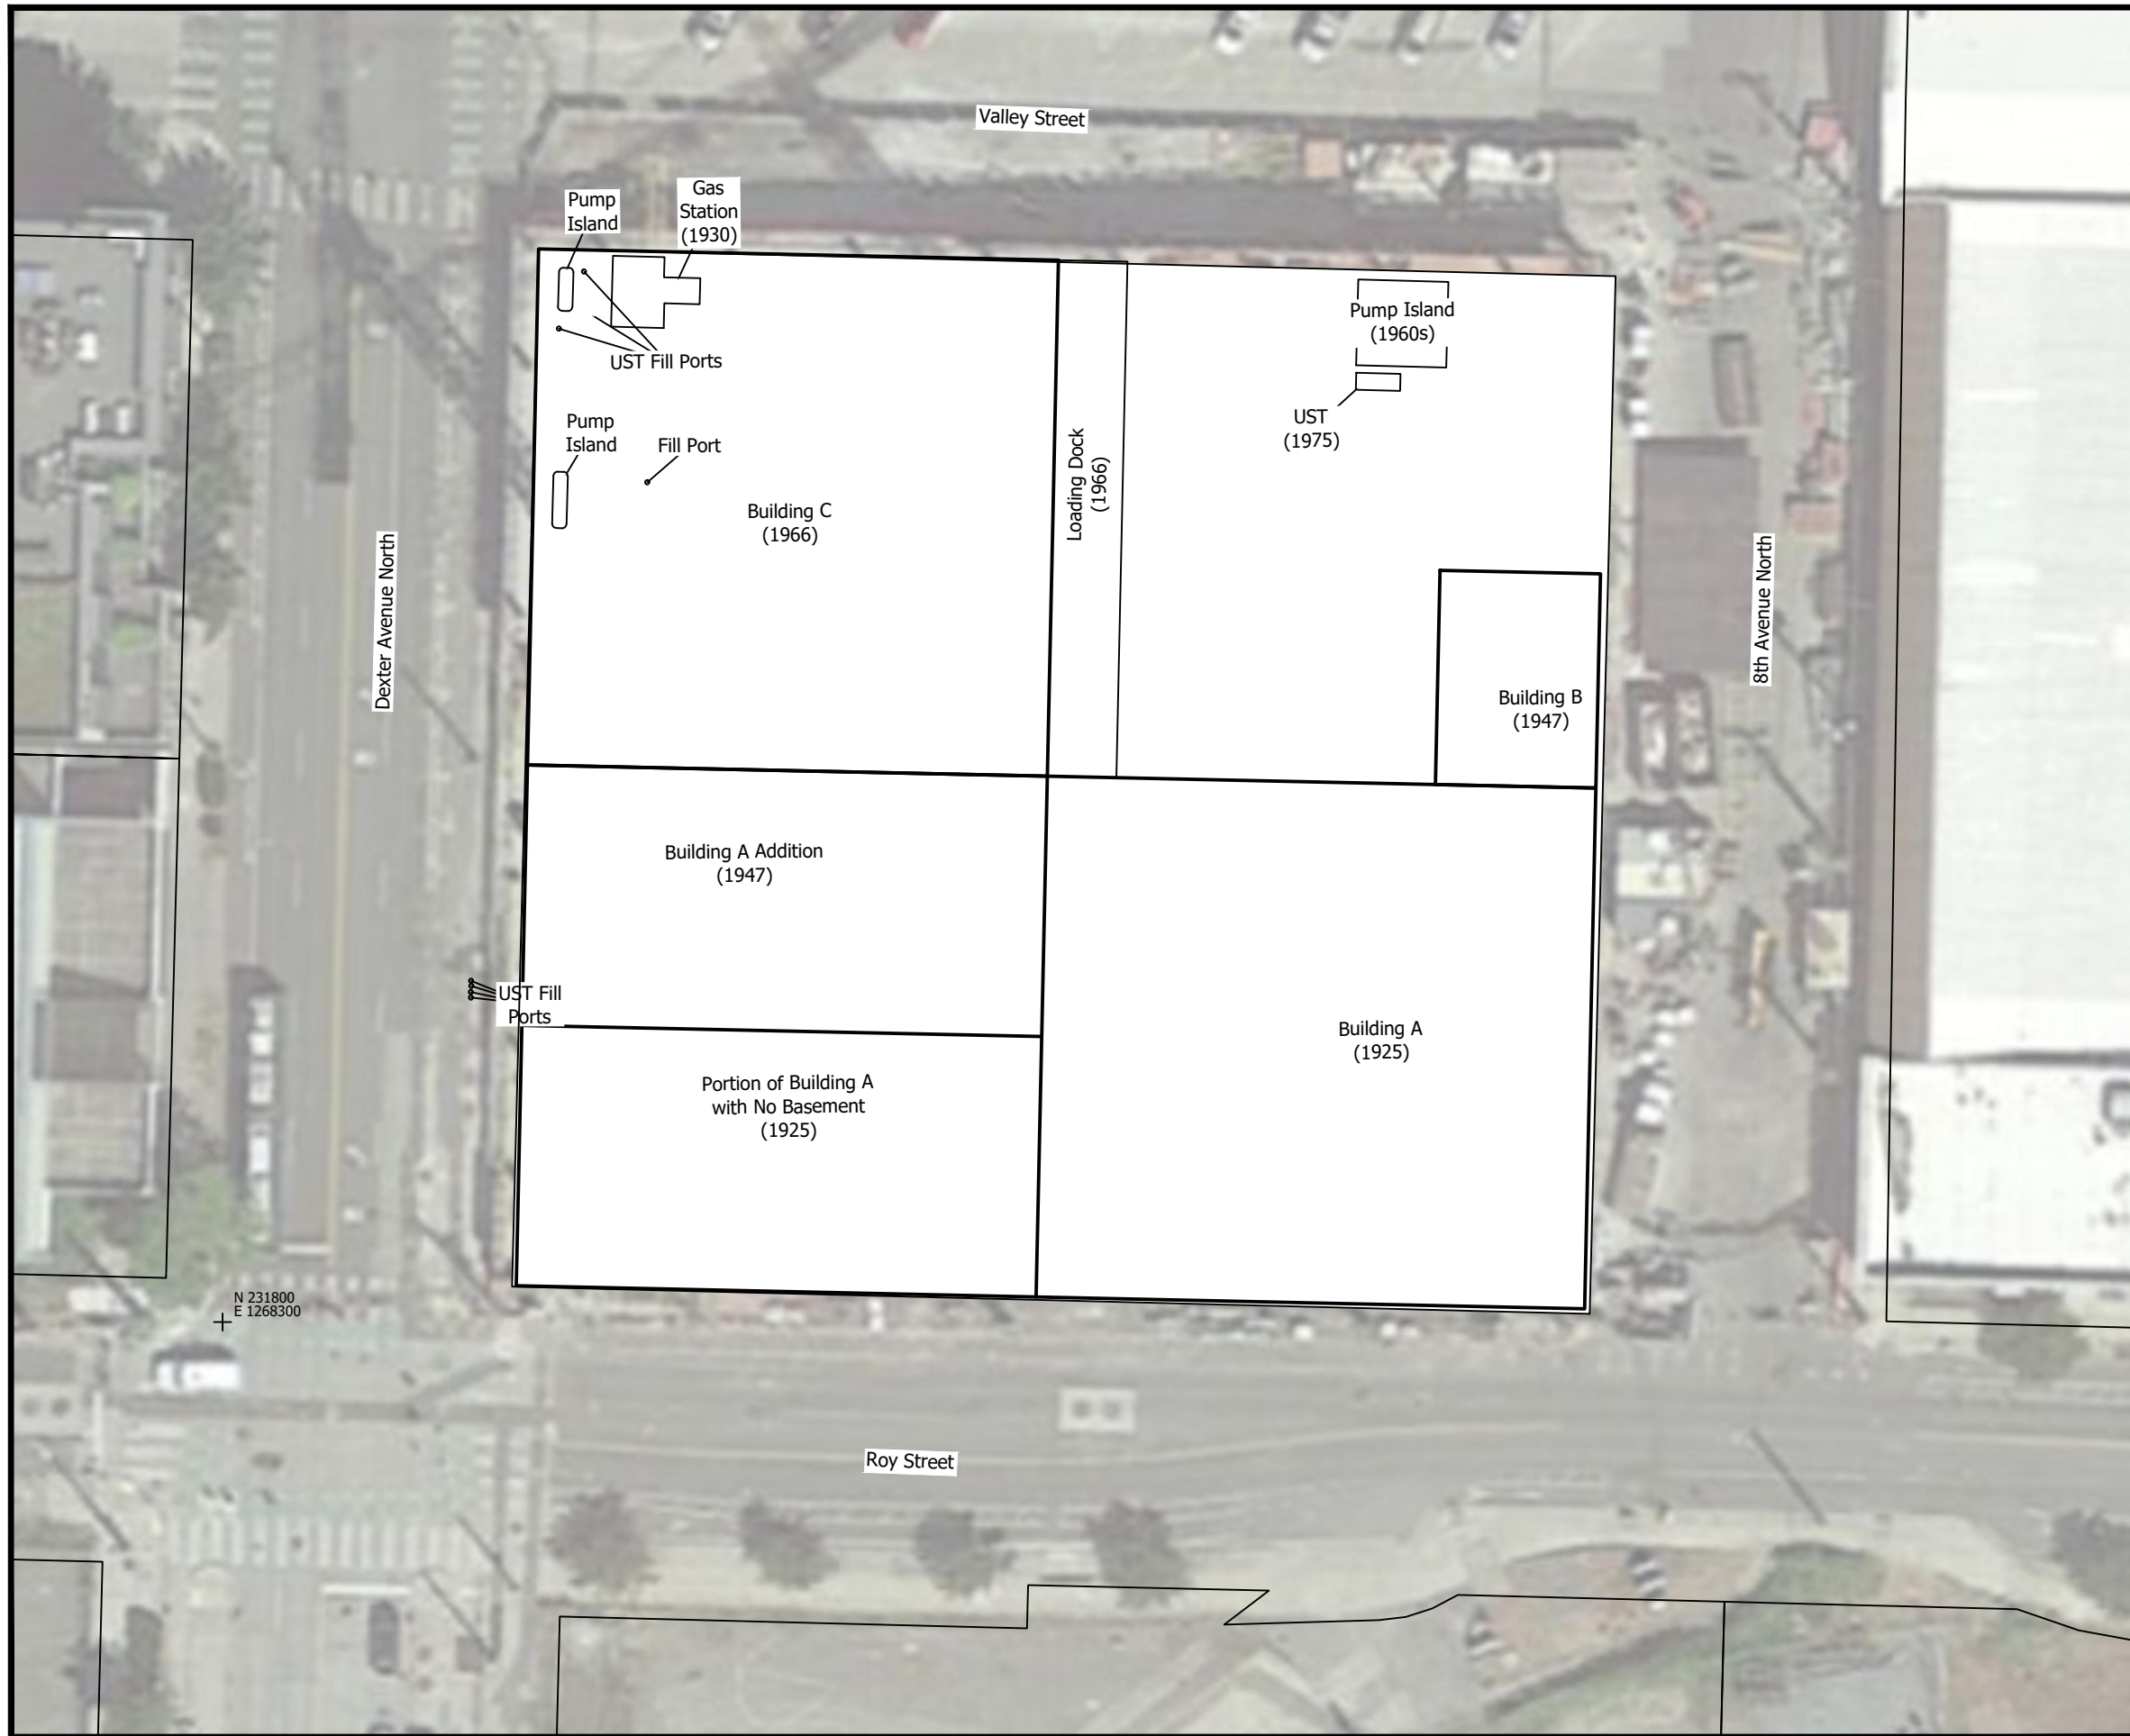
FIGURE
3

Historical Property Features
American Linen Supply Co Dexter Ave Site
700 Dexter Avenue North
Seattle, Washington

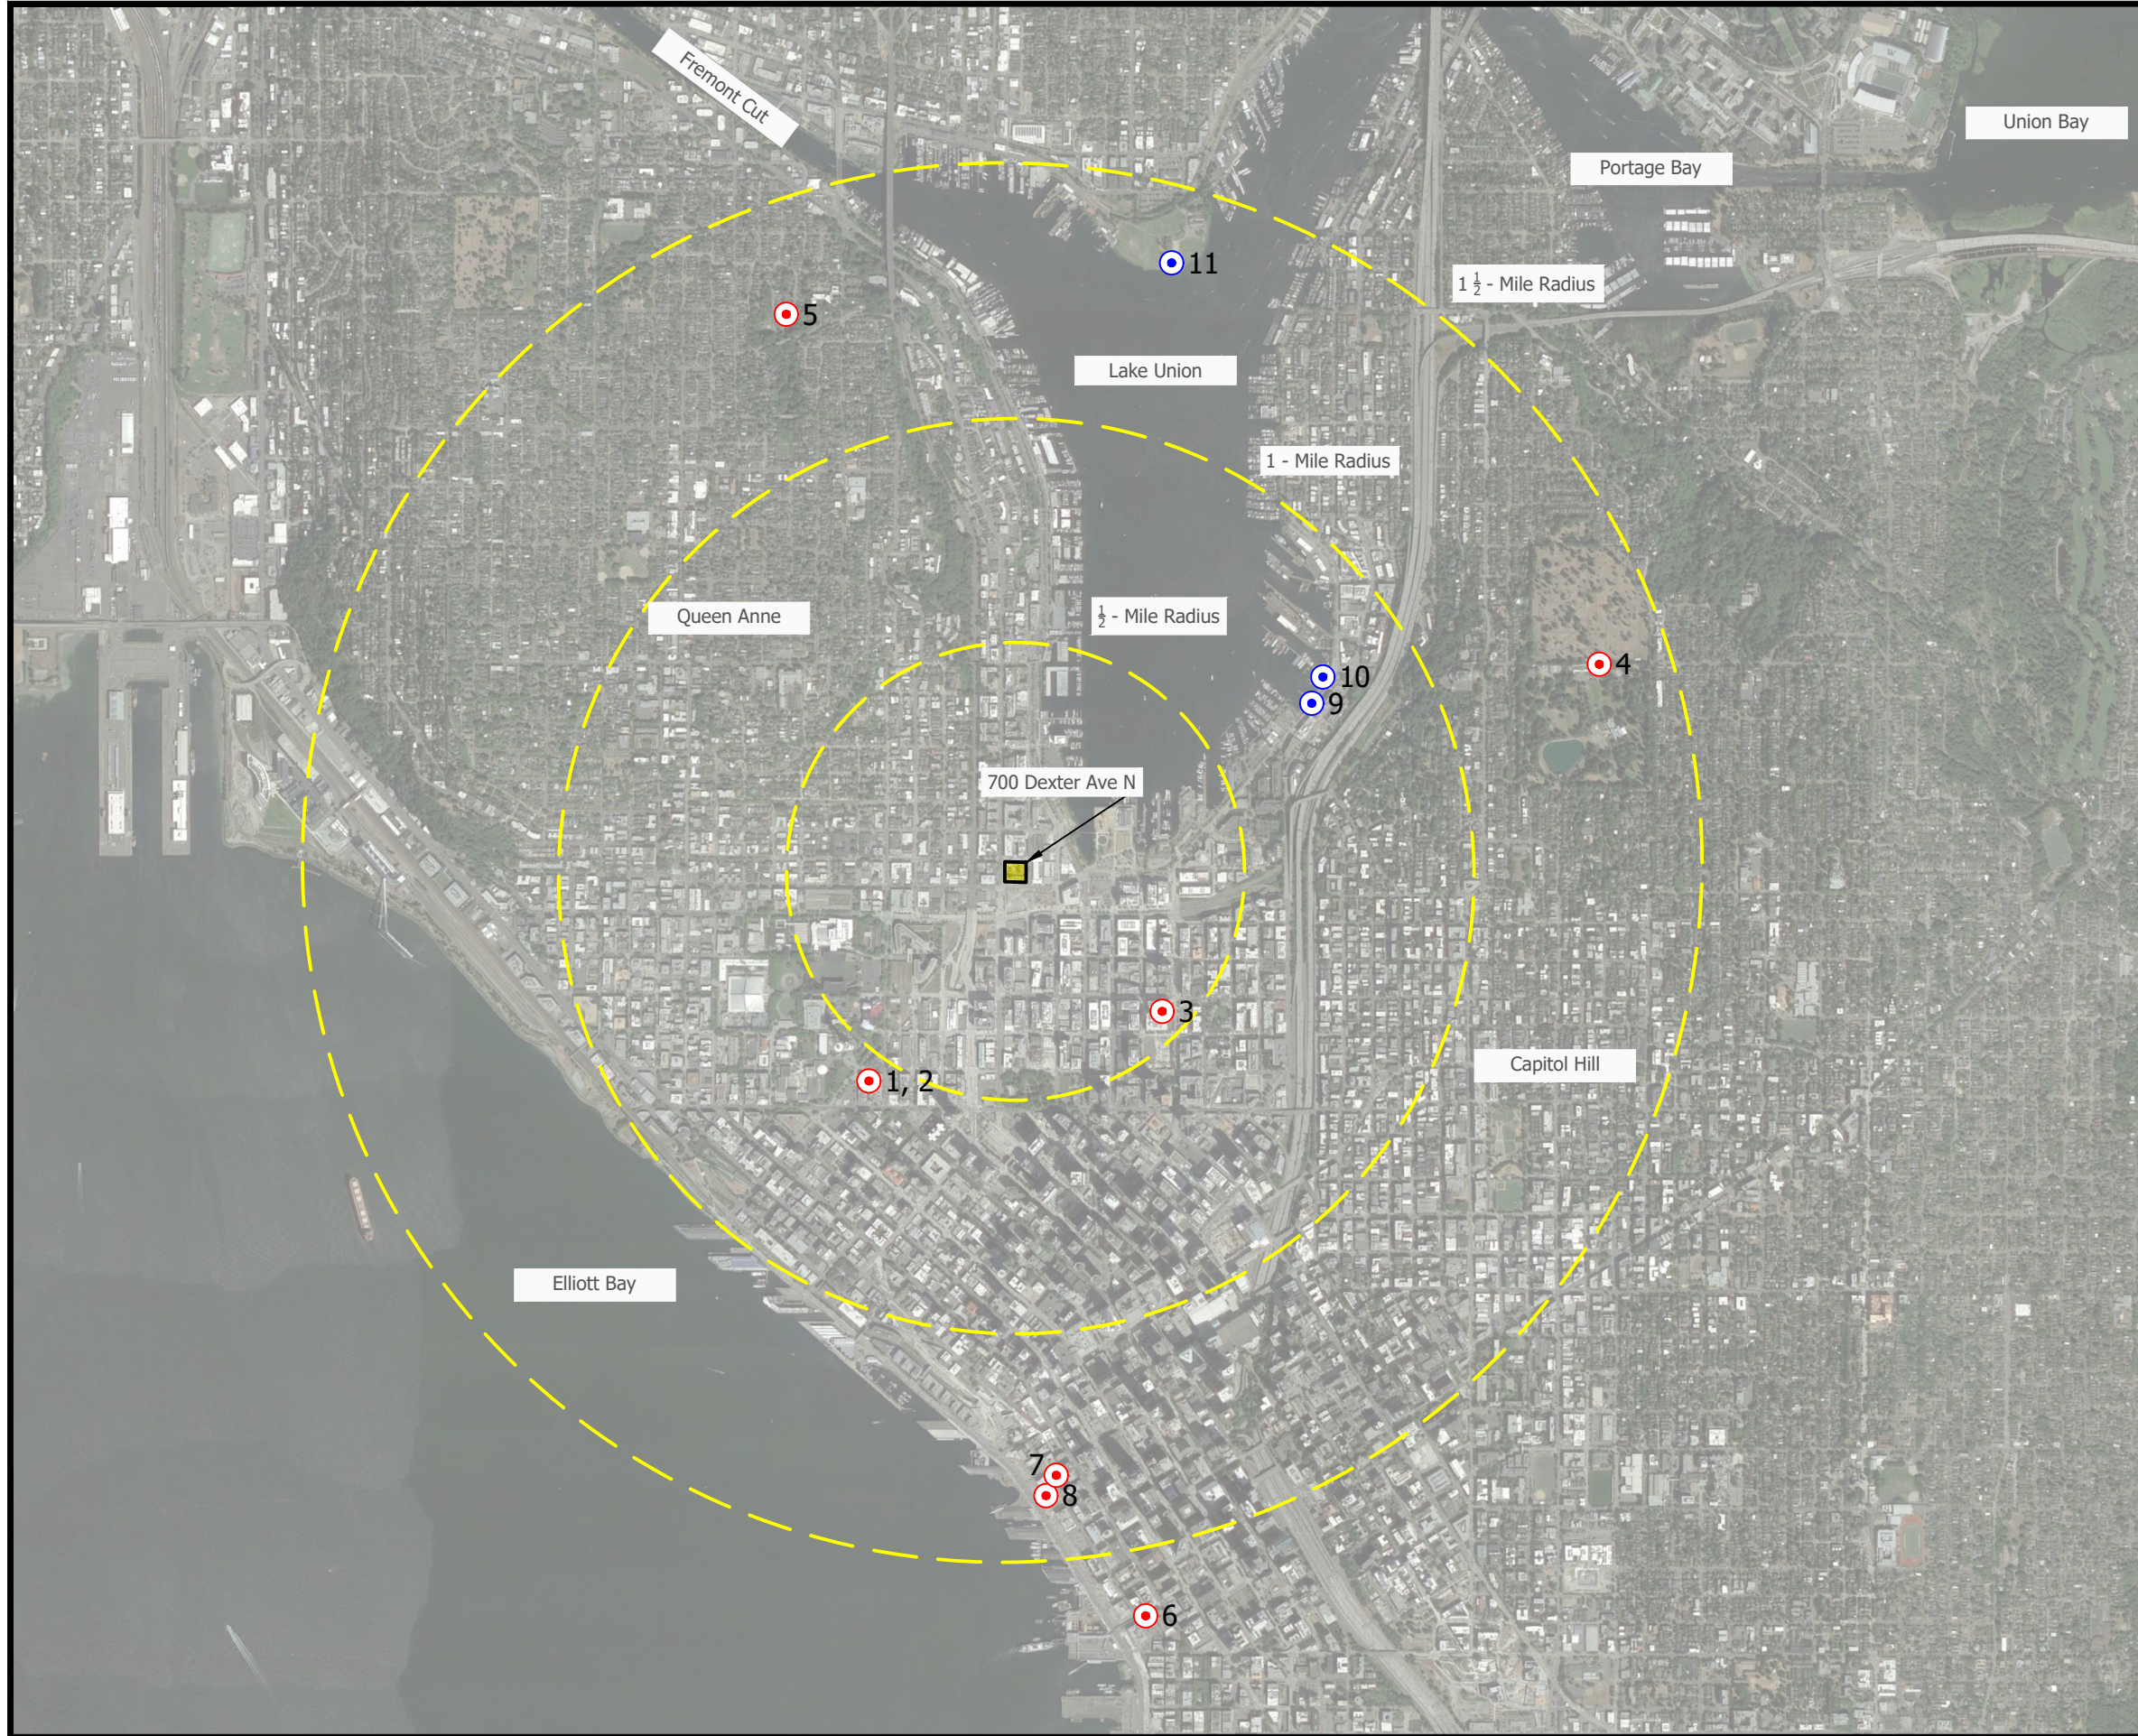
FIGURE
9

Potential Water Use Near South Lake Union
 American Linen Supply Co Dexter Ave Site
 700 Dexter Avenue North
 Seattle, Washington

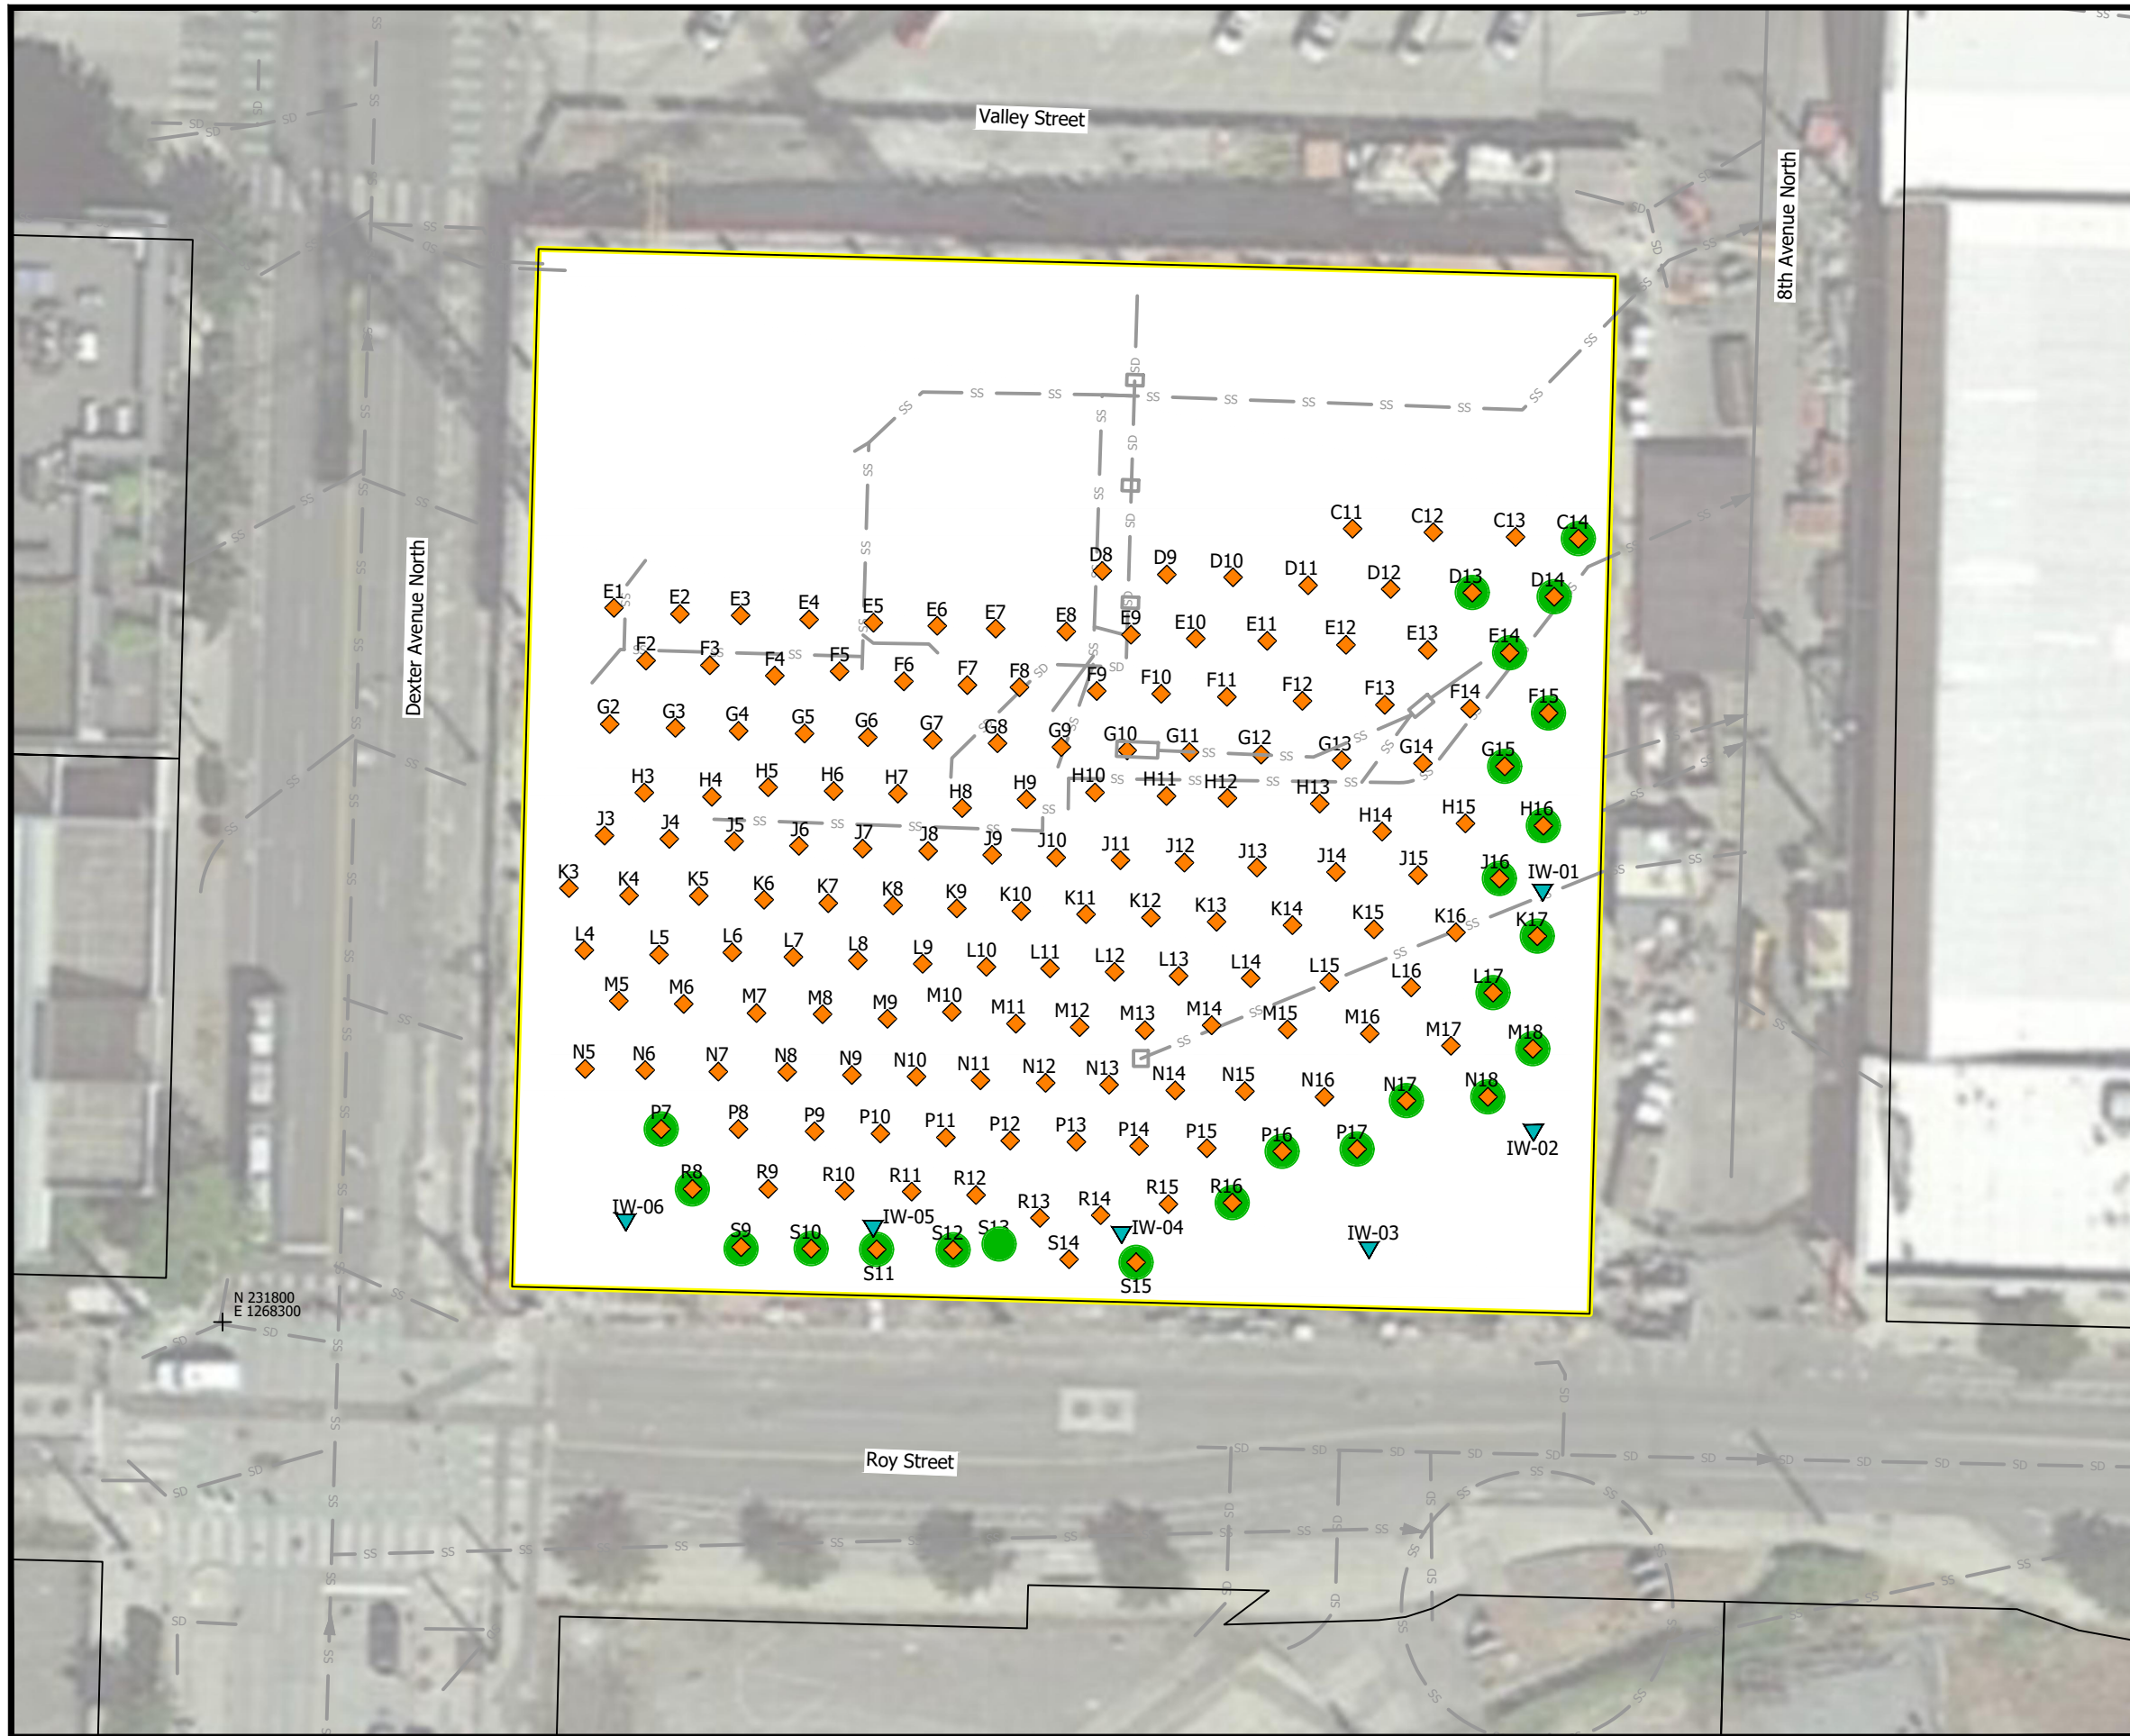
FIGURE
14

ERH/SVE System Layout and Pilot Study Wells
 American Linen Supply Co Dexter Ave Site
 700 Dexter Avenue North
 Seattle, Washington

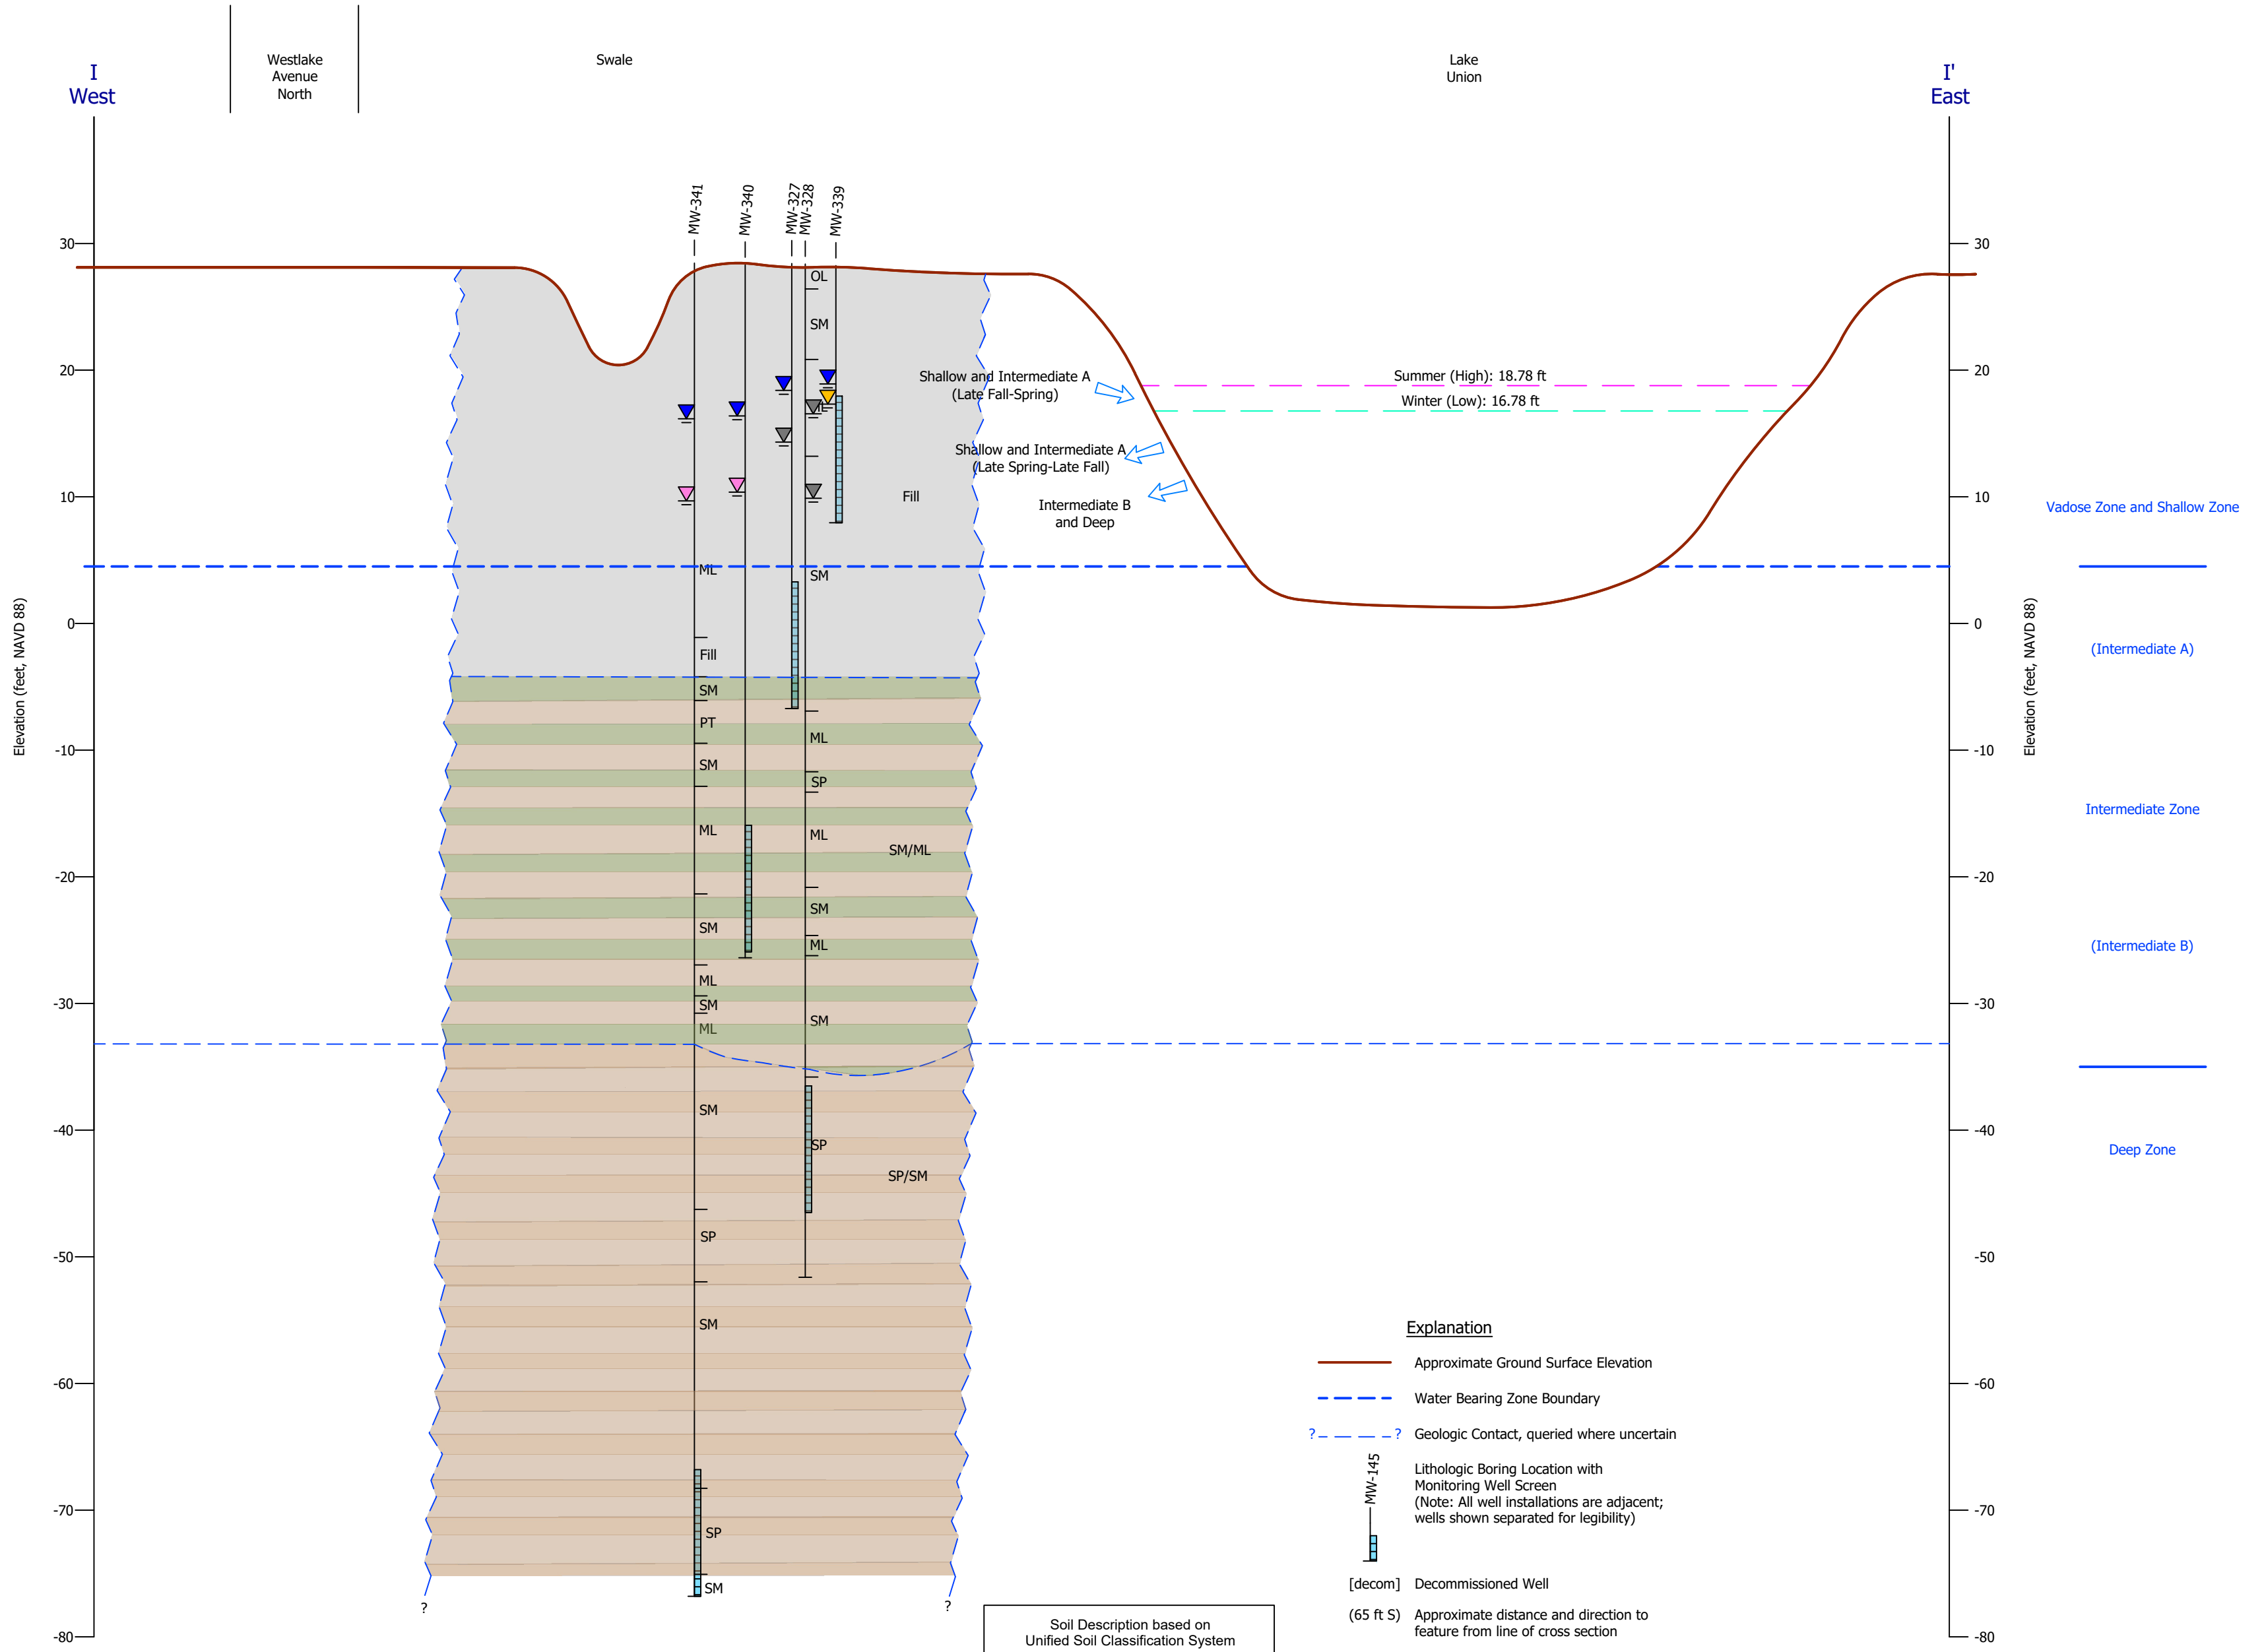
FIGURE 23

Geologic Cross Section I-I'
 American Linen Supply Co Dexter Ave Site
 700 Dexter Avenue North
 Seattle, Washington
