SUBJECT: Supplemental Gas Probe GP-32S Methane Exceedance

PROJECT NUMBER: 553-1550-067

PROJECT NAME: South Park Landfill

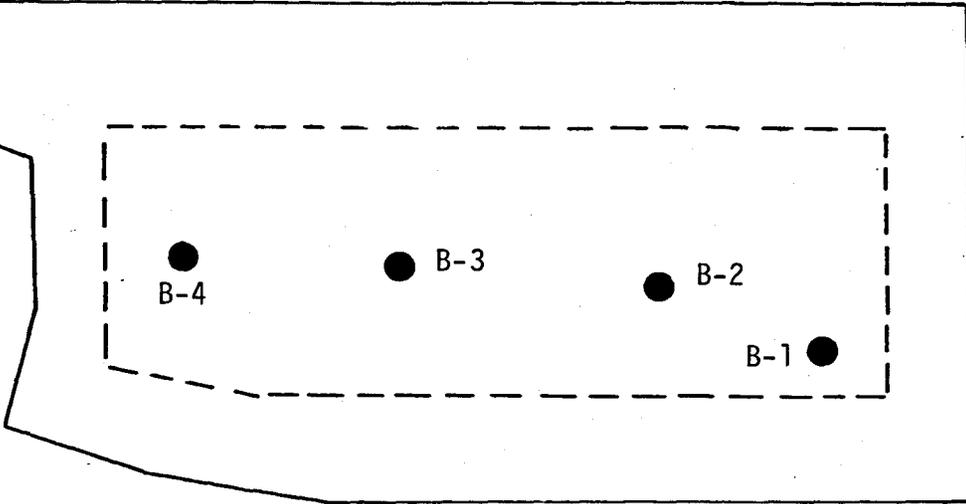
● B-4 Indicates  
Boring Location

In the borings No. 1 through No. 4, soft, gray silt and loose, dark gray, silty sand was encountered to depths of 13.5 to 20.0 feet. Beneath this, a medium dense to dense, dark gray to black sand was noted.

At borings No. 2, 3, and 4, fill was encountered to depths of 4.5 to 7.0 feet. The fill generally consisted of a loose, gray sand with considerable wood and miscellaneous debris.

A geotechnical investigation was completed on the Frank Lenci Corporation parcel in 1979, prior to construction of the current building (RZA 1979). Four boreholes were drilled on the parcel to depths of 24 to 31.5 feet below ground surface (bgs). Waste was encountered in boreholes B2, B3, and B4 from approximately 4.5 to 7 feet bgs. The report notes “The fill generally consisted of a loose, gray sand with considerable wood and miscellaneous debris.” The locations of the three boreholes indicate the waste extends beneath a substantial portion of the current building. A copy of the report is included in Attachment C.

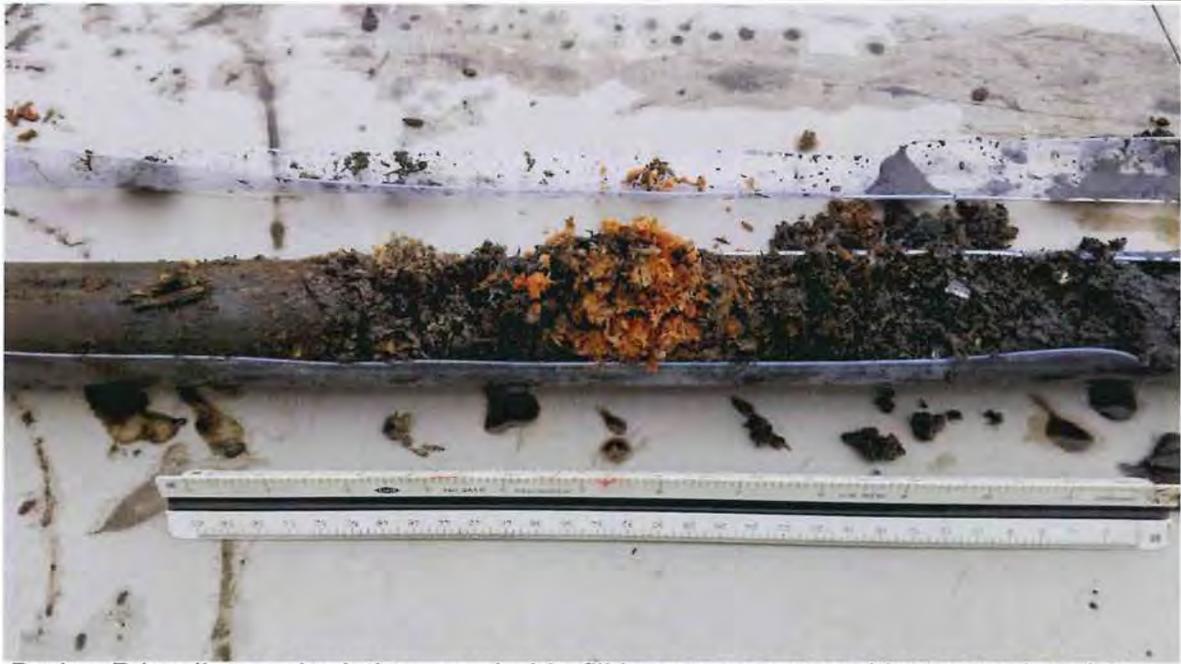
Boring B1 soil core depicting wood-chip fill layer encountered between 4 and 6 feet below the ground surface.

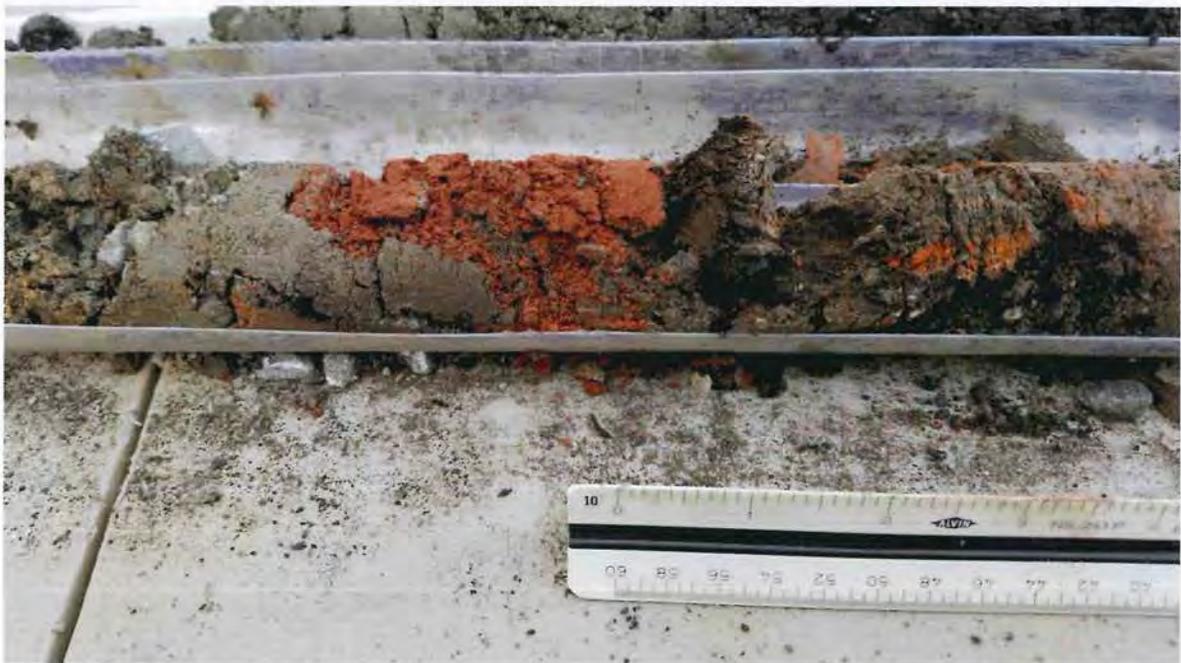
Boring B2 soil core depicting a mixture of wood-chips, brick debris, and organic silts.

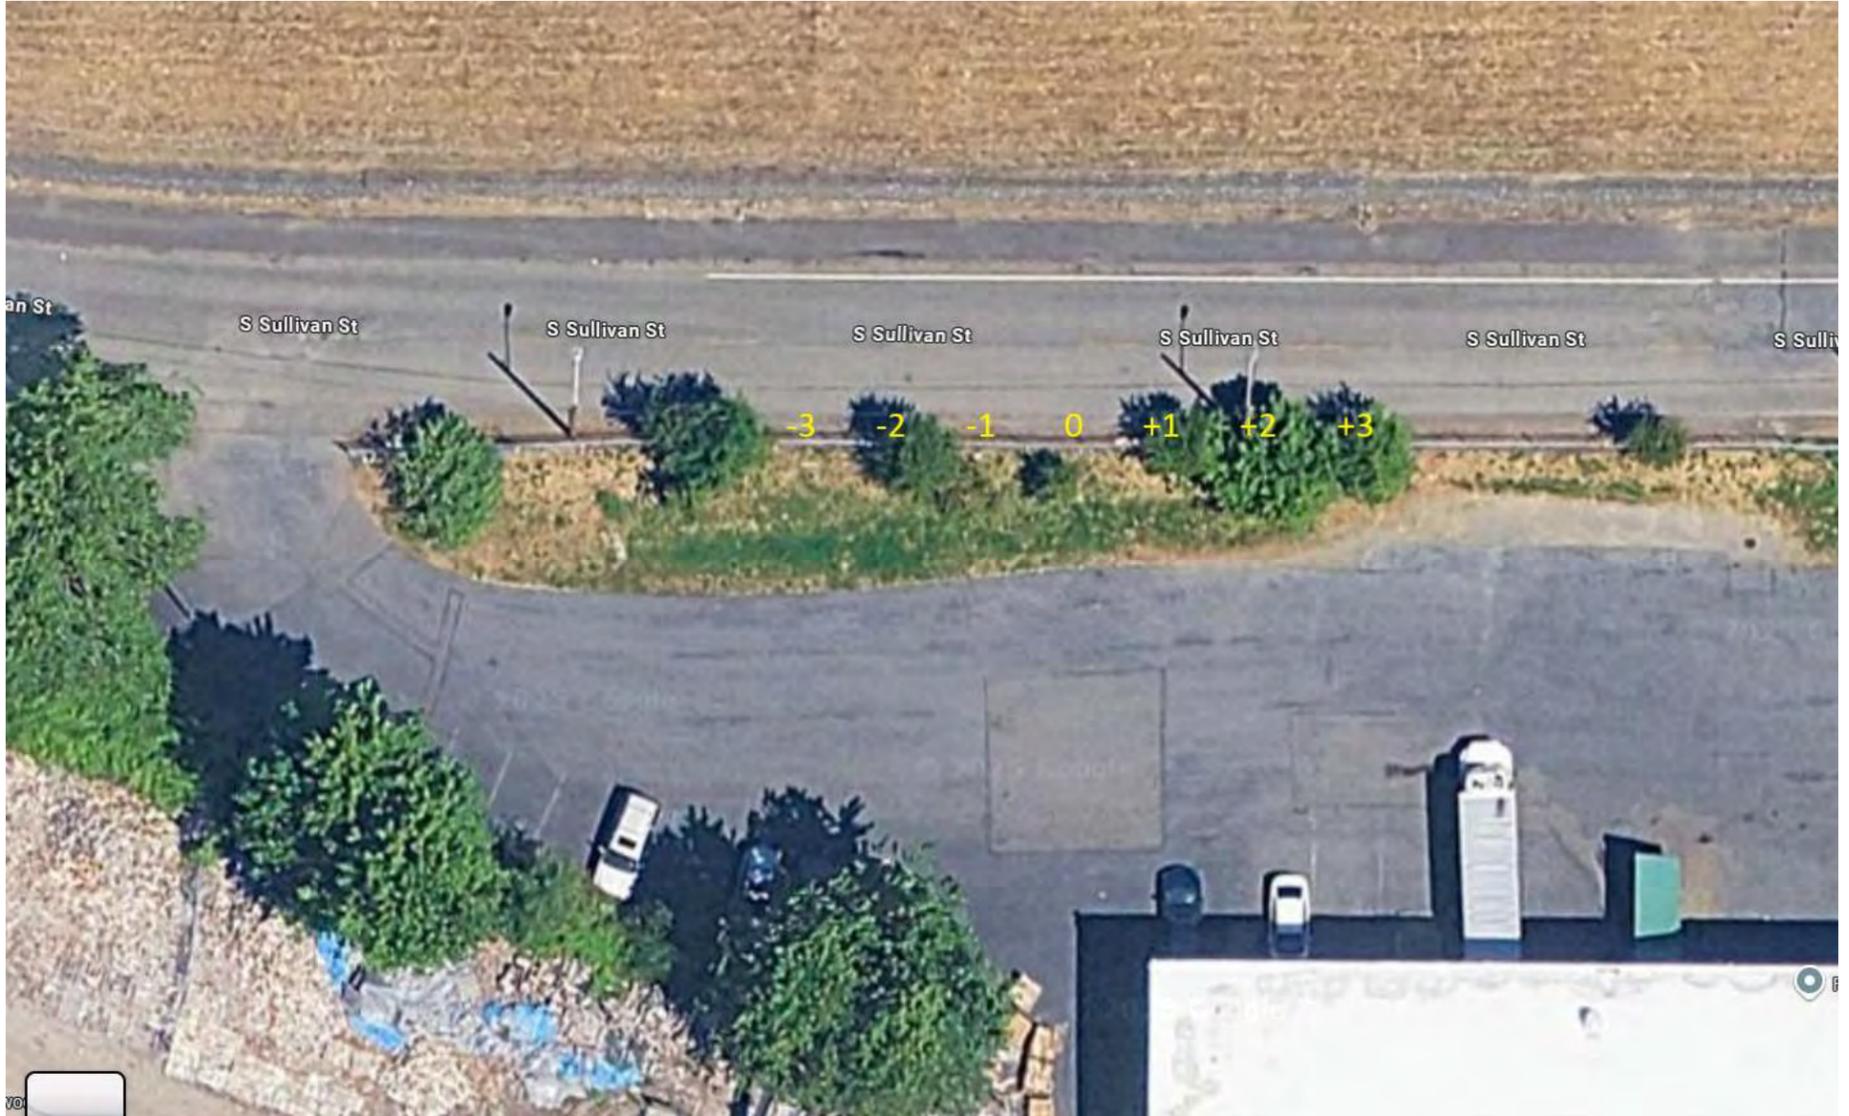
Bar Hole test result :

Since there was a rapid barometric pressure change from 30.05 to 30.00 between noon on November 2, 2025, and today, I believe this is a good opportunity to conduct bar hole testing to evaluate whether gas is migrating from the landfill toward the GP-32S area. I tested seven bar holes spaced approximately 5 feet apart along the property fence near the roadside. The results are summarized in the table below.

date : 11/03/2025 Time: 10:45 AM
