# INACTIVE AND ABANDONED MINE LANDS— Azurite Mine, Whatcom County, Washington

WASHINGTON  
DIVISION OF GEOLOGY  
AND EARTH RESOURCES

Open File Report 2002-3  
August 2002

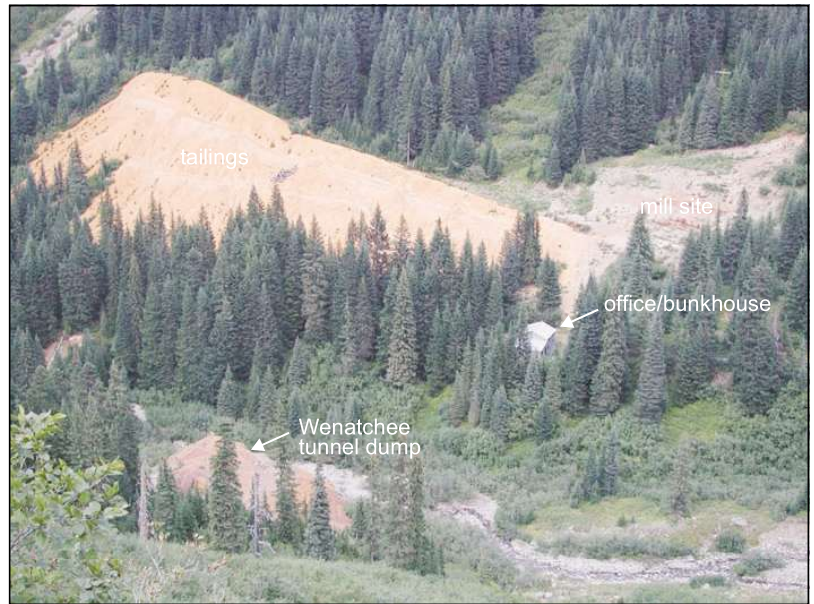
**Figure 2.** Overview of site, looking to the northeast. Mill Creek flows downstream from right to left. Photo was taken from access road near Discovery tunnel.

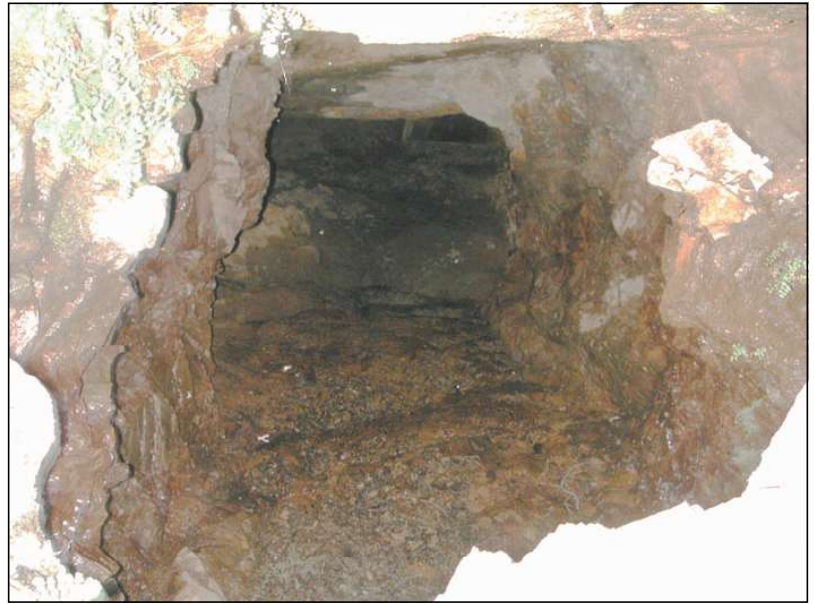
The greatest physical hazard encountered at the site occurs at an elevation of 5220 feet where an inclined raise intersects the surface at the top of an underground stope. Its floor slopes downward at an angle of 47 degrees to the 250 foot sublevel and possibly beyond (Fig. 3). Horizontal openings below this raise consist of the Discovery tunnel (Fig. 4), Burnham tunnel, Tinson tunnel, and Wenatchee tunnel (in descending order of elevation). The Wenatchee tunnel became the main haulage level. It is covered by colluvium slough except for a 24 by 16 inch opening (Fig. 5). It intersected the north-south trending Azurite vein 1800 feet from the portal in 1935. Four sublevels within the mine were driven at 100-foot intervals below the Tinson tunnel. They are identified as the 350, 450, 550, and 650 levels (DGER mine map file). Another sublevel, the 1050, was opened 150 feet beneath the Wenatchee tunnel in a last-ditch effort by Azurite Gold Co. to develop additional reserves in 1940. Ore broken in the 45-degree-dipping shrinkage stopes was transferred to the ‘77 Raise’, which connected all production workings. Detailed maps showing the extent and dates of underground development are available in DGER mine map files.

**Figure 3.** Vent opening at the top of the stope. View is down-dip 45 degrees. Water is dripping inside.

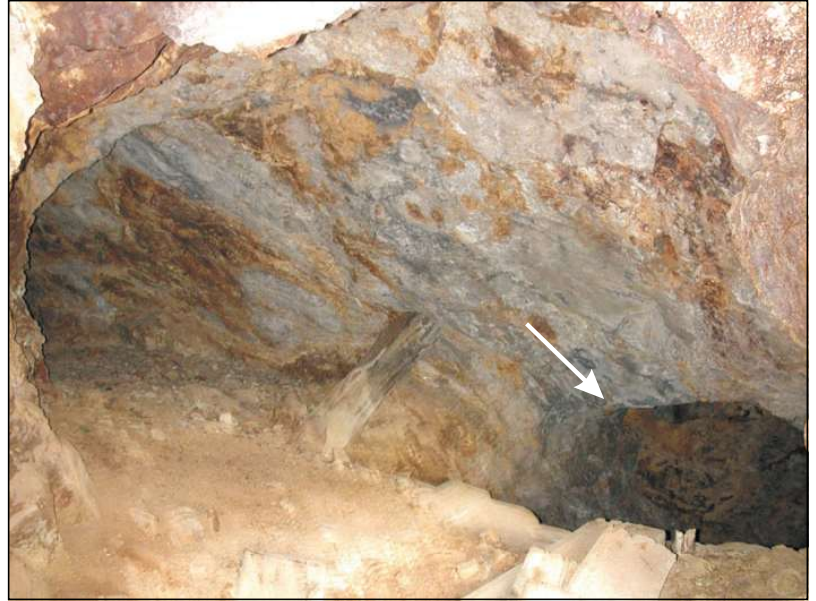
**Figure 4.** Discovery tunnel adit. Arrow points to mined-out area on Azurite vein dipping -45 degrees.

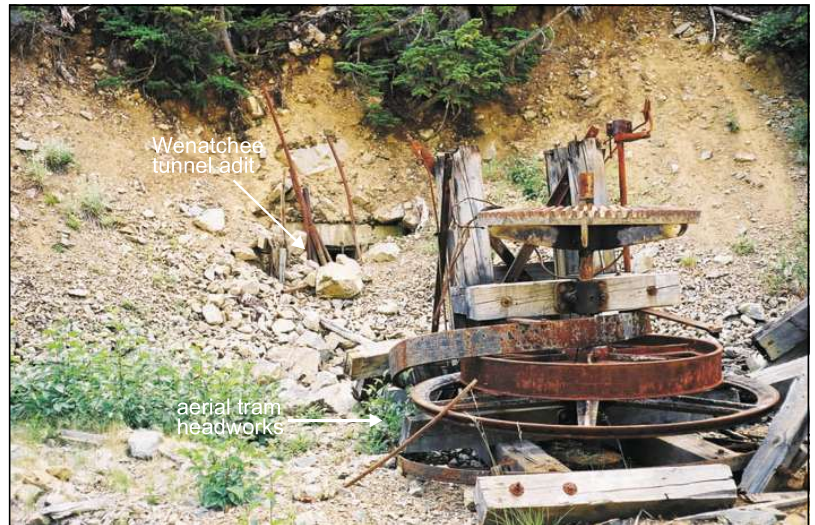
**Figure 5.** Wenatchee tunnel adit and tramway headworks. View to the west.

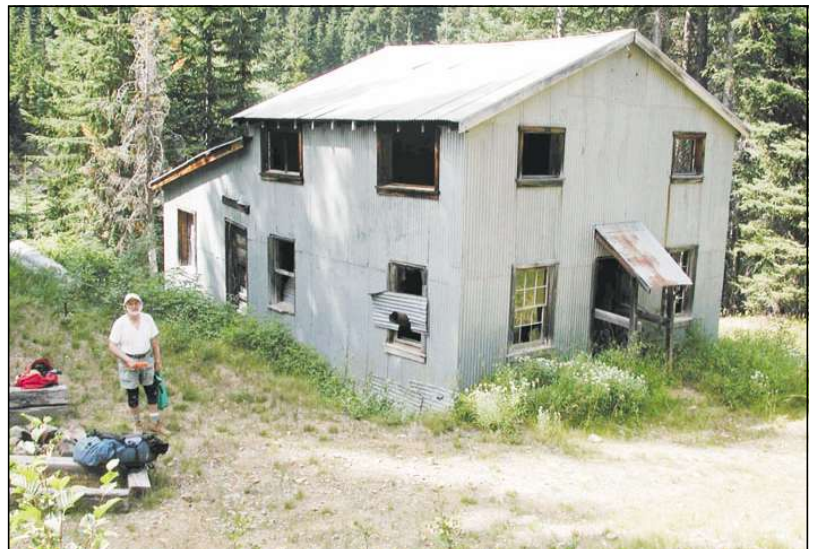
No hazardous materials were discovered during site characterization by DGER. The lone remaining structure on the property is a corrugated-steel-clad wooden building standing on the east bank of Mill Creek opposite the Wenatchee tunnel adit. It appears to have been used as a combination bunkhouse and office (Fig. 6). The interior is in a poor state of repair. All traces of the mill are gone except the concrete footings, a stripped-down diesel engine, burned timbers, and scrap iron (Fig. 7). An empty 10,000 gallon diesel storage tank, headworks, and buckets from the aerial tramway and miscellaneous pneumatic drill parts lie near the Wenatchee tunnel portal.

**Figure 6.** Bunkhouse/office built by American Smelting and Refining Co., circa 1936.

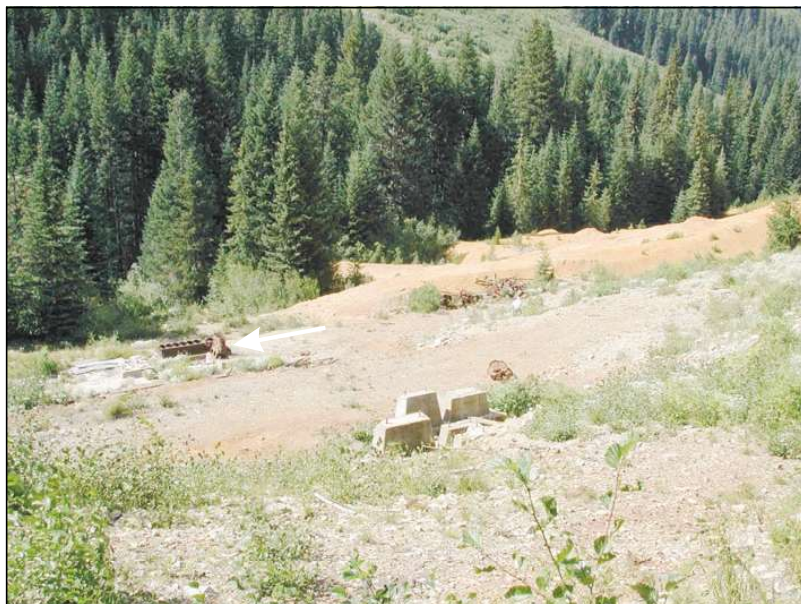
**Figure 7.** Azurite mill site. Footings in foreground; arrow points to 400 HP diesel engine. View to the northwest.

**Mill data:** Data in Washington Division of Geology and Earth Resources (DGER) mine files indicate that the 100 tons per day mill built by AS&R relied on a bulk gravity concentration of all sulfide minerals, followed by a sodium cyanide addition that dissolved gold and other metal values. Zinc dust added in the last step released a gold precipitate that was subsequently reduced to bricks in a small melting furnace. Ferrous sulfate was added in the barren solution tank to complex the adverse effects of sodium cyanide. Two 400-horsepower diesel engines located next to the mill generated electrical power for the entire site (*Wenatchee World*, 1938). All mill equipment has been removed. The mill building was destroyed by fire in 1949.

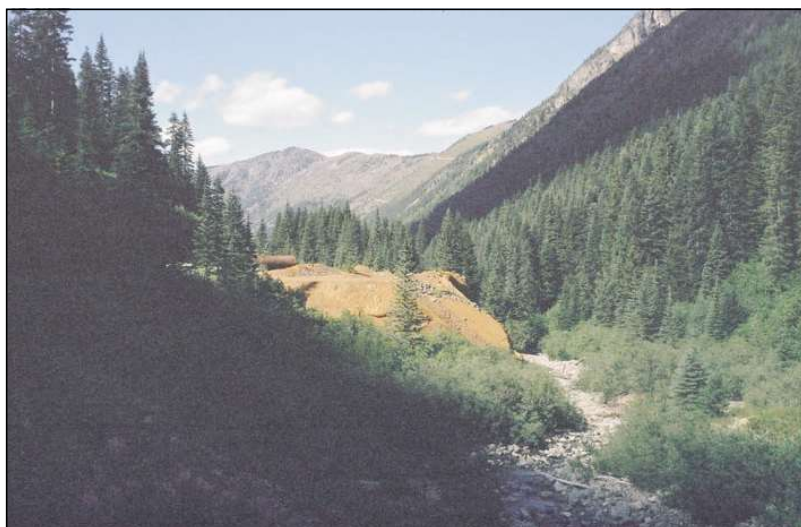
Dumps from openings driven prior to the AS&R lease are of minimal size and quantity. However, the waste rock dump adjacent to the Wenatchee tunnel haulage level covers 1.94 acres. We estimate the volume to be about 5000 cubic yards. The waste rock is heavily iron stained. A channel sample taken across the

dump's slope analyzed 47 percent iron and exhibited values of arsenic and copper that exceeded values listed for "Unrestricted Use" in WAC 173-340-900 (Model Toxics Cleanup Act) by factors of 190X and 12X respectively. High water during spring runoff has eroded the dump highwall leaving an undercut face 30 feet high (Fig. 8). Tailings on the east side of Mill Creek have oxidized to a bright orange and support sparse communities of silver fir, alder and grasses (Fig. 9). Erosion and downslope movement of tailings material is minimal due in large part to *in situ* cementation. Soil samples taken below the oxidized horizon exhibited widely varying values for arsenic, copper, and lead, all of which exceeded the above WAC standard. A U.S. Bureau of Mines-sponsored study of the tailings by Harding-Lawson Associates (1980) found an average of 0.071 ounces per ton of gold in samples from five drill hole locations. Based on their estimate of 41,000 tons of tailings, the dump contains approximately 3000 ounces of unrecovered gold. A grab sample taken by DGER from the tailings contained 43 milligrams per kilogram of gold (1.25 ounces per ton), determined by the inductively coupled plasma method.

**Figure 8.** Wenatchee tunnel dump. Mill Creek downstream direction is toward bottom of photo. Note the undercut highwall and 10,000 gallon diesel storage tank. View to the north.

A grab sample taken of waste rock at the portal of the Wenatchee tunnel contained 470,000 milligrams per kilogram iron, or about 50 percent of the material present. The high iron content acts as the dump's cementing agent. This sample also ran exceptionally high in arsenic. At 3800 milligrams per kilogram, the arsenic level is 190X the level listed in Table 4; the copper level is 12X.

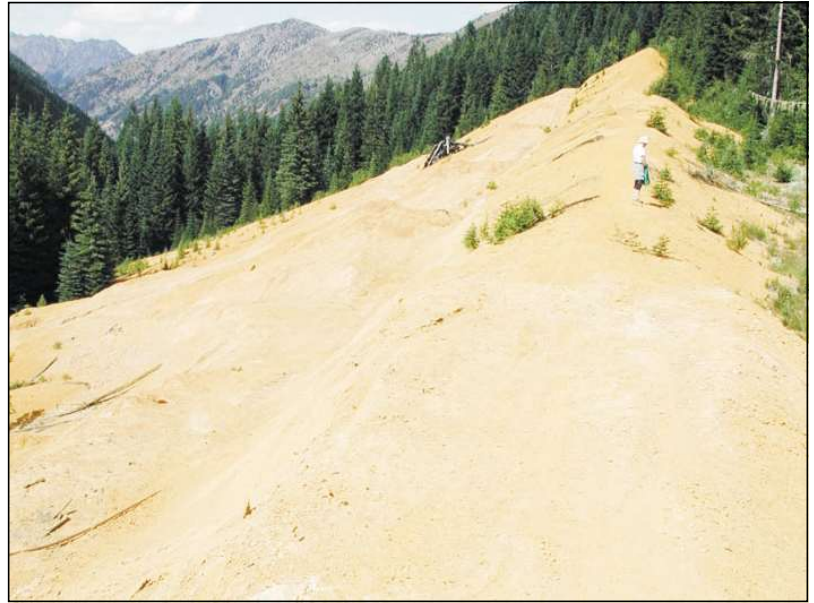
**Analysis of tailings and dumps:** Tailings cover 5.5 acres of surface and have oxidized to a bright orange color. Borings taken by Harding-Lawson Associates (1980) show thicknesses ranging from 4 to 9.5 feet. Their report estimates a volume of 27,000 cubic yards, or approximately 41,000 tons, depending on water content.

**Figure 9.** Azurite mill tailings. Note the isolated communities of western hemlock and Engelmann spruce.

It is doubtful if any attempt was made by the lessee AS&R to create an embanked impoundment for the tailings. The tailings appear to have been dumped on a cleared portion of the slope adjacent to the mill and allowed to run downhill from a pipeline or pulled northward from the mill area by an in-line slusher and cable system. At the northwestern-most corner, thin deposits of tailings cross the access road and flow down a steep 30-foot

Toxic levels of arsenic, copper, and lead were found in tailing samples taken at three different locations (Table 3). Levels for these metals correlate almost exactly with analyses reported during a U.S. Bureau of Mines contract (Harding-Lawson Associates, 1980). Iron analyses were consistently in the 100,000 milligrams per kilogram range, representing roughly 10 percent of the material present. These levels are consistent with input from the mineralization present—pyrite, pyrrhotite, arsenopyrite, galena, chalcopyrite—and input from mill reagents—ferrous sulfate, lead acetate, lead oxide, lime, and sodium cyanide.

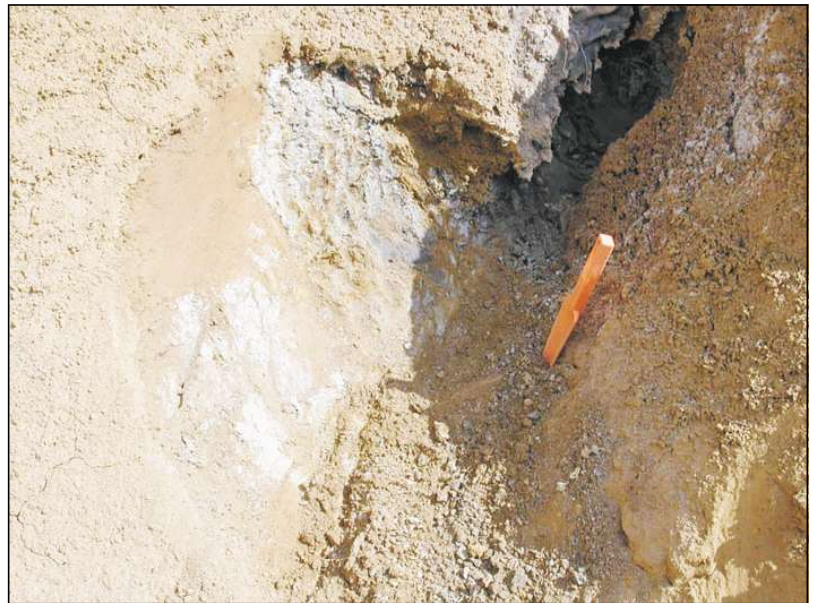
Sample S3A was taken from a tailings layer of bluish, unoxidized sandy clay 12 inches beneath a gully surface in the central portion of the area. The sulfate analysis was 20,000 milligrams per kilogram or 2 percent of the total by weight. This result explains the presence of white-gray salts deposited on the surface at several locations (Fig. 11). When analyzed using induced coupled plasma technology, the sample yielded 43 milligrams per kilogram of gold, which equates to 1.25 ounces per ton. This result is considerably higher than the Harding-Lawson Associates (1980) data. The sample may have been taken from a volume of material deposited when the mill was out of trim. The Harding-Lawson assays, which were taken over a wider area, ranged from 0.03 to 0.142 ounces per ton gold. Their analyses were done by atomic absorption technology.

**Figure 11.** Site of soil sample S3A. Note blue unoxidized horizon and white salt deposit. Plastic trowel for scale.
