**PHASE I  
ENVIRONMENTAL SITE ASSESSMENT  
ASTM E-1527-97**

**GRESHAM TRANSFER, INC., FACILITY  
24300 PACIFIC HIGHWAY SOUTH  
KENT, WASHINGTON 98032**

**BANK OF AMERICA**

**MARCH 31, 1998**

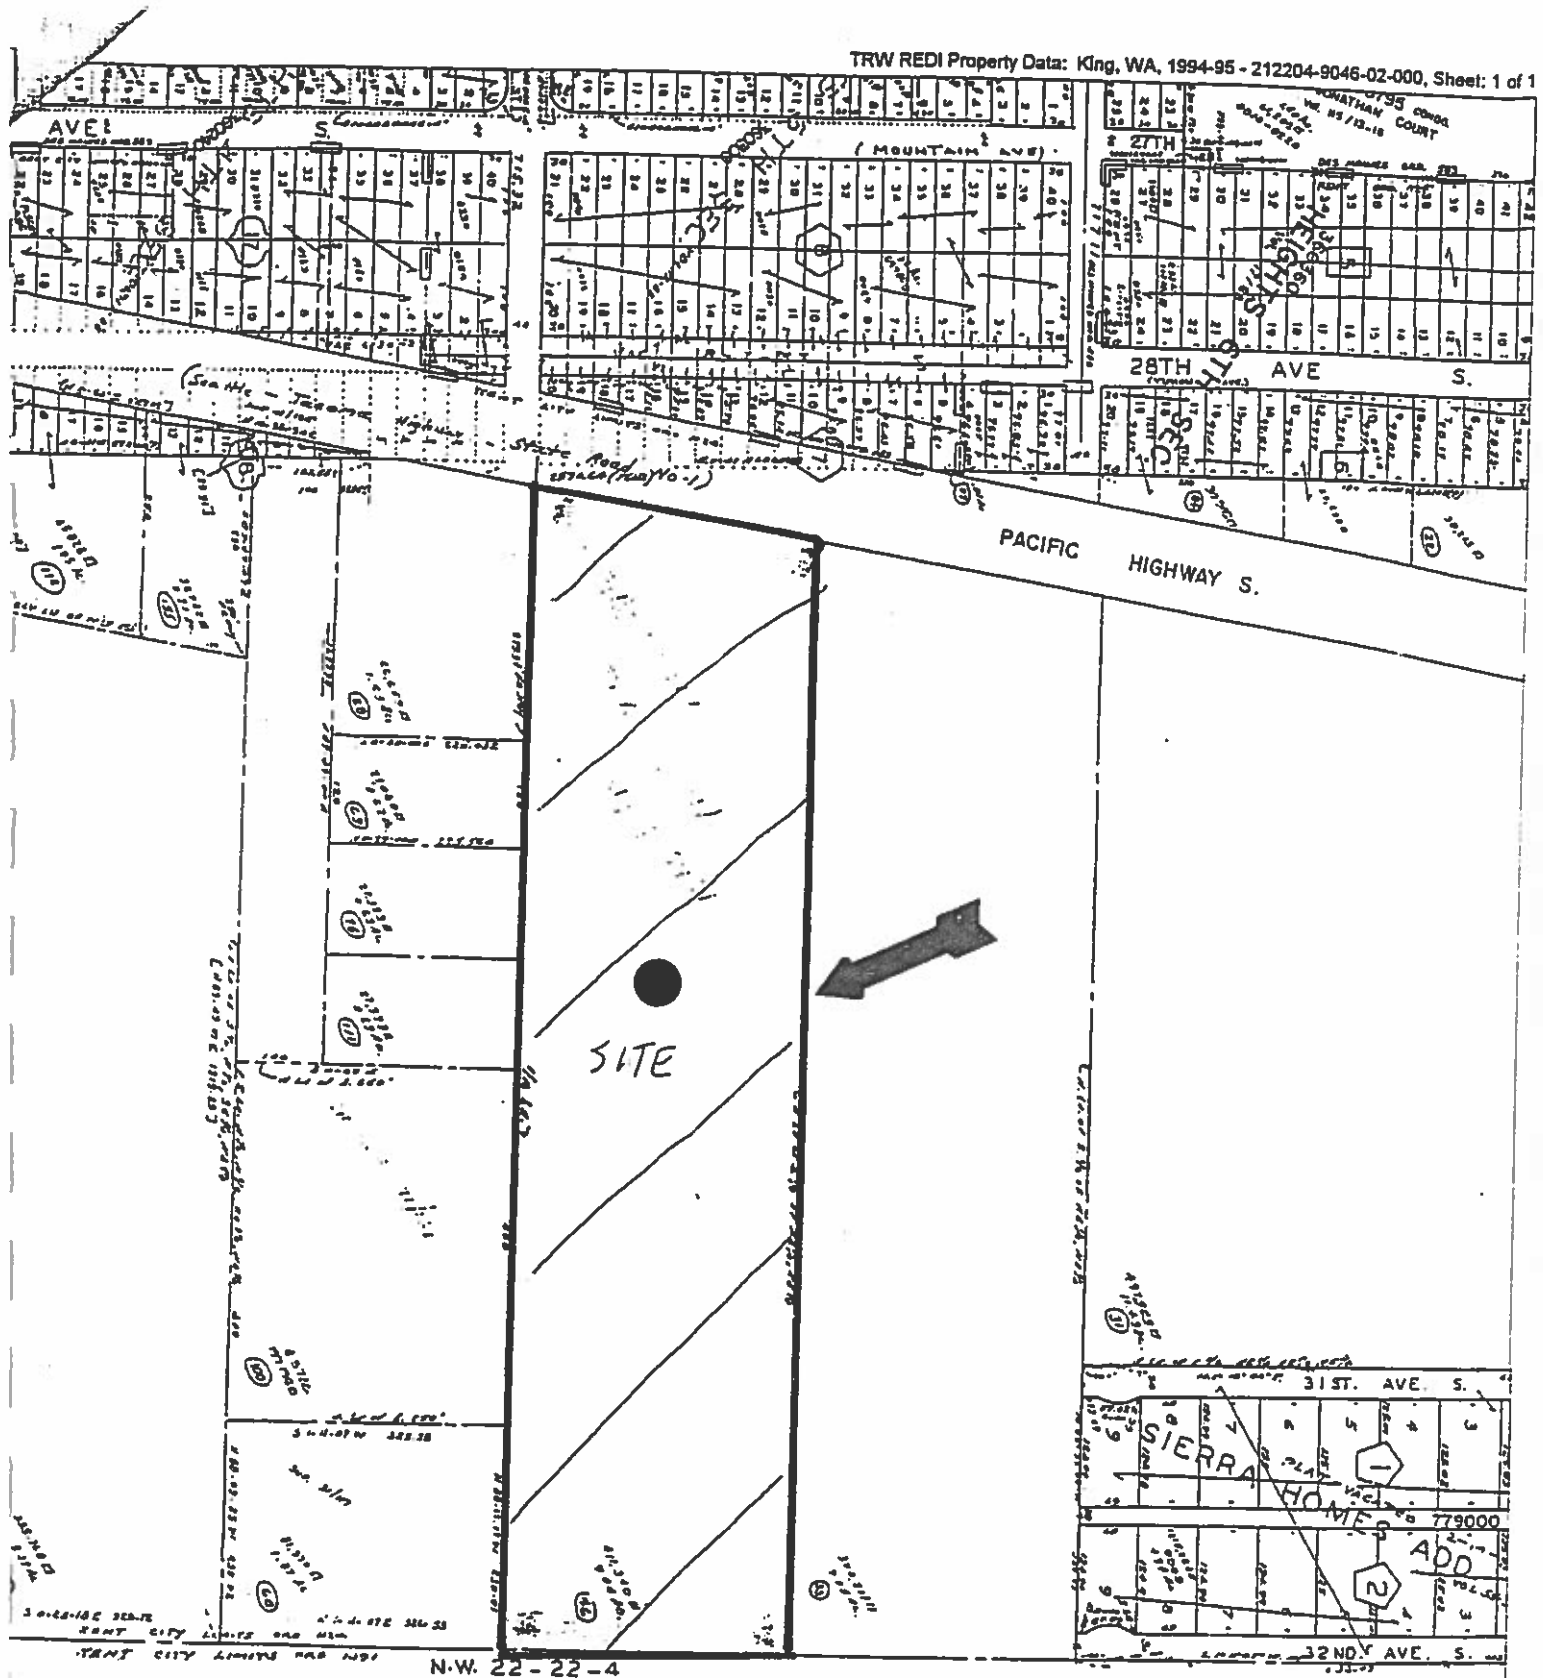
FIGURE 2 Current Site Plan Drawing and Location of Buildings and Equipment Location On-Site.  
SITE PLAN DRAWING

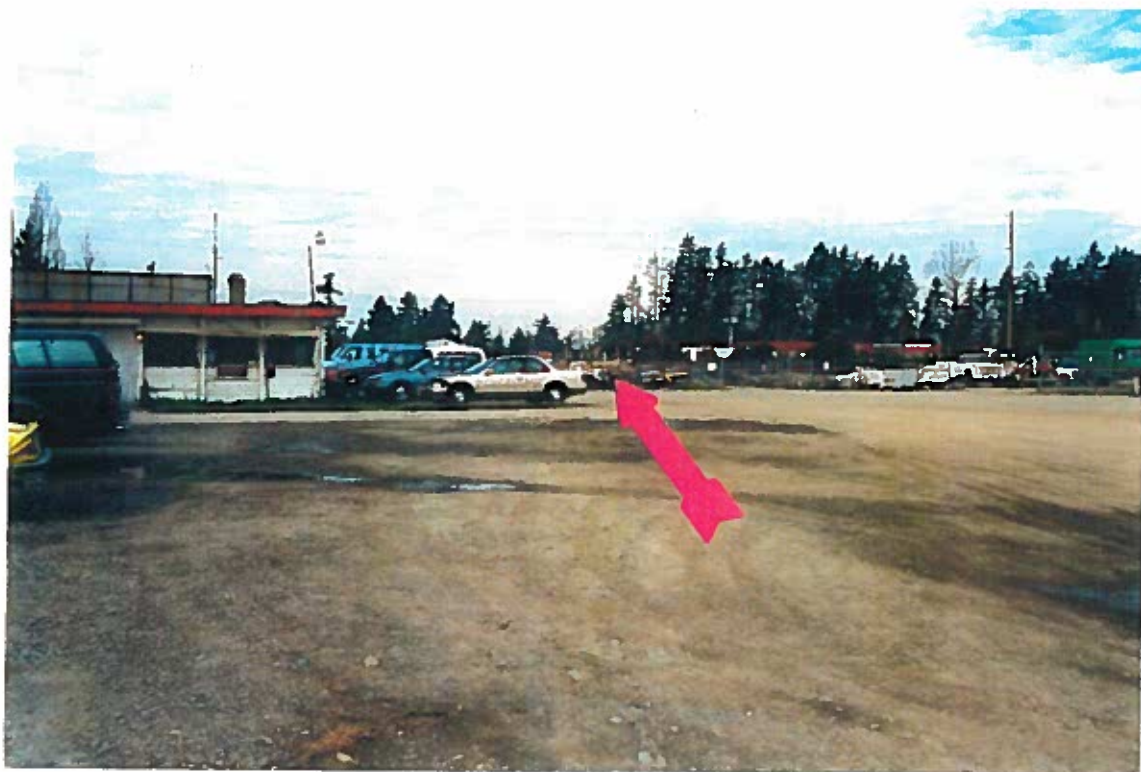
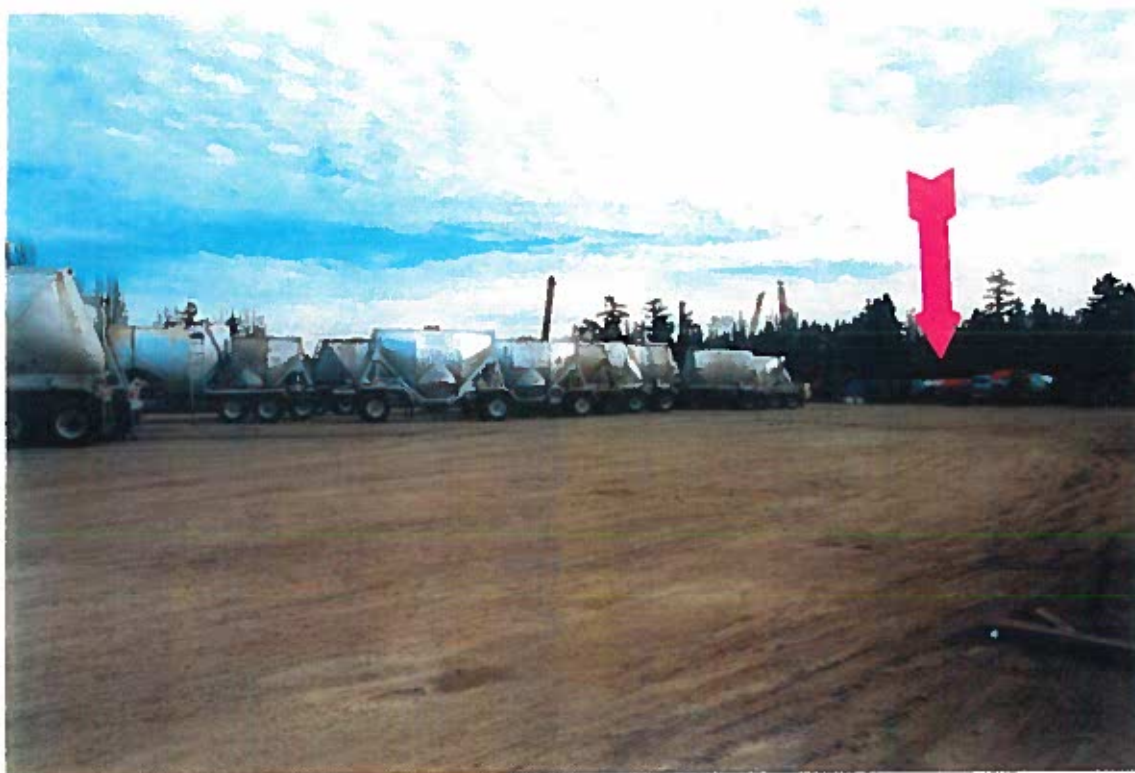
**FIGURE 1** Top view of the east side of the Main Office Building of Gresham Transfer, Inc., looking west with the Red Arrow pointing to the entrance off Pacific Highway South. Bottom view is looking east at the gravel parking lot area with the Red Arrow pointing to the east boundary of the subject property.

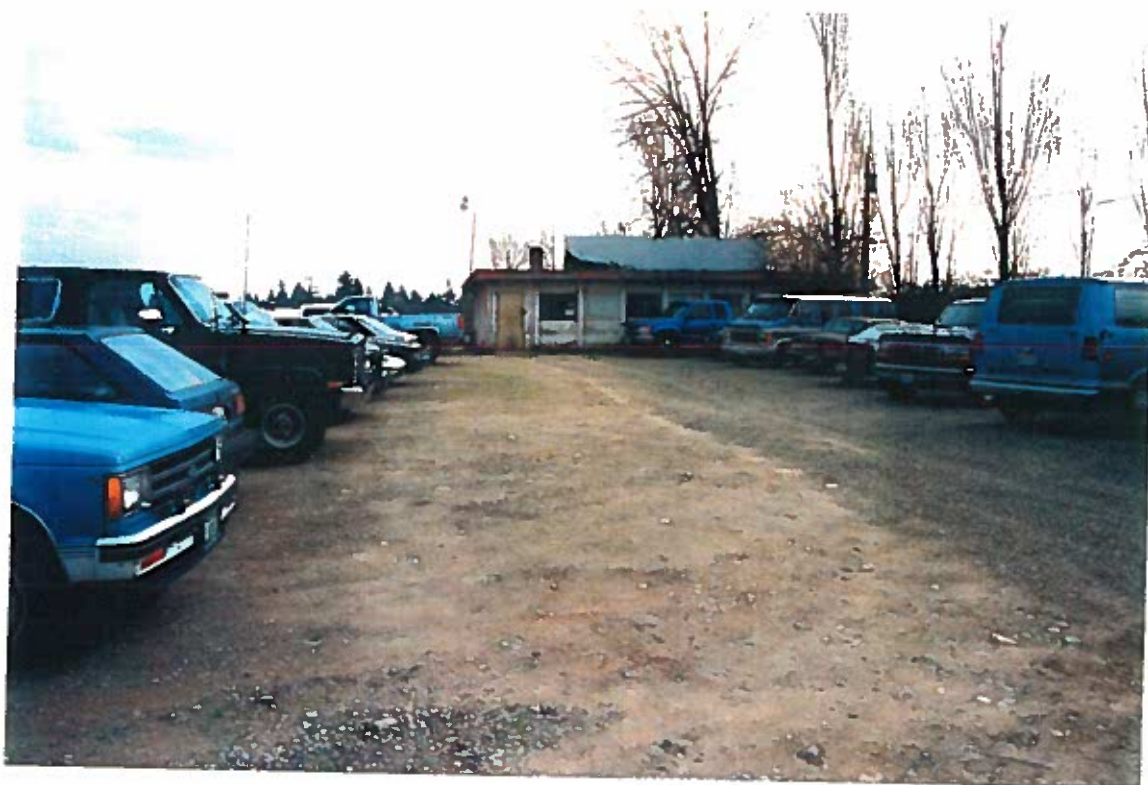
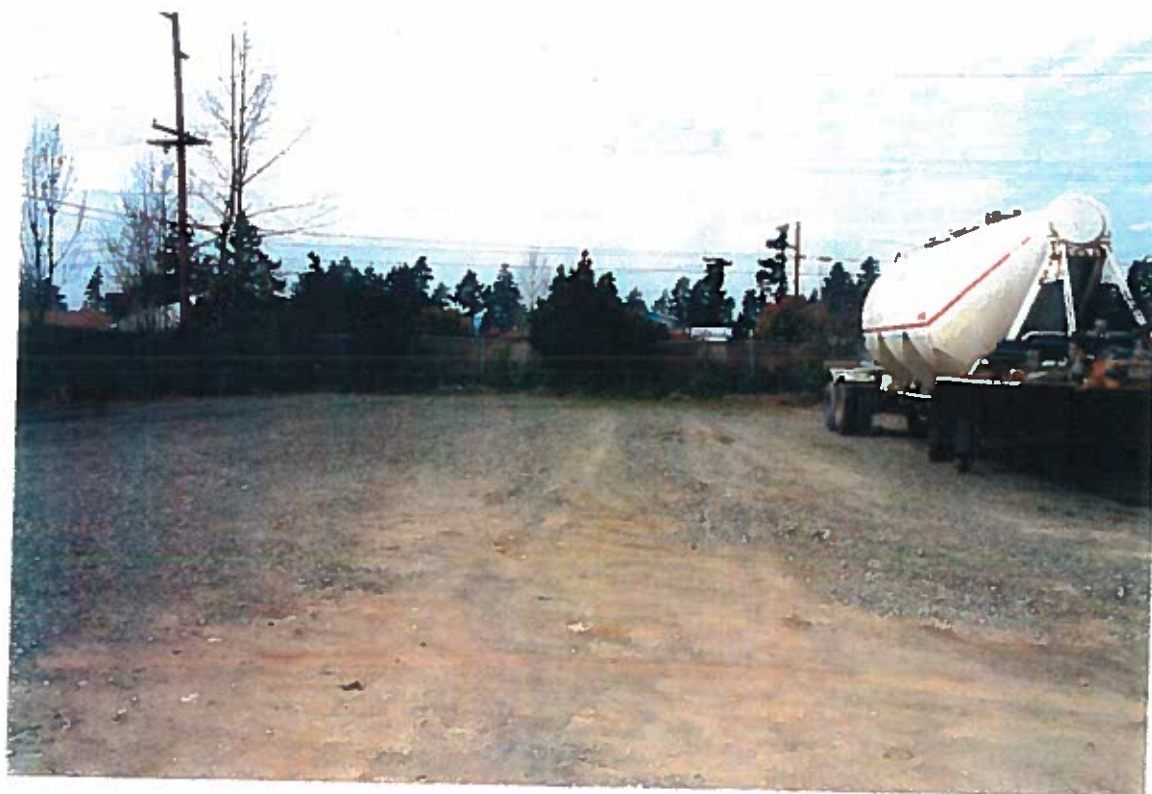
**FIGURE 2** Top view of the office building looking east and the employees parking lot located on the right side as you enter the subject property. Bottom view is looking west at the additional parking area in the southwest corner of the subject property.

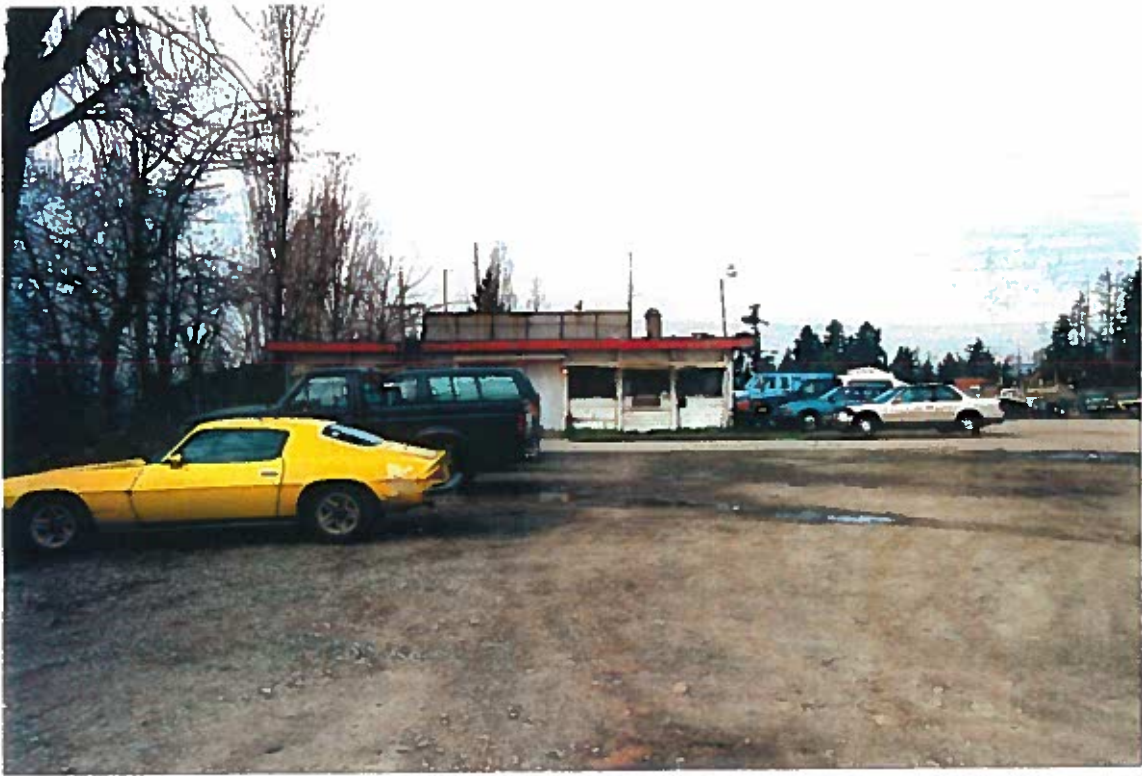
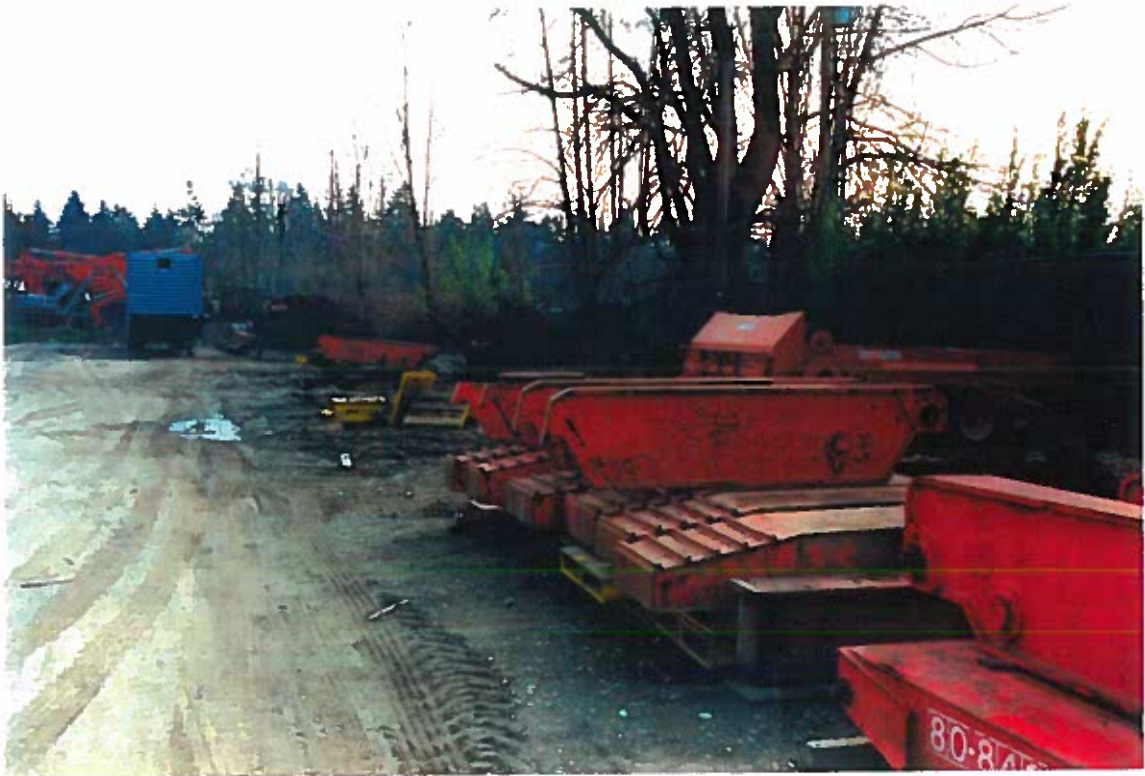
**FIGURE 3** Top and bottom views of the south side of the subject property's parking lot with equipment parking.

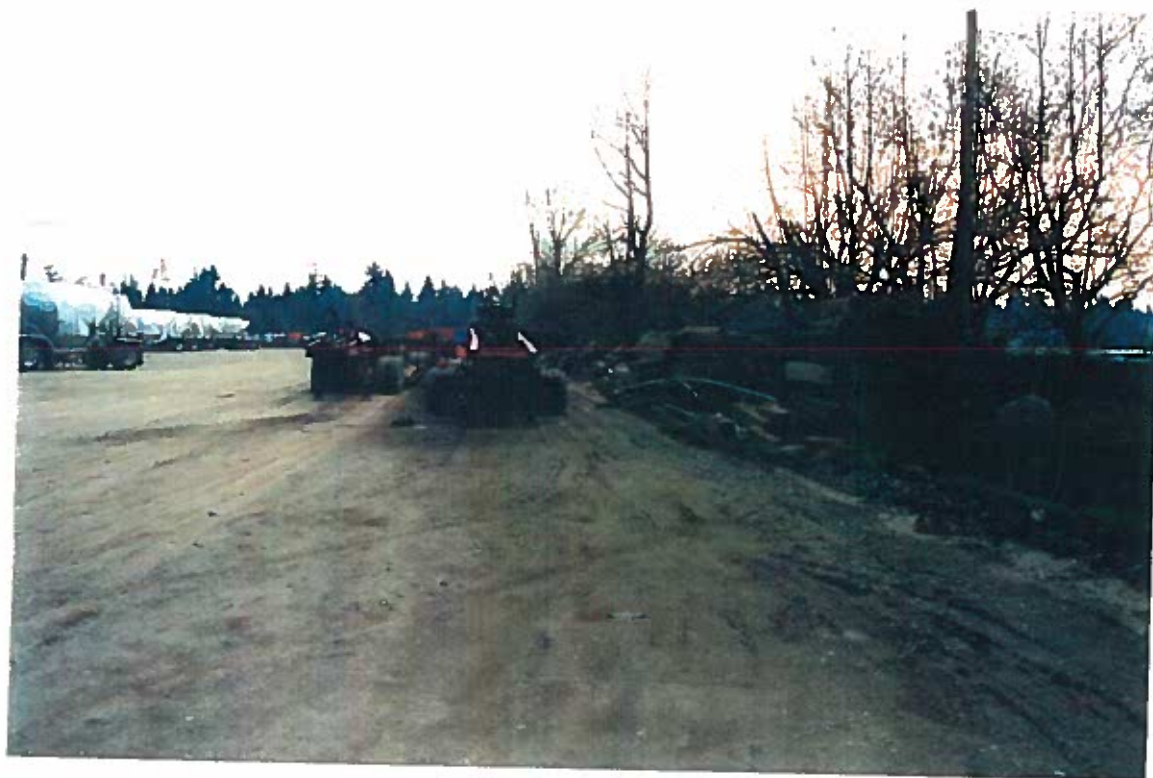
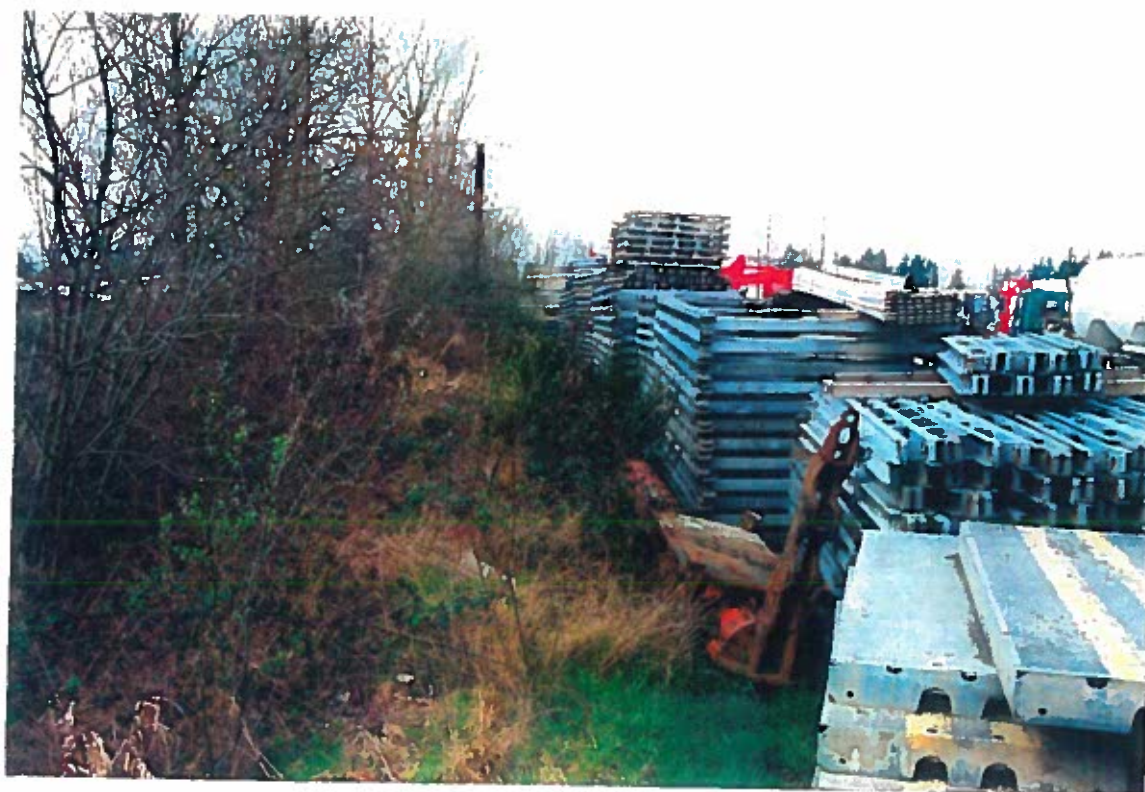
**FIGURE 5** Top and bottom views show the equipment items stored on the south side of the parking lot as you go east toward the back of the subject property.

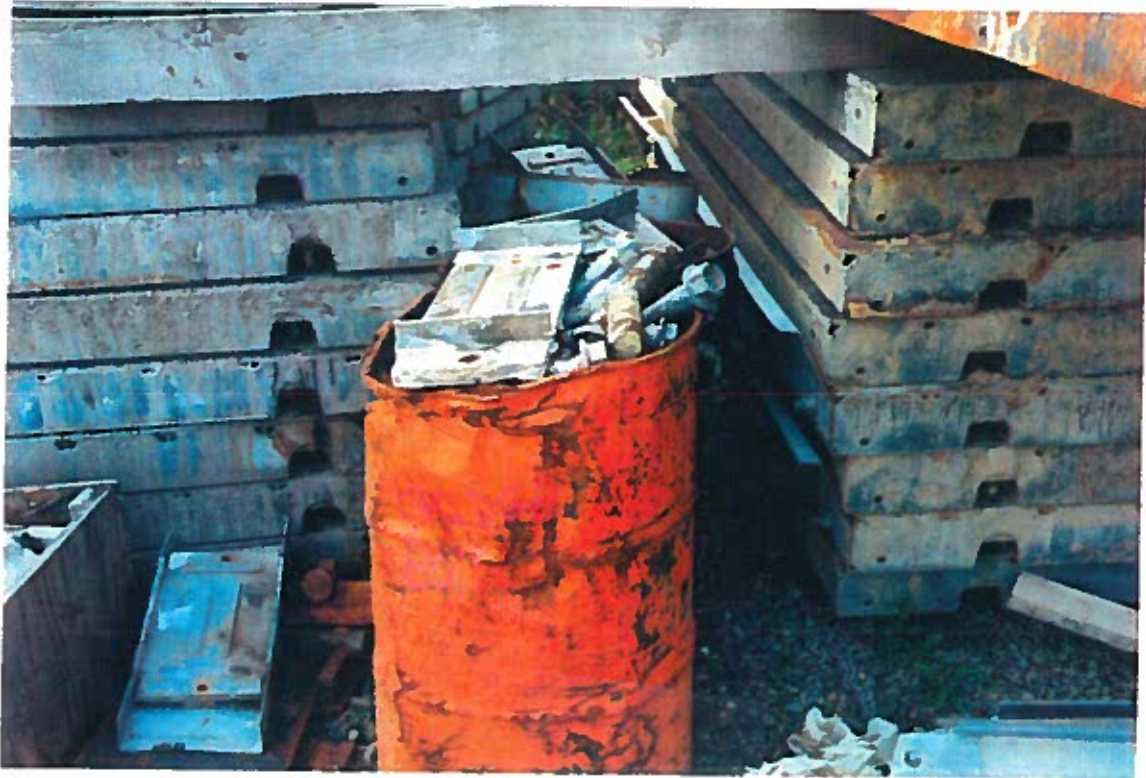
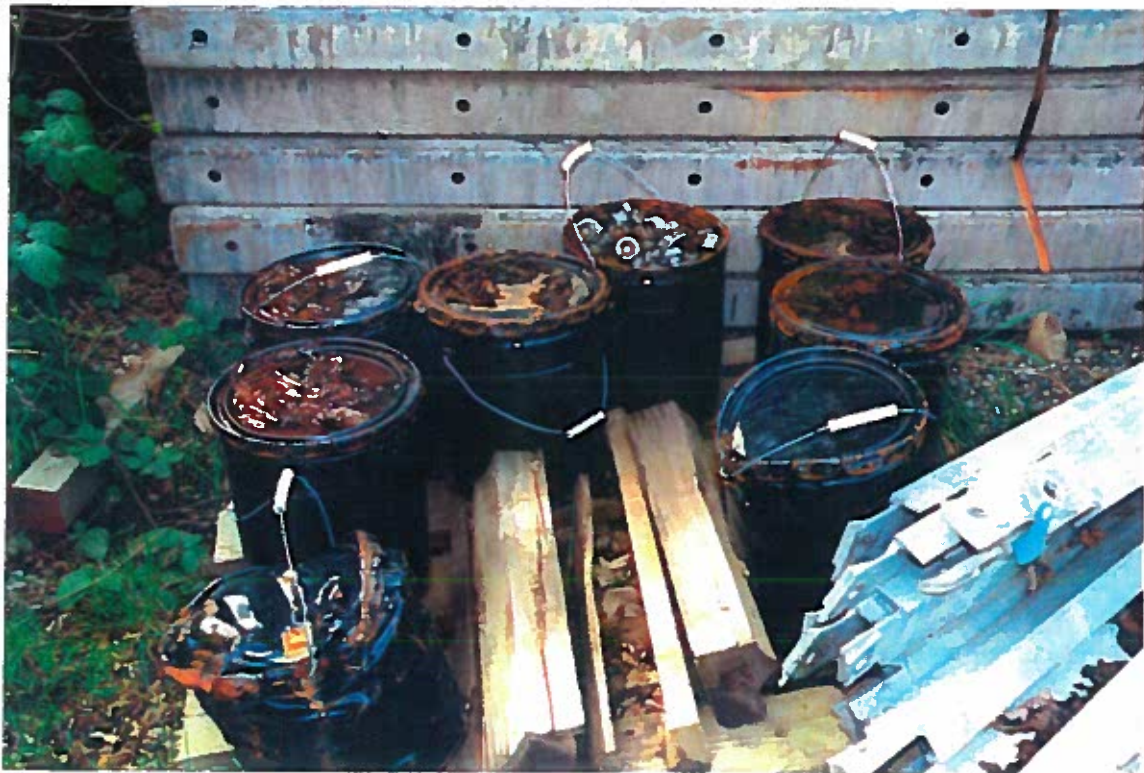
FIGURE 6 Top and bottom views of containers with hardware stored for future use.

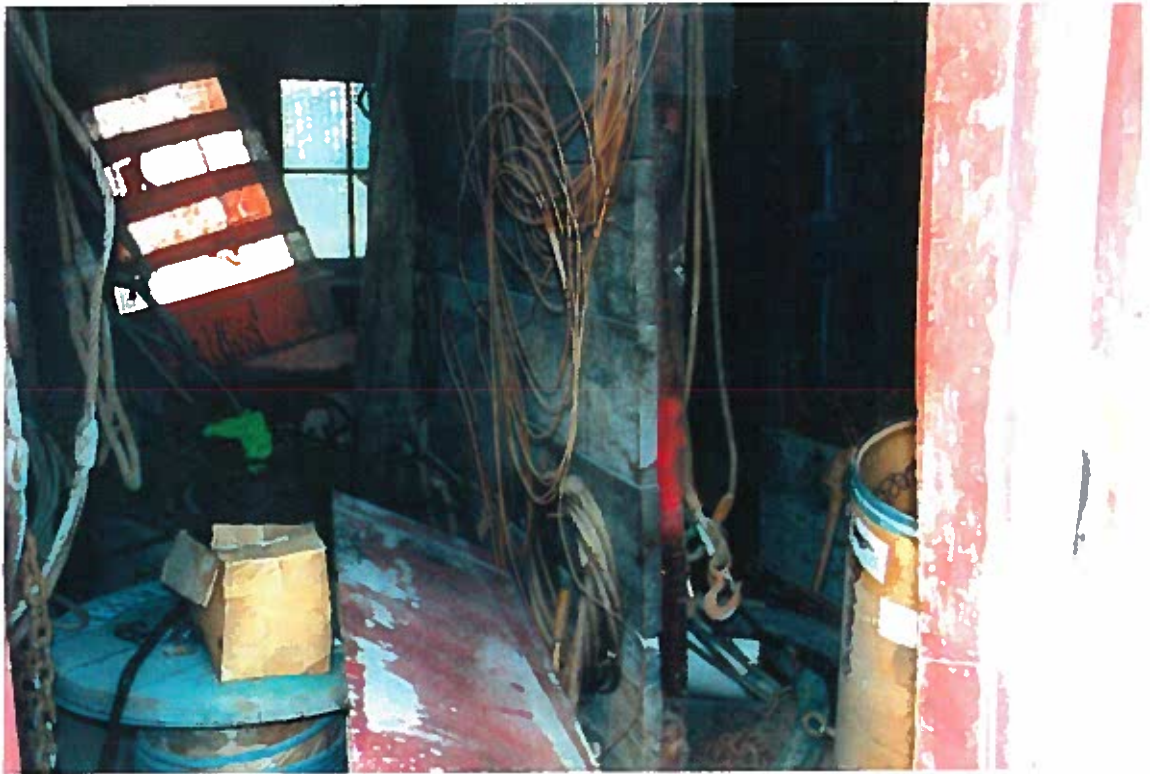
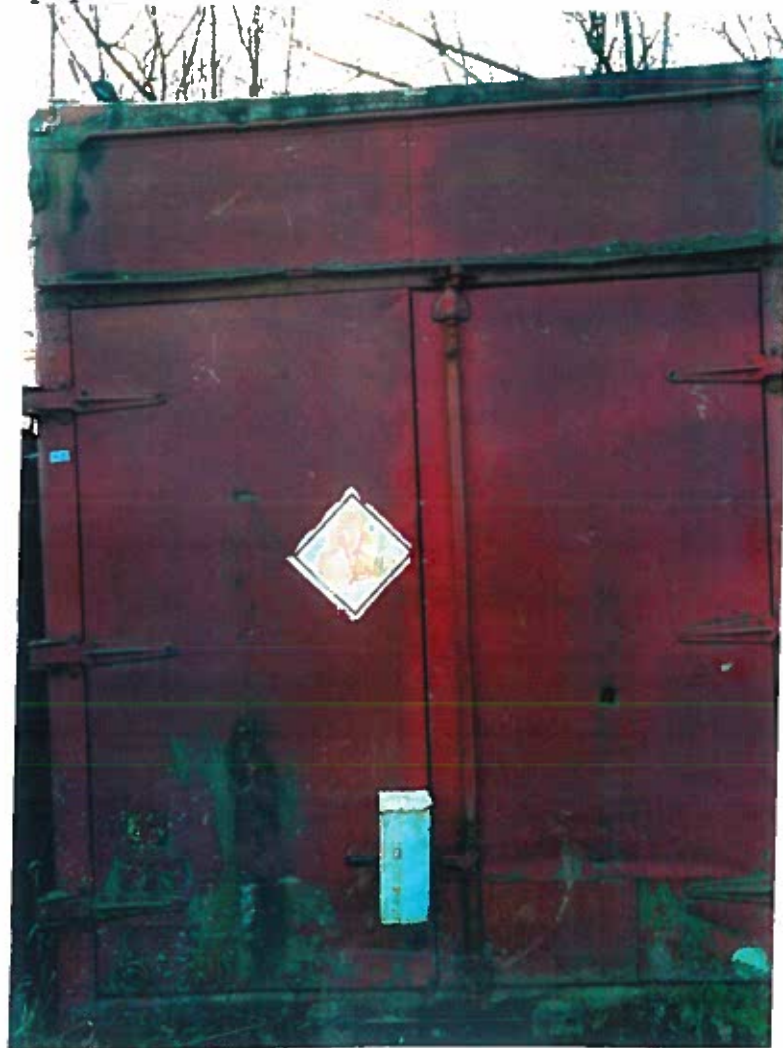
**FIGURE 7** Top view of a small shed adjacent to the container in the bottom view with old construction items and equipment stored. Bottom view of a small storage container with equipment located inside.

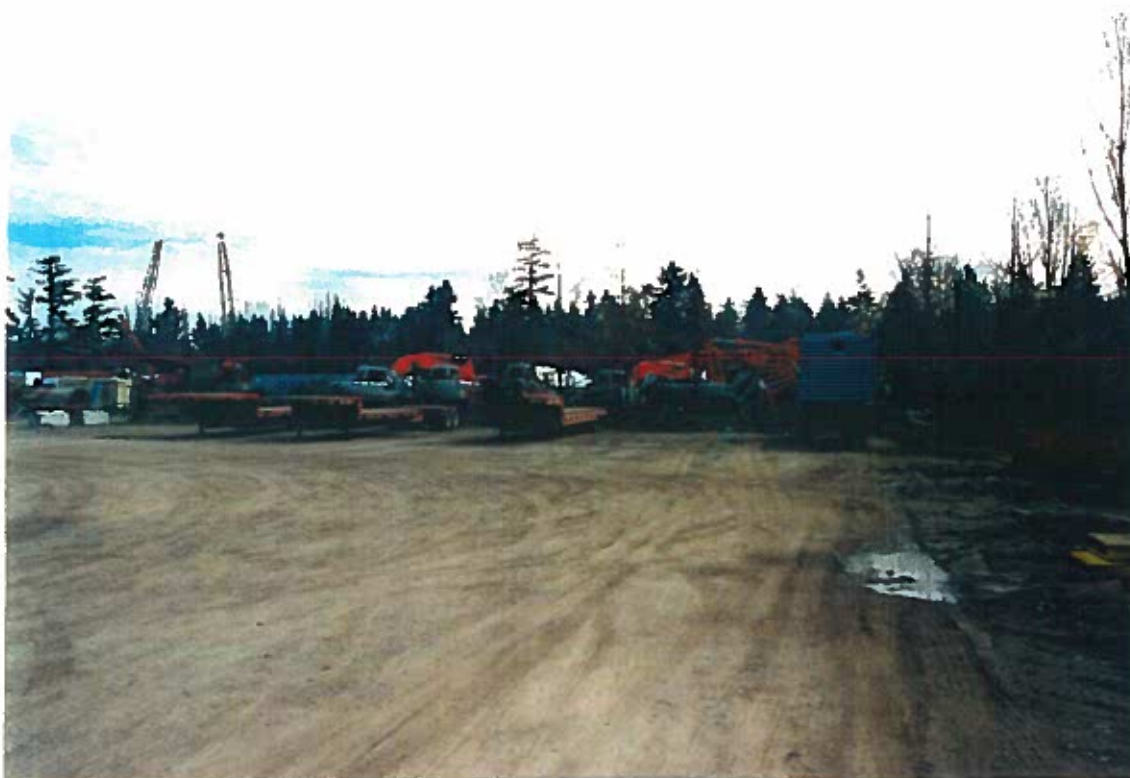
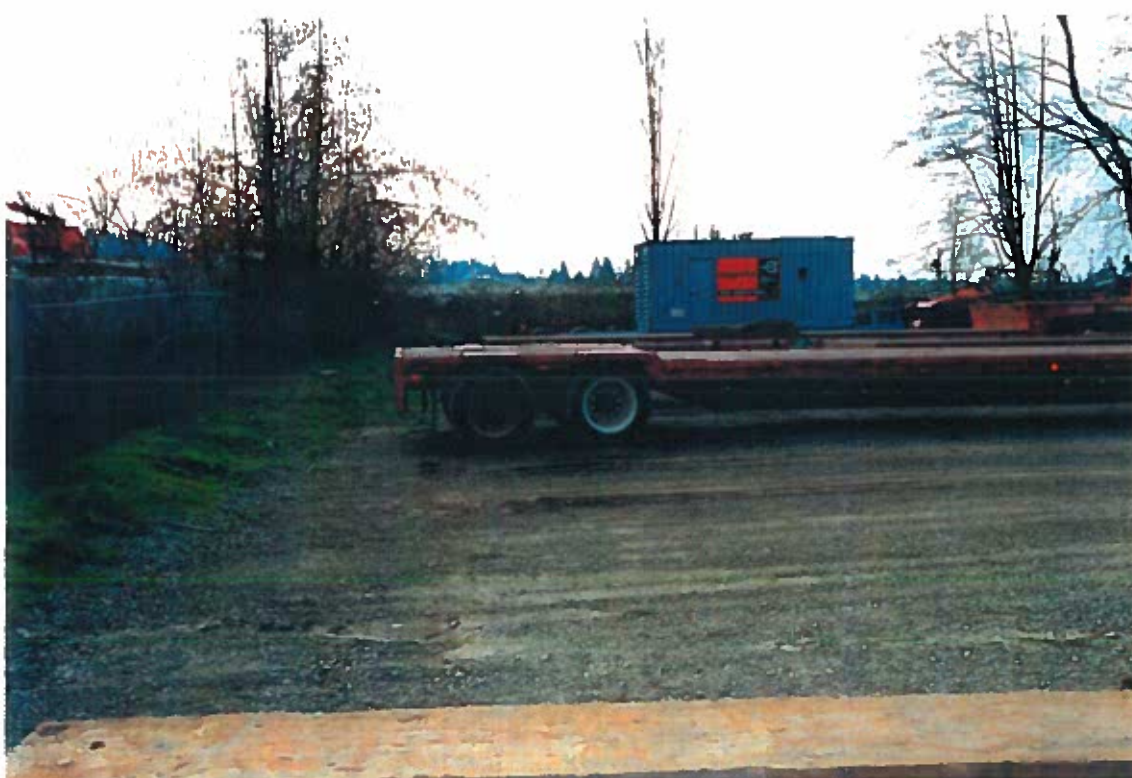
**FIGURE 8** Top looking east at more equipment items stored on the south side of the subject property. Bottom view is looking east at the southeast corner of the subject property.

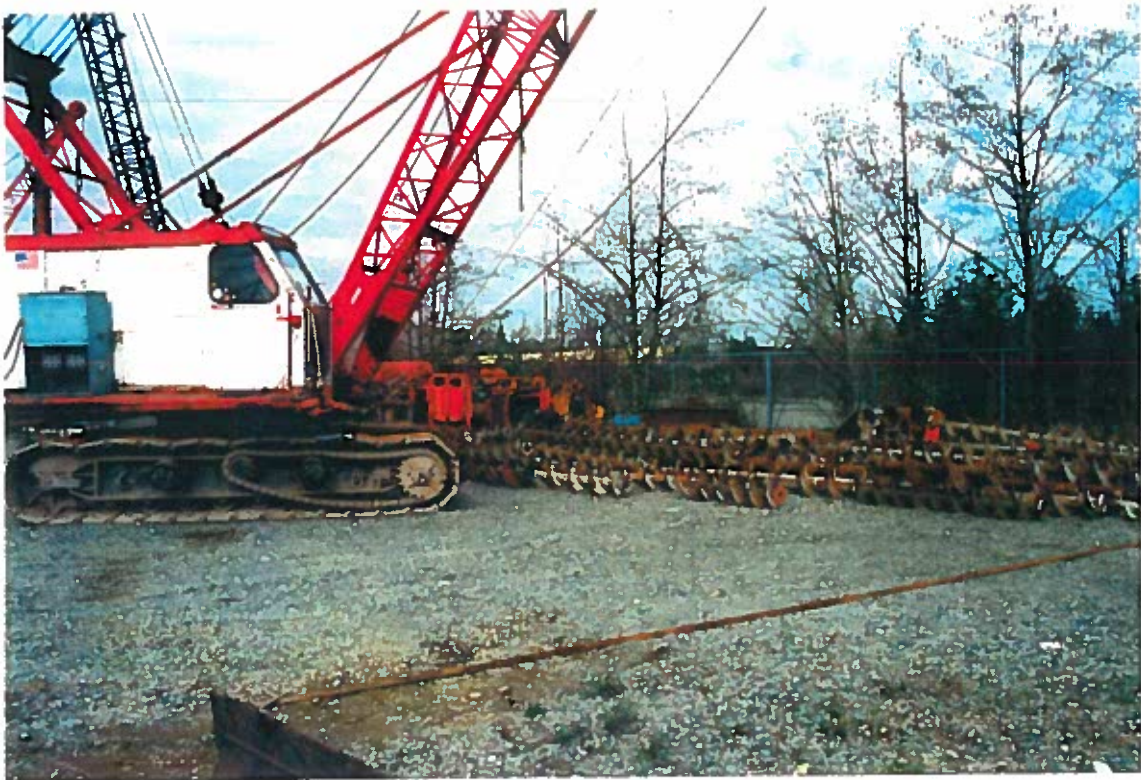
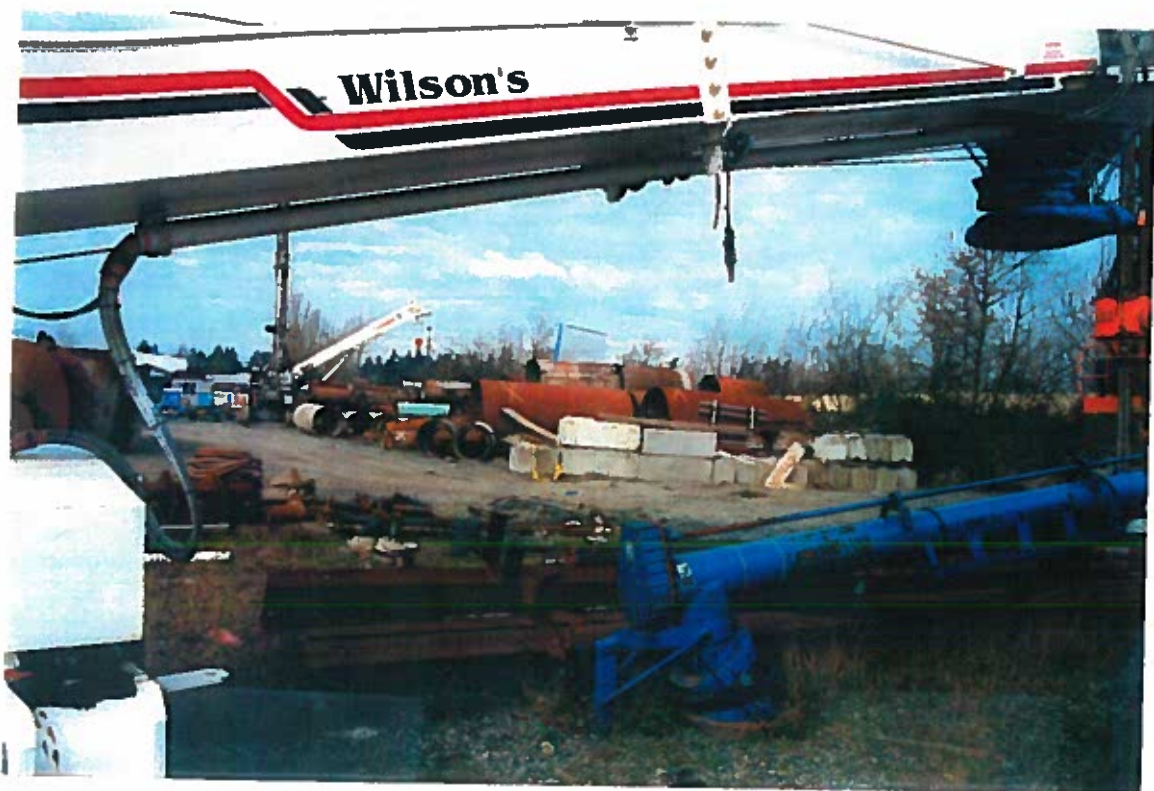
FIGURE 9 Top and bottom views of construction equipment stored on the very east end of the subject property.

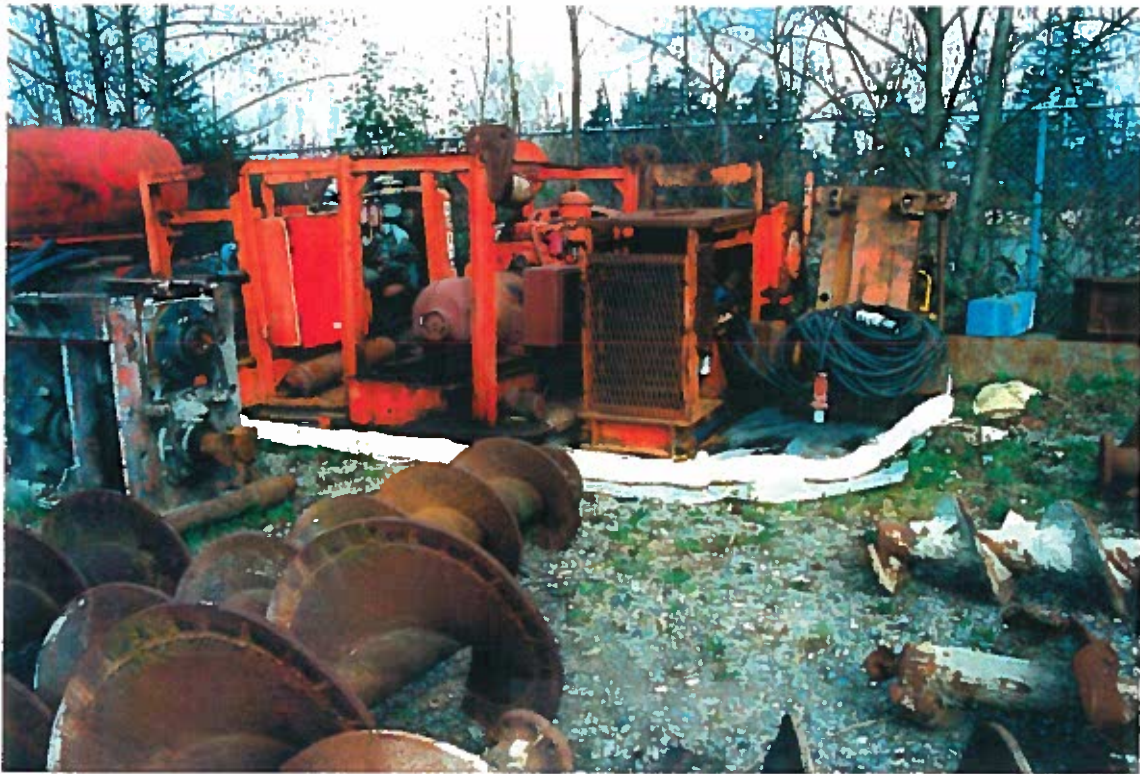
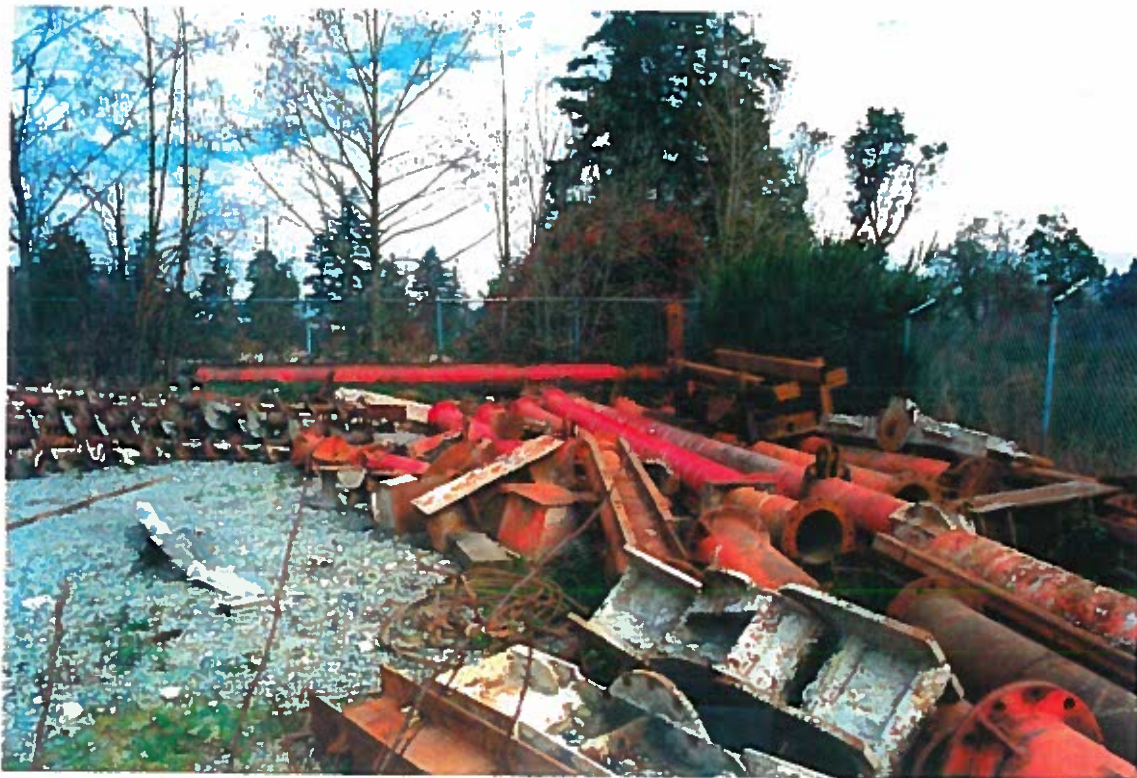
FIGURE 10 Top and bottom views of the construction equipment stored on the northeast corner of the subject property.

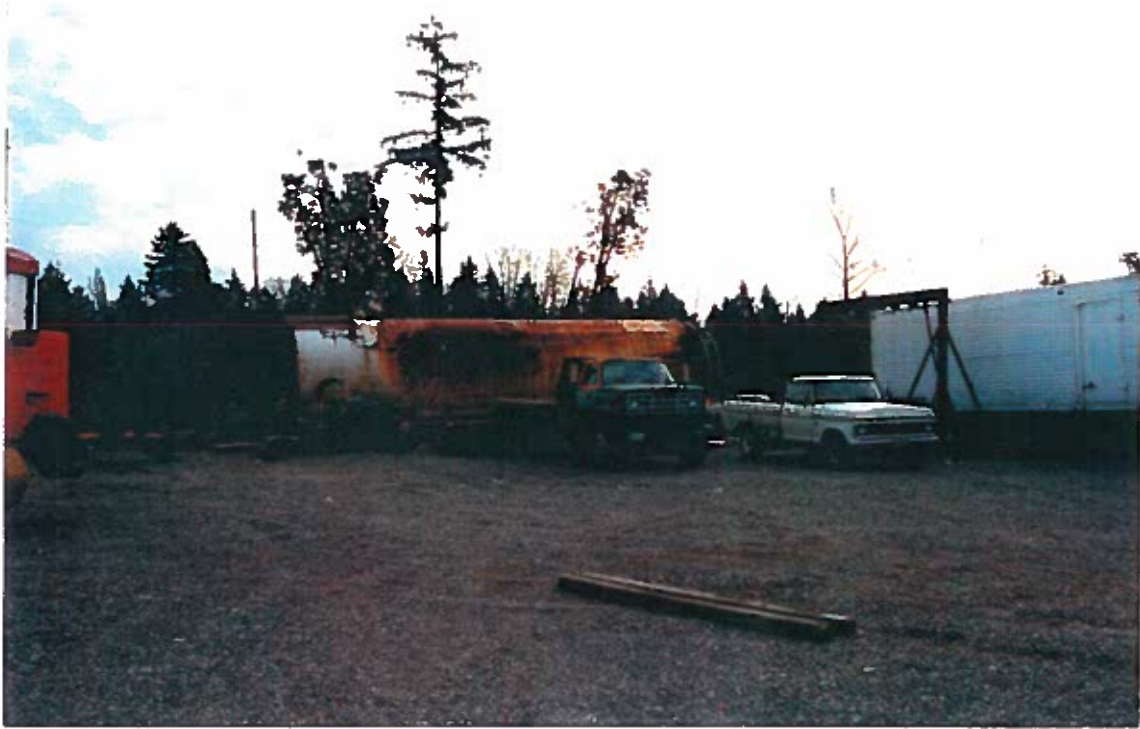
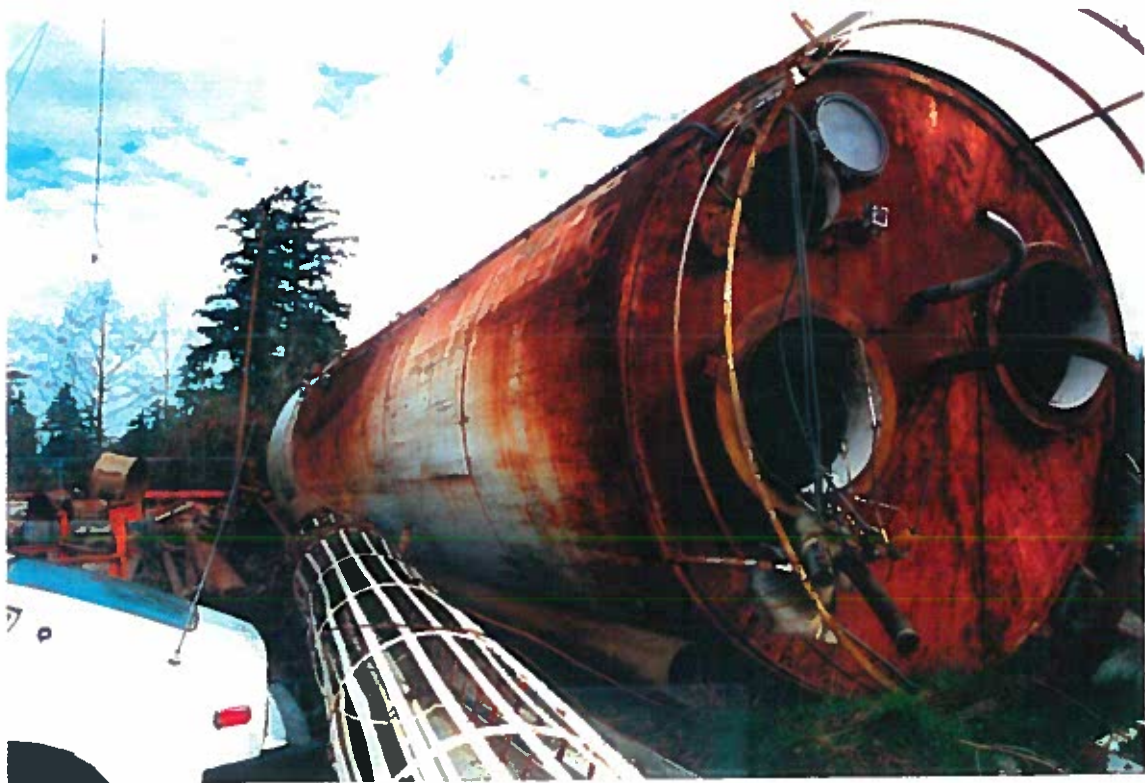
**FIGURE 11** More old used equipment stored on the northeast corner of the subject property.

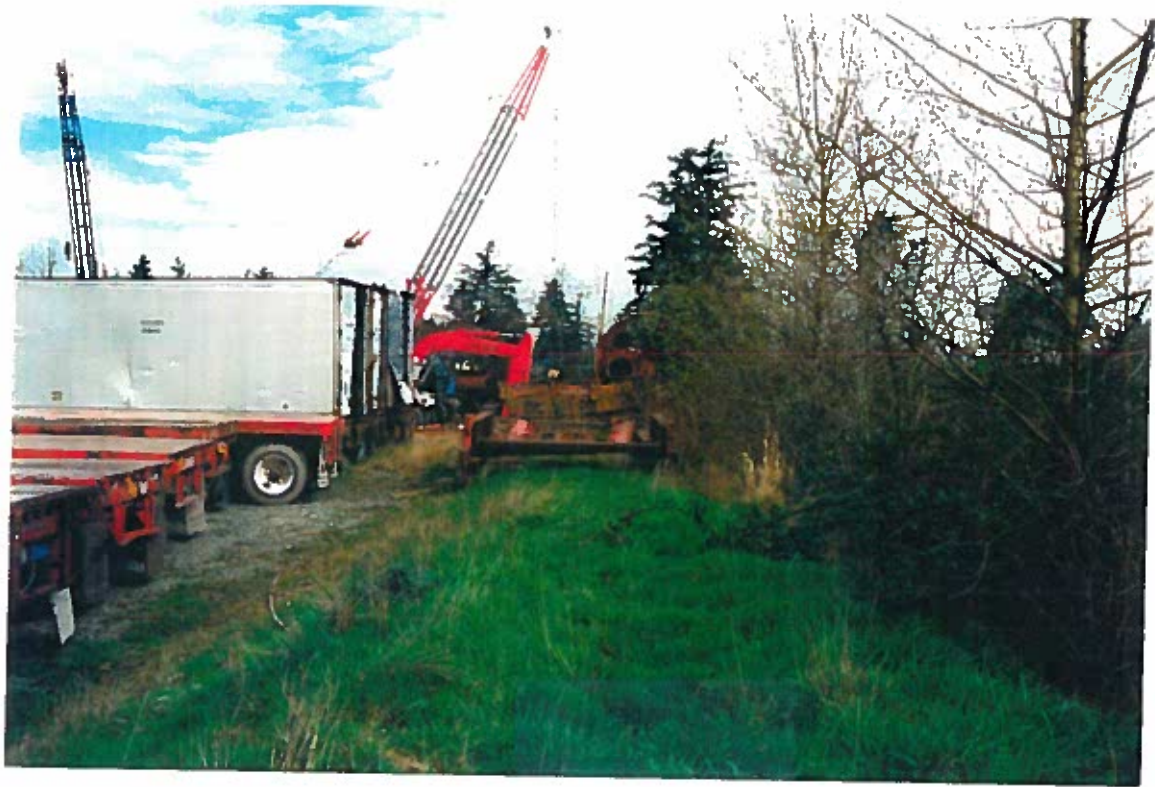
**FIGURE 12** Top view is looking north at the east boundary of the subject property where trailers are stored. Bottom view is looking east at the Swamp area which is adjacent and on the east side of the subject property.

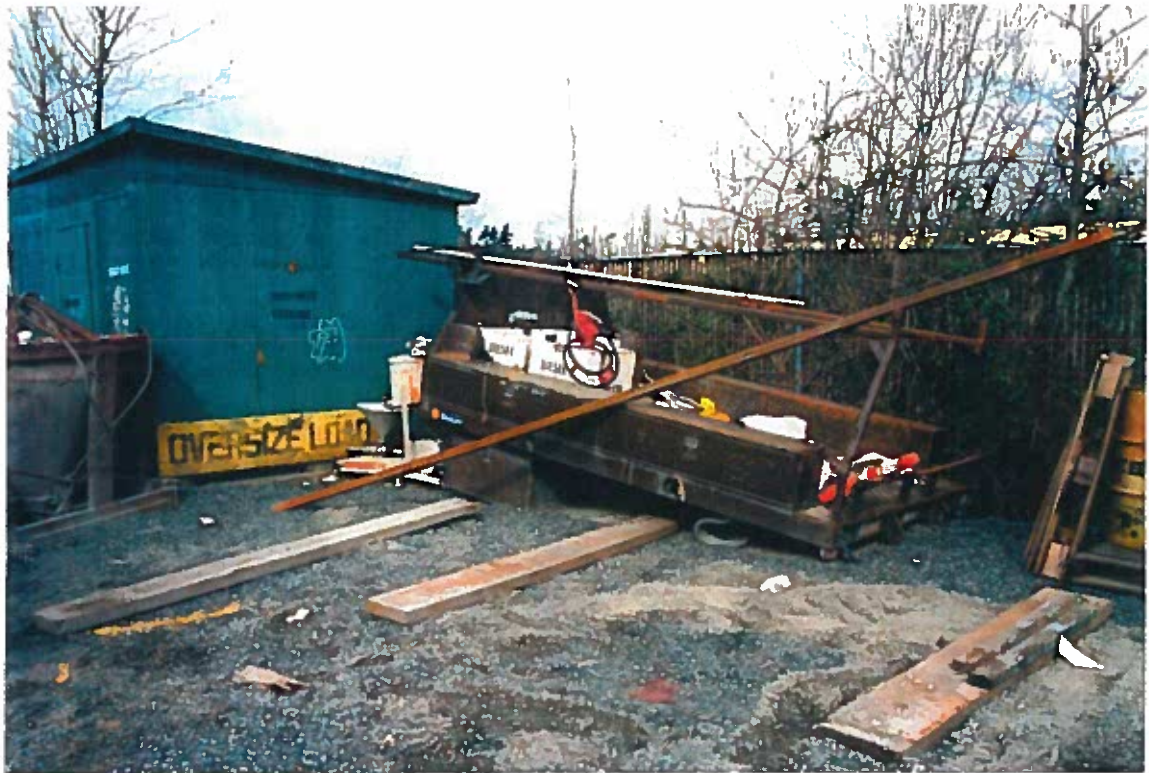
**FIGURE 13** Top and bottom view of a contractor's (welding) shed with hazardous materials used in his operation and is located on the north side of the subject property.
