**PHASE I  
ENVIRONMENTAL SITE ASSESSMENT  
ASTM E-1527-97**

**GRESHAM TRANSFER, INC., FACILITY  
24300 PACIFIC HIGHWAY SOUTH  
KENT, WASHINGTON 98032**

**BANK OF AMERICA**

**MARCH 31, 1998**

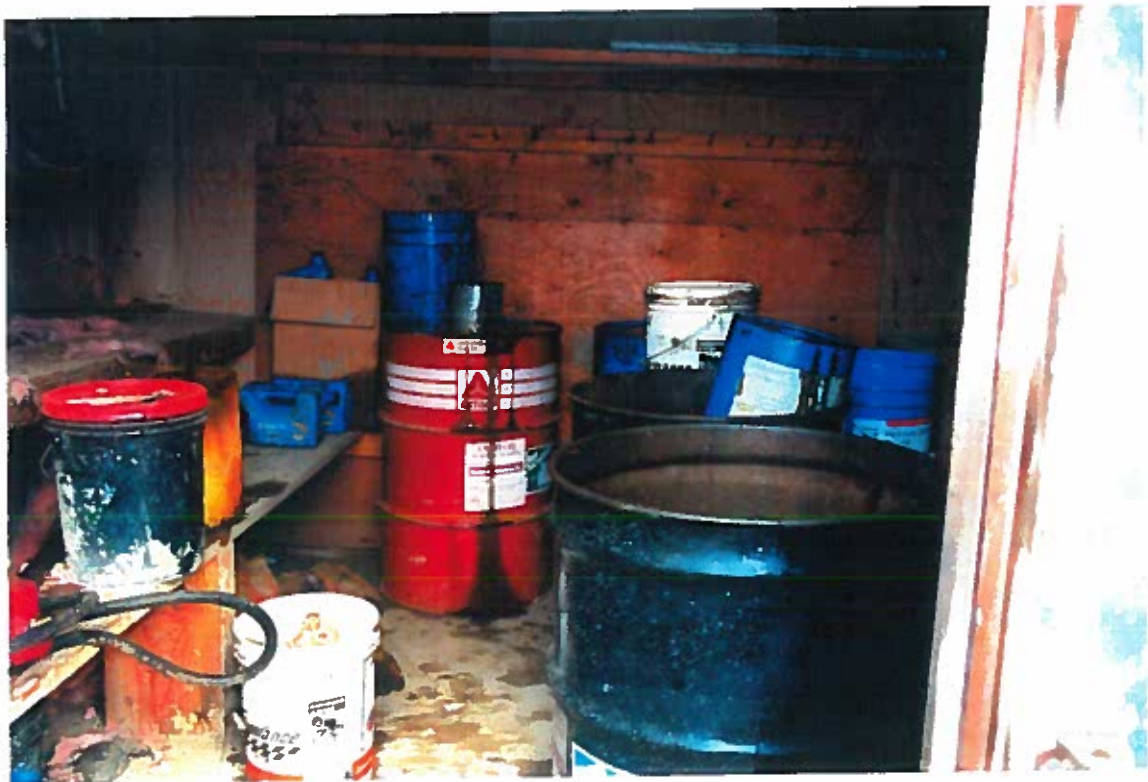
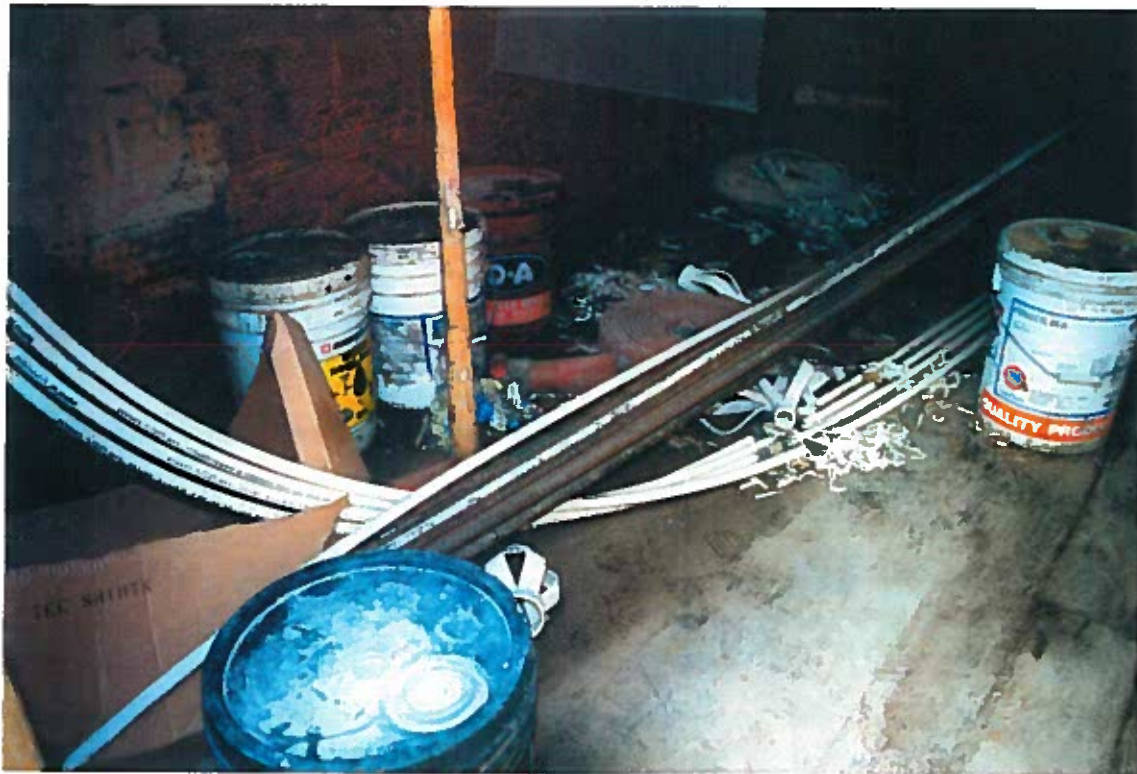
**FIGURE 14** The welding contractor has several containers with the hazardous materials used in his operation stored inside small trailer containers and on wooden pallets.

There were several containers on-site that contained hazardous materials that are used by the tenants as well as Gresham Transfer, Inc., in their daily operations and are shown in the on-site photographs in Section 12.0, Appendix B.

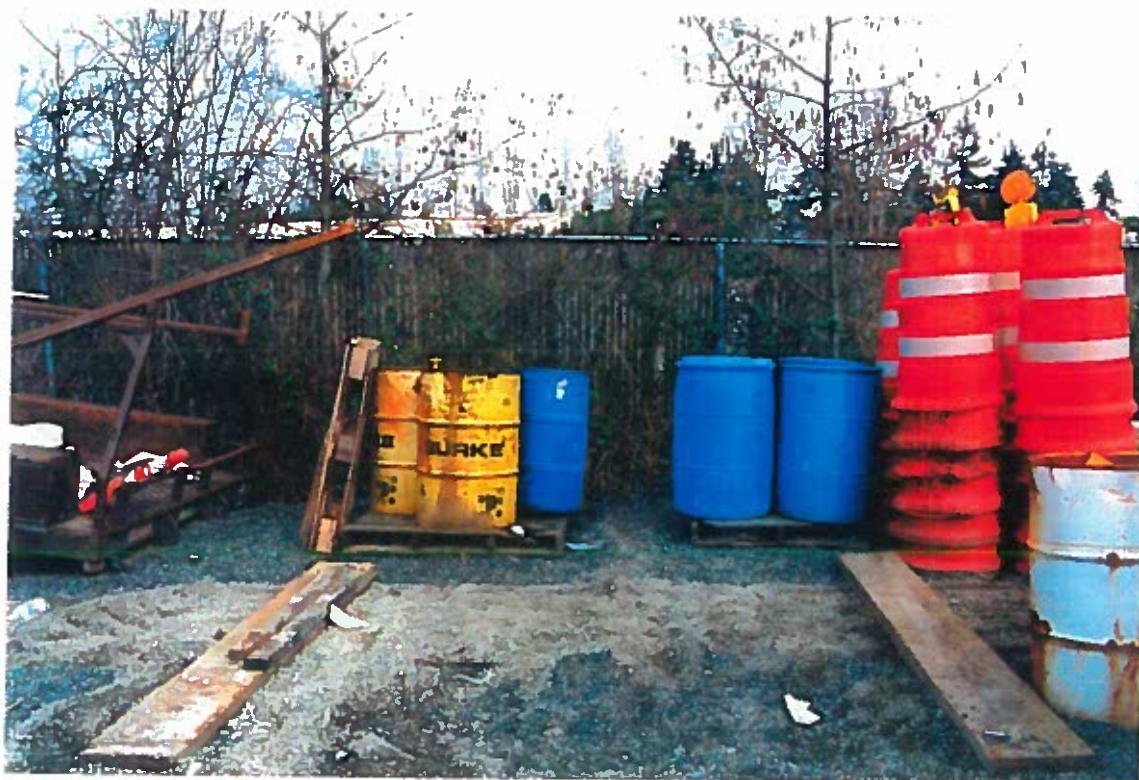
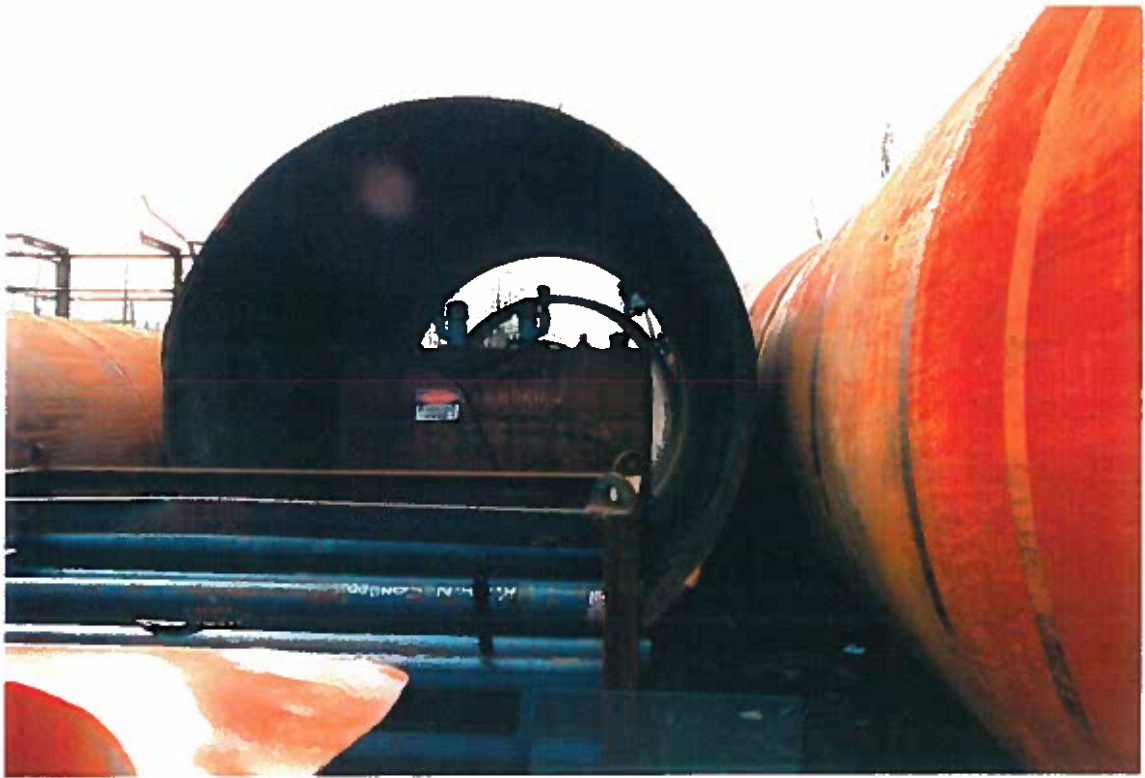
**FIGURE 15** The welding contractor has three small aboveground portable fuel storage tank located at his operation.

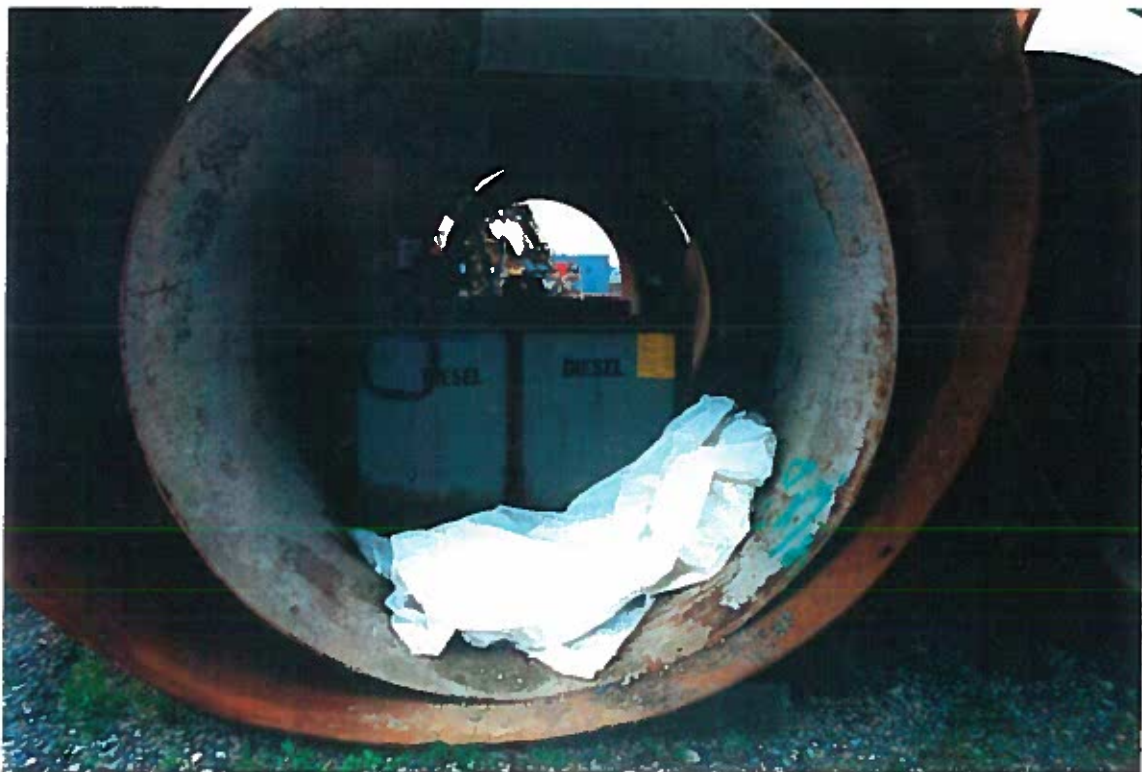
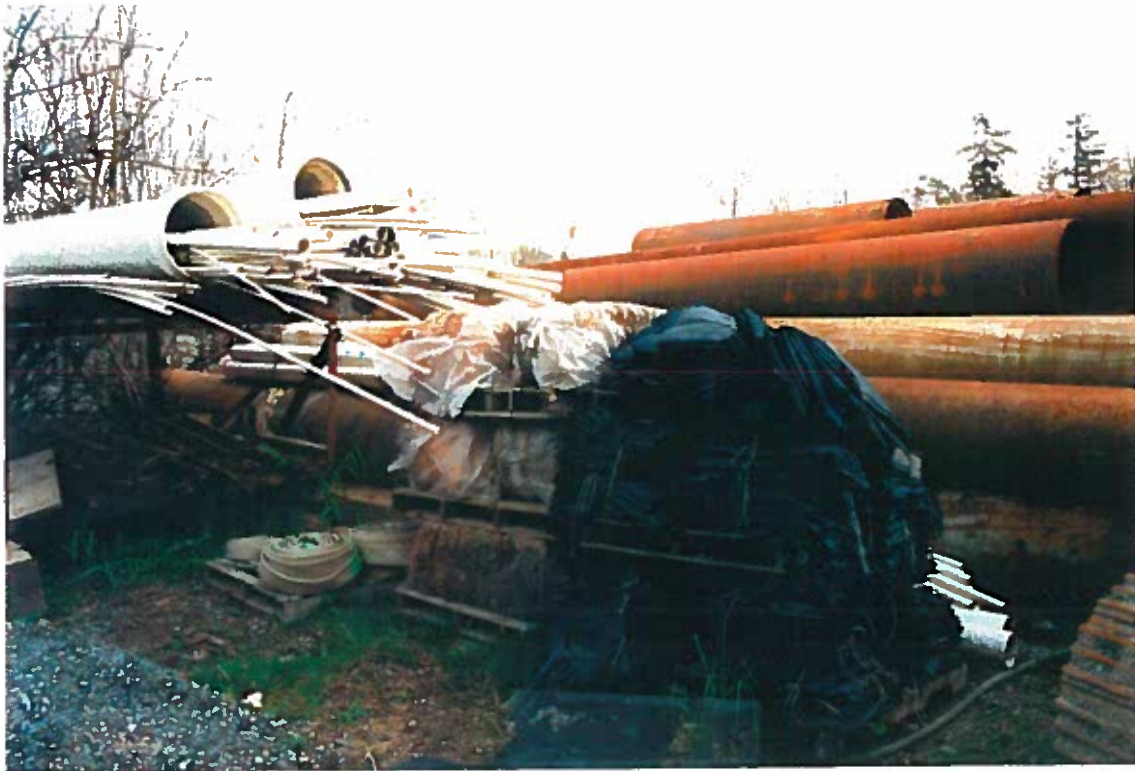
**FIGURE 16** The top view showing some piping and other associated materials stored on-site at the welding operation. Bottom view shows the old paper type of insulation stored in the trailer container located on the east side of the parking area.

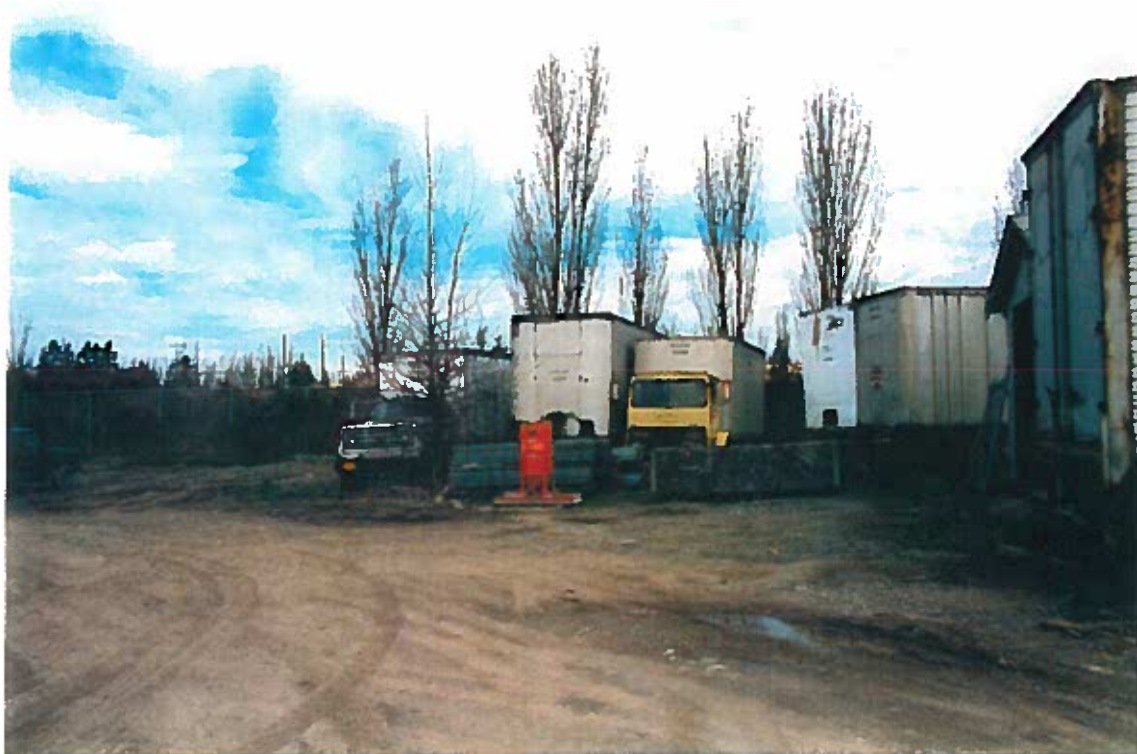
FIGURE 17 Trucks and containers parked on the north side near the washing area which is on the east side of the Quonset Hut.

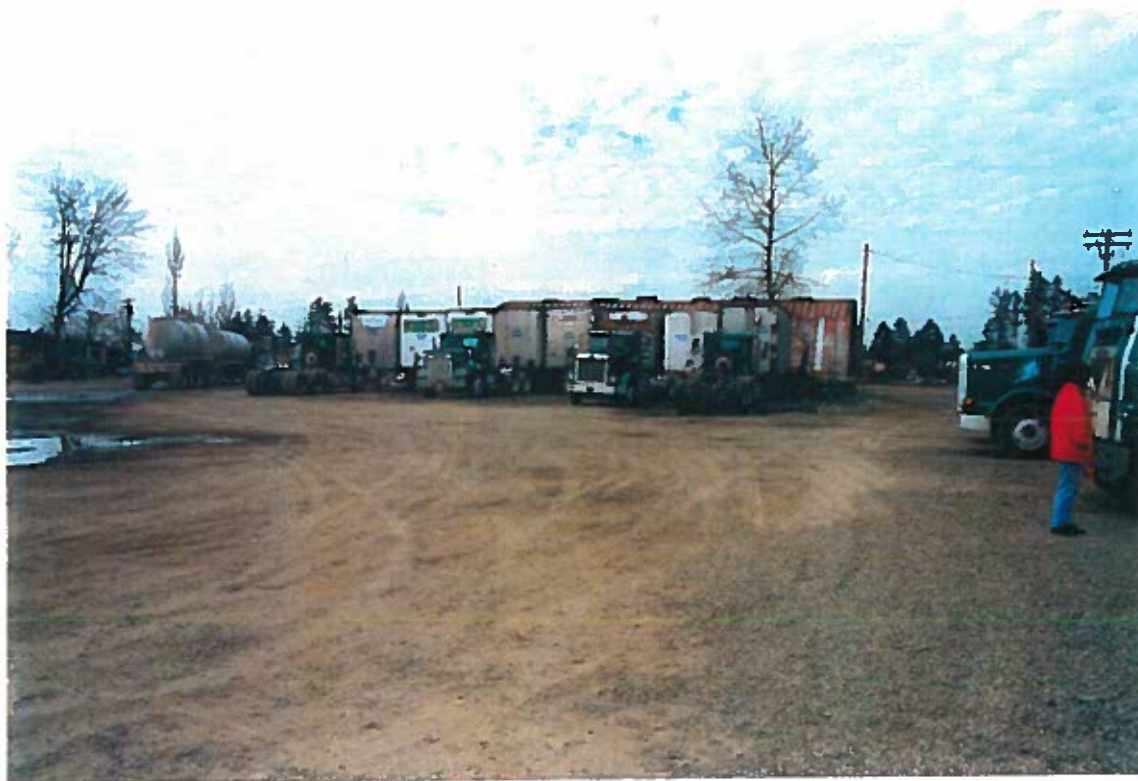
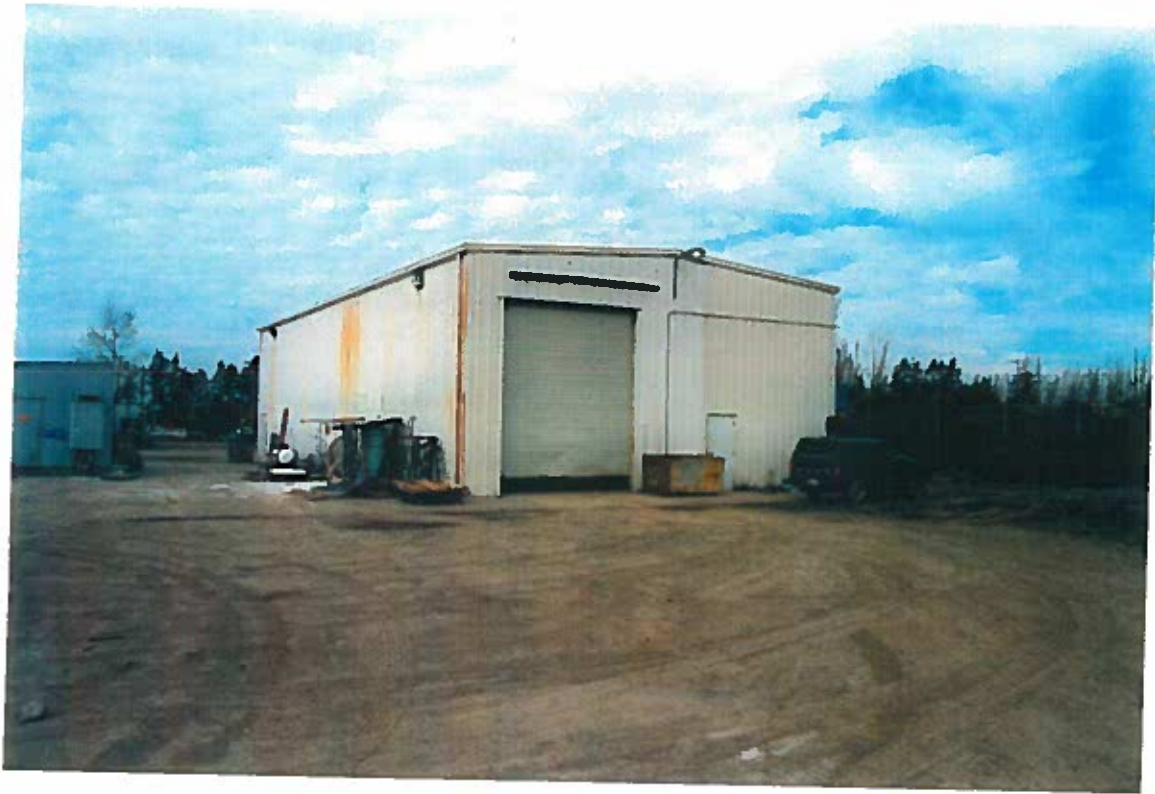
**FIGURE 18** To view is looking west at the main maintenance building used by Gresham Transfer. Bottom view shows the truck wash water collection sump located on the south side of the maintenance building.

Recommend that the truck washing cement-lined sump along side (south side) of the maintenance building be closed and filled with appropriate material.

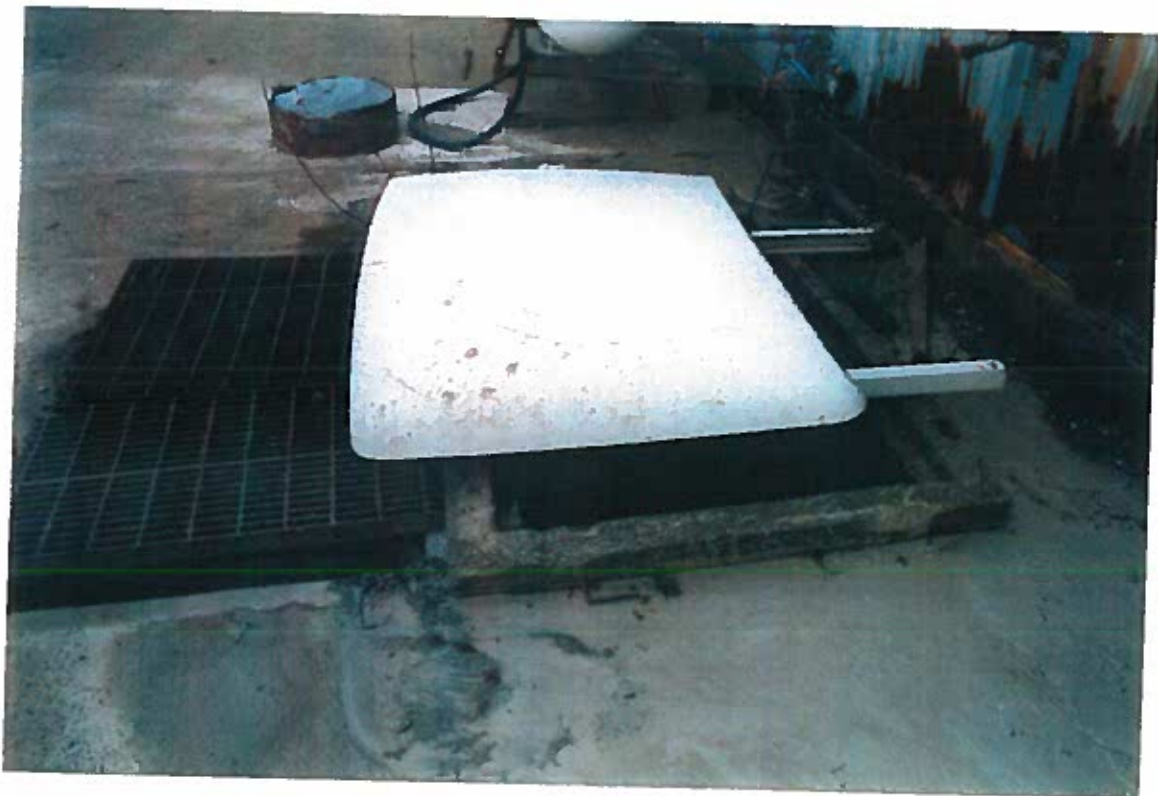
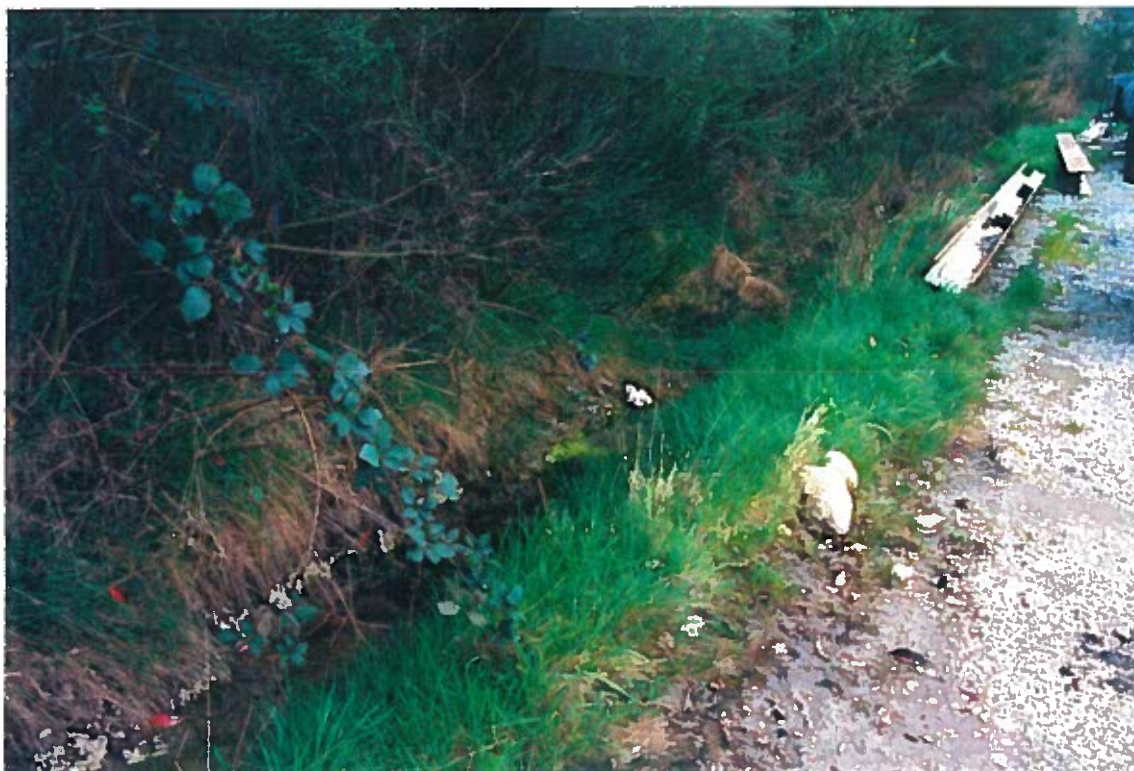
**FIGURE 19** Top view of the small run-off water collection ditch located on the north side of the subject property adjacent to the maintenance building. Bottom view of the electrical utility system used by the maintenance building operation.

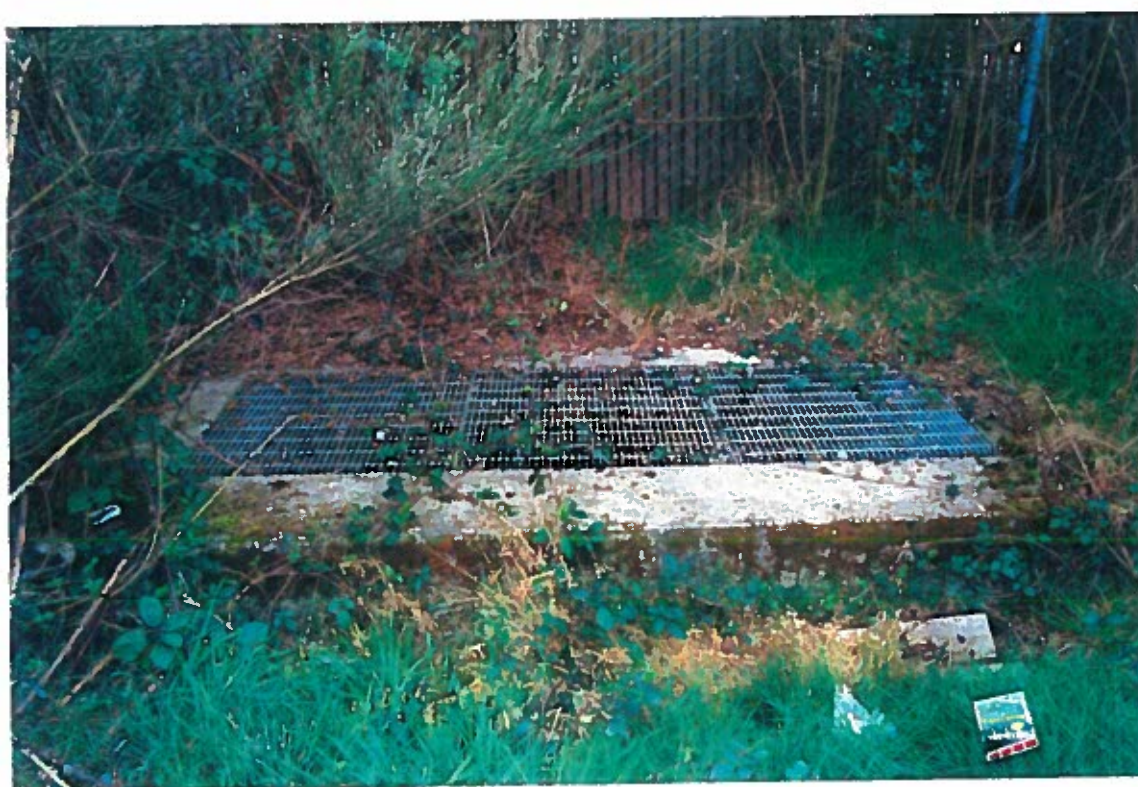
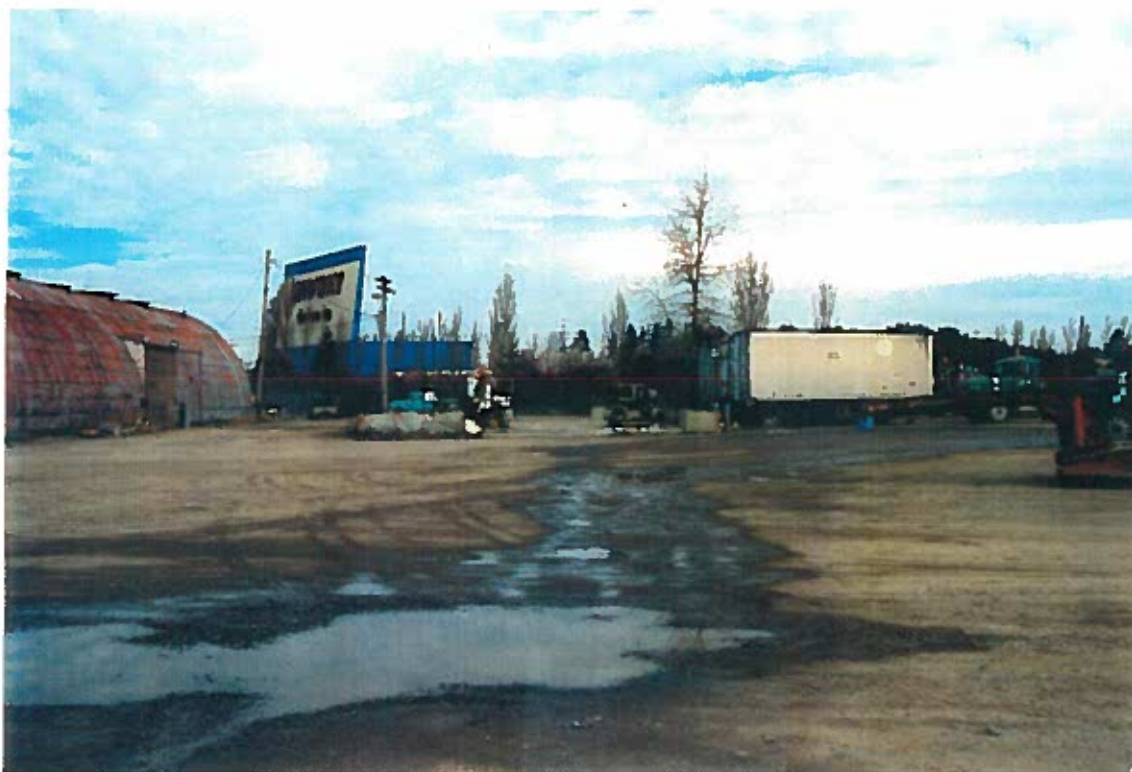
There were no odors of petroleum products noted in the truck wash cement pad area of the Site that would suggest improper washing procedures were being used.

**FIGURE 20** Top and bottom views of the cement pad (Old Quonset Hut location) that is used for washing equipment. Water from the above water area runs into the collection ditch located on the north side of the subject property as seen in Figure 19.

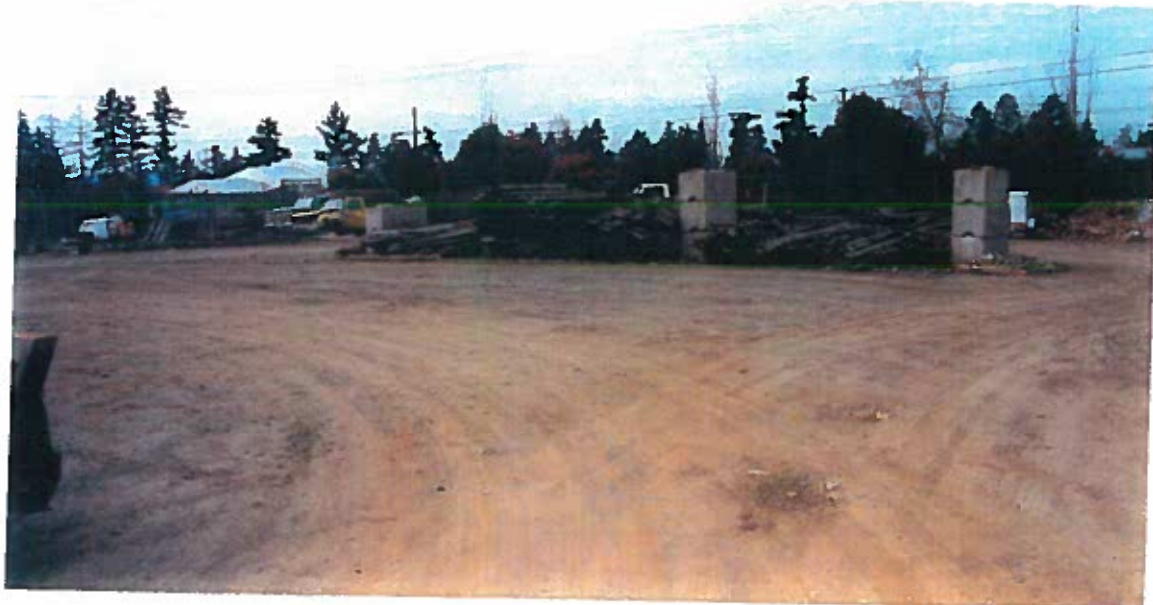
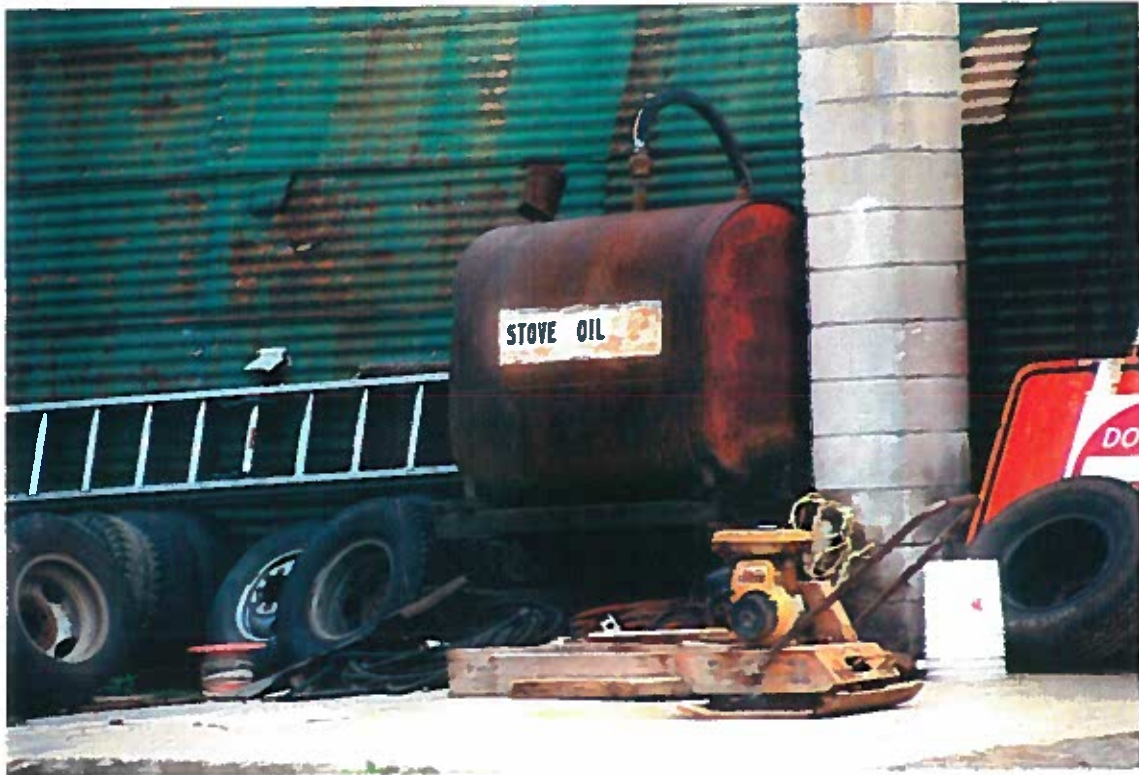
**FIGURE 22** Top view of the aboveground fuel storage tank used by the Quonset Hut tenant. Bottom view of the hazardous materials storage located in the maintenance building used by Gresham Transfer.

The only hazardous materials used on-site are associated with the truck maintenance and repair shop and are handled according to the Regulations of the DOE if any hazardous waste is generated or collected.
