AE 0044-12 3.7.N  
Focused Phase II  
Environmental Site  
Assessment  
FL-252 Draft 2

**Focused Phase II Environmental Site Assessment  
Report  
Sound Transit – Federal Way Link Extension  
Parcel FL-252, Gresham Transfer/Former Widing  
Transportation Facility  
24300 Pacific Highway South  
Kent, Washington**

File No. 4082-039-01

July 25, 2018

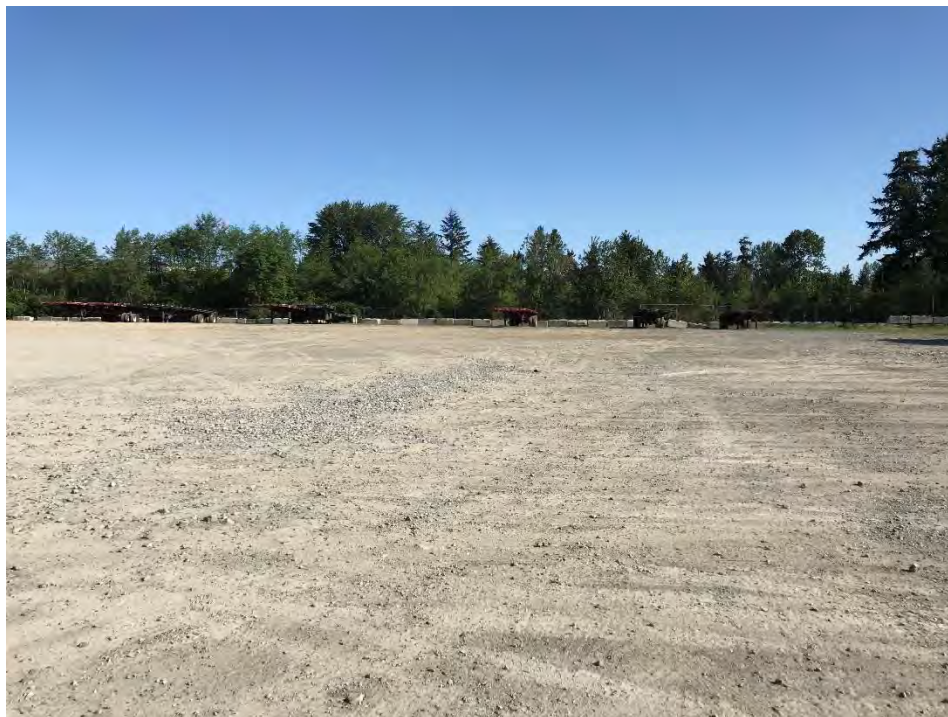
**Photograph 1 – Eastern portion of parcel FL-252 where Sound Transit is proposing guideway, access and drainage easements and where aerial guideway will be constructed; view to east.**

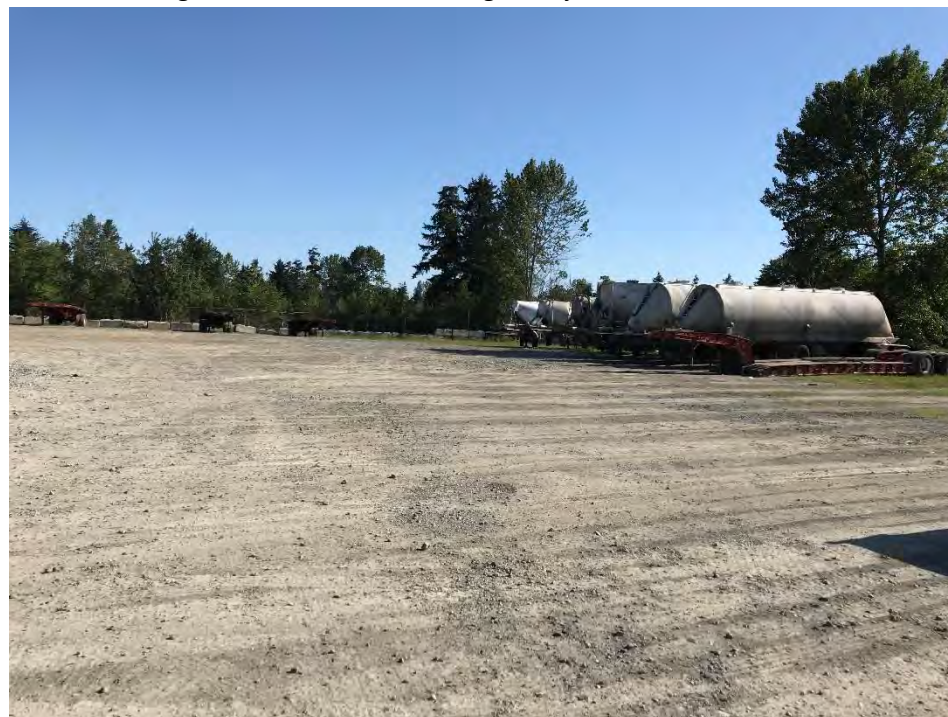
**Photograph 2 – FL-252 – Southeastern margin of parcel FL-252, view toward southeast.**

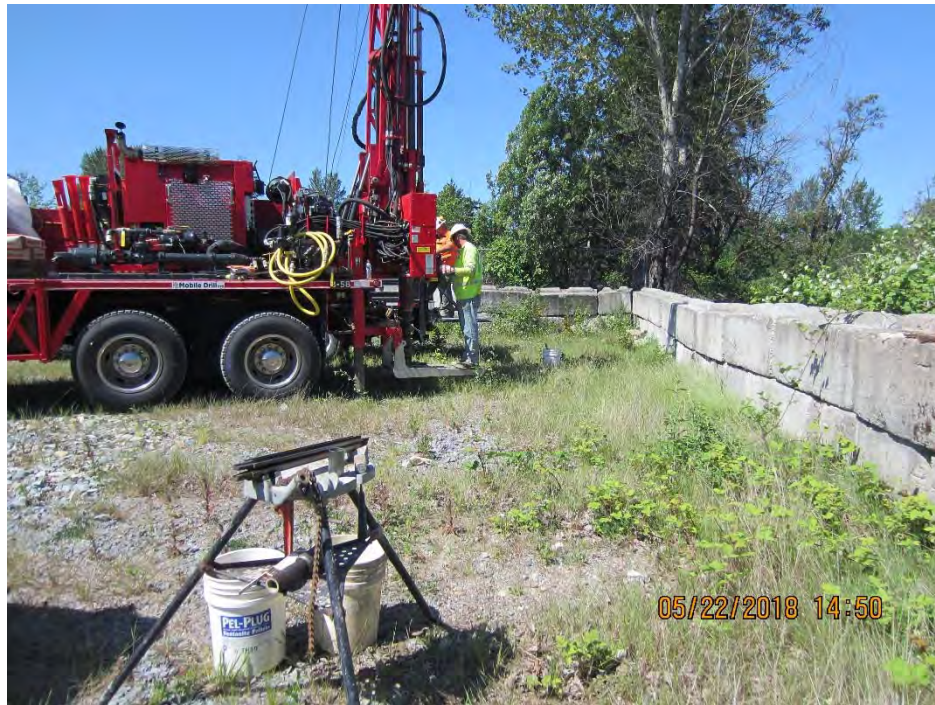
Photograph 3 – Exploration FL252-B1 in the northeast corner of the parcel FL-252, view to north.

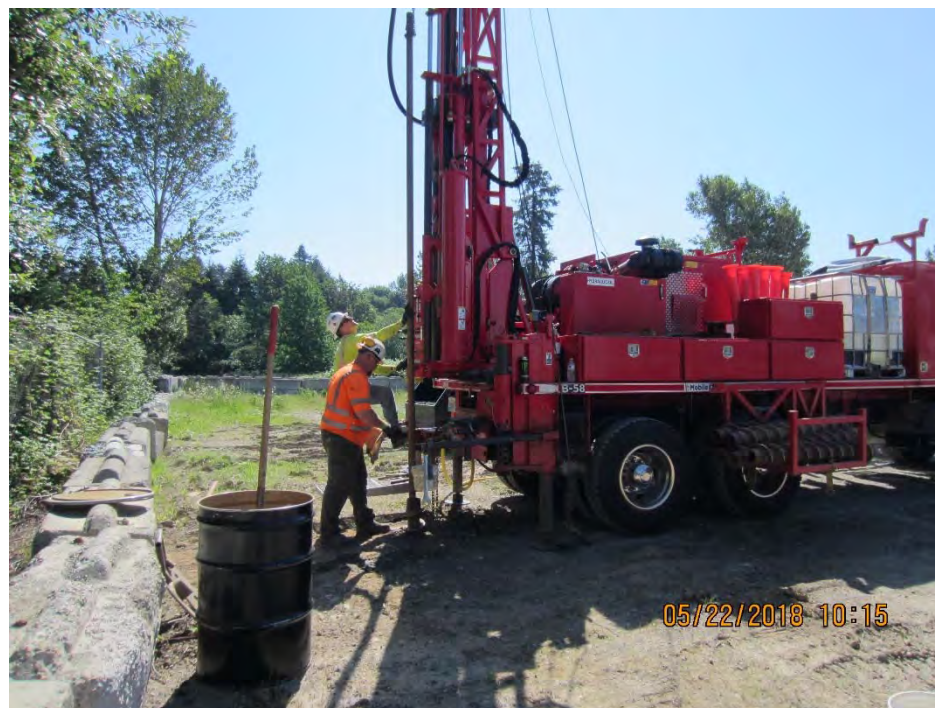
Photograph 4 – FL-252 – Exploration location FL252-B2 that was completed as a monitoring well, view to east.

In accordance with WAC 173-160, we recommend decommissioning of monitoring well FL252-B2 if it is no longer needed.

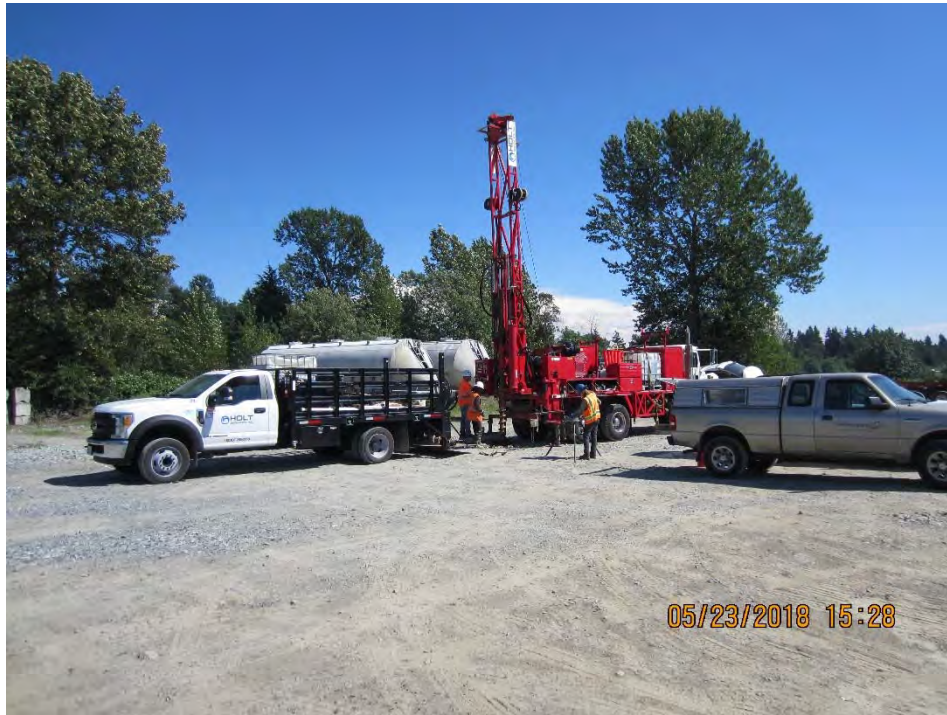
Organics, roots and wood debris suspected to be fill were noted in a dark brown sandy layer observed in FL252-B3 at a depth of 1 to 1.5 feet bgs, and in FL252-B4 at a depth of 5 to 5.5 feet bgs.

Photograph 5 – FL-252 – Exploration FL252-B3 in the central-eastern portion of the subject property, view looking southeast.

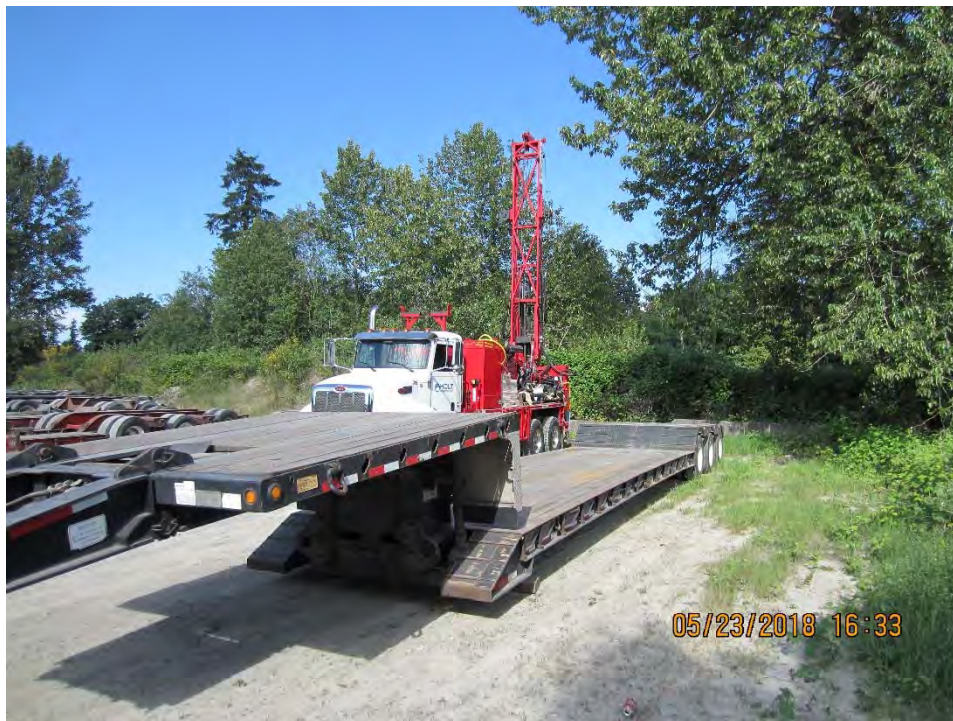
- **Fill of Unknown Origin** - Approximately 8 feet of loose fill material containing wood debris was encountered during drilling of geotechnical boring FWLE-A26P located in the southeast corner of the Parcel (Figure 2). The specific source(s) of this fill was not determined from the available sources. Imported fill of unknown origin may contain contaminants such as petroleum, metals or polycyclic aromatic hydrocarbons (PAHs).

Photograph 6 – FL-252 – Exploration location FL252-B4 in the southeastern corner of the subject property near geotechnical boring FWLE-A26P, view looking east.

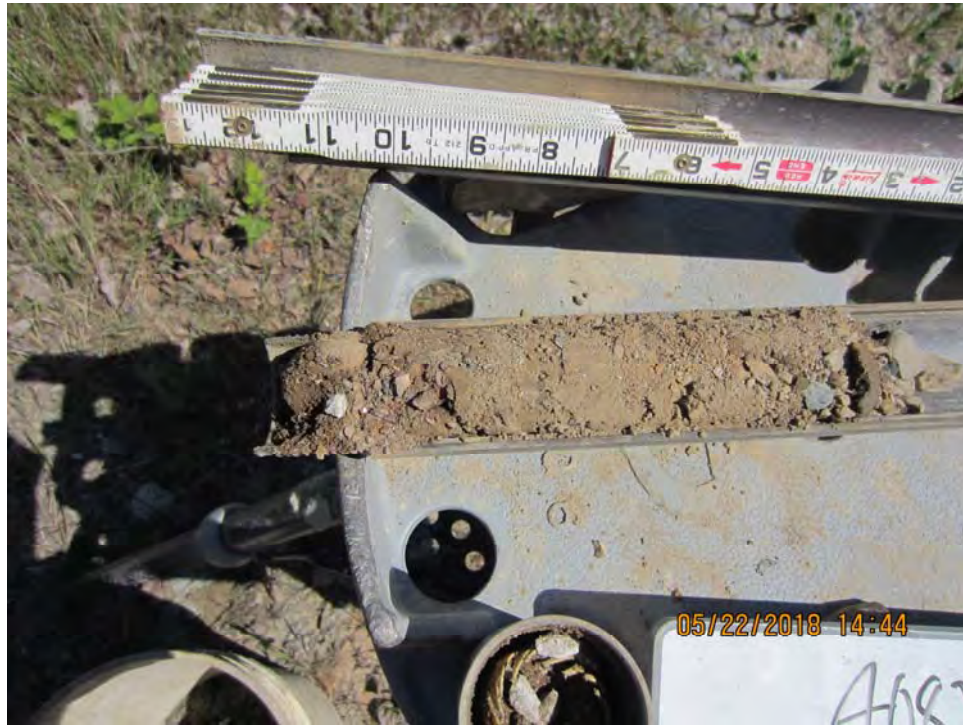
Carcinogenic and noncarcinogenic PAHs were detected in soil samples FL252-B1-0-1.5 (lube oil also detected), FL252-B1-2.5-3.5, FL252-B3-0-1, FL252-B4-0-1 (lube oil also detected) and FL252-B4-5-6 feet bgs (diesel and lube oil also detected as noted above). The detected concentration of cPAHs in sample FL252-B1-0-1.5 (0.7828 mg/kg) was greater than the corresponding MTCA Method A cleanup level of 0.1 mg/kg. Based on these boring locations and sample depths, the source(s) of cPAHs and petroleum hydrocarbons detected in these samples may be related to past releases from truck maintenance or washing operations.

Photograph 7 – FL-252 – Exploration location FL252-B1 soil core from surface to 1.5 feet below ground surface. Arsenic and cPAHs were detected in this sample at concentrations greater than corresponding MTCA cleanup levels.

We recommend Sound Transit contractors follow procedures to identify and characterize excavated soil in accordance with contaminated/impacted soil screening and handling plans and the contract documents. Soil segregation, handling, stockpiling, waste characterization, and end use/disposal

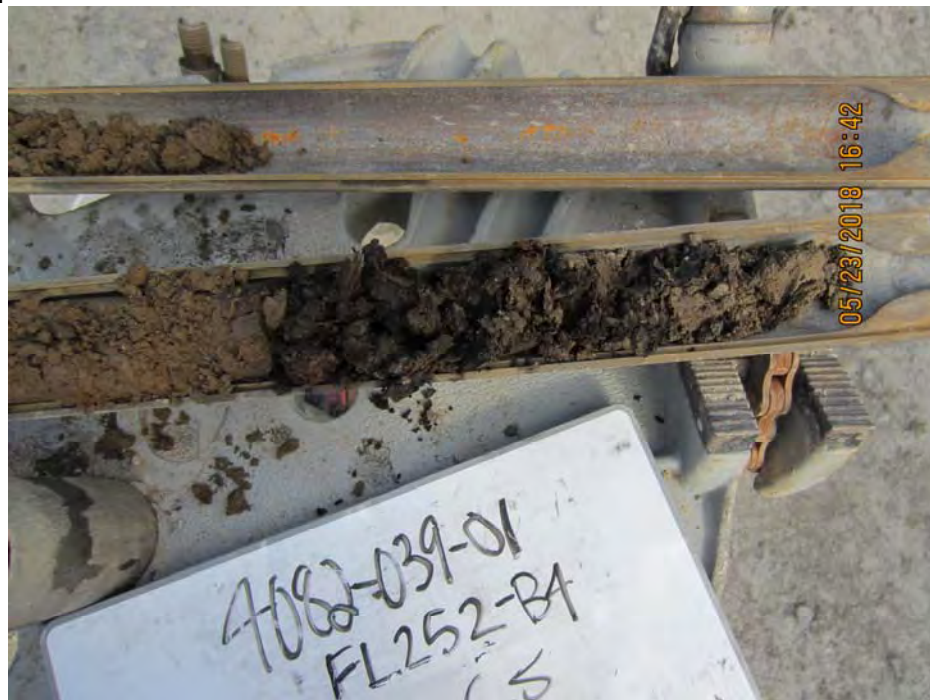
Photograph 8 – FL-252 – Exploration FL252-B4 soil core from 5 to 6.5 feet below ground surface. The dark layer contained wood chunks. Lube oil-range petroleum hydrocarbons were detected in this sample at a concentration greater than the MTCA Method A cleanup level.
