FS# 100004797

Washington State Department of Ecology
Toxics Cleanup Program

RE: REMEDIAL ACTION FINAL REPORT: REMEDIATION PROJECT •
MONTROE PROPERTY 22120 100TH AVE SE, KENT, WASHINGTON

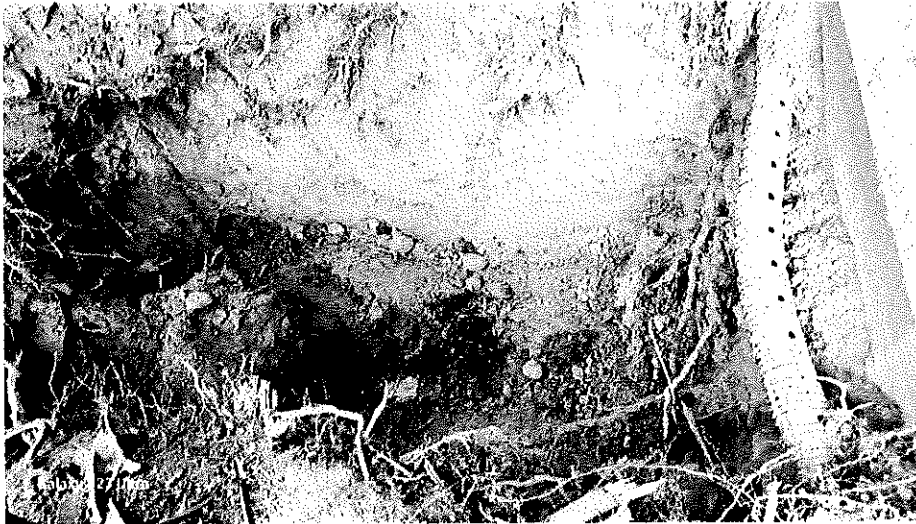
Figure No. 2.

Photo of petroleum impacted soil prior to excavation

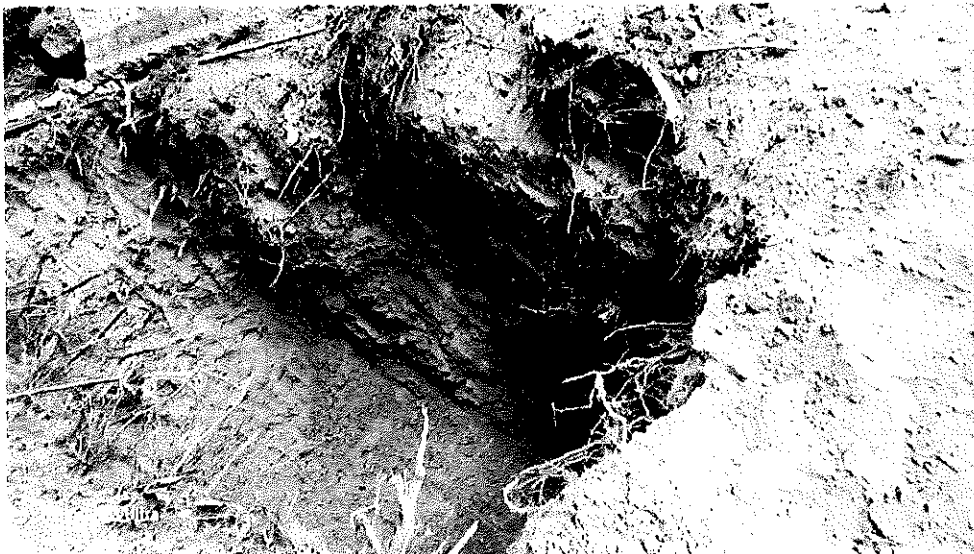
Figure No. .

Photo of the NW side of the excavation pit after the removal of 32.43 tons of PCS.

The excavation of gasoline contaminated soil was completed by Dianes Tank Removal Services, LLC and CC Edwards Construction, in June 26, 2025. Contaminated soils were excavated by CC Edwards and transported for delivery to Heidelberg Materials, Sno River Delta Soils, 17 E Marine View Drive, Everett, Washington as Petroleum Contaminated Soils (Class 3 Soils). The excavation of the project concluded with the property having had 32.43 tons of contaminated soil removed from the Project Site.

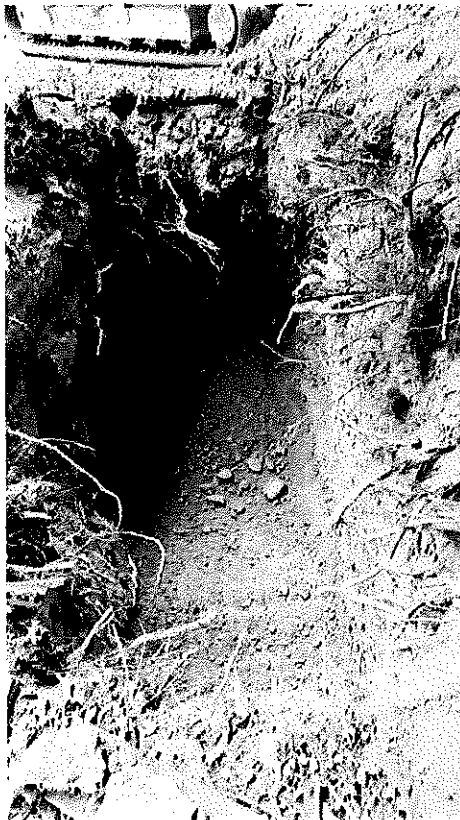
Bottom of excavation

**Photograph above depicts excavation pit after the removal of 34.28 tons of PCS from the site.*

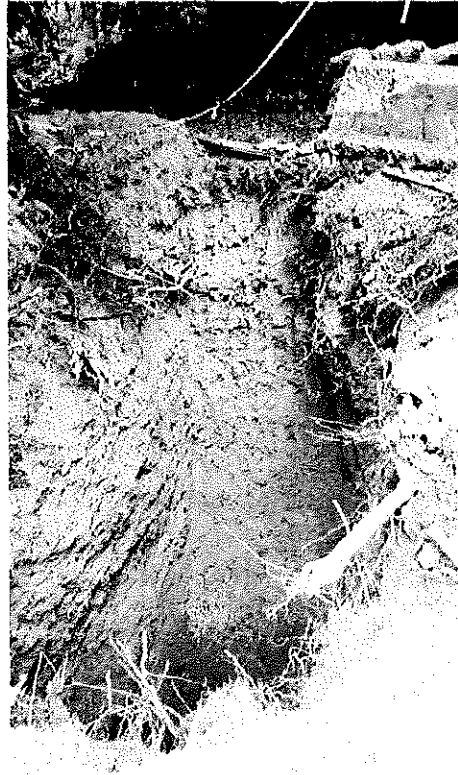
SW side of excavation

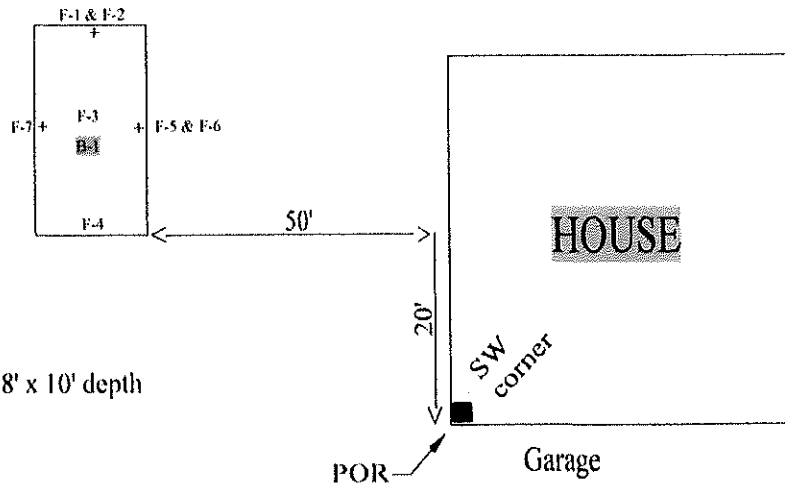
Soil Sample Locations and Mapping

*Note: Excavation pit: 14' x 8' x 10' depth
