# REMEDIAL INVESTIGATION REPORT

Texaco Strickland Site

Prepared for: Strickland Real Estate Holdings, LLC and  
Chevron Environmental Management Company

Project No. 180357 • January 19, 2026 • FINAL

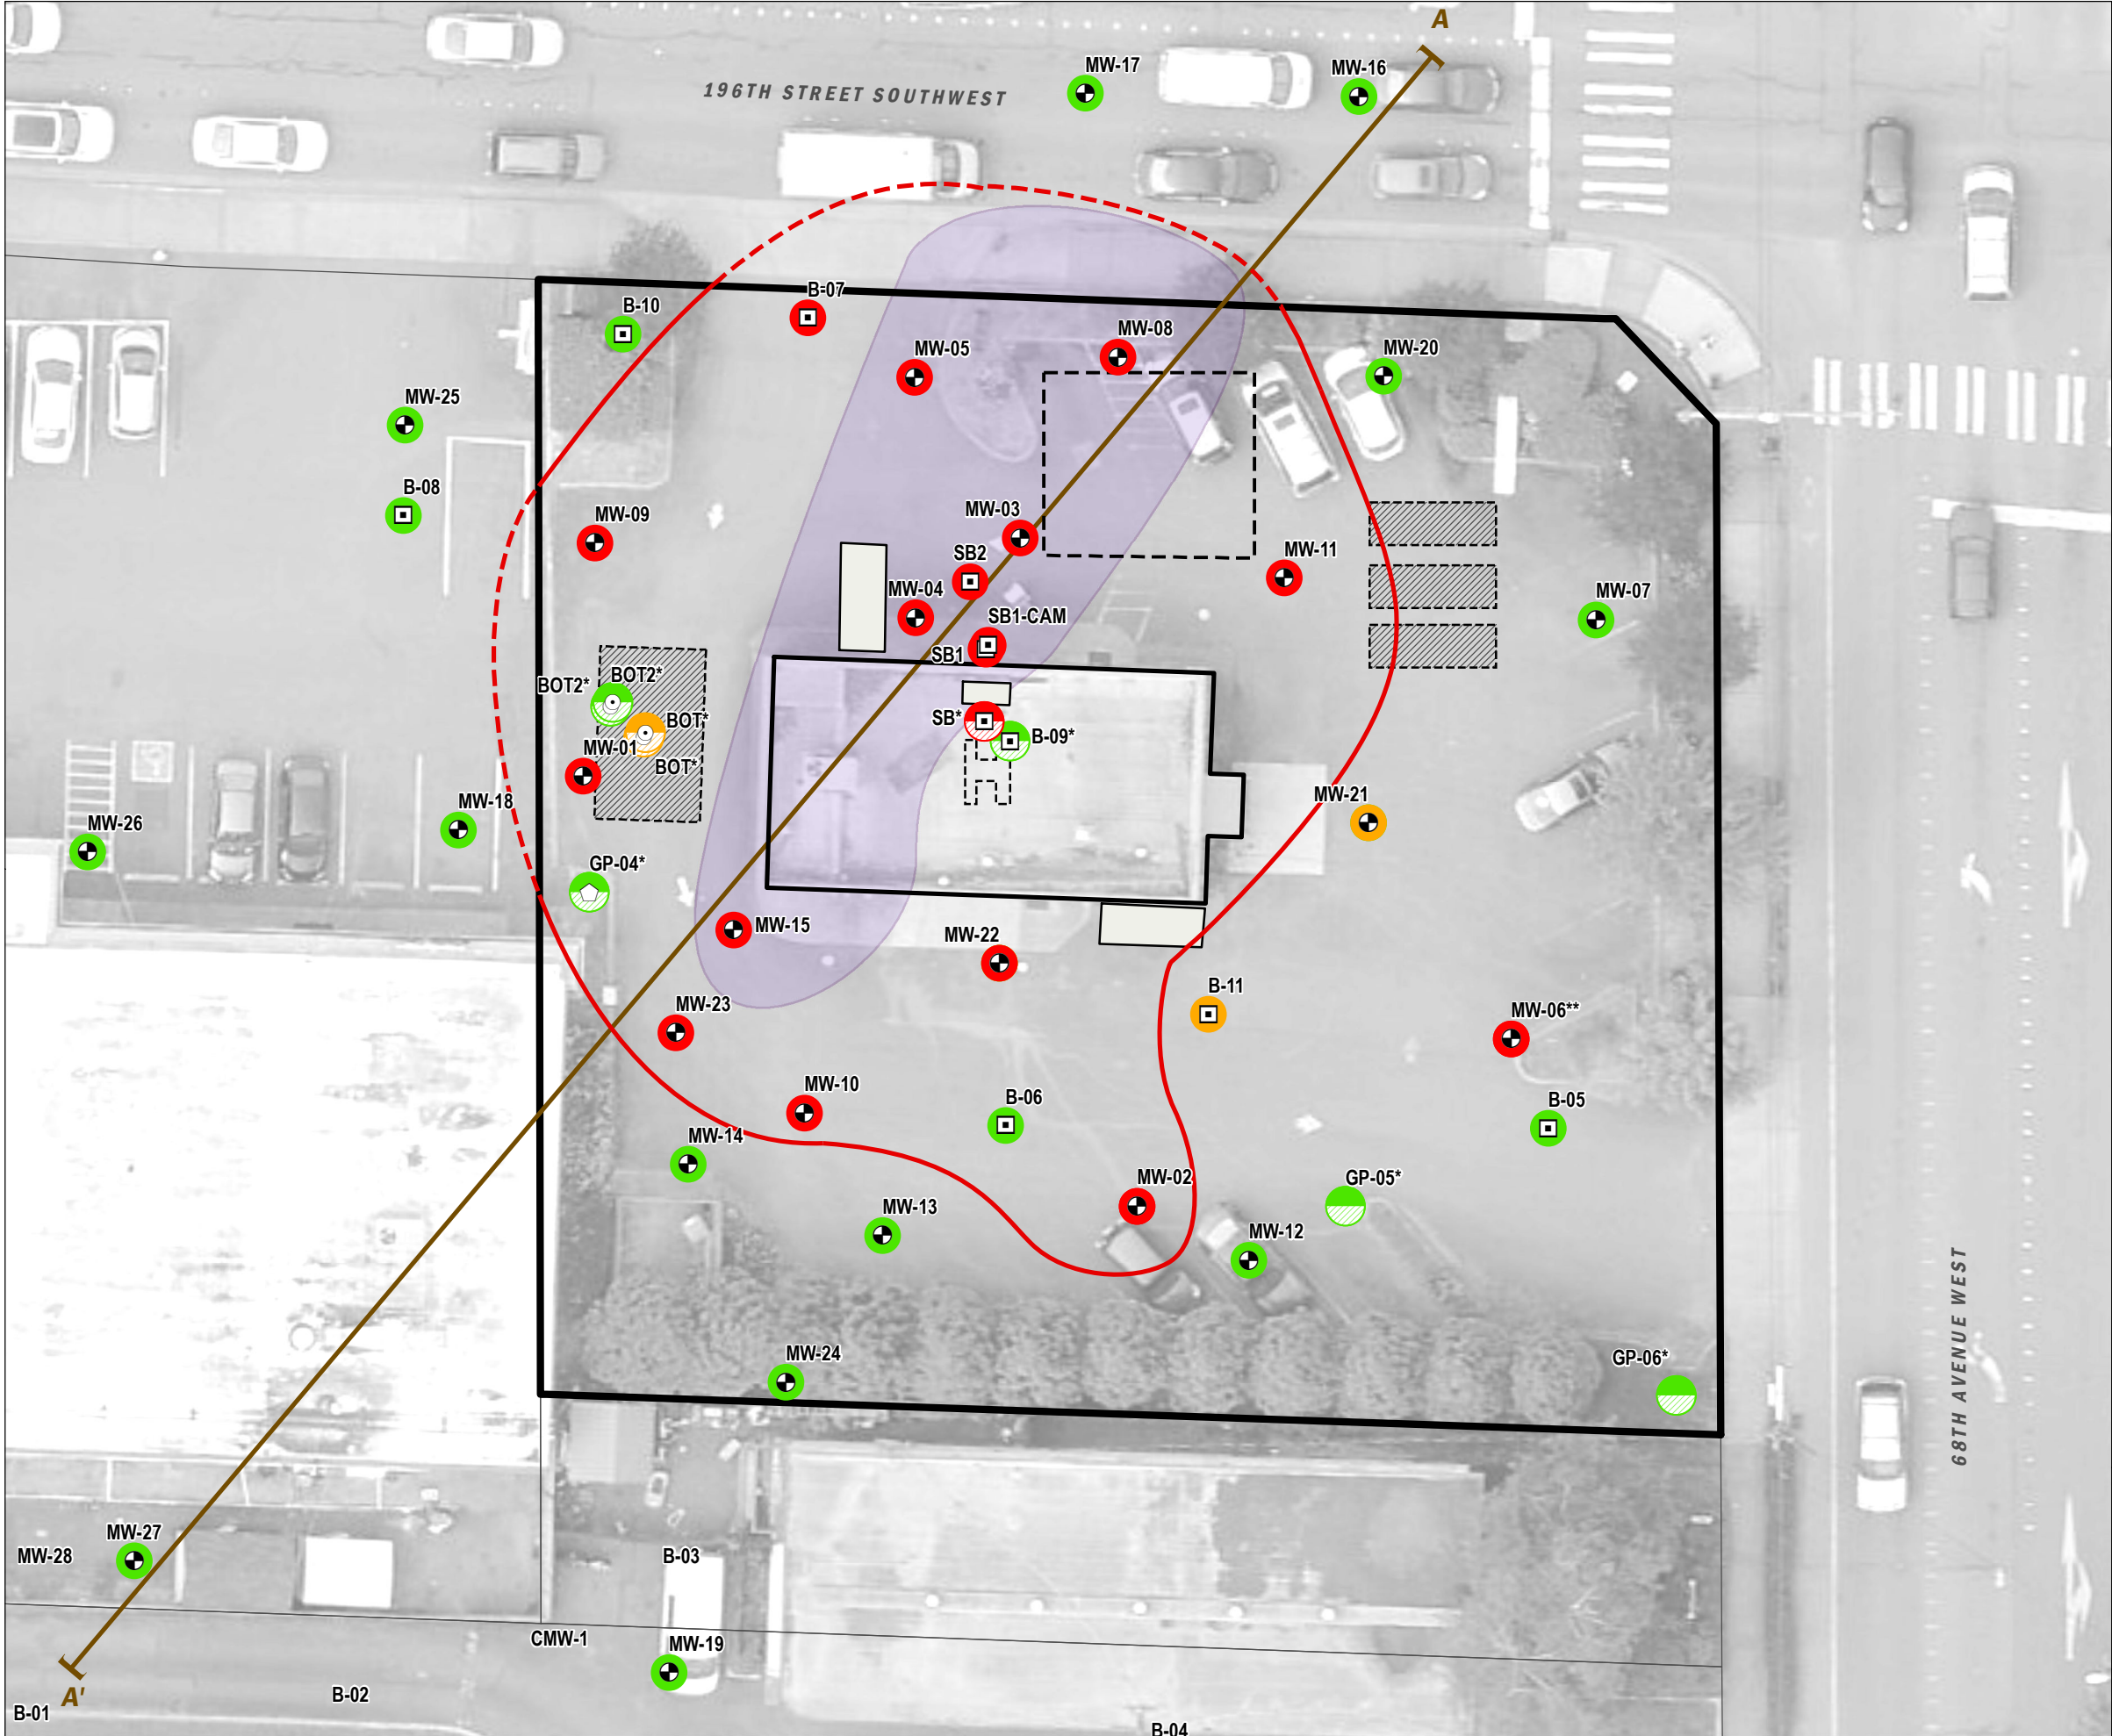
FIGURE NO.  
**3**

- One or more analytes detected at concentrations greater than the MTCA Method A cleanup levels in soil.
- One or more analytes detected at concentrations less than the MTCA Method A cleanup levels in soil.
- Analytes not detected.

\* Shallow Soil Sample Result  
(less than 5 feet below ground surface)

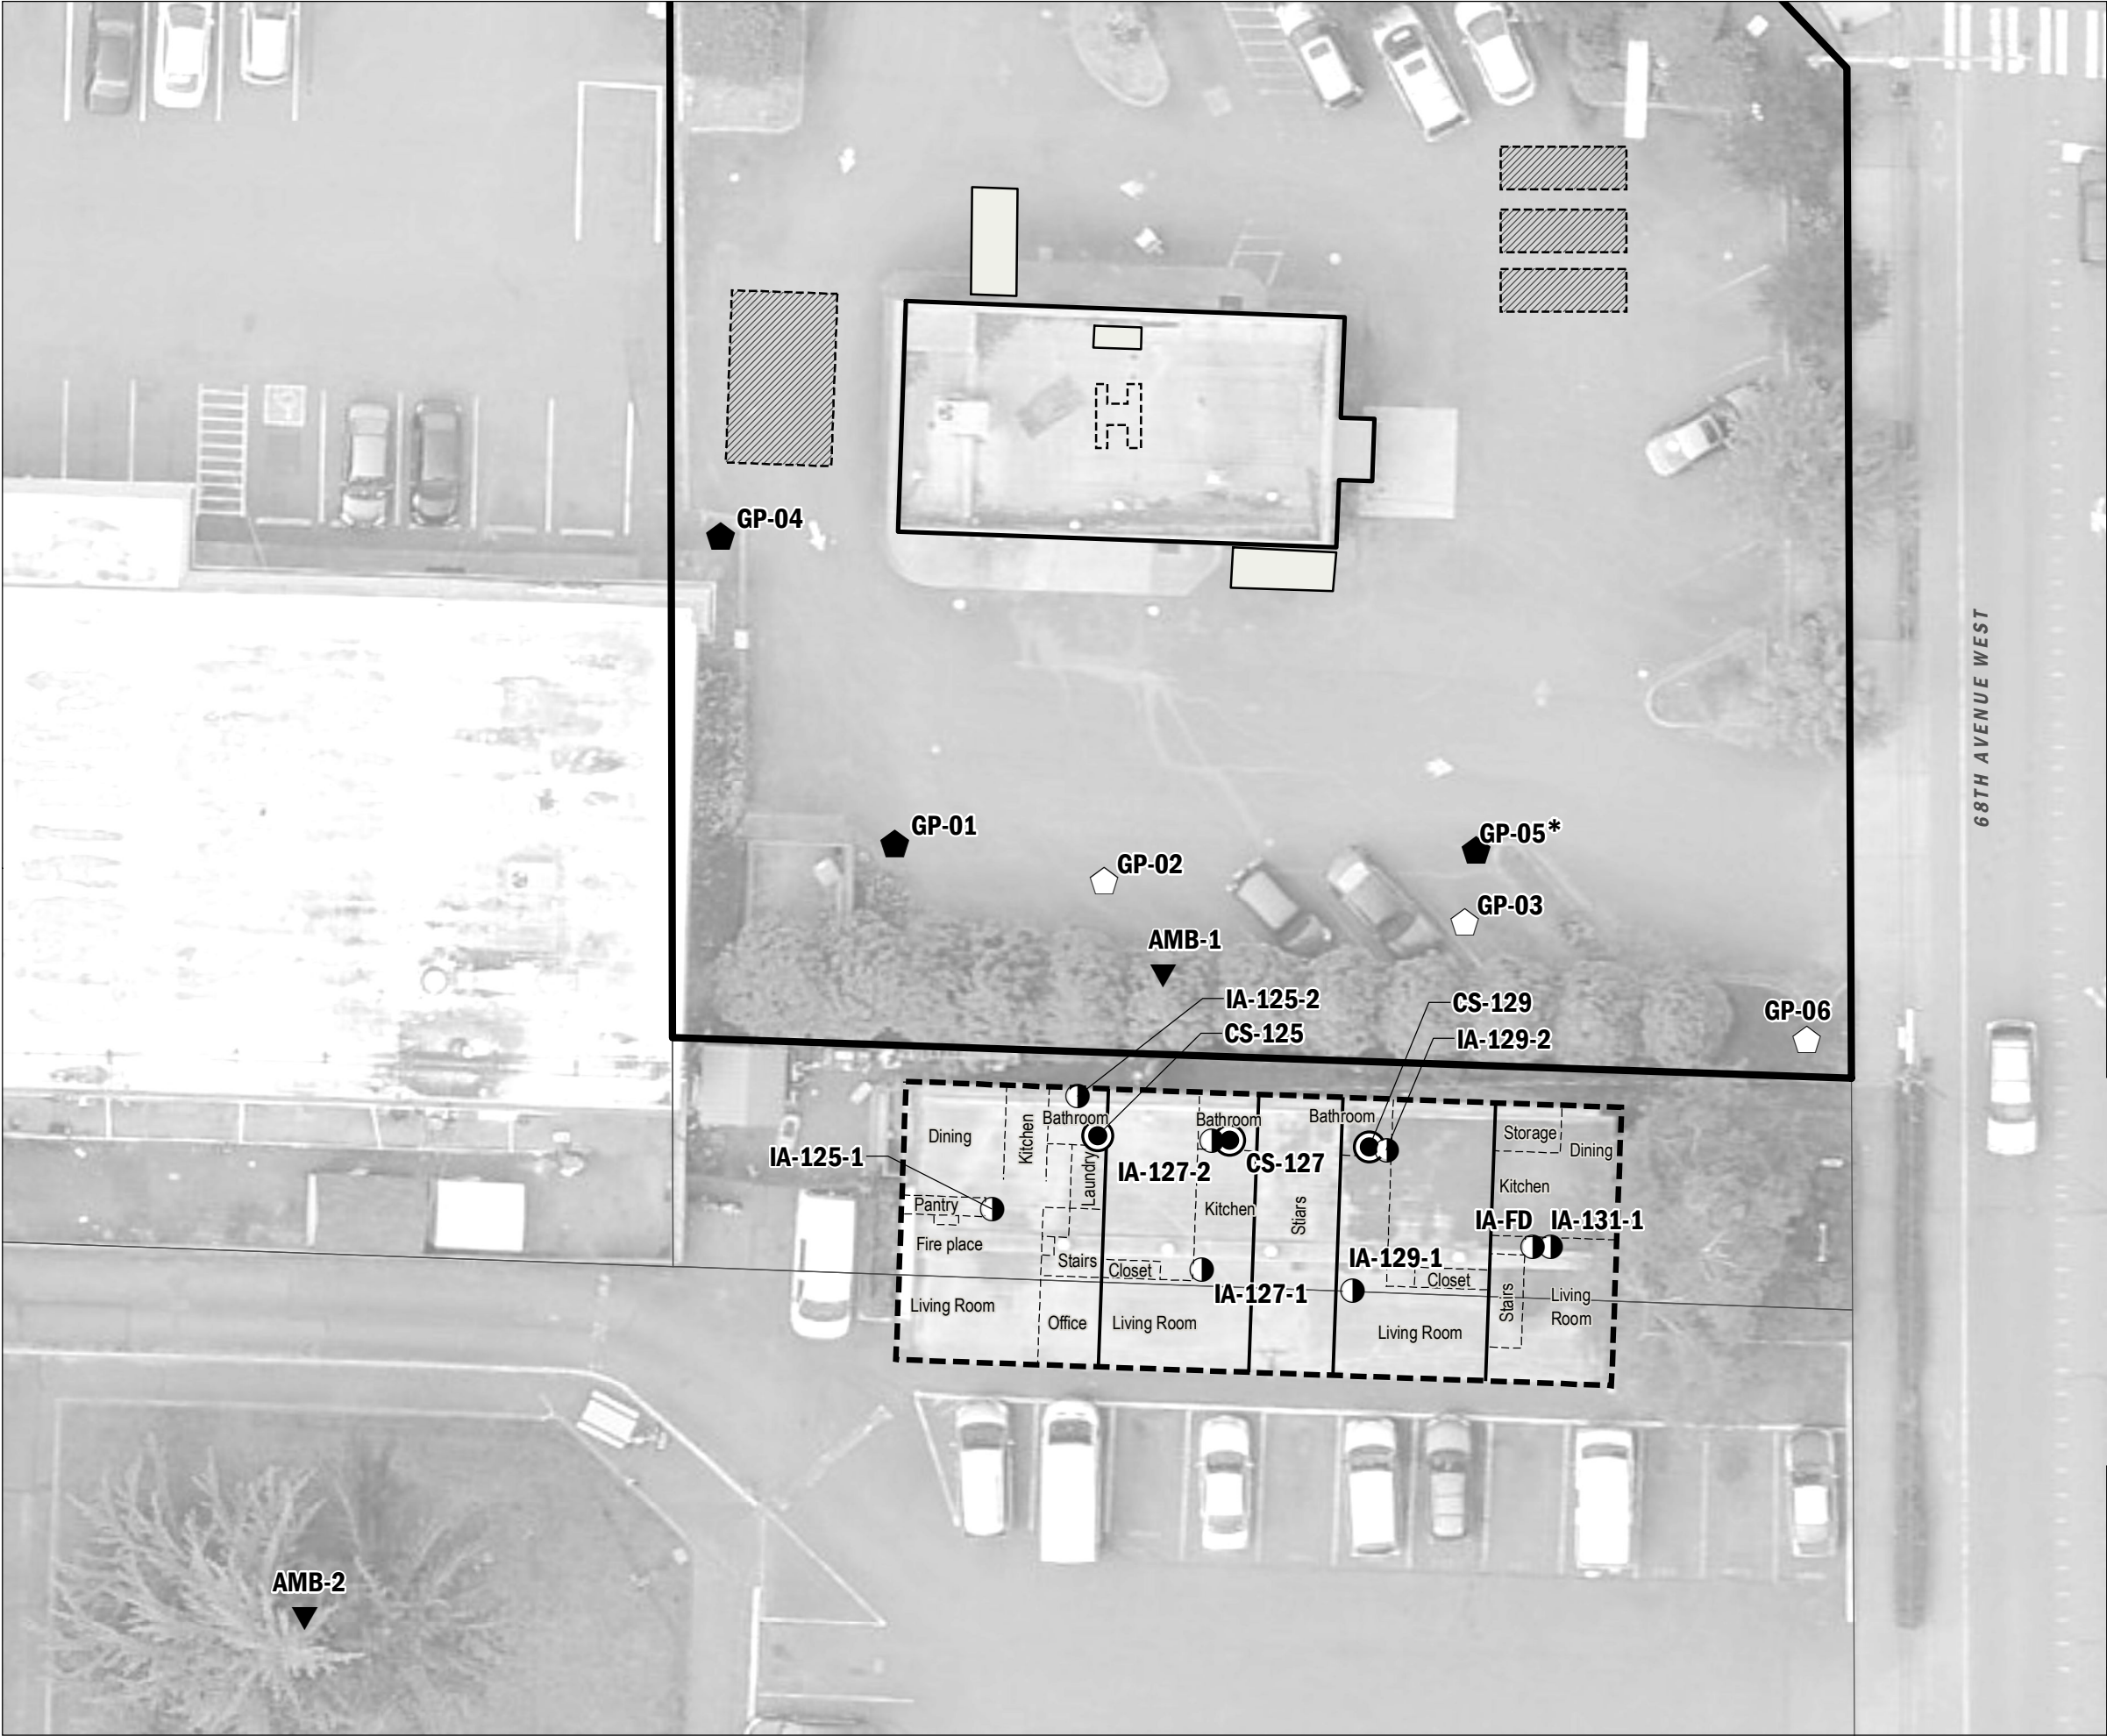
- Crawlspace Air Sampling Location
- Indoor Air Sampling Location
- Ambient Air Sampling Location
- Soil Gas Probe
- Soil Vapor Sample (Not Sampled During This Event)
- Aloha Cafe Building
- Chri-Mar Apartment Building
- Property Boundary
- Former UST (Removed)
- Existing UST (Closed-In-Place or Abandoned)
- Tax Parcel

Based on the results of July 2021 crawlspace air sampling, additional investigation of the potential vapor intrusion exposure pathway within residential spaces in the Chri-Mar Apartments building was required to complete the Tier II vapor intrusion assessment. The following section details the Tier II vapor intrusion assessment, consisting of sampling events in December 2021, November 2022, January 2023, and February 2023. The approach and scope of work was detailed in the Vapor Intrusion Assessment Results and Recommendations Memorandum (VIARRM, Aspect, 2021c) and the sampling results are presented in Section 4.4.3. All sample locations from the vapor intrusion sampling events are shown on Figure 7.
