# REMEDIAL INVESTIGATION WORK PLAN

DESC Belmont Permanent Supportive  
Housing Project

1727, 1733, and 1737 Belmont Avenue  
Seattle, Washington

Project No. AS240571 • December 1, 2025 FINAL

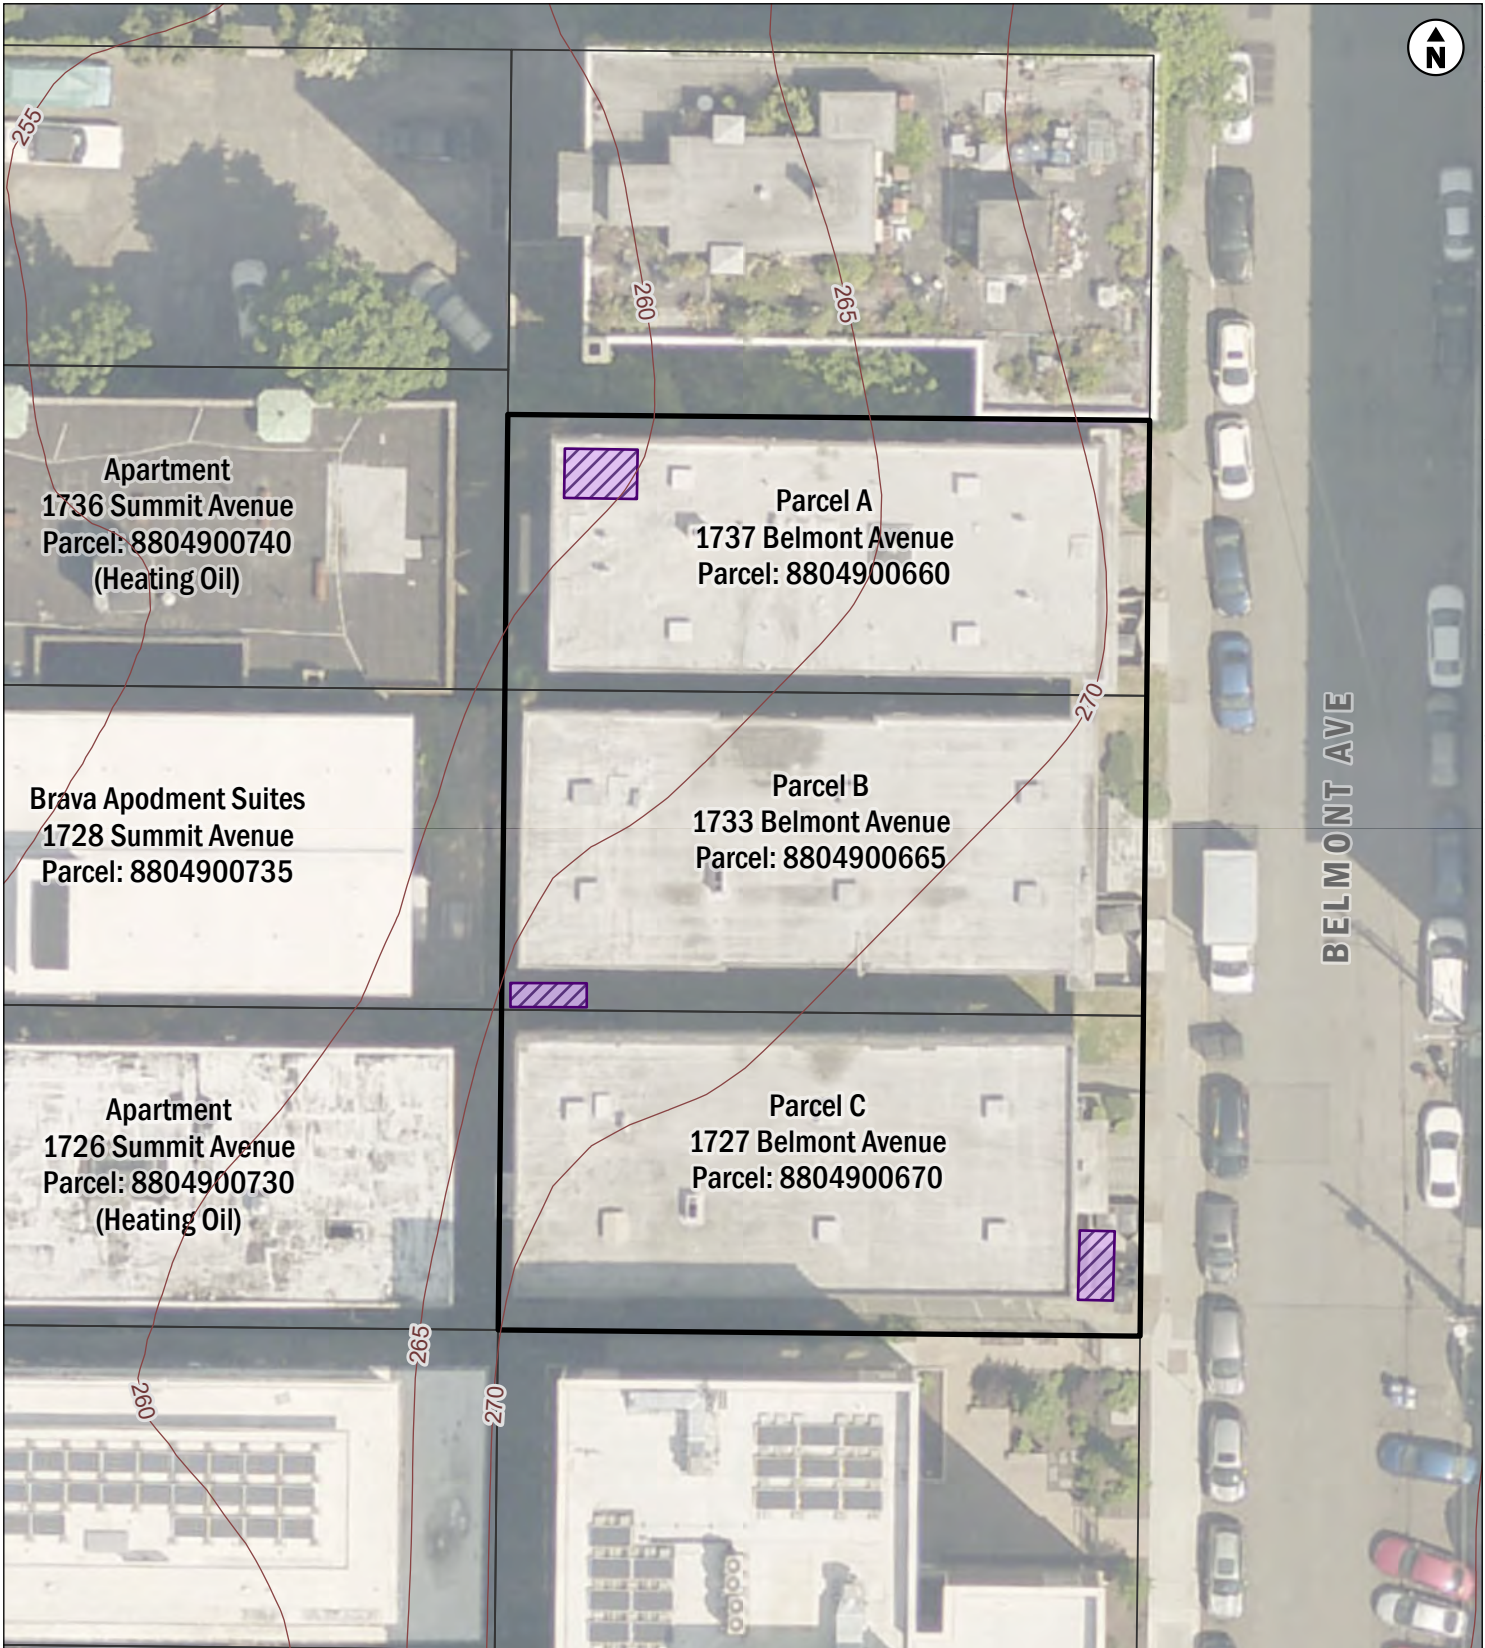
AUG-2025	BY: HRC / HMD	FIGURE NO. <b>2</b>
	PROJECT NO. AS240571	REVISED BY: KMJ

- Decommissioned Heating Oil UST
- Site Property
- King County Tax Parcel
- Elevation Contour (5-ft interval)

Each of the three buildings on the Subject Property were historically heated by oil-burning furnaces (SES, 2024). The fuel for each furnace was primarily stored in an UST located on each of the three Parcels below the foundation slabs, shown in Figure 2. Additionally, an aboveground storage tank (AST) that formerly contained heating oil was observed in the mechanical room of the building on Parcel A of the Subject Property (SES, 2023). This AST was removed during building demolition in 2025. The oil-burning furnaces were used until at least 1995 when the buildings' heating systems were converted to natural gas. All three USTs were then decommissioned in place in 1996, as described below.

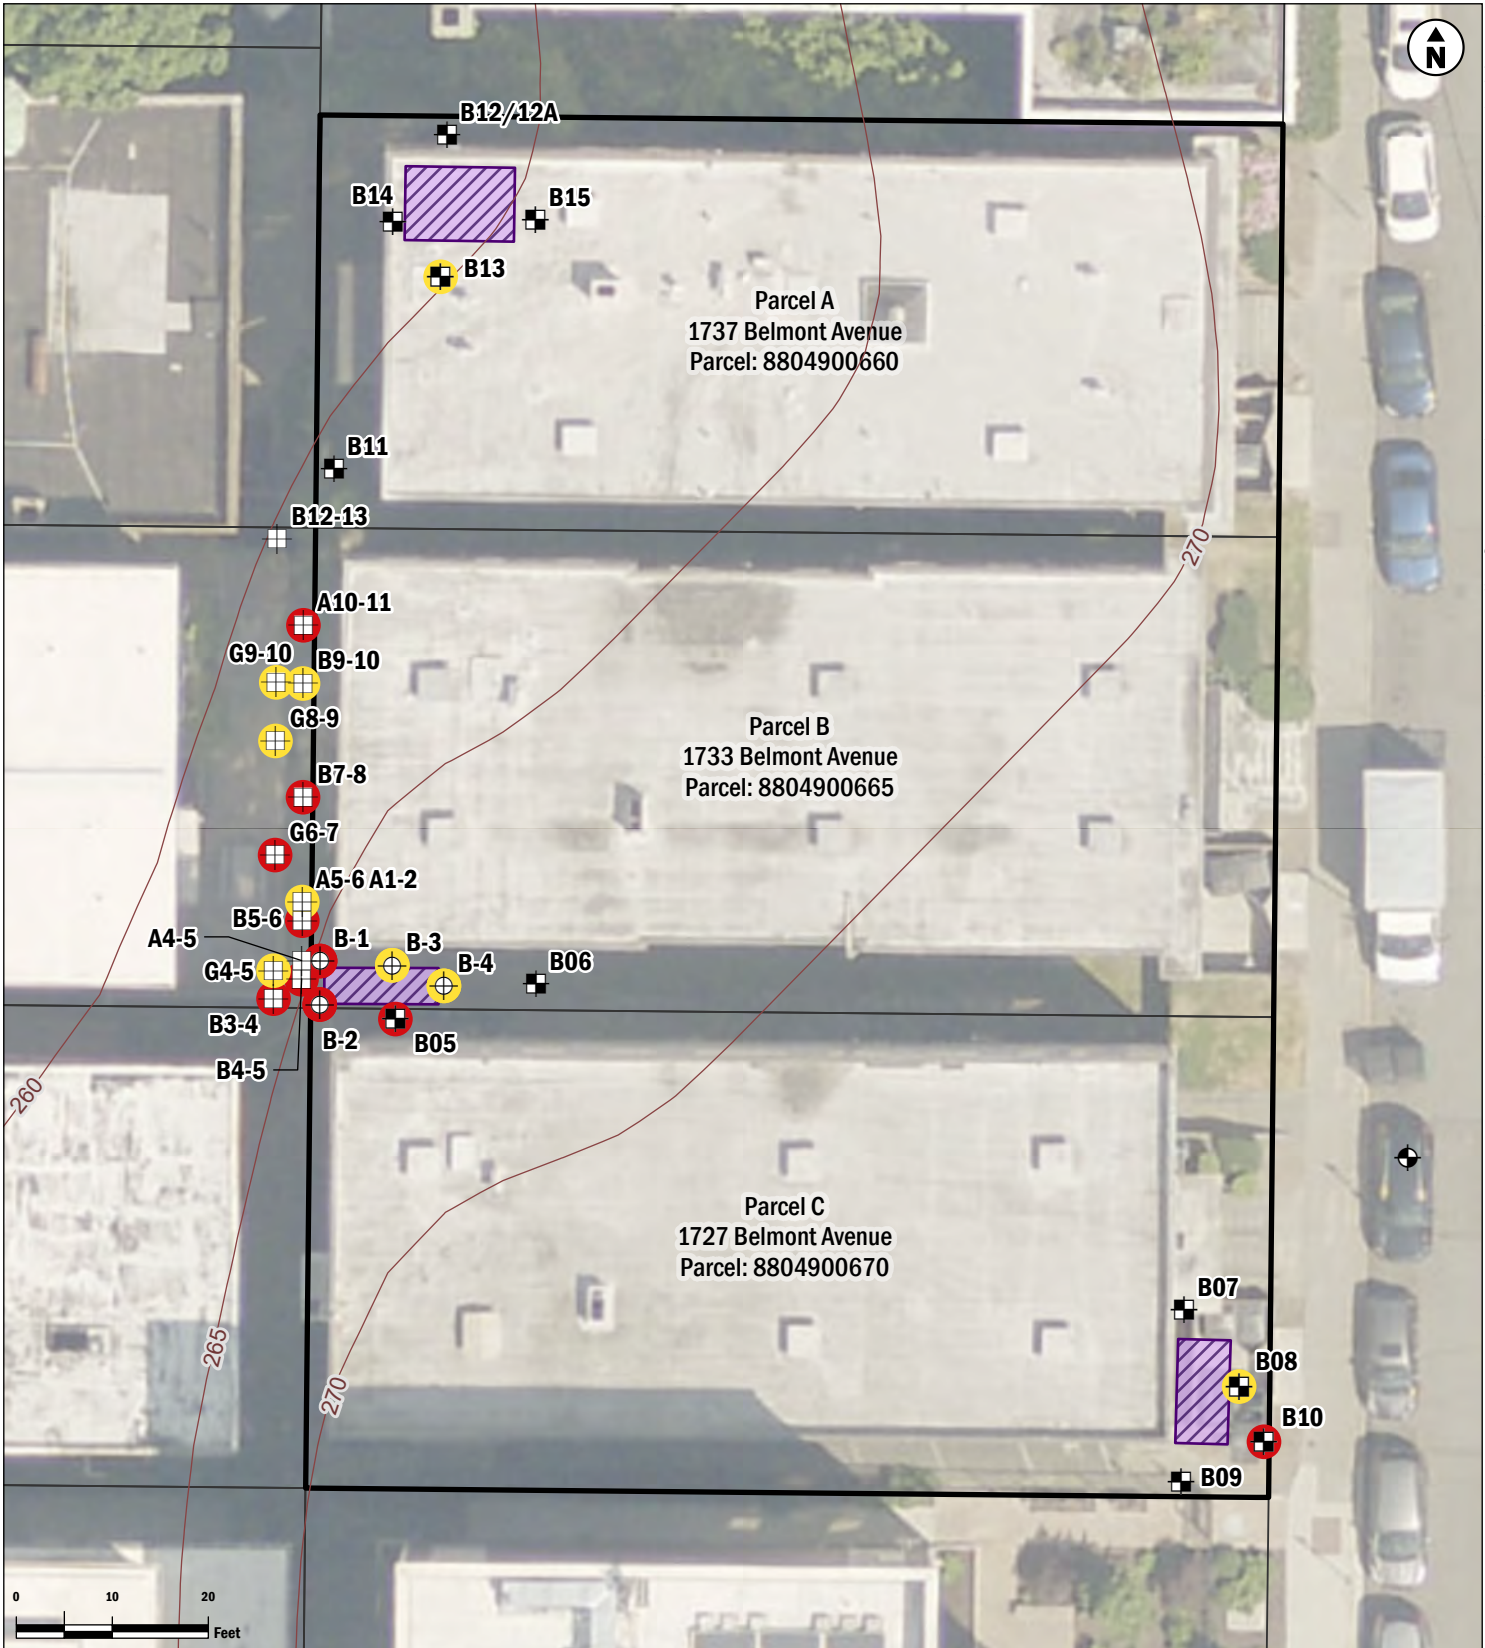
AUG-2025 <small>PROJECT NO. AS240571</small>	BY: HRC / HMD REVISED BY: KMJ	FIGURE NO. <span style="font-size: 24pt; font-weight: bold;">3</span>
---	--	--

<p><span style="color: red;">●</span> Denotes TPH-D and/or TPH-O in soil at concentrations exceeding MTCA Method A Cleanup Levels</p> <p><span style="color: yellow;">●</span> Denotes TPH-D and/or TPH-O in soil at concentrations below MTCA Method A Cleanup Levels</p> <p><span style="border: 1px solid black; border-radius: 50%; padding: 2px;">⊕</span> PBS Boring (2017)</p> <p><span style="border: 1px solid black; padding: 2px;">⊕</span> PBS Soil Sample (2017)</p>	<p><span style="border: 1px solid black; border-radius: 50%; padding: 2px;">⊕</span> PBS Groundwater Monitoring Well</p> <p><span style="border: 1px solid black; padding: 2px;">⊕</span> SoundEarth Boring (2017)</p> <p><span style="background-color: #ccccff; border: 1px solid black; padding: 2px;">▭</span> Decommissioned Heating Oil UST</p> <p><span style="border: 1px solid black; padding: 2px;">▭</span> Site Property</p> <p><span style="border: 1px solid black; padding: 2px;">▭</span> King County Tax Parcel</p> <p><span style="color: red;">~</span> Elevation Contour (5-ft interval)</p>

Previous environmental investigations were conducted at the Site between 1995 and 2024, as described in this section. We performed a site visit on July 31, 2025, to document the condition of the Subject Property. Information and data collected during that site visit are included in this section. Historical exploration locations are shown in Figure 3 and historical data is summarized in Table 1.

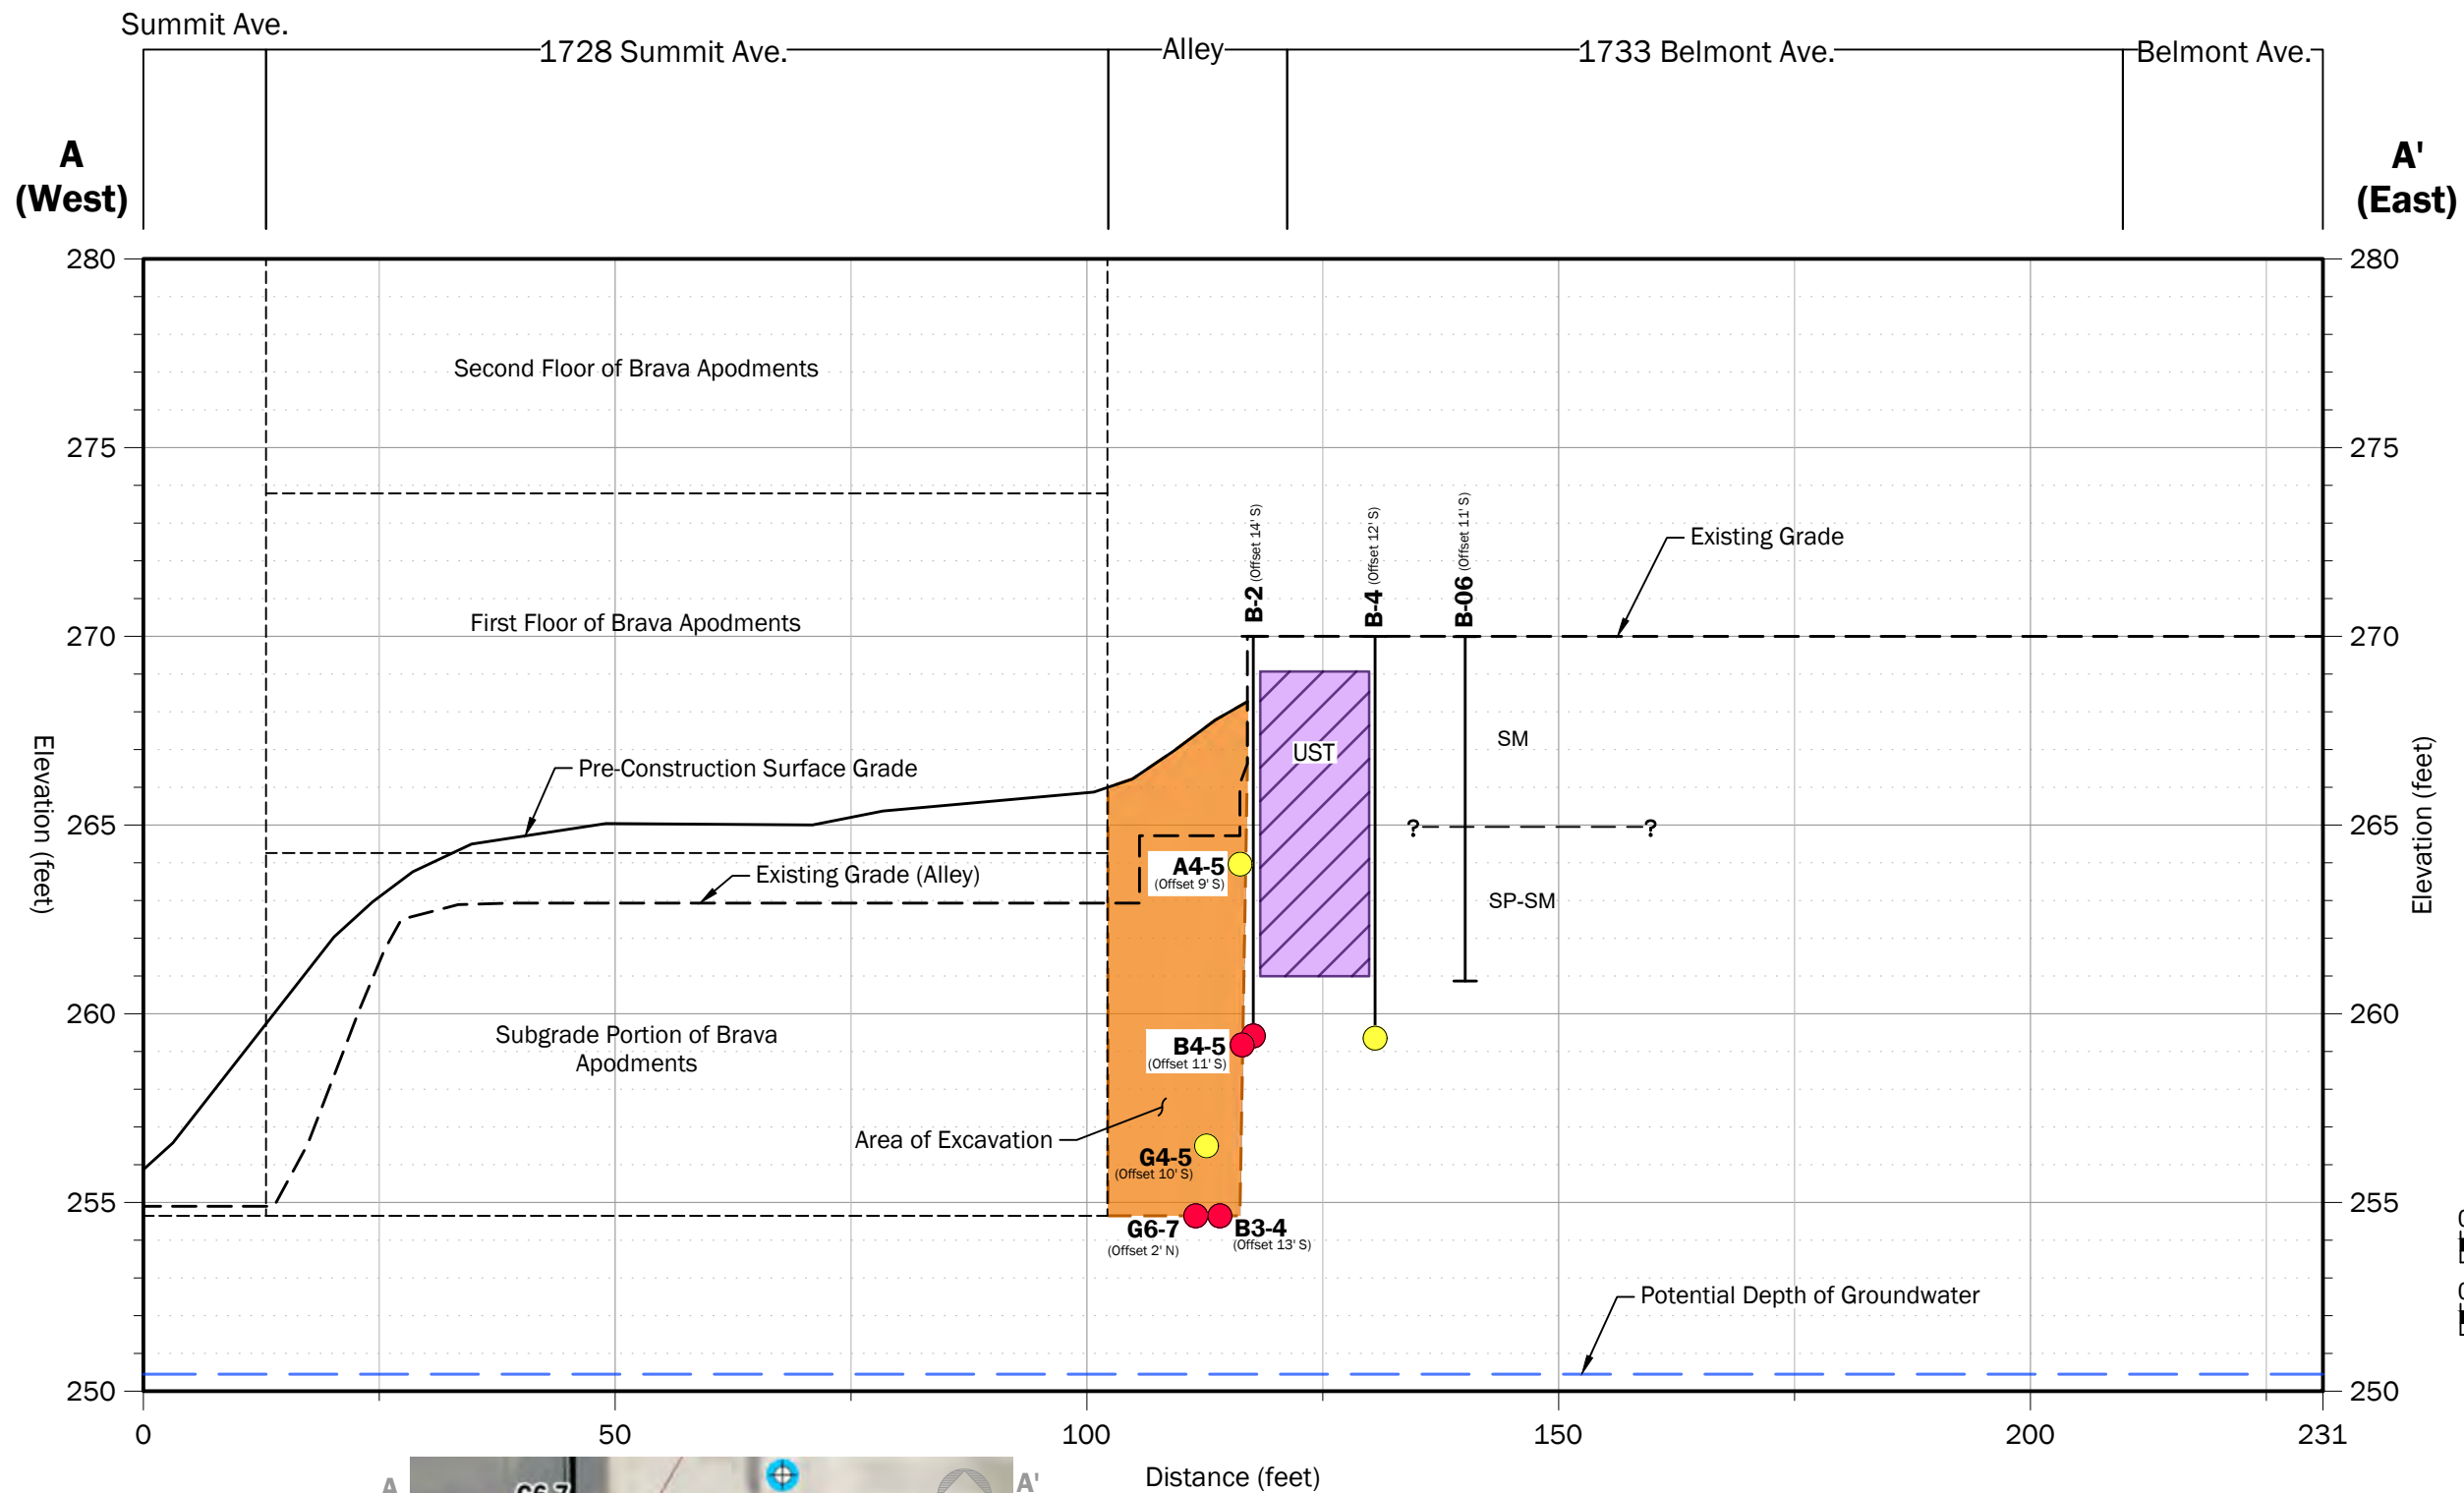
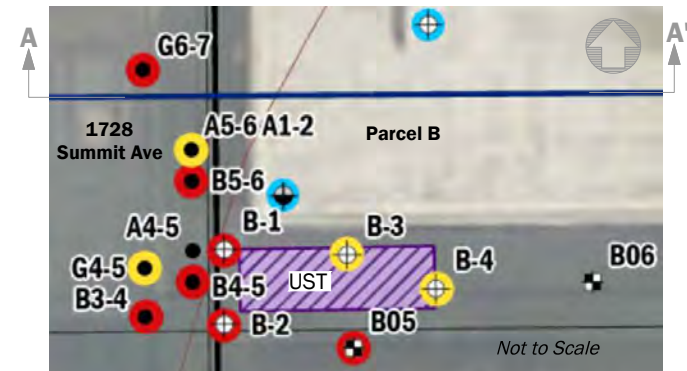
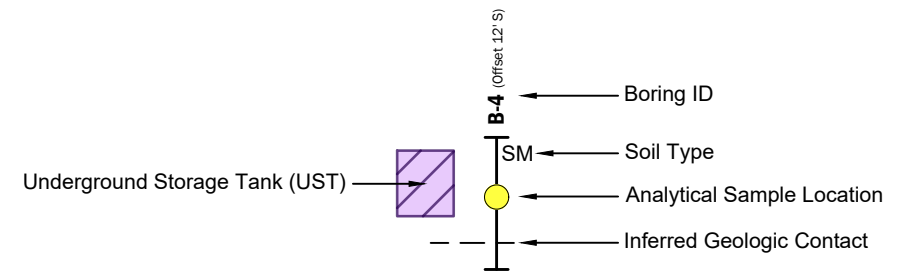
<p><b>Cross-Section A-A'</b></p> <p>Remedial Investigation Work Plan DESC Belmont Permanent Supportive Housing Project 1727, 1733, and 1737 Belmont Avenue Seattle, Washington</p>	
	<p><b>FIGURE 6</b></p>
<p>PROJECT NO: AS240571</p>	<p>NOVEMBER 2025</p>

- Analytical Results**
- One or more of contaminants of concern detected at a concentration greater than the MTCA Method A cleanup level.
  - One or more of contaminants of concern detected at a concentration less than the MTCA Method A cleanup level.
  - Contaminants of concern not detected.
- Soil Types**
- SM: USCS Silty Sand
  - SP-SM: USCS Poorly-graded Sand with Silt

Soil observed in previous investigations at the Subject Property consisted of brown silty sand with gravel, tan to brown sandy silt, and tan to brown sand with silt and fine gravel to the maximum explored depth of 12 feet bgs (SES, 2024).

Proposed exploration depths and soil sample intervals for this field program were chosen based on the assumption that the elevation of the foundational building slab is equivalent to the 'ground surface elevation'. The ground surface elevation was used as a point of reference by historical investigations, as the current ground surface at the Subject Property was artificially raised to the elevation of Belmont Avenue with imported backfill (approximately 6 feet above the building foundation).
