**2006 INTERIM REMEDIAL MEASURES COMPLETION REPORT
FOR THE BEE-JAY SCALES SITE**

**Chevron Environmental Management Company
& BP America, Inc.**

December 14, 2007
24CH.67201.00

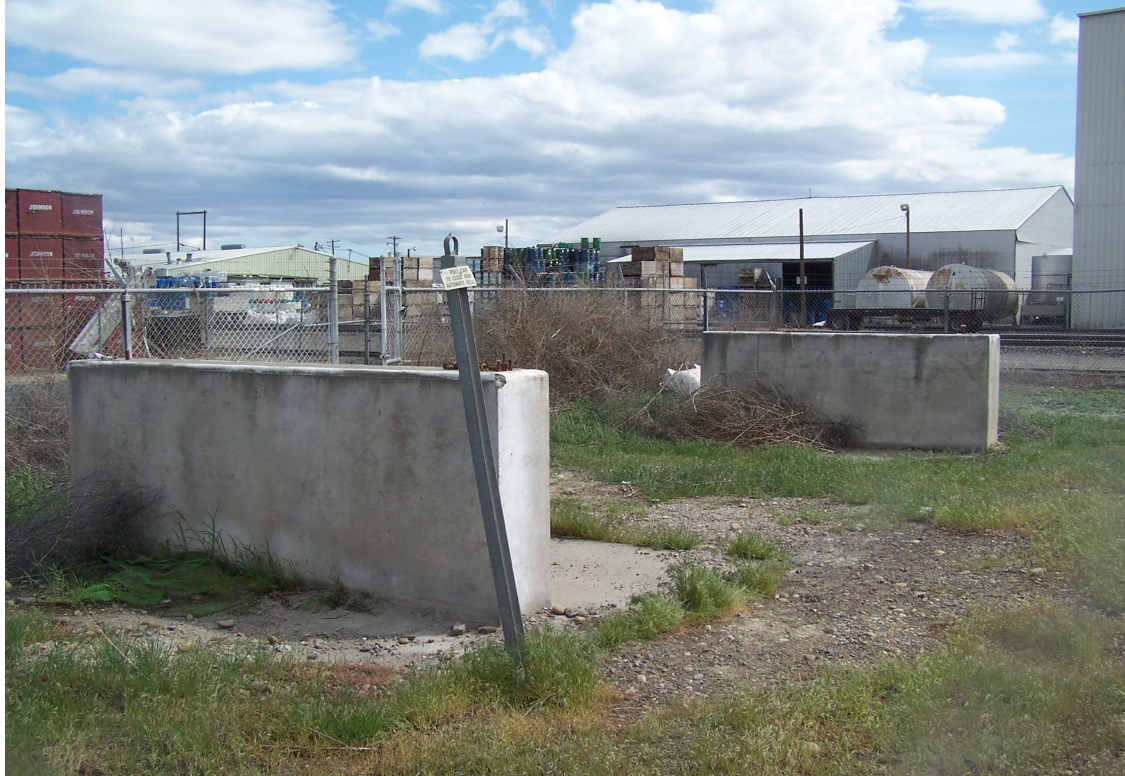
PHOTO No. 1

Concrete tank saddles and debris removed during closure activities.

The concrete tank saddles (approximately 4 feet high by 10 feet long by 12 inches thick), associated concrete slab (approximately 12 feet long by 12 feet wide by 12 inches thick), concrete debris pile (approximately 11 feet in diameter by 6 feet high), and miscellaneous debris and brush located to the west of the lagoon were removed to eliminate potential safety hazards and allow heavy equipment access to the lagoon. All concrete was broken into pieces of less than 3 feet in size, and the concrete, debris, and brush were loaded into dump trucks and trucked off-site to Alba Excavating in Grandview, Washington.

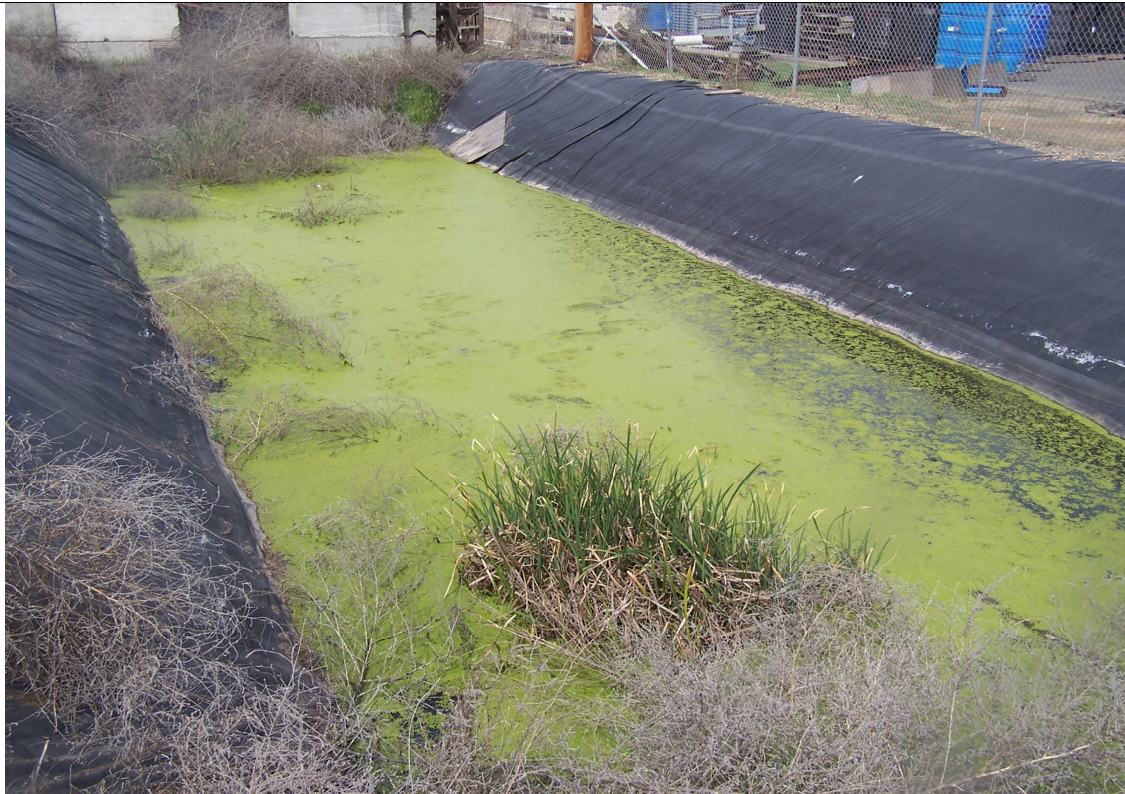
PHOTO No. 2

Lagoon prior to closure activities.

The lagoon was observed to be sloped, with a footprint approximately 67 feet long by 28 feet wide at the top, and a footprint approximately 53 feet long by 16 feet wide at the base. The approximate depth of the lagoon was 10 feet, with 3 feet of water present at the time of closure. The water in the lagoon was sampled during the site visit in order to generate a profile for disposal.

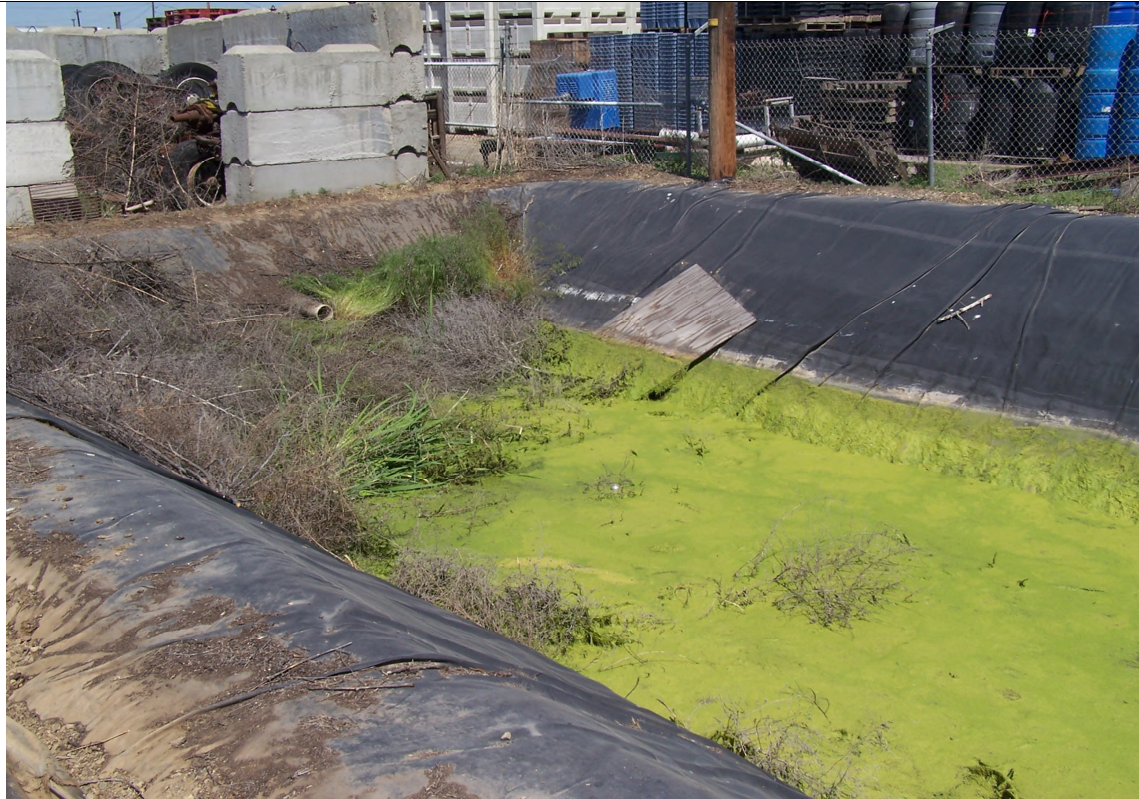
PHOTO No. 3

Lagoon and debris prior to closure activities.

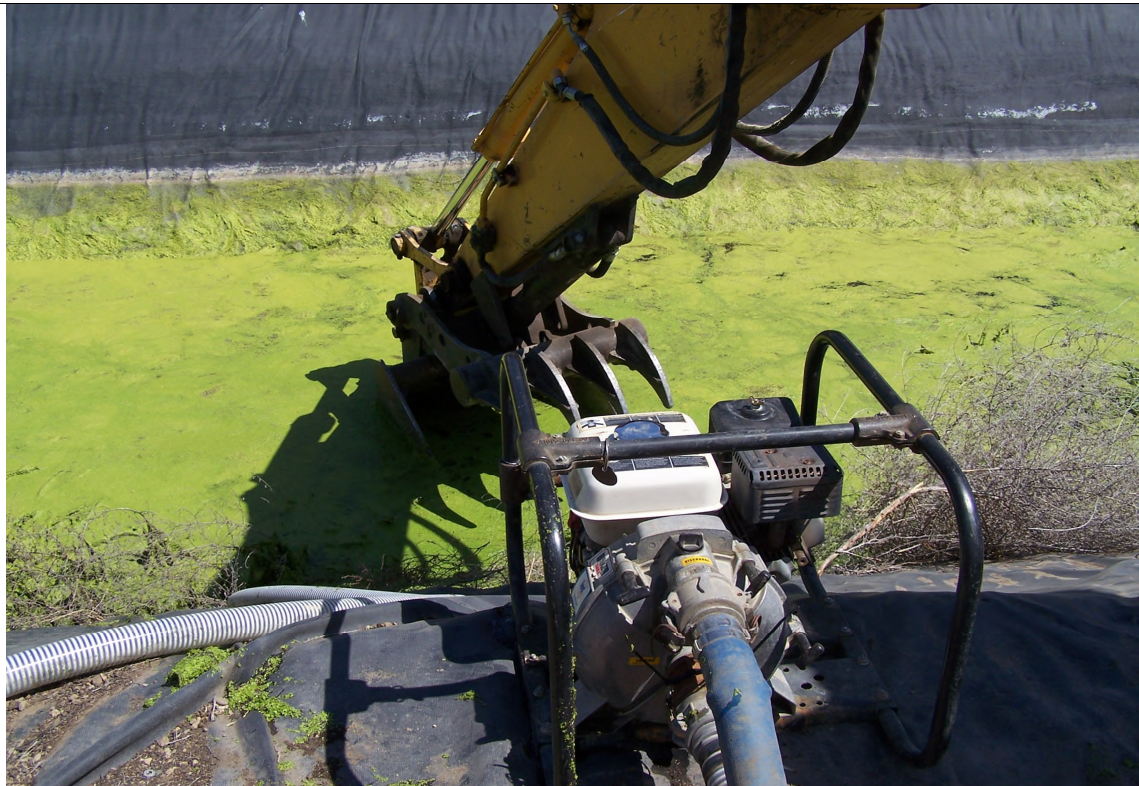
PHOTO No. 4

Removal of lagoon material and water.

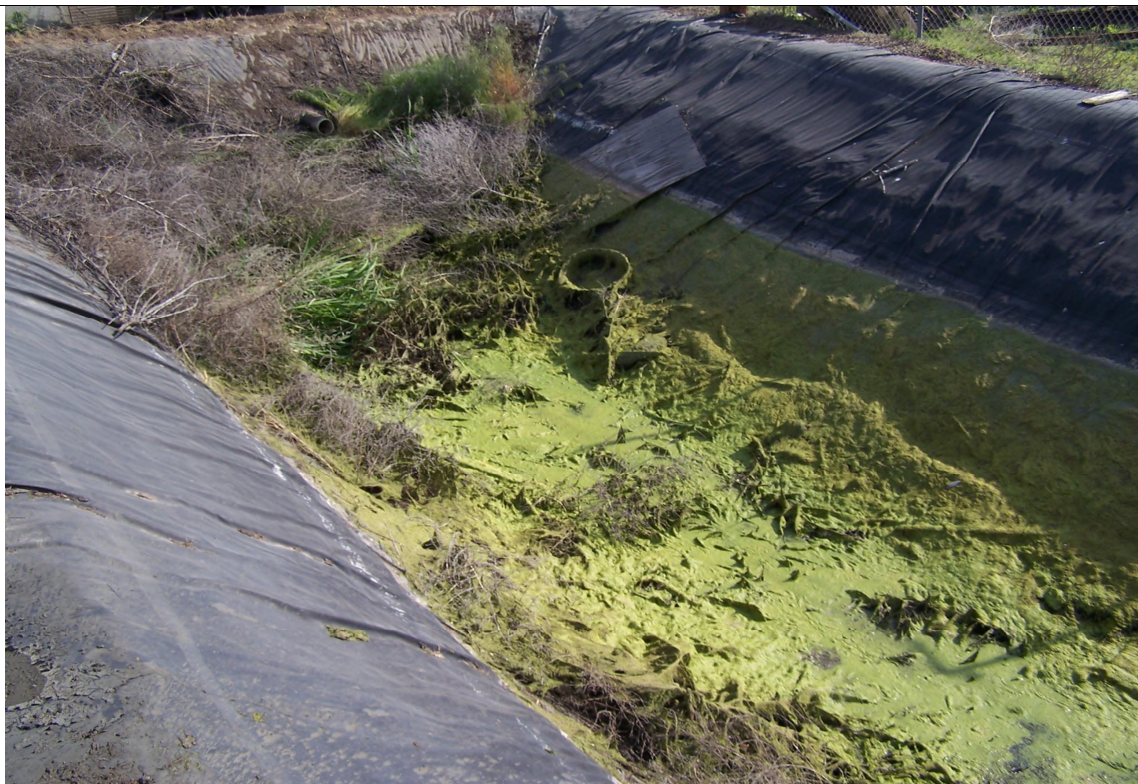
PHOTO No. 6

Lagoon following water removal.

Following removal of the lagoon water, approximately 1-foot of sediment/sludge was observed in the bottom of the lagoon. Approximately 15 cubic yards (cy) of sand and 28 cy of sawdust were mixed into the lagoon sediment/sludge using the excavator bucket to stabilize it and remove any moisture before transport. The stabilized sediment/sludge was loaded into lined roll-offs.

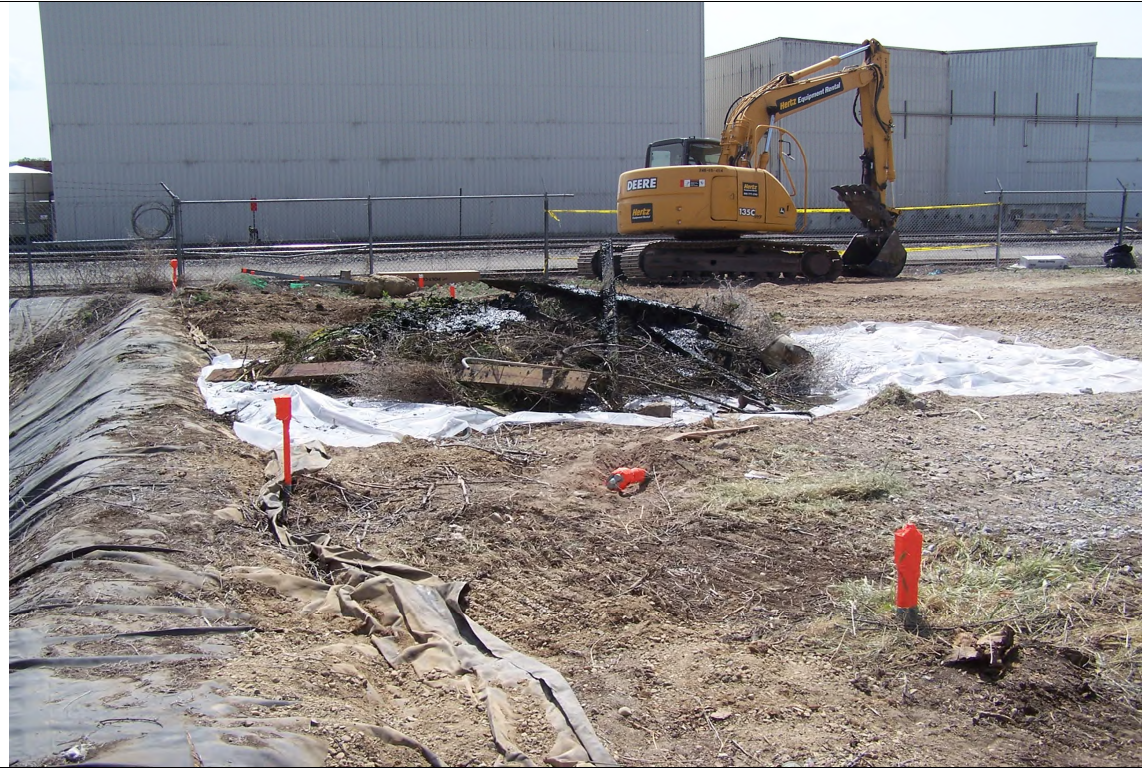
PHOTO No. 7

Debris removal from lagoon.

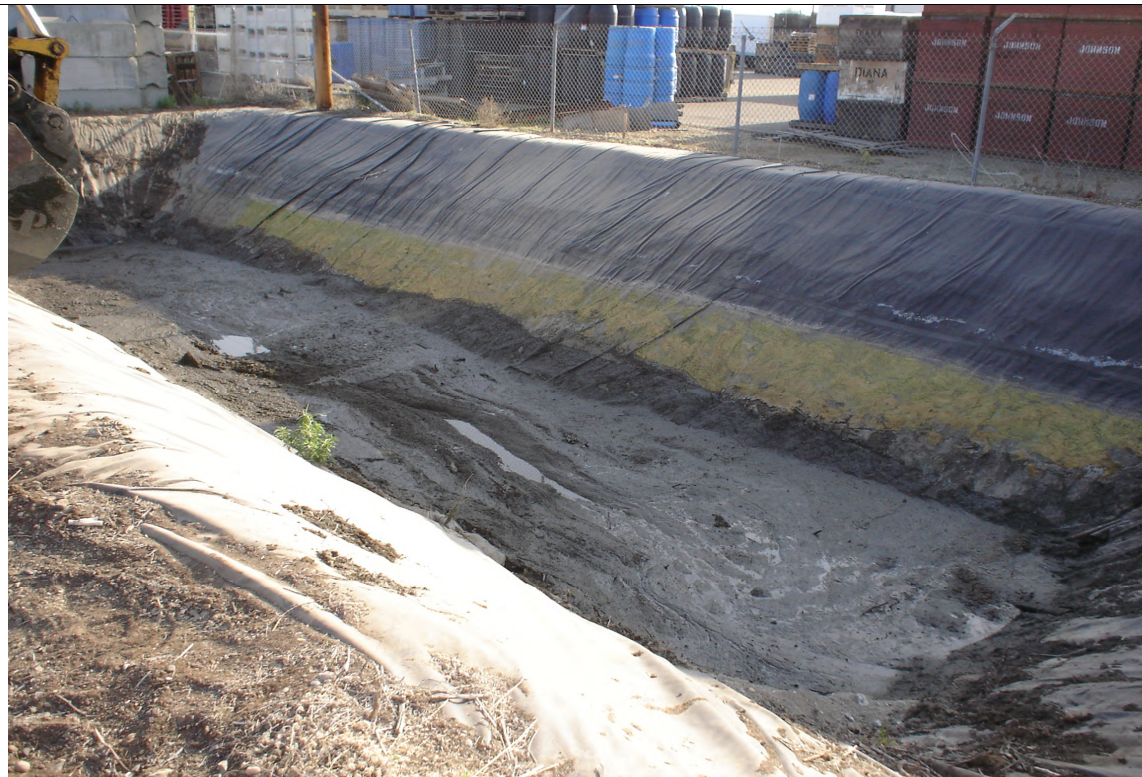
PHOTO No. 8

Lagoon after water and debris removal.

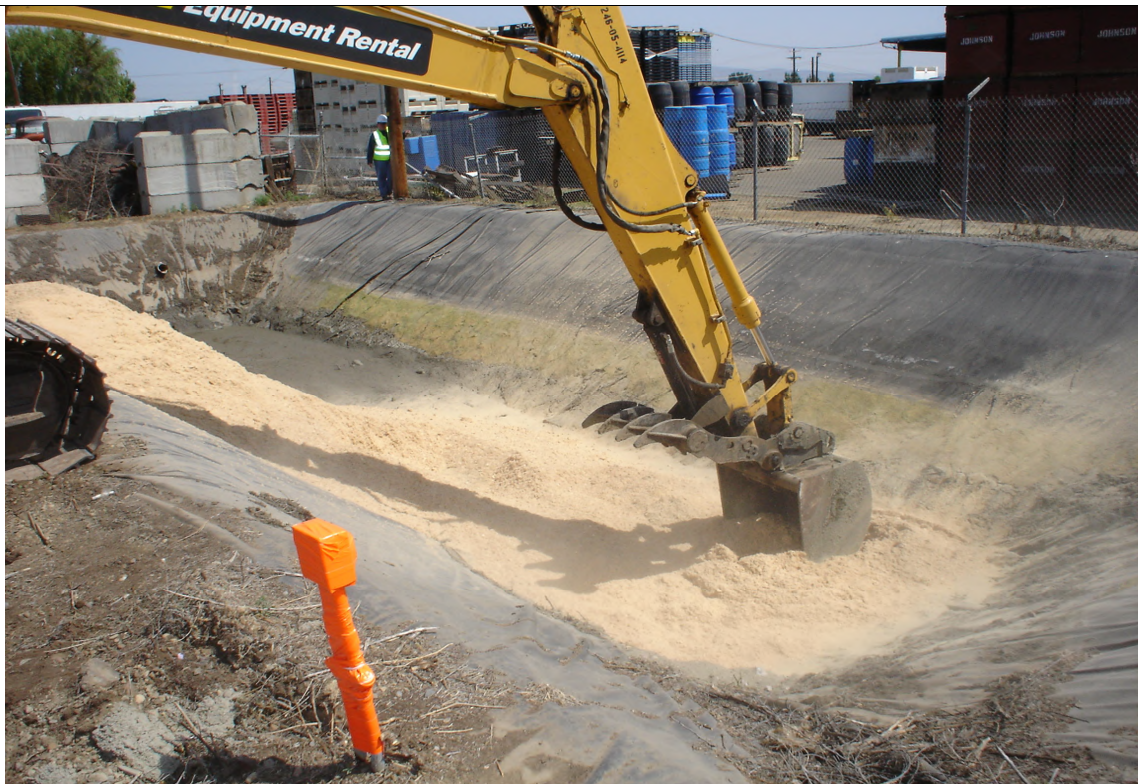
PHOTO No. 9

Addition of sawdust to stabilize remaining lagoon material.

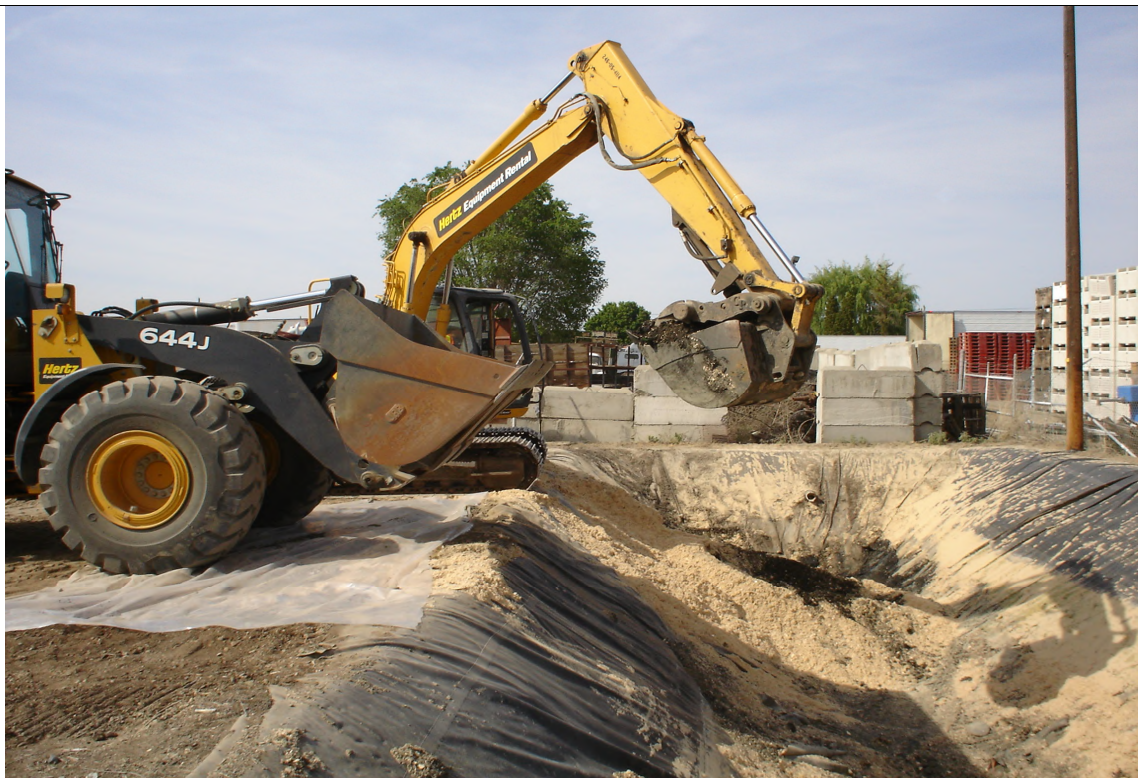
PHOTO No. 10

Stabilization and removal of lagoon material.

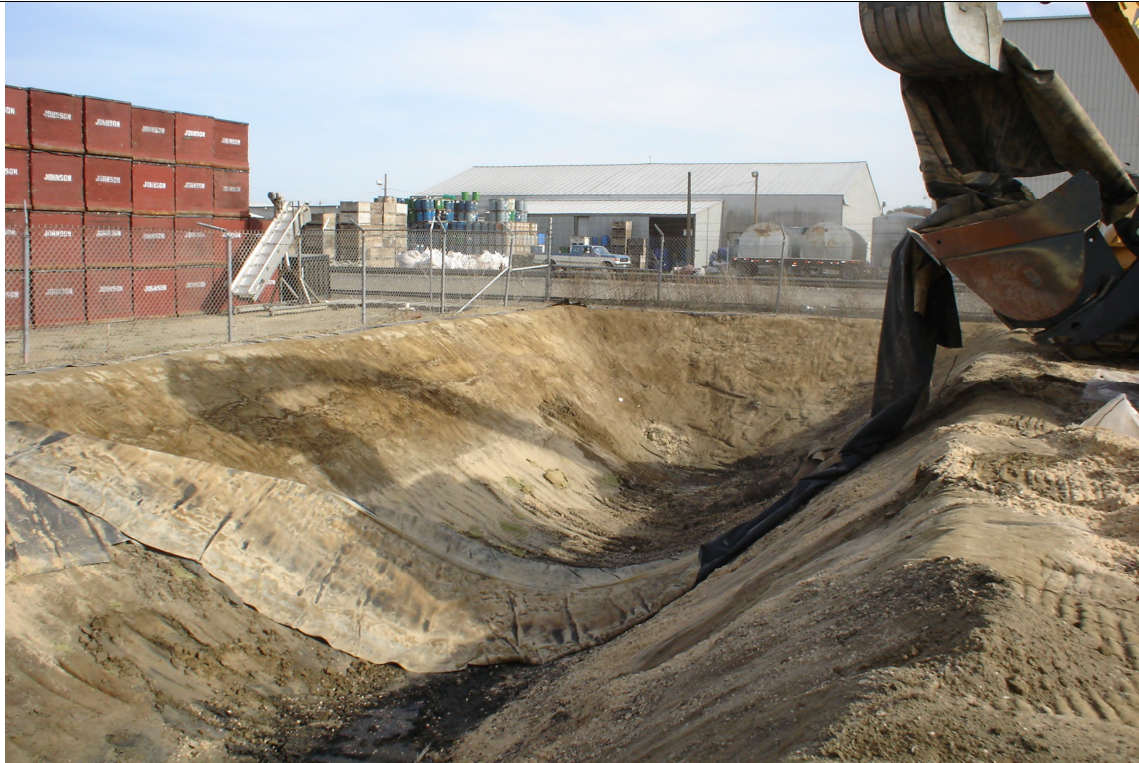
PHOTO No. 11

Liner removal.

Following removal of the sediment/sludge, the lagoon liner was removed in sections and loaded into the lined roll-offs. Some minor holes were observed during removal, and soil beneath the liner exhibited slight staining. The stabilized sediment/sludge disposal was handled by Chemical Waste Management in Arlington, Oregon. Disposal documentation is included in Appendix B.

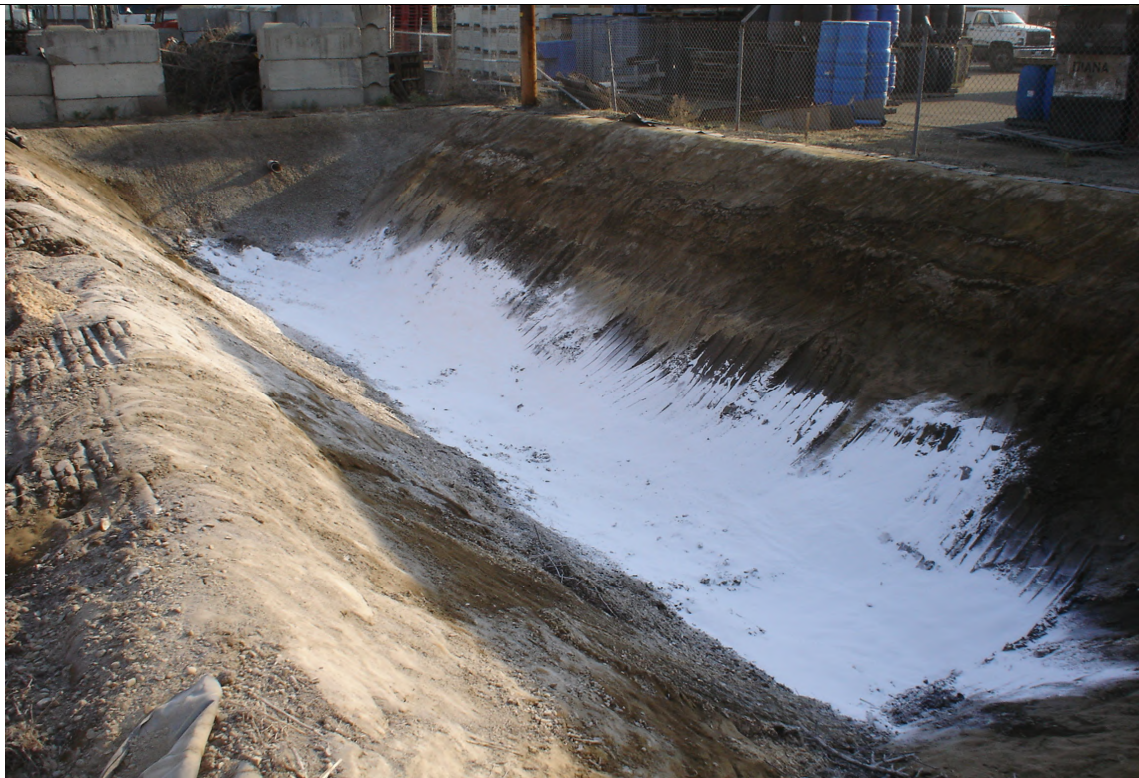
PHOTO No. 12

Calcium acetate placement.

Once the liner was removed, approximately 1,000 pounds of calcium acetate was placed into the bottom of the lagoon using the excavator bucket. The calcium acetate will allow for treatment of nitrate by serving as an electron donor for enhanced denitrification. Calcium acetate is a highly soluble, food-grade salt that will dissolve into the moisture of the soils to facilitate treatment of soil located immediately below the lagoon. The calcium acetate will further disperse over time by diffusion and convective transport associated with precipitation events.

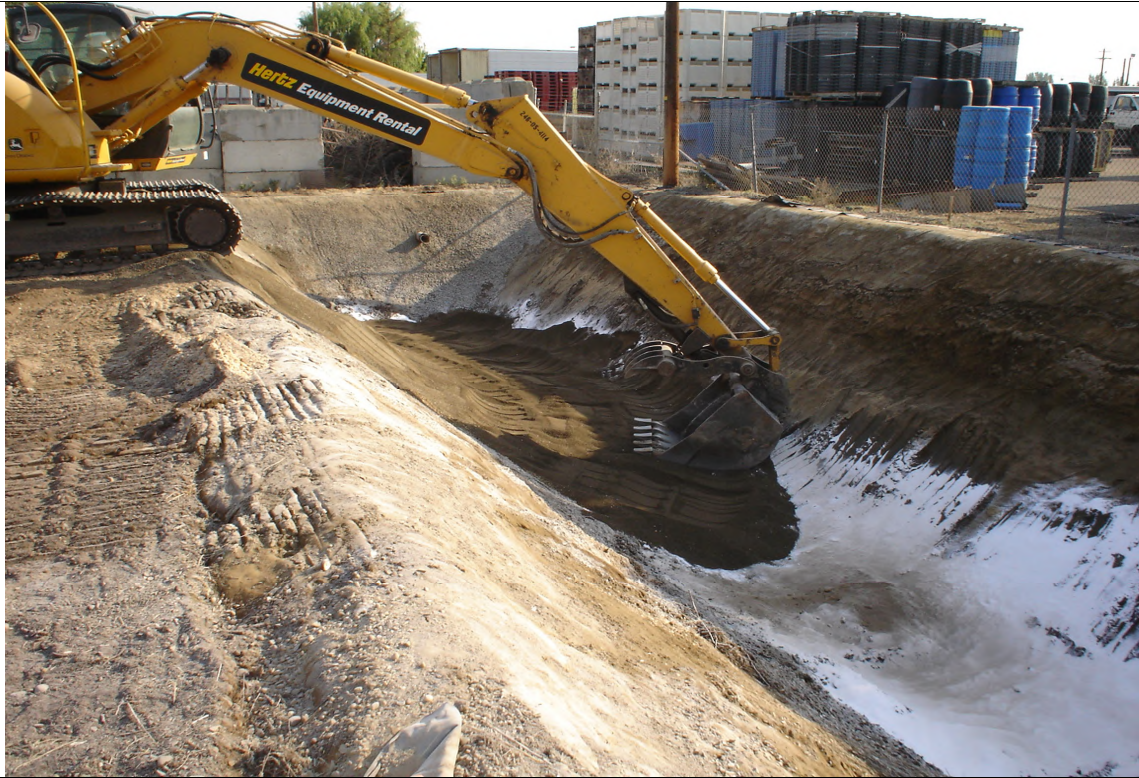
PHOTO No. 13

Backfill

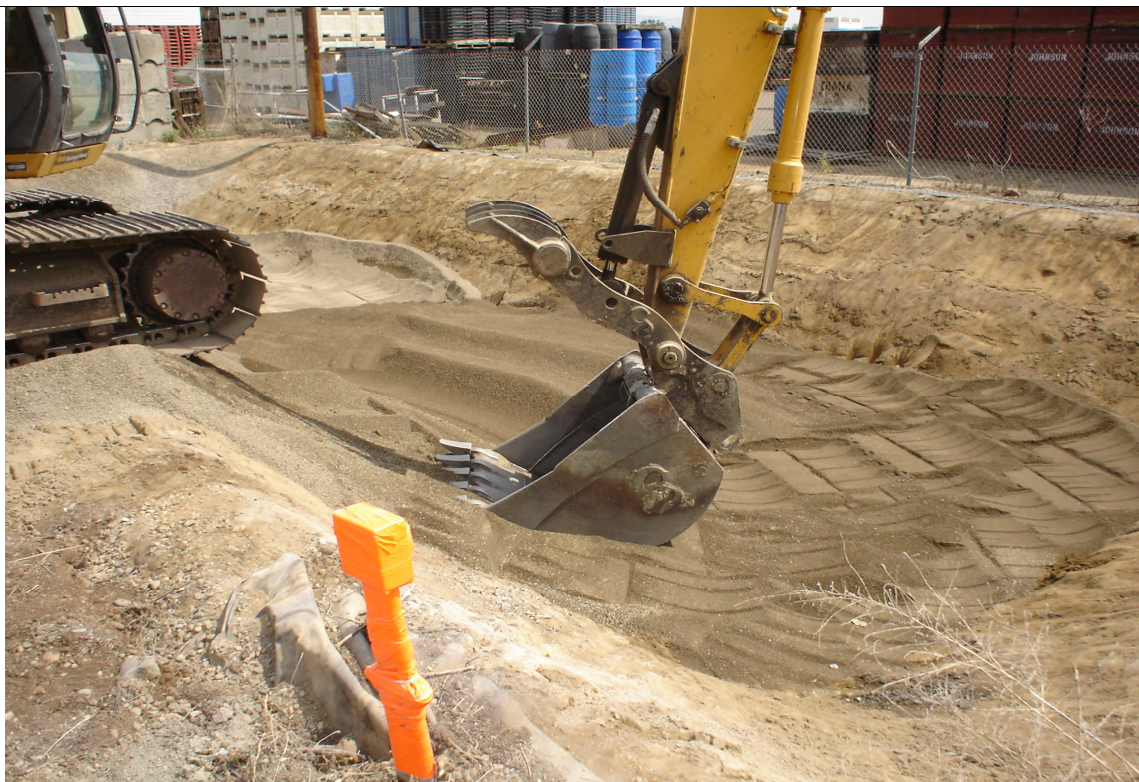
PHOTO No. 14

Backfill and compaction.

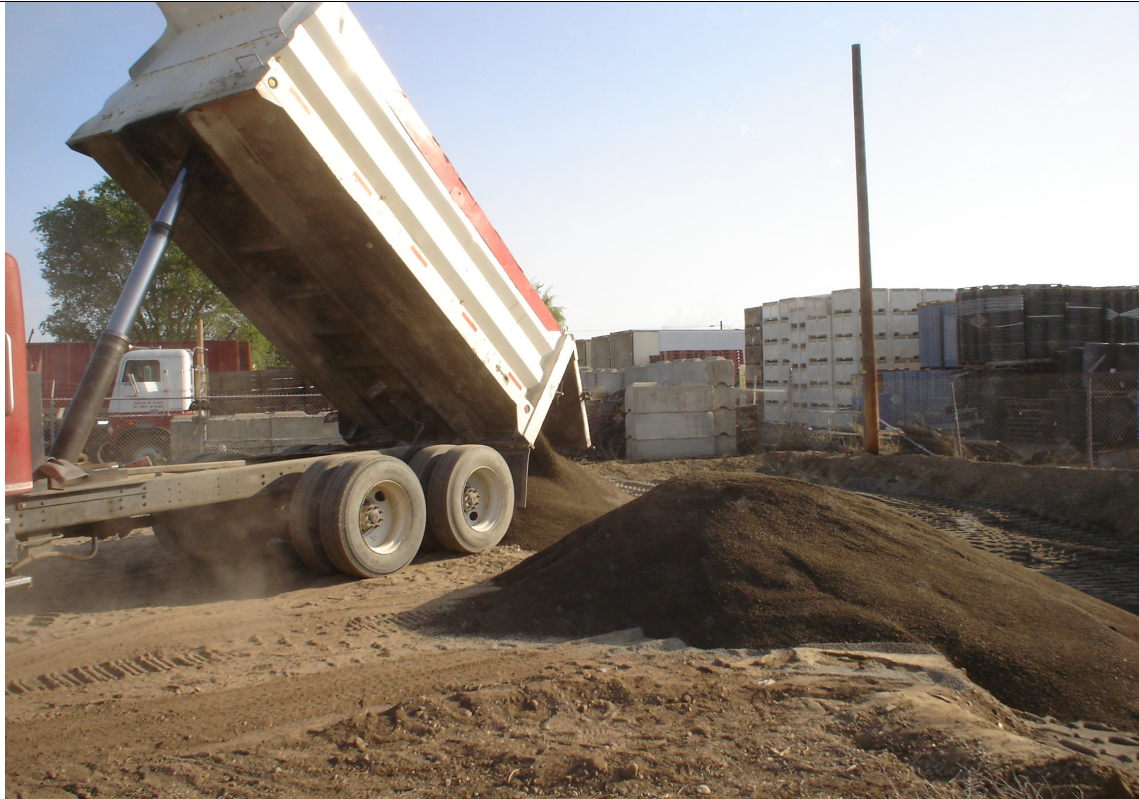
PHOTO No. 15

Dumping of fill material.

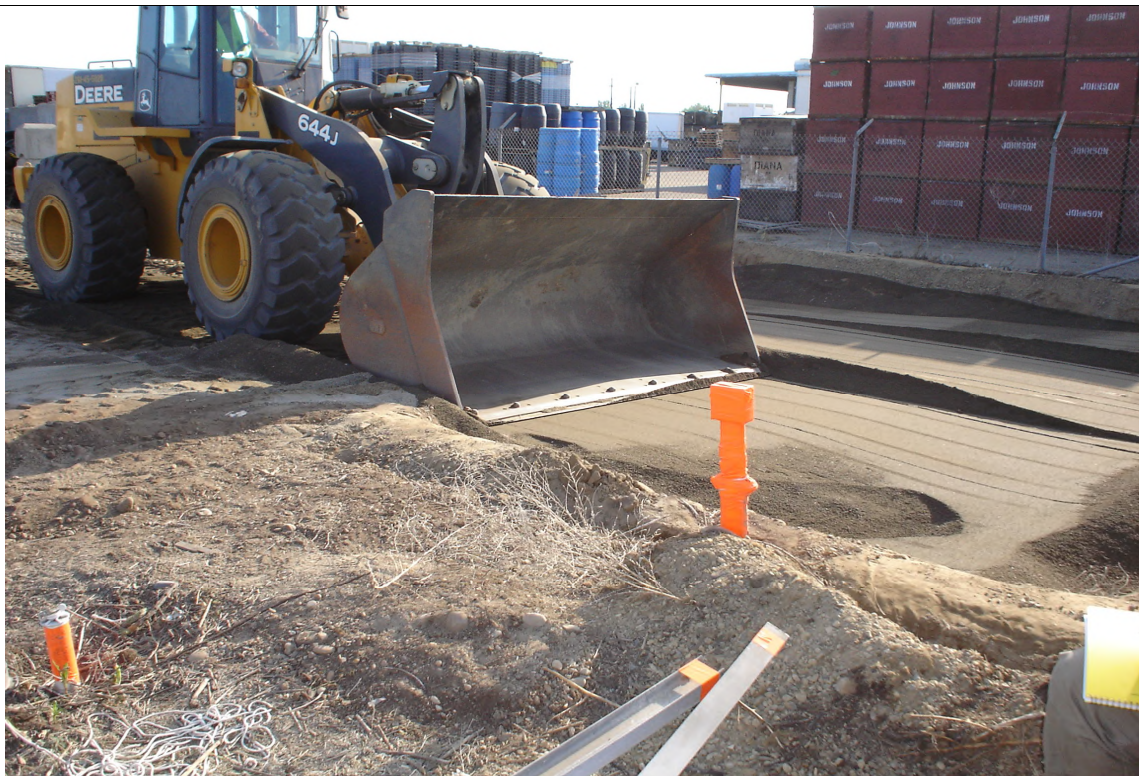
PHOTO No. 16

Compaction.

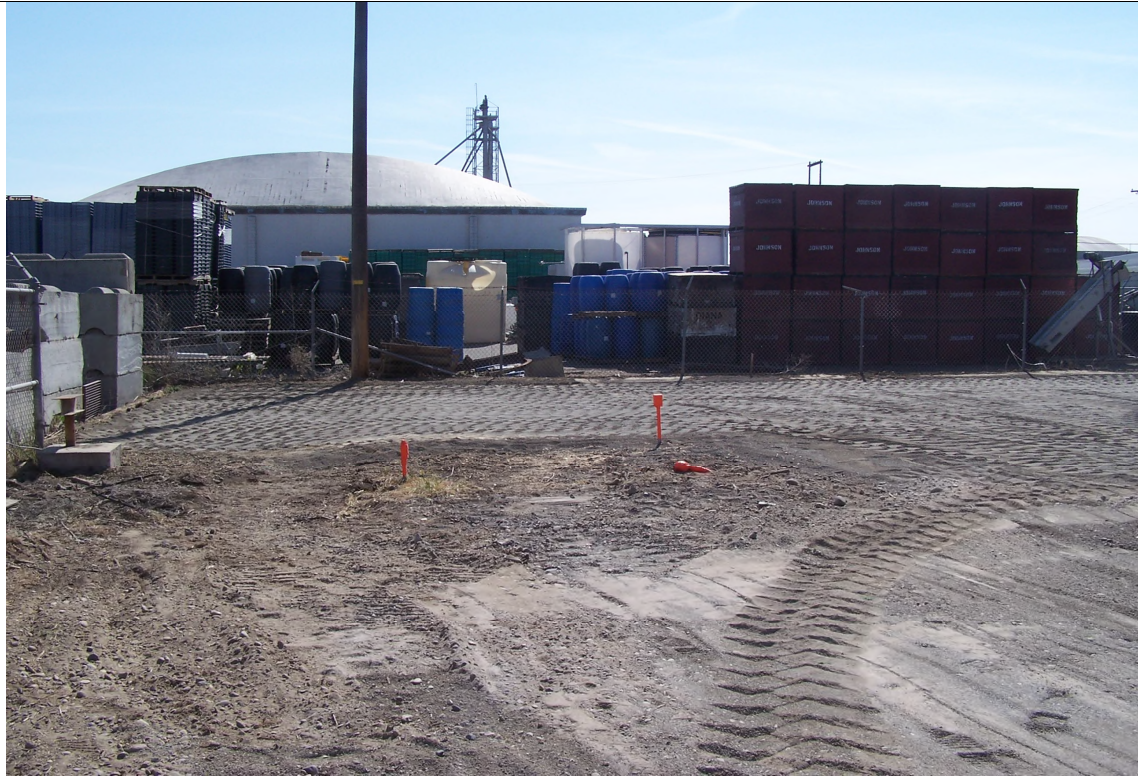
PHOTO No. 17

Grading of final surface.

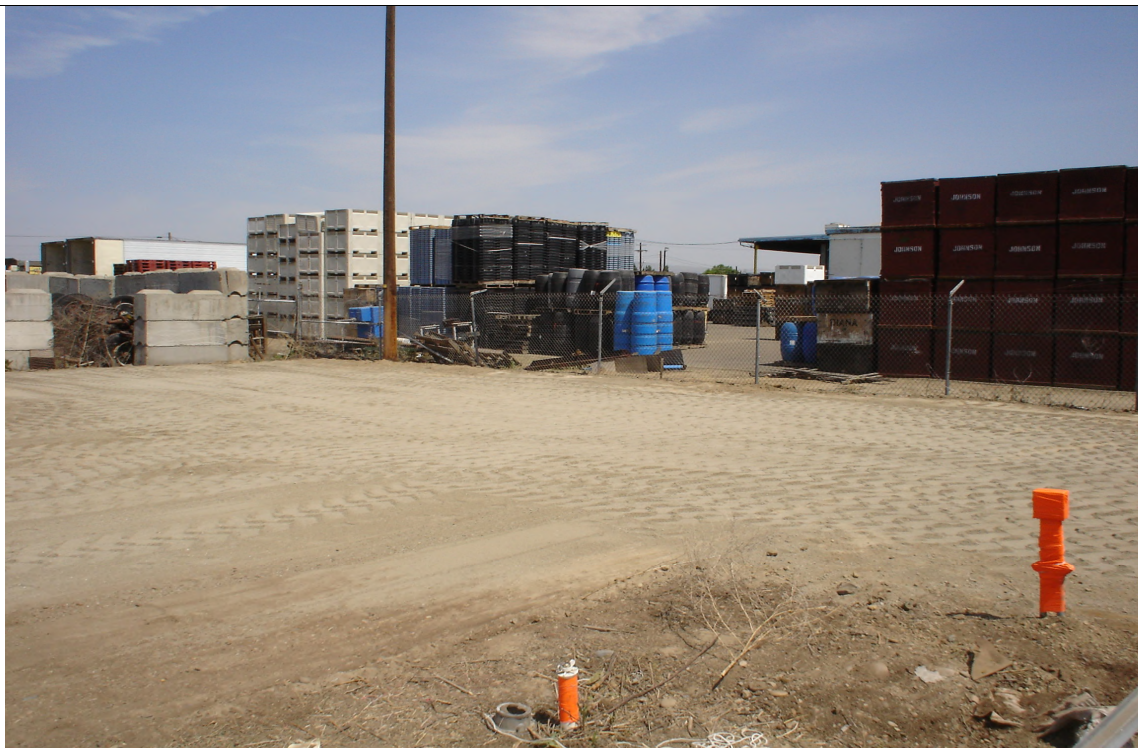
PHOTO No. 18

Completed lagoon closure.

The former lagoon was removed as a potential source and safety hazard, and calcium acetate was placed into the excavation to mitigate any residual impacts remaining in the soil. All activities, including fence removal and re-installation, debris removal, water removal, stabilization, liner removal, calcium acetate placement, and backfill and compaction, were completed safely and without incident.
