TECHNICAL MEMORANDUM

TO: Betsy Severtsen, City of Renton
FROM: Kalpana Prasad, GIT, and Brian O’Neal, PE, Landau Associates, Inc.
DATE: February 26, 2026
RE: Retention Wall Repair Environmental Oversight
The Stoneway Property
Renton, Washington
Landau Project No. 0829024.030

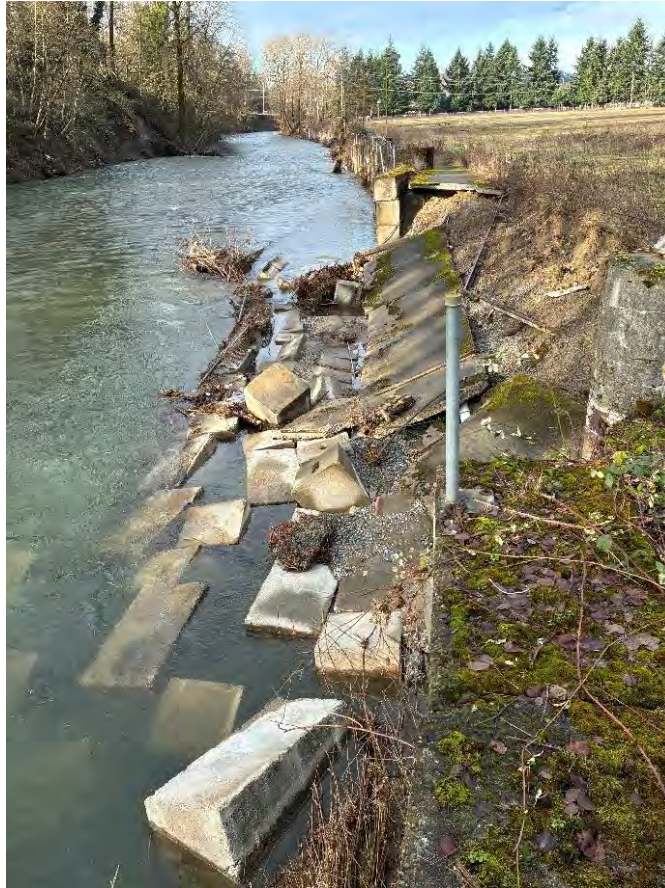
Pic 1. Preconstruction site conditions, looking west.

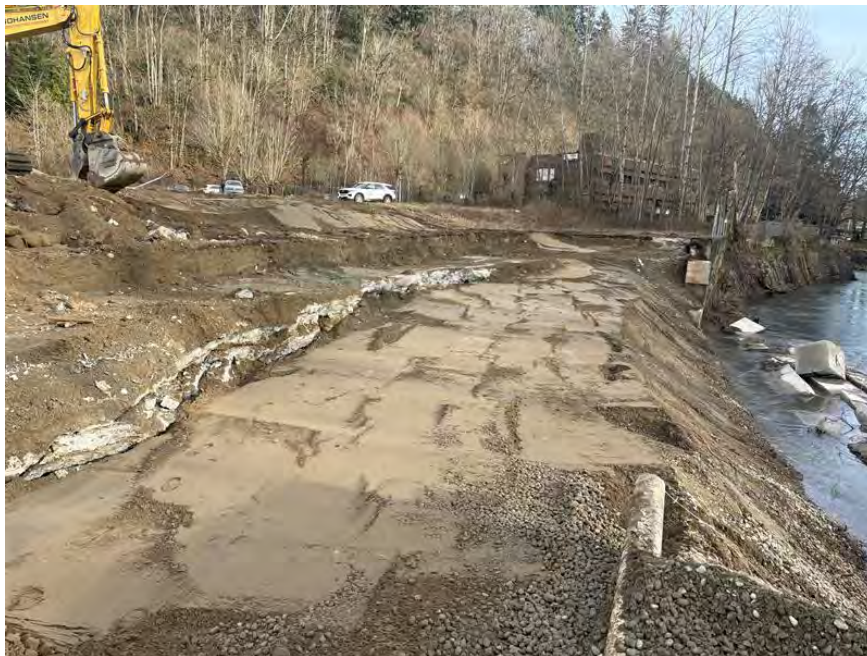
On January 9, 2026, Landau returned to the Site to observe further soil excavation activities. Johansen had exposed a concrete bench that extended across the southern portion of the excavation. The bench was located approximately 18 in below the original surface grade and was exposed approximately 7 ft north from the southern edge; the bench generally consisted of two 1- to 2-ft layers of concrete with a thin layer of soil between the two concrete layers in some places, consistent with placement of concrete in a settling pond. An image of this bench can be found in photos from the Site (Attachment 2). Landau field-screened the soil being stockpiled from the upper 18 in of the excavation using pH test strips, indicating no high-pH soils above the concrete bench.

As Johansen dug down in an attempt to find the bottom of the concrete bench on the eastern side of the excavation, Landau and a representative from the City noticed a change in the nature of the soil under the concrete bench from being brown and sandy to gray and silty. When Landau field-screened this gray silty soil, it was determined to have a field pH result of approximately 12 to 13. Johansen stopped digging and replaced the soil that had been moved to expose the concrete bench and covered the entire excavation in plastic before halting work for the weekend.

Pic 2. Exposed concrete bench above high-pH soils, looking east.

The following week, Johansen mobilized a breaker to begin breaking the concrete shelf so as to create the necessary slope. Landau observed the stockpiling of concrete debris and field-screened soil in and around the concrete shelf for pH using pH test strips and an Oakton pH meter. The concrete and the high-pH soil were stockpiled separately from the clean-soil stockpile. Landau determined that the soil between the two concrete layers had variable pH ranging from approximately 8 to 12. Landau collected one sample of this material from the west side of the excavation (CS-1). Landau also instructed Johansen to dig under the concrete bench on the east side of the excavation to expose the high-pH soil observed the previous week and collected a sample (CS-2). Landau instructed Johansen to shake off any soil clinging to the concrete debris before stockpiling the concrete.

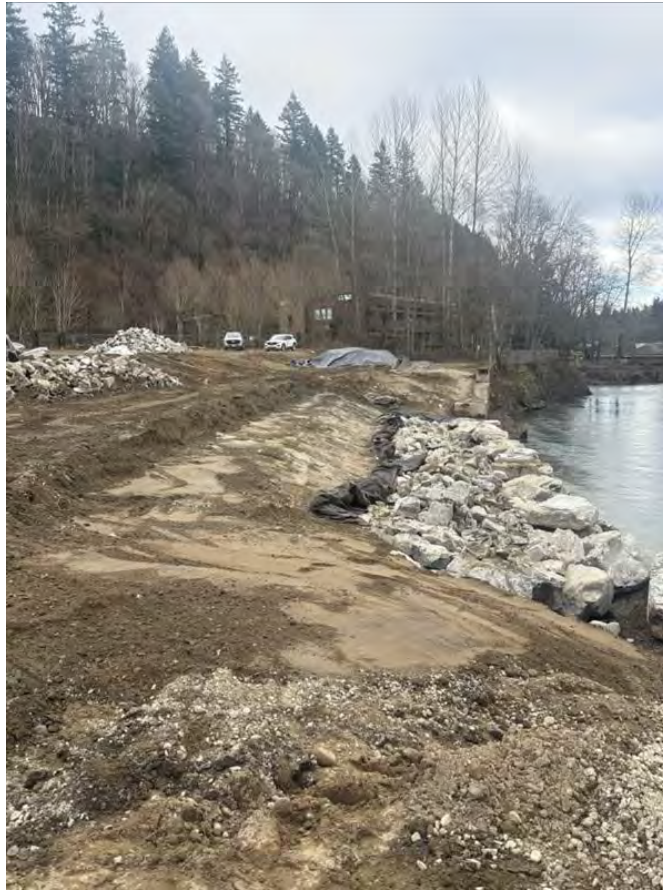
Pic 3. Clay placed over section of high-pH soil within 2 feet of the final slope, looking east.

After conversations with Landau, GeoEngineers, and Johansen, the City modified their original design to include a 2-ft-thick layer of clean imported clay, which Johansen procured from the Mountain Loop Mine in Granite Falls, Washington, that was placed over areas where high-pH soil would remain in place and be within approximately 2 ft of the final slope's surface. The purpose of the clay layer was to prevent erosion of high-pH soil to the Cedar River. The extent of this clay cover was determined by Landau staff who field-screened the entire extent of the final 3:1 slope. Based on field-screening, there was no indication of high-pH soil within 2 ft of the final western end of the slope. See Figure 2 for the approximate area where the clay was placed and compacted with the bucket of the excavator prior to placement of the geotextile and riprap (see photo in Attachment 2). The plan to use clay to cap the high-pH soil remaining in place was communicated to Ecology.

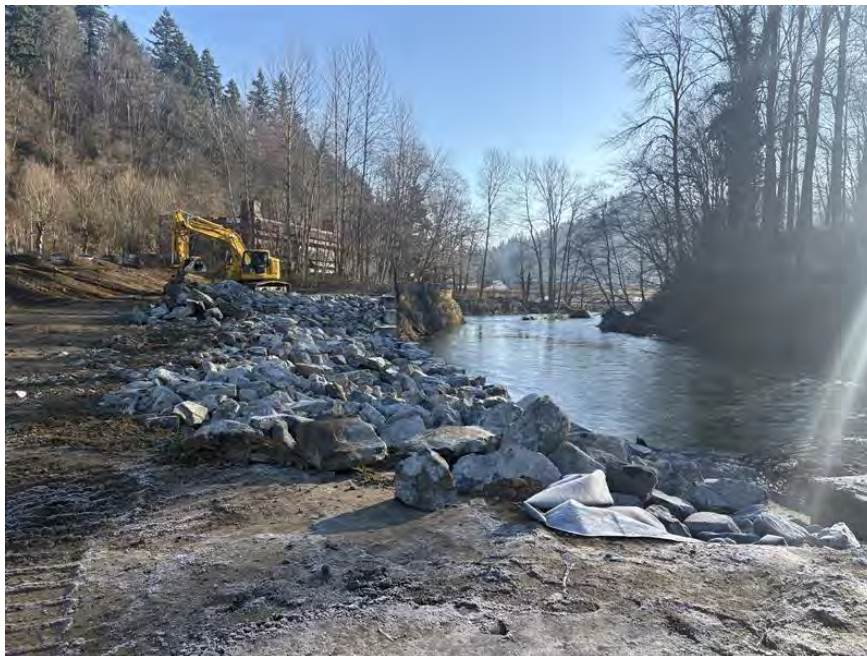
Pic 4. Final conditions of wall repair area.

Following Landau's initial sampling, and after receiving approval to begin work on the project from the City, Johansen mobilized to the Site on January 7, 2026, and began excavation and wall repair work the following day. The agreed-upon design for the wall repair was to remove wall debris and excavate soil to create a 3:1 slope in the collapse area. The slope would be lined with a non-woven geotextile and then armored with large "five-man" rock at the base and type 5 riprap further up the slope to create a 2:1 slope.
