## FIGURES

**FIGURE 1-1**  
**SITE LOCATION MAP**  
**5900 West Marginal Way Site**  
**Seattle, Washington**

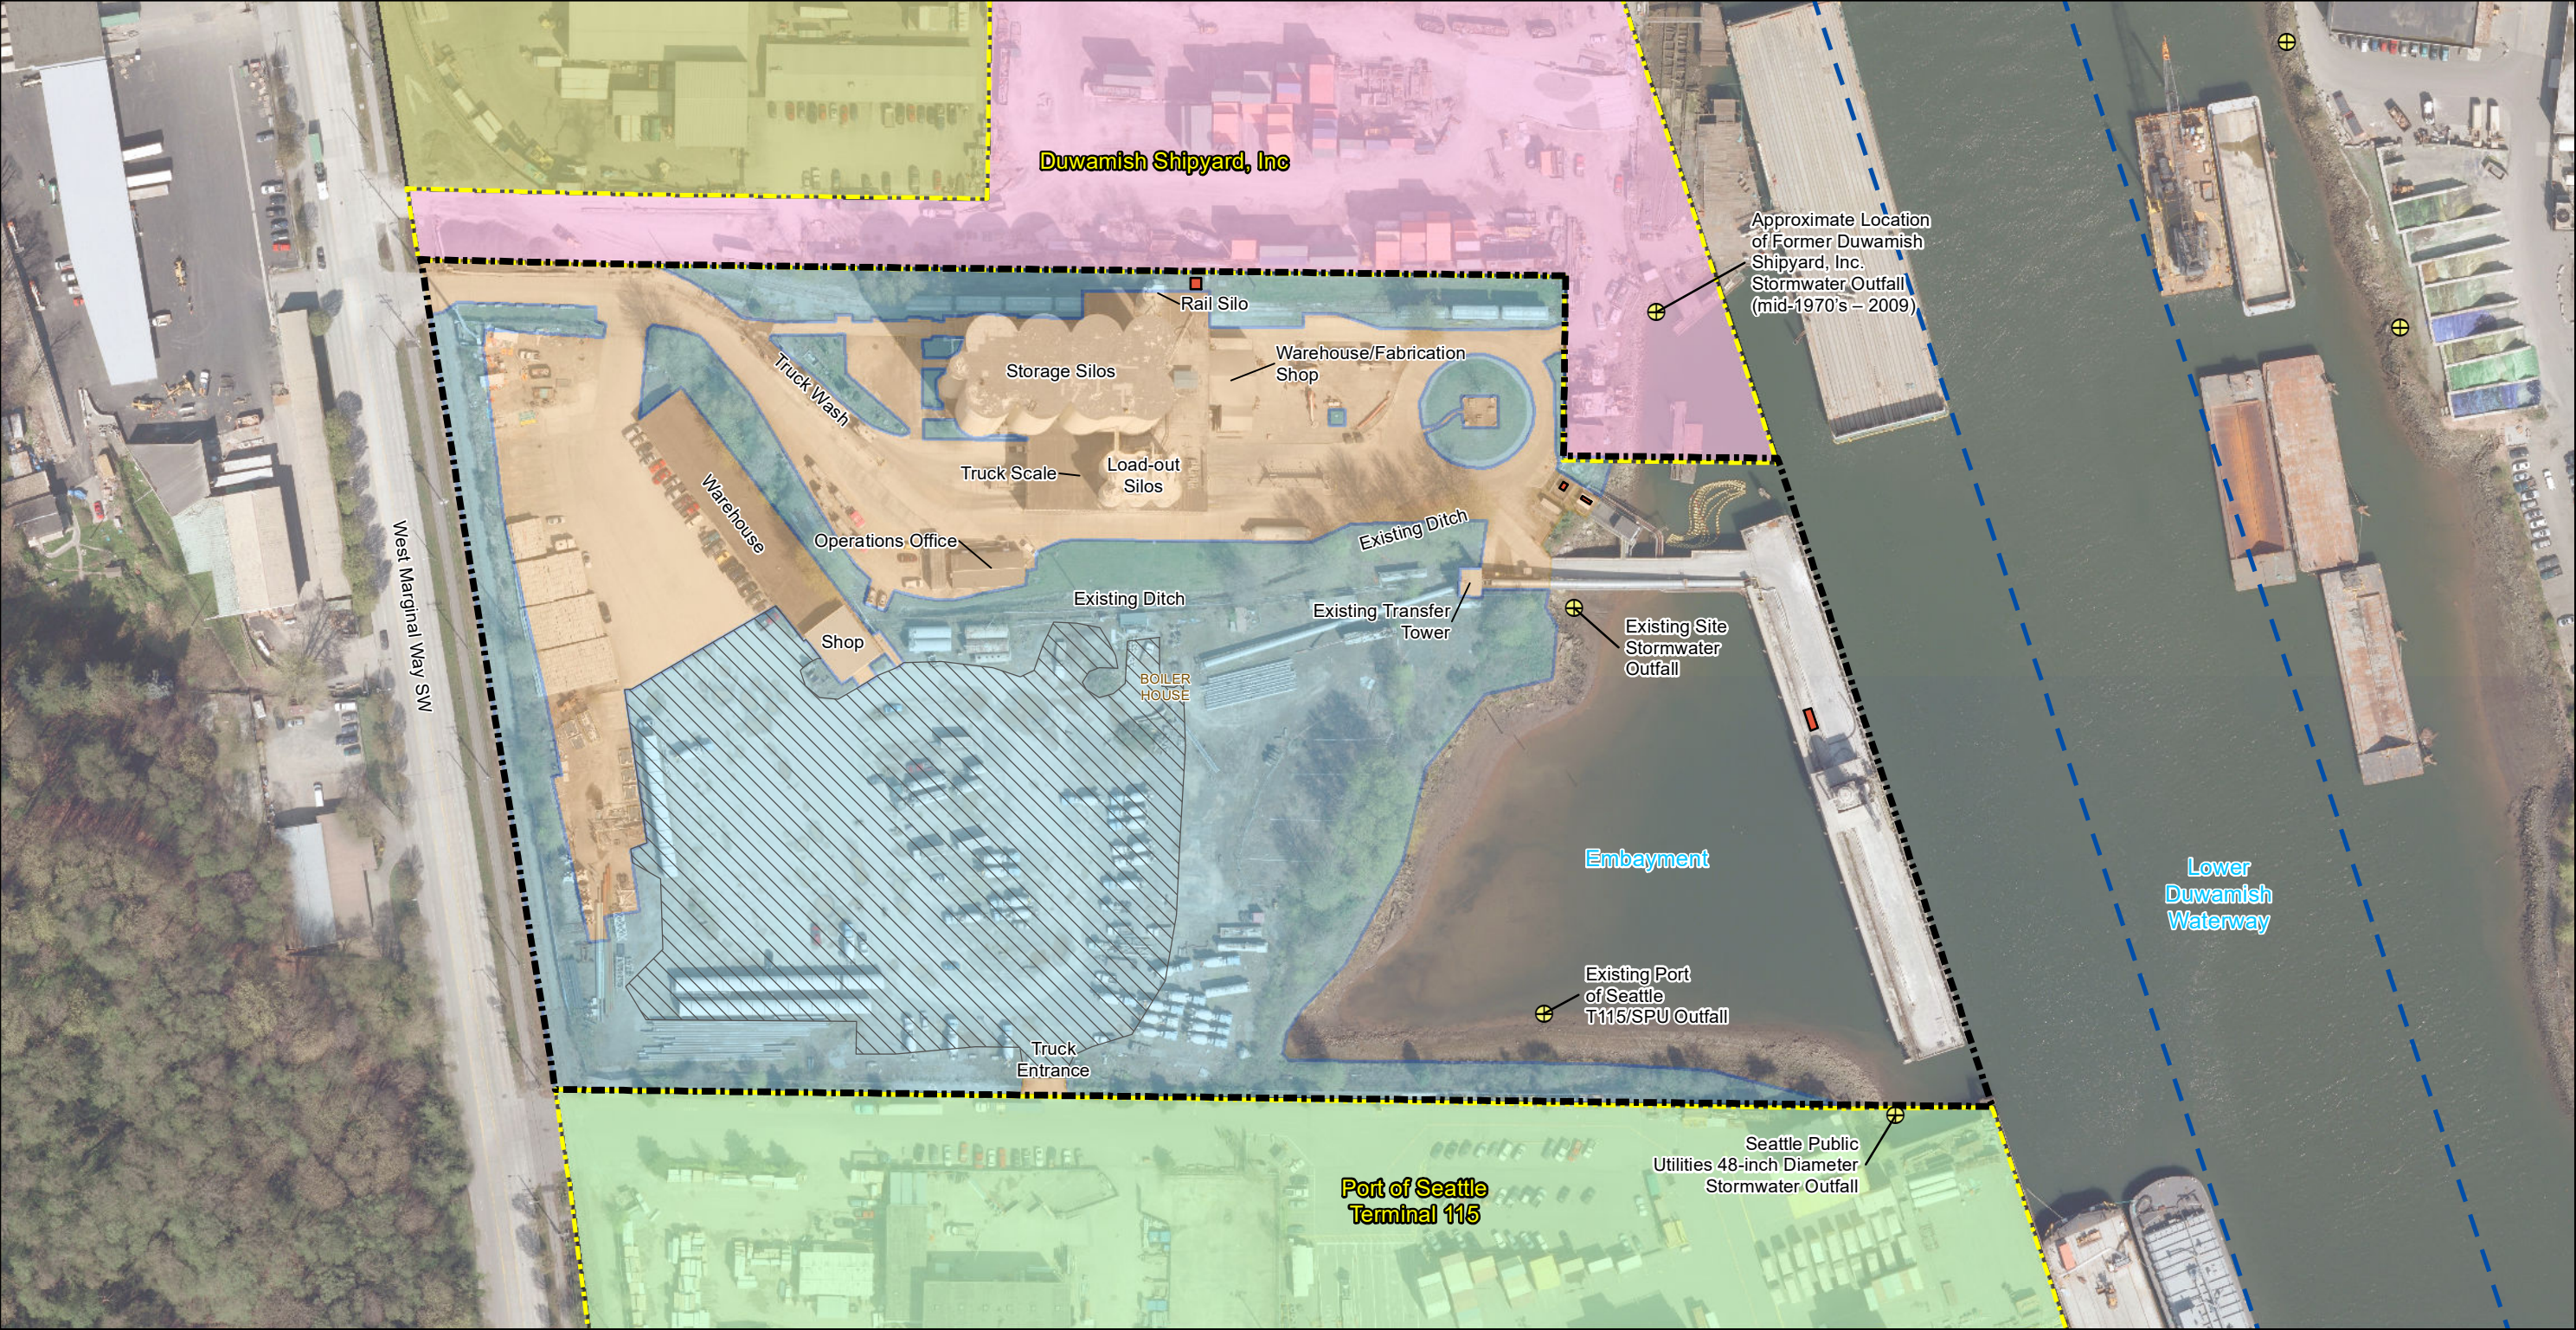
**FIGURE 2-3**

**CURRENT SITE LAYOUT**

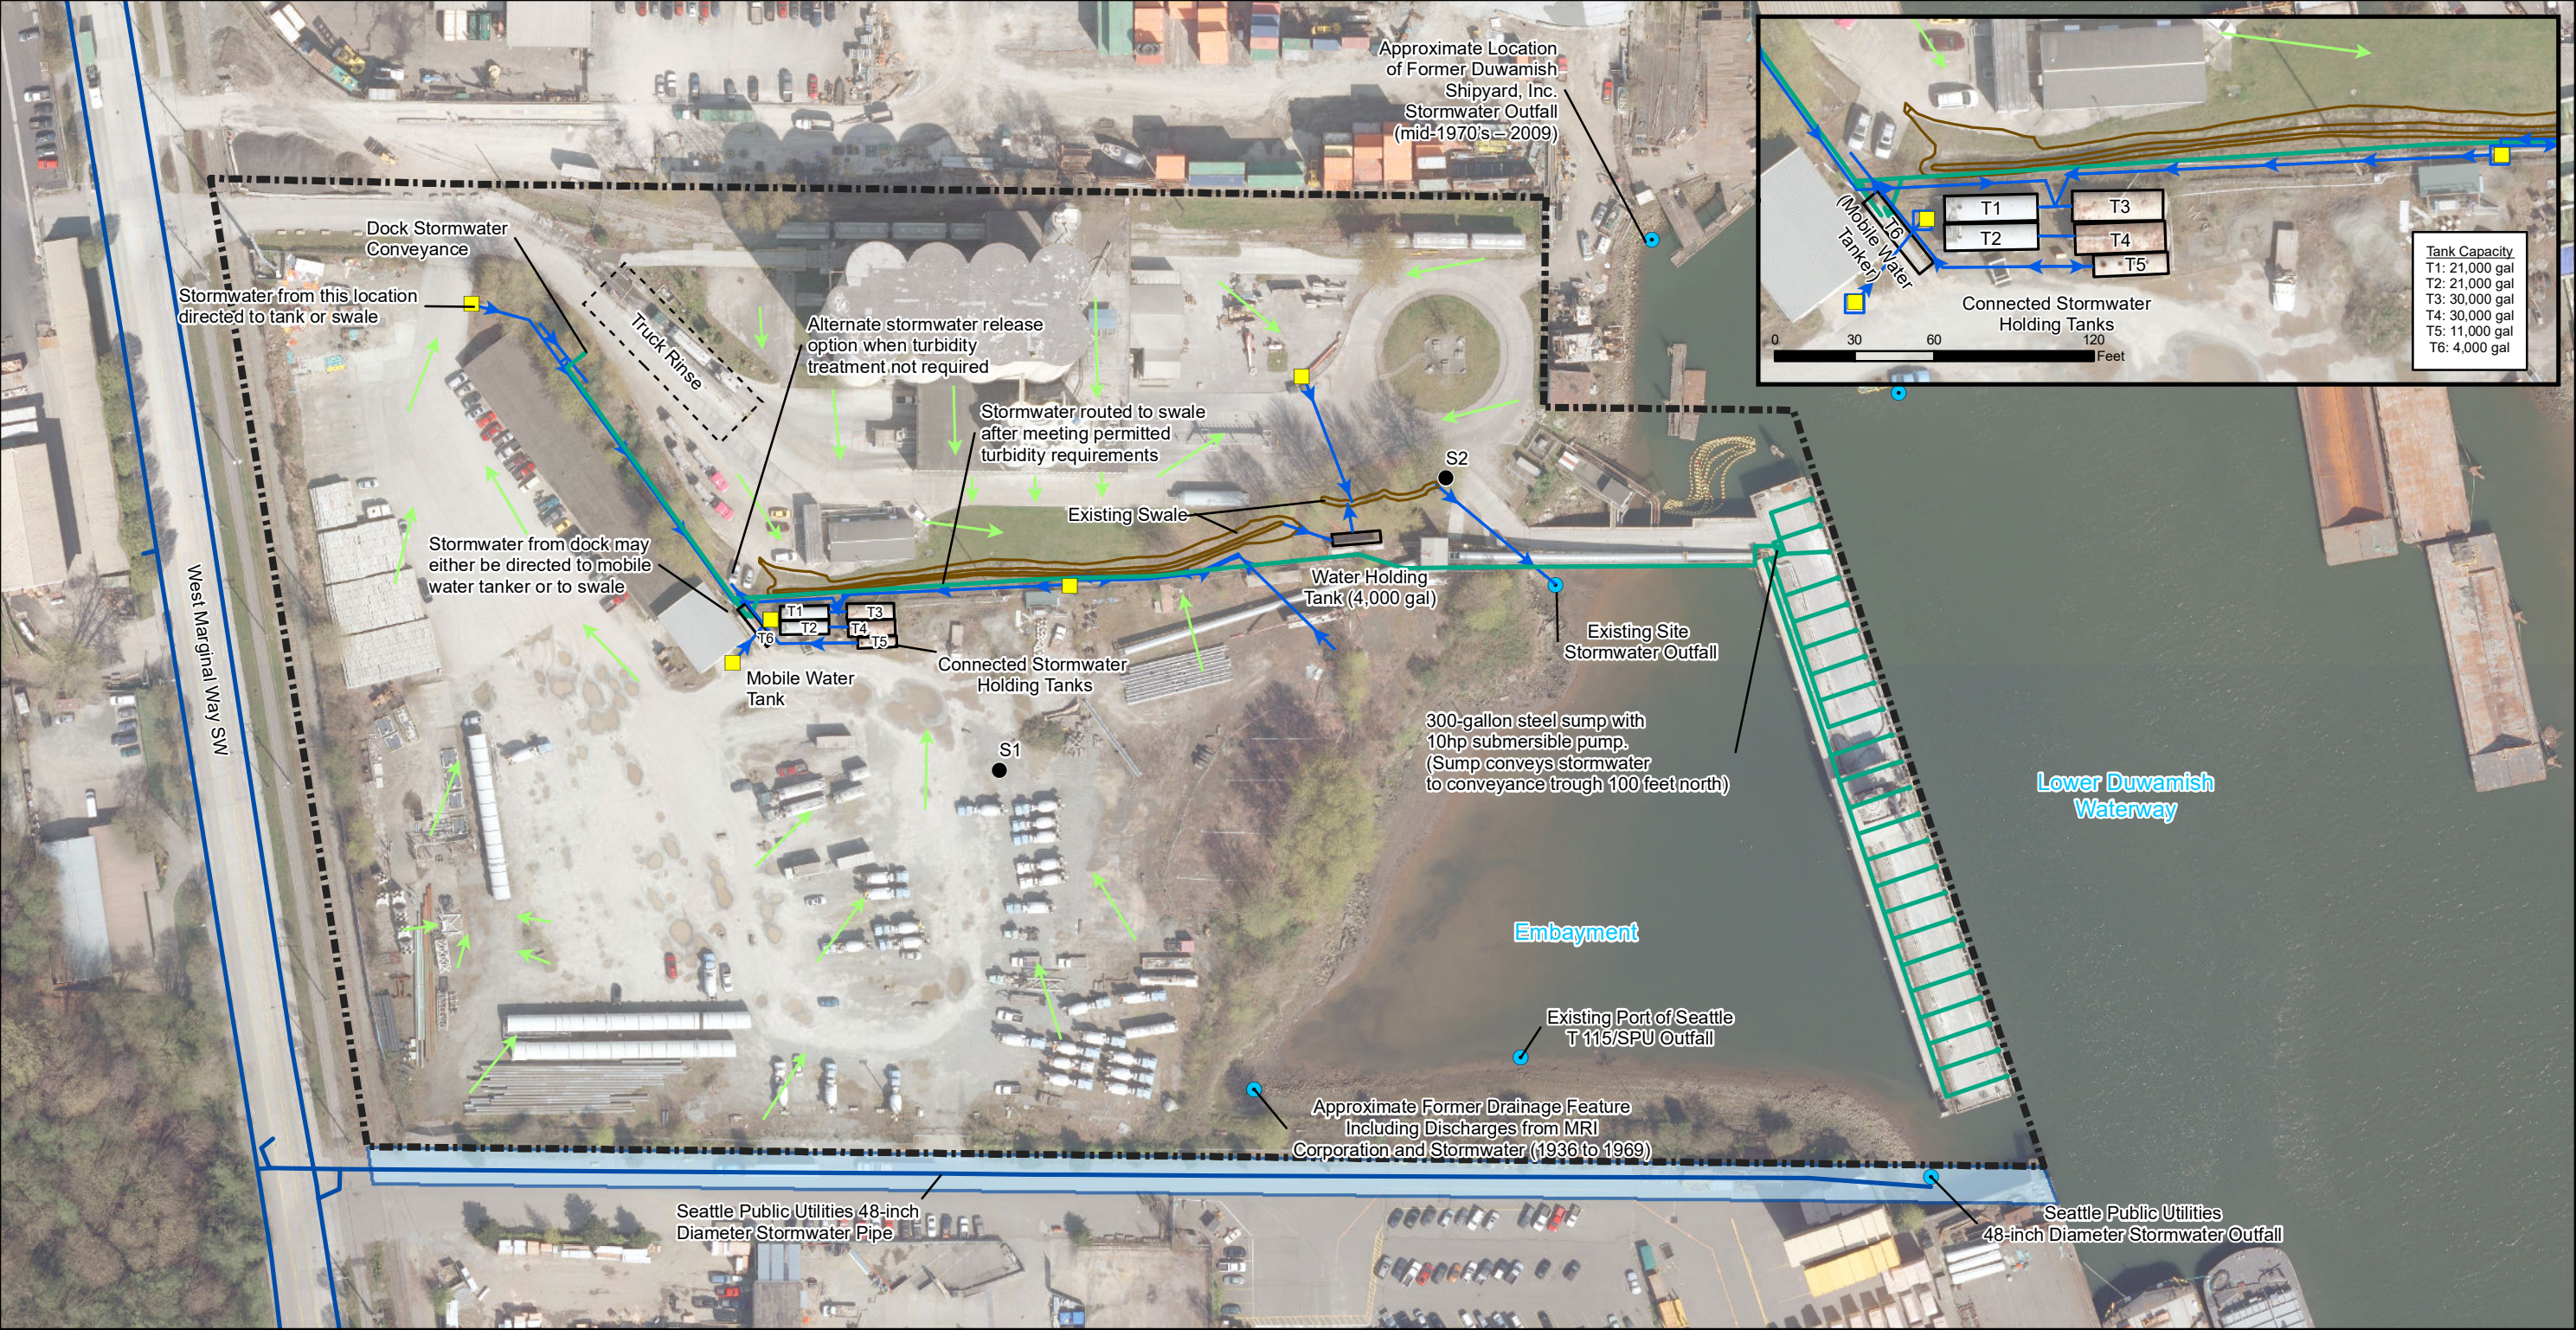
**FIGURE 2-5**  
**CURRENT STORMWATER CONVEYANCE SYSTEM**  
**5900 West Marginal Way Site**  
**Seattle, Washington**

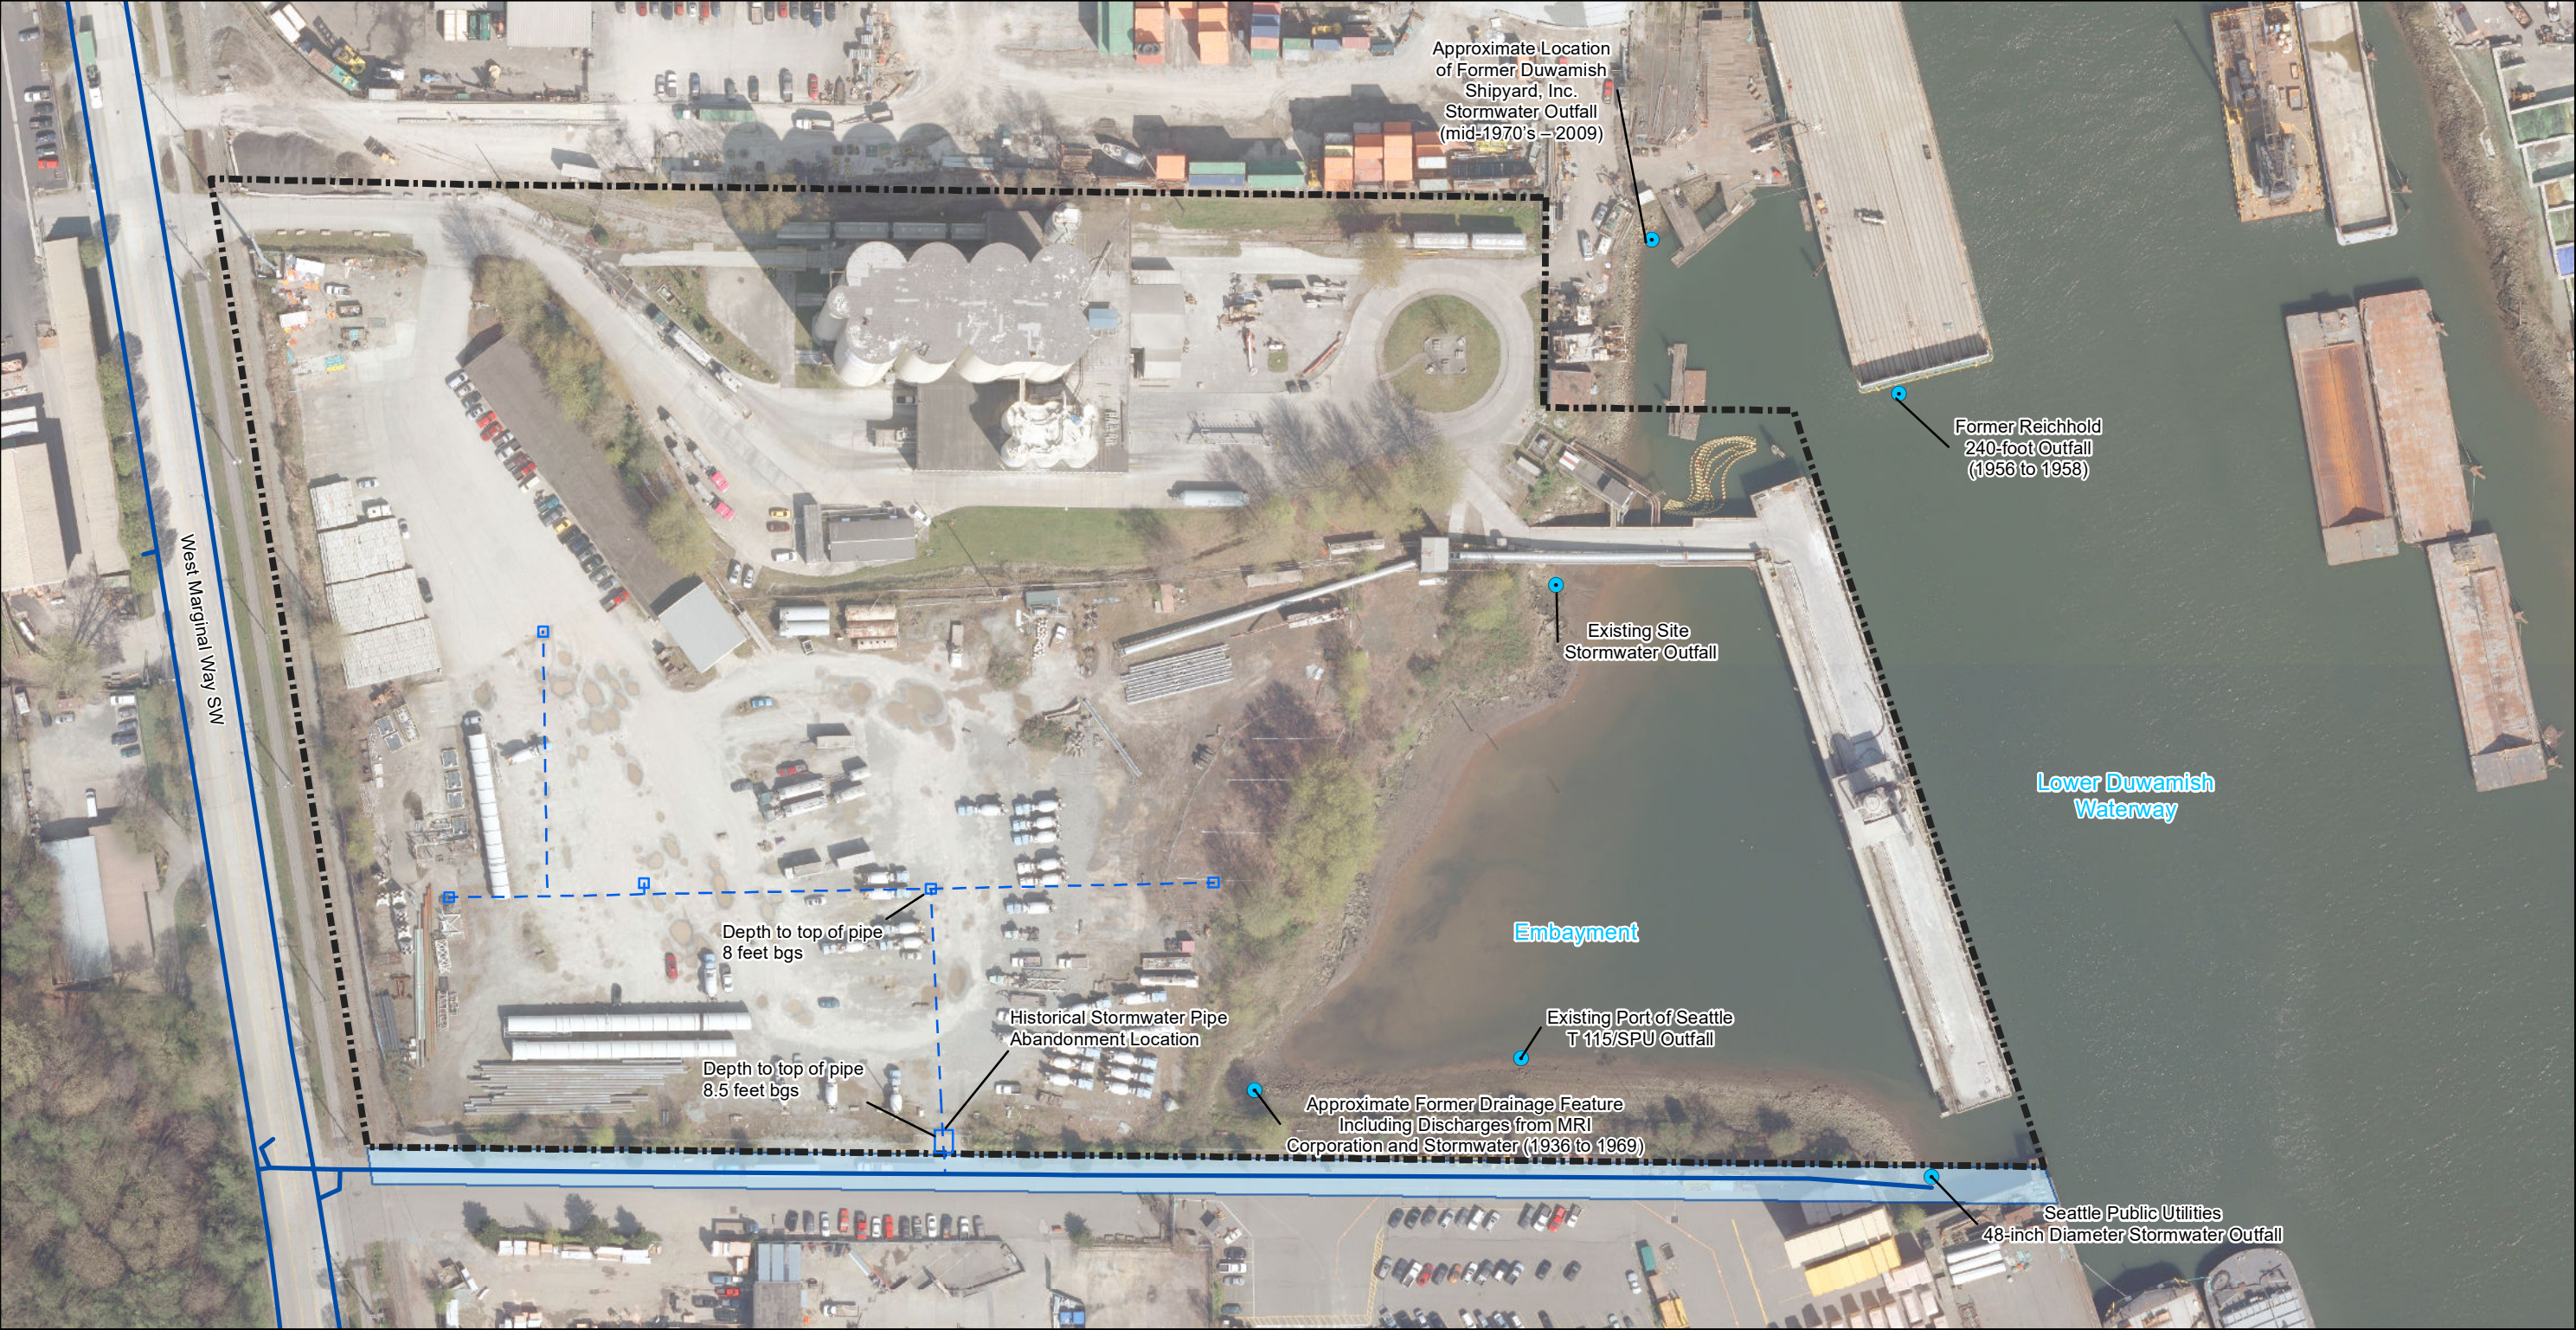
- Stormwater Outfall
- Catch Basin Location (Abandoned by filling with concrete prior to 1991)
- - - 15 Inch Diameter Historical Stormwater Conveyance: Inactive prior to 1991 and abandoned August 2014
- Stormwater Drainage Mainline
- SPU Stormwater Drainage Easement
- ▤ Property Boundary

**FIGURE 2-6**  
**HISTORICAL STORMWATER PIPE**  
**5900 West Marginal Way Site**  
**Seattle, Washington**

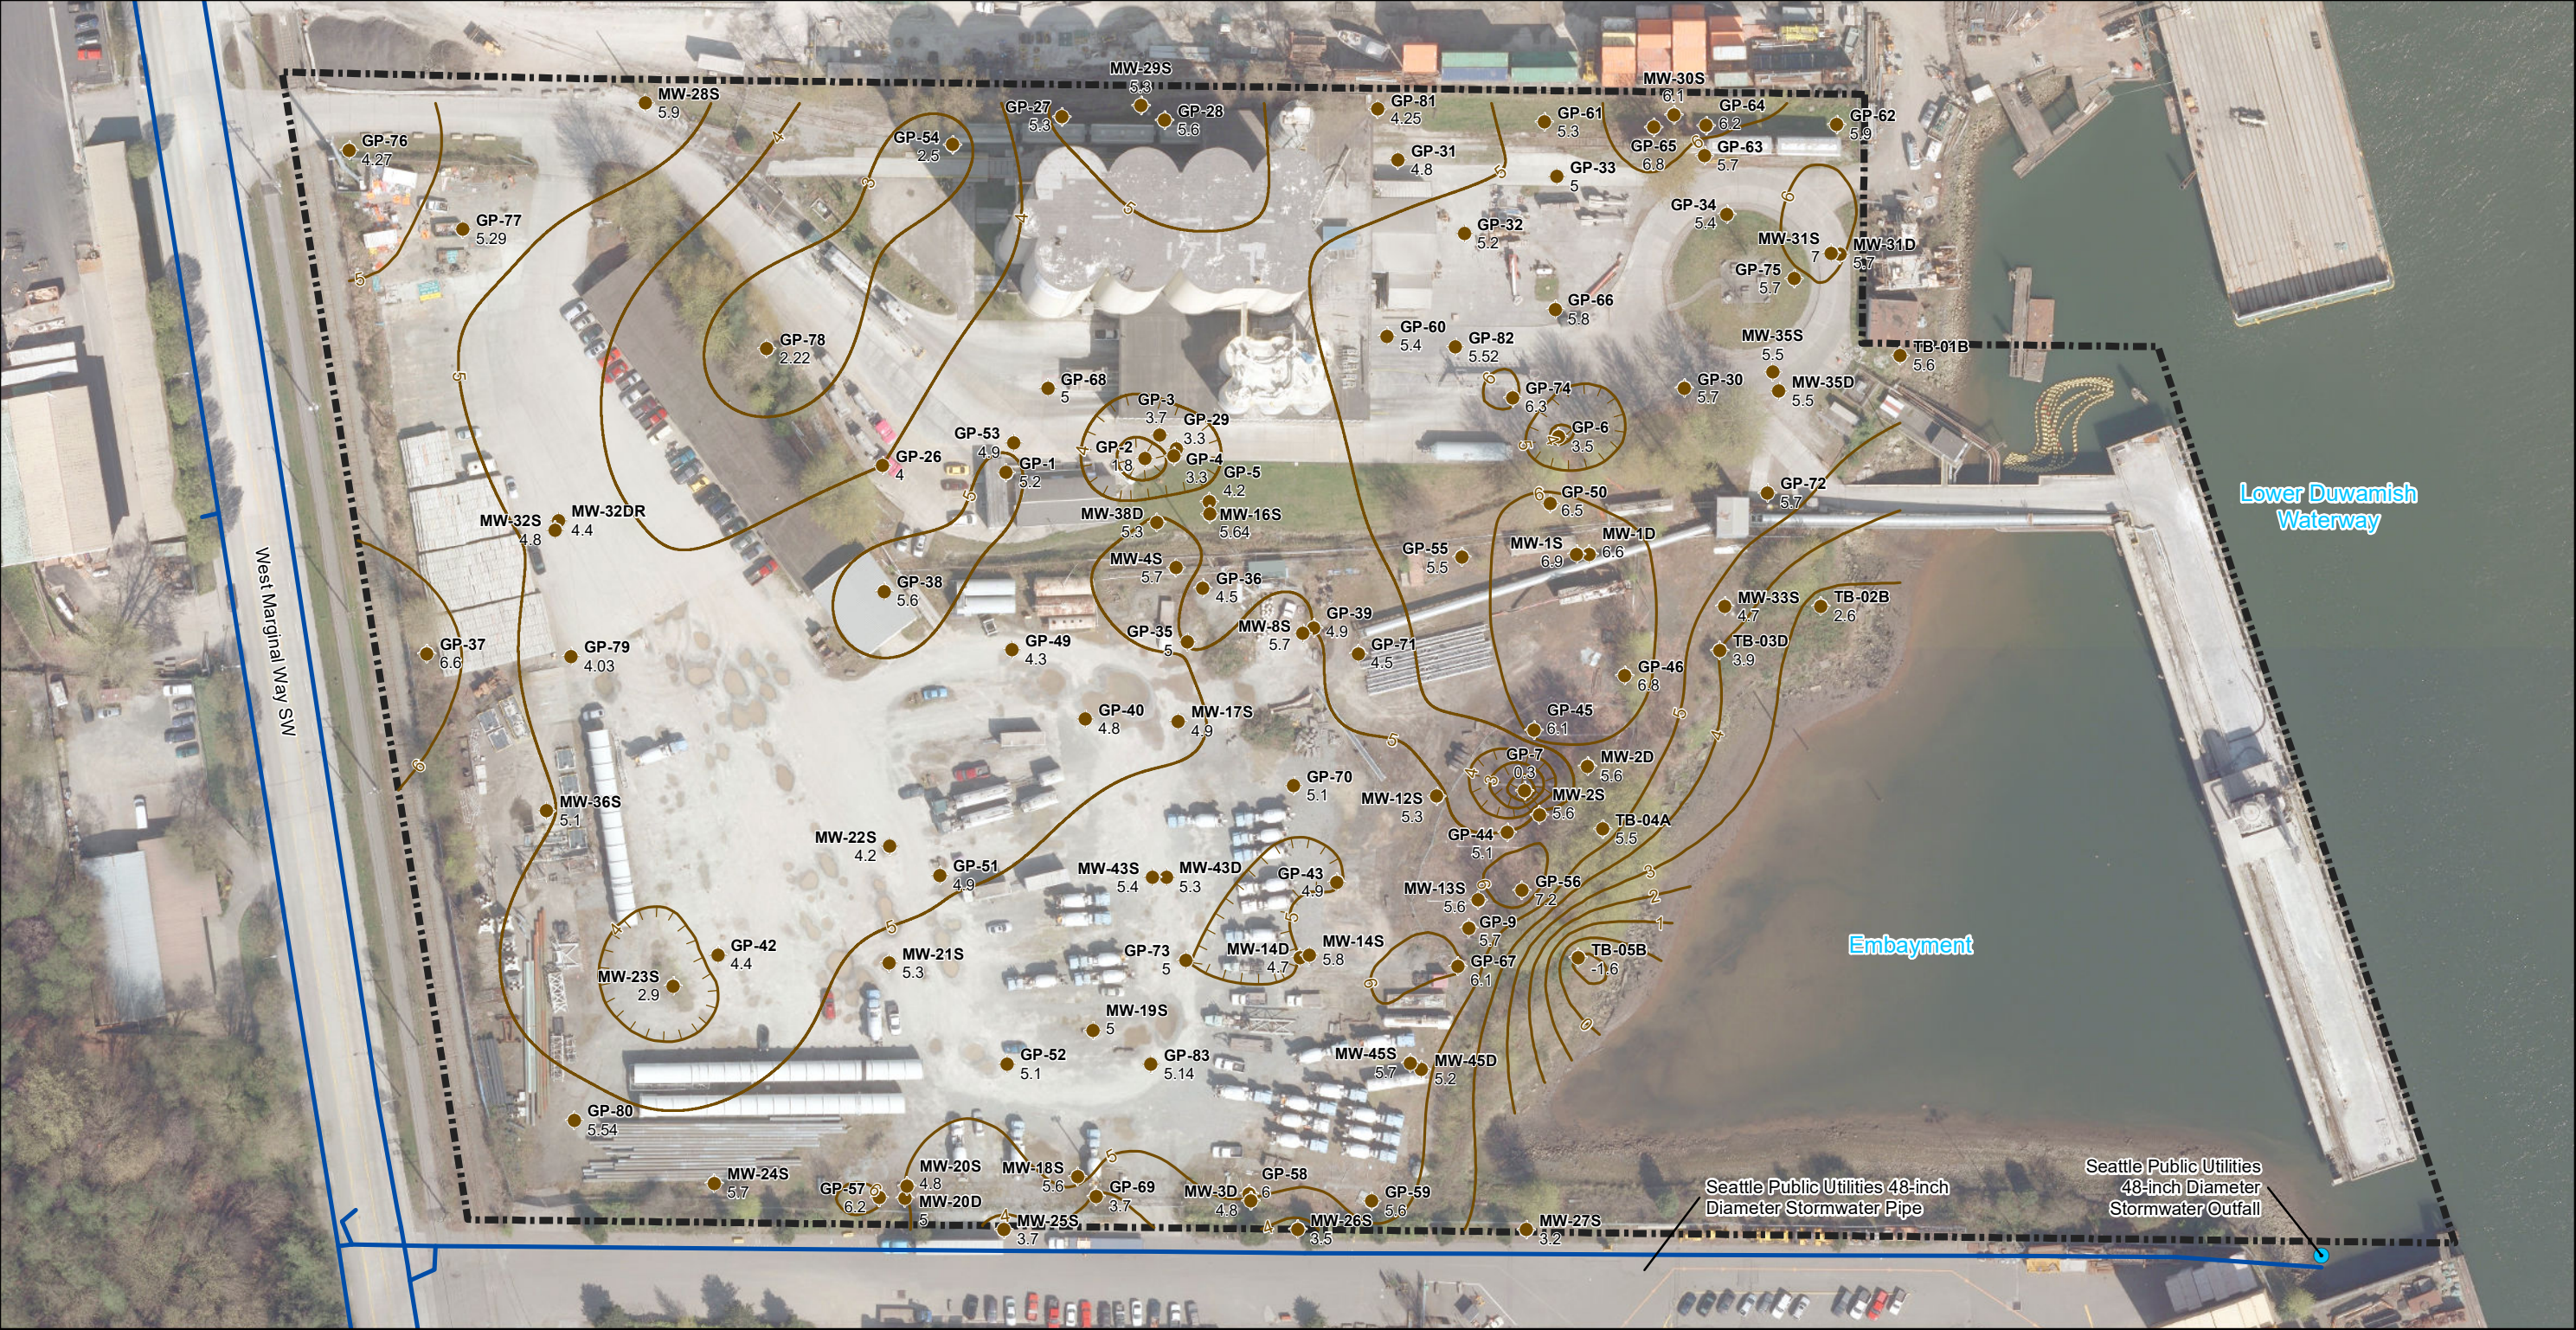
**FIGURE 2-20**

**TOP OF AQUITARD ELEVATION CONTOUR MAP**

Notes:  
- Aerial: King County: 3/23/2012, 0.25 ft per pixel  
- Elevations in feet above mean sea level, NAVD88.

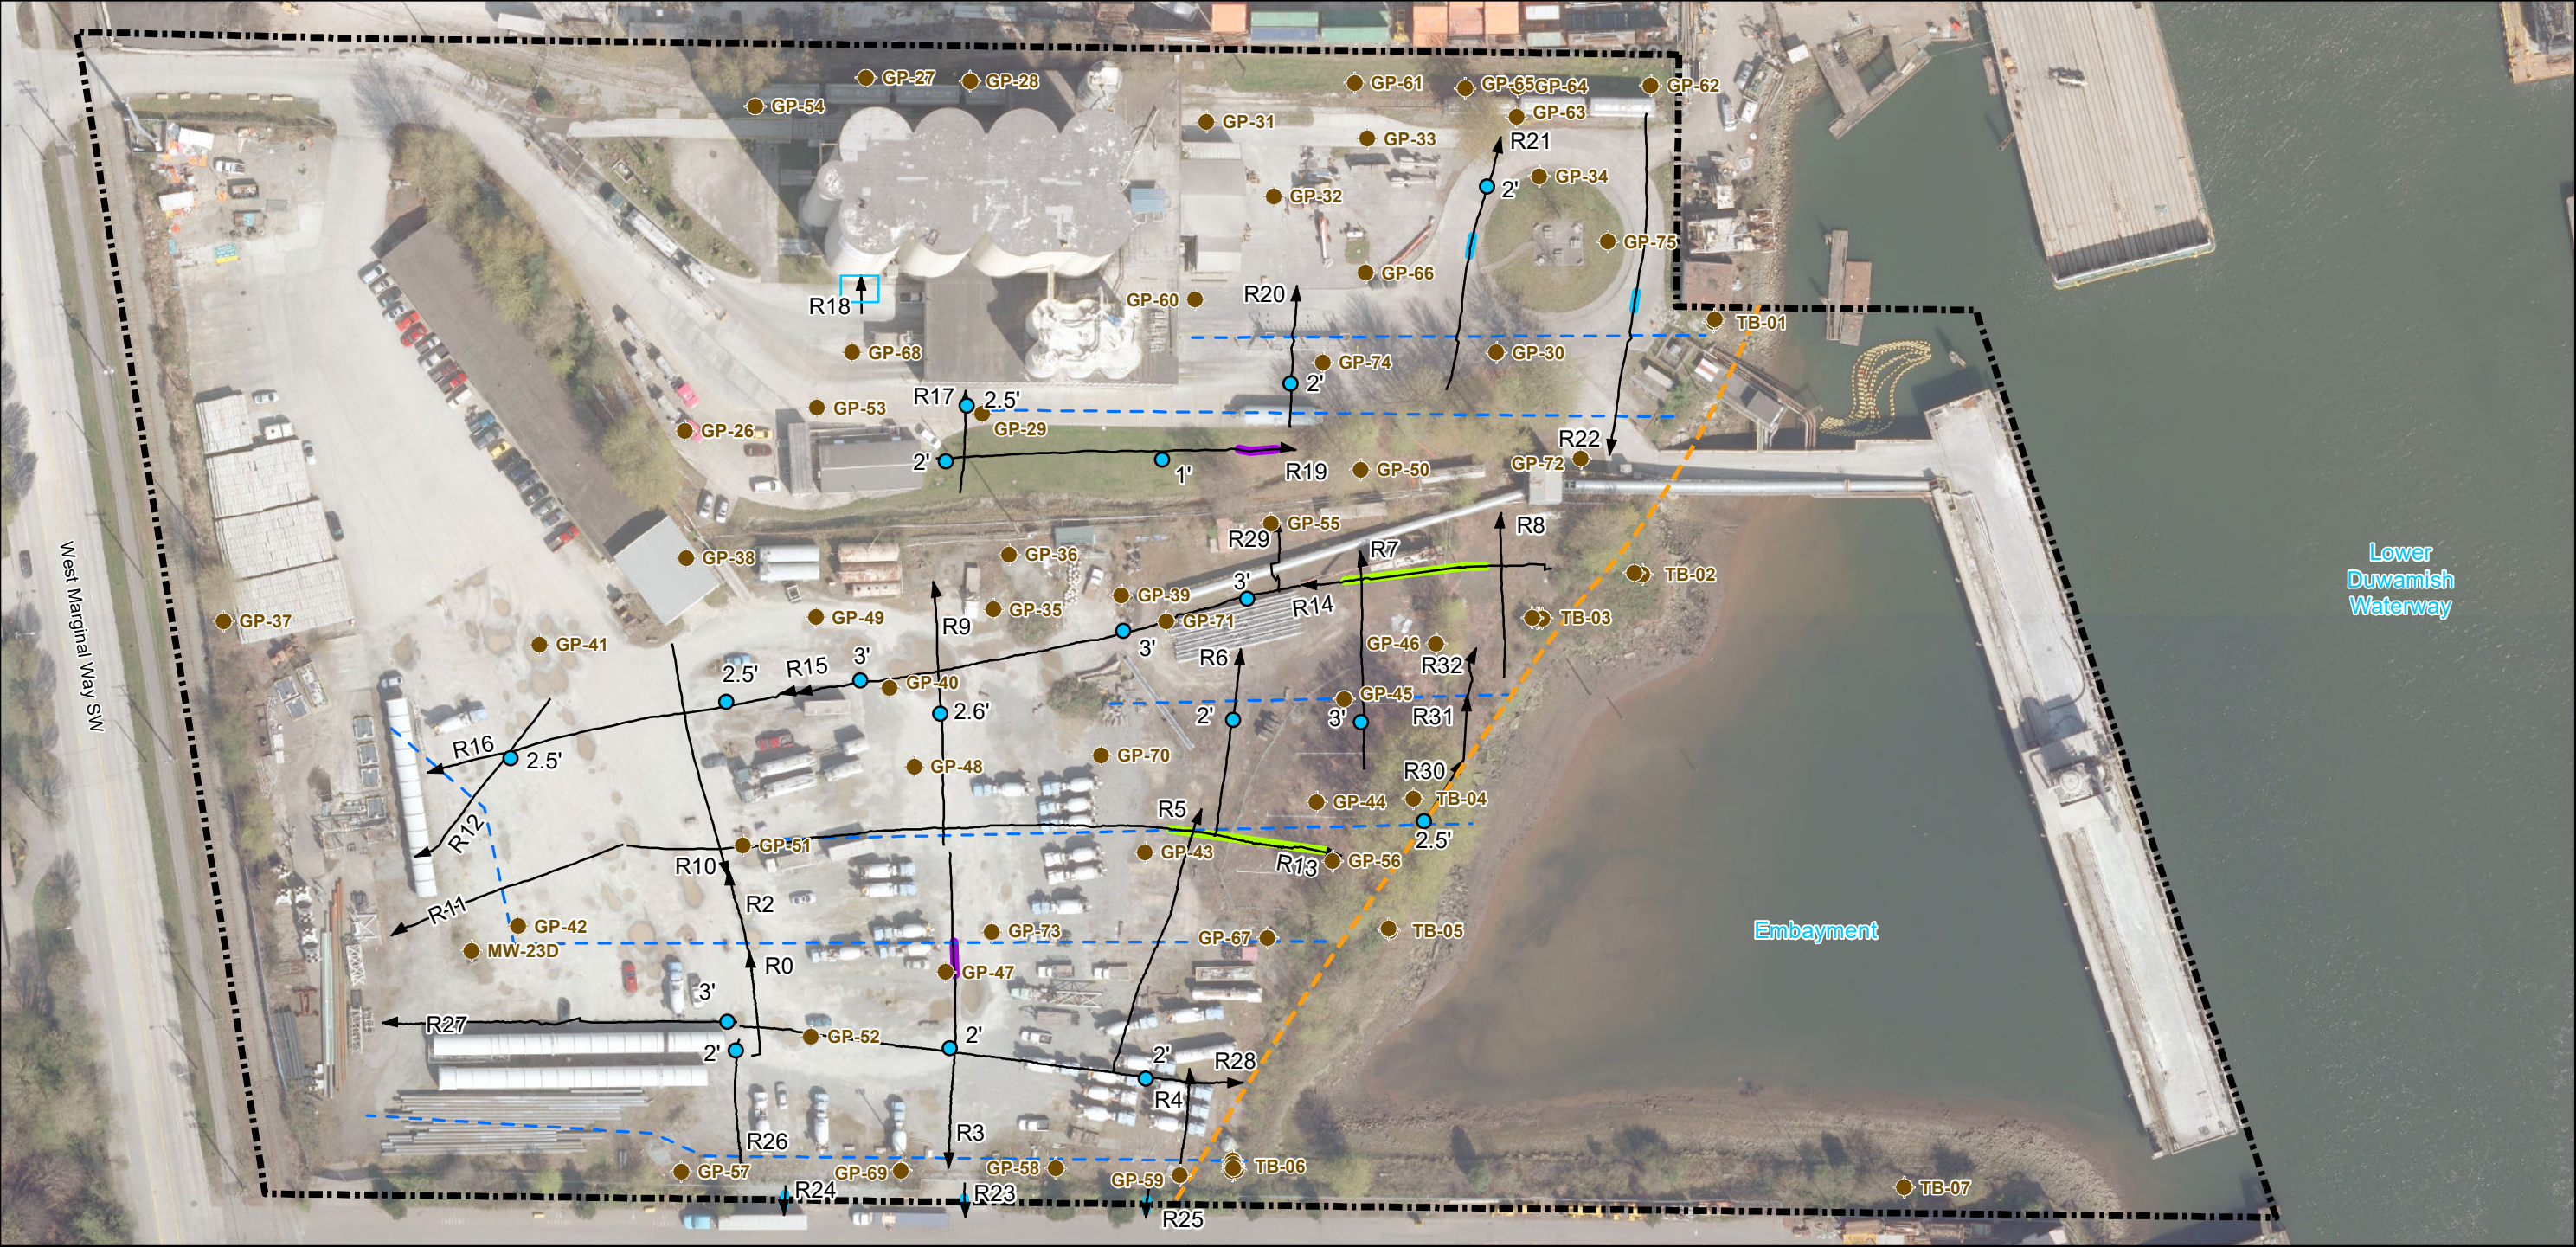
Former drainage ditch locations are based on Figure 6 from the Final Remedial Investigation and Feasibility Study Work Plan, dated August 2012, prepared by the Washington Department of Ecology (Ecology).

**FIGURE 3-5**

**GPR TRANSECTS AND SOIL BORING LOCATIONS**

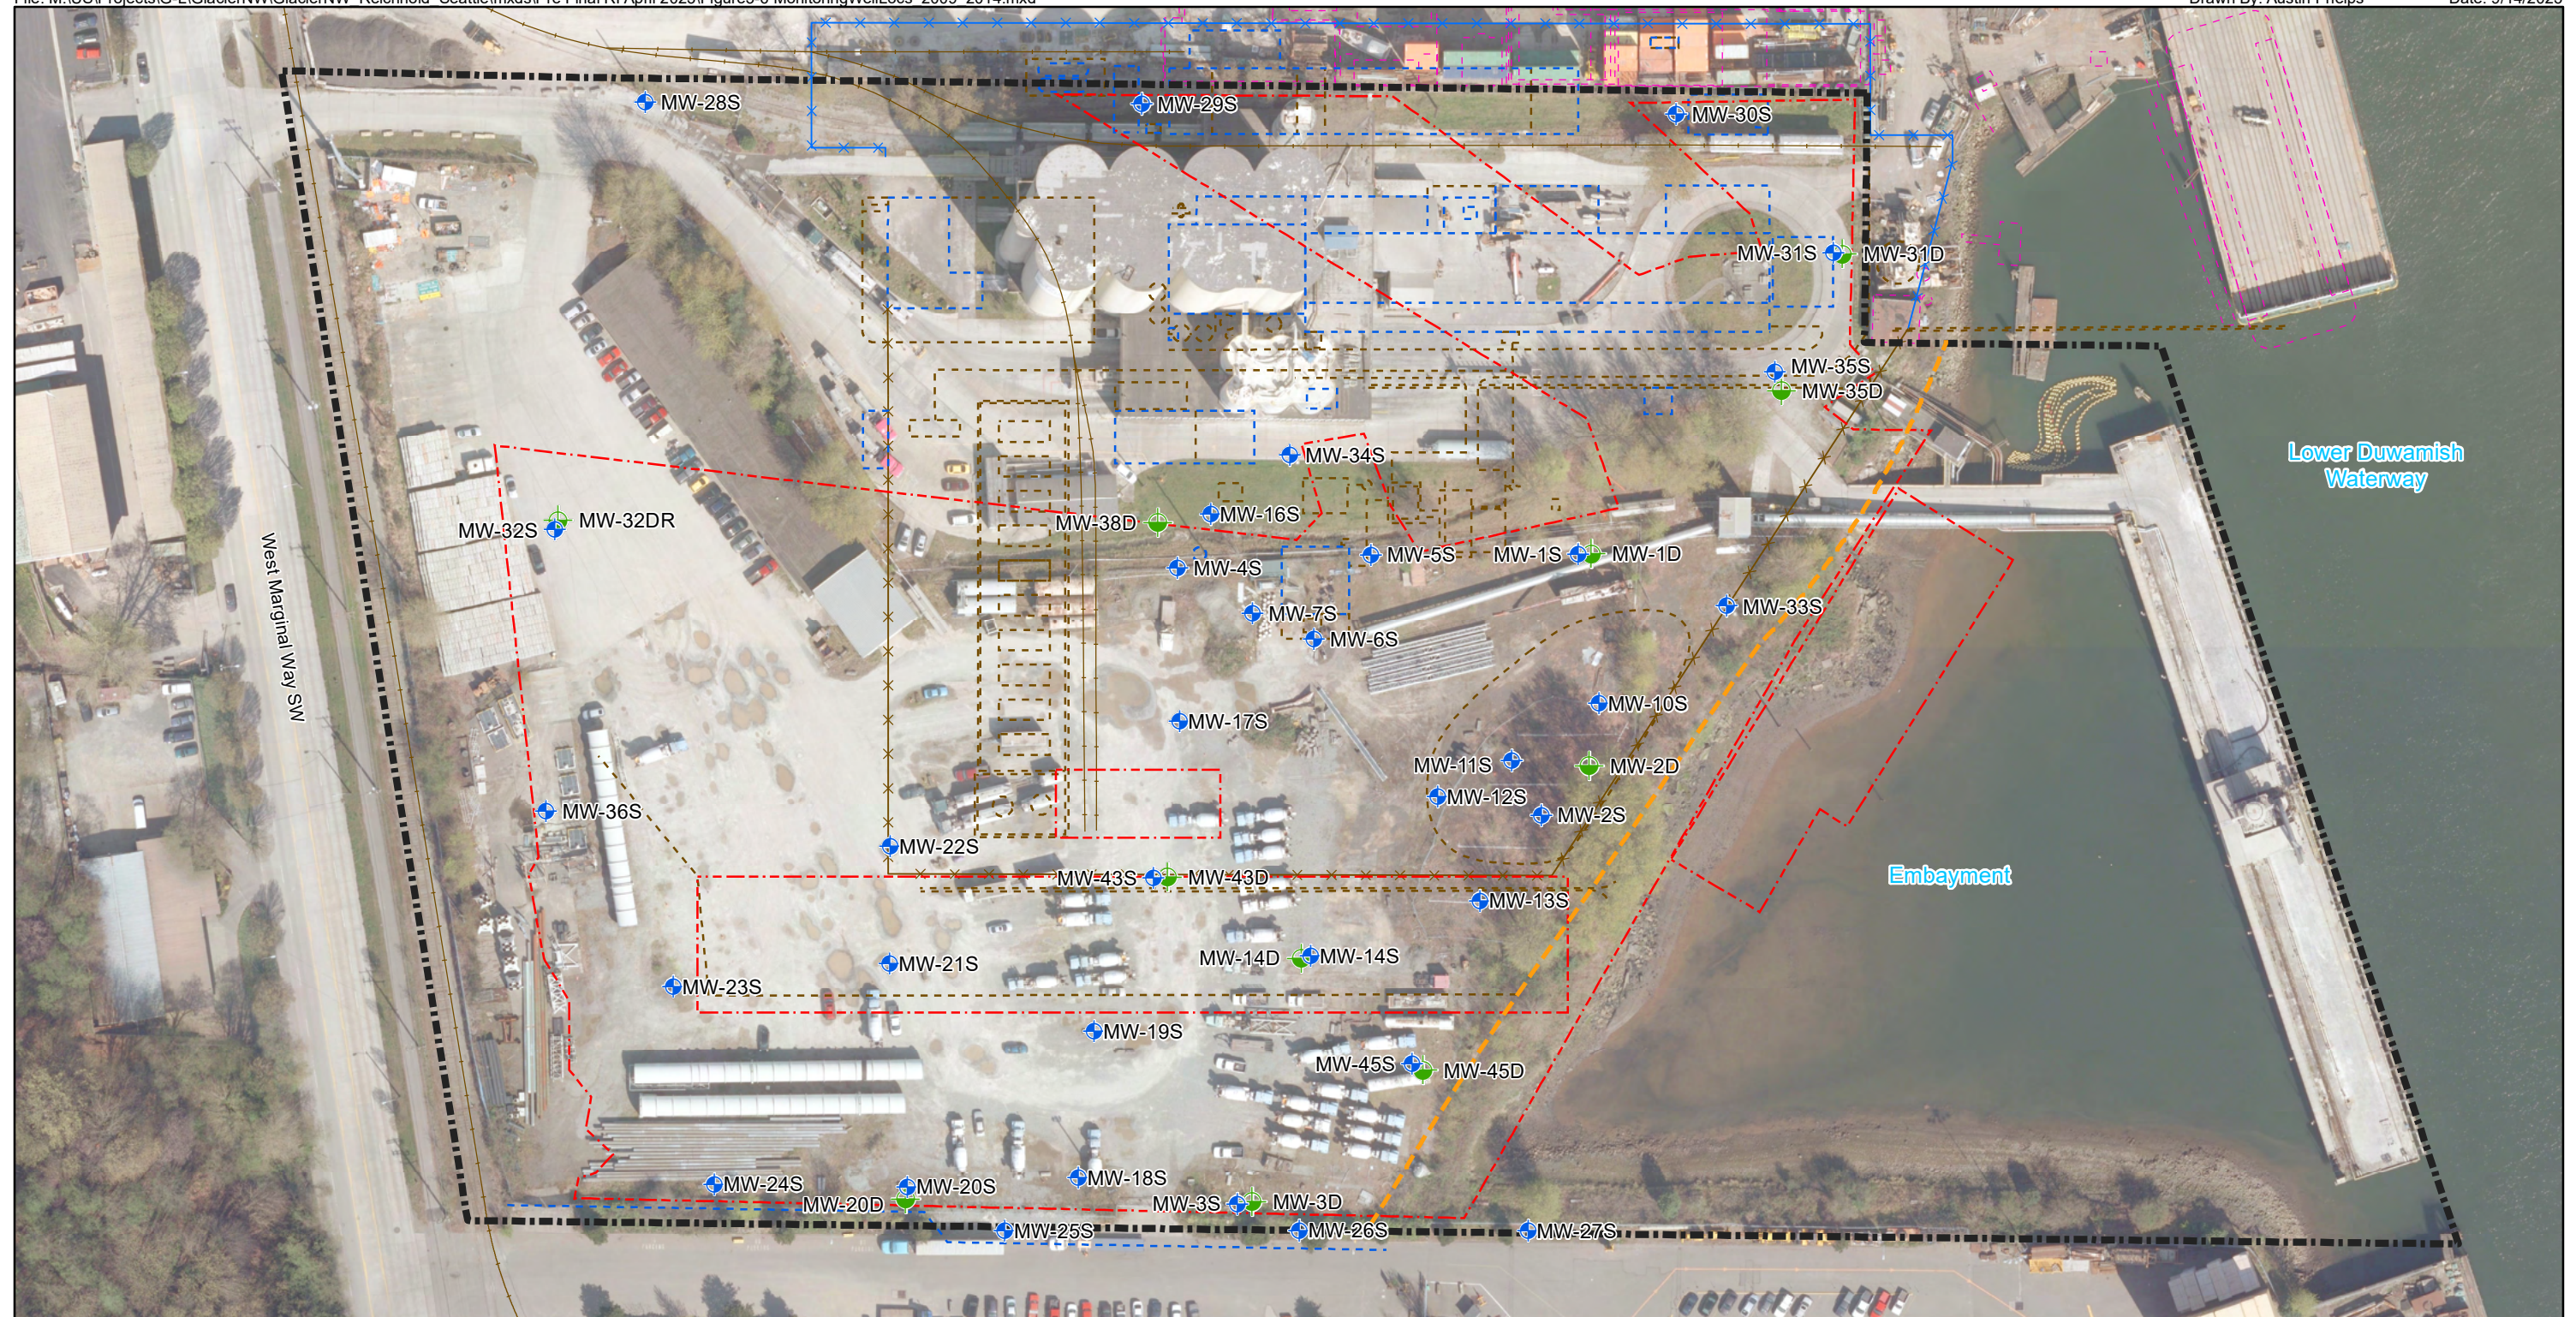
**FIGURE 3-6**  
**EXISTING MONITORING WELL NETWORK**  
*5900 West Marginal Way Site*  
*Seattle, Washington*
