## FIGURES

**FIGURE 1-1**  
**SITE LOCATION MAP**  
**5900 West Marginal Way Site**  
**Seattle, Washington**

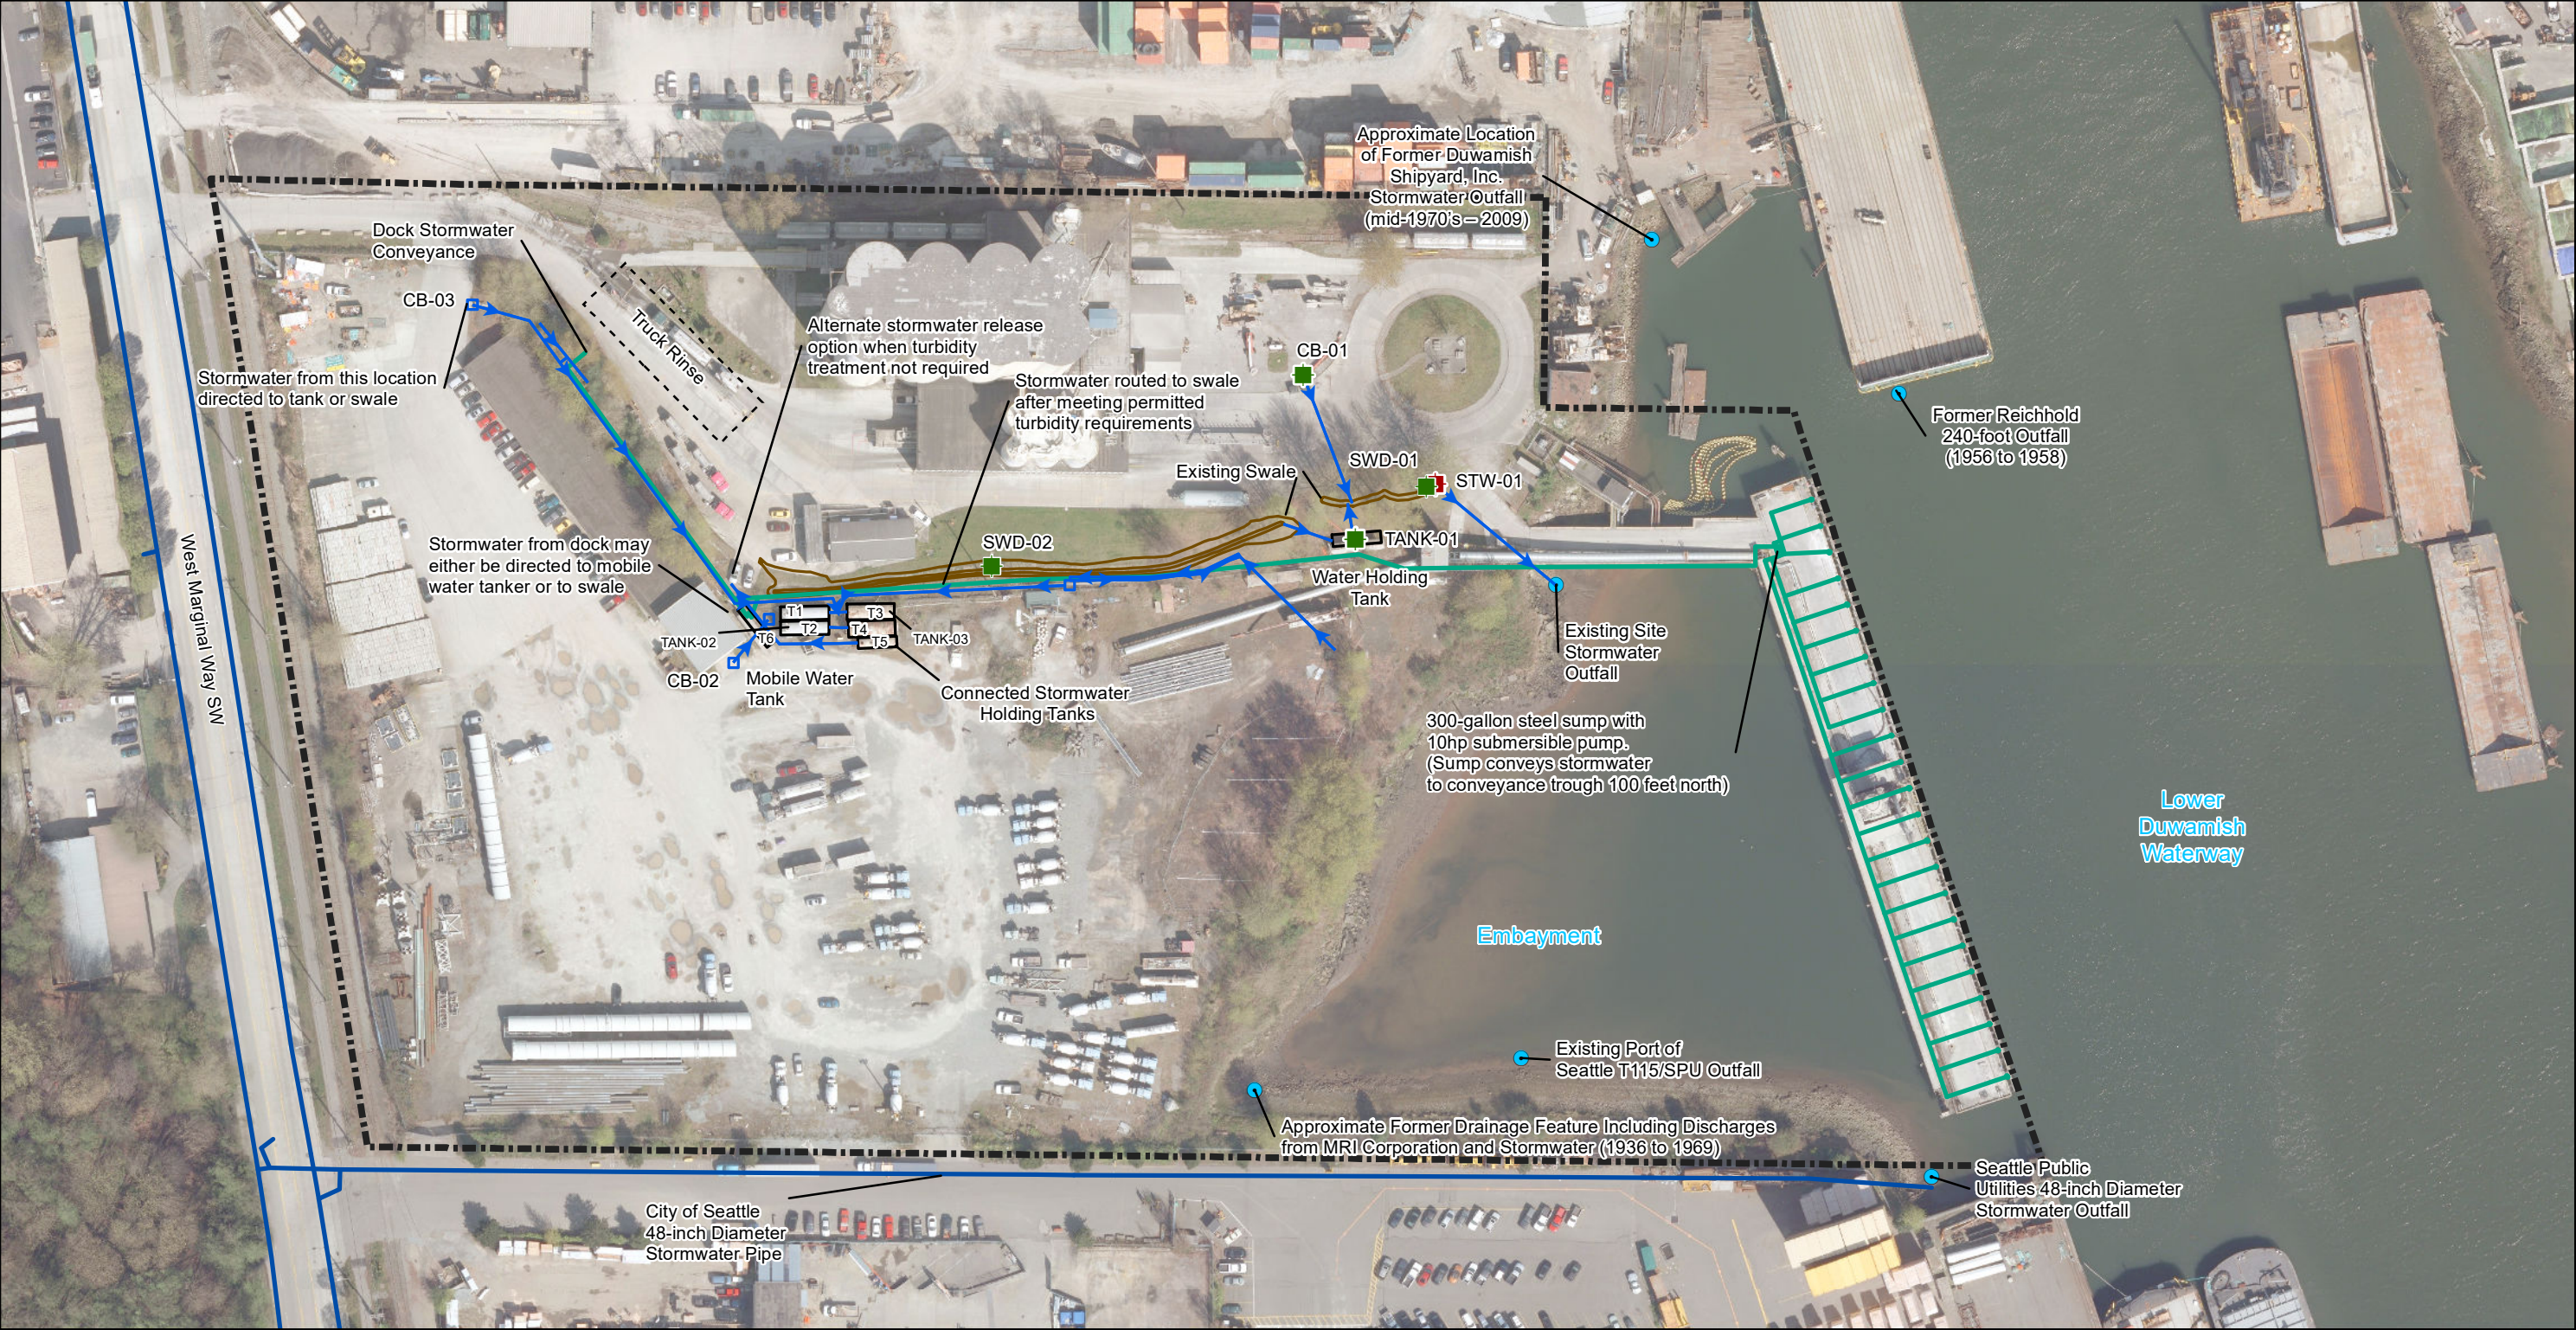
**FIGURE 3-7**  
**STORMWATER INVESTIGATION**  
**5900 West Marginal Way Site**  
**Seattle, Washington**
