**YEAR 3 EELGRASS BIOMASS AND DELINEATION REPORT  
CUSTOM PLYWOOD MILL SITE  
CLEANUP SITE IDENTIFICATION NO. 4533  
PHASE III SUBTIDAL SEDIMENT CLEANUP  
FIDALGO BAY  
ANACORTES, WASHINGTON**

File No. 0202972-000  
June 5, 2026

**Year 3 Eelgrass Delineation Report**

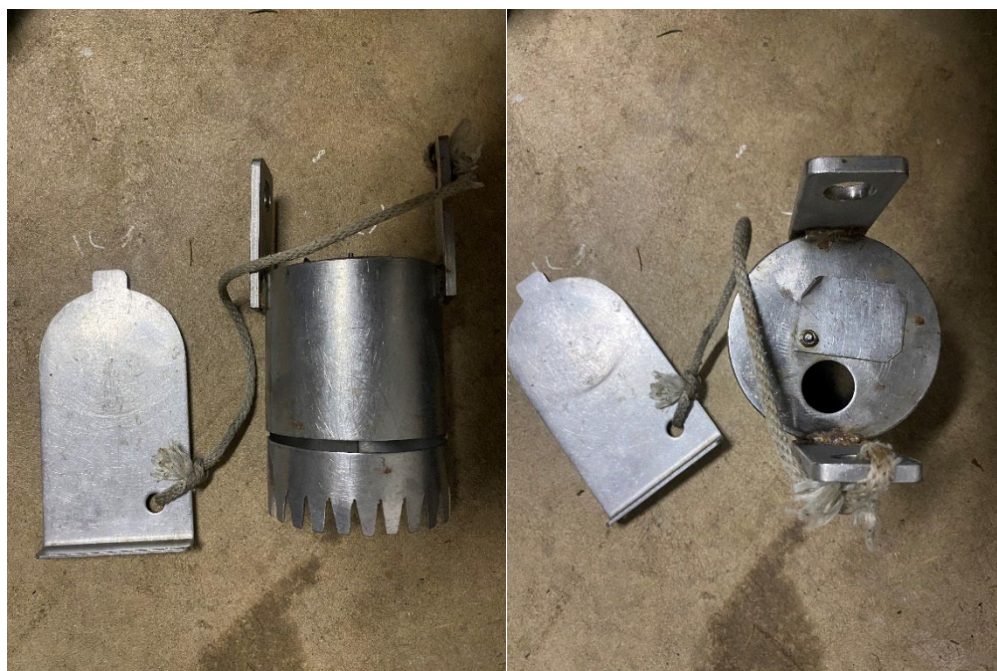
*Figure 2. Four-Inch Stainless Steel Hand Corer*

Divers then collected two 4-inch core samples from each density location for belowground eelgrass biomass analysis, collocating the belowground sample location to align with where the five aboveground shoots were collected. Divers utilized a stainless steel four-inch hand core for collecting the sediment samples (Figure 2). The belowground biomass samples were also placed into labeled bags and placed into the cooler for transport to shore. Upon returning to shore, the cooler containing the shoot biomass and belowground biomass samples was transferred to Haley & Aldrich staff for transport to the analytical laboratory.

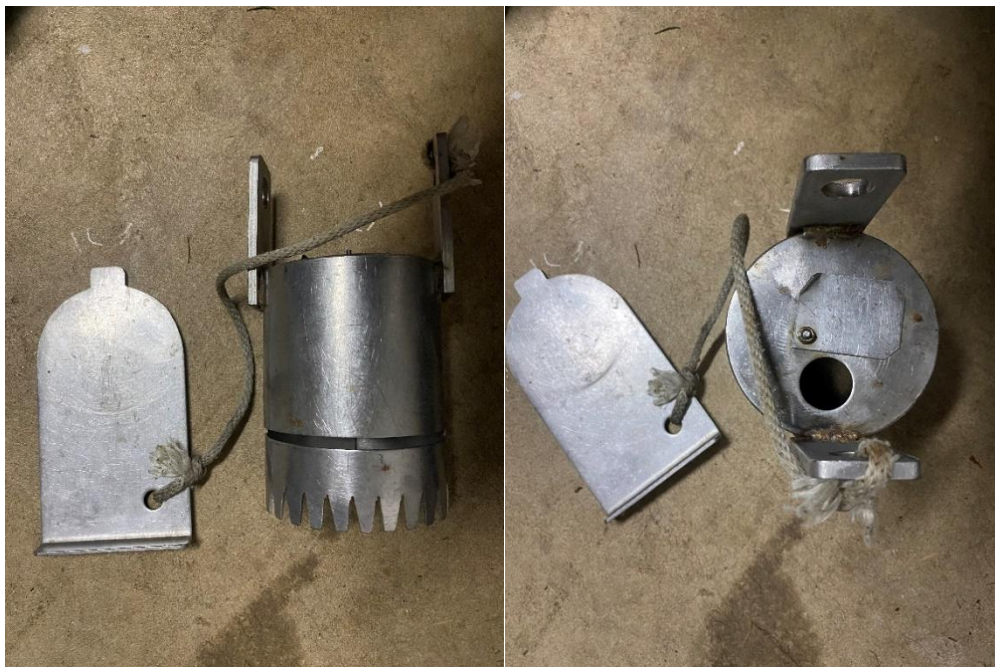
**Figure 2. Four-inch stainless steel hand corer**

location for belowground eelgrass biomass analysis using a hand core (Figure 2). After returning to the surface, the eelgrass shoots were inspected for clinging sediment or macroalgae; any sediment/macroalgae on the shoots were gently removed. Once sampling was complete, the shoots and the 4-inch cores were placed into a cooler for transport to a laboratory for analysis. Samples were given to Haley & Aldrich, Inc. (Haley & Aldrich), who stored the samples in a freezer until analysis was conducted by Haley & Aldrich. Photos taken during sample collection can be seen in Attachment A.

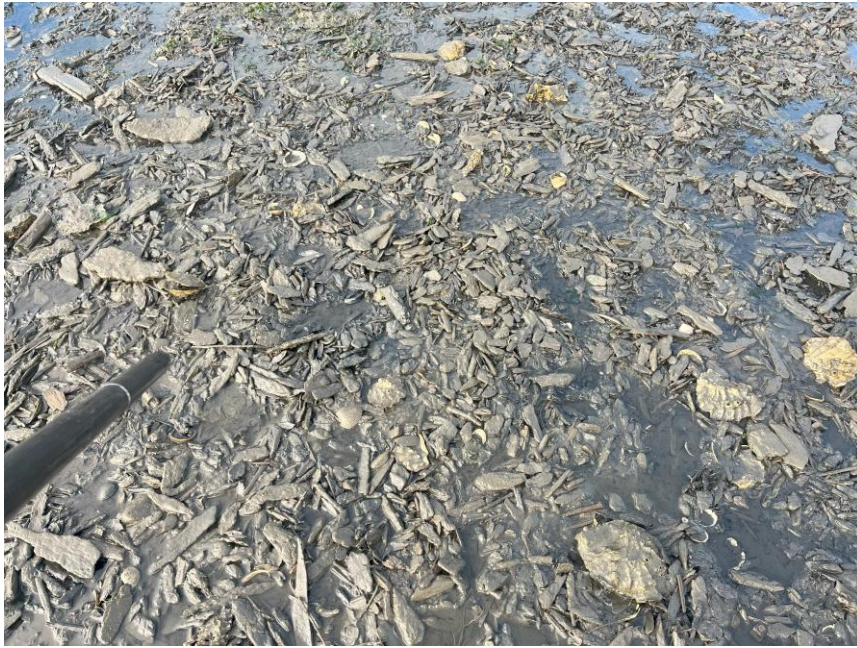
**Figure 3. Close up image of the wood waste on the south side of the spit**

Anthropogenic materials were noted throughout the survey but were not the focus of this survey. In 2022, wood waste was observed in sites M-2, M-6 and REF-2; however, in the 2024 survey, wood waste was present at TLC-1, M-4, 2021 transplant plot 11 and on the southern side of the spit (Figure 3).

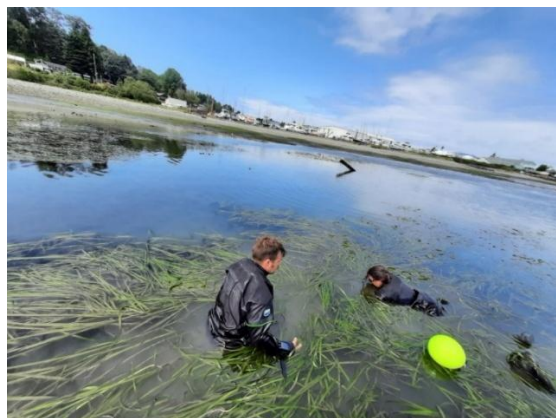
**Figure 4. MSA team counting the eelgrass within the 2021 Transplant Area, Plot 11**

In the 2021 transplant plot 11, the substrate was very muddy with shell hash and contained a lot of wood chips. There was a layer of wood chips present throughout the entire survey plot. Additionally, there was *Saccharina latissima* present. However, the eelgrass bed was very dense and contained 195 shoots within the entire semicircle (Figures 3 & 8). The 2021 plot 12 had a large void of eelgrass and only contained 14 shoots (Figures 4,5, & 8). The substrate was also very muddy without any other submerged aquatic vegetation present. Due to the lack of eelgrass, MSA biologists also counted 6-ft along the outer edge of the semicircle and documented 27 shoots. After further investigation, this site was unfortunately misrepresented due to GPS accuracy issues while on-site that were clarified upon reviewing the GPS data back at the office. The horizontal accuracy was only 3.0 m, meaning the horizontal location used in the field was likely only within 3 meters of the actual position. Therefore, the void of eelgrass was not within the 2021 plot 12 transplant area and should have been at the edge of the main bed. Regardless, the 2021 transplant area has seen an increase in density since the total shoot count between both sites in 2022 was 66 shoots and is >195 shoots in 2024.

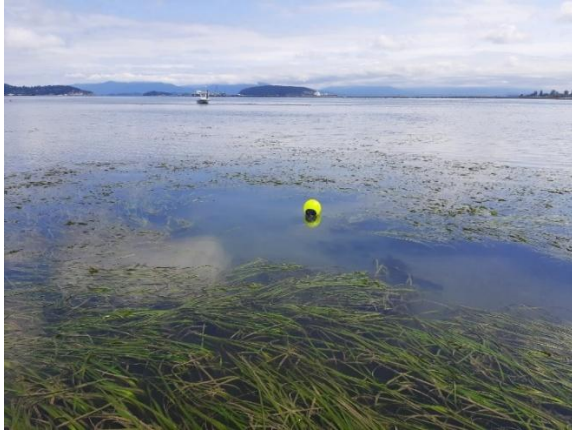
**Figure 5. Photo depicting the eelgrass which was thought to be the void within the 2021 Transplant Area, Plot 12**

\*It is important to note that this void was not representative of the 2021 Transplant Area, Plot 12 due to a GPS error. Surrounding the void, the eelgrass bed was dense, which is likely more representative of the actual sample location.

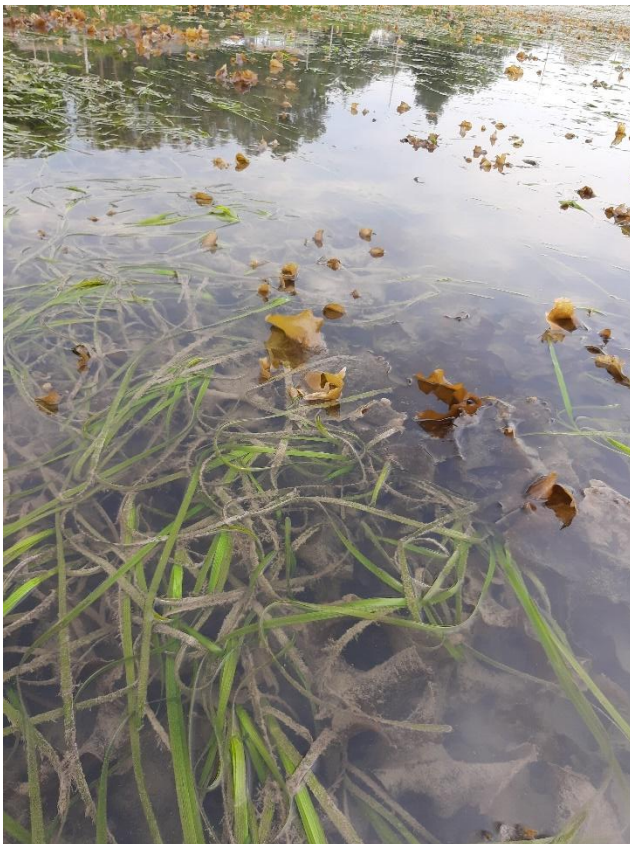
**Figure 8. Large percent coverage of *Saccharina* at site TLC-2**
