# **2025 Operations, Maintenance, and Monitoring Annual Report South Park Landfill Settlement Area SPPD (CenterPoint)/City Area**

**Seattle  
Public  
Utilities**

March 2026

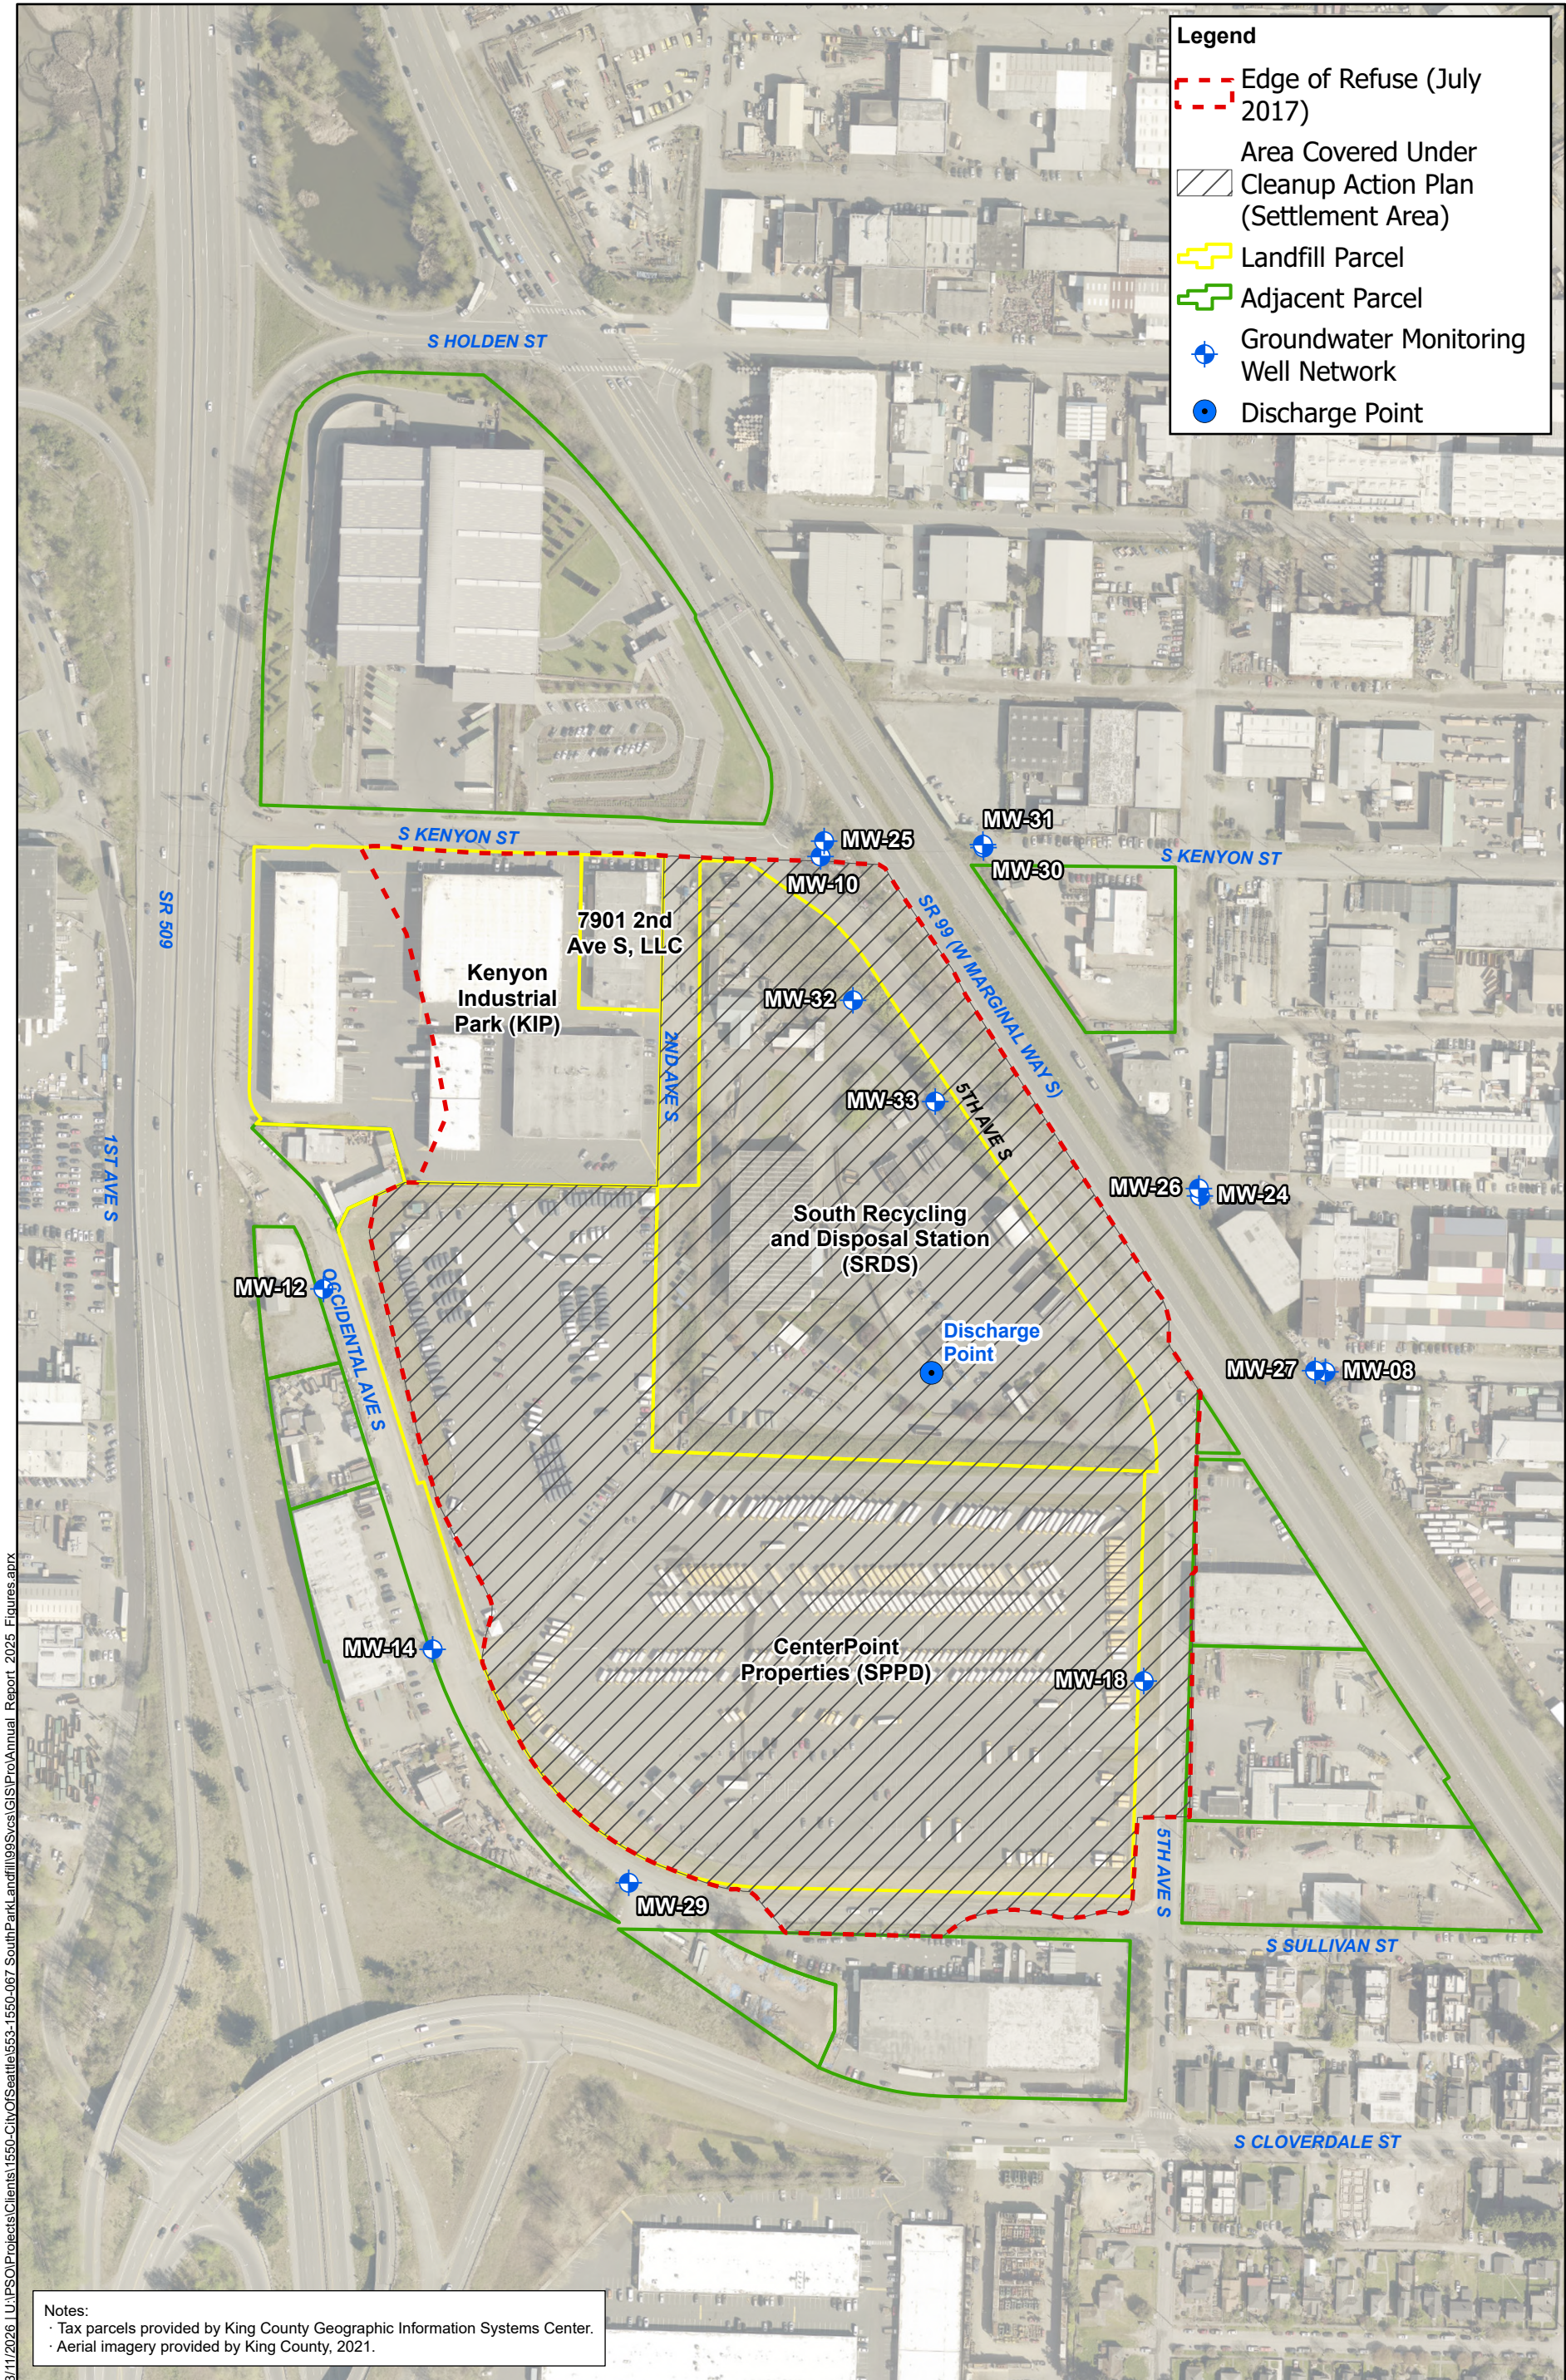
Figure 3  
Perimeter Gas Probe Network  
South Park Landfill

The perimeter gas probe network for the Settlement Area includes 21 probes installed at 17 locations (Figure 3), including four supplemental shallow probes installed in 2025 at locations where existing gas probes have typically been blocked by water. Installation of the supplemental shallow gas probes occurred in late July through August of 2025 and is described in Section 3.2.2.

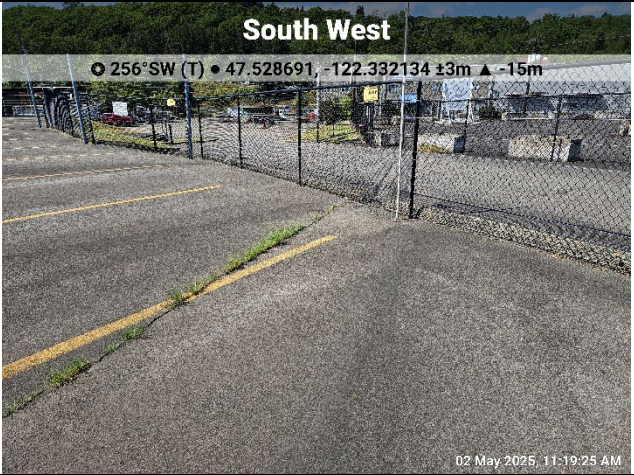
| CPSP Location | Description | October 2024 Inspection | | May 2025 Inspection | | | | Photographs |
|---|---|---|---|---|---|---|---|---|
| AC-20 | Minor cracks | Increased plant growth in the crack.<br><br>Follow-up reinspection | No actions taken or required | Revised determination | Determined not to be a significant issue impacting the cap. | N/A | N/A | |

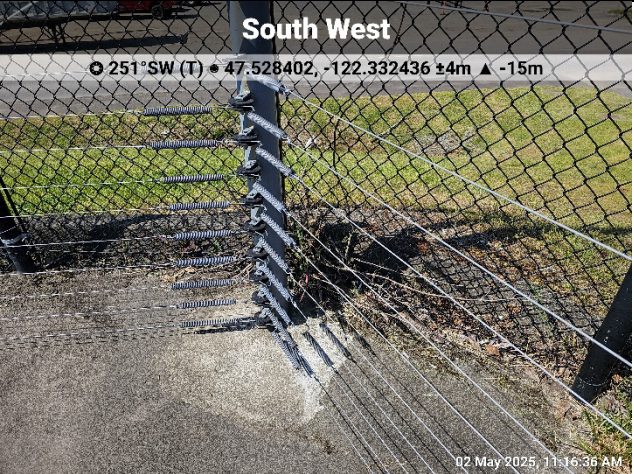
| CPSP Location | Description | October 2024 Inspection | | May 2025 Inspection | | | | Photographs |
|---|---|---|---|---|---|---|---|---|
| AC-21 | Holes near fence allowing growth of plants & ponding presence | Plant has been mostly removed. Seal pavement where the plant was growing. | Plant was cut back. Maintenance form was submitted. | No significant changes observed | Previous recommendations remain. Continue to inspect to see if the plant continues to grow and disrupt the asphalt. | Past Due | CenterPoint | |

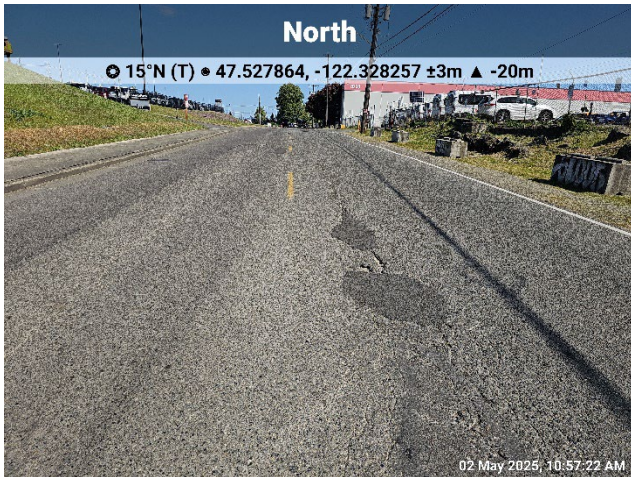
| ROW Location | Description | October 2024 Inspection | | May 2025 Inspection | | | | Photographs |
|---|---|---|---|---|---|---|---|---|
| AC-2 | Asphalt open cracking | Cracks got extended and holes are deeper. Some of the holes are close to penetrating the cap.<br><br>Repatching should be coordinated with SDOT. | No action taken | Improved | Previous pothole and some deep cracks were patched; however, several cracks are deeper and need repair.<br><br>Repair/repatching should be coordinated with SDOT. Reported on the SDOT Find It, Fix It app. | December 2025 | SDOT | |

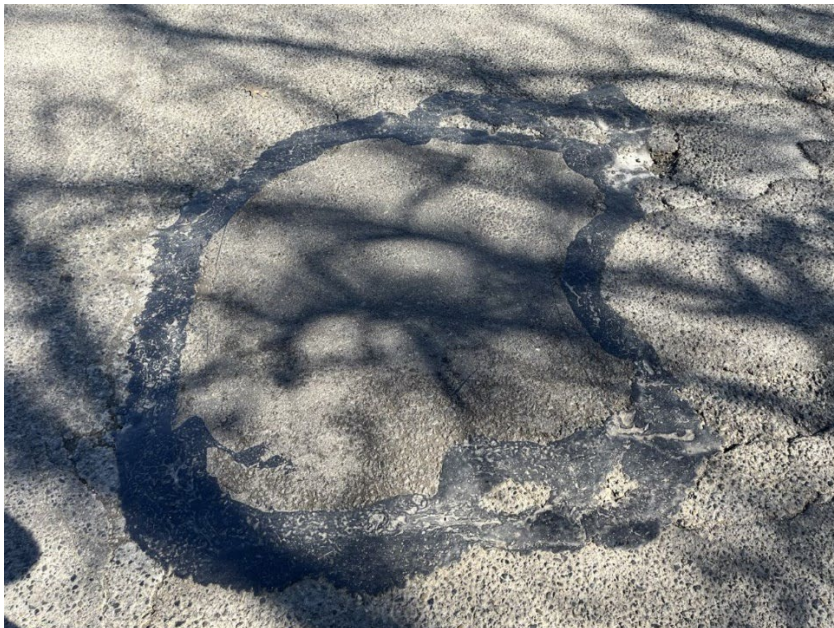
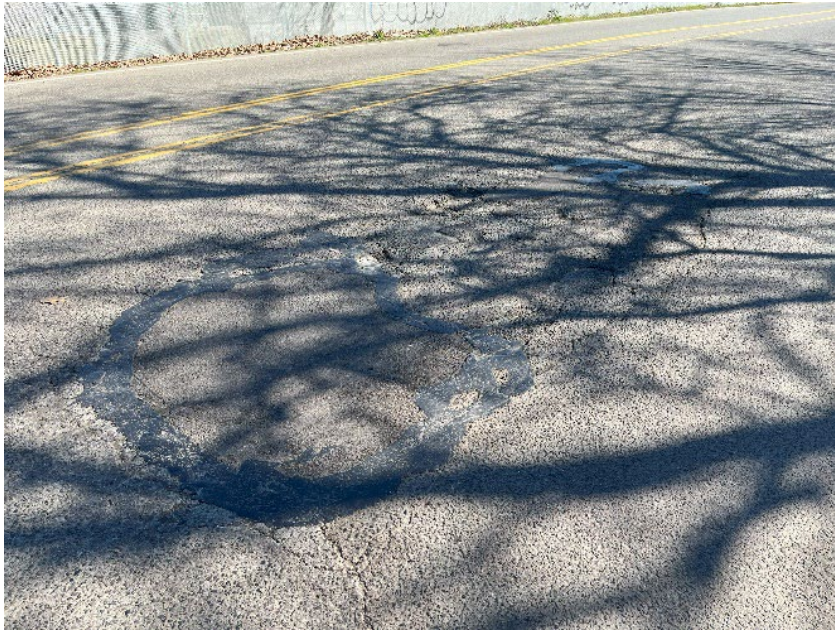
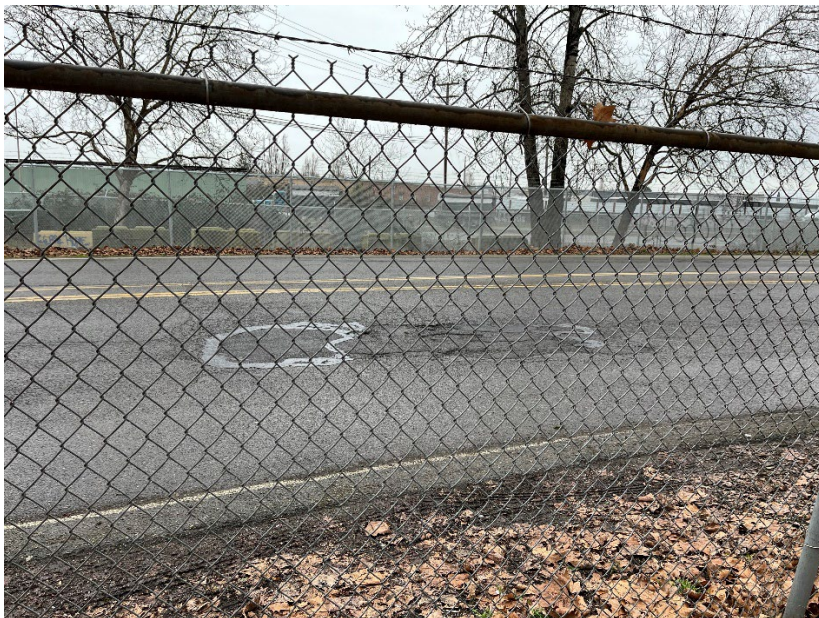
ROW AC-4. Complete. Large and smaller potholes patched with asphalt.

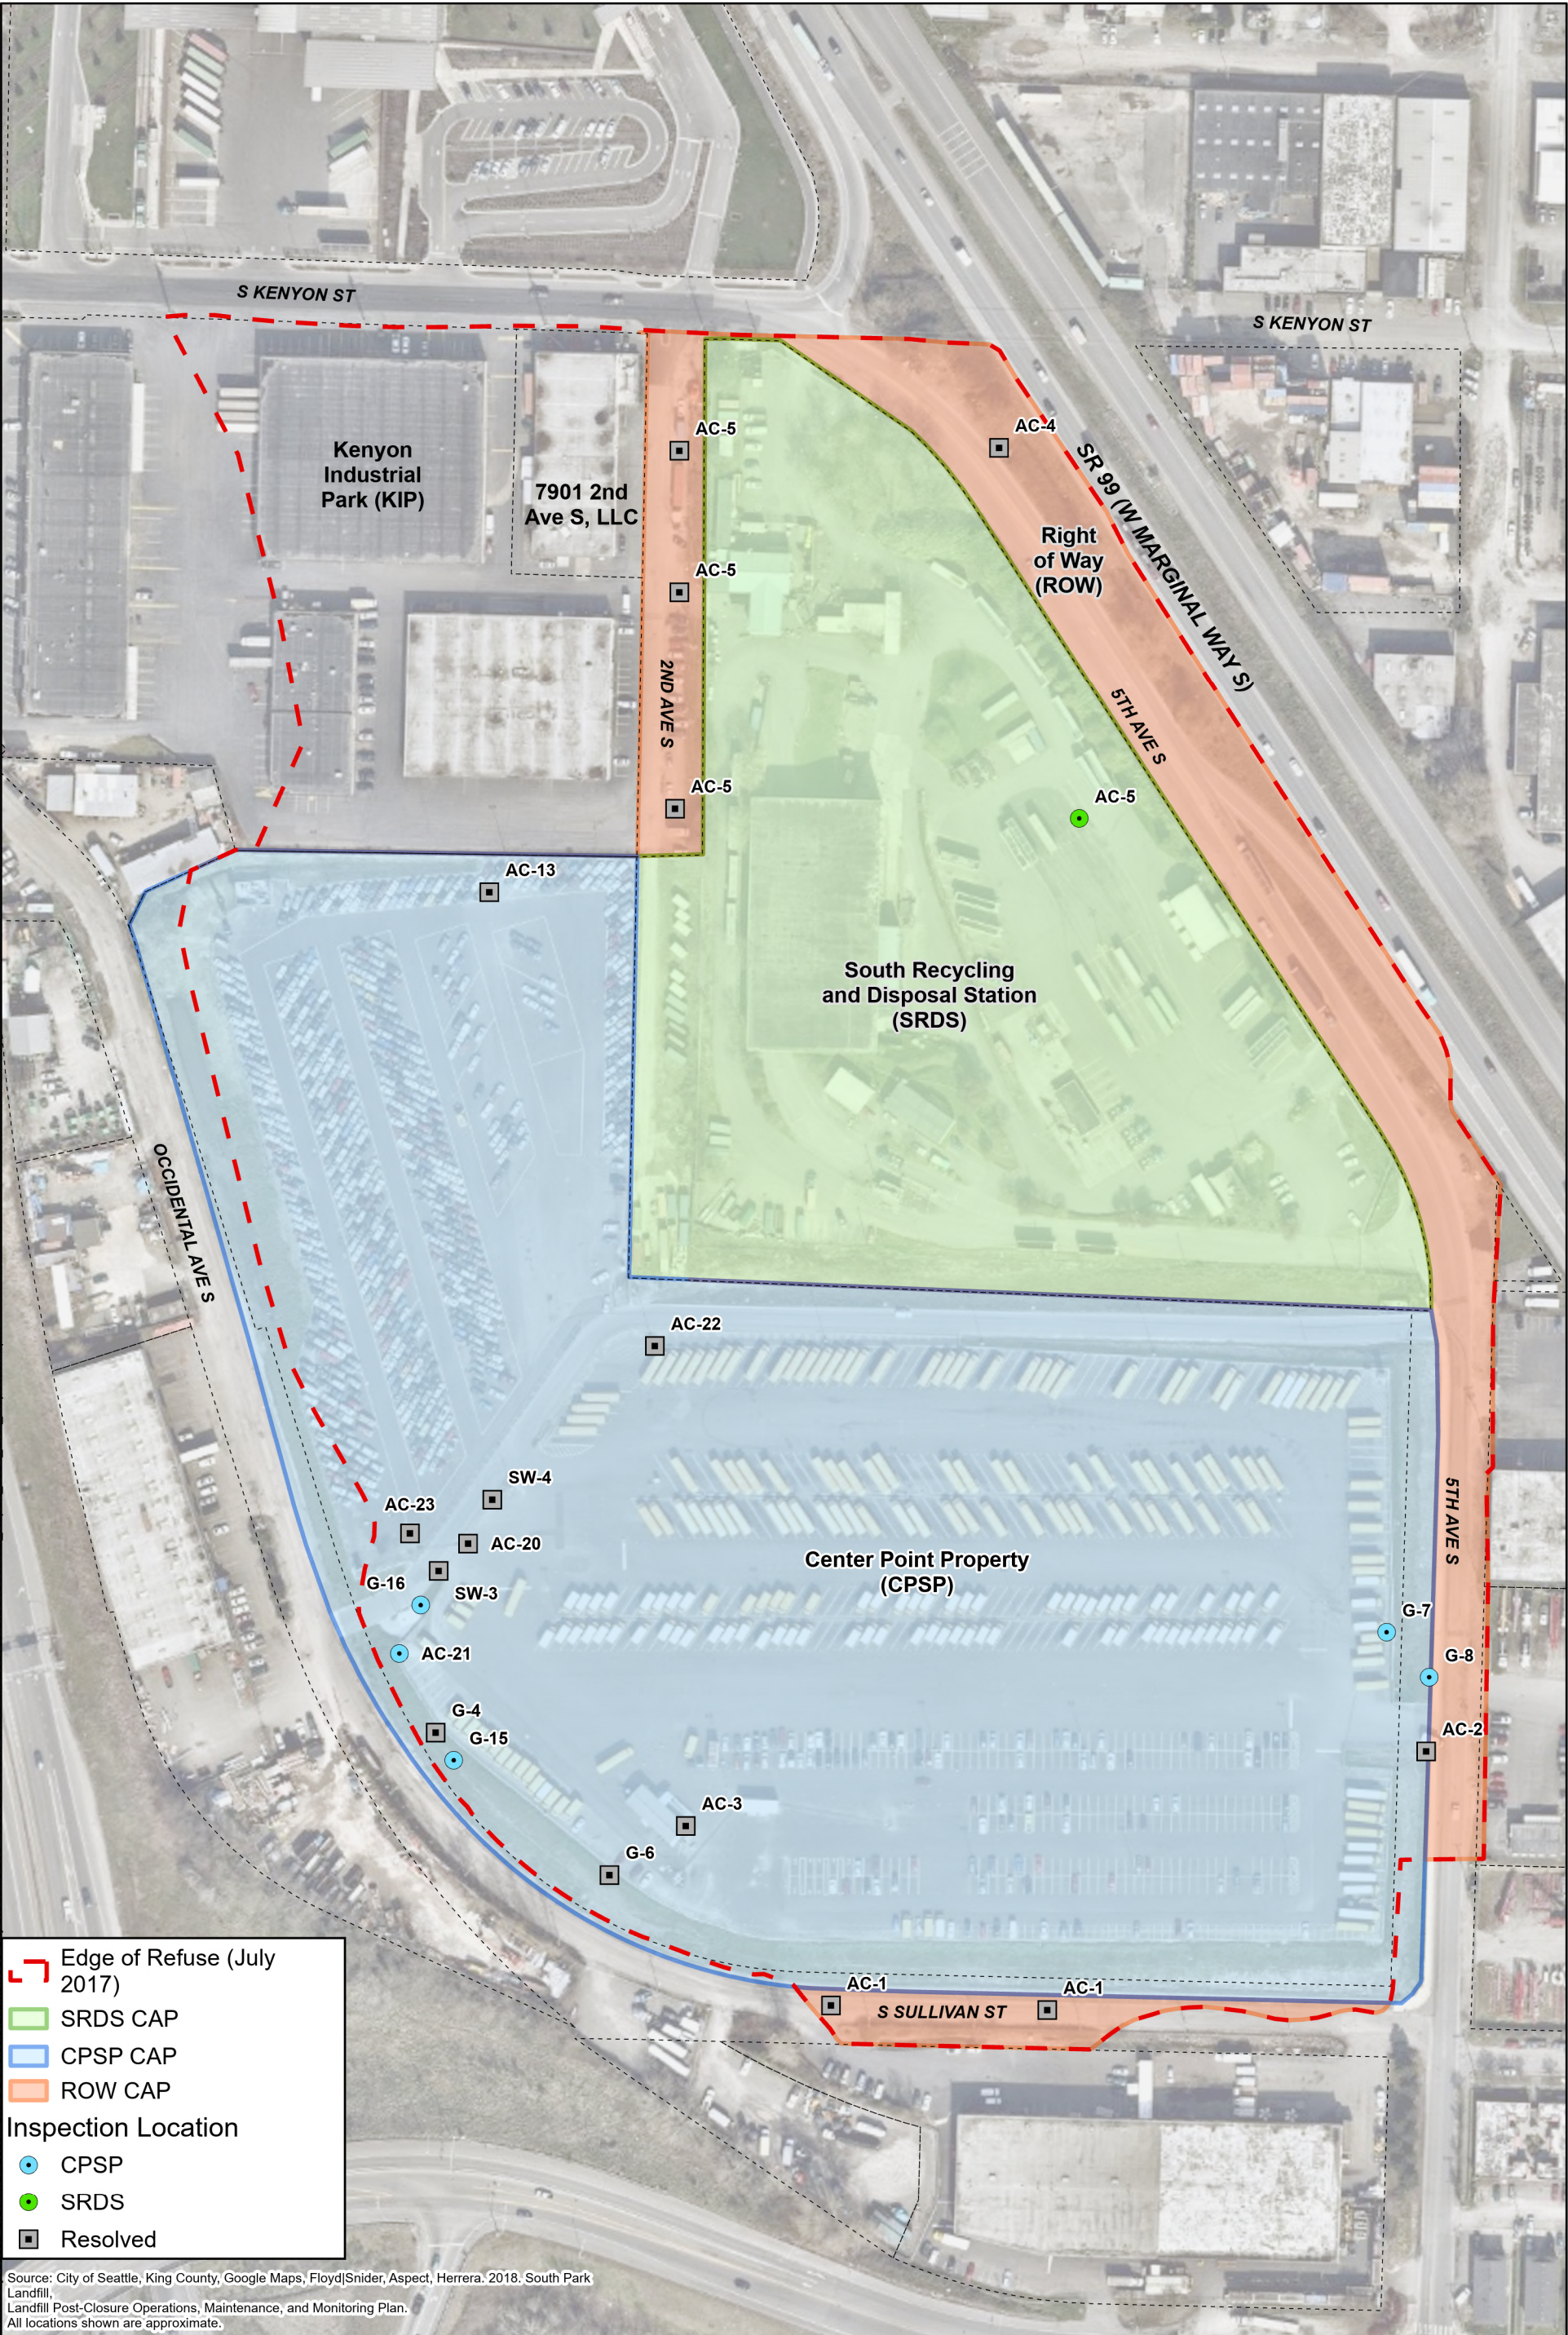
Landfill Cap Inspection October  
2025 Site Plan with Locations of  
Concern, South Park Landfill

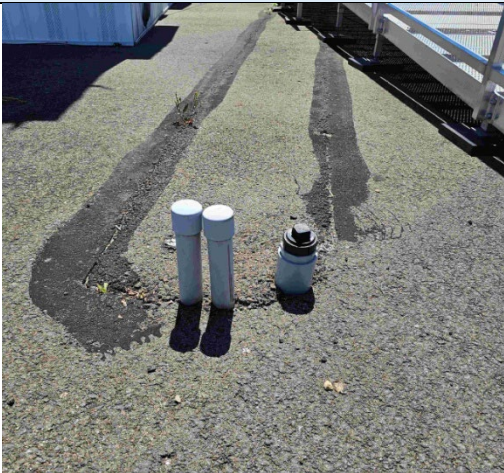
| CPSP Location | Description | May 2025 Inspection | | October 2025 Inspection | | | | |
|---|---|---|---|---|---|---|---|---|
| AC-3 | Uncapped pipe | Pipe remains uncapped. Put cap on pipe. | Past Due | Resolved | The pipe was capped. | N/A | N/A | |

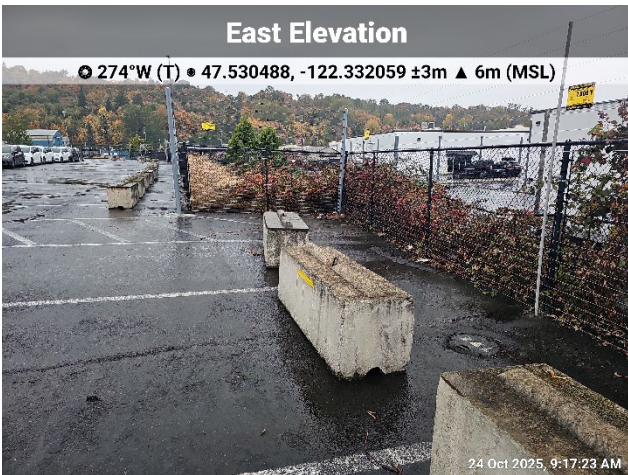
| CPSP Location | Description | May 2025 Inspection | | October 2025 Inspection | | | | |
|---|---|---|---|---|---|---|---|---|
| AC-13 | Blackberry shrubs growth and stagnated water behind the concrete blocks | No sediment buildup and sheen, but blackberry growth observed. Regular maintenance of blackberries is recommended. | Plants were cut back. The maintenance form was submitted. | Resolved | Blackberry maintenance completed. Will continue to observe, but condition improved. | N/A | N/A | <div>East Elevation</div> <div>📍 274°W (T) • 47.530488, -122.332059 ±3m ▲ 6m (MSL)</div> |

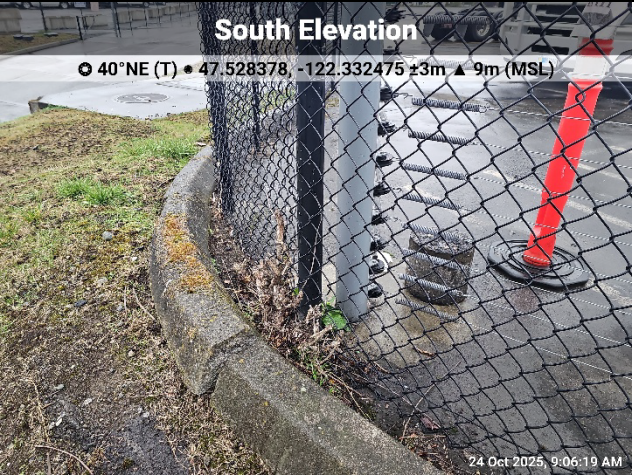
| CPSP Location | Description | May 2025 Inspection | | October 2025 Inspection | | | | Photographs |
|---|---|---|---|---|---|---|---|---|
| AC-21 | Holes near fence allowing growth of plants & ponding presence | Plant was mostly removed. Seal pavement where the plant was growing. Continue to inspect to see if the plant continues to grow and disrupt the asphalt. | None. | No significant changes observed | Previous recommendations remain. The plant appears to have further damaged the curb so unsure of subsurface impacts and potential cap disruption. | Past Due | CenterPoint | |

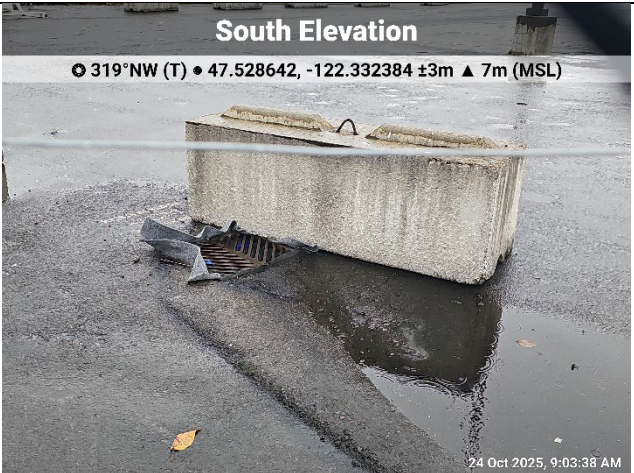
| CPSP Location | Description | May 2025 Inspection | | October 2025 Inspection | | | | Photographs |
|---|---|---|---|---|---|---|---|---|
| AC-23 | Separation of pavement from storm drain | Most of the plant next to the storm drain has been removed but the roots are still there, and the cap penetration was not sealed. Plant roots had pushed up the pavement. Repair and seal pavement. | Sediment, roots, and the stump were removed, and the lifted asphalt was replaced. The asphalt surrounding the catch basin was repatched and perimeter-sealed. | Resolved | Conditions improved. No issues observed though Ecology block obstructed some of the area. | N/A | N/A | |

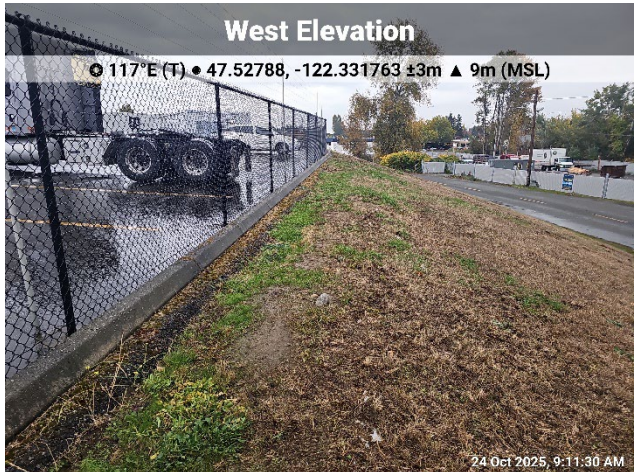
| CPSP Location | Description | May 2025 Inspection | | October 2025 Inspection | | | | |
|---|---|---|---|---|---|---|---|---|
| G-6 | Geomembrane exposed in this area | <p>Geomembrane is still exposed.</p> <p>Locations with exposed geomembrane are of the highest concern due to the potential compromise of the landfill cap. The configuration of the geomembrane and cover at the interface of the parking area does not appear to be in accordance with Figure 5 of the Interim Action Work Plan (IAWP). The geomembrane appears to be directly below the asphalt with no drainage layer or surfacing layer in between. Along with Site Coordinator, prepare a plan to reestablish cover over the geomembrane. Most likely, the area should be exposed, and the geomembrane tested for damage before repairs are made. The crest of slope should then be provided cover to the maximum extent possible considering the existing asphalt and curb configuration.</p> <p>Geomembrane still exposed. Previous recommendations remain.</p> | Action Not Yet Completed. | Resolved | No exposed geomembrane observed though no resolution action documented. Will continue to monitor but condition status changed to resolved. | N/A | N/A | |

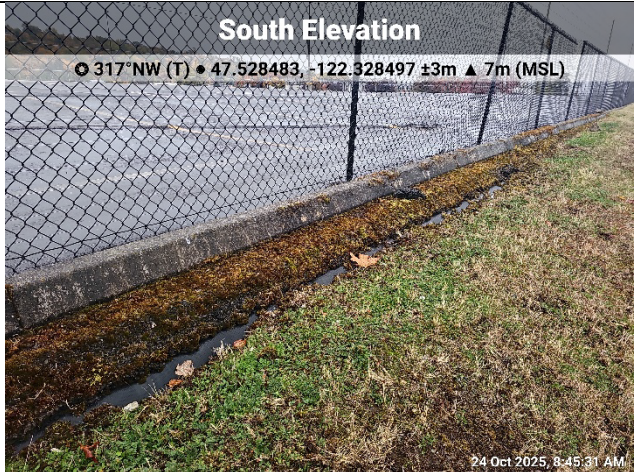
| CPSP Location | Description | May 2025 Inspection | | October 2025 Inspection | | | | |
|---|---|---|---|---|---|---|---|---|
| G-7 | Exposed and damaged geomembrane at the parking area interface | <p>Geomembrane is still exposed. This issue is observed in various pockets along the fence down to the sidewalk. Previous recommendations remain.</p> | Action not yet completed. | No significant changes observed | Geomembrane is still exposed. Previous recommendations remain. | Past Due | CenterPoint | |

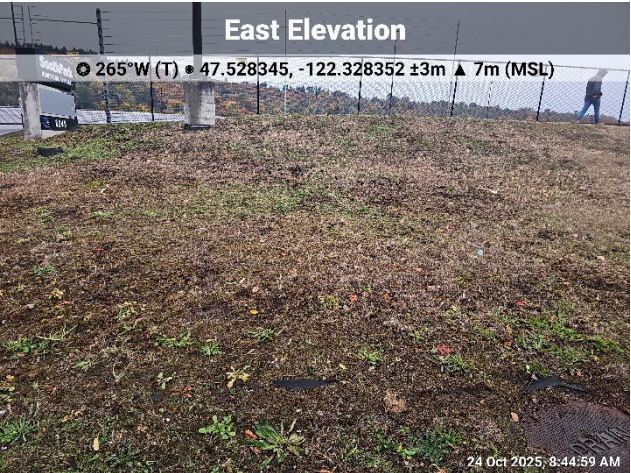
| CPSP Location | Description | May 2025 Inspection | | October 2025 Inspection | | | | Photographs |
|---|---|---|---|---|---|---|---|---|
| G-8 | Exposed geomembrane around utility access hole | Work with Site Coordinator to prepare a plan to re-establish cover over the geomembrane. The geomembrane should be carefully exposed to not damage the geomembrane and inspected to determine if it is excess material or part of the cover. Make repairs as necessary and install adequate cover soil in accordance with the IAWP. | No documentation of actions taken. | No significant changes observed | Geomembrane is still exposed. Previous recommendations remain. | Past Due | CenterPoint | |

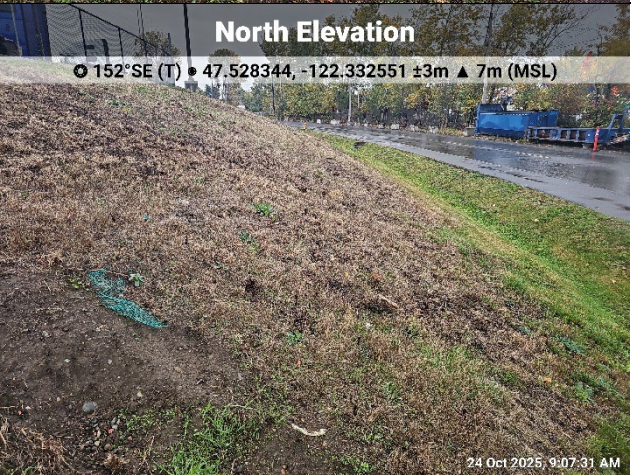
| CPSP Location | Description | May 2025 Inspection | | October 2025 Inspection | | | | Photographs |
|---|---|---|---|---|---|---|---|---|
| G-15 | Erosion and rilling on the bank. | Geomembrane is not exposed, but clear evidence of erosion and rilling on the bank at the southwest corner of the CPSP property. Further erosion could lead to exposure and damage to the membrane. Recommend reestablishing the dirt and grass on the hillside. | Action not yet completed. | No significant changes observed | Clear evidence of erosion on slope. Previous recommendations remain. | December 2025 | CenterPoint | |

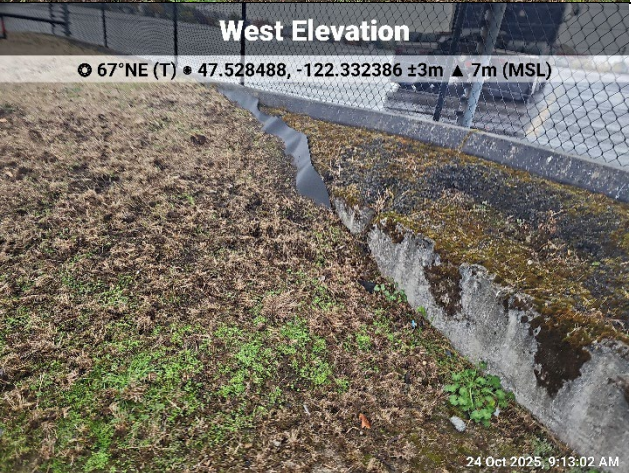
| CPSP Location | Description | May 2025 Inspection | | October 2025 Inspection | | | | Photographs |
|---|---|---|---|---|---|---|---|---|
| G-16 | Geomembrane exposed in this area | The geomembrane is exposed at the edges of the hillside. Recommend reestablishing the dirt and grass on the hillside. | Action not yet completed. | Conditions slightly worsened | Geomembrane exposed at edges. Previous recommendations remain. | December 2025 | CenterPoint | |

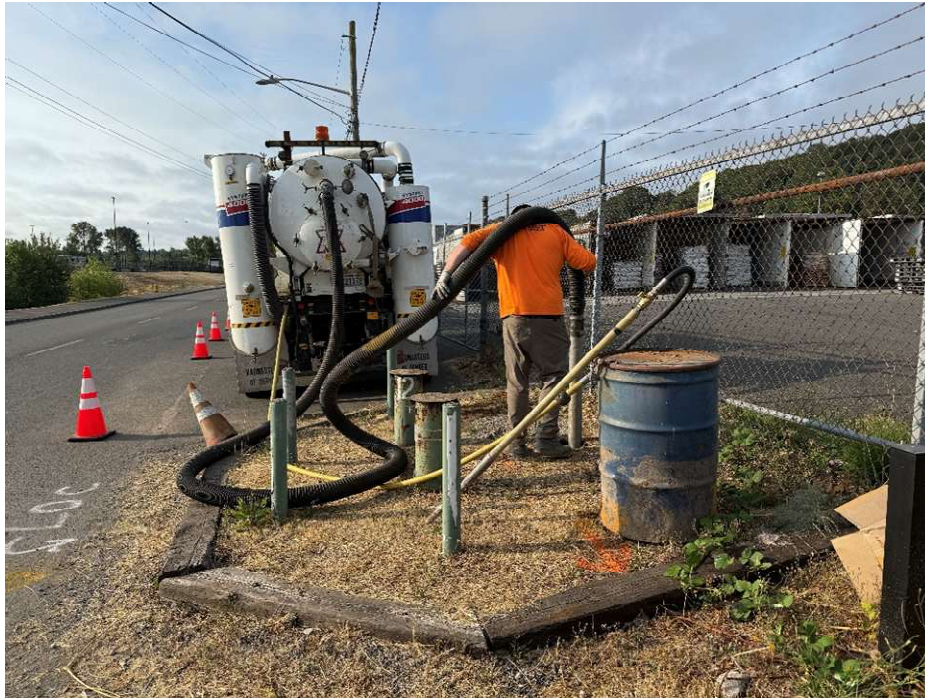
Excavation for supplemental gas probe GP-11S using vector truck and air knife.

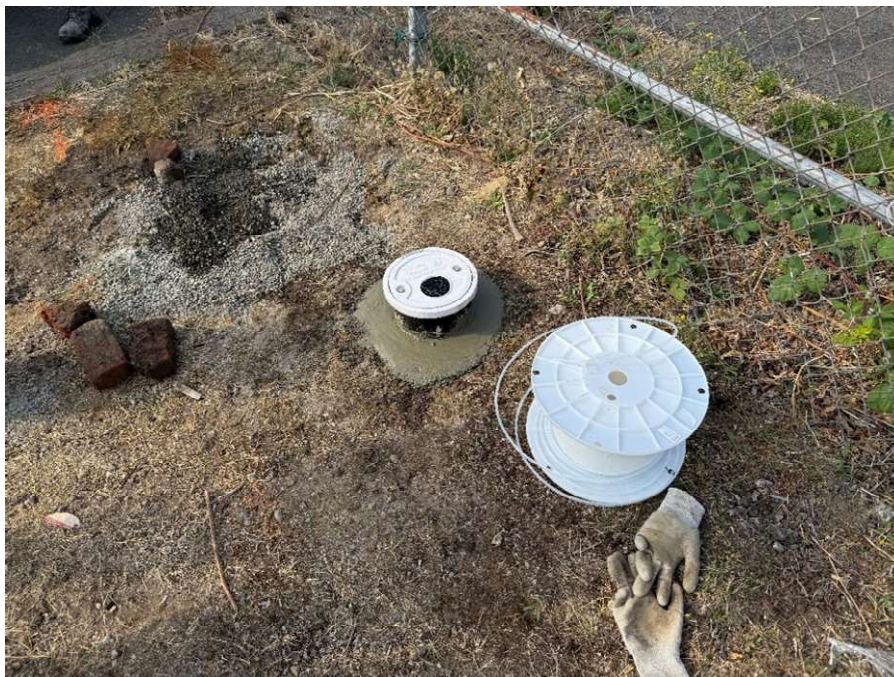
Completed supplemental gas probe GP-11S with flush-mount monument set slightly above ground surface.

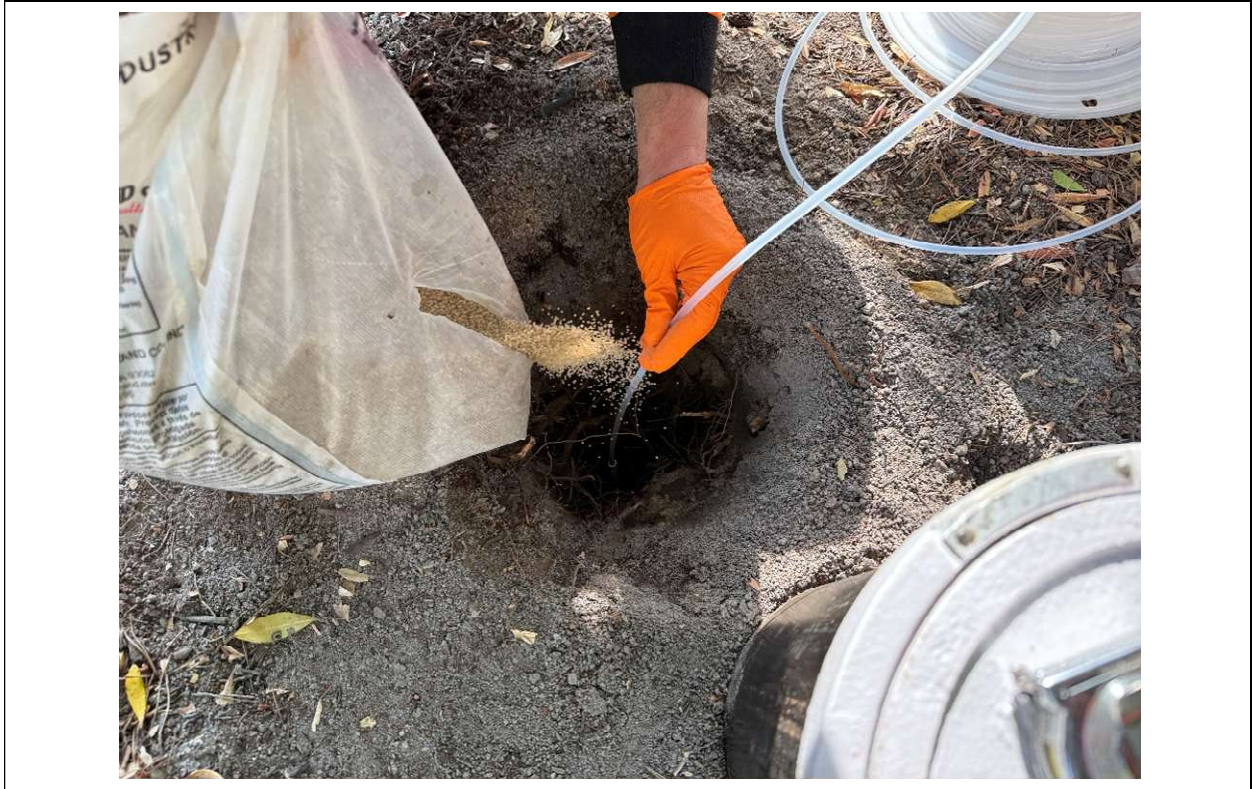
Installation of GP-13S. Wire mesh screen and LDPE tubing lowered into excavation, filter pack sand being placed above and below screened interval.

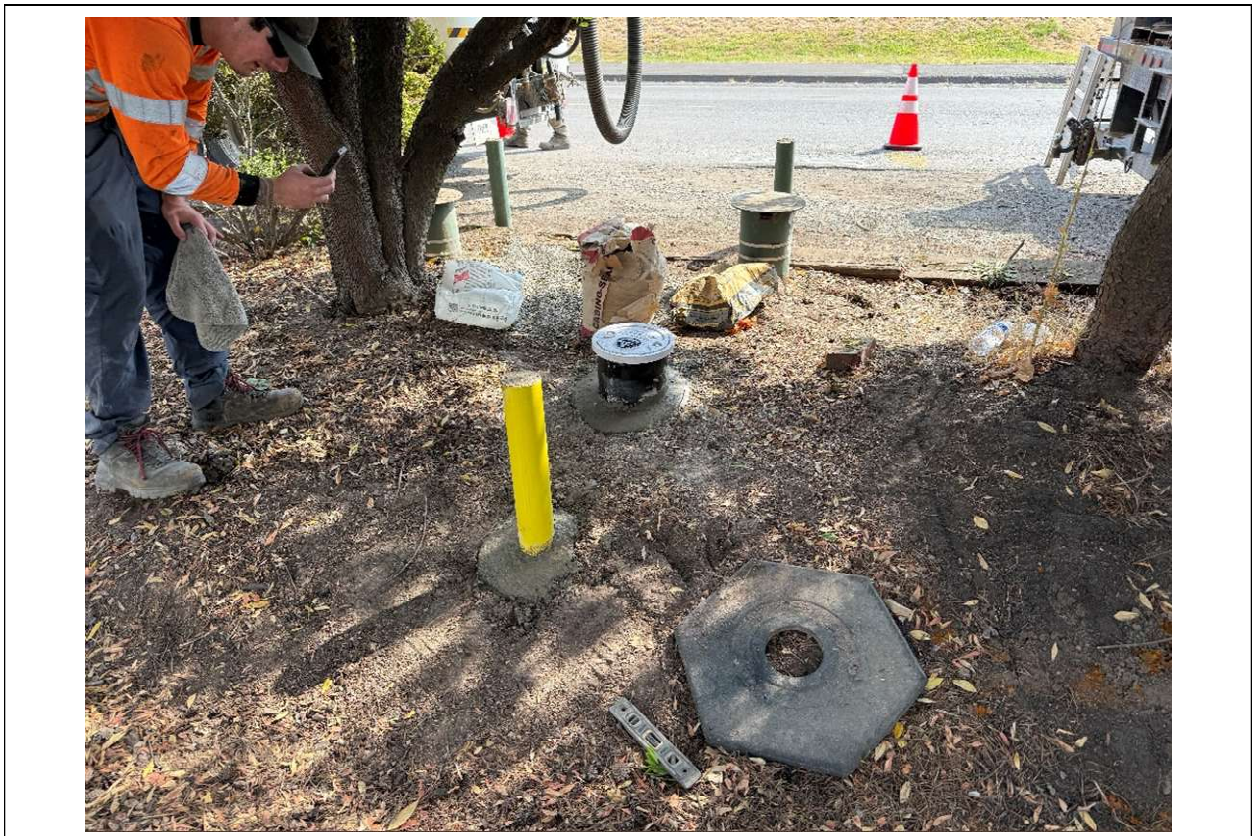
Completed supplemental probe GP-13S and installed protective bollard.

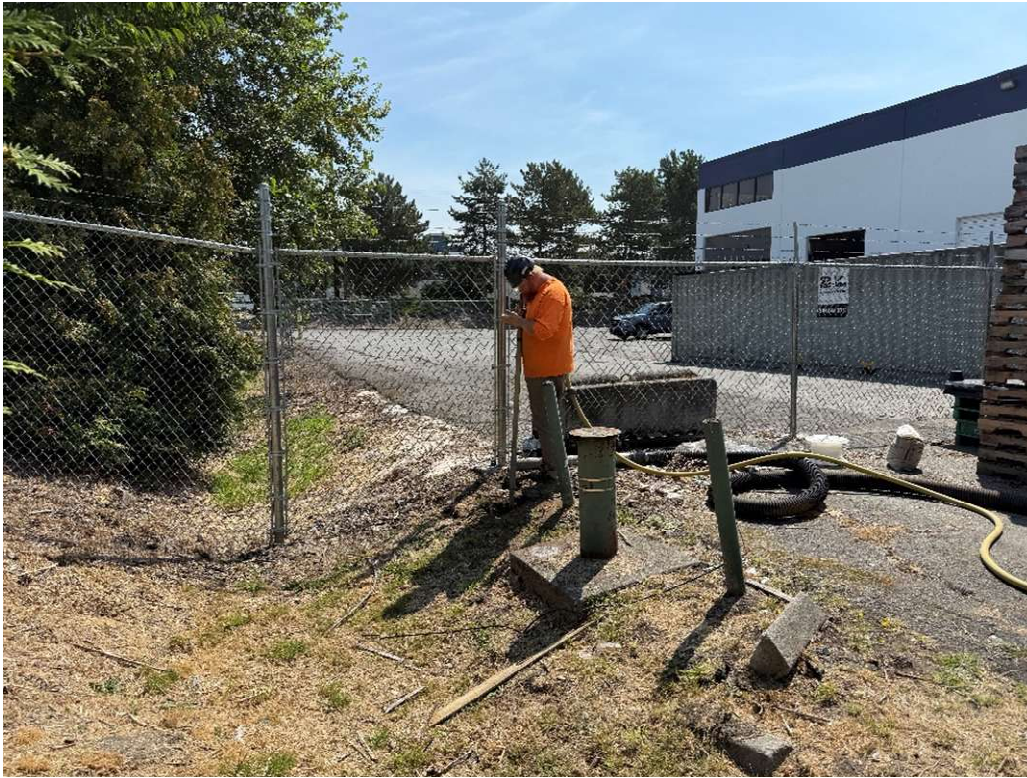
Excavation for supplemental gas probe GP-15S using vactor truck and air knife near GP-15 and drainage feature.

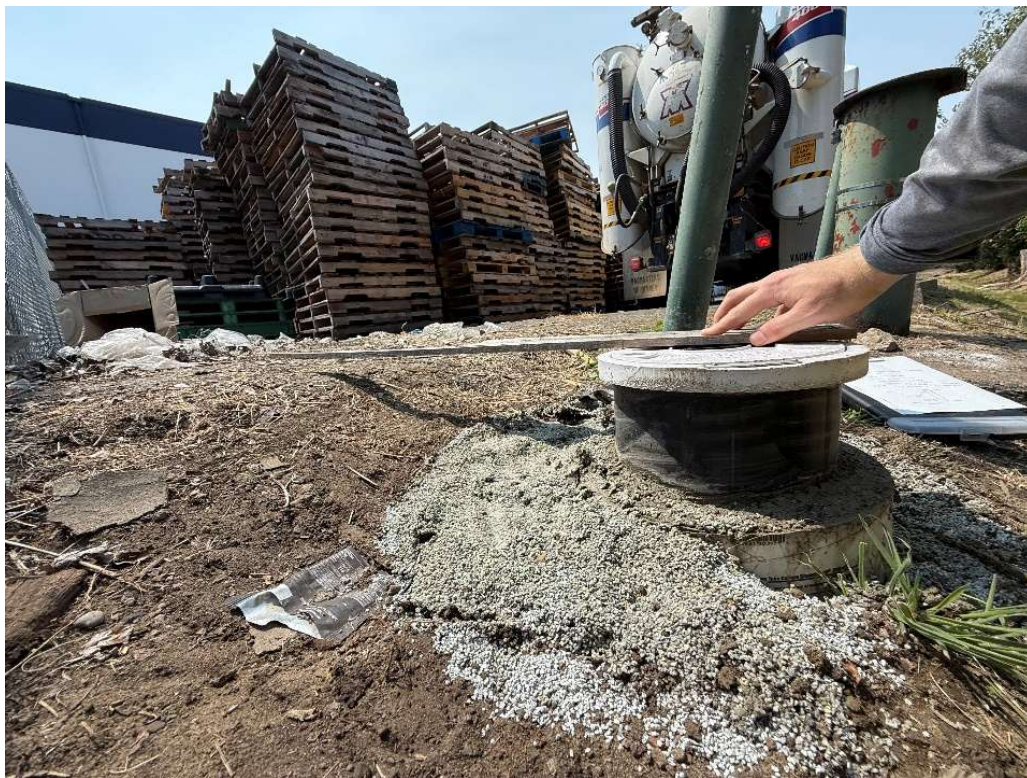
Completed supplemental probe GP-15S with sonotube, installed 1 to 2 inches above paved surface.

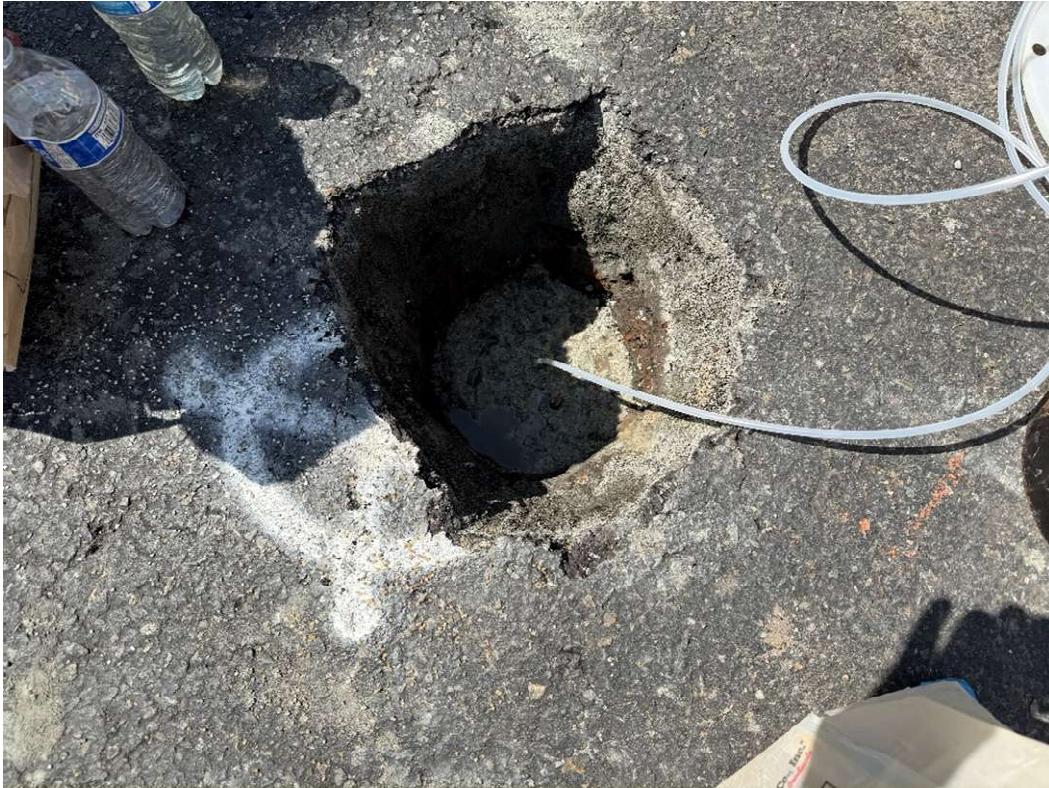
Installation of hydrated bentonite seal at GP-32S.

Based on construction observations, leak testing, and subsequent monitoring, the supplemental gas probes are generally suitable for use in routine landfill gas monitoring in accordance with the OMMP. GP-32S has exhibited elevated methane concentrations during subsequent monitoring events. Groundwater levels at this location have also been observed to rise above the screened interval, which may limit the ability to collect representative landfill gas measurements during periods of high groundwater. Evaluation of this location for long-term compliance monitoring is being addressed separately.

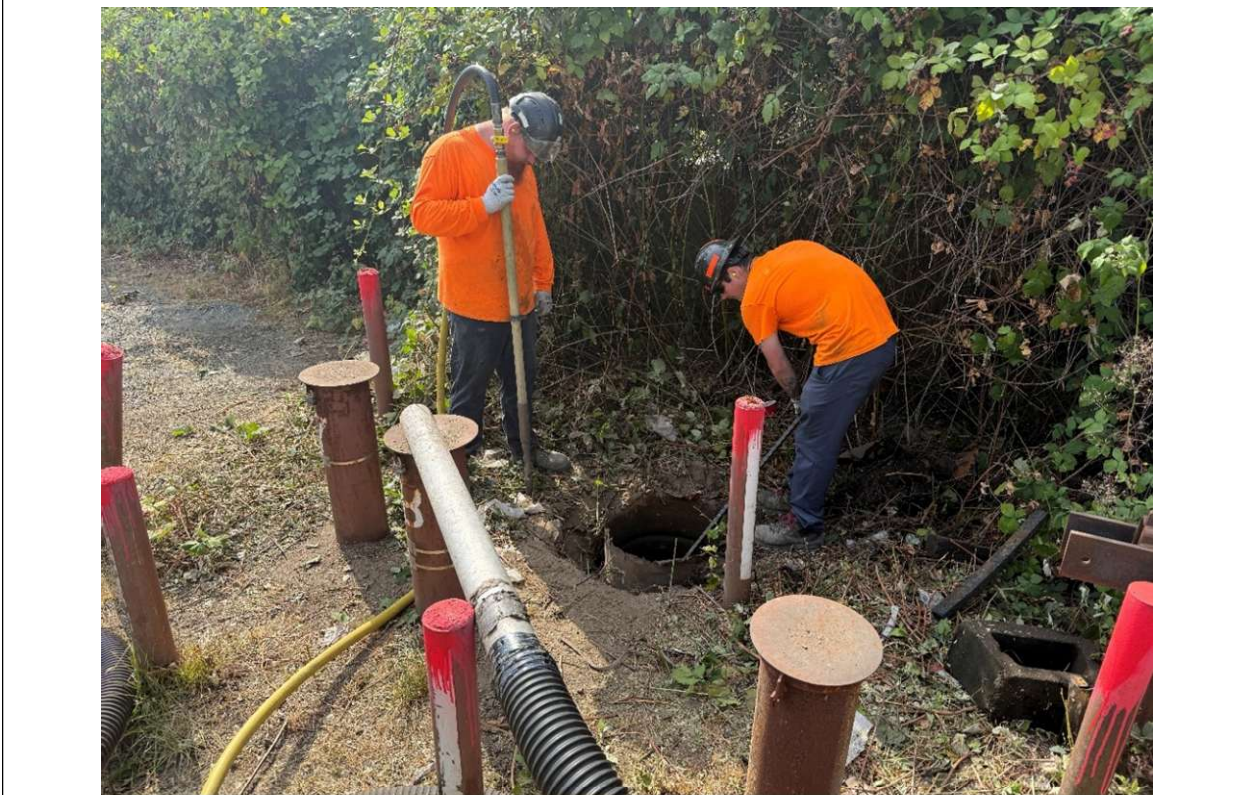
Removal of embedded and sheared drum at MW-24 location using air knife and vector truck.

Additional maintenance activities were completed, including removal of abandoned embedded drums and repair of the GP-28 concrete collar and MW-24 standup monument lid.

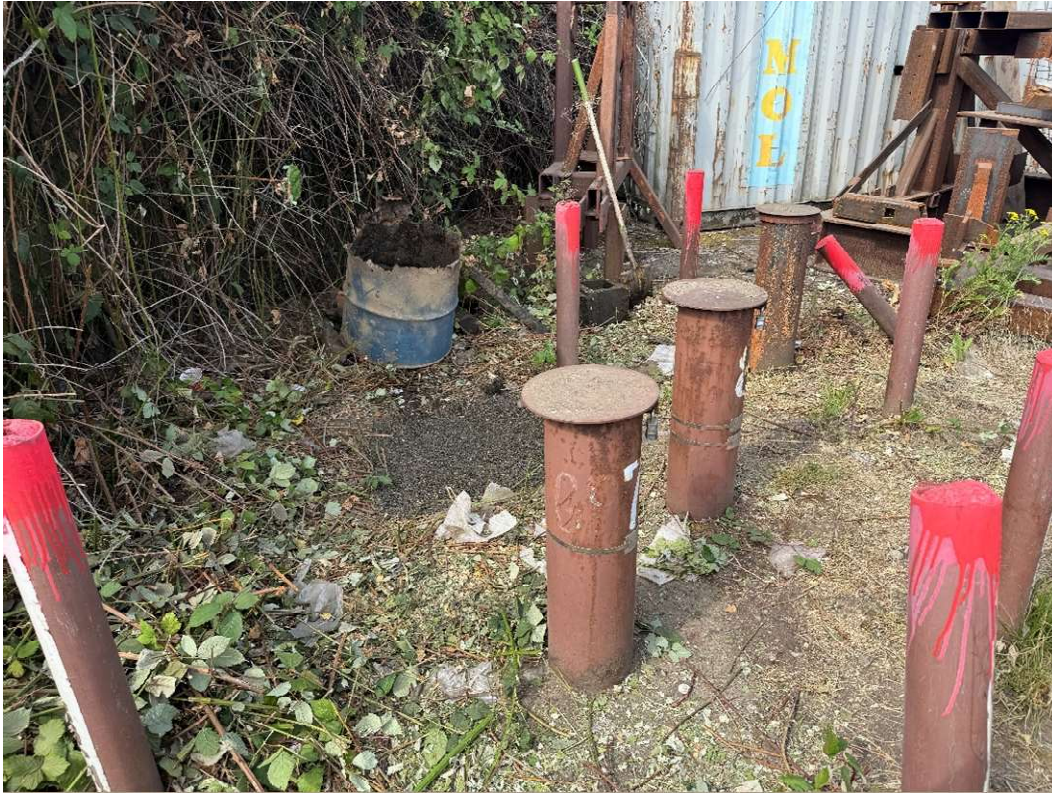
Drum removal at MW-24 location. MW-24 lid, pre-repair also in image, located behind and to the right of drum.
