# **2025 Operations, Maintenance, and Monitoring Annual Report South Park Landfill Settlement Area SPPD (CenterPoint)/City Area**

**Seattle  
Public  
Utilities**

March 2026

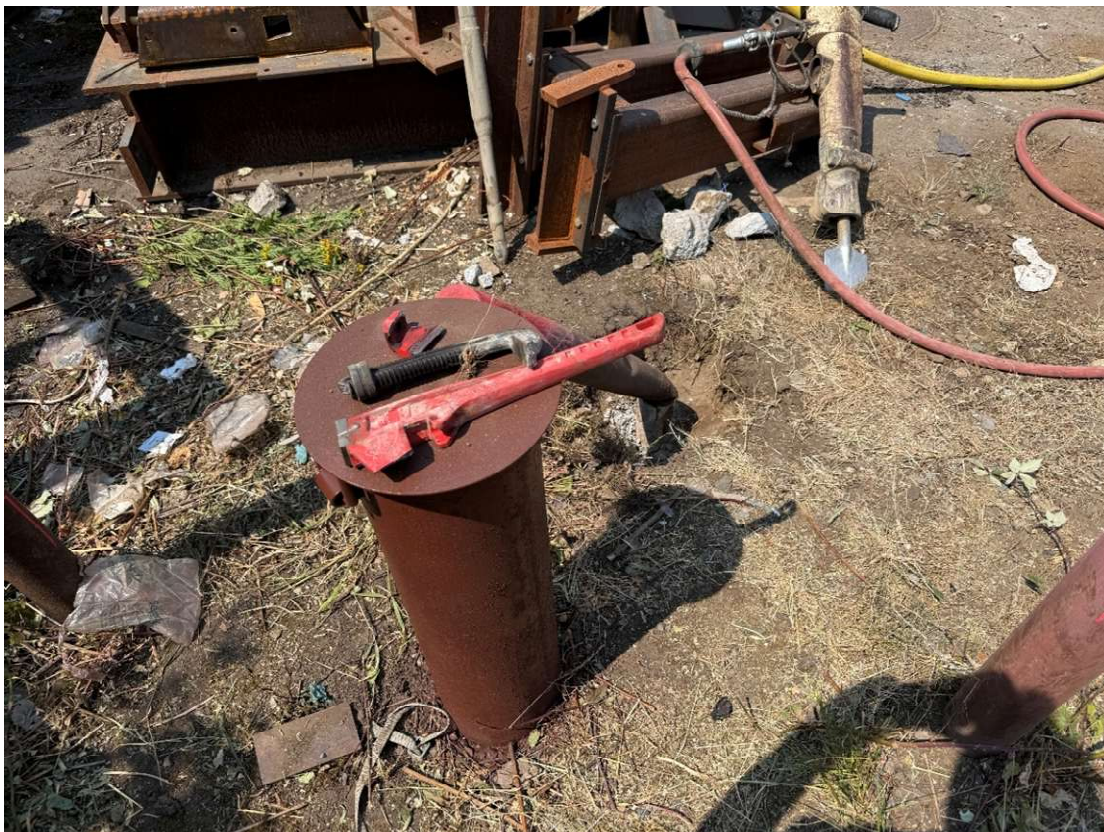
Pea gravel backfill of embedded drum depression.

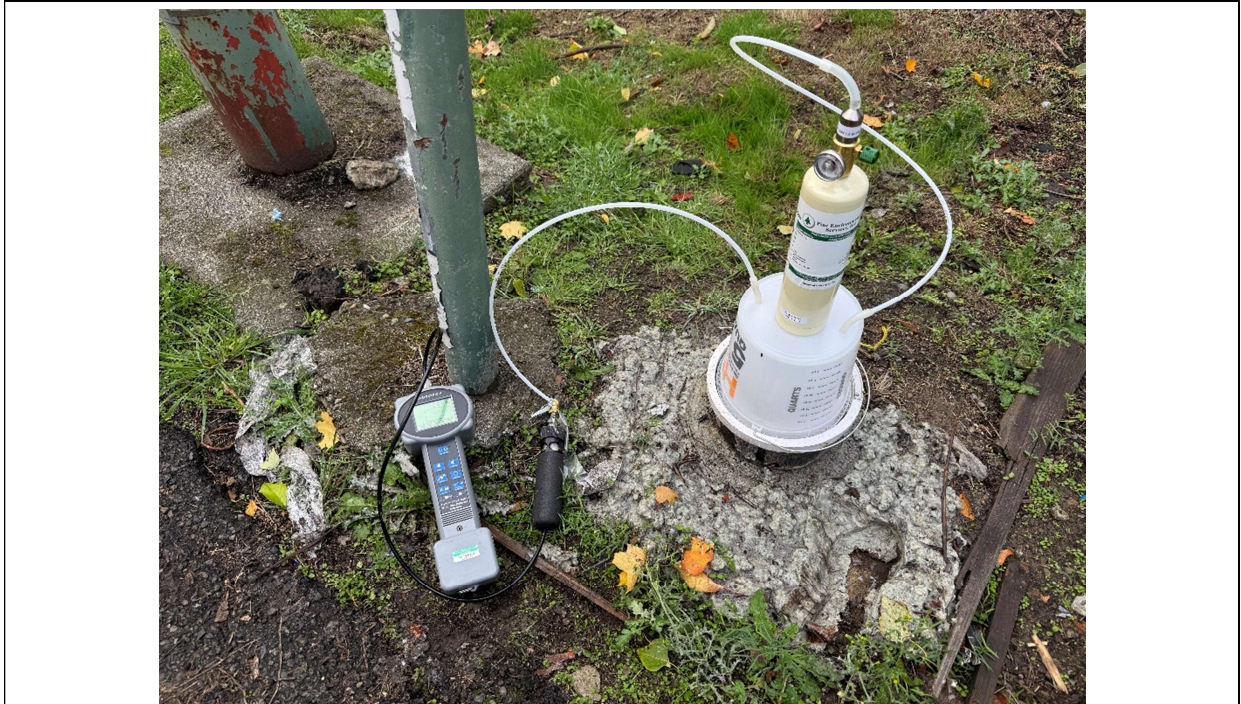
Repaired monument at GP-28.

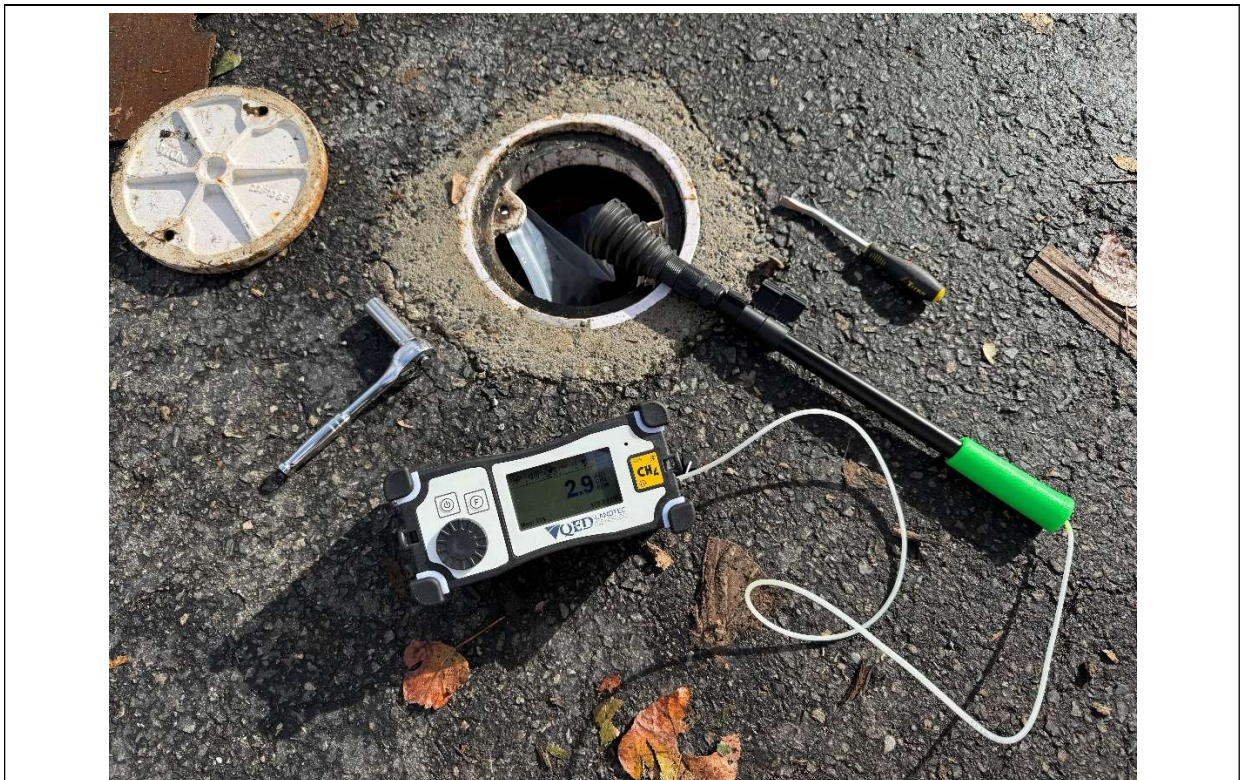
Helium leak detection testing at GP-15S.

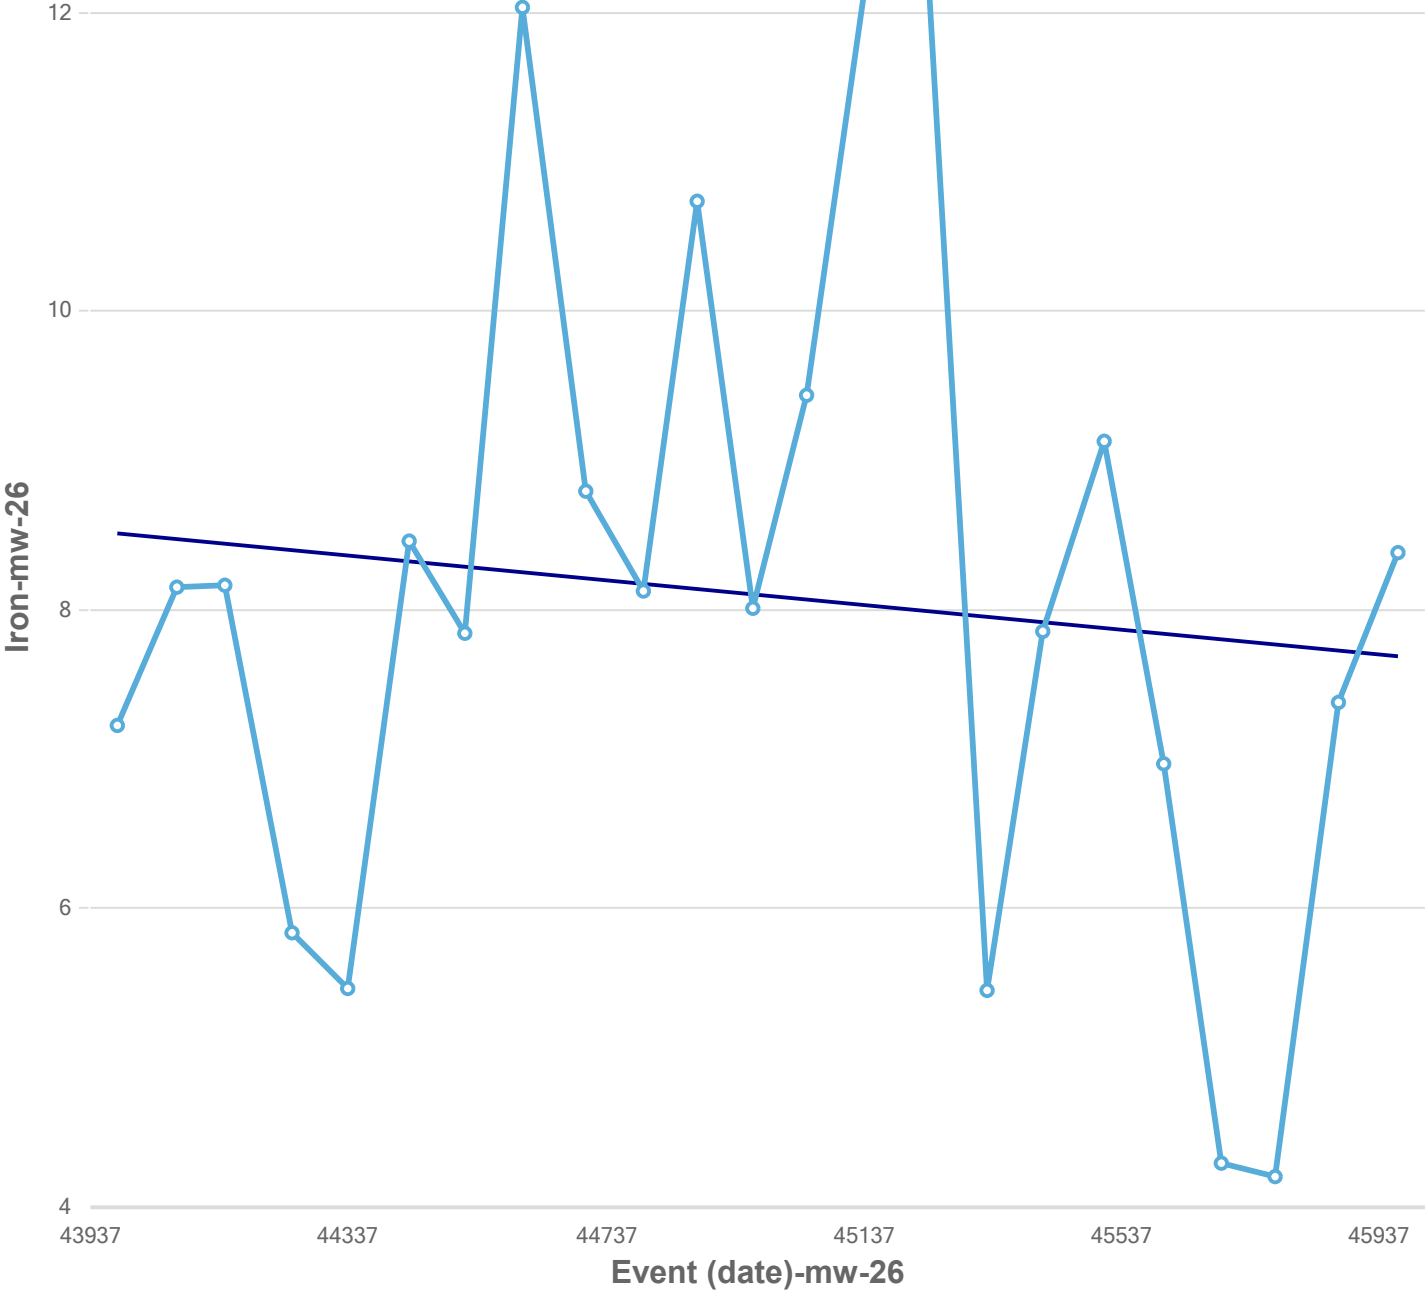
Mann-Kendall Trend Test

| Insufficient statistical evidence of a significant trend at the specified level of significance. | |

| Mann-Kendall Trend Analysis | |
| n | 23 |

Per the CAP, the Mann-Kendall test was used to statistically evaluate groundwater quality trends for vinyl chloride ( $\mu\text{g/L}$ ), total iron ( $\text{mg/L}$ ), and total manganese ( $\text{mg/L}$ ) using monitoring data collected in 2020 through 2025. The Mann-Kendall test is a nonparametric trend evaluation procedure that can be used when there are missing values or when the data do not conform to any particular distribution. The Mann-Kendall test only uses directional differences (positive, zero, negative) of the data rather than the measured values. In statistical terms, the Mann-Kendall test is a nonparametric test for zero slope of the linear regression of time-ordered data versus time (Gilbert 1987). For the Mann-Kendall test, the null hypothesis ( $H_0$ ) is no trend (i.e., the observations are randomly ordered in time), which is tested against the alternative hypothesis ( $H_A$ ) of an increasing or decreasing monotonic trend.

- For all wells, censored values were replaced with estimated values using the ROS method prior to statistical analysis. The ROS method fits a regression line to the uncensored data, then assigns values from that line below the detection limit to estimate concentrations for the censored observations. The uncensored values are then combined with the estimated censored values for further statistical analysis.
- Wells with more than 50 percent but less than 90 percent non-detects for a specific chemical were analyzed using the Mann-Kendall test; however, the results should be interpreted with caution, as significance of the analysis may be diminished due the large number of censored data. Statistical evaluations are typically not performed on data sets with more than 50 percent non-detects because meaningful trends are difficult to determine due to the large number of censored values.
