STATE OF WASHINGTON  
DEPARTMENT OF ECOLOGY

RE: EARLY NOTICE LETTER REGARDING THE CARLSON DISTRIBUTING FACILITY, LOCATED IN COLVILLE, WASHINGTON, BEING WITHIN THE SW  $\frac{1}{4}$  NE  $\frac{1}{4}$ , OF SECTION 8, T. 35 N., R. 39 E.W.M.

# INITIAL INVESTIGATION FIELD REPORT

Carlson Oil Distributor

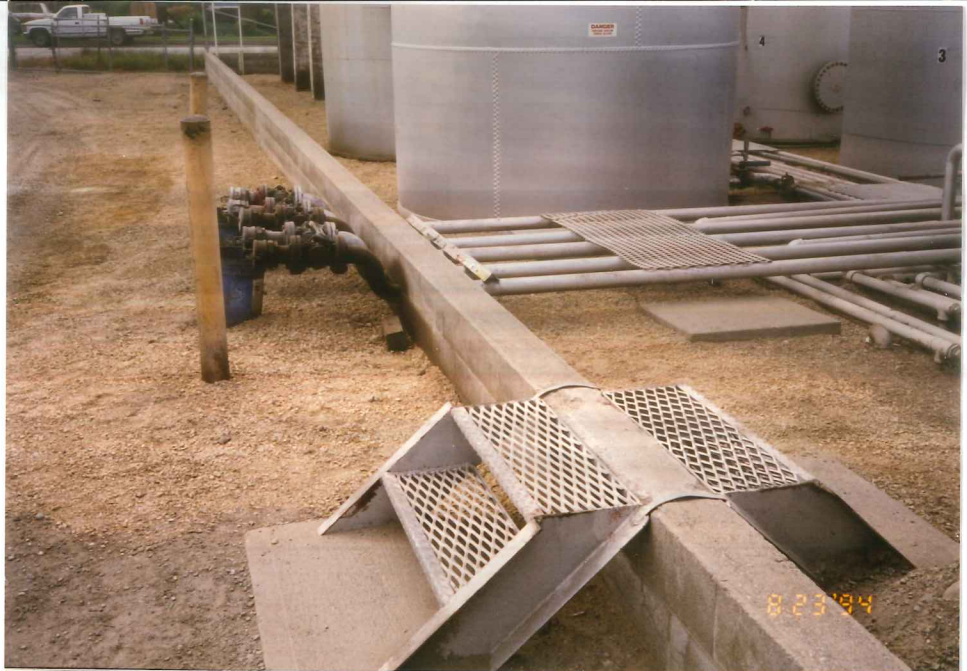
Carlson Distr., Colville 8/23/94

Inside of AST's containment dred.  
Monitoring well<sup>(C-6)</sup> located in petroleum  
sludge on left. Well is whitish  
circle. Fresh gravel on ground.  
Photo looking south. Photo by Dave G.

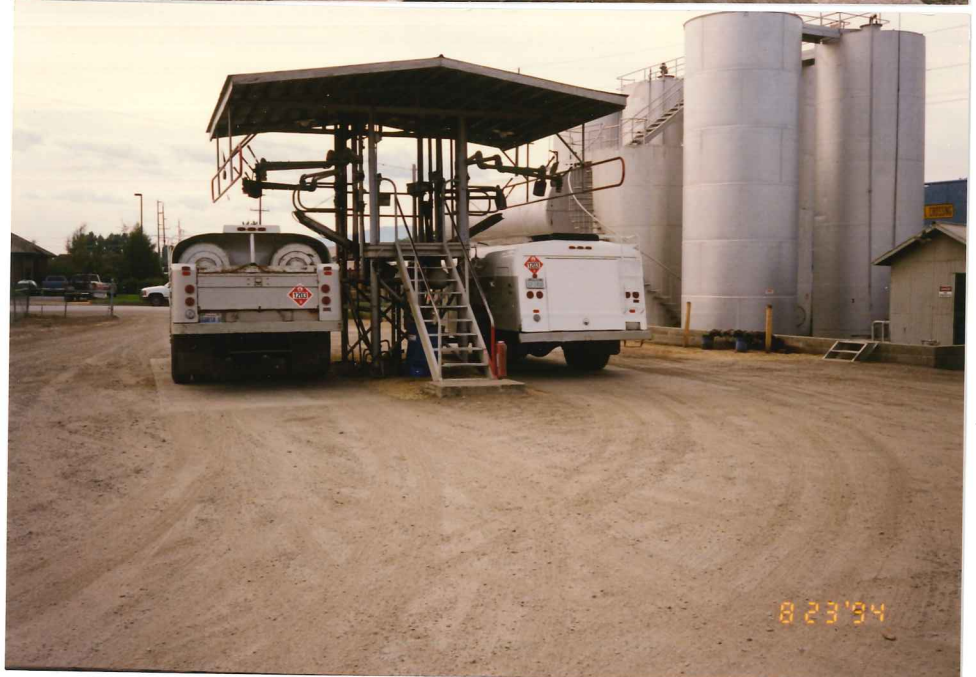
Carlson Distr., Colville 8/23/94

Overhead Sill lines. Photo looking  
south.

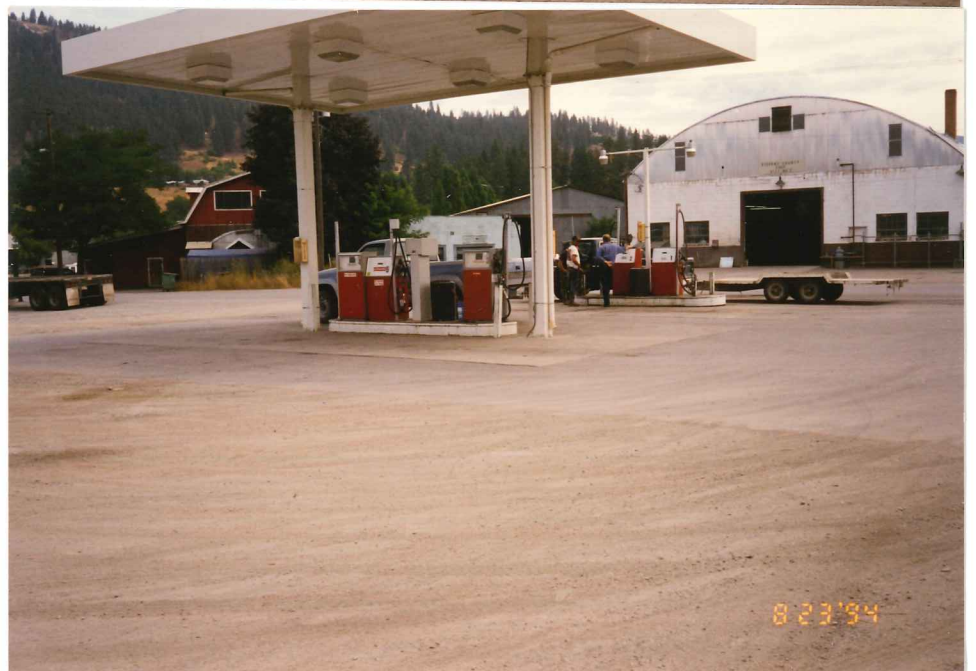
Carlson Distr., Colville 8/23/94

Pump Island at north end of facility  
Stevens County Shop in background.  
Photo looking northeast.

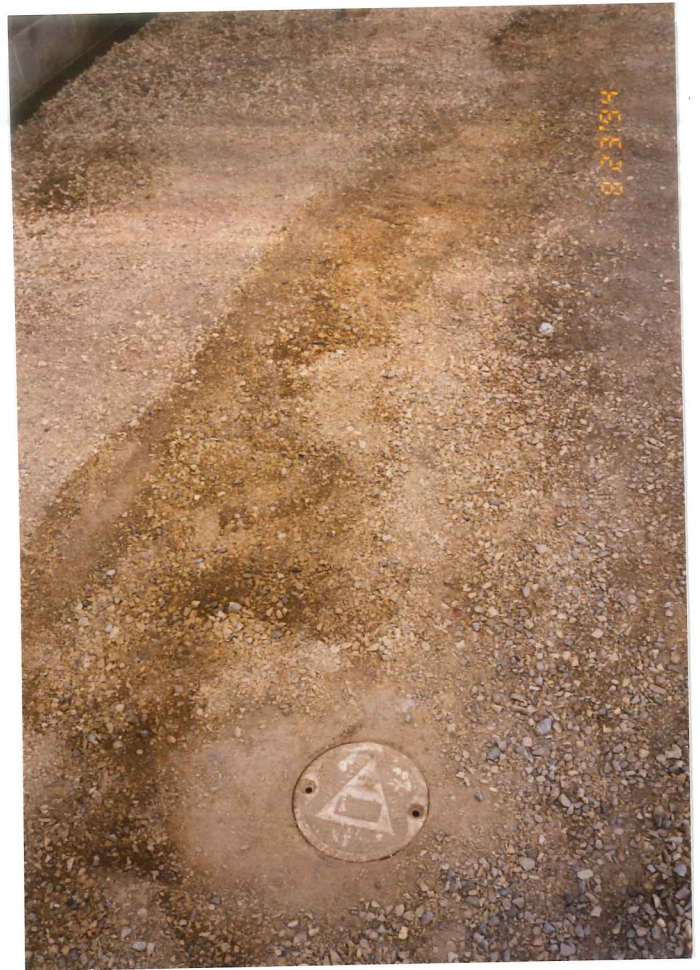
Description of observations: Some petroleum staining of surface soils below  
at fuel delivery connections/locations - possibly due to  
disconnect operations and spillage. No cache bdsing  
installed at delivery or supply locations. Monitoring  
well # CD-6 is located in shallow depression just out  
side of AST containment wall and next to connect/disconnect  
refuel lines. Well is within recent petroleum stain on ground  
surface. Upon removing well cover (with <sup>no</sup> rubberseal), observed  
standing water inside cover. Water was at level of PVC riser. Cap  
on riser was loose and did not provide positive seal. Evidence  
of water staining (with petroleum in water) from top of riser

Description of past practices likely to be responsible for contamination: down inside of PVC. Water  
visible in well at bottom. Well likely impacted from surface  
runoff/spillage. Discussed potential present & future problems  
with Mr. Carlson. Per independent boring "logs" evaluation,  
soil contamination may be in <sup>shallow</sup> vertical zone possible historic ground

Carlson Distr., Colville 8/23/94  
Monitoring well (top) located by AST's connect  
lines. Petroleum discoloration visible on  
ground surface. Well integrity question-  
able. AST's refining well visible in  
photo, top left. Photo looking northwest.  
Photo by Dave G.
