# **Twin Bridges Removal Action Draft Interim Action Plan**

**Monte Cristo Mining Area  
Silverton, WA**

Washington State Department of Ecology  
Olympia, Washington

October 2026

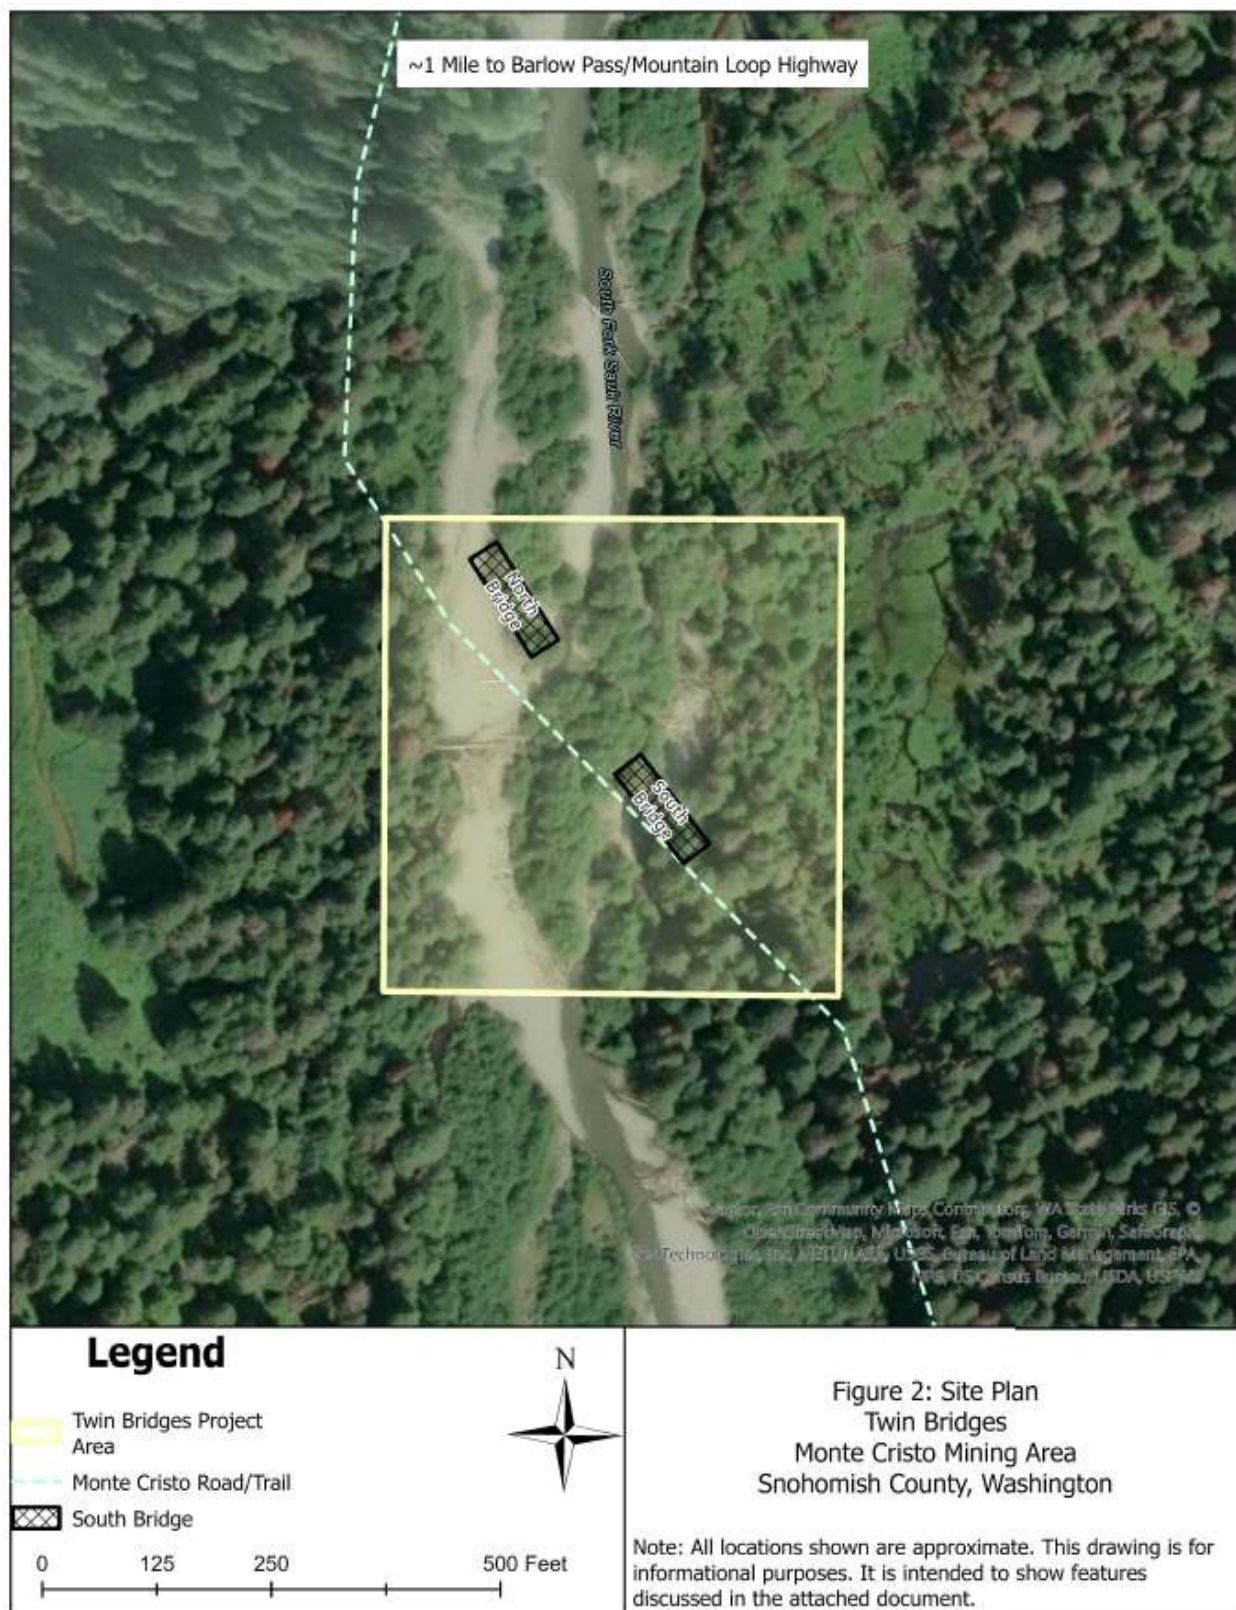
Figure 2: Site Plan

Bridge decommissioning and creosote pile removal are the focus of this project. There are two bridge structures present at the site, identified as the North Bridge and South Bridge as shown on Figure 2. The South Bridge remains intact and is currently used by recreational trail users to cross the main channel of the South Fork Sauk River. Removal of South Bridge is not part of this interim action.
