***Final
Phase II – Interim Intertidal
and Selected Subtidal
Remedial Action
Interim Action Work Plan –
Cleanup Action Plan and
Engineering Design Report
Custom Plywood Site
Anacortes, Washington***

***Prepared for
Washington State
Department of Ecology
under Agreement with GBH
Investments, LLC***

***February 2013
17800-27***

Prepared by
Hart Crowser, Inc.

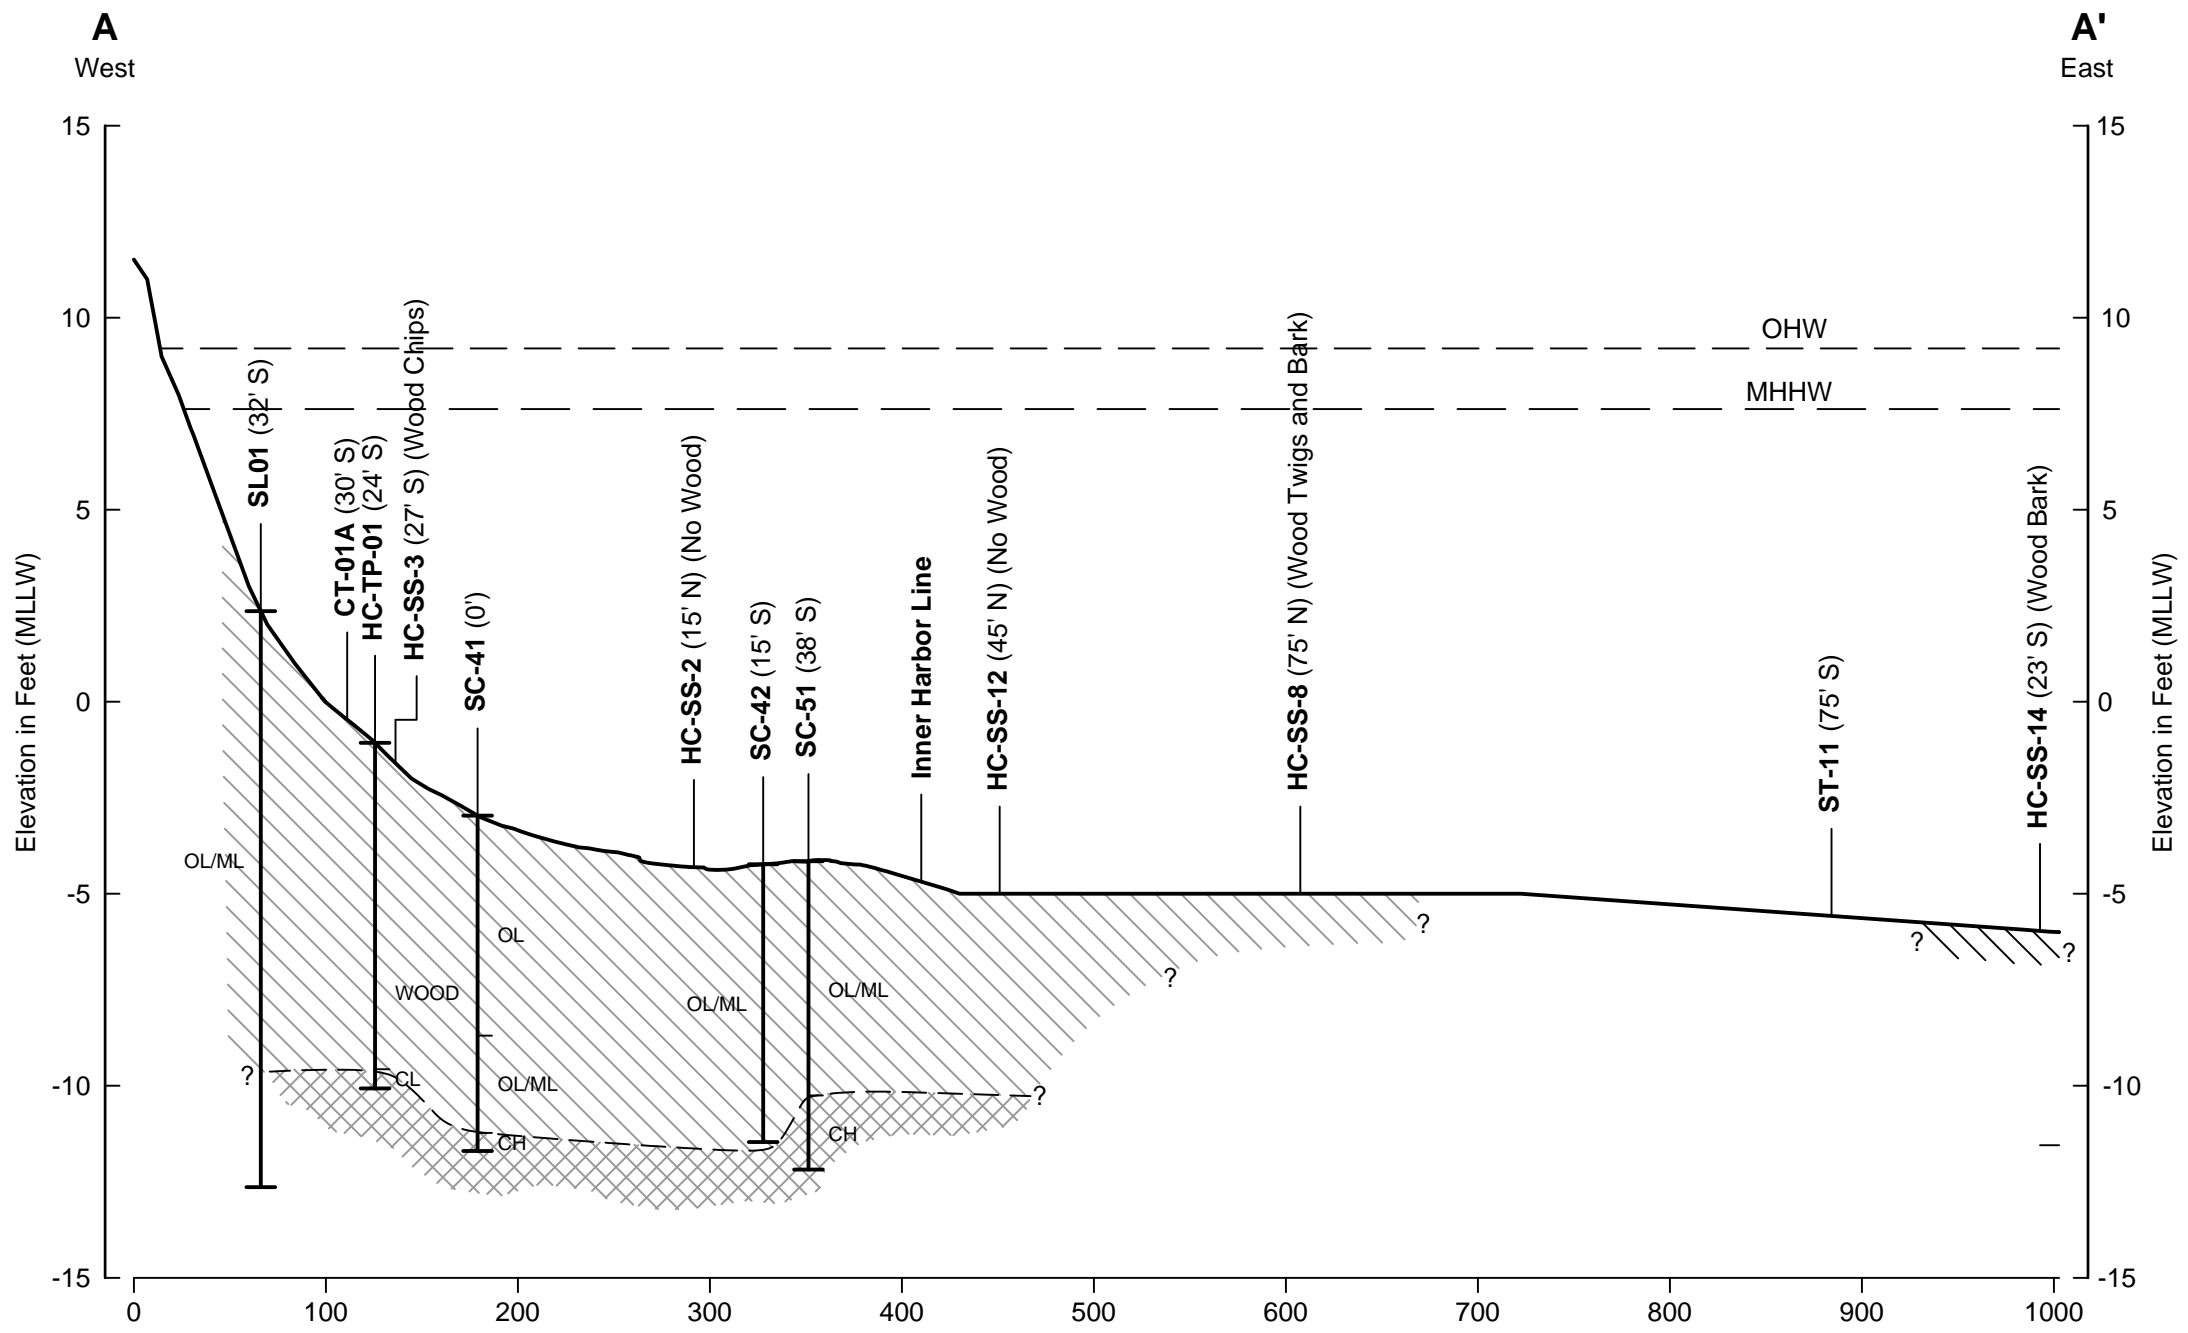
Cross Section A-A'
Aquatic Remediation Alternative A-3
Existing Conditions

- SL01** (32' S) Exploration Number (Offset Distance and Direction)
- Exploration Location
- Inorganic and Organic Silts with Varying Amounts of Wood Debris
- Native (CL/CH), Inorganic Clays
- MHHW Mean Higher High Water
- OHW Ordinary High Water

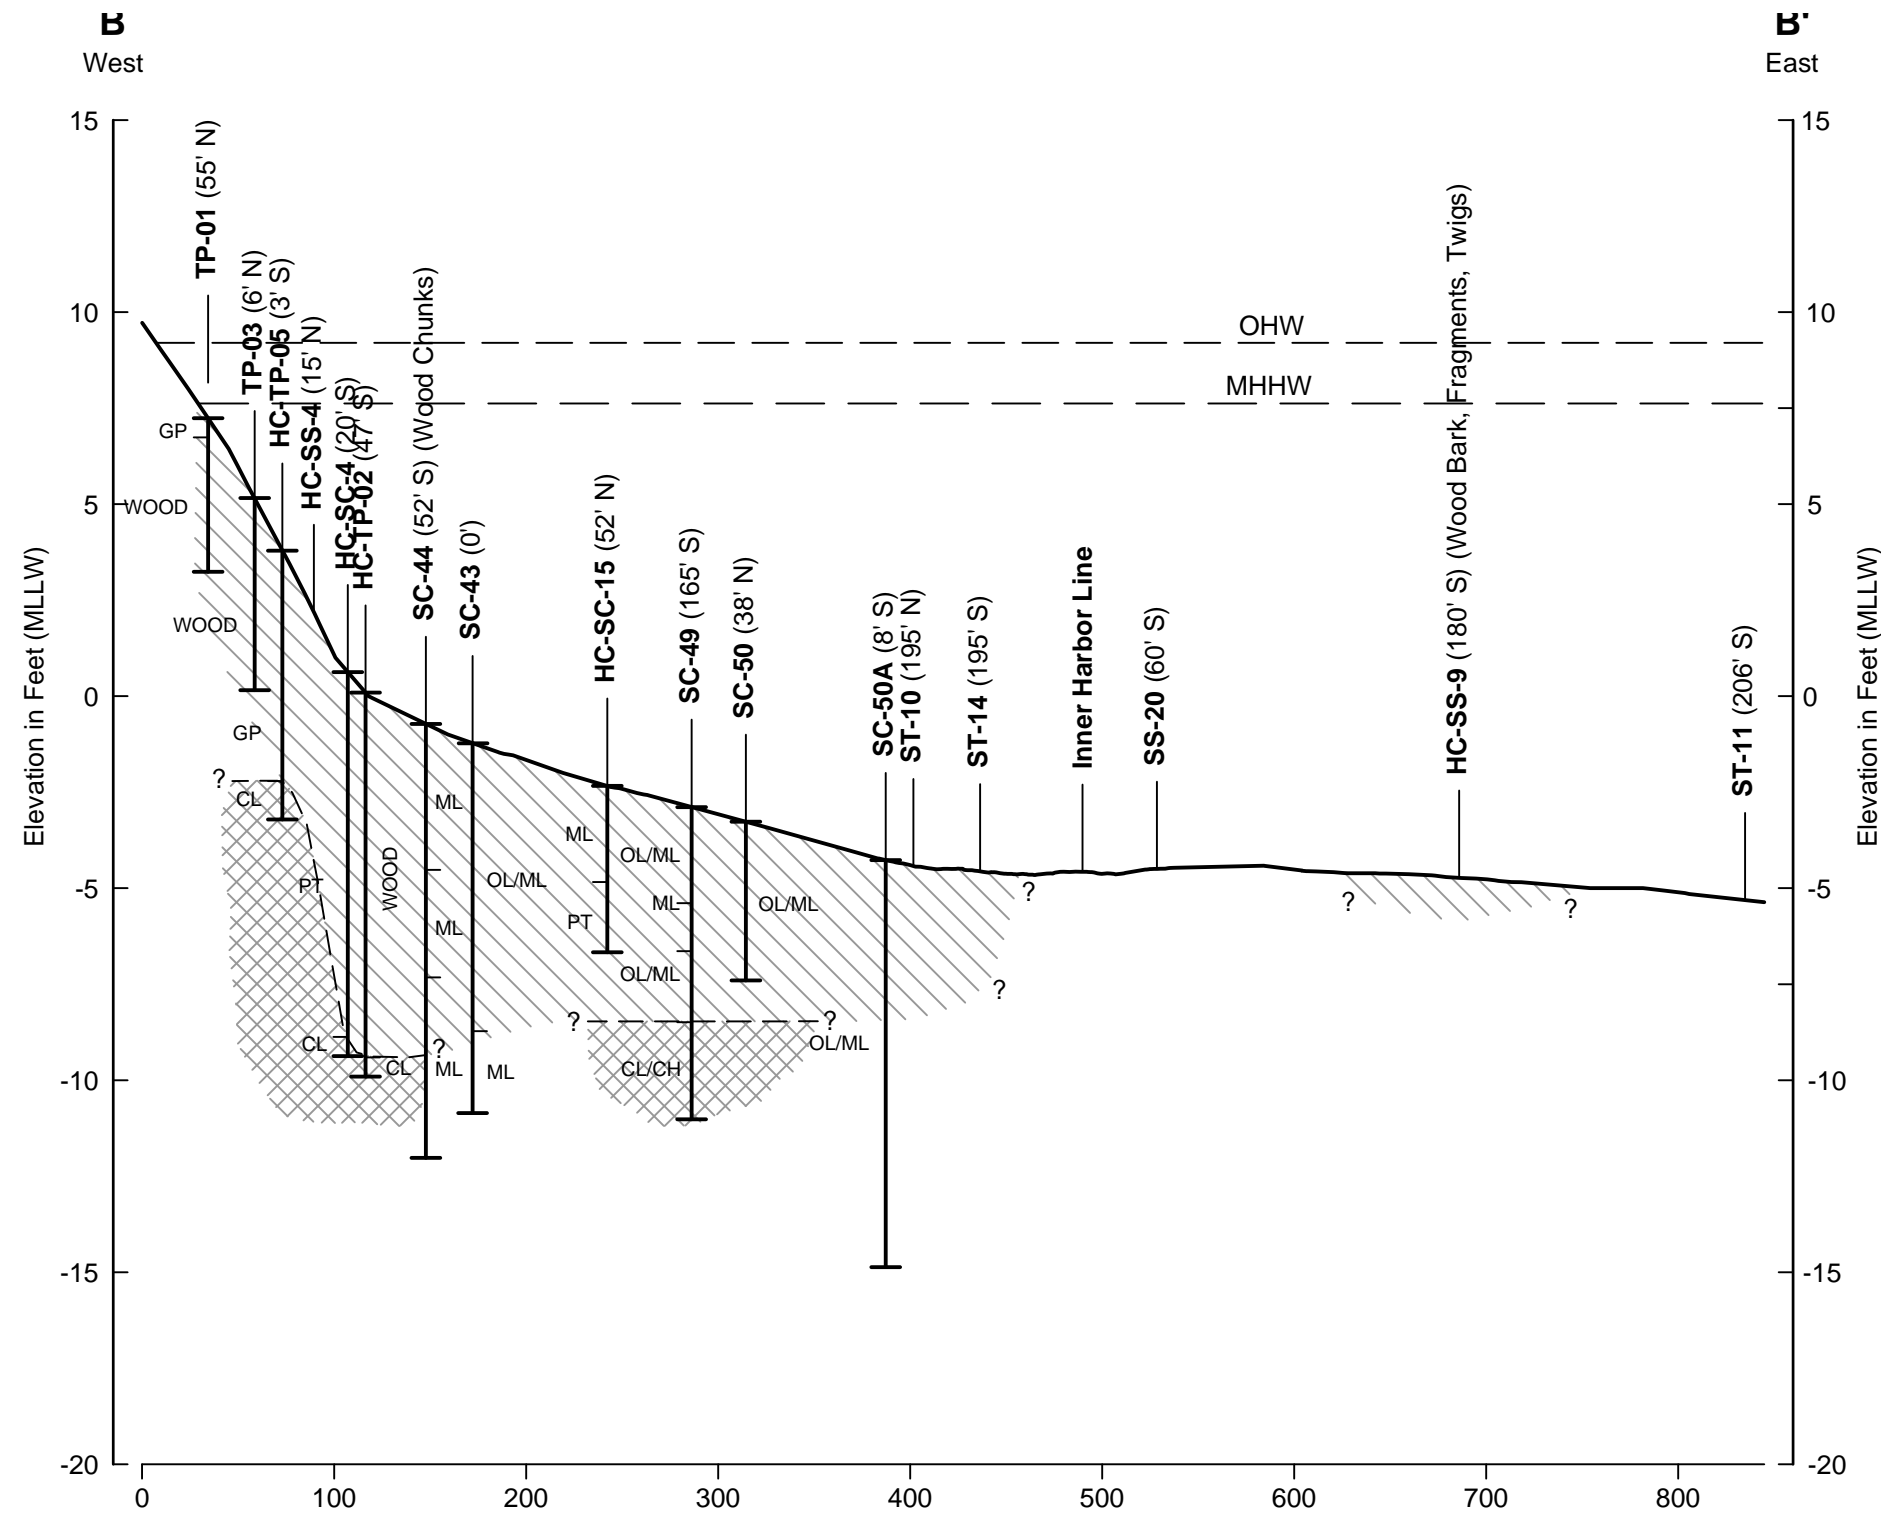
Custom Plywood Site Anacortes, Washington	
Cross Section B-B' Aquatic Remediation Alternative A-3 Existing Conditions	
17800-27 (CAP-EDR)	2/13
	Figure 2-4

TP-01 Exploration Number
(55' N) (Offset Distance and Direction)

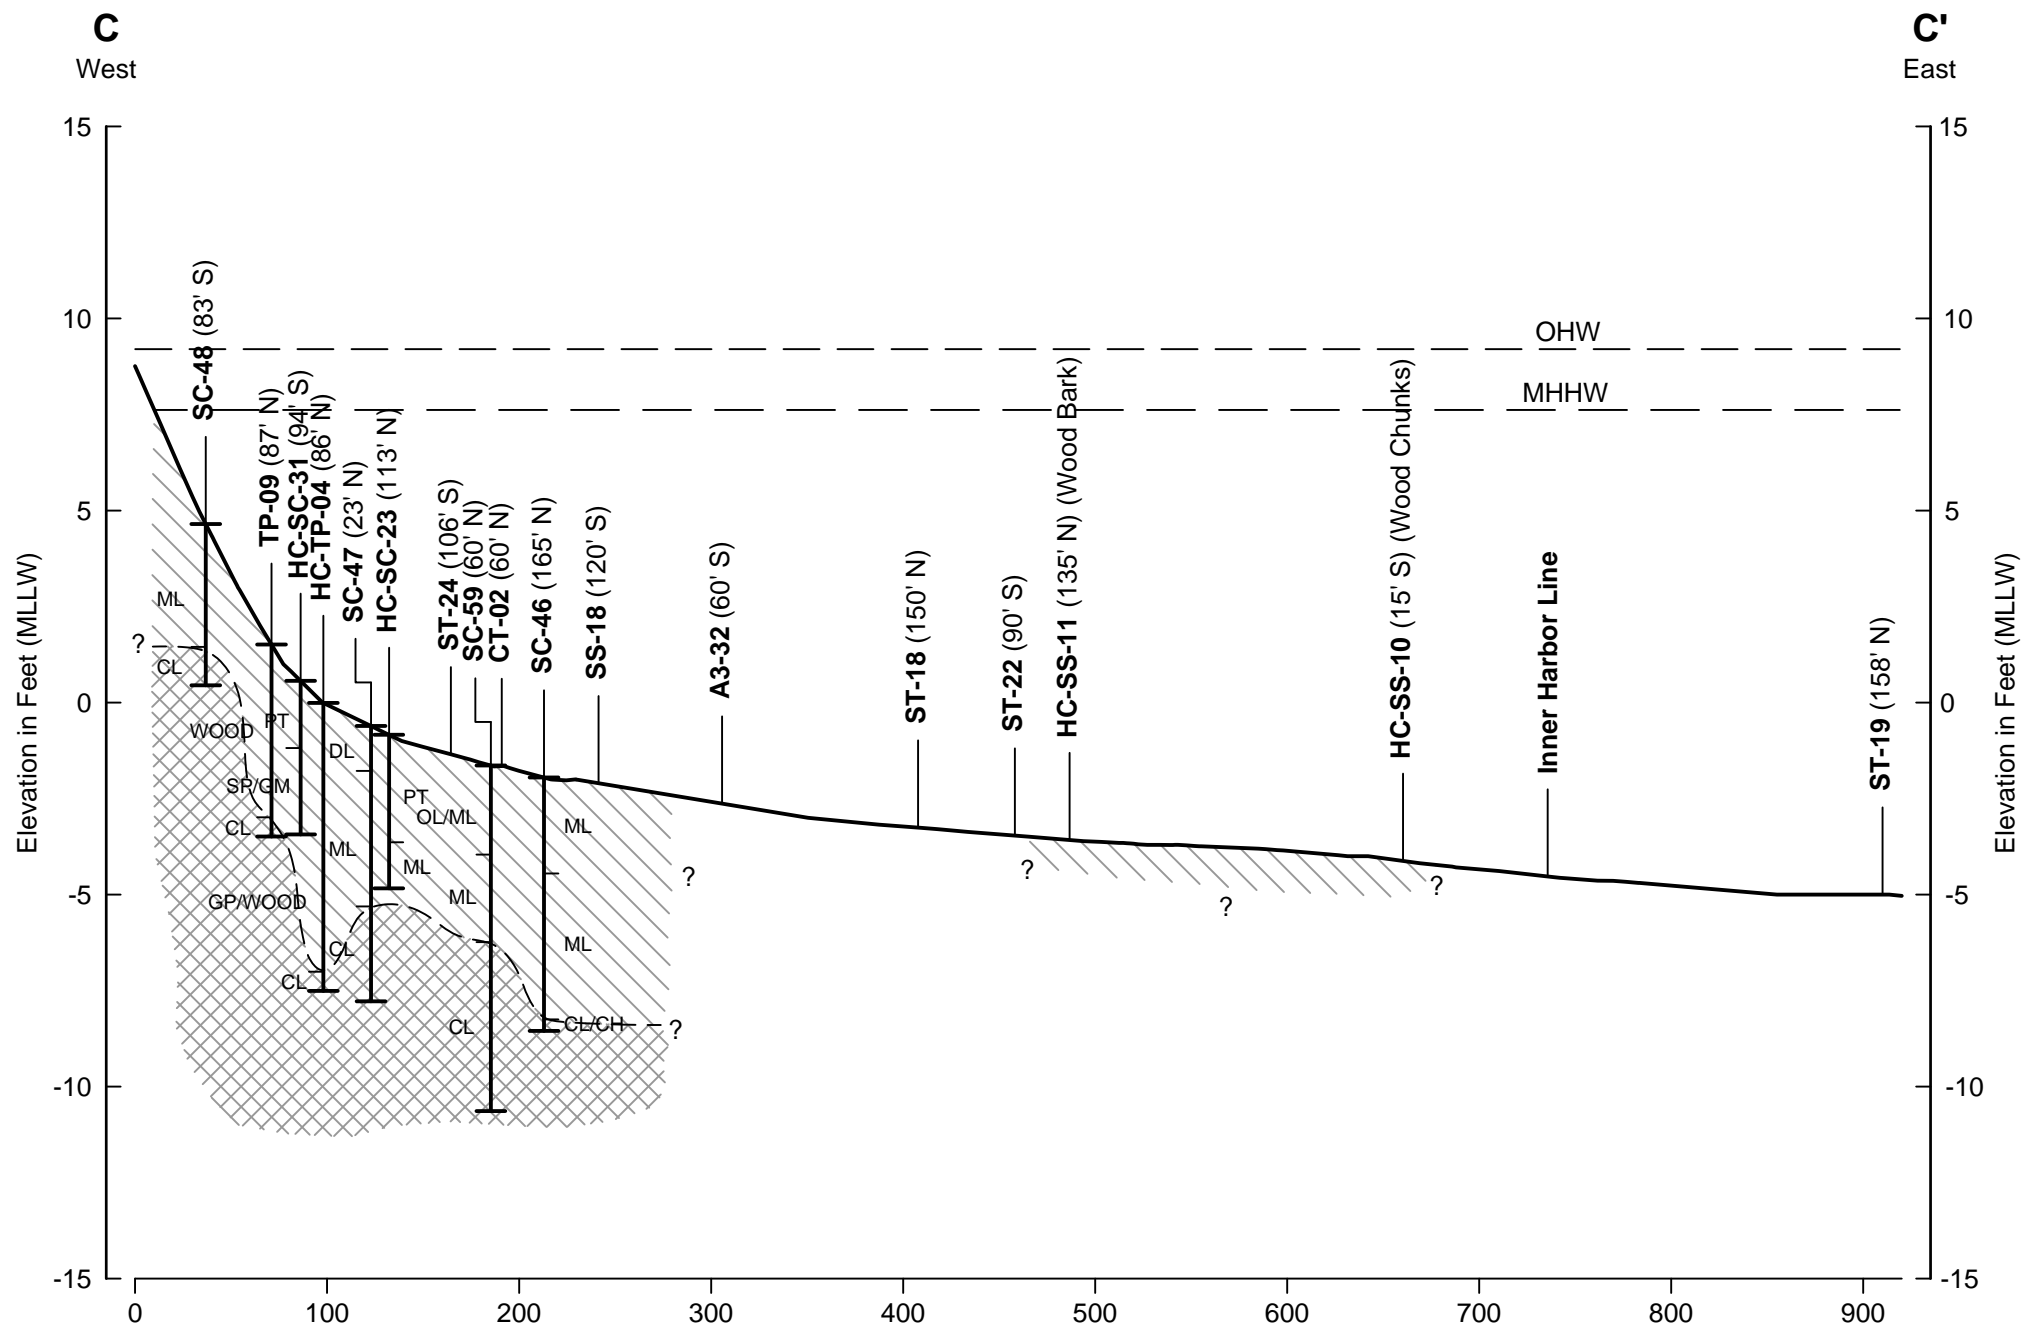
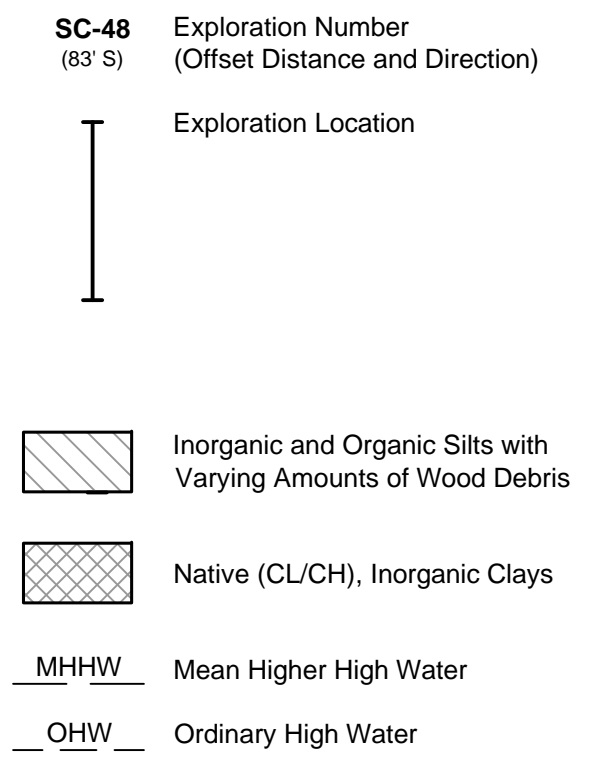
Custom Plywood Site Anacortes, Washington	
Cross Section C-C' Aquatic Remediation Alternative A-3 Existing Conditions	
17800-27 (CAP-EDR)	2/13
	Figure 2-5

Notes:
 1. Vibracore logs were corrected for compaction.
 2. See Figure 2-2 for cross section location.

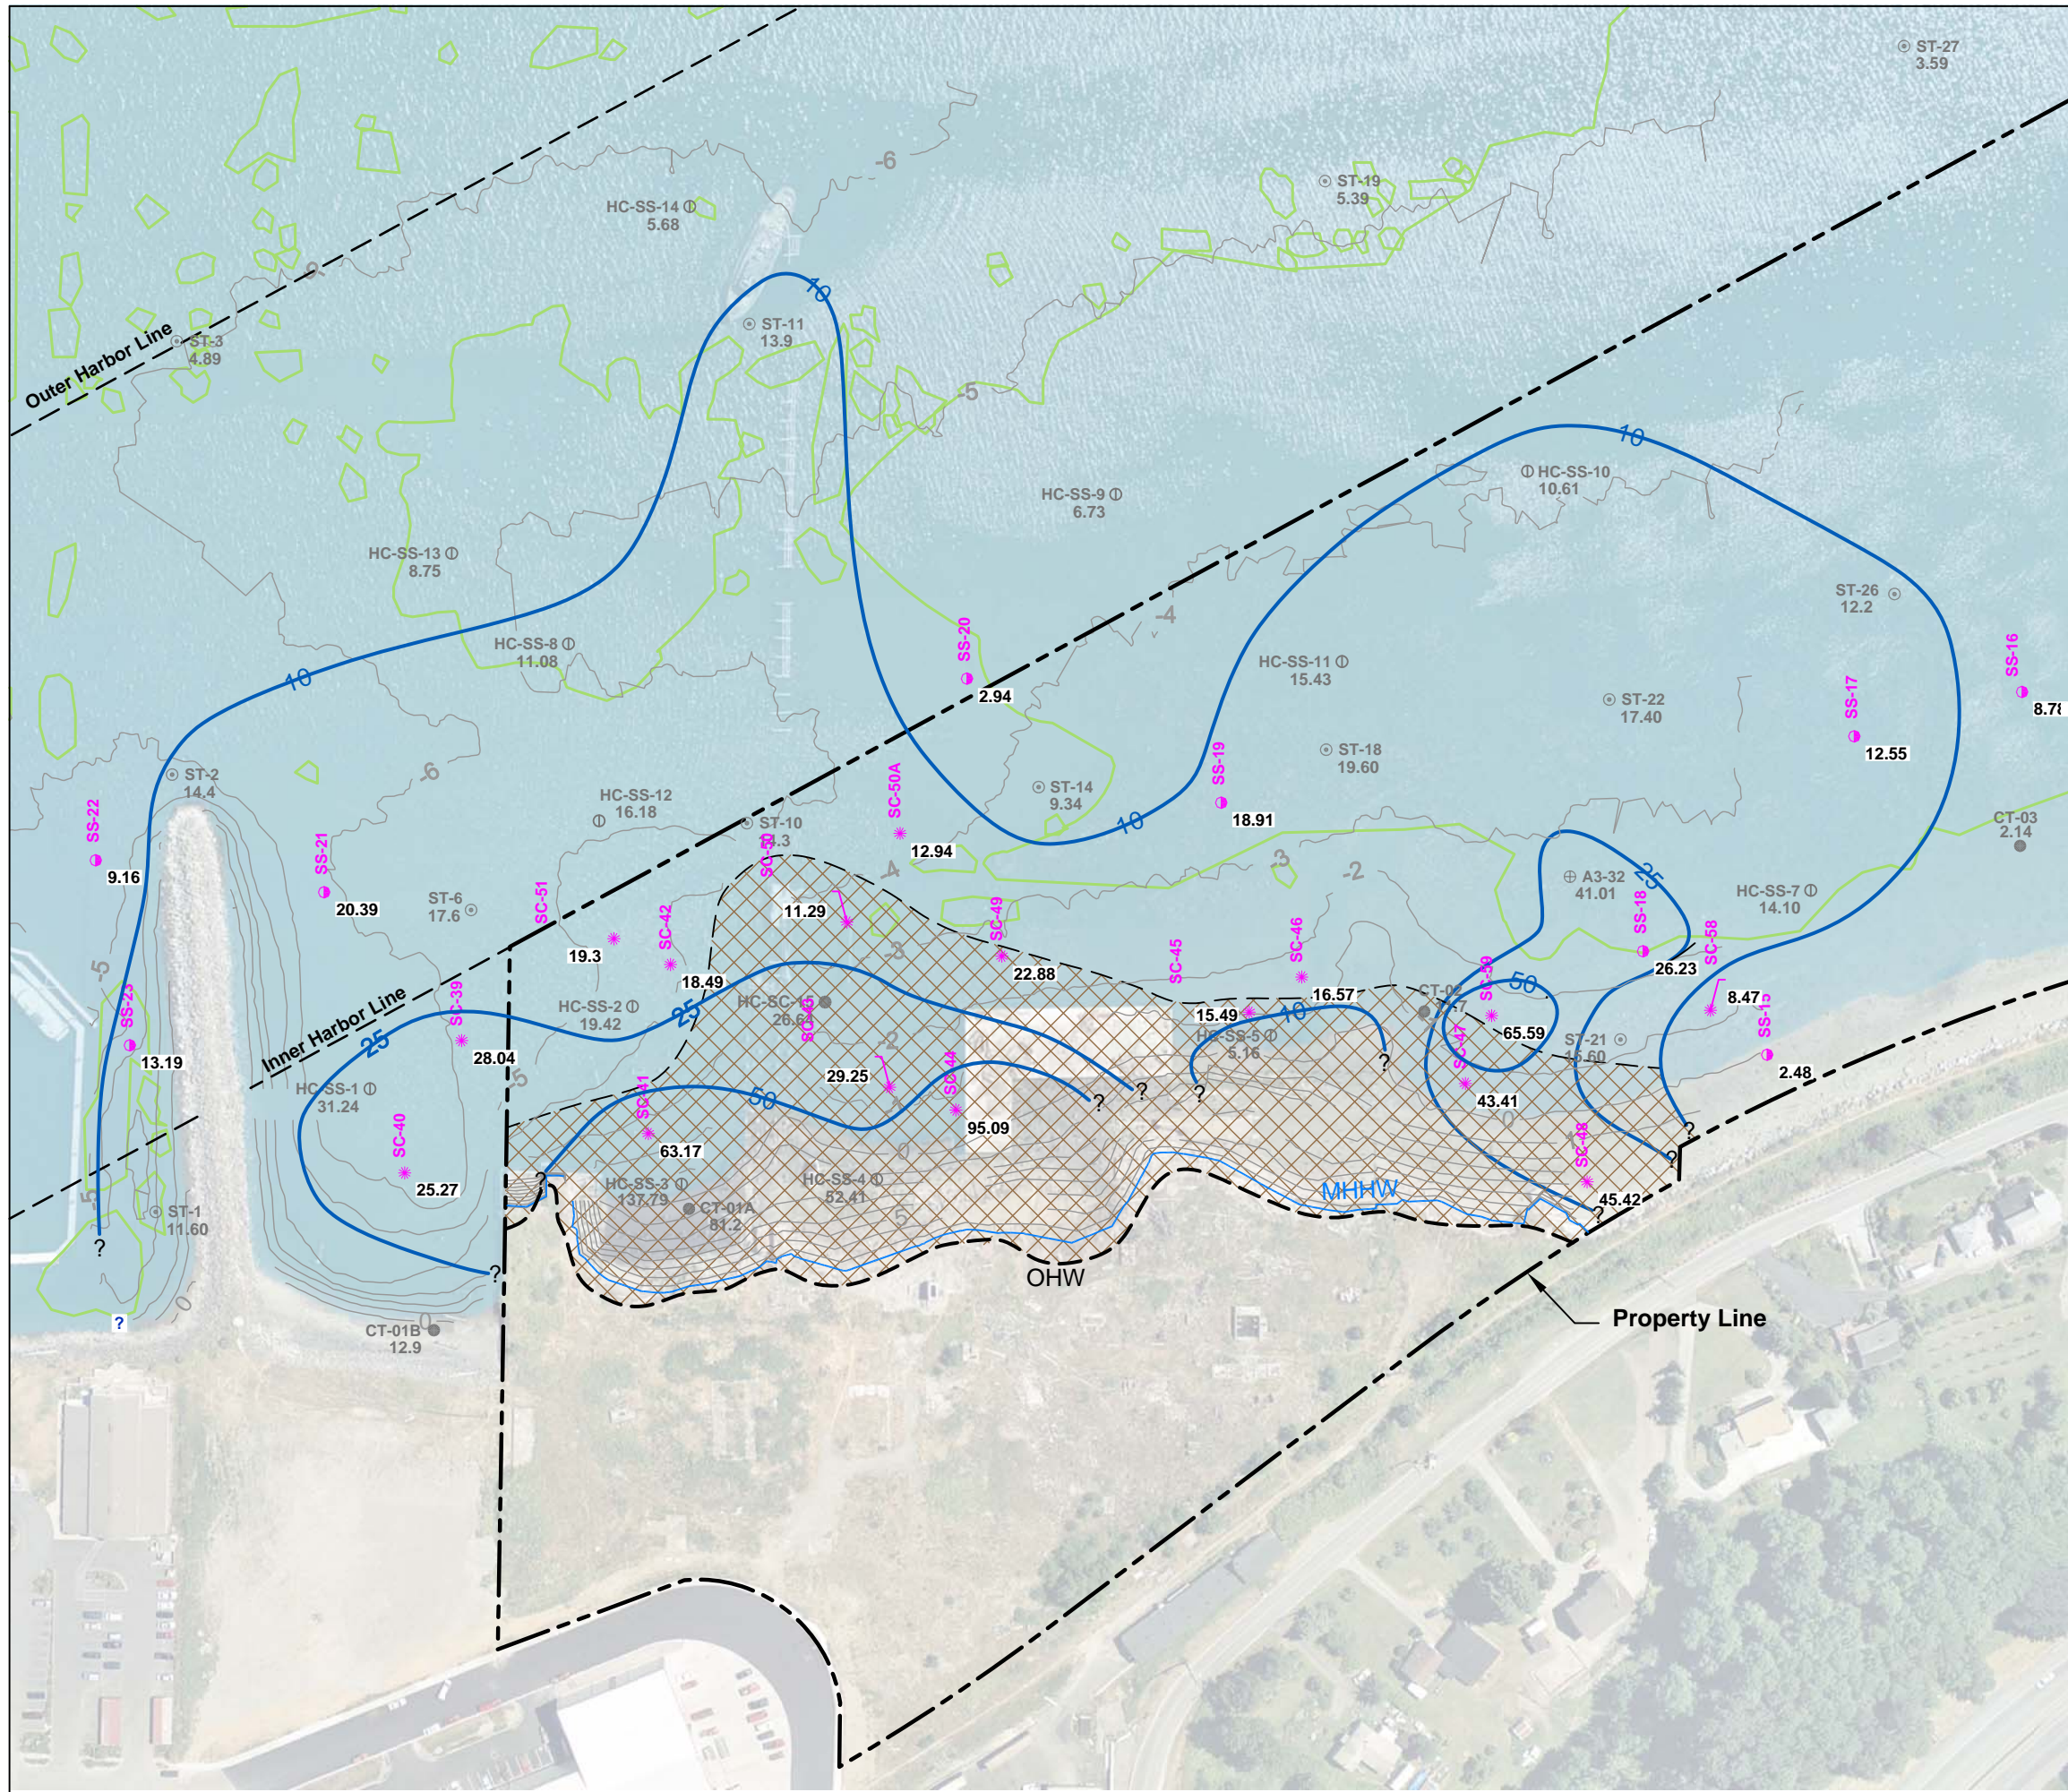
- Sediment Exploration Location and Number**
- SS-16 ● Surface Sediment Sample (Hart Crowser 2012)
 - SC-40 ● Vibracore Sample (Hart Crowser 2012)
 - HC-SS-2 ⊕ Surface Sediment Sample (2010 Hart Crowser)
 - HC-SC-2 ● Vibracore Sample (2010 Hart Crowser)
 - CT-01A ● Surface Sediment Sample (2010 SAIC)
 - A3-23 ⊕ Surface Sediment Sample (2008 SAIC)
 - ST-1 ⊕ Surface Sediment Sample (2008 Geomatrix)
 - 8.99 Discrete Surface Sample Dioxin Concentration in parts per trillion (ppt) TEC (1/2 DL TEC)
 - ⊠ Inferred Extent of Wood Waste 6 Feet Thick or More
 - Approximate Extent of Eelgrass Beds
 - 10 — Dioxin TEC Contour in ppt
 - MHHW Mean Higher High Water
 - OHW Ordinary High Water

Sediment quality investigations supporting the RI identified SMS CSL bioassay failures, but no exceedances of SQS chemical criteria. The RI indicated that other contributing factors, such as holding times, may have promoted bioassay failure. The RI also included results of relatively limited dioxin testing in sediment within the former Custom Plywood property area. SAIC conducted additional surface sediment sampling, collection, and testing near the former Custom Plywood facility and elsewhere in Fidalgo and Padilla Bays in 2010. Results from previous investigations verified the presence of near-surface dioxin concentrations exceeding the 1.4 ppt background established by Ecology for Fidalgo Bay following SAIC's 2010 investigation (FS Appendix A). Additional sediment quality sampling for dioxin was conducted in December 2010 (presented in FS Appendix E) and January 2012. Dioxin concentrations ranging up to 95 ppt were detected in the nearshore area during the January 2012 sediment investigation, with multiple locations exceeding 25 ppt (see Figure 2-7).

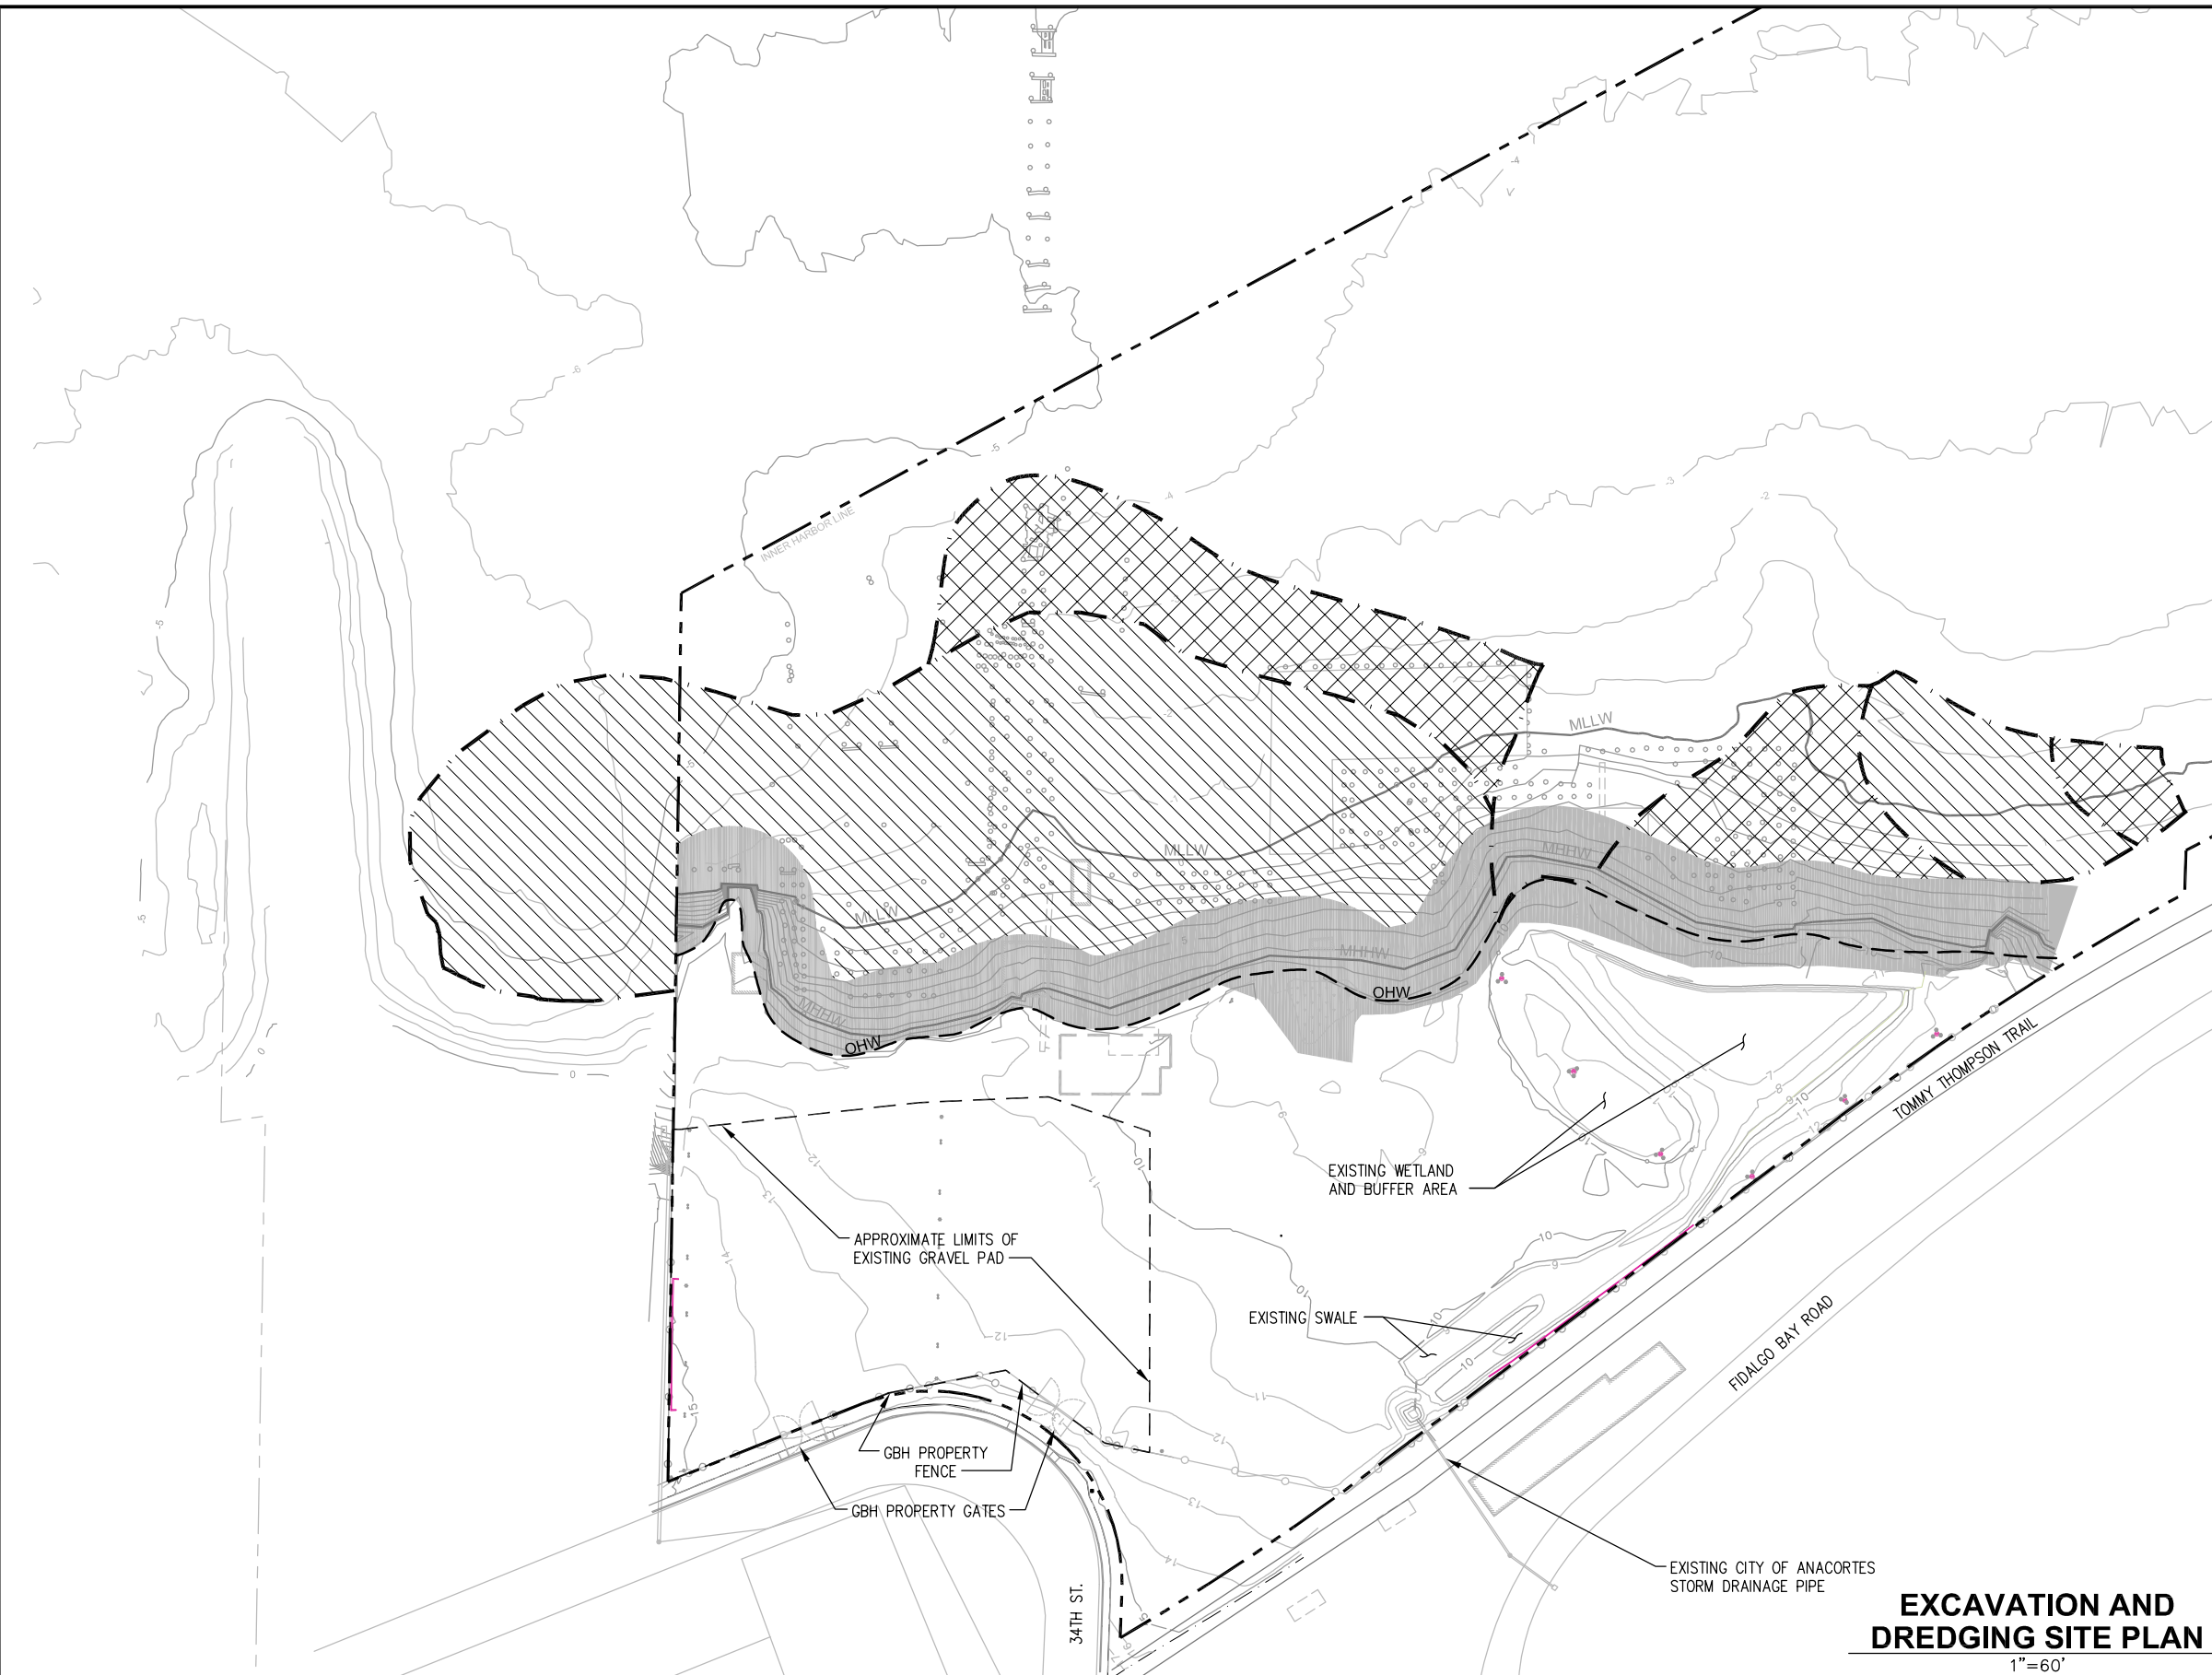
EXCAVATION AND DREDGING SITE PLAN
 1"=60'

DREDGE TO CONTACT WITH NATIVE SEDIMENT WHERE DIOXIN TEC > 25 ppt.

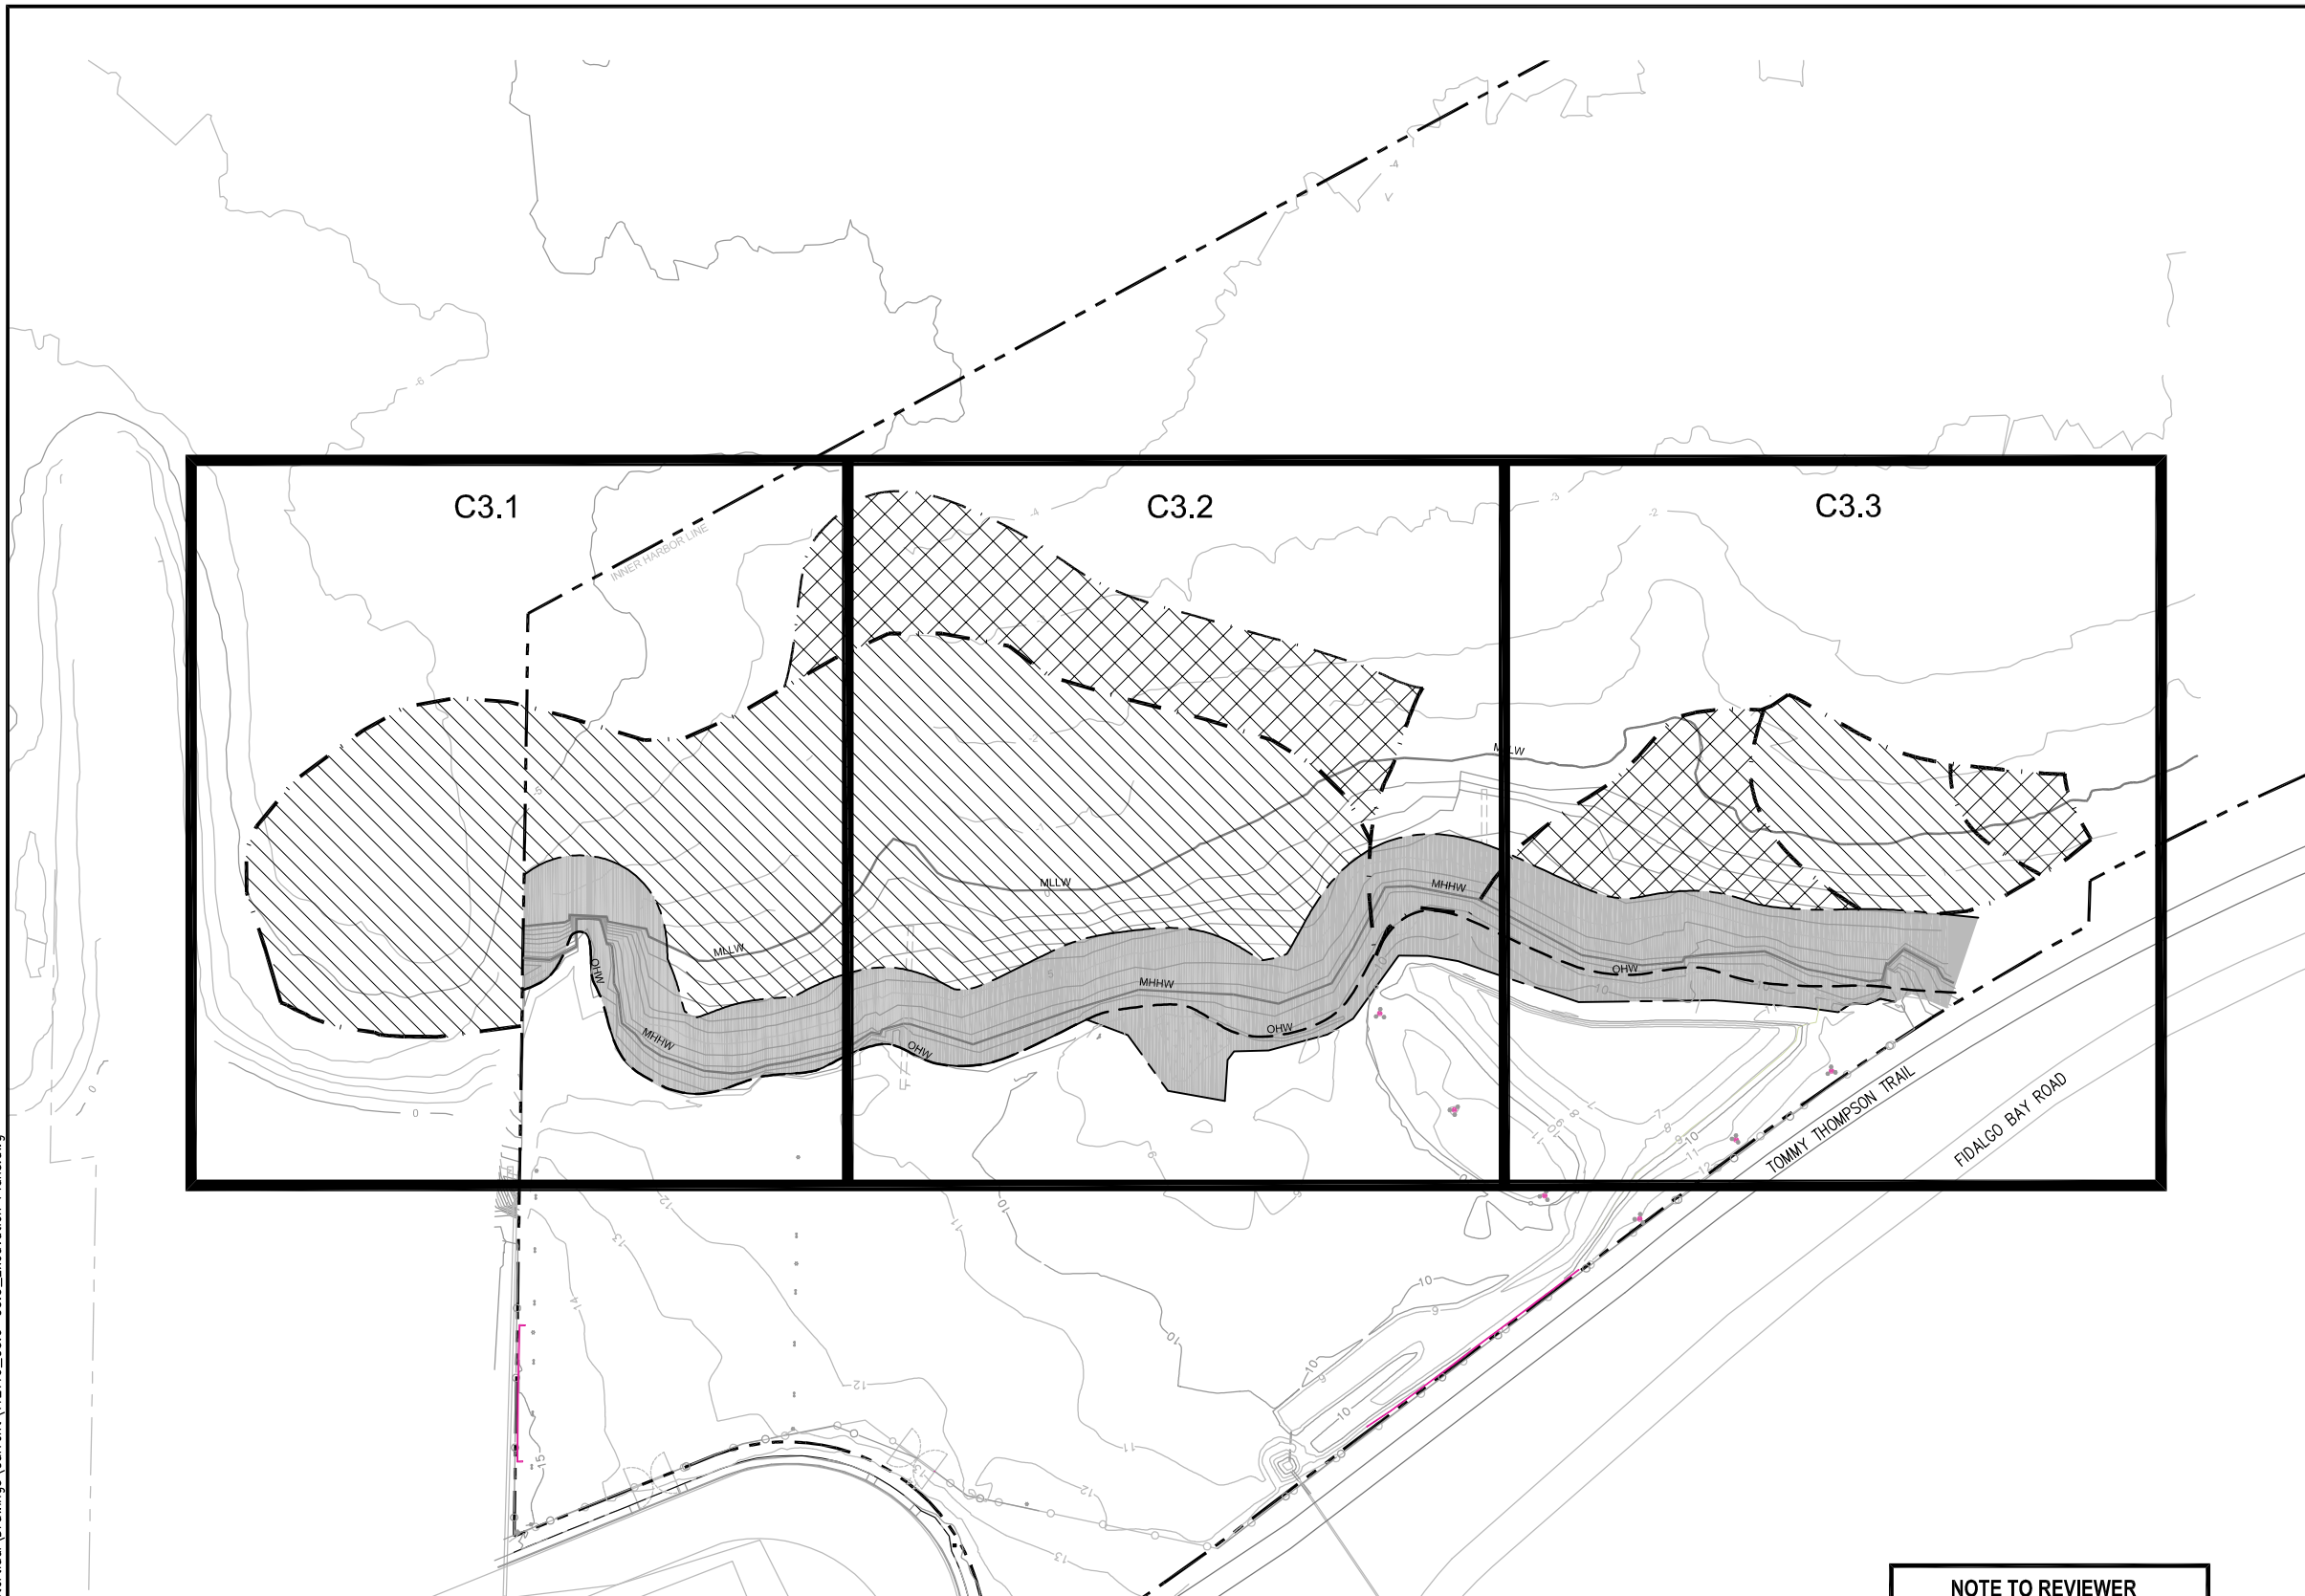
1. SOIL AND MATERIAL REMOVED DURING EXCAVATION AND DREDGING, INCLUDING CONSTRUCTION WATER, SHALL BE HANDLED PER THE SPECIFICATIONS. CONTRACTOR SHALL CONTACT ECOLOGY OR ECOLOGY'S REPRESENTATIVE IMMEDIATELY UPON NOTICING EVIDENCE OF CONTAMINATION OR SUSPECTED CONTAMINATED MATERIAL BEYOND THAT NOTED HEREIN.

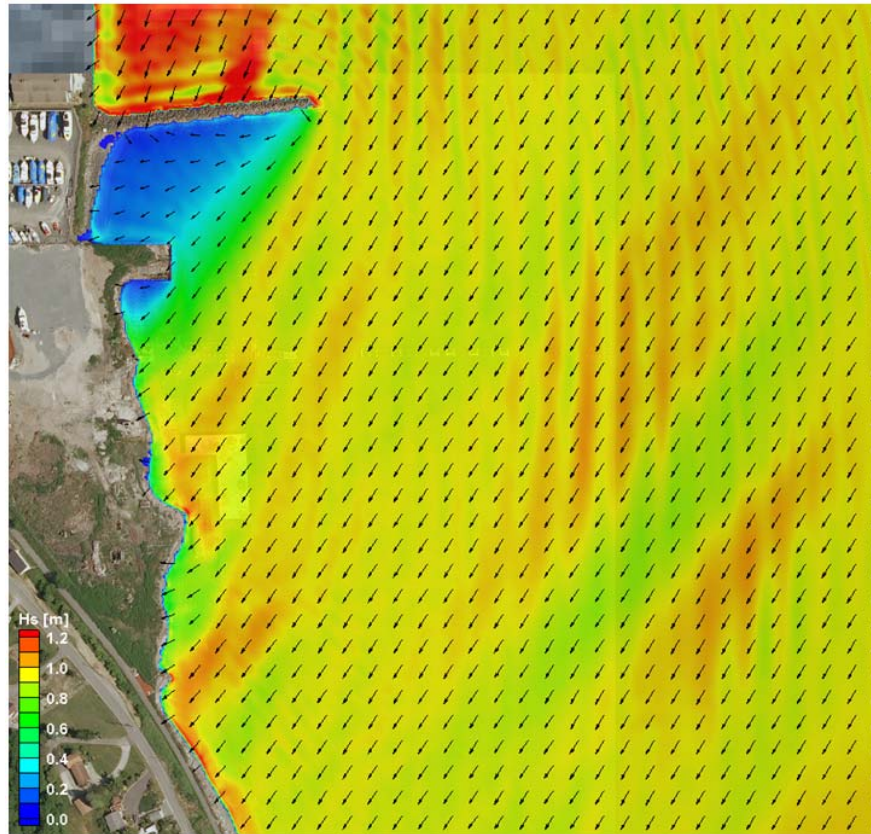
Figure 1. 25-year waves from NE for existing site conditions at MHHW

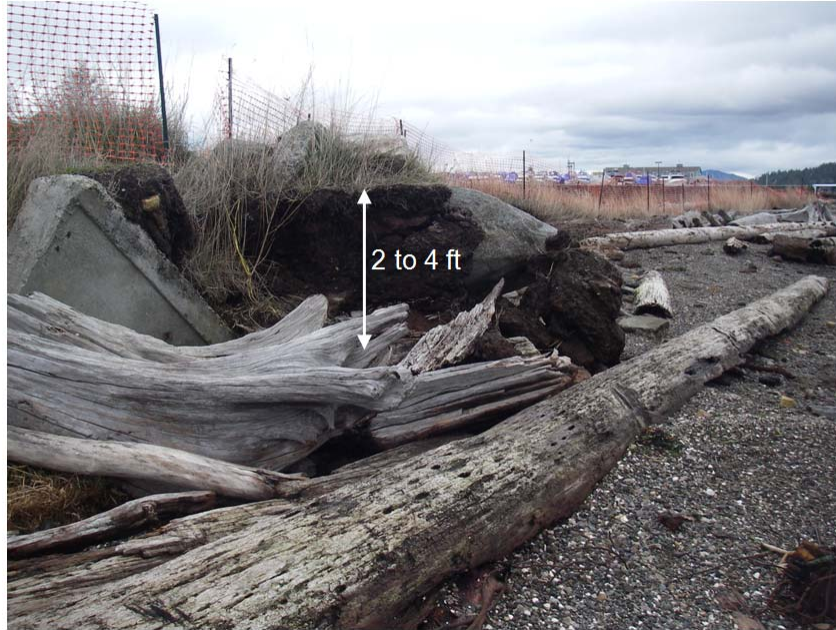
Figure 2. Erosion evident along shoreline at south end of project

Site conditions show an actively eroding shoreline. Ecology blocks and rubble have been placed over time to help stabilize the shoreline and prevent or slow further erosion and to prevent inundation by extremely high tide events. The in-water structures provide some protection from wind and wave energy. Coastal wave modeling for the property shows that most of the wave energy propagates from the northeast, which is aligned with the longest fetch, but differs from the predominant wind pattern (refer to Appendix B-2 of the FS and Appendix D of this report). This strongly suggests that the beach face is subject to acute, episodic erosion events similar to the event during the winter of 2010, causing visible erosion along the shoreline. Although the predominant (more frequent) wave and wind conditions support a smaller stable grain size in the nearshore
