SUBJECT: CLOSURE SITE ASSESSMENT AND LIMITED SITE
CHARACTERIZATION REPORT, SUNNYSIDE, WA.

Project Number: PHC-0194

UST Closure Site Assessment and Limited Site Characterization Report

For Soil Sampling Activities at the
Pet Health Clinic Facility,
Sunnyside, WA

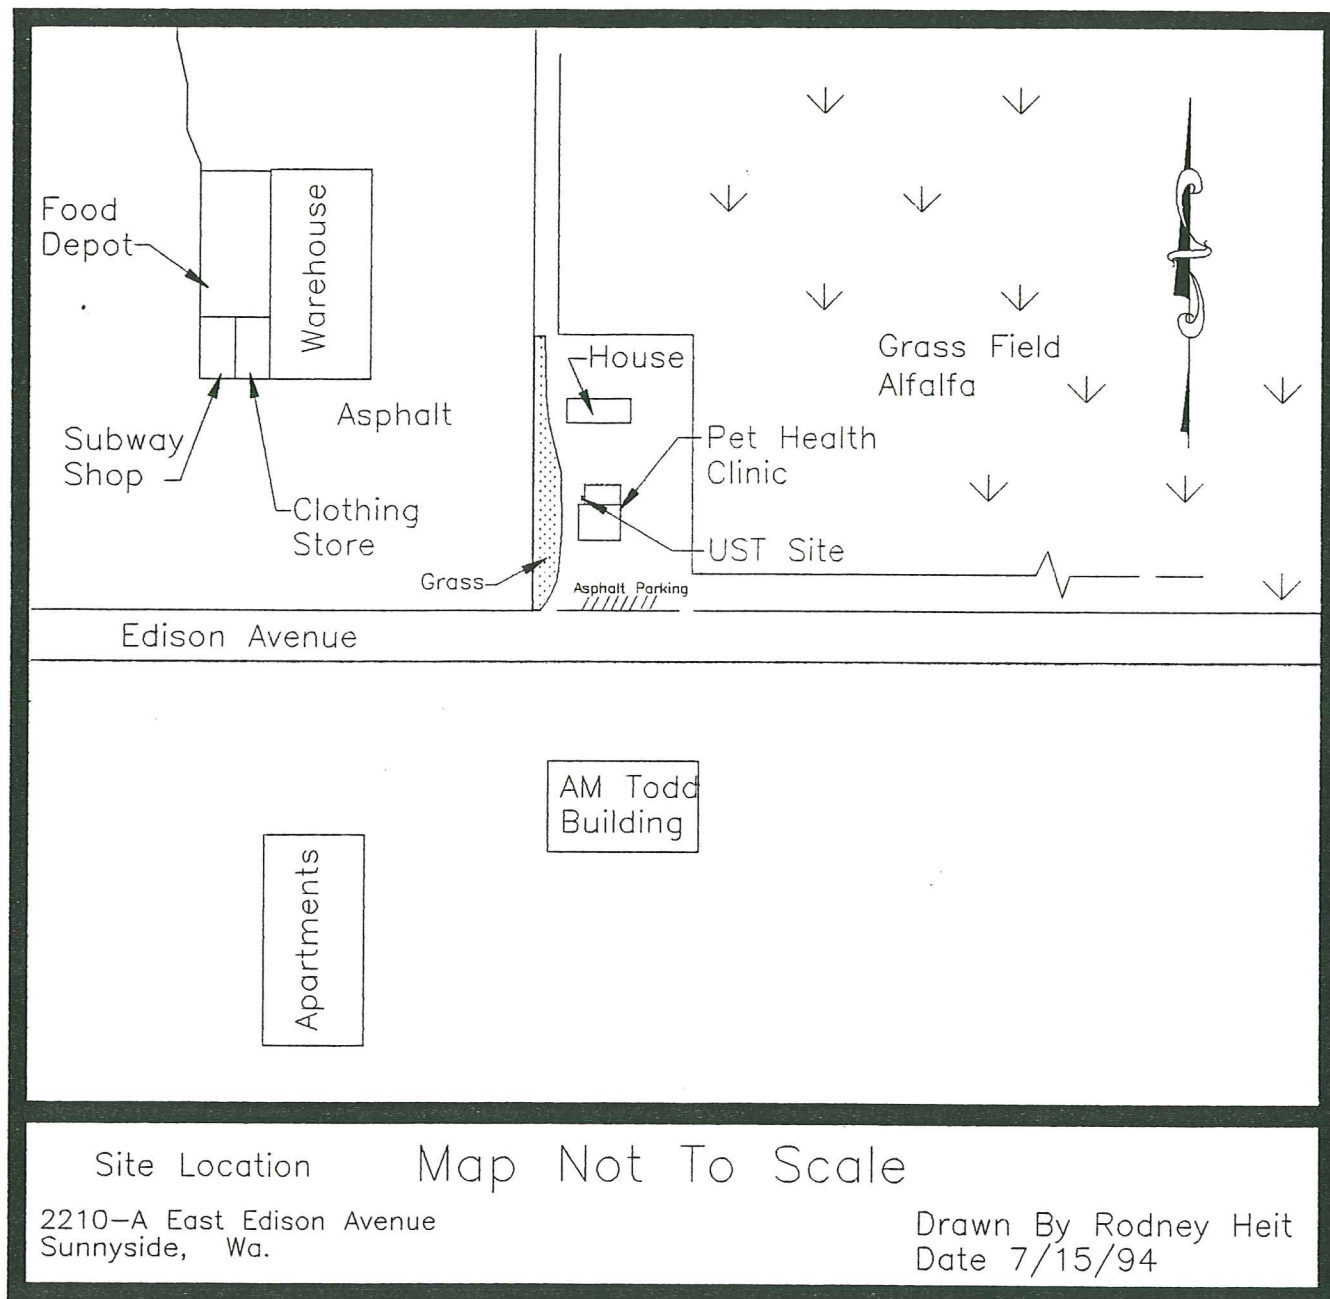
Figure 2. Site Vicinity Map

The facility is occupied by a veterinary clinic as shown by Figure 2. Kennels are located immediately north of the clinic. The kennel is constructed of cyclone fenced pens upon a concrete pad. A residence is located approximately 100 feet north of the kennels. A drinking water well is located between the kennels and the residence. This well serves both the residence and the clinic.

An asphalt driveway lies adjacent to the west side of the clinic building. A lawn lies west of the driveway and extends to the western property boundary. A row of small pine trees is located just inside the western property boundary. A major portion of these trees appear to be distressed. The property west of the facility consists of parking for the Sunnyside Mall which is located approximately 100 feet west of the site. The property east of the facility is a pasture. East Edison Avenue is located immediately south of the subject property. Commercial businesses are located south of Edison Avenue. The facility layout and adjacent land use is shown by Figure 2.

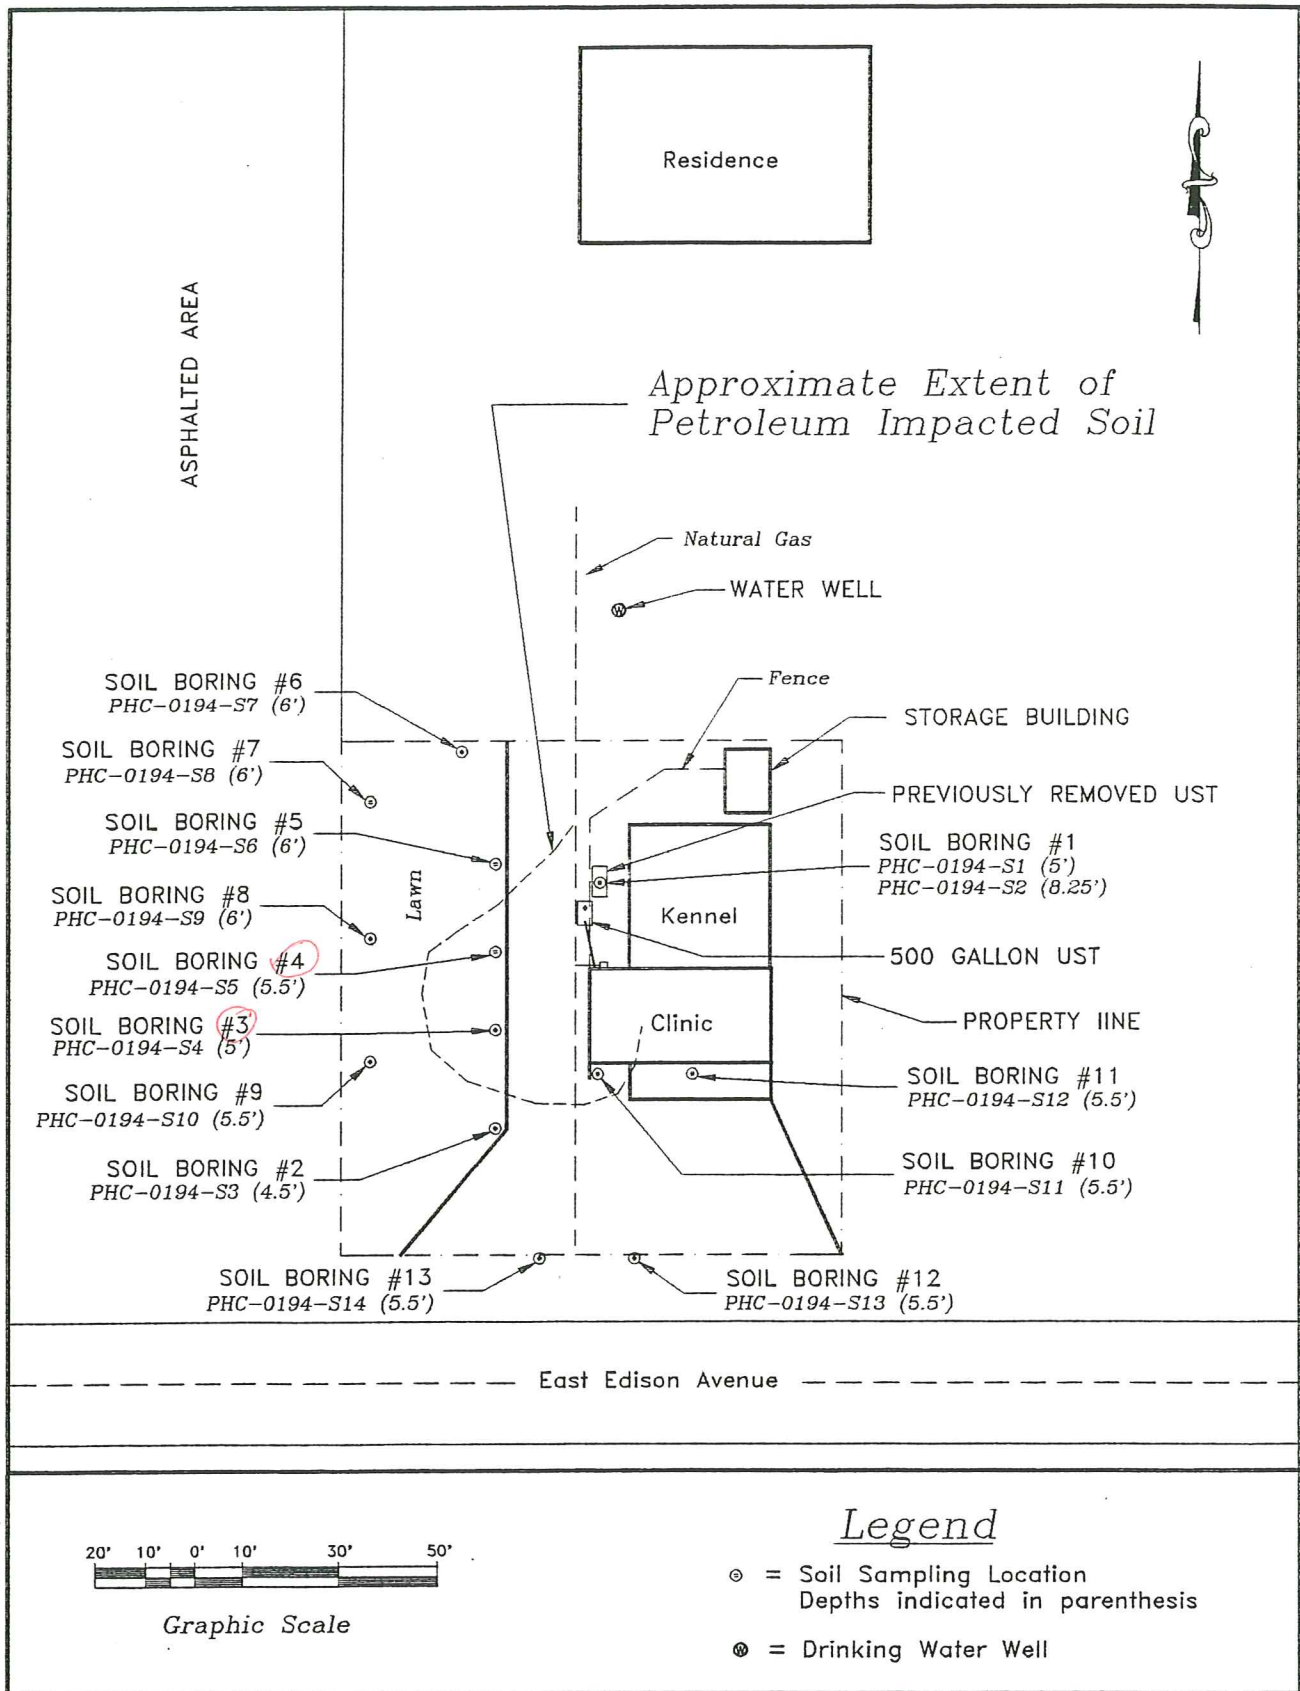
Figure 3. Soil Boring and Soil Sampling Locations

Soil Boring #1 was established at the original position of the previously removed UST as shown by Figure 3. This position was covered by crushed gravel aggregate. Soil samples PHC-0194-S1 and PHC-0194-S2 were collected at this location from depths of 5 feet BGS and 8.25 feet BGS, respectively. Analysis of sample PHC-0194-S1 found diesel range hydrocarbons at a concentration of 1,940 parts per million (ppm) while analysis of PHC-0194-S2 found diesel range hydrocarbons at a concentration of 1,648 ppm. Comparison of the analytical results (Appendix E) with the "Method A Cleanup Levels" (Cleanup Levels) of WAC-173-340-740 (Appendix F) indicates that remedial action is required at this location to reduce diesel range hydrocarbon concentrations to acceptable levels.

Soil Boring #2 was established within the lawn area, southwest of the clinic building as shown by Figure 3. Sage collected one (1) soil sample PHC-0194-S3 at this location from a depth of 4.5 feet BGS. Analysis of this sample found no detectable petroleum hydrocarbons. Comparison of the analytical results (Appendix E) with the Cleanup Levels (Appendix F) indicates that no remedial action is required at this location.

Soil Boring #3 was established within the lawn area, west of the clinic building as shown by Figure 3. Sage collected one (1) soil sample PHC-0194-S4 at this location from a depth of 5 feet BGS. Analysis of this sample found diesel range hydrocarbons at a concentration of 1,585 ppm. Comparison of the analytical results (Appendix E) with the Cleanup Levels (Appendix F) indicates that remedial action is required at this location to reduce diesel range hydrocarbon concentrations to acceptable levels.

Soil Boring #4 was established within the lawn area, northwest of the clinic building as shown by Figure 3. Sage collected one (1) soil sample PHC-0194-S5 at this location from a depth of 5.5 feet BGS. Analysis of this sample found diesel range hydrocarbons at a concentration of 685 ppm. Comparison of the analytical results (Appendix E) with the Cleanup Levels (Appendix F) indicates that remedial action is required at this location to reduce diesel range hydrocarbons to acceptable levels.

Soil Boring #5 was established within the lawn area, west of the kennel structure as shown by Figure 3. Sage collected one (1) soil sample PHC-0194-S6 at this location from a depth of 6 feet BGS. Analysis of this sample found no detectable petroleum hydrocarbons. Comparison of the analytical results (Appendix E) with the Cleanup Levels (Appendix F) indicates that no remedial action is required at this location.

Soil Boring #10 was established near the southwest corner of the clinic building as shown by Figure 3. Sage collected one (1) soil sample PHC-0194-S11 at this location from a depth of 5.5 feet BGS. Analysis of this sample found diesel range hydrocarbons at a concentration of 1,187 ppm. Comparison of the analytical results (Appendix E) with the Cleanup Levels (Appendix F) indicates that remedial action is required at this location.

Since petroleum impacted soil appears to be in contact with the groundwater, Sage recommends installation of at least three (3) groundwater monitoring wells to facilitate collection of groundwater samples and to determination of hydrogeologic conditions. Samples should be collected from the wells and analyzed for gasoline, diesel and BTEX.

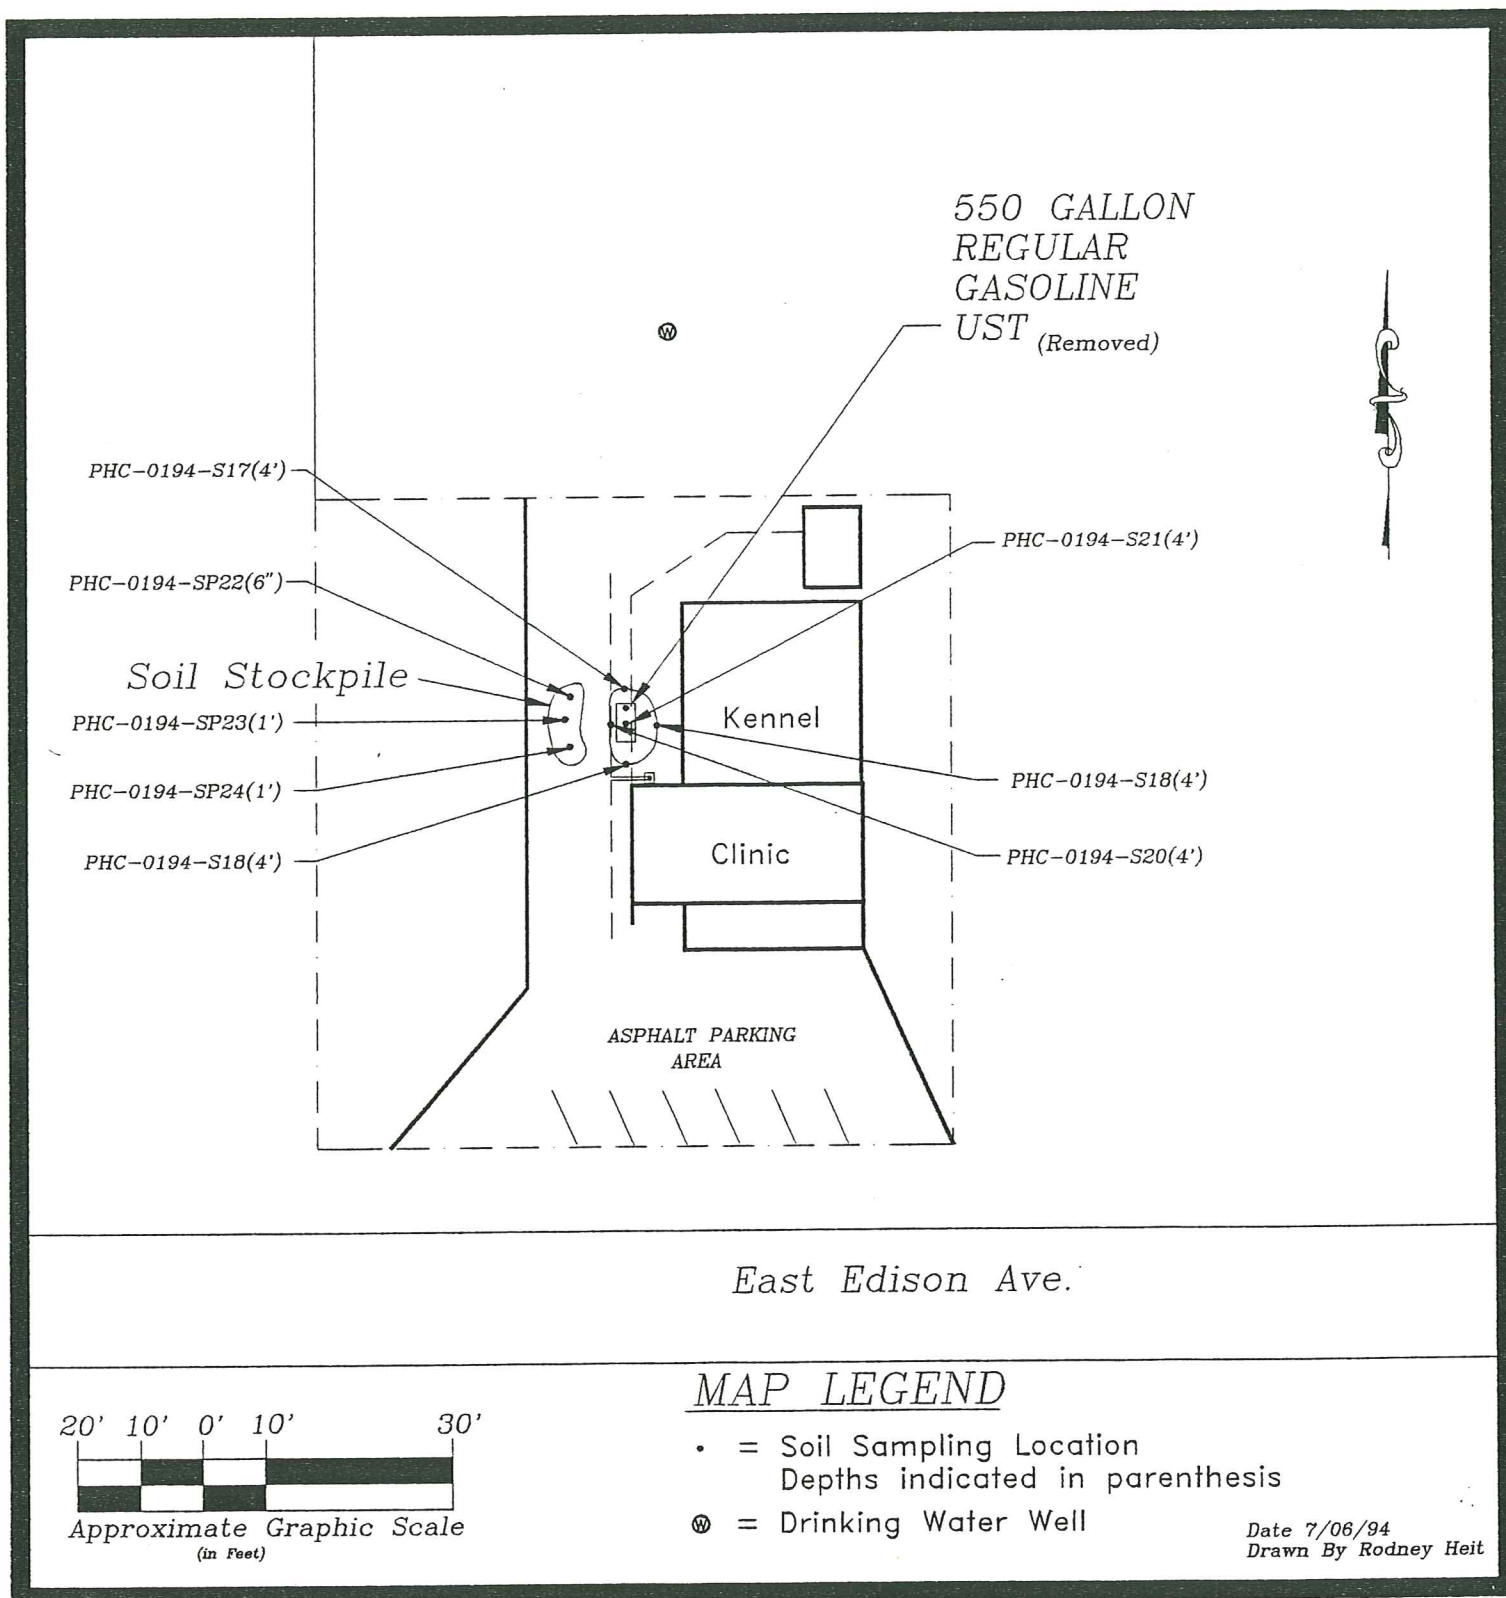
Figure 4. UST Removal Sampling Locations

HMB removed the 500 gallon UST on July 1, 1994. Sage performed a visual inspection of the tank and the excavation. The tank was corroded and multiple holes, one of which is approximately ten (10) inches in diameter. Soil exposed within the entire tank excavation and the stockpile of soil generated during the tank removal process appear to be impacted by petroleum hydrocarbons.

Upon removal of the tank, Sage collected five (5) soil samples (PHC-0194-S17 through PHC-0194-S24) from within the tank excavation. Sage also collected three soil samples from the stockpile of soil generated during the tank removal process. Soil sampling methodologies are described by Appendix G and sampling locations are shown by Figure 4. Since a release had been confirmed, only one of these samples (PHC-0194-S21) was submitted to MTC for independent laboratory analysis. Analysis of this sample found:

- ♦ aged gasoline at a concentration of 2,500 ppm,
- ♦ diesel at a concentration of 1,560 ppm,
- ♦ no detectable benzene,
- ♦ toluene at a concentration of 371 ppb,
- ♦ ethylbenzene at a concentration of 8,100 ppb,
- ♦ xylenes at a concentration of 28,600 ppb and
- ♦ no detectable lead.

Comparison of the analytical results (Appendix E) with the Cleanup Levels (Appendix F) indicate that remedial action is required at this location to reduce aged gasoline, diesel and xylene concentrations to acceptable levels. The tank excavation was backfilled with imported fill and the stockpile of soil generated during the tank removal process. Sage also completed a copy of the WSDOE UST Site Check/Site Assessment Checklist and it is attached as Appendix H. HMB has completed a copy of the WSDOE Temporary/Permanent Closure and Site Assessment Notice and it is attached as Appendix I.
