Technical Memorandum

To: Mark Conan
From: Paul Ecker LHG, and Chris Rhea
Date: 03-05-2013
Subject: Final Site Characterization Report and Request for No Further Action Determination
Plaid Pantries Store #23
Vancouver, Washington
Ecology Voluntary Cleanup Program File #SW1166
EES Project #E-839

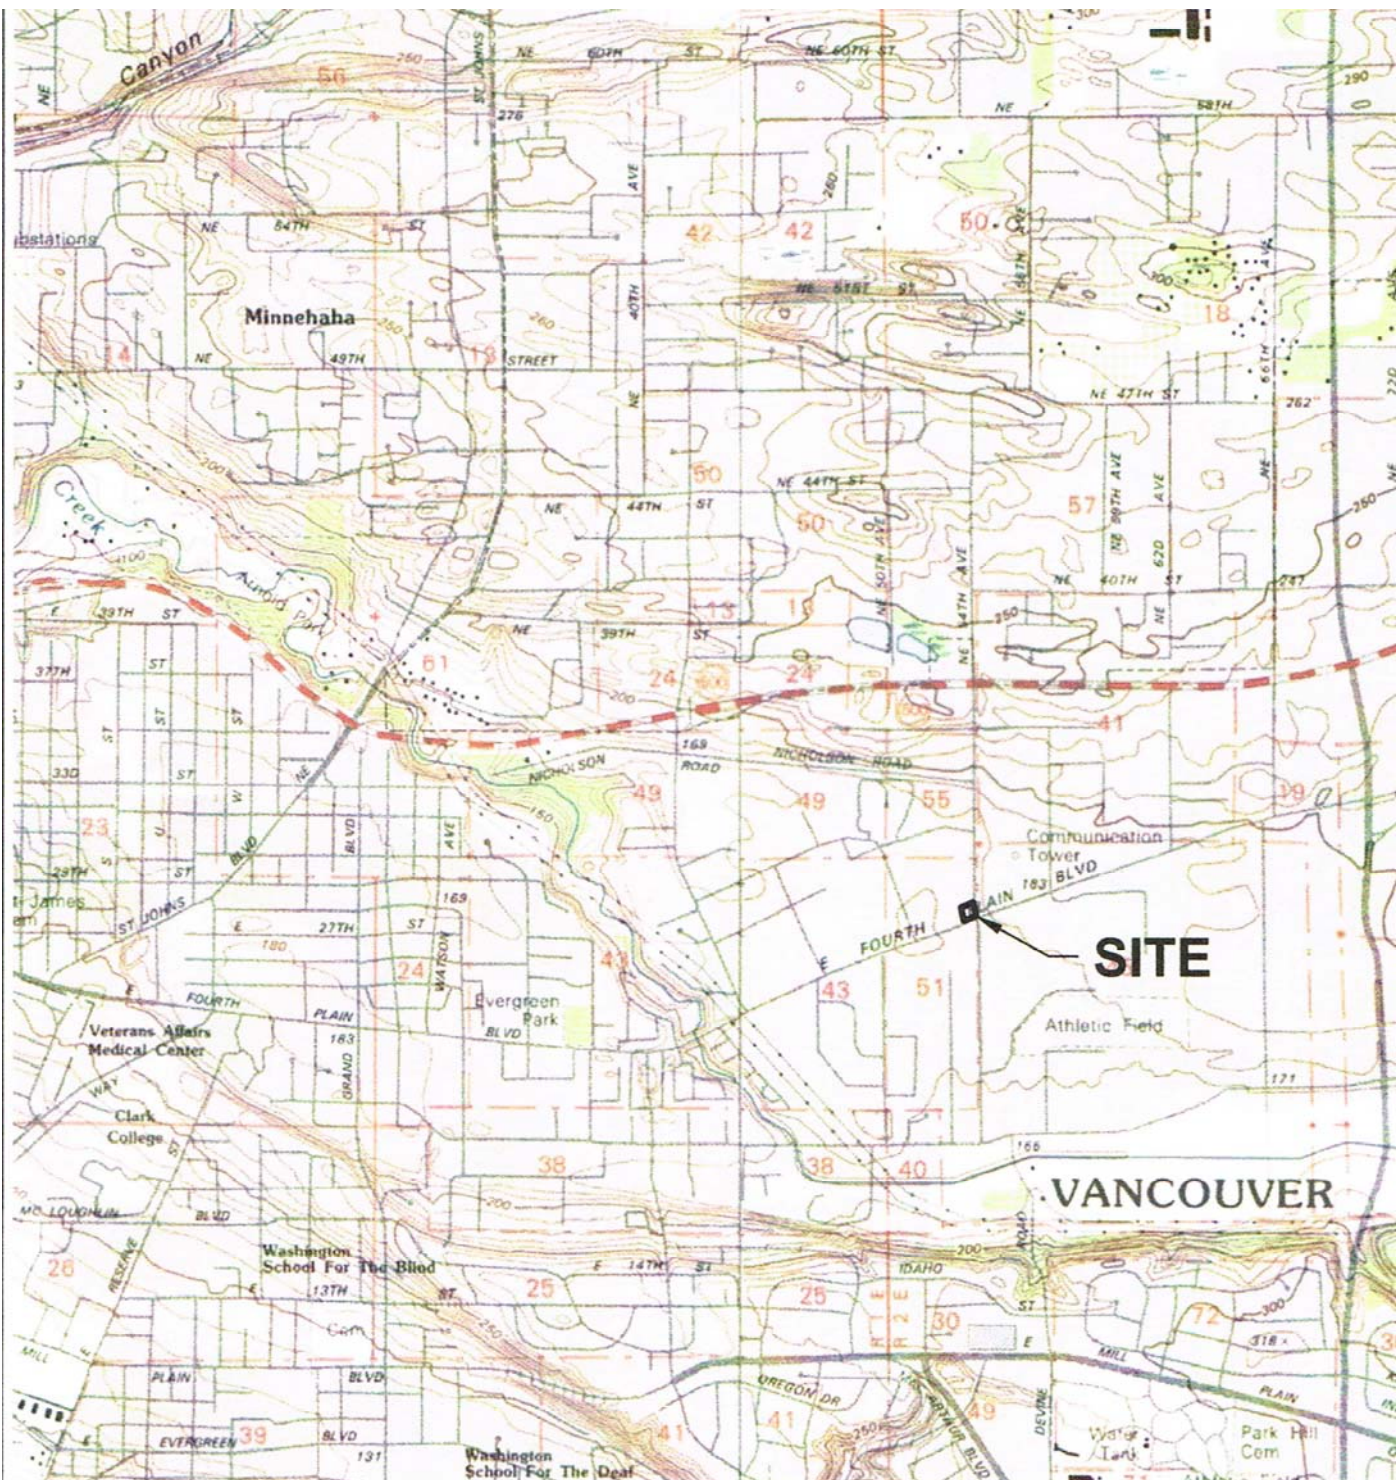
USGS, VANCOUVER WASHINGTON / OREGON
 7.5 MINUTE QUADRANGLE, 1990
 BASE MAP PROVIDED BY MAPTECH. APPROXIMATE SCALE IN FEET

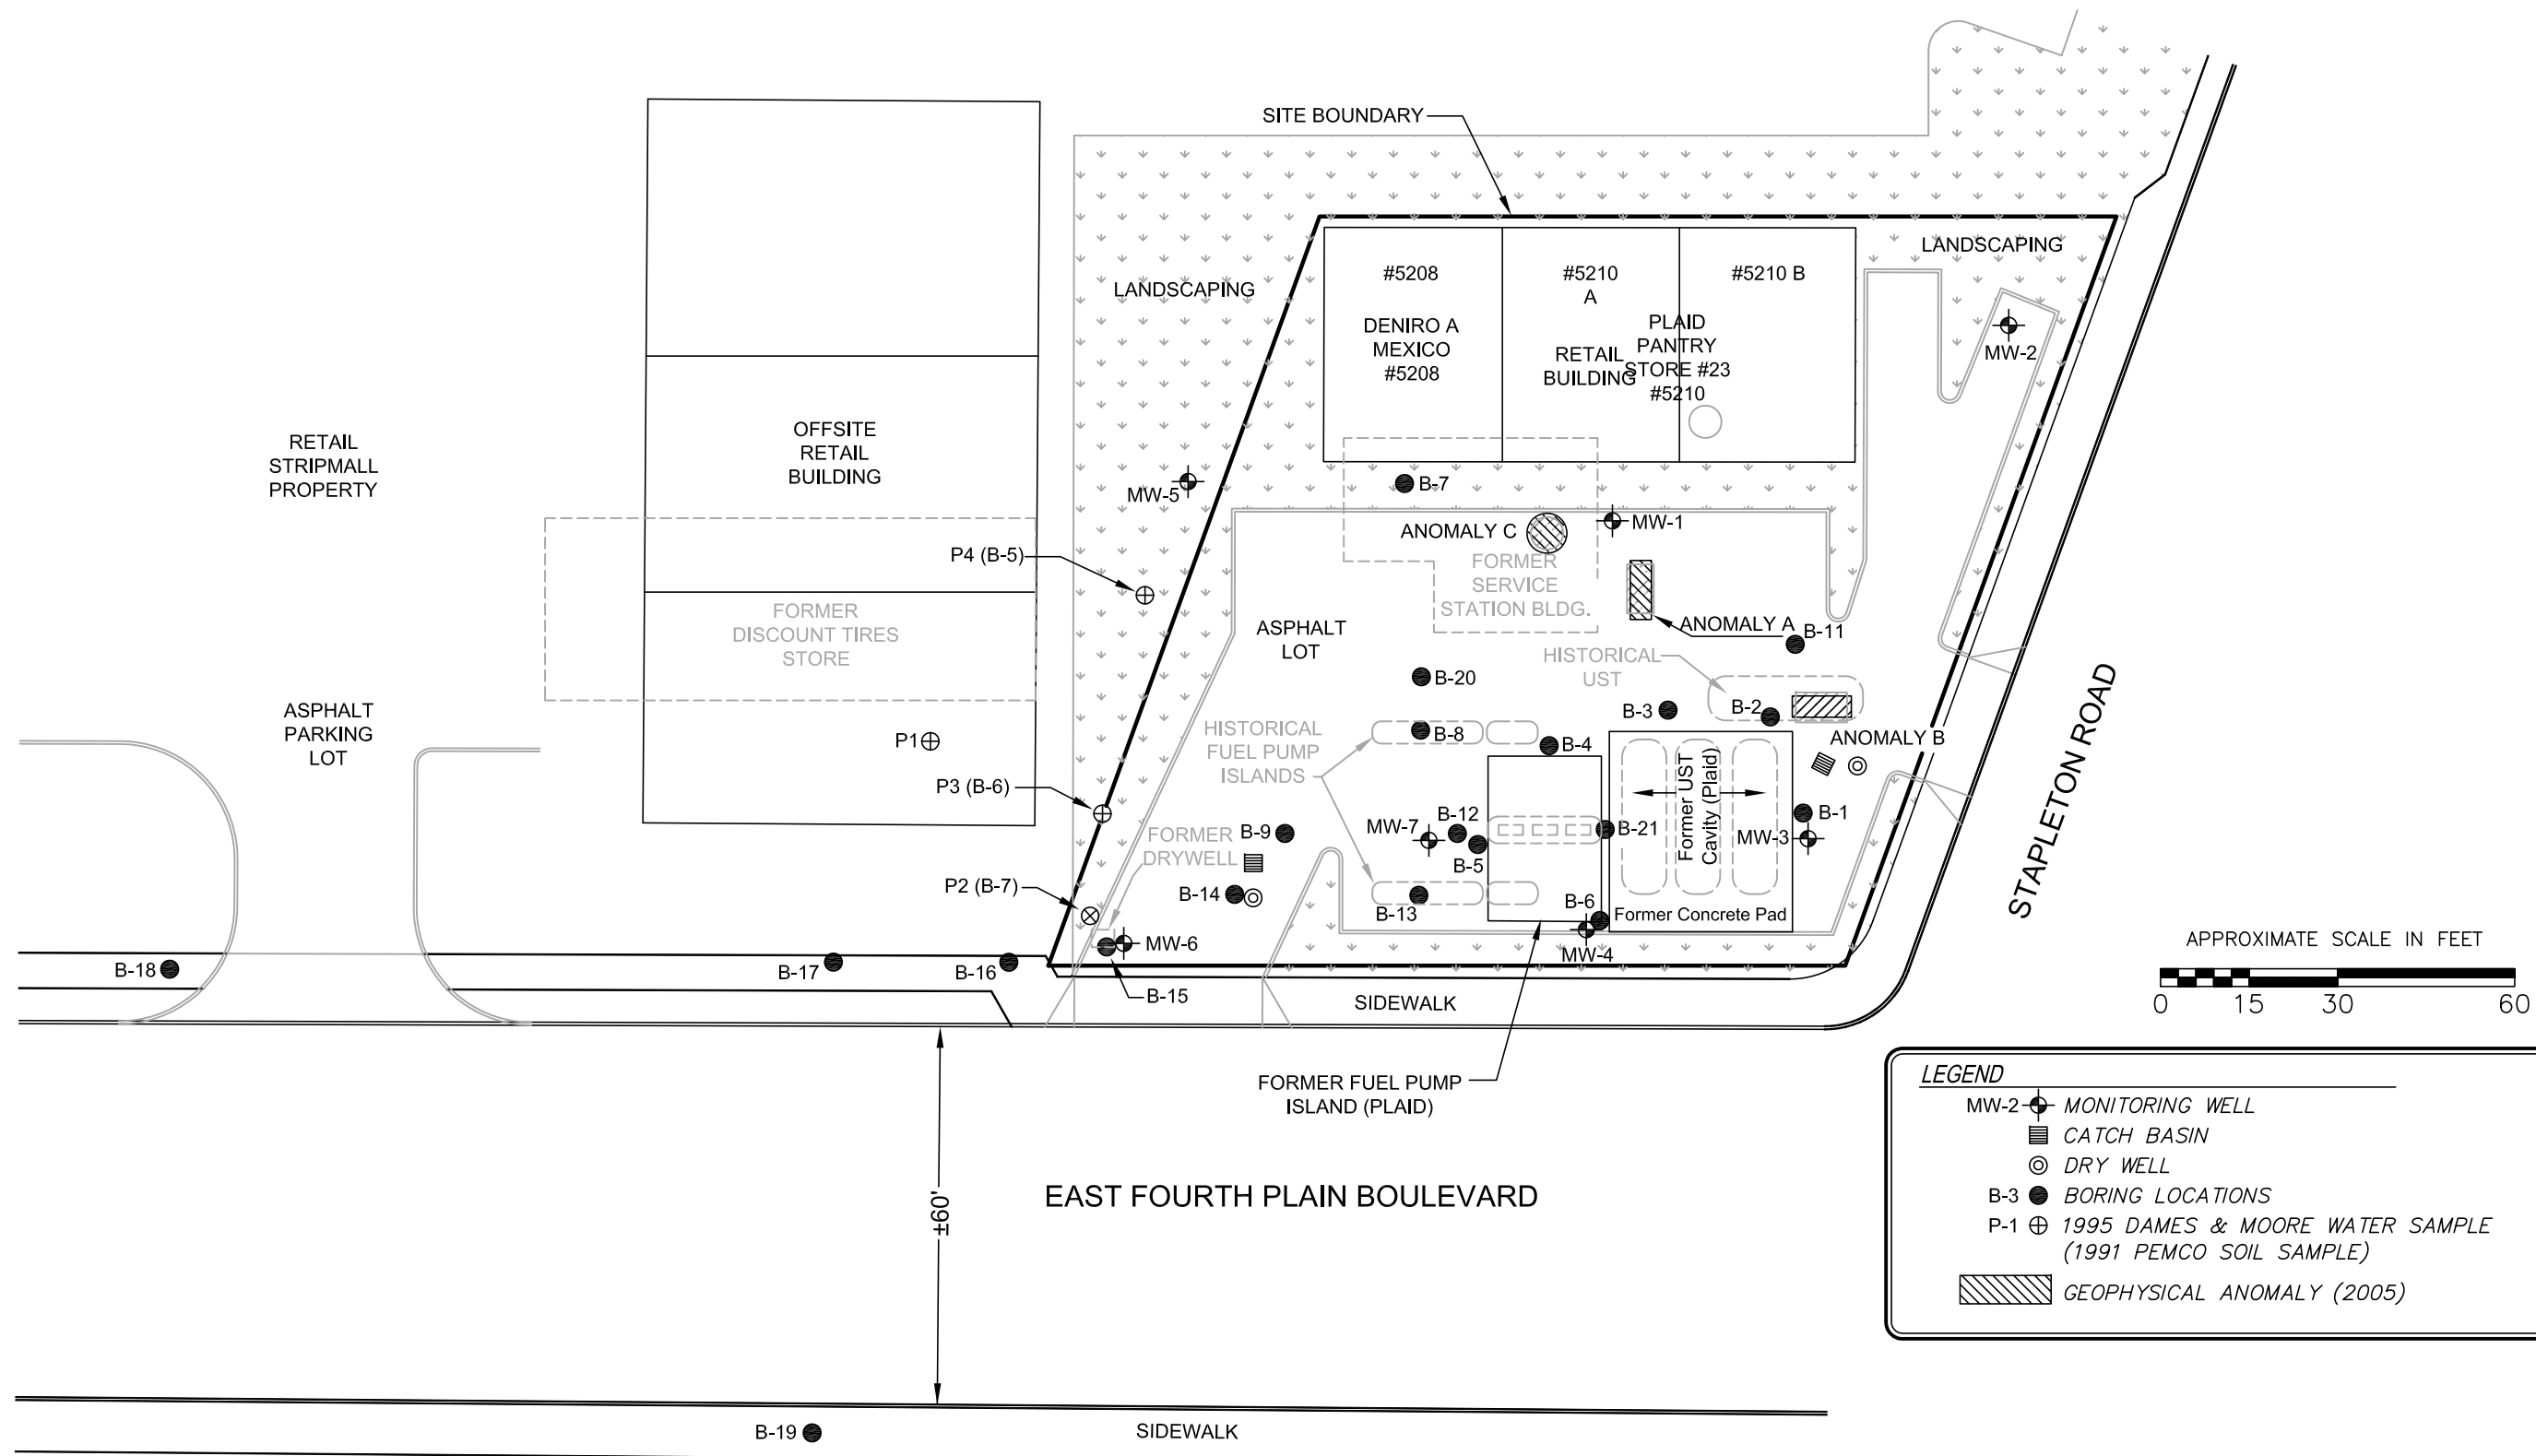
operated as a Chevron service station during much or all of its operations prior to Plaid. The pre-Plaid service station building was located near the southwestern margin of the existing site building and was demolished during site redevelopment in the early 1980s. Current and historical site infrastructure is illustrated on Figure 2.

The subject site is currently occupied by a commercial strip mall and paved parking lot area located along a commercial thoroughfare in Vancouver, Washington (Figure 2). The subject property is owned by M&P Properties. Plaid was a tenant and operated the site as a retail gasoline station and convenience store between 1982 and early 2002. The Underground Storage Tank (UST) Site Number Plaid registered with Ecology was 11397. During Plaid's operations, only gasoline is known to have been stored and dispensed at the site. Leaded gasoline may have been dispensed at the site during phase-out of that product in the 1980s. EES understands that Plaid did not store or dispense other hydrocarbons such as diesel fuel, bulk motor oil, or bulk solvents at any time during its site operations.

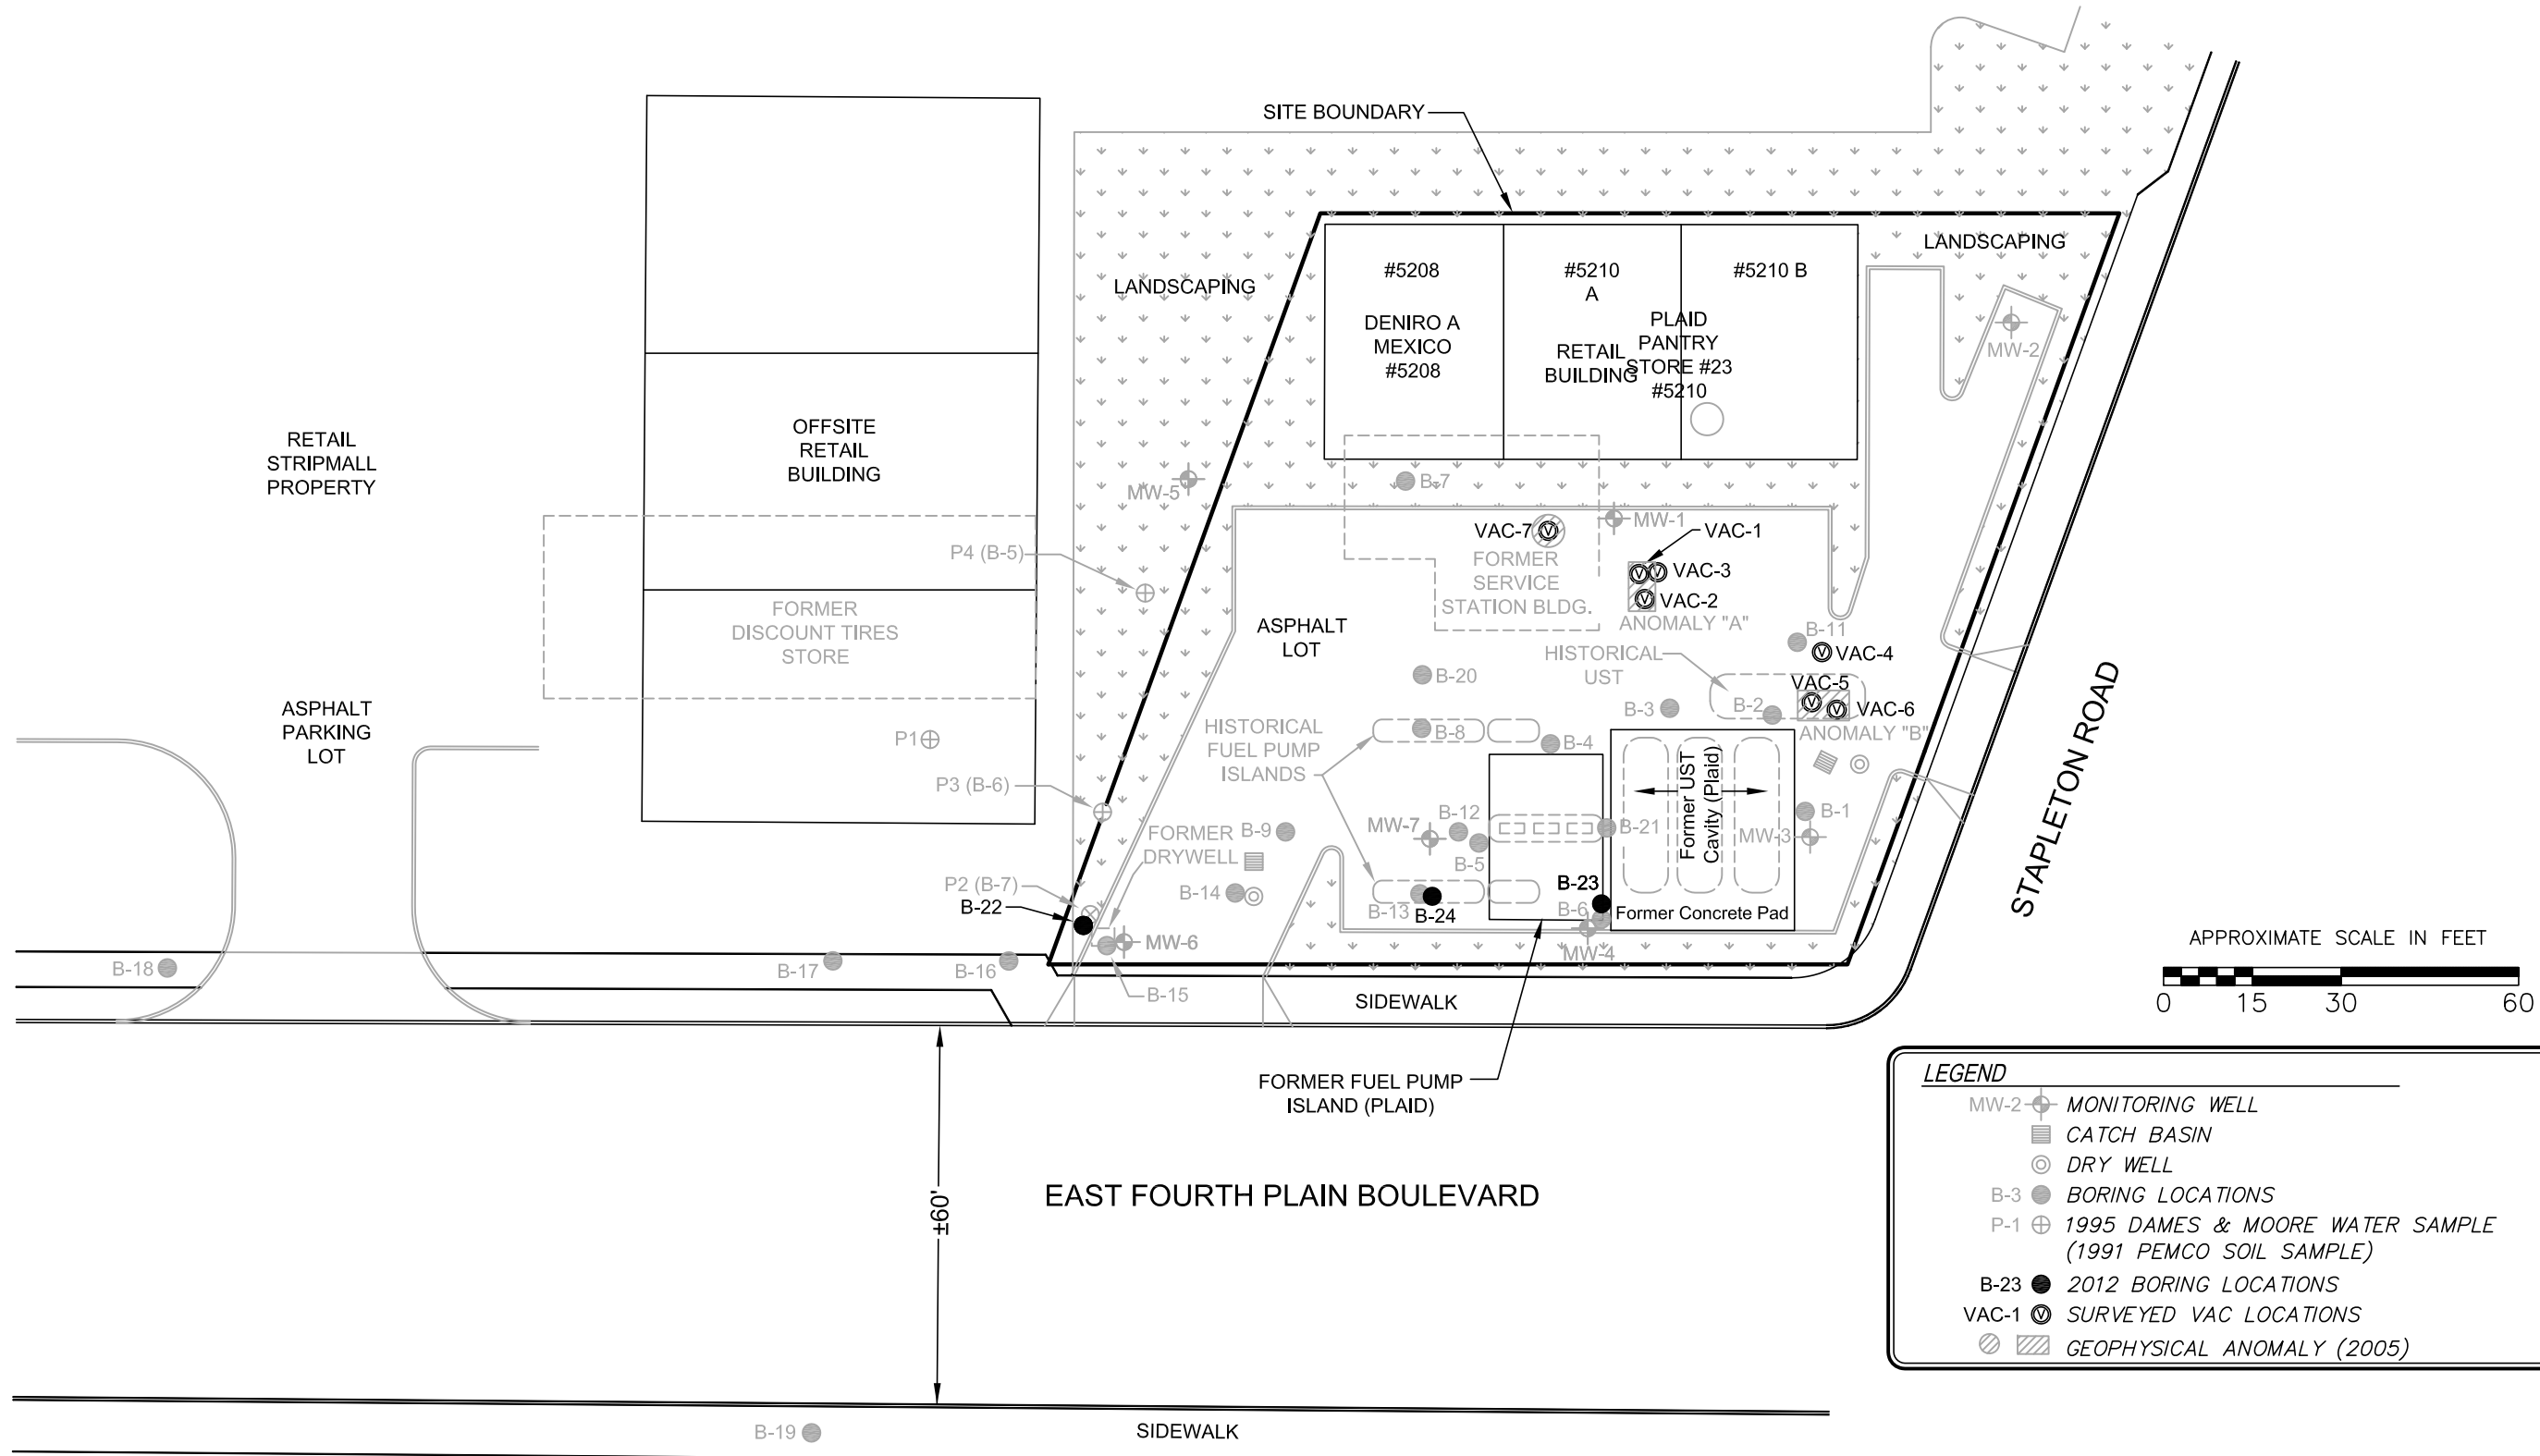
Confirmation soil sampling was conducted using direct-push drilling techniques at three locations where elevated gasoline and/or BTEX compounds historically were detected in soil, as specifically requested by Ecology (Figure 3):

- Boring location B-22 adjacent to Dames & Moore/Pemco soil boring B-7/P2, near the southwest property corner;
- Boring location B-23 adjacent to PNG soil boring B-6, near the southwest corner of the former Plaid UST pit; and
- Boring location B-24 adjacent to PNG soil boring B-13, near the west end of the former southern fuel dispenser island associated with pre-Plaid operations.

In accordance with the work plan, four-inch diameter air-knife excavation techniques were used at specific locations where a prior (2005) geophysical survey had identified two subsurface anomalies that Ecology suspected may represent USTs from pre-Plaid site operations (Figures 2 and 3). A third small anomaly was also evaluated as summarized below.

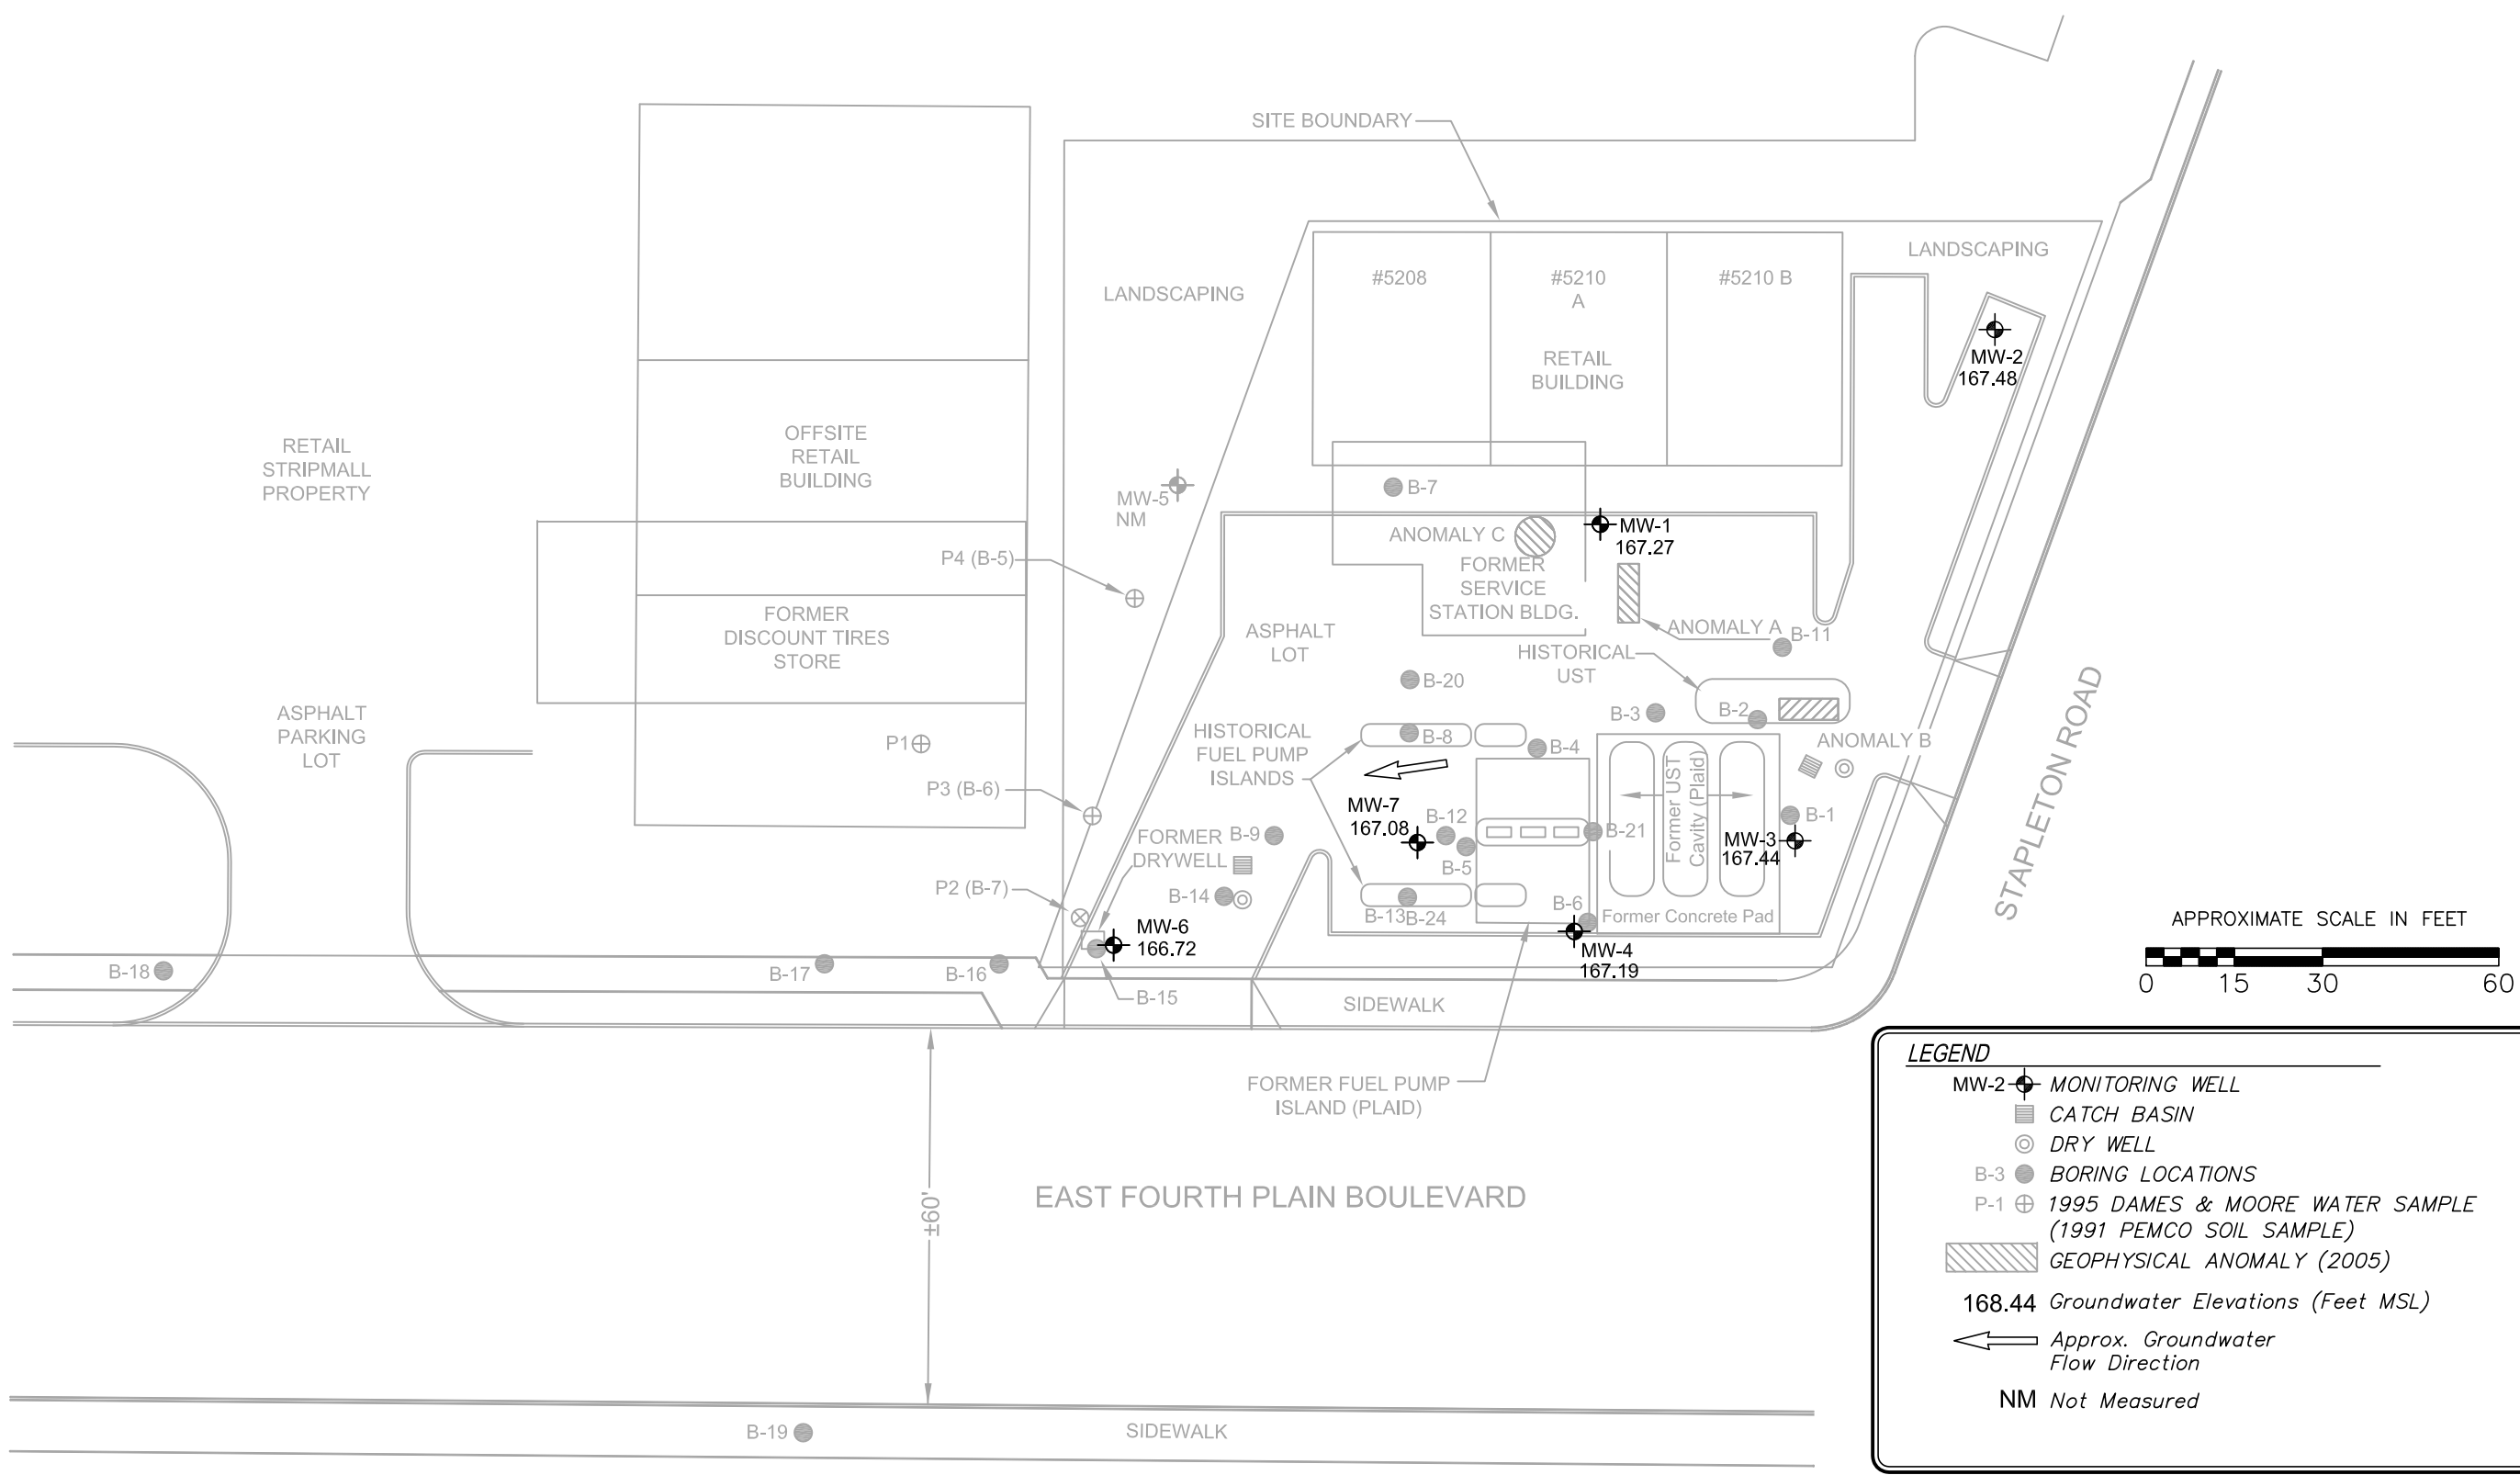
WATER TABLE ELEVATIONS AND FLOW DIRECTION (4/19/2012)

Water table maps for April, July, and October 2012, and January 2013 are provided as Figures 4 through 7, respectively, and indicate that groundwater flow is generally to the west/southwest (consistent with prior observations at the site). Specifically, the most recent water table

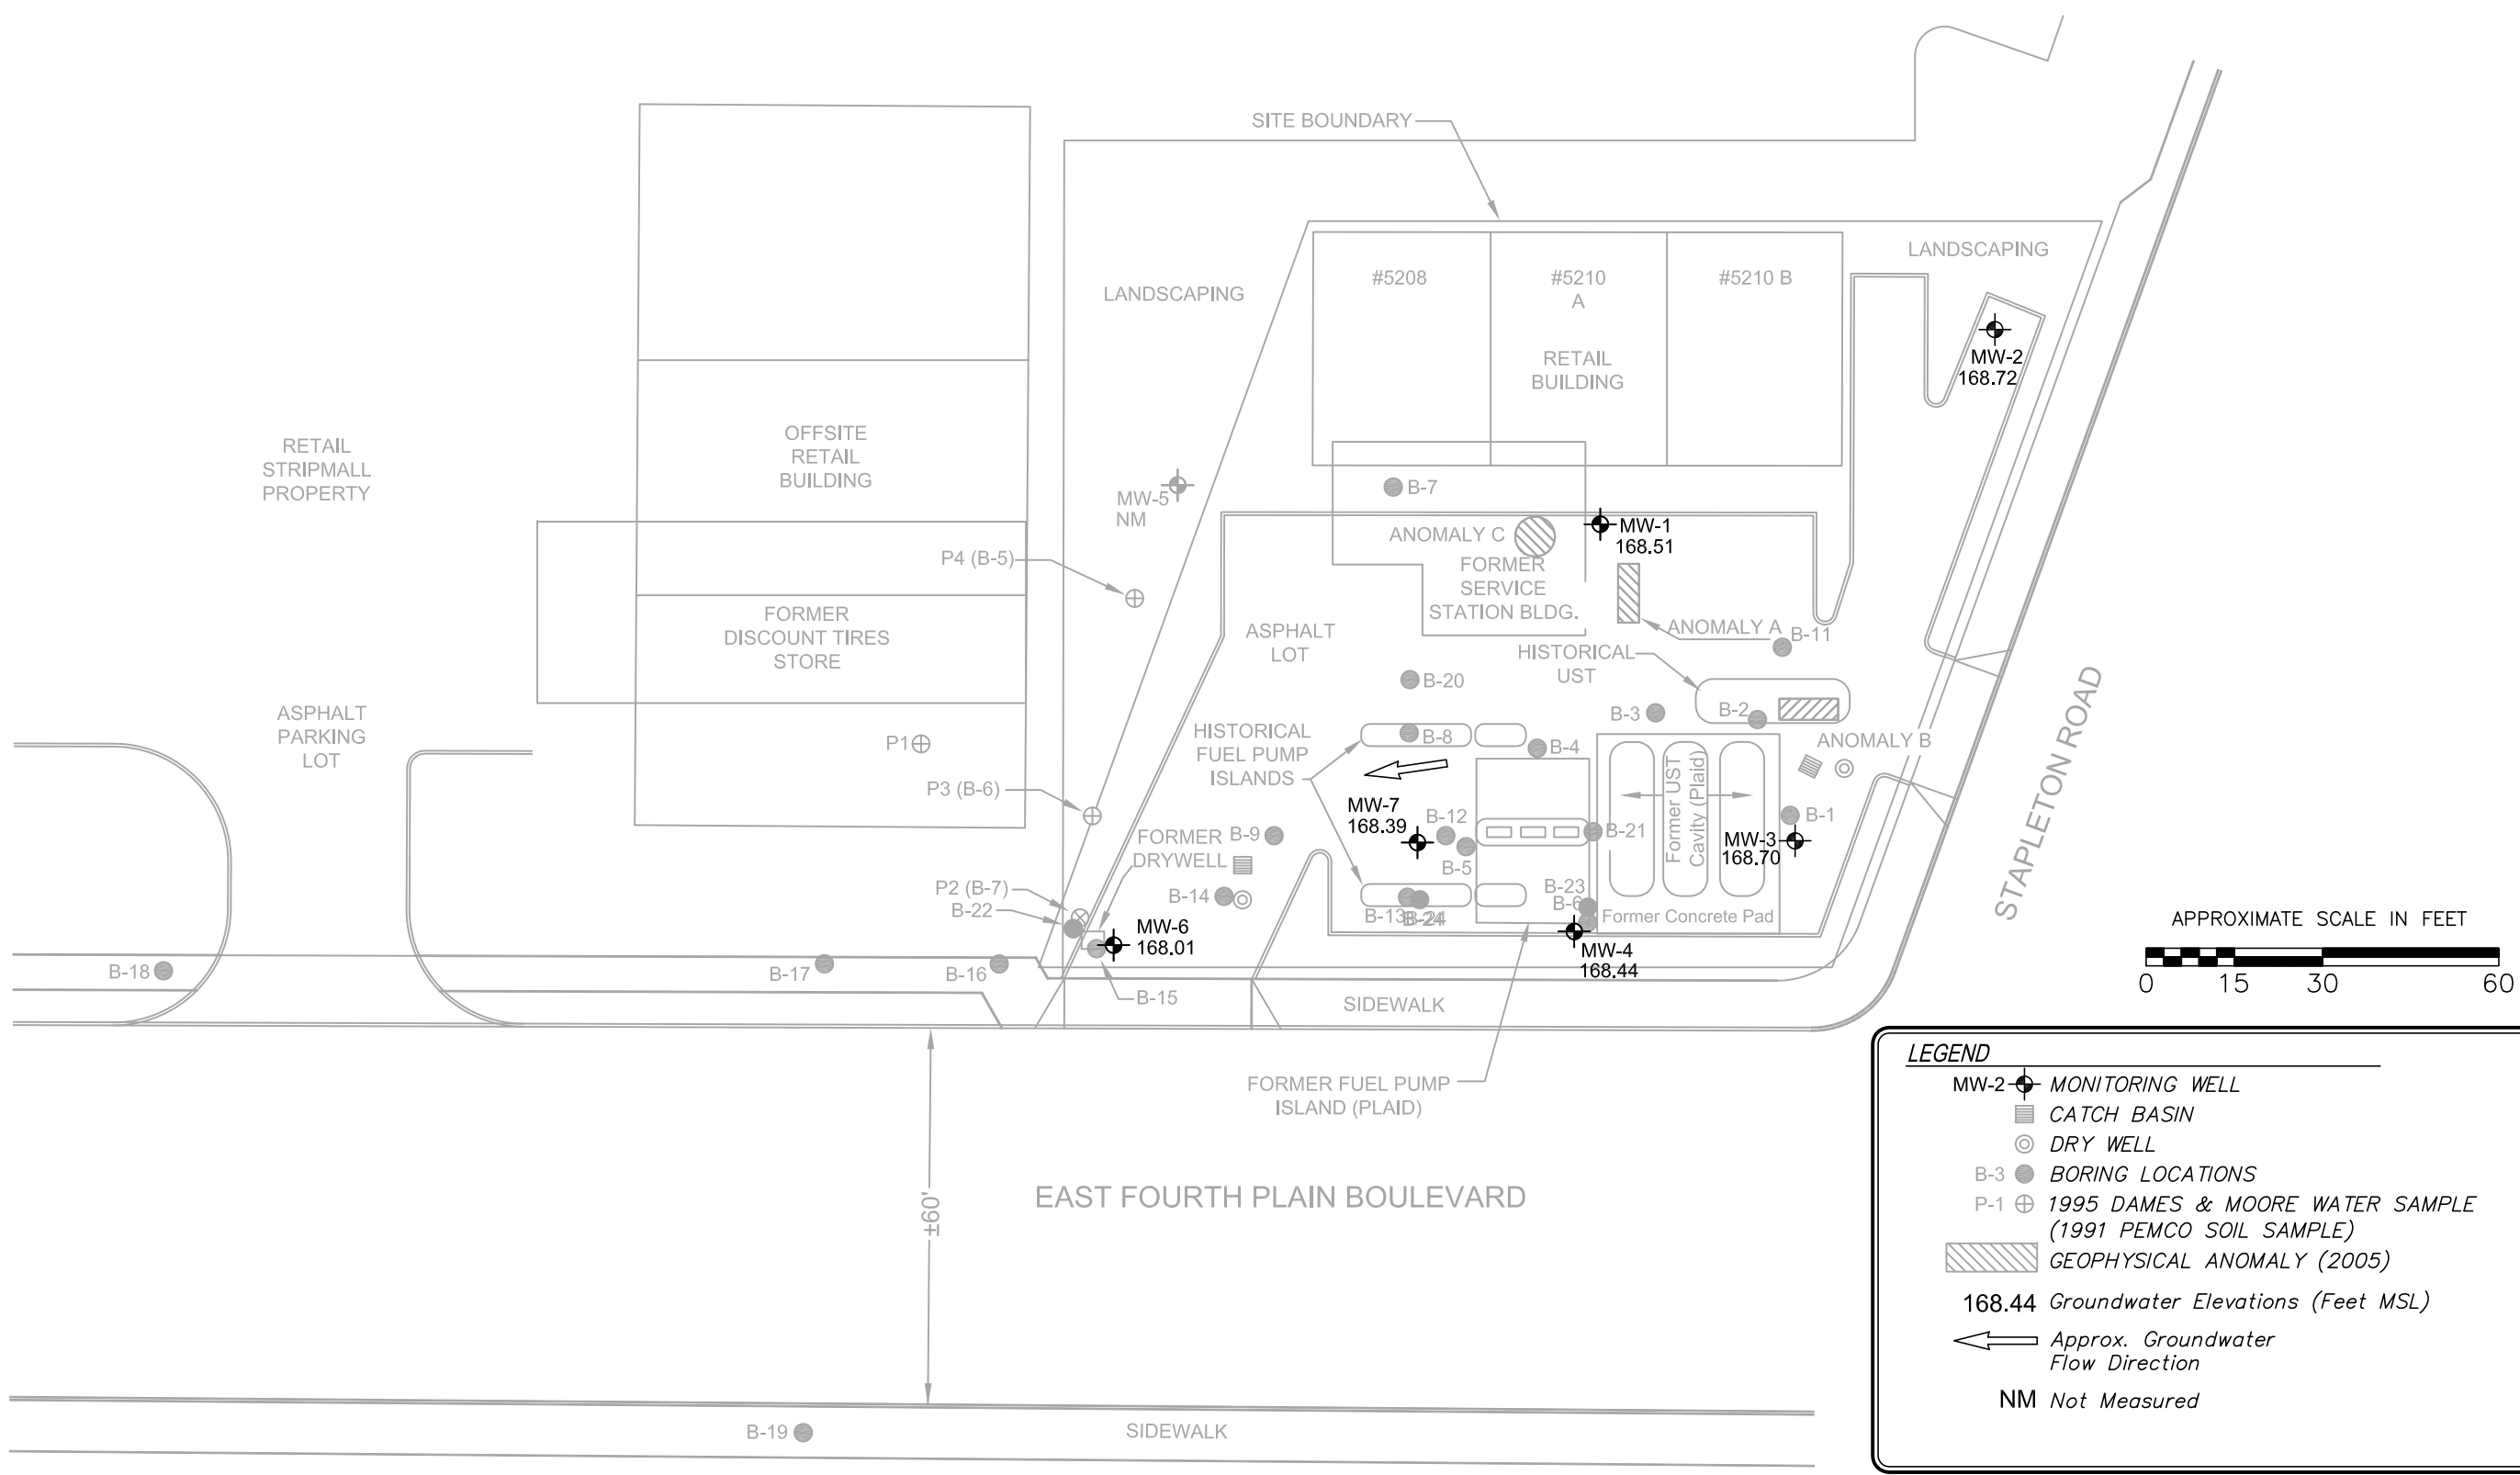
WATER TABLE ELEVATIONS AND FLOW DIRECTION (1/7/2013)

measurements indicate a potentiometric surface sloping to the southwest at a gradient of 0.005 vertical feet per horizontal foot, as measured between monitoring wells MW-3 and MW-6.

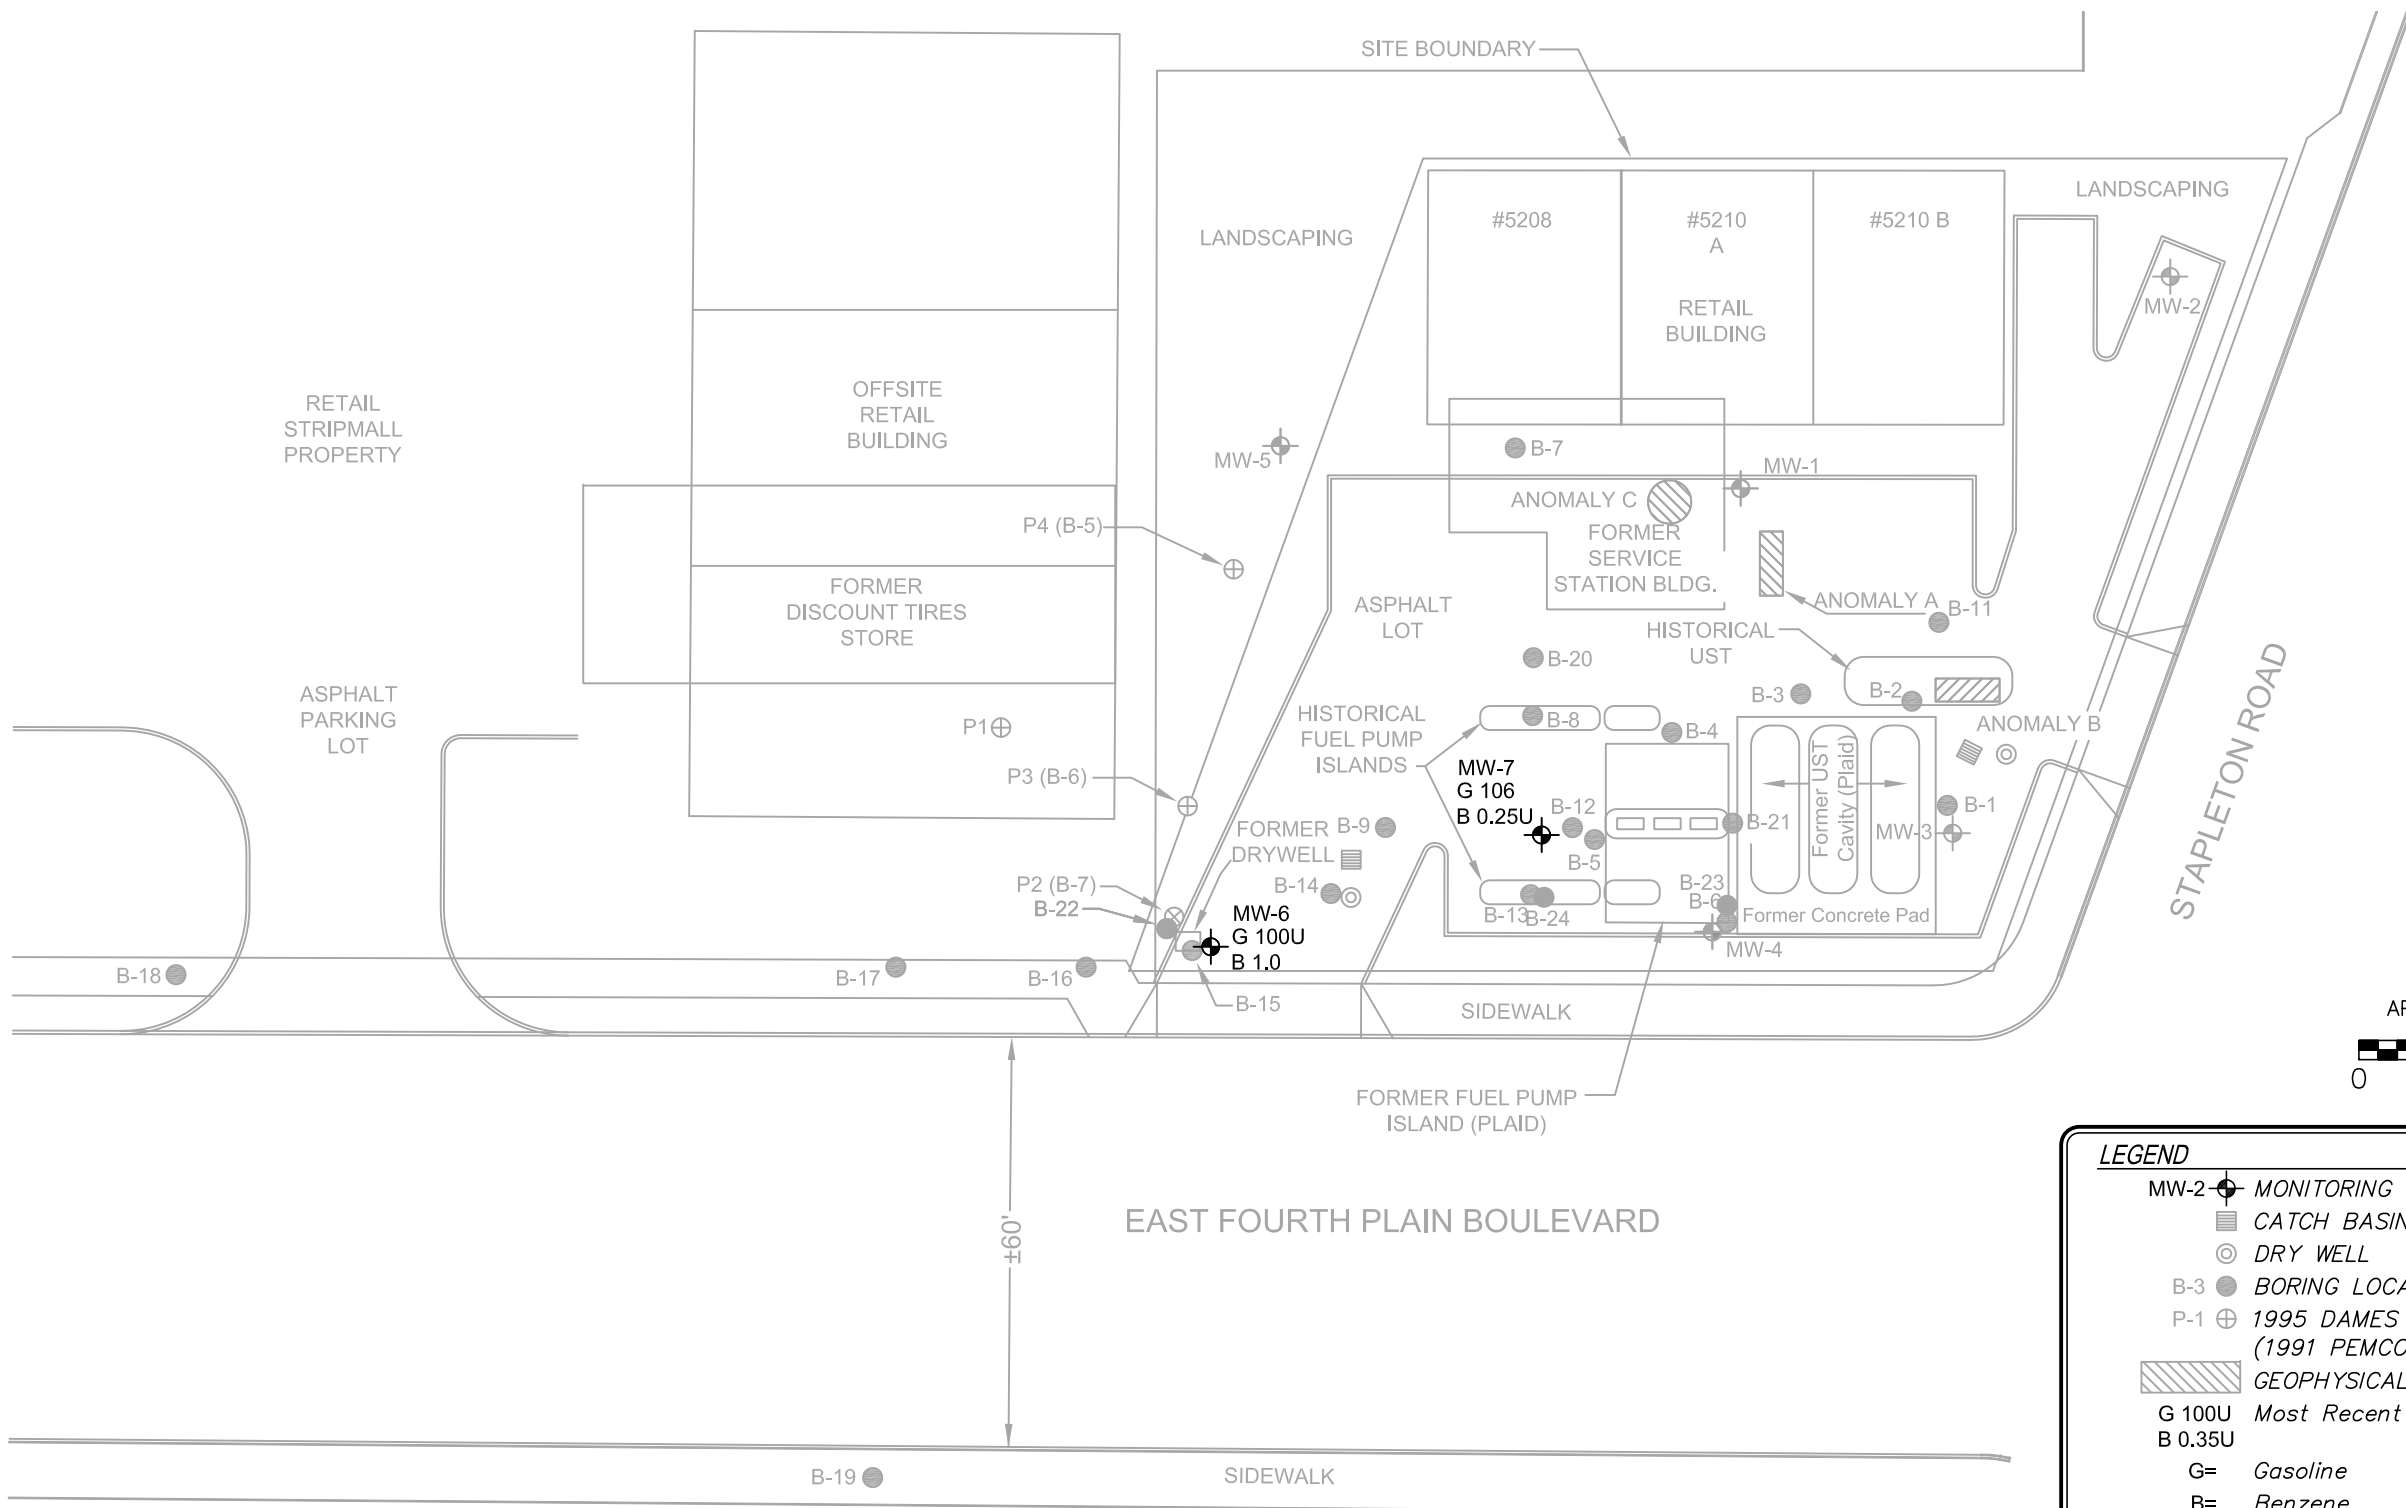
Groundwater analytical testing results are summarized in Table 4 and on Figure 8 for gasoline and benzene. The Apex Labs laboratory report is included in Attachment C.

Fuel hydrocarbons were not detected in the groundwater sample collected from monitoring well MW-6. A gasoline-range hydrocarbons concentration of 106 micrograms per liter was detected in monitoring well MW-7. This gasoline-range hydrocarbon concentration is well below the Ecology MTCA Method A groundwater cleanup level of 1,000 micrograms per liter. Use of this cleanup level is considered valid as benzene was not detected, and ethylbenzene, toluene,

Low levels of volatile gasoline constituents were detected in the groundwater samples collected from both monitoring well MW-6 and MW-7. Detected analytes included benzene, ethylbenzene, xylenes, 1,2,4-trimethylbenzene, 1,3,5-trimethylbenzene, and naphthalene. Detected concentrations are summarized in Table 4. None of the gasoline constituents detected in groundwater exceeded Ecology MTCA Method A groundwater cleanup levels.
