Technical Memorandum

To: Mark Conan
From: Paul Ecker LHG, and Chris Rhea
Date: 03-05-2013
Subject: Final Site Characterization Report and Request for No Further Action Determination
Plaid Pantries Store #23
Vancouver, Washington
Ecology Voluntary Cleanup Program File #SW1166
EES Project #E-839

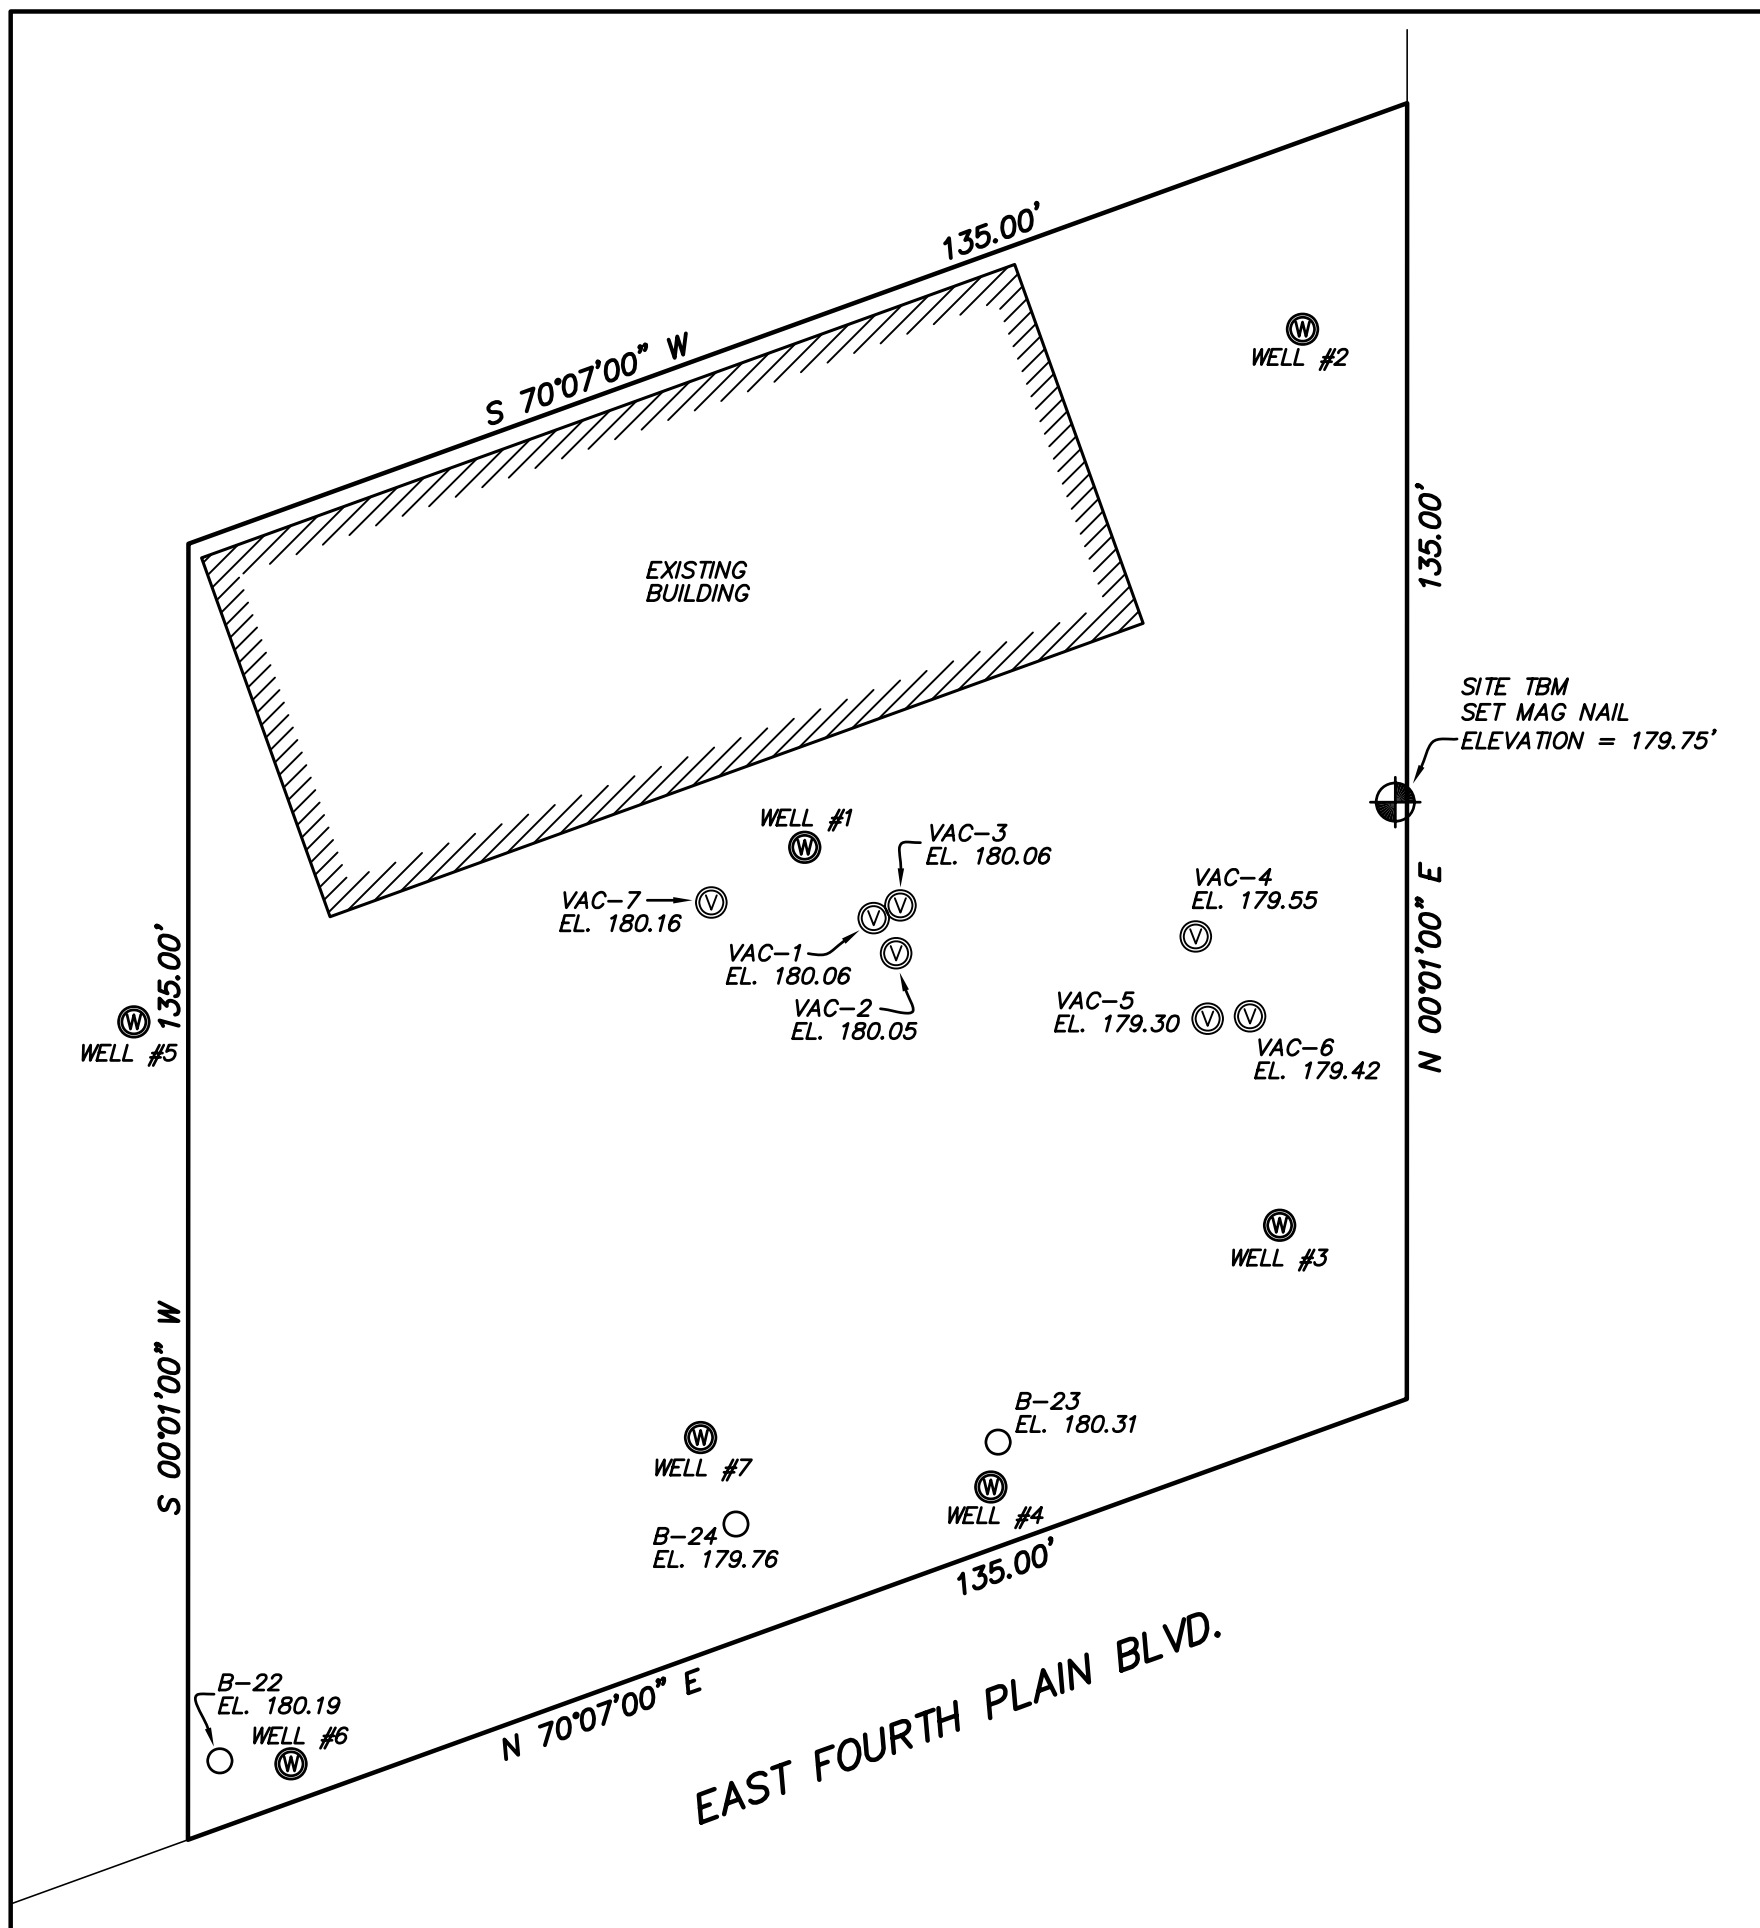
Wellhead Survey Map

In accordance with Ecology's request, Plaid's seven-well network was surveyed by Centerline Concepts Land Surveying, Inc., using a licensed Professional Land Surveyor. The survey verified well locations and top of casing elevations relative to mean sea level as referenced to a local USGS benchmark. A copy of Centerline's survey map is provided as Attachment D. Wellhead elevations are incorporated into the groundwater elevation data summary table (Table 2).
